# EFFECTIVENESS OF ASPHALT PENETRATING SEALERS IN EXTENDING NEW ASPHALT PAVEMENT LIFE

The Office of Pavement Engineering  
Ohio Department of Transportation

January 2017

1. Report No. FHWA/OH-2017/3	2. Government Accession No.	3. Recipient's Catalog No.	
4. Title and Subtitle Effectiveness of Asphalt Penetrating Sealers in Extending New Asphalt Pavement Life		5. Report Date January 2017

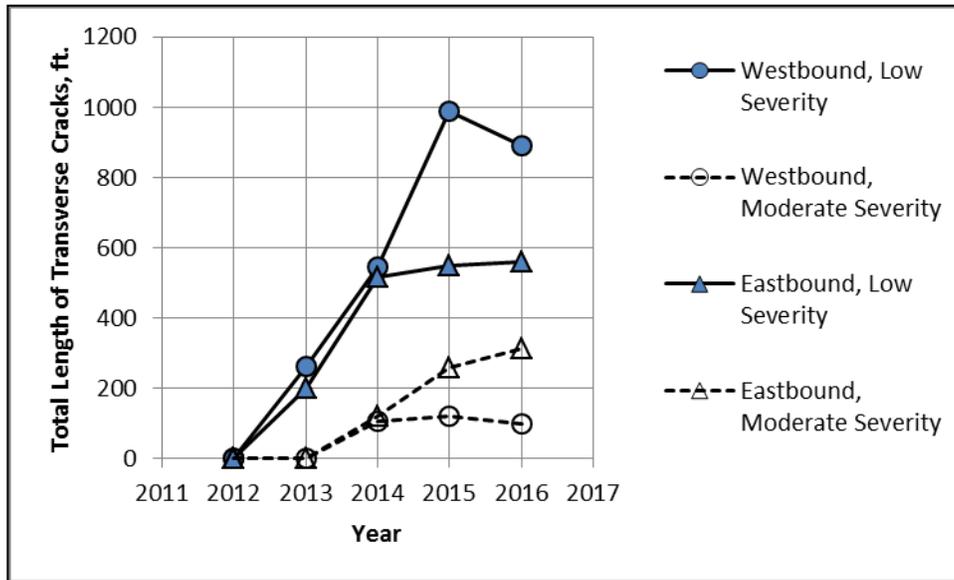
**Figure 33. Project US-40, Springfield: Growth of Transverse Crack Lengths within Monitoring Period for Control Sections**

The transverse cracks are reflection cracks from the underlying transverse joints and mid-slab cracks of the JPCP. Some of these cracks are relatively wide and exhibit adjacent cracking to the transverse crack and/or crack deterioration (see figures 25 and 28). Reflection cracks started to occur even before sealer application. Figure 33 shows the growth of total and moderate severity transverse crack lengths in the two control sections (one in the eastbound and one in the

In summary, transverse cracks (reflection cracks) are the predominant distress along all test sections. Longitudinal cracks along the longitudinal construction joints and localized, low severity raveling were also recorded. The following summarizes the differences between the ODOT and FHWA/LTPP distress surveys.

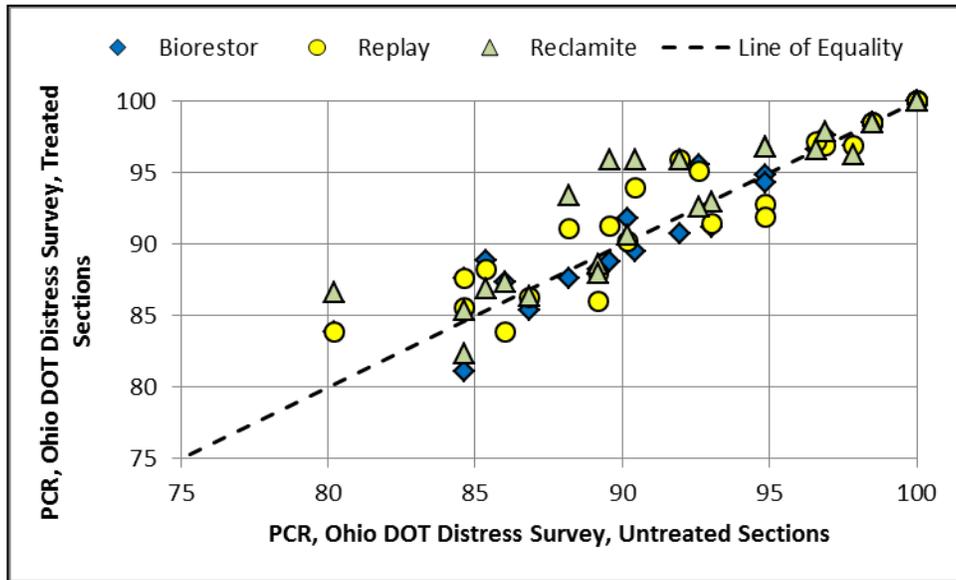
Figures 79 and 80 provide a comparison in the calculated PCR values between the control and treated sections using the ODOT and FHWA/LTPP distress surveys, respectively. As shown, there is no consistent or significant difference between the PCR values calculated for the control and treated sections from the ODOT distress surveys. Conversely, a small consistent difference was observed using the FHWA/LTPP distress surveys; the treated sections consistently exhibited a slightly higher PCR value (see figure 80).

**Figure 79. Comparison of PCR Values between Control and Treated Test Sections using the ODOT Distress Surveys**

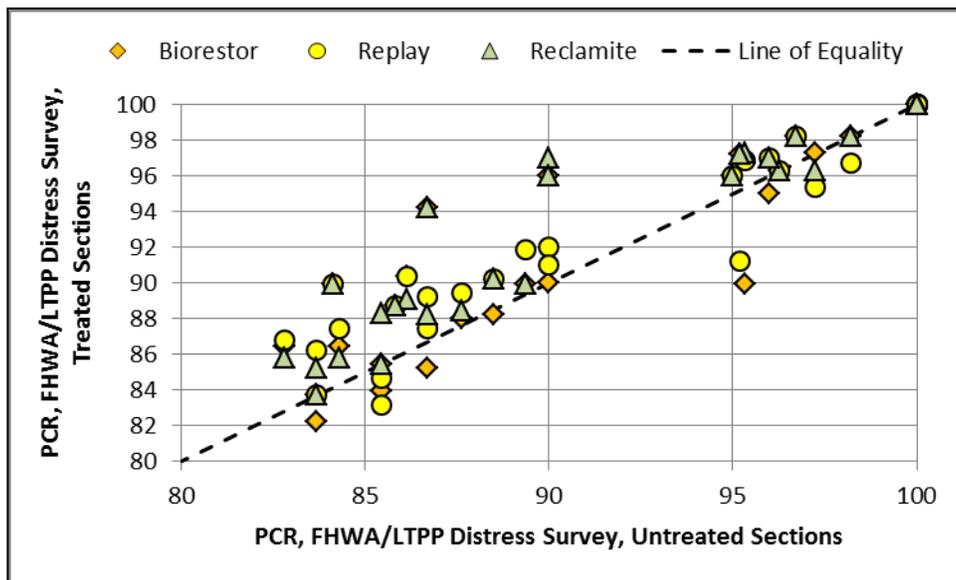
**Figure 80. Comparison of PCR Values between Control and Treated Test Sections using the FHWA/LTPP Distress Surveys**

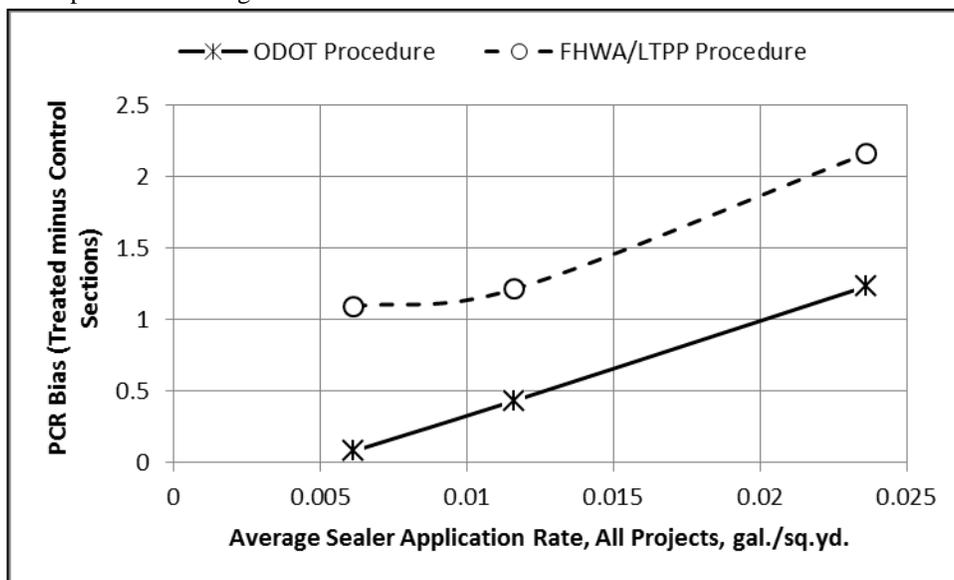
Table 20 summarizes the average residual error or bias and standard error between the control and treated sections for all projects. On the average, the treated sections had a slightly higher PCR value than the control sections and the difference was higher using the FHWA/LTPP distress surveys in comparison to ODOT distress surveys. The treated sections with Reclamite exhibited the greater difference from the control sections, followed by the Replay and Biorestor treated sections. Figure 81 shows the average bias in PCR values between the treated and control sections in comparison to the average sealer application rate. As shown, the higher the sealer application rate, the greater the difference or bias in PCR values between the treated and control sections.

**Figure 81. Average Bias or Difference in PCR Values between the Treated and Control Sections as Related to the Average Sealer Application Rate**

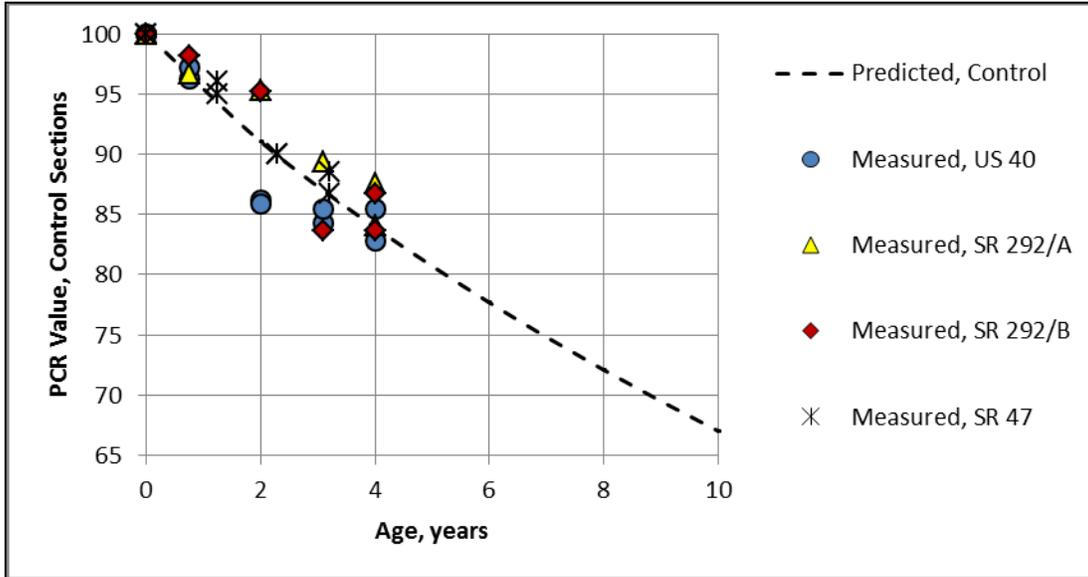
**Figure 82. Predicted PCR Value Compared to the Measured PCR Values using the FHWA/LTPP Distress Surveys for the Control Sections**

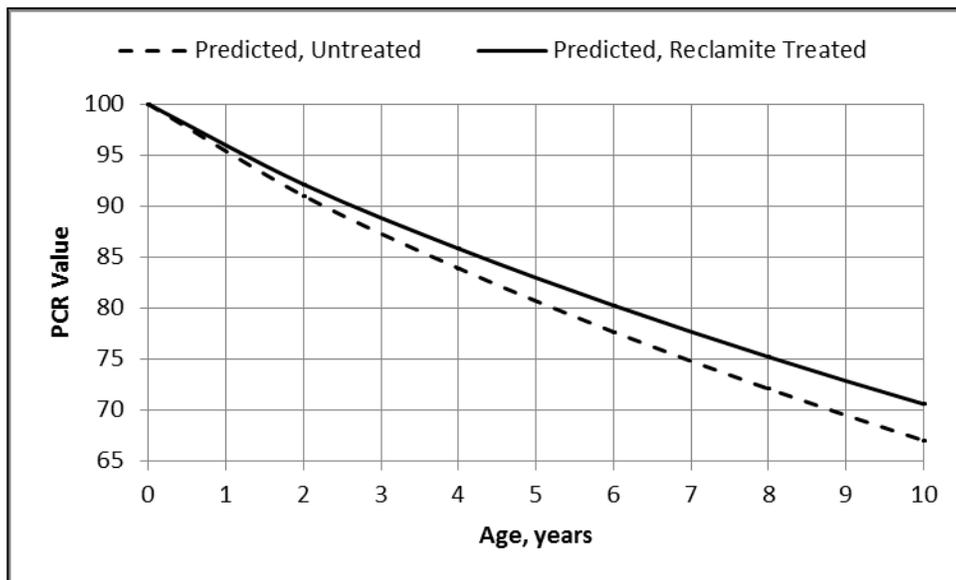
Equation 1 was used to predict the PCR values over time given an average 2 point PCR difference at 4 years for the Reclamite material (see table 20). The predicted PCR for the control surface in comparison to the treated surface is shown in figure 83. The extended service life for the treated sections is no more than one year for the bias of the Reclamite treated sections at a PCR terminal value of 75. A PCR of 75 was used to establish the difference in age between the treated and control sections, because that is the value used by ODOT between a pavement condition rating of good and fair (ODOT, 2006).

**Figure 83. Predicted PCR Value between the Reclamite and Control Surfaces (Based on a 2-Point PCR Difference, or Bias)**

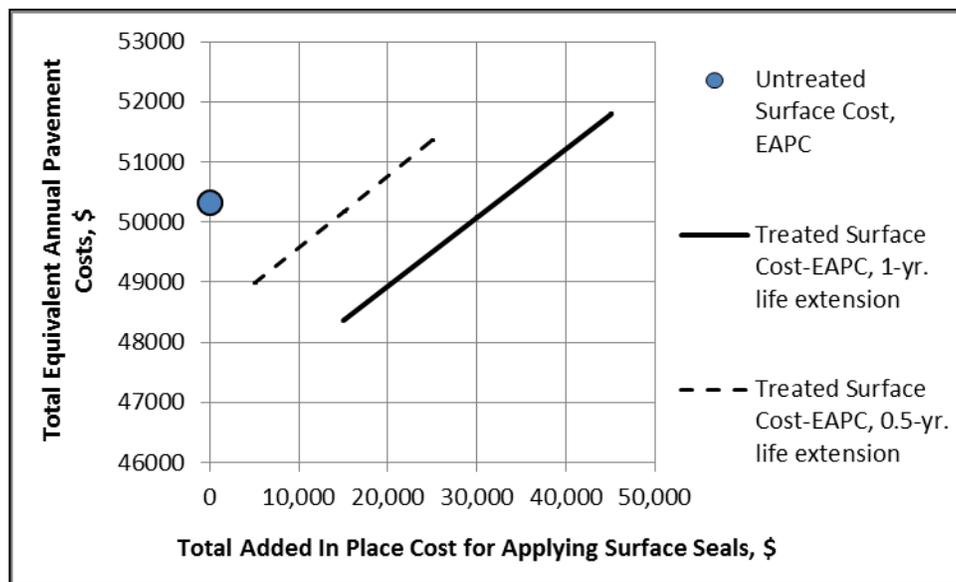
Figure 87 shows the EAPC for the example with and without a treated surface for a 0.5 year and 1-year life extension (see table 20 and figure 83). As shown, penetrating sealers are cost effective as long as the application cost is less than about \$15,000 for a 0.5-year life extension and about \$30,000 for a 1-year life extension. The cost to apply the penetrating sealer should include the material and application costs, traffic control costs, and skid resistance testing costs.

**Figure 87. Total Equivalent Annual Pavement Costs Calculated for Different Conditions between Treated and Untreated Surfaces**

increase in service life (see figure 87). The added cost needs to include all costs related to applying the sealer to the pavement surface: material and application costs, traffic control costs, and skid resistance testing costs, as a minimum.

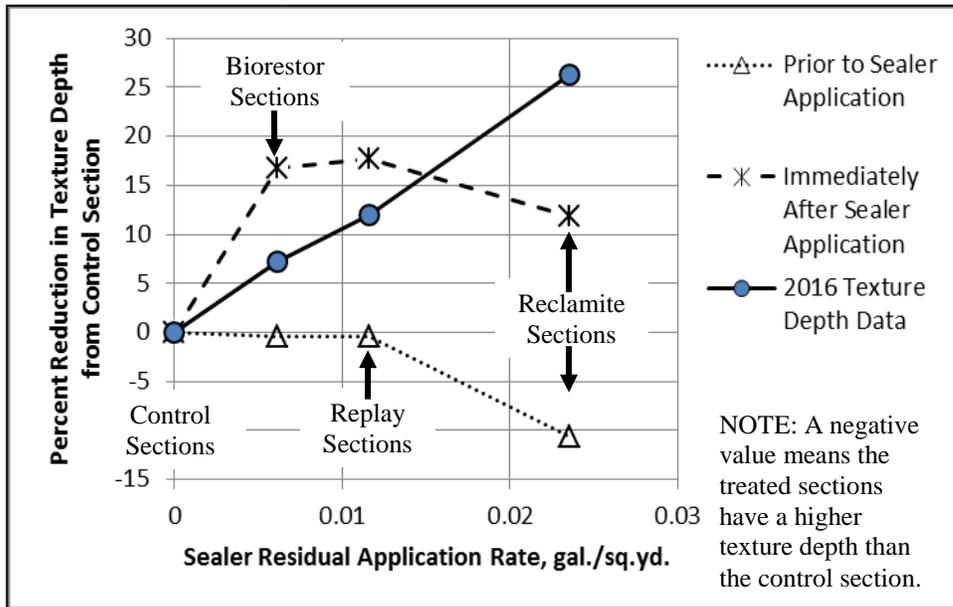
2. As noted in observation #5, texture depth significantly increased over time for all test sections (see figures 59 to 62). Immediately after sealer application, the wearing surface for the SR-292/B project had the greater texture depth and the SR-47 surface had the lower texture depth (see table 6). In 2016, however, the US-40 project exhibited the lower texture depth, while the SR-292/A project exhibited the higher texture depth for the control sections (see table 18). Figure 88 shows the average percentage change in texture depth between the treated and control sections for different points in time for all projects. As shown, the Reclamite surfaces with the higher residual application rates exhibit the greatest reduction in texture depth compared to the control section in 2016. The greatest reduction or difference from the control sections simply means the least change in texture depth over time.

**Figure 88. Percentage Reduction (Difference) in Texture Depth between the Treated and Control Surfaces Prior To, Immediately After, and in 2016**
