Alternative Stream Channel Maintenance at Bridge Crossings

February 2017

Final Report

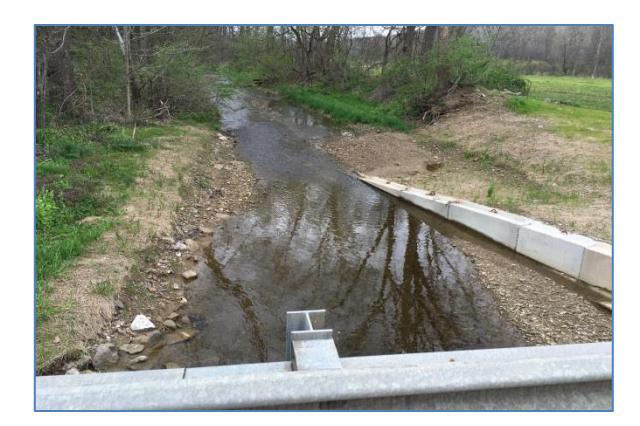
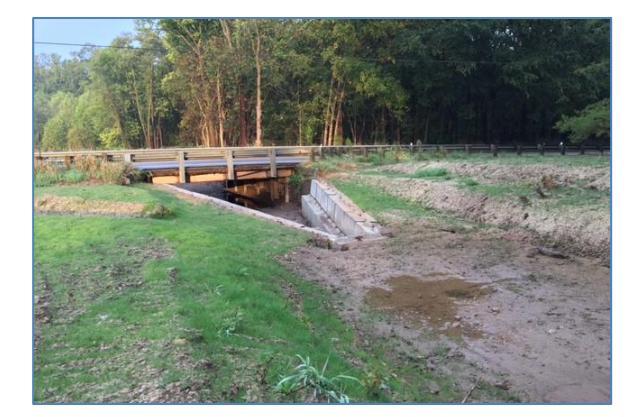
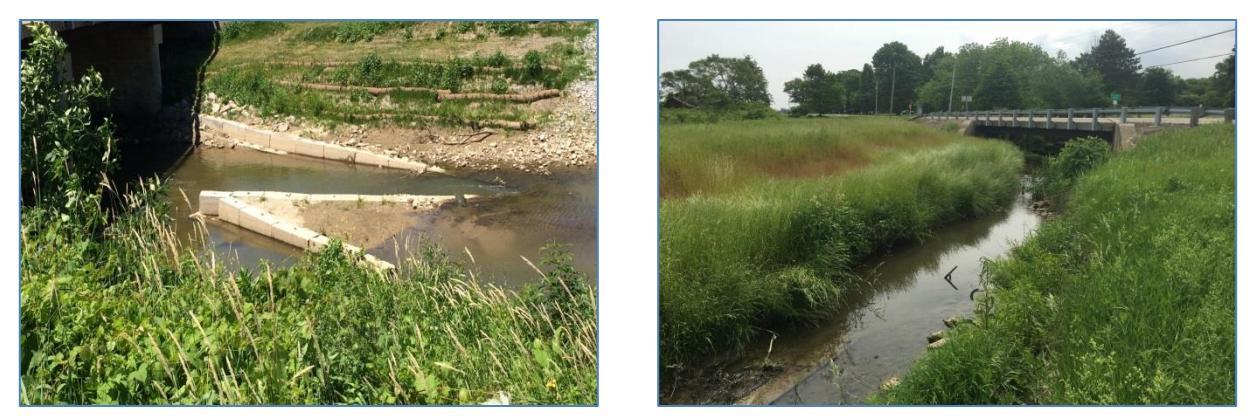
Figure 1. Examples of the natural channel design practices used in the research. Top left: Single-arm vane (WAY 083). Top right: Cross vane (ASD 603). Bottom left: W-weir (FUL 020). Bottom right: Two-stage channel (SAN 412).

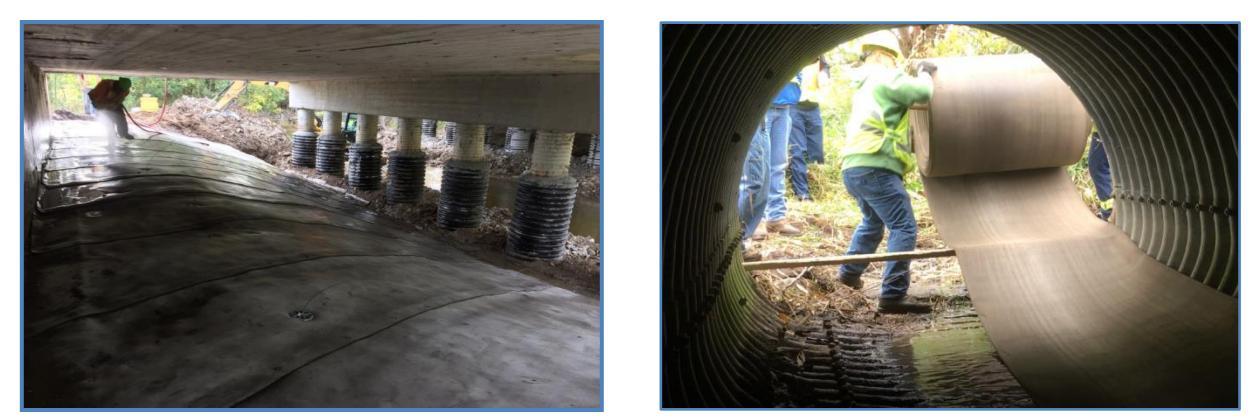
A number of new construction materials were trialed at several project sites including a flexible, concrete cloth material that is rolled out, anchored to soil, wetted, and left to cure in place. This material was used as an alternative to hand placement of rip-rap slope protection under a low-clearance bridge at OTT 579 0186 (Figure 3). Due to the ease of installation, the project team worked with Medina County to test installation and performance of the material in a culvert lining project at MED 224 near Beulah Road. The material was used to provide a durable wear surface for a heavily worn section of a corrugated metal pipe in an effort to extend the useful service life of the structure. Three additional culvert lining projects (two in the City of Canton and one in Butler County) were visited and evaluated to make an independent assessment of the performance of the material. At all locations the material appeared to be performing well and remained in place and functional with little signs of wear. However, none of the projects were much more than one year old and additional monitoring would be prudent. Additional details and photographs of the Medina and Butler County projects are provided in Appendix G.

Figure 3. Application of concrete cloth material. Left: Slope stabilization beneath a low clearance bridge(OTT 579). Right: Culvert lining project in Medina County (MED 224).

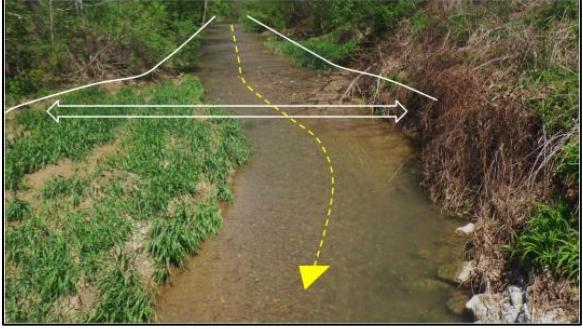
The site exhibits channel instability problems, including channel migration that is undermining the left bank wing wall and bar deposition reducing hydraulic capacity. This crossing has two spans, each 22 feet. The bridge is a 44 foot two-span concrete bridge with reinforced piles. The channel in the vicinity of the bridge had originally been constructed with a base width to match both spans. Regional curves of bankfull channel dimensions suggest a channel 25 to 26 feet wide. Measurements of stable reaches upstream with herbaceous vegetation are about 24 feet wide, close to a single 22 span of the bridge.

Figure 15 The channel in the vicinity of the bridge had originally been constructed much wider than the stable channel in the area.

The realigned channel utilized one span for low and intermediate flows and left the floodplain bar so that both spans would flow during high events, generally accessed only a few times annually to biannually.

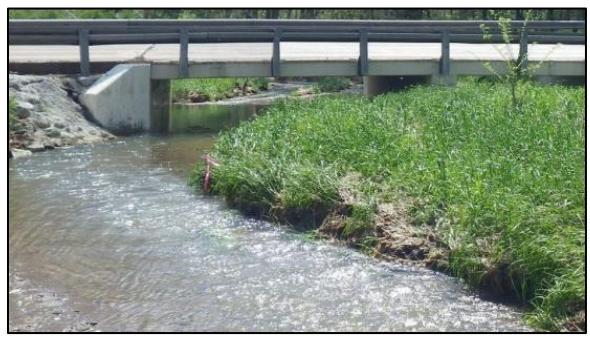
Figure 16 Poor channel alignment from a floodplain bar forming and driving bank erosion.

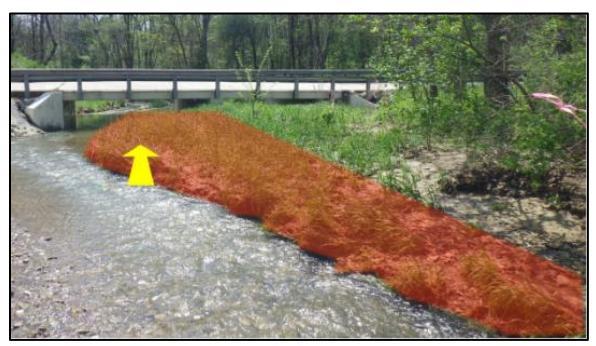
Figure 17 The highlighted portion of the floodplain bar was removed to align low and intermediate flows with one span. The second span provides hydraulic capacity for large events.

After the channel was realigned with the bridge, a block vane was used to prevent channel migration and to keep the channel in alignment with the bridge. Note that the downstream end of the vane touches the bridge abutment. Also, at the downstream end, where the vane is highest, an additional footer layer of block was placed to ensure the footer is below the maximum depth of scour. The bank opposite the vane is armored with buried riprap.

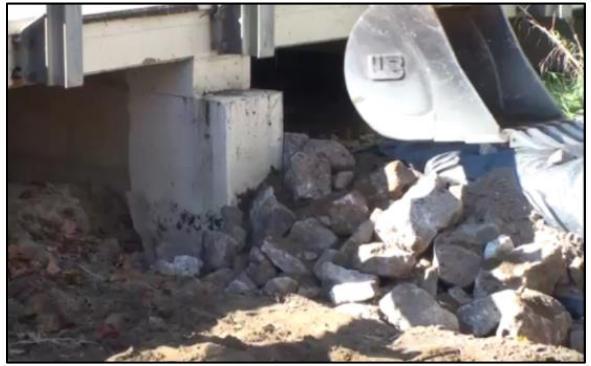
Figure 19 The bank opposite the vane was armored with buried riprap.

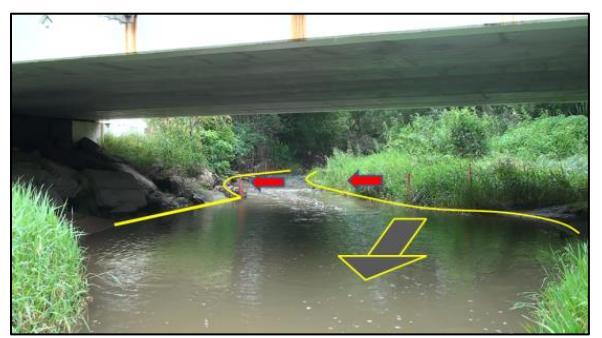
The channel alignment upstream was poor and causing scour at the right abutment/wing-wall. The meander pattern appears to have migrated down valley and, at one time, the channel upstream was over widened. It appeared that both the over-widening and meander pattern migration led to a bar forming off the left bank and bank erosion of the right bank.

Figure 23 Looking upstream the channel has migrated river right and a floodplain bar forming on river left.

A vane was installed along the right bank upstream of the bridge to re-align the flow with the bridge. Rather than abutting the wing wall, riprap was placed at the bridge abutment and wing wall and the vane begins about 20 feet upstream. The bar was not lowered and had only minimal grading at the point of the bar as required for construction of the vane and re-seeding.

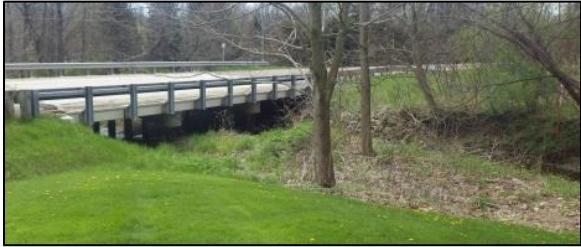
Channel alignment was poor upstream of the bridge. The channel was far to the right of center. The right bank was eroding and a bar had formed from the left bank across more than half the bridge opening. The bridge has 3 spans, with the middle span similar to the natural bankfull channel width; however, the channel formed around both sides of the right set of piers.

Three factors appear to have contributed to the existing problems. First, the channel had at one time been over widened in the approach to the bridge, prompting bar formation. Second, the channel meander pattern appears to have migrated down valley, perhaps aggravated by some fill placed up stream. And third, this stream, like others in the area, are known to have high bedload, as is evident from the prevalence of active bars of coarse gravel and cobble and lateral channel migration. Together, these factors have continued to drive the channel into the right bank, eroding it and causing the alignment to become worse.

Figure 28 The floodplain bar with trees growing on it viewed looking downstream from the left bank.

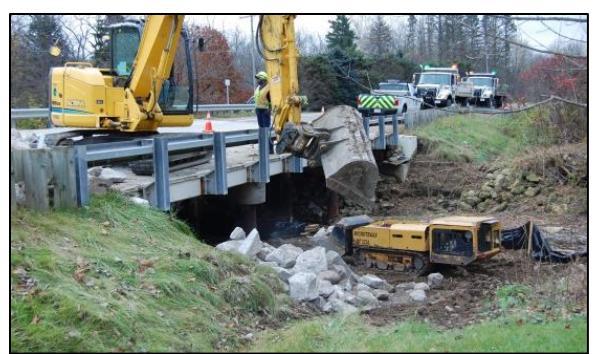
Figure 30 The remote control excavator removed sediment and placed rock under the bridge deck.

Work occurred in two phases, the first in 2014 when a remote control excavator was used under the bridge deck to remove sediment accumulations and place rip rap under both side spans.

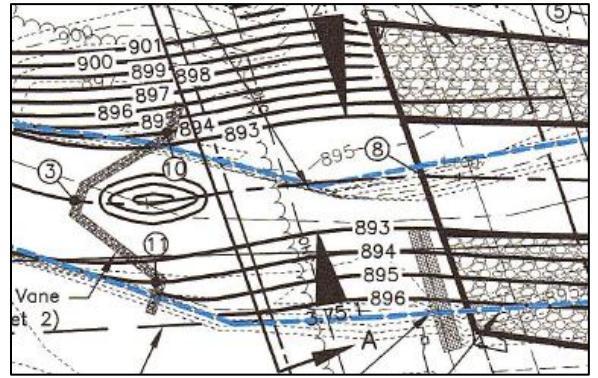
Figure 32 The construction plans. Note the narrow bed width between the vane and the bridge.

Shortly after construction, bed material started to accumulate upstream from the bridge, in the area where scour was intended to occur.

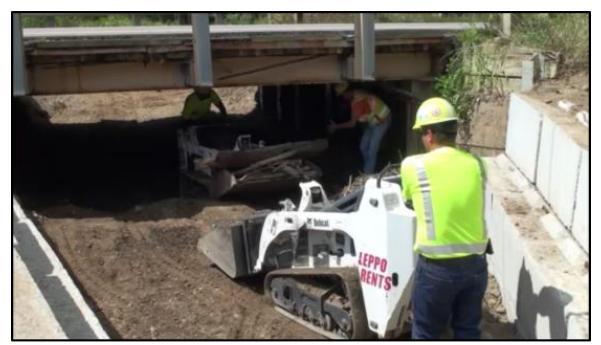
It was necessary to over-excavate under the deck to gain access with equipment. It is anticipated that the over-excavation will partially refill with bed material.

Figure 40 Over-excavating under the deck for access with equipment.

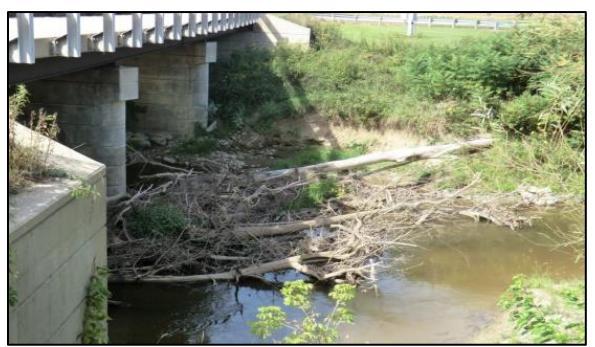
Debris collecting on one of the bridge piers had been an ongoing maintenance burden. The bridge consists of three spans and the width of the natural channel is about 1.5 times wider than each of the spans. The far right span has developed a floodplain bar and the channel is split between the center and left spans. Historic channelization (straightening and lowering) of this large (206 sq.mi.) river have made it prone to adjustments. Two abandon bridge abutments just upstream of this bridge have been sufficient to initiate some lateral migration.

Figure 43 Debris accumulation on the left pier and erosion on the right bank.

A w-weir was constructed to direct flow (and debris) around the pier and away from the eroding bank. Also, a floodplain bench was lowered and expanded through the right span.

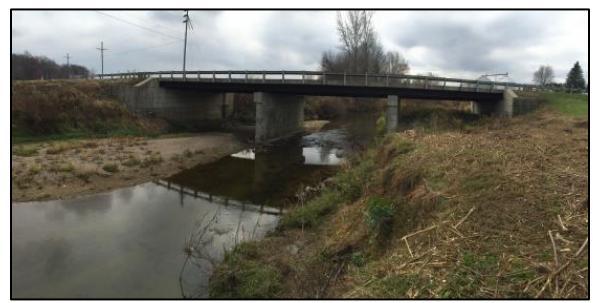
Figure 44 Viewed looking downstream, a low bar on left and a high depositional floodplain bar in the right span.

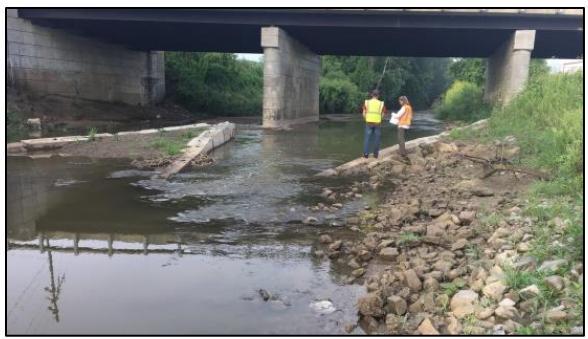
Figure 51 The structure after one season.

After one year, the structure appears to be functioning well with no debris accumulating on the pier. The block on the far left end has shifted and the left bar has scoured away. Maintenance may eventually be required on the left side of the channel if the low bar does not re-develop.

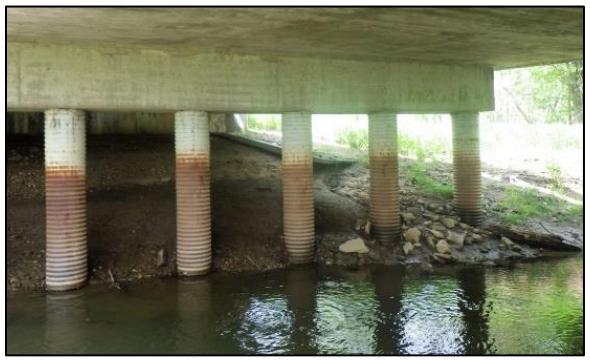
After bridge maintenance to repair badly corroded piers, the abutment slopes were re-stabilized. The abutment slopes were bare and had experienced some scour. Access was limited by low clearance under the bridge deck.

Figure 58 The left bank prior to construction.

Concrete cloth will be used as an alternative to the traditional technique of placing rock. Concrete cloth has the advantage of easy installation without requiring equipment.

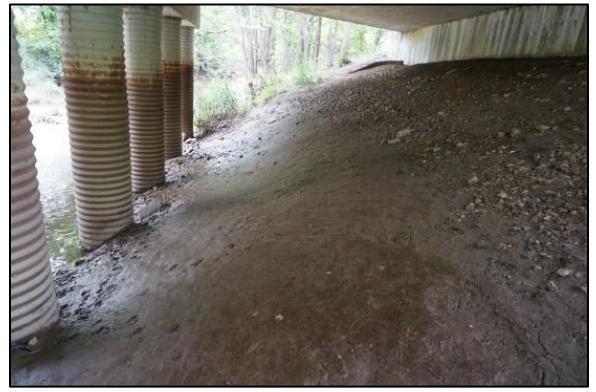
Figure 59 Exposed slopes prior to construction.

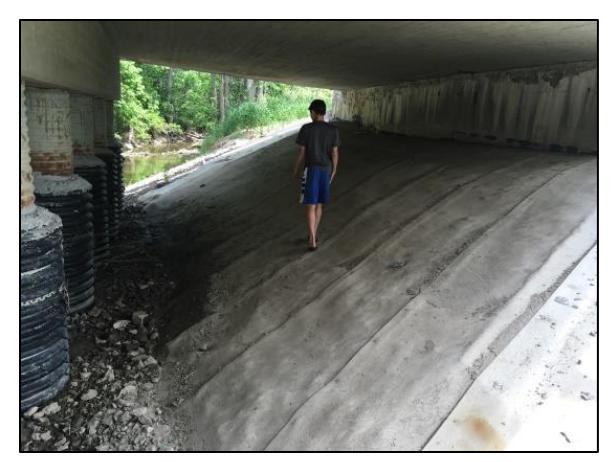
Construction was in October, 2015, and proceeded as anticipated, with hand labor and no machine access needed. After one season of high flows (winter/spring 2016), the material appears as it did when installed.

Figure 64 A season after construction.

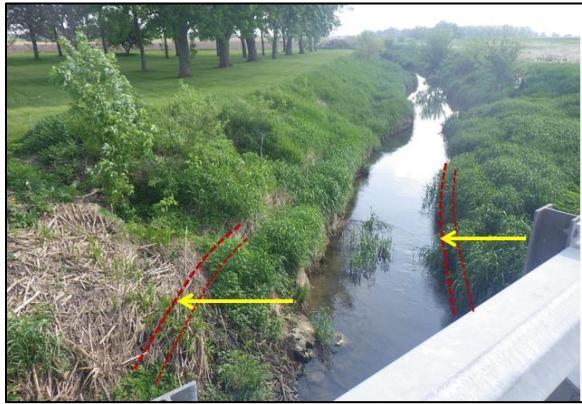
Figure 52 Looking upstream. Bar deposition and active bank erosion.

Past over widening of the channel in the vicinity of the bridge initiated the alignment problem. Within the widened sections upstream and down, a floodplain bar predictably formed, re-narrowing the channel against the opposite bank. Once initiated, the meander pattern has continued to develop and worsen the alignment. The right piers are now mid-channel and are obstructing flows and collecting debris.

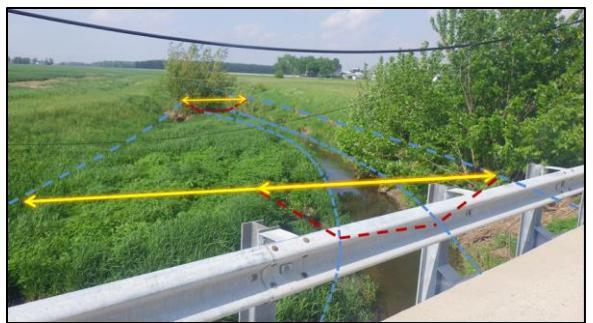
Figure 53 The additional width excavated at the bridge predictably lead to this asymmetric compound form.

One proposal is that the channel and bars be reconfigured with a compound cross sectional shape in proper alignment. When a cross section is constructed overly wide, a compound cross sectional form predictably develops on its' own. If it develops on its own, then the bar forms on one side and the channel is pushed into the opposite bank. So if a compound channel were constructed, it could be made to aligned with the bridge and be less prone maintenance problems.

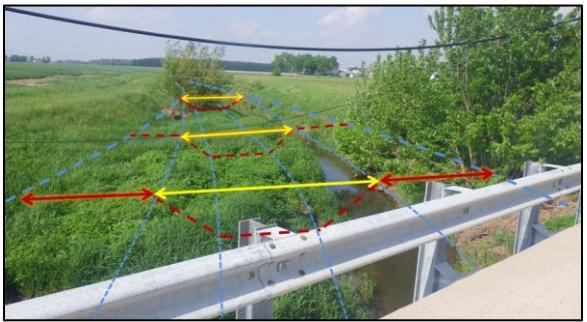
Figure 54 The constructed two-stage channel option.

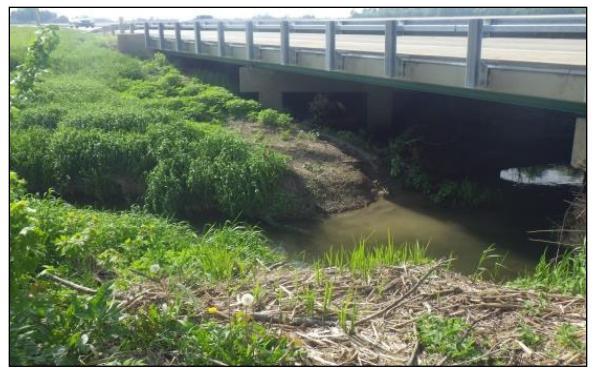
Figure 56 The location of a vane that would stop and scour the advancing point bar.

Another option for this site, that would require significantly less disturbance, is to simply construct a single vane upstream from the right pier and let the current adjust and maintain alignment. One advantage of vanes is that they influence the flow well upstream of the structure, adjusting the flow and providing bank protection 2 to 3 times longer than the structure itself. The structures long gradual affect would shift the current off the right bank and direct it through the middle span. This could be accomplished without additional earthwork, except as required to install the structure.

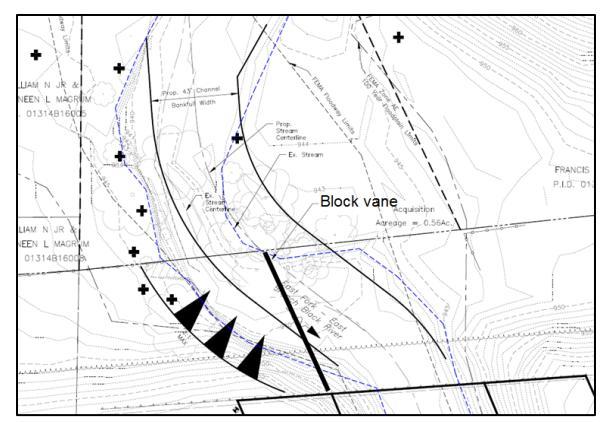
Figure 59 Plan upstream showing realigned channel and block vane.

The project proposes to realign the channel with the bridge. To keep the alignment, a block vane will be constructed at the right pier. The vane has an advantage over simply armoring the bank, in that the vane protects not just the bridge abutment and adjacent bank, but it also affects the flow farther upstream beyond the right-of-way.

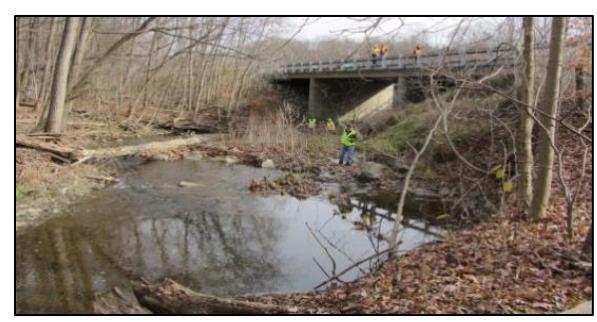
The problem is being caused by the downstream migration of the meander pattern. The meander upstream on the right side of the valley has moved down valley and is now eroding the road embankment just to the right of the bridge abutment. Fortunately, the second bend upstream does not appear to have moved as much or as rapidly and it is not crowding the problem bend.

Figure 60 Looking downstream at the section of channel to be moved left.

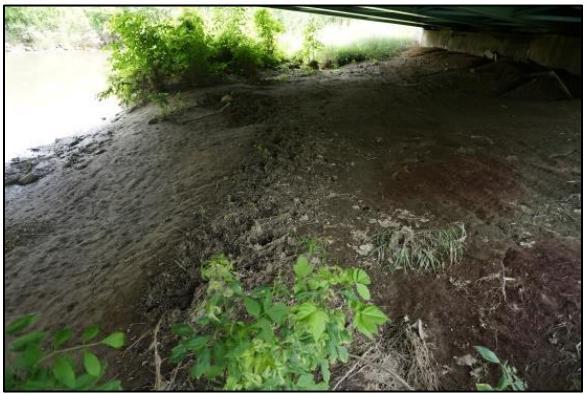
The abutment slopes under the deck were to be re-stabilized after structural maintenance to the bridge deck is done. The abutment slopes were exposed and had experienced some scour. Access was limited by low clearance under the bridge deck.

Figure 61 Exposed slopes under the deck.

Armoring the exposed slopes under the deck was to be achieved with Flexamat. The material was to be unrolled on one side of the bridge and pulled through the areas with low clearance.

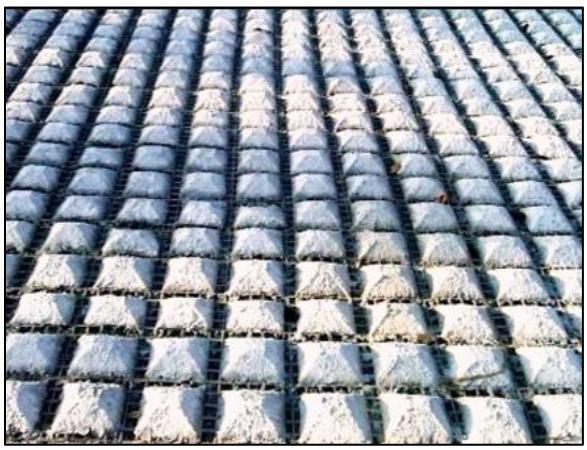
Figure 62 Flexamat.

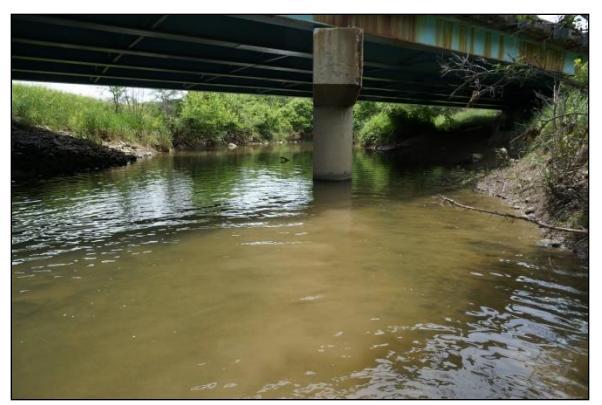
Also, the two-span bridge has a central pier mid-channel that is exposed to low and intermediate flows and prone to accumulating debris. This has reportedly not been a significant enough maintenance burden or structural threat to warrant construction of a w-weir to divert flow around the pier.

Figure 63 Looking downstream at the central pier.

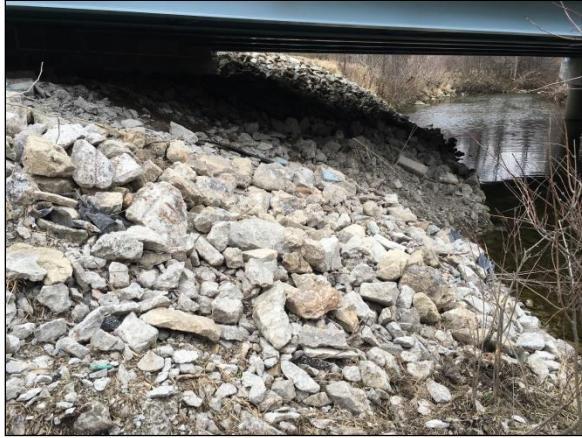
Figure 64 Concrete rubble placed instead of Flexamat.

Concrete rubble, made available from the bridge deck maintenance, was placed on the most exposed areas, negating the need for placing Flexamat.

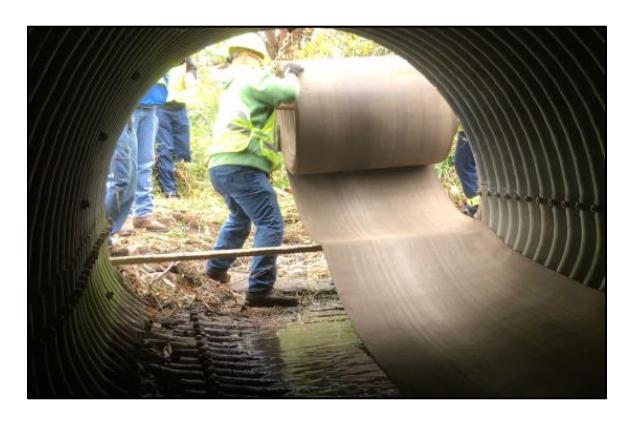
Figure 70 Concrete cloth pulled from the roll suspended from an excavator.

Concrete cloth was used to cover the most corroded section of the CMP, 50 feet of length from the upstream end and about 8.5 feet of the bottom and up the sides. It was also used to repair the transition from the headwall to the CMP.

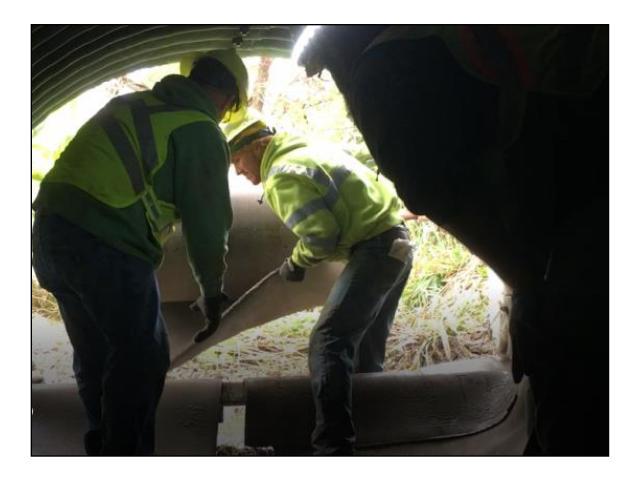
Figure 5 The last of three 55 foot lengths of material installed longitudinally.

The concrete cloth can be oriented longitudinally or transversely. Both methods have been used in culvert lining applications. For this project, the concrete cloth was installed longitudinally. Transverse installation has the advantage of using short sections that can be carried by hand and can be cut to the

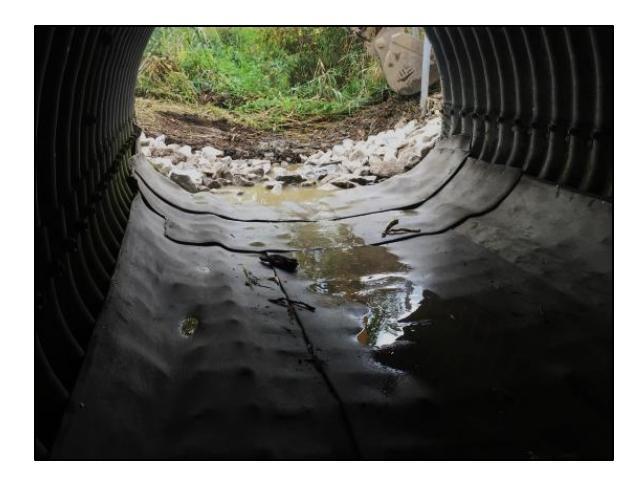
This project is expected to stop piping around the CMP and abrasion from sediment. Hopefully, it will also reduce, or at least slow, further corrosion. Under the concrete cloth the CMP will still experience wetting but perhaps with less oxidation. Sealing the top edge of the concrete cloth against the CMP, has been discussed as a strategy to reduce oxidation further. However, sealing the top edge has not been done. A procedure for monitoring the CMP's integrity, where it is now covered by the concrete cloth, will need to be developed.

Figure 8 The completed project.

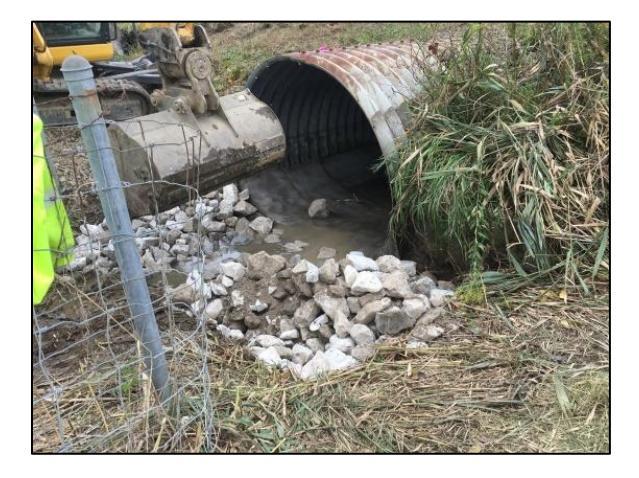
Figure 9 The completed project.

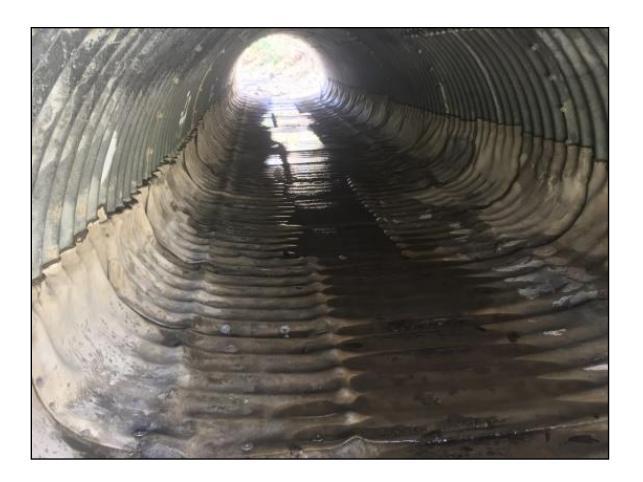
The CMP is corroded along the bottom of the pipe. Concrete cloth was placed in transverse lengths starting at the downstream.

Figure 710 Concrete cloth installed.

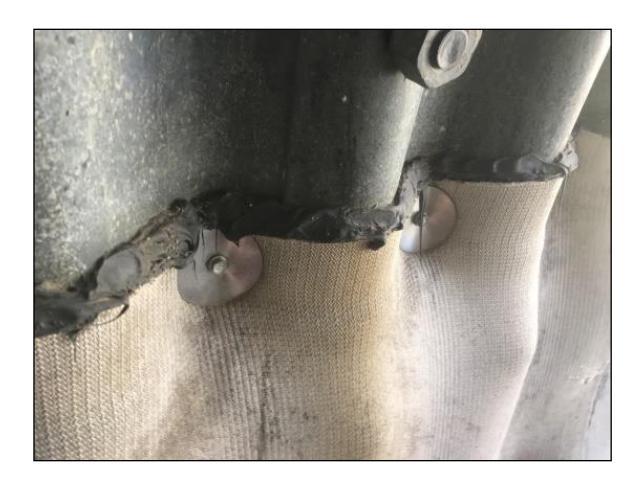
Figure 12 The edges of the concrete cloth sealed to the CMP.

The concrete cloth can be oriented longitudinally or transversely. Both methods have been used in different culvert lining applications. For this project, the concrete cloth was installed transversely. Advantages of longitudinal installation are that it requires fewer seams and relies, not on each joint for strength, but on the tensile strength of the material. Transverse installation has the advantage of using short sections that can be carried by hand and the material can be cut to the width of coverage needed. The shorter sections are also easier to work into the pipe corrugations and create seal along the edges.

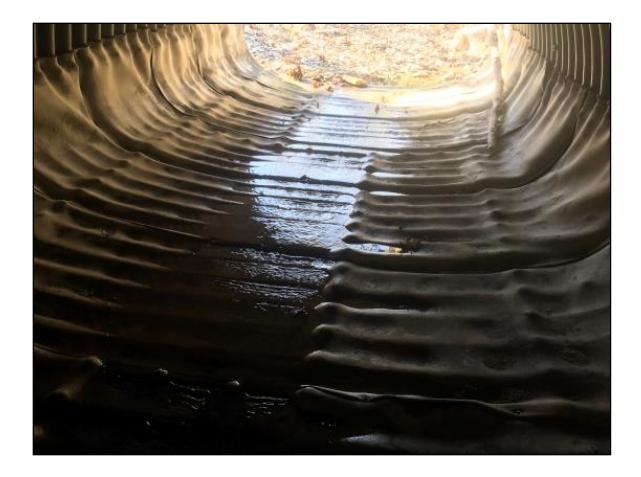
The pipe and concrete cloth appeared to be stable and functioning as intended. Some minor abrasion of the surface fabric of the concrete cloth was evident where the bolts that fasten together sections of the CMP protrude and cause a bump in the concrete cloth. The cloth's concrete interior was not perceptibly worn.

Figure 14 Completed project viewed looking upstream.

A procedure for monitoring of the integrity of the CMP, covered by the concrete cloth, will need to be developed.

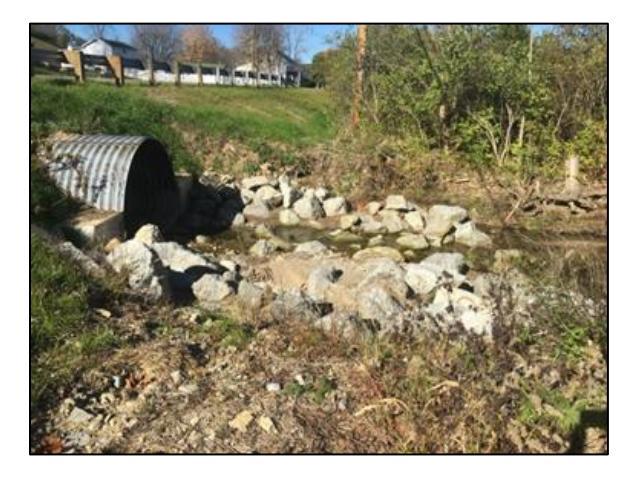
Figure 15 Downstream.
