ULTRASONIC IMAGING FOR CONCRETE INFRASTRUCTURE CONDITION ASSESSMENT AND QUALITY ASSURANCE

Research Report No. FHWA-ICT-17-007

A report of the findings of
ICT PROJECT R27-146
Ultrasonic Imaging for Concrete Infrastructure
Condition Assessment and Quality Assurance

Illinois Center for Transportation
April 2017

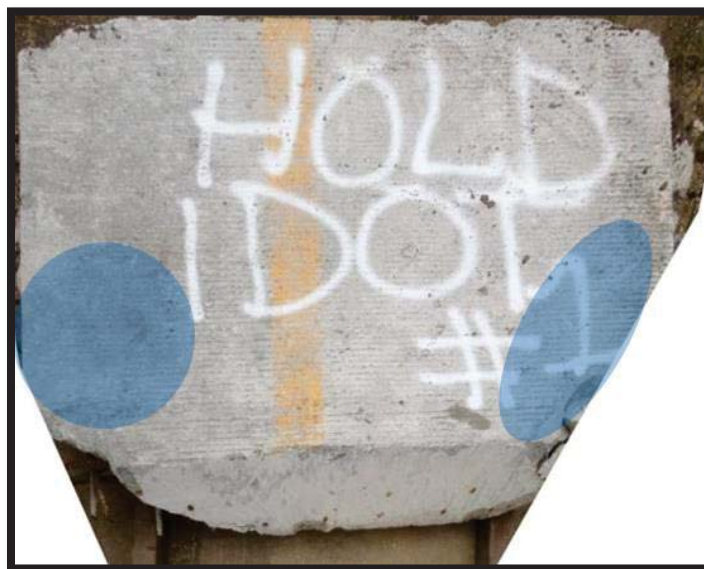
Each slab was inspected visually and with traditional chain sounding methods. Pictures of each slab are presented in Figures 37 through 39. For each slab, regions of significant sounding delamination interest are indicated in the figures with a blue highlight.

Figure 37: Sounding delamination results (highlighted in blue) for IDOT deck specimen Slab 1.

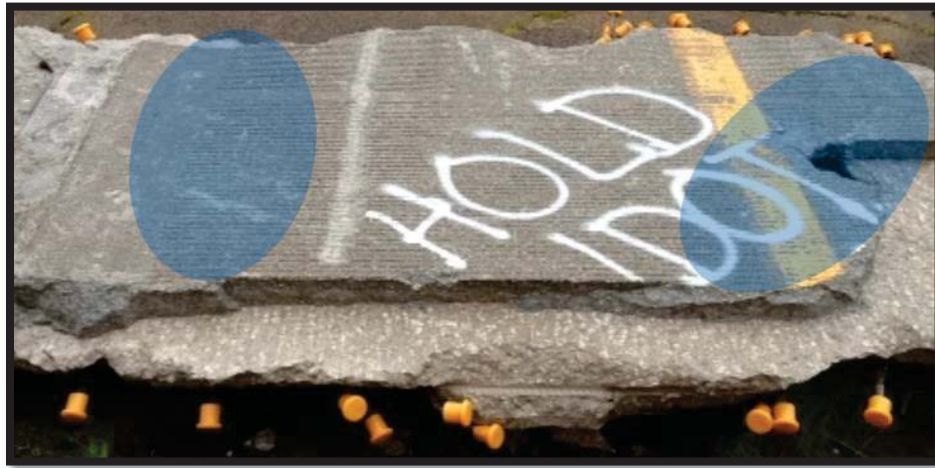
Figure 38: Sounding delamination results (highlighted in blue) for IDOT deck specimen Slab 2.

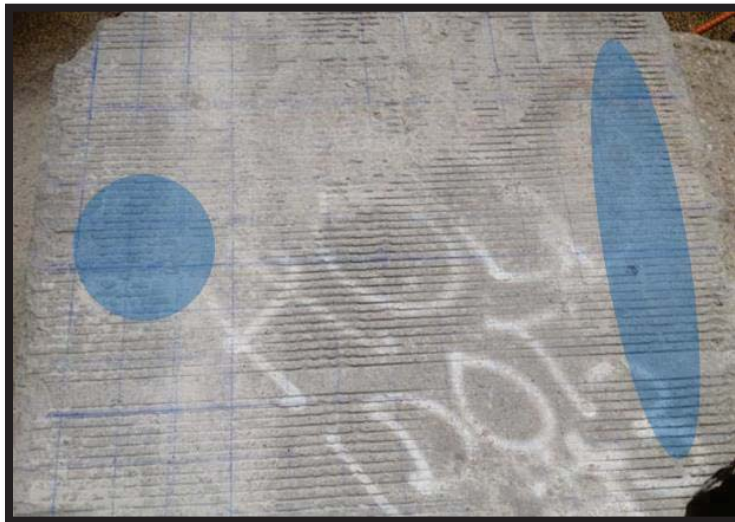
Figure 39: Sounding delamination results (highlighted in blue) for IDOT deck specimen Slab 3.

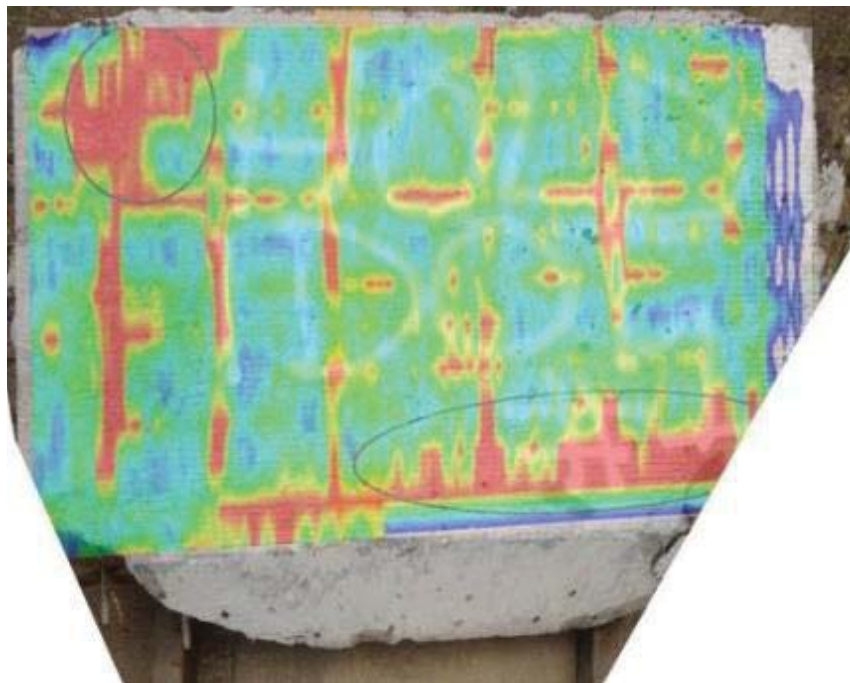
The ultrasonic map images generated by the MIRA platform are plotted as an overlay to the photographs of each slab in Figures 40 through 42. In general, most of the areas identified through sounding was also confirmed through the ultrasonic map images. In Slabs 1 and 3, a region that was identified with sounding was not observed as a reflection in the contour plots. Additionally, one region in Slab 1 was identified by ultrasonic inspection that was not identified by sounding.

Figure 40: Map scan of delamination reflectors from 0 to 160 mm (0 to 6 in.) in Slab 1 transposed on top of a plan view photograph.

The failure of delamination identification by ultrasonic inspection on the left side of Slab 3 suggests that the interpolation or configuration may play a role in the effectiveness of ultrasonic inspection on delaminations. The delamination on Slab 1 not captured by ultrasonic inspection may be the result of edge effects of the discrete sample causing an audible sounding difference.

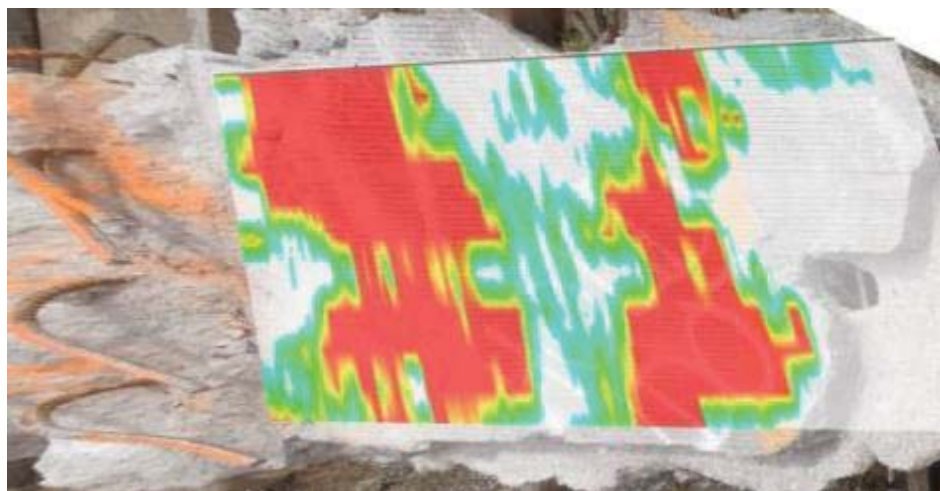
Figure 41: MIRA results plan view sliced from 0 to 160 mm (0 to 6 in.) for IDOT field bridge Slab 2.

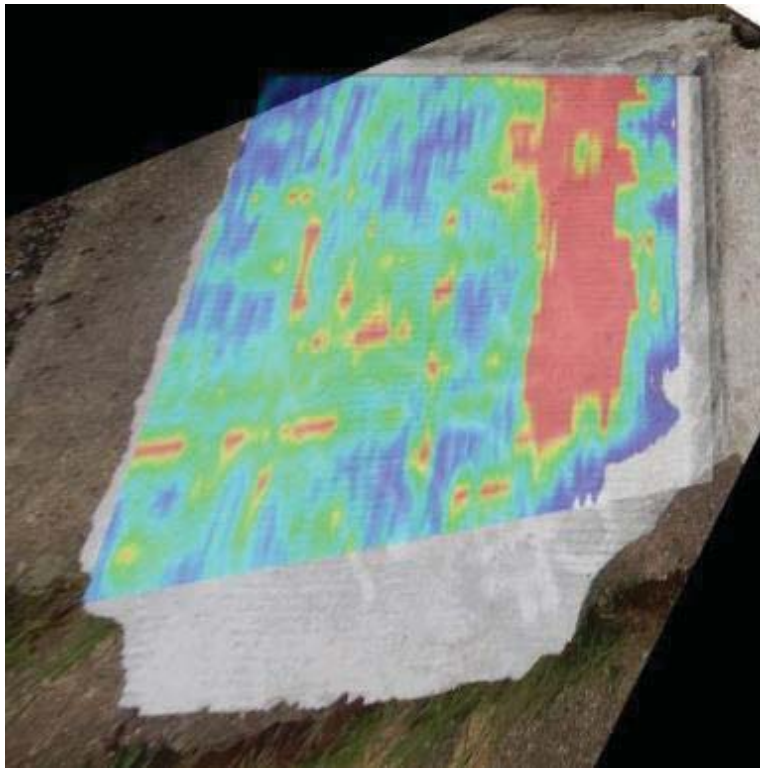
Figure 42: MIRA results plan view sliced from 0 to 150 mm (0 to 5.9 in.) for IDOT field bridge Slab 3.

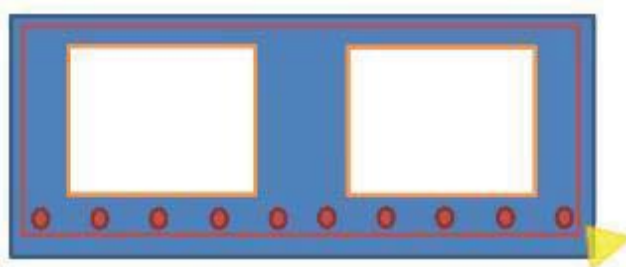
Visual Observations: Box girders (Figure 47) display corrosion product staining, exposed stirrups and localized spalling of stirrup cover concrete. Damage was focused along bridge centerline and edge of each of the two lanes, concentrated at points distanced approximately 1.5 m (5 ft) longitudinally along each box girder. Water appeared to have seeped down the girder and penetrated the cover at the bottom corner of the suspended girder. Safety support girders were in place to provide additional support. Additional effort was needed to locate scan areas that were exposed, damaged and within reach of the operators. Future tests of bridge girders will require the assistance of a bucket truck for access. Assumed girder profile as drawn, with corrosion location highlighted by a yellow triangle.

Figure 47: Simplified double box girder cross section. Yellow triangle denotes common area where corrosion products were observed.

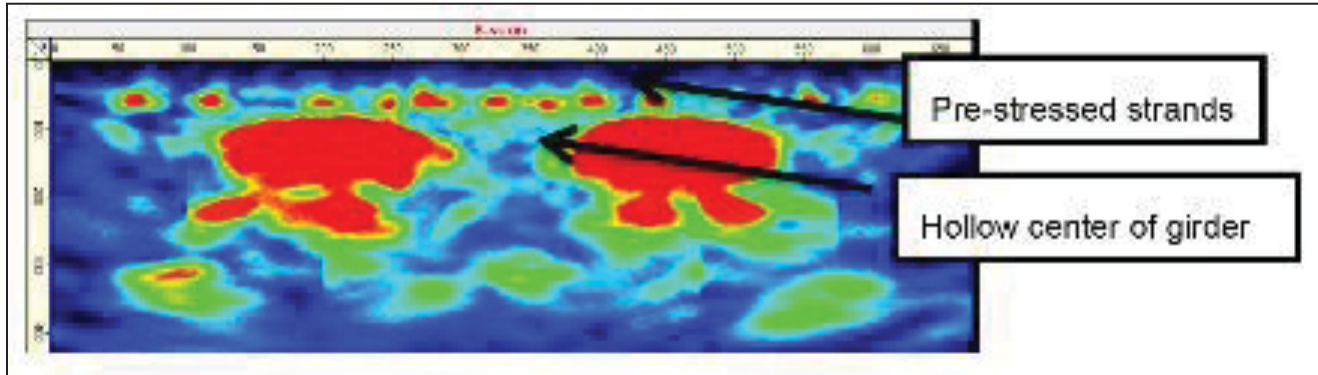
Results: The first set of scans (Figures 48 and 49) present a map profile box girder with no visual signs of corrosion. Figure 48 shows the encased strands, voided box area, and intact concrete middle web. Figure 49 displays the continuous void and the confining reinforcement present when scanned

Figure 48: Double box girder scanned from bottom. Orientation perpendicular to bridge traffic flow, no visual signs of corrosion. Units of the plot are in millimeters, 1 in. = 25.4 mm.

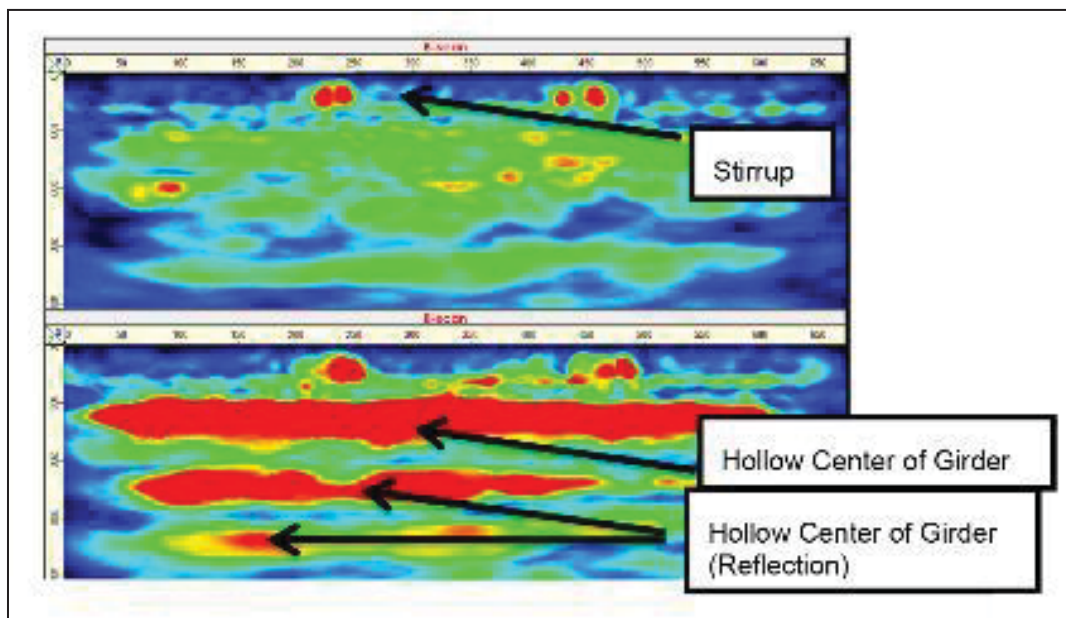
Figure 49: Double box girder scanned from bottom. Orientation parallel to bridge traffic flow, no visual signs of corrosion. Aligned parallel to box girder web (top); aligned parallel to box girder void (bottom). No visual signs of corrosion. Units of the plot are in millimeters, 1 in. = 25.4 mm.

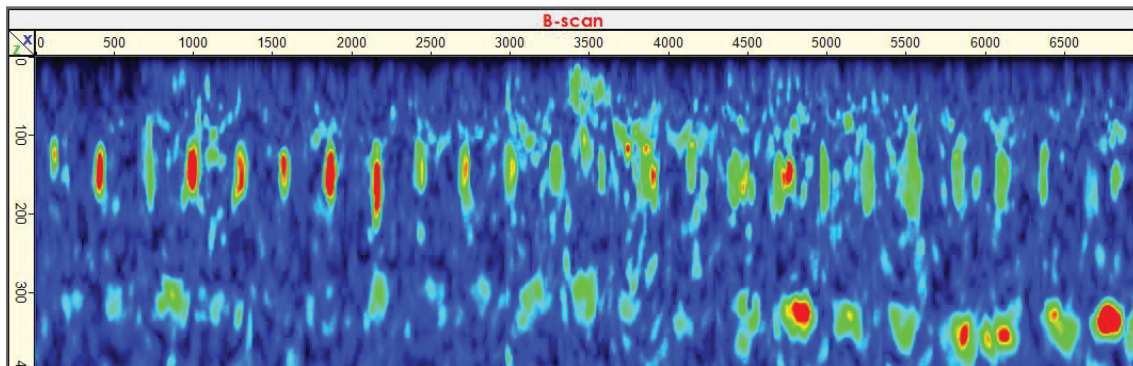
Results: The results for the three acceptable joints are presented in Figures 57 through 62. To identify a joint position, the depth should be read from the centroid of the reflector. The west side of Joint 1 (Figure 58) had significant dust on the surface from being recently saw-cut. The cement dust significantly decreased the amount of energy penetrating into the slab. As a result, the reflections in some portions of the images were noticeably decreased. Figure 59 shows a scan on a relatively early-age concrete slab at location Joint 9, which was only a single lane wide. The reflectors around the rebar were noticeably increased. On the other side of the same joint (Figure 60), the reflections from the scattering in the early-age concrete made dowel bar identification impossible.

Figure 58: Joint 1, west side. Units of the plot are in millimeters, 1 in. = 25.4 mm.

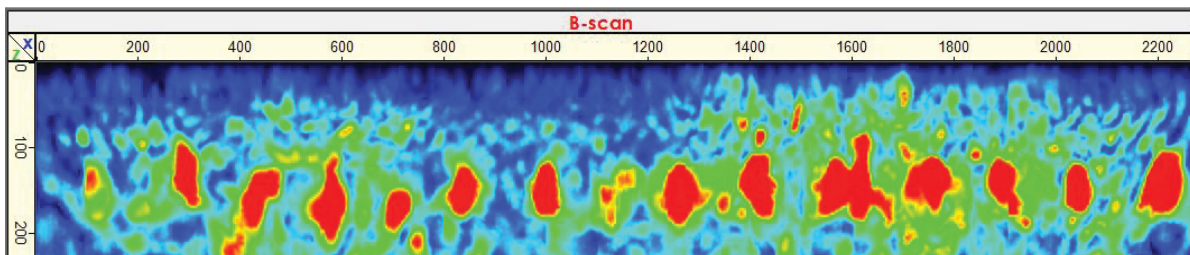
Figure 59: Joint 9, east side (only 2 days old). Units of the plot are in millimeters, 1 in. = 25.4 mm.

Another critical observation from this trip was the importance of concrete age for inspection. The early age (2 days after casting) of the concrete material around Joint 9 caused non-structural reflection noise. The pavement still exhibits significant plastic behaviors at a small energy scale. The increased random noise in the resulting images obscured the ability to identify dowels or the thickness of the slab. This poor early behavior can be expected and should be used when planning ideal inspection windows in project scheduling. Based on the results observed in this study, a minimum age of 1 week should be required before testing with the ultrasonic shear wave imaging device.

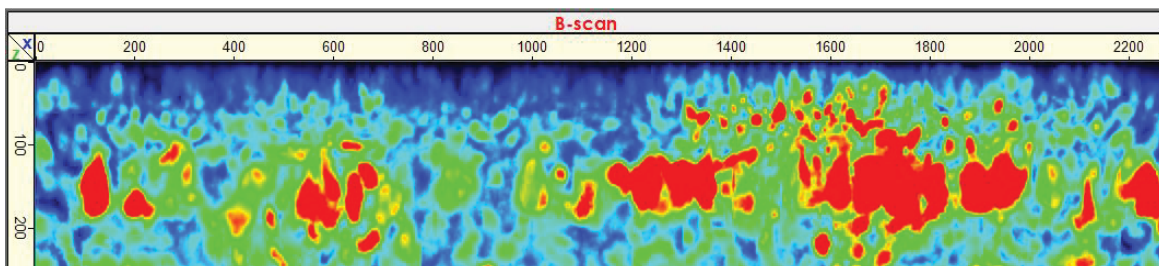
Figure 60: Joint 9, west side (only 2 days old). Units of the plot are in millimeters, 1 in. = 25.4 mm.

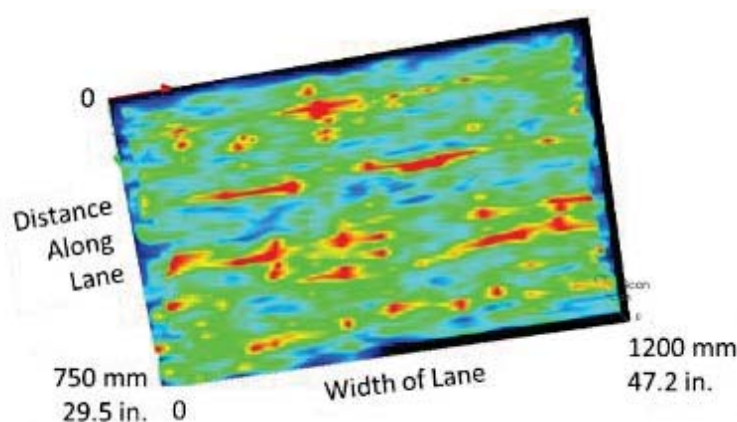
During initial MIT scanning, Joint 26 was identified as lacking any indication of dowels. On the basis of a site visit, some debate existed about whether the MIT experienced interference or whether the contractor had not inserted dowels. The team performed a map scan (Figure 63) and confirmed the MIT scan's findings that the joint lacked any dowels.

Figure 63: Joint 26, map scan results displayed as a plan view over the joint area.

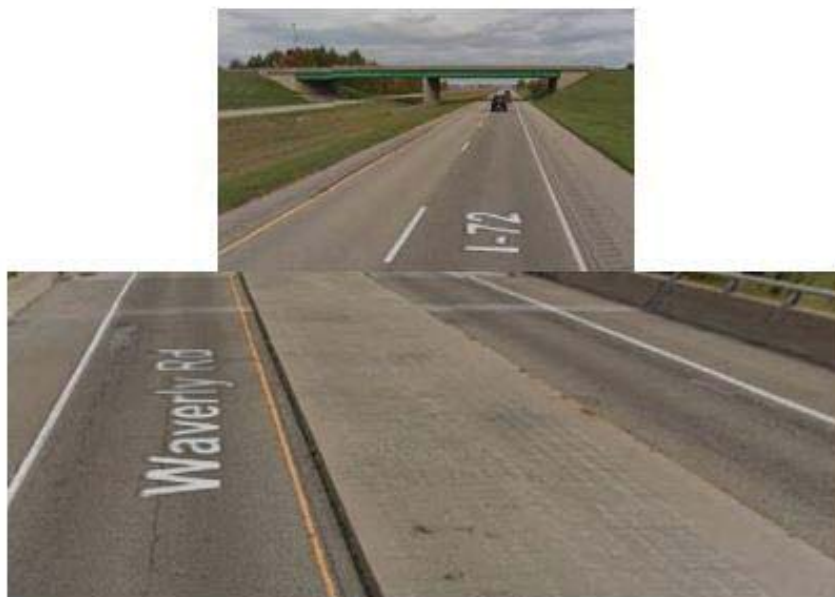
Visual Observations: The structure is a four-lane bridge with center curb median, approximately 50 to 75 mm (2 to 3 in.) of asphalt over a 203 mm (8 in.) concrete deck supported by steel girders. The bridge span is across a four-lane divided interstate with a center pier in the median (as pictured in Figure 65). Northbound lanes had asphalt disintegration between lanes of traffic localized to 3048 mm (10 ft) long approximately 3962 mm (13 ft) north of the southern edge of the deck. Figure 64 provides photos before work began, as captured in 2013 by Google Images. Areas of deterioration are visible along the white line on the northbound and southbound lanes.

Figure 64: Bridge profile (top right), deck view midspan looking south in northbound lane with expansion joint visible (bottom).

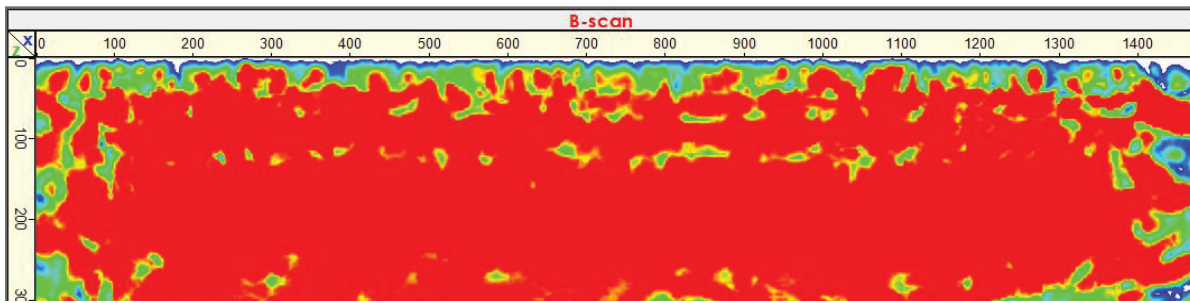
A map mode scan was captured on the southbound lanes to identify the recently patched region of the deck. The images produced by the standard Ideals software package that comes with the MIRA unit are presented in Figures 65 through 67. Owing to the significant roughness caused by the milling operation, the device was unable to automatically determine a consistent wave velocity. Independent processing with the free OpenSAFT MATLAB software allowed for a static velocity to be defined in the existing scan in post-processing. The adjusted B-scan image shown in Figure 67 is represented in Figure 68. The concrete patched area was anticipated to have distinctly different material properties than the original concrete deck. In the collected image, no distinct reflector of the patched area was observed.

Figure 67: Topside of southbound lanes after milling exposed concrete (perpendicular to top traffic flow). Units of the plot are in millimeters, 1 in. = 25.4 mm.

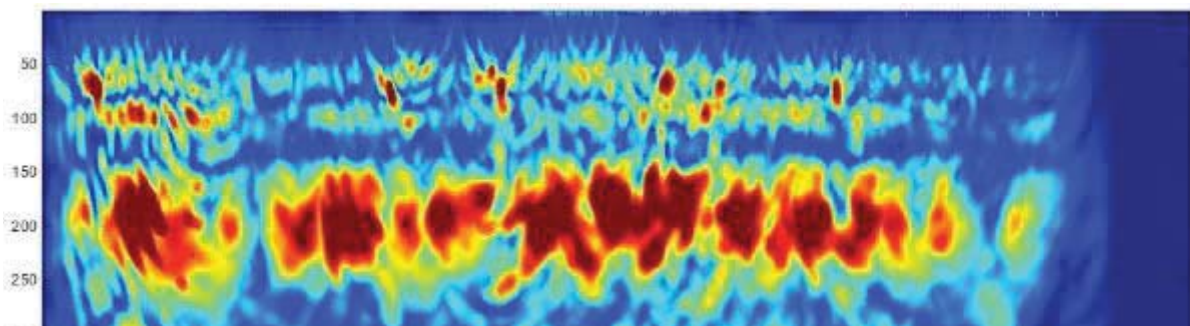
Figure 68: Topside of southbound milled lanes, OpenSAFT (perpendicular to top traffic flow). Units of the plot are in millimeters, 1 in. = 25.4 mm.

MIRA scanning on a milled surface disrupted the detection of the wave velocity. This disruption resulted in a saturated image with no useful information. By assuming a constant wave velocity value in advance, a resulting image was reprocessed using the OpenSAFT scripts. In the resulting scan of a milled surface, significant noise was still observed, and the full-thickness backwall reflector location was skewed by the constant velocity assumption.

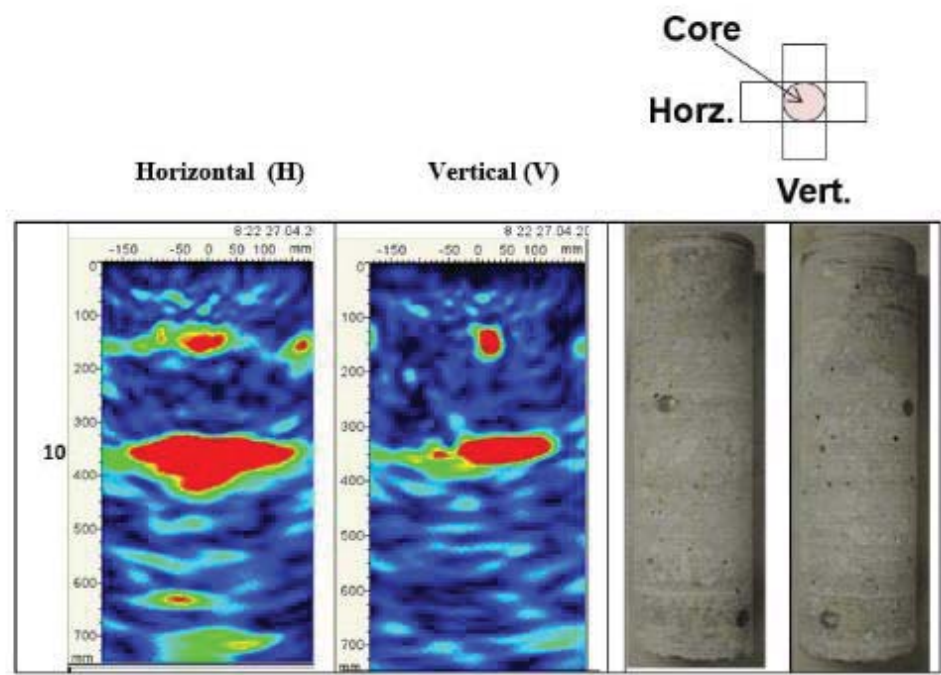
Results: The scan record and core photograph for an example parapet location are provided in Figure 70. Additionally, a complete record of all MIRA and photographic images at each coring location are included in Appendix D of this report. Core locations 1–9 were located on the west parapet of the southbound lane. Core locations 10 through 18 were located on the east parapet of the southbound lane of the bridge. In general, Cores 1 through 9 presented increased scattering noise at each location compared with Cores 10 through 18.

Figure 70: Example scans and core photographs from parapet location 10.

The sampled cores displayed no obvious signs of significant voiding within the parapet wall section. Several core locations appear to have fractured. The cause of this fracture could be poor consolidation and/or a side effect of the horizontal coring procedure. With the collected data, an analysis was done to determine whether the MIRA data could correlate with a cracked extracted core.

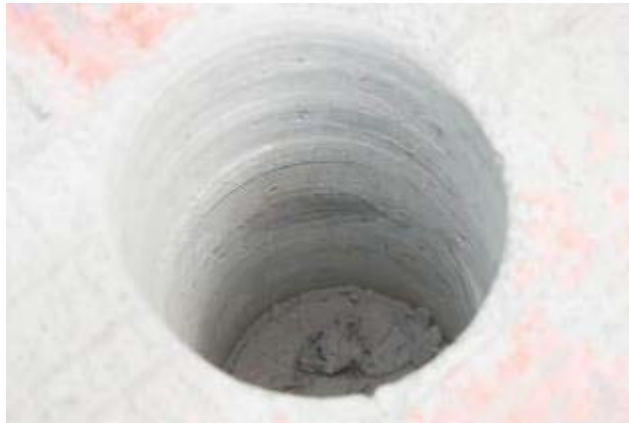
Figure 74: Visual dowel bar depth at an existing cored location.

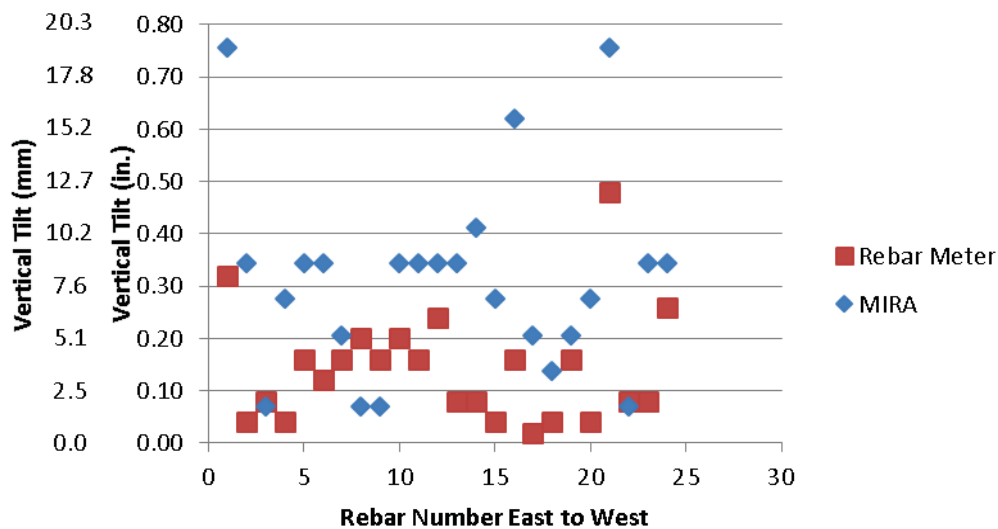
The final test carried out was to evaluate the position of dowel bars along a full joint of hardened concrete. This test took measurements on each side of a joint and calculated vertical tilt and horizontal alignment measurements as presented in Figures 76 and Figure 77. Figure 76 presents the absolute vertical tilt of the measured dowel bars. On average, the values obtained through MIRA measurement are larger than the values obtained through the rebar meter. Because no cores were

present at the joint scanned no visual observation occurred during this measurement, the expected error of the measurement (as reported in Table 2) should be taken into consideration before interpretation.

Figure 76: Vertical tilt measurements for 38.1 mm (1.5 in.) dowels at Sta. 01+08 joint.

According to the American Concrete Pavement Association's specification for dowel misalignment (ACPA 2013), the maximum allowed vertical tilt is 25.4 mm (1 in.). The error observed from measurements and the maximum allowed tilt are on the same order of magnitude. Because a tilt measurement is the difference between two depth measurements, the expected average error is 6.35 mm (.25 in.) for the rebar meter and 12.7 mm (0.5 in.) for the MIRA device. The small magnitude of measurement error of the allowed tilt prevents a definitive misalignment decision to be generated. Only incidents of significant deviation are able to be determined through the MIRA scanning method.

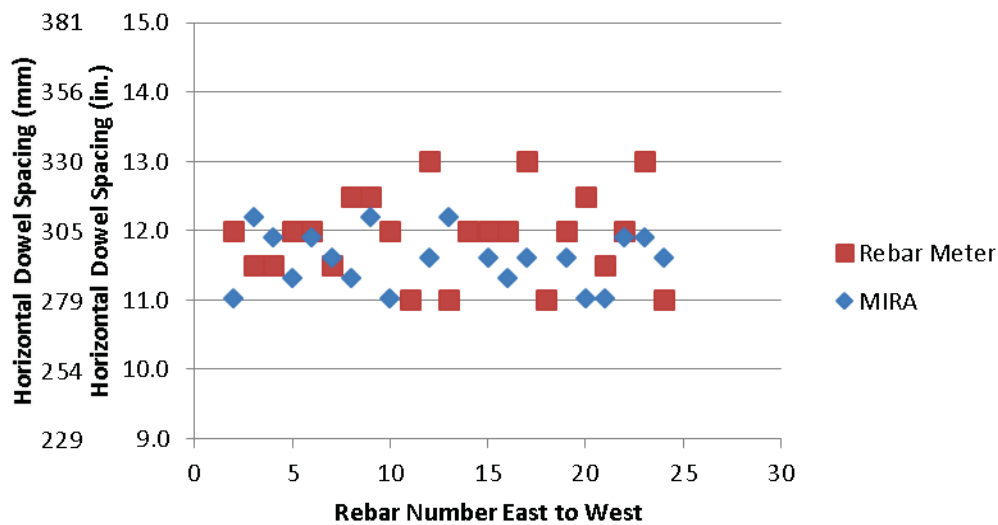
The horizontal misalignment measurements shown in Figure 77 identify horizontal dowel spacing determined from the MIRA scan. As a result of operator positioning error, three dowel spacings are omitted from the plot. In general, the variability of dowel spacing determination by the MIRA device was visually lower than the variability observed through application of the standard rebar meter.

Figure 77: Horizontal spacing for 38.1 mm (1.5 in.) dowels at Sta. 01+08 joint.

The horizontal translation is highly dependent on the ability of the operator to measure and place the MIRA device in a perfect fashion. The ACPA specification for individual dowel maximum horizontal displacement is 50.8 mm (2 in.). The horizontal errors observed were less than the allowed maximum displacement. The MIRA device alone appears to be useful as a measurement tool for horizontal dowel spacing.

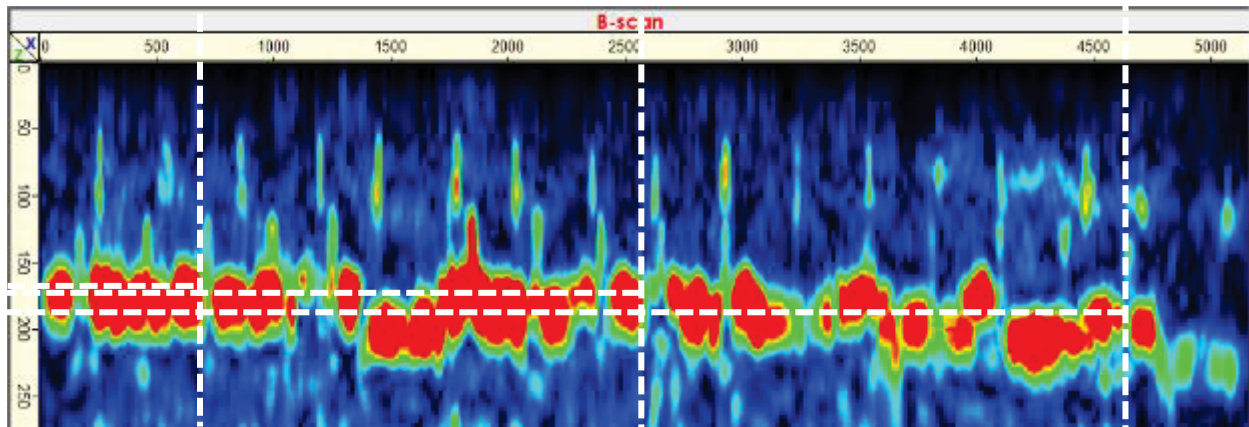
Figure 78: Fillet B thickness cross section; white lines display ruler locations. Units of the plot are in millimeters, 1 in. = 25.4 mm.

Discussion: To measure the repeatability and demonstrated field confidence in the MIRA device, the first cross section was scanned twice (Figures 78 and 79). A comparison of the two scans for each bay was summarized in Table 5. The maximum thickness difference between the two datasets was 32 mm (1.3 in.). The difference between the two datasets significantly decreases the practical value of the individual thickness measurements. Prior to this field test, the expected maximum difference was ± 7.3 mm (0.29 in.), as observed during a previous field study.

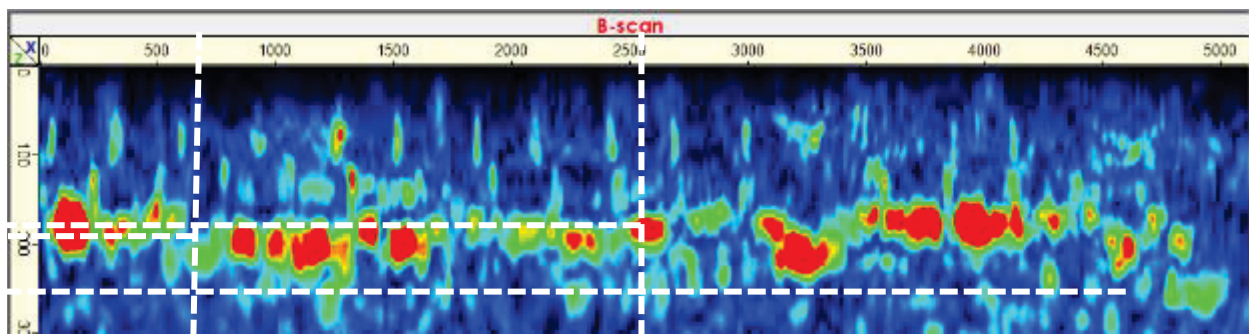
Figure 79: Fillet B cross section repeated. Units of the plot are in millimeters, 1 in. = 25.4 mm.

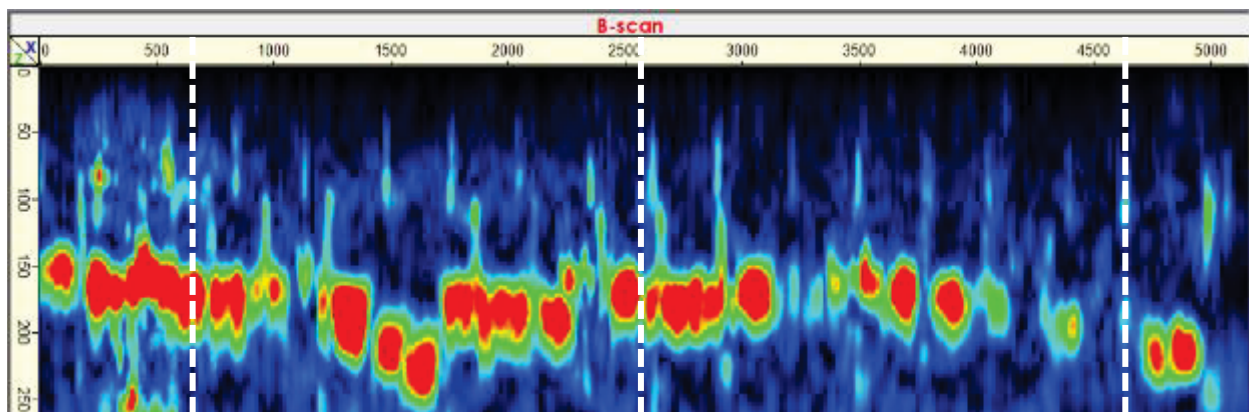
Figure 81: Fillet D cross section. Units of the plot are in millimeters, 1 in. = 25.4 mm.

After accounting for the observed error, the scanned deck thickness was consistently observed to be below the target thickness of 203.5 mm (8 in.). The location of the minimum observed deck thickness was at Bay 1 Cross-Section Fillet D, with an estimated thickness of 169 ± 18 mm (6.6 ± 0.7 in.).

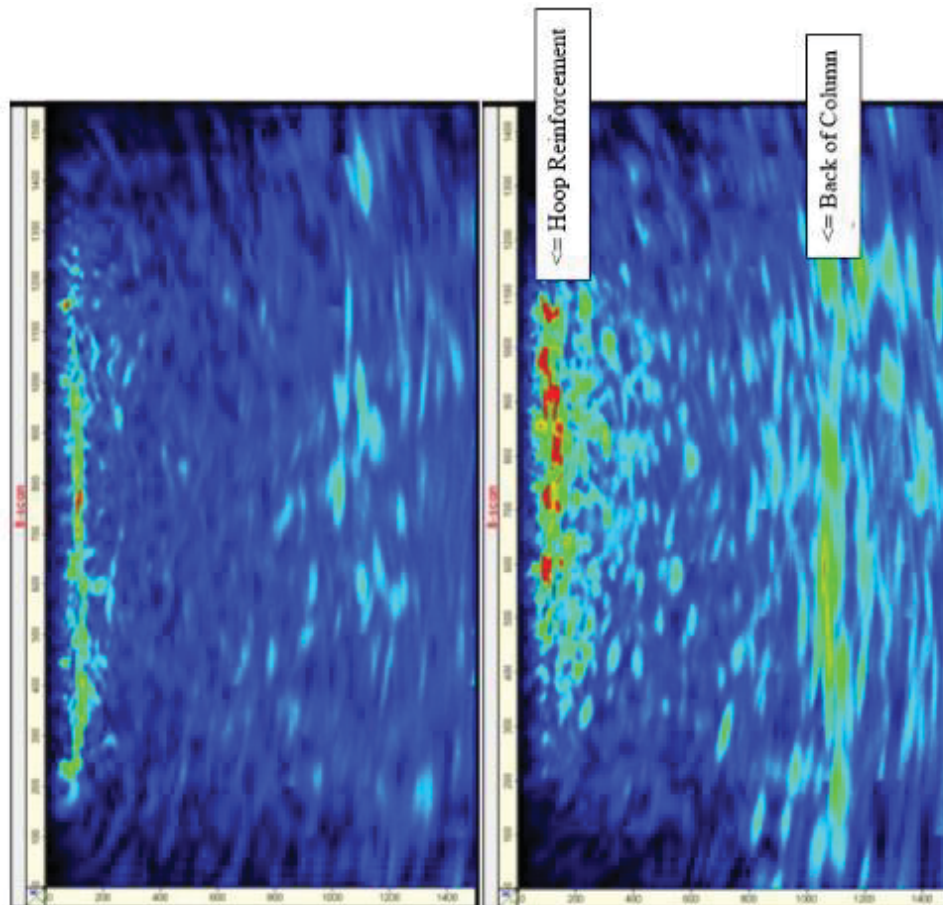
The second scanned area was on a support column that was repaired with fiber reinforcement, as pictured in Figure 91b. The column was scanned on two sides; the device was oriented such that the long axis was parallel to the long axis of the column. The column was then scanned vertically along the long axis of the device. This orientation allowed all 12 sets of transducers to be in contact with the surface. Two locations (the northwest and northeast sides) on the same column were scanned. The results of these scans are presented in Figure 89c. The first scan (a) in the set was on a region where the FRP texture was rough and little surface epoxy pooling was visible. The second scan (b) in the set was on a region, Figure 89b, where the FRP texture was smooth and surface epoxy was apparent. In the second scan, strong backwall reflections were able to be observed just beyond 1 m (3.28 ft) in depth.

Figure 89c: Two different vertical B-scans of a 1 m (3.28 ft) diameter FRP-wrapped column, northeast (on left) and northwest (on right sides. The plots are rotated to represent the orientation of the vertical column that was scanned. Units are in millimeters, 1 in. = 25.4 mm.

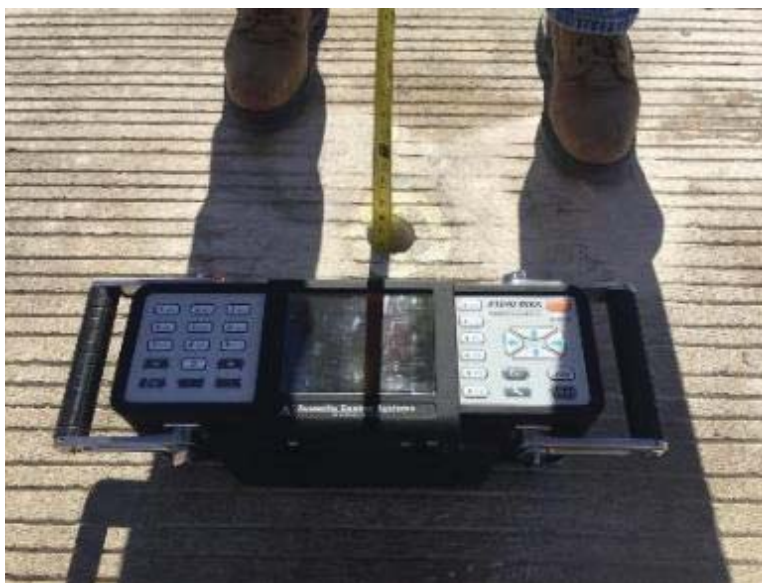
Visual Observations: At the center of one bridge, a hole was drilled through the thickness of the slab. The measurement indicated a thickness of 190 mm (7.5 in.), as shown in Figure 90.

Figure 90: Measuring the thickness of a hole drilled through the slab.

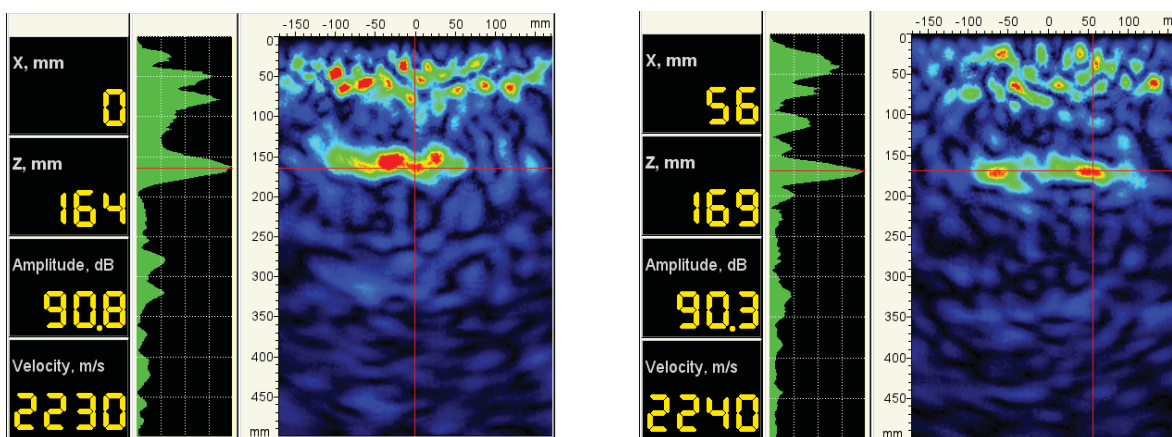
A newly constructed RCC storage lot was investigated as part of the survey of RCC pavements in Illinois. The 178 mm (7 in.) design thickness was confirmed by a MIRA scan (Figure 91), validating that the ultrasonic device is useful for concrete structures other than conventional concrete pavements. Additional scans at this project site were taken near a cold joint (Figure 92), where evidence of strong reflectors was seen in the thickness of pavement; this could be evidence of poor compaction or poor consolidation of the RCC at a cold joint.

Figure 92: Two MIRA B-scans of an RCC pavement near a cold joint, possibly indicating poor compaction or consolidation. Units of the plot are in millimeters, 1 in. = 25.4 mm.

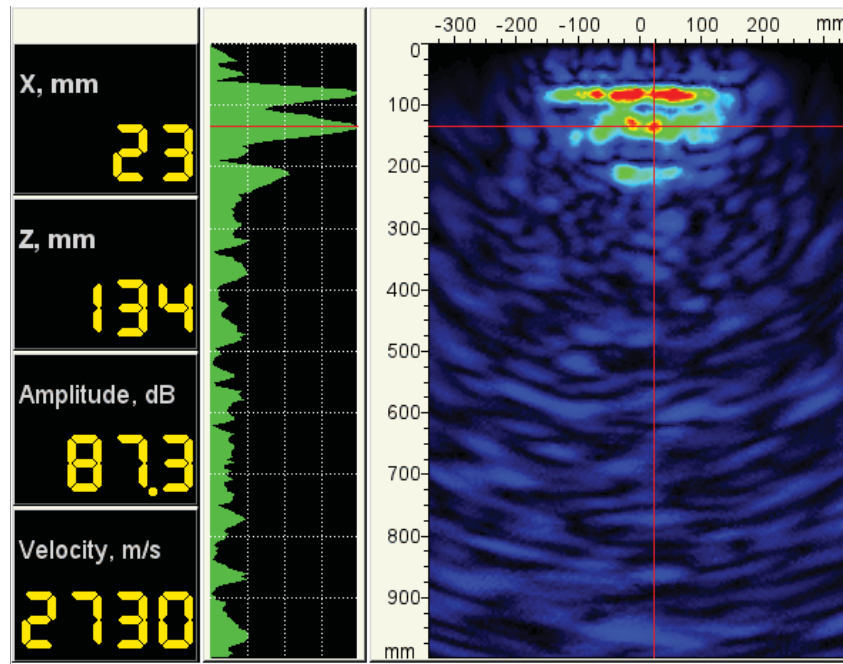
The UTW project that was surveyed consisted of a nominal 10 cm (4 in.) UTW concrete overlay (9.9 to 11.7 cm (3.9 to 4.6 in. constructed thickness), a 10 to 13 cm (4 to 5 in.) post-milled asphalt pavement substrate, and an existing concrete substrate of 20 cm (8 in.) variable thickness. Figure 93 shows reflections at two depths, which could indicate the backwall reflections of the UTW overlay and the asphalt pavement substrate; this scan suggests that the composite thickness of the overlay and asphalt pavement substrate is about 13 cm (5.3 in.). Figure 94 shows a backwall reflection at a depth of almost 33 cm (13 in.), which could be the backwall reflection of the composite pavement consisting of the UTW overlay, the asphalt pavement, and the original concrete pavement. The presence of a reflection at a depth such as indicated in Figure 94 could be indicative of good contact or bond between each of the three layers.

Figure 93: A MIRA B-scan indicating possible backwall reflections at the interface between the UTW concrete overlay and asphalt and between the asphalt and the bottom layer of concrete. Units of the plot are in millimeters, 1 in. = 25.4 mm.

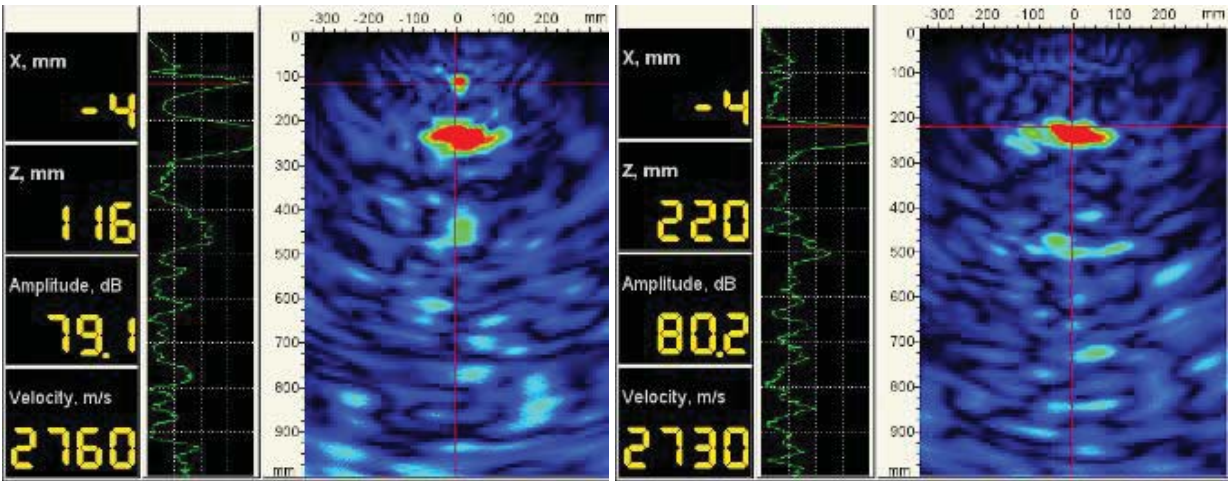
Discussion: The concrete pavement was found to have an estimated slab thickness of about 0.23 m (9 in.). Each curb-slab longitudinal joint tested had seven tie bars, and each transverse joint had ten dowel bars. The dowel bars were spaced 0.30 m (12 in.) with a length of around 0.61 m (2 ft). IDOT standards are for dowels length and spacing to be 0.46 and 0.30 m (18 and 12 in.), respectively. The center of the dowel bars was located at a depth of about 0.110 m (4.25 in.) from the surface based on the MIRA scans. The tie bars spacing varied from 0.61 to 0.76 m (2 to 2.5 ft) and the tie bar length varied from 0.61 to 0.73 m (2 to 2.4 ft). Per IDOT standards, tie bar lengths are expected to be 0.76 m (2.5 ft), and tie bar spacing of curb/gutter to slabs or longitudinal construction joints should be approximately 0.61m (2ft). The depth of the tie bars (center) from the slab surface was approximately 0.11 m (4.25 in.) like the dowel bars. A summary of the tie bar calculations for each street block is shown in Tables 8 through 10. The diameter of the tie bars or dowels cannot be resolved with MIRA in its current programmable configuration.

Figure 96: Green Street B-scans for the depths of dowel bar (left) and slab thickness (right). Units of the plot are in millimeters, 1 in. = 25.4 mm.

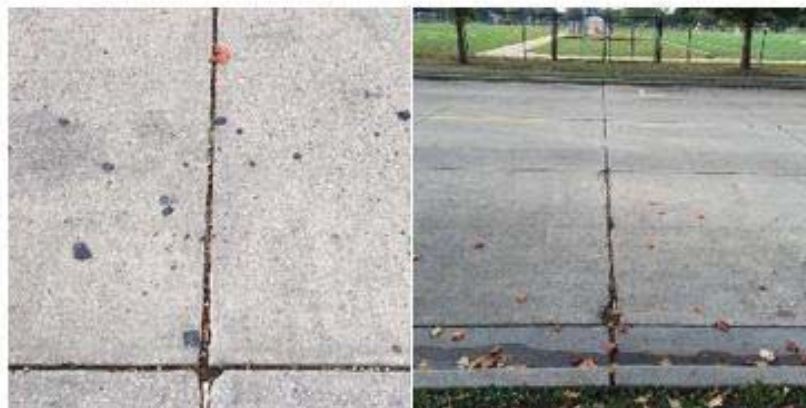
Figure 97: Stadium Drive with unsealed joints.

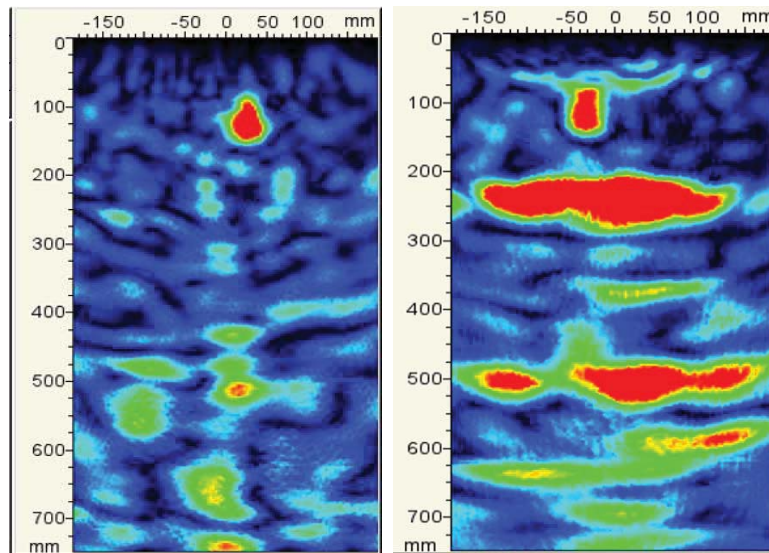
Results: Many of the B-scans on First Street did not have backwall reflection, which is used to estimate the slab depth as seen in Figure 101. In such a situation, the absence of backwall reflection is interpreted as transmission of the majority of the wave energy downward. One explanation for this is a concrete slab bonded to the original asphalt pavement with the impedance of asphalt and concrete not significantly different and therefore, leading to the absence of reflection. In some areas, a backwall reflection existed which could mean no asphalt was present or an unbonded interface exists. Without a core through the slab and base layer, it is difficult to determine why a backwall reflection was not seen on many of the B-scans.

Figure 101: B-scans without backwall reflection and with backwall reflection.
Units of the plot are in millimeters, 1 in. = 25.4 mm.

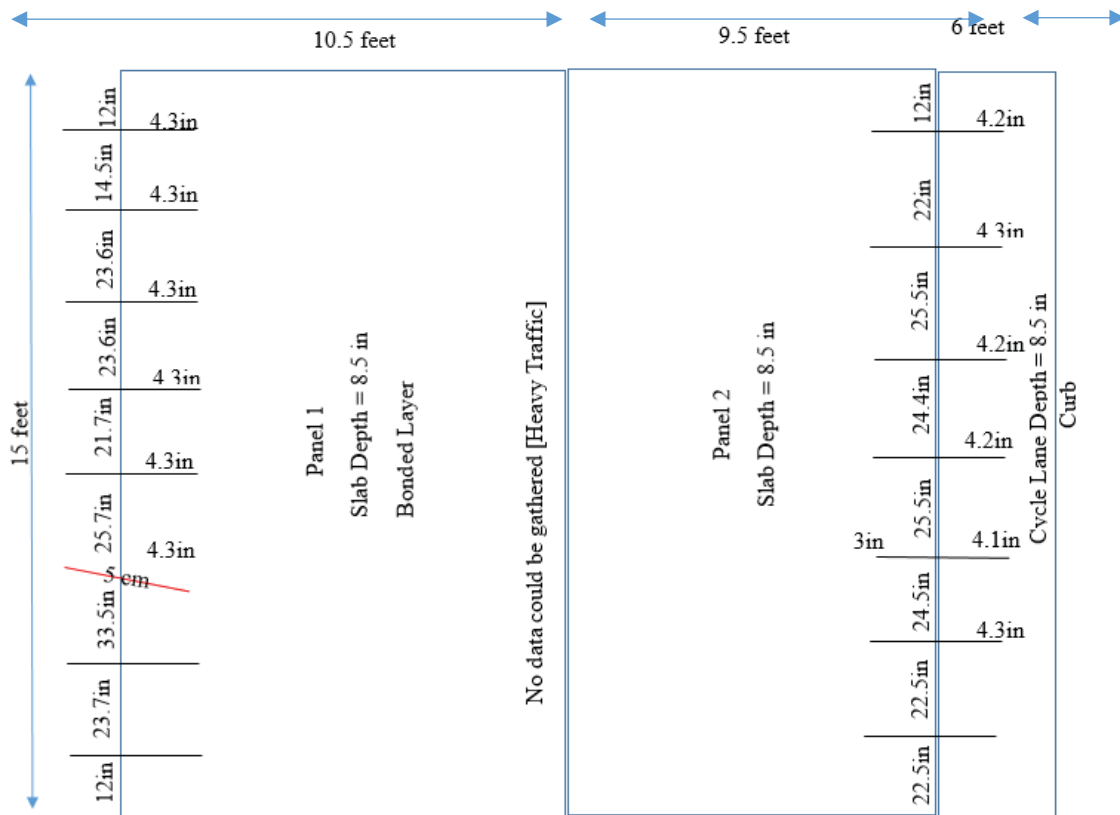
Figure 102: Tie bar location in the MIRA-inspected panels on the First Street. 1 in. = 25.4 mm.

In Figure 102, the average tie bar spacing was found to be around 0.61 m (24 in.) with a depth of 0.11 m (4.3 in). One tie bar in Slab Panel 1 was found to be horizontally misaligned (highlighted red in the figure). Tie bars along centerline joint and dowel bars in transverse joints could not be investigated because of the heavy traffic.

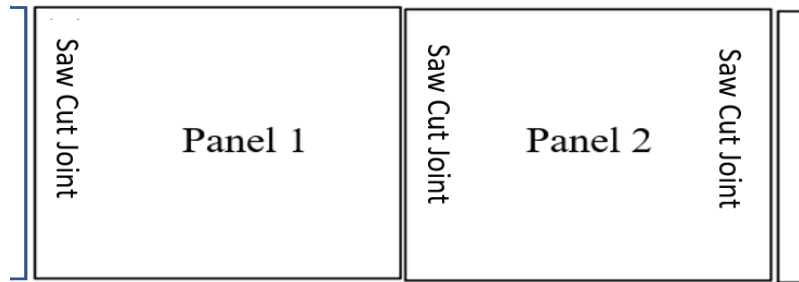
Observation: The longitudinal dimension of panels were 4.88 m (16 ft) with an expected slab thickness of 0.20 to 0.25 m (8 to 10 in.). The parking lane and the main lanes were 1.83 and 3.35 m (6 and 11 ft), respectively, in the transverse direction. Transverse contraction joints are shown in Figure 103. One of the inspected panels (Panel 2) was cracked.

Figure 103: Inspected Panels on Springfield Avenue in Urbana.

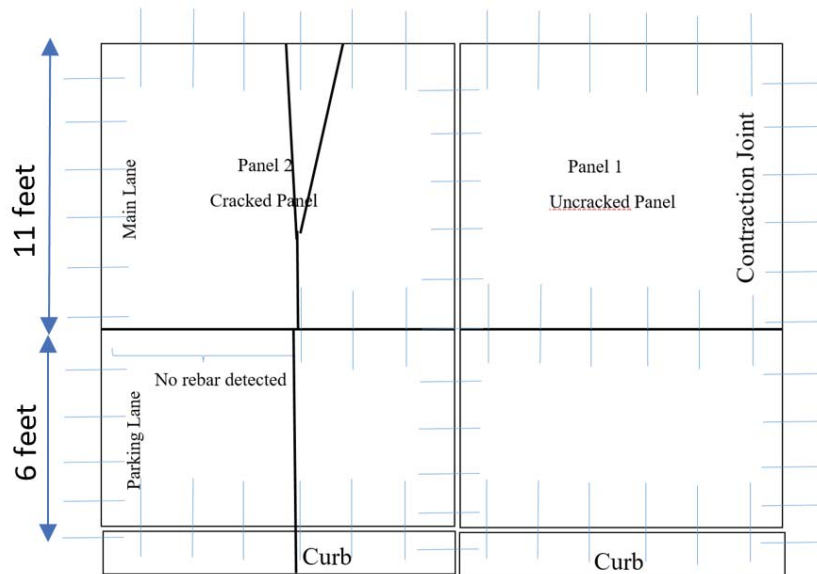
Discussion: The dowel bars were found to be 0.51 m (20 in.) long and consistently spaced at 0.30 m (1 ft.) at the contraction joints. The tie bars were found to have a consistent spacing of 0.76 m (2.5 ft.). No rebar misalignment was found, and all reinforcements were located at their respective depths consistently, shown in Figure 105. In Panel 2, three tie bars were found missing from the lane-parking lane joint.

Figure 105: Tie and dowel bar location in the inspected panels.

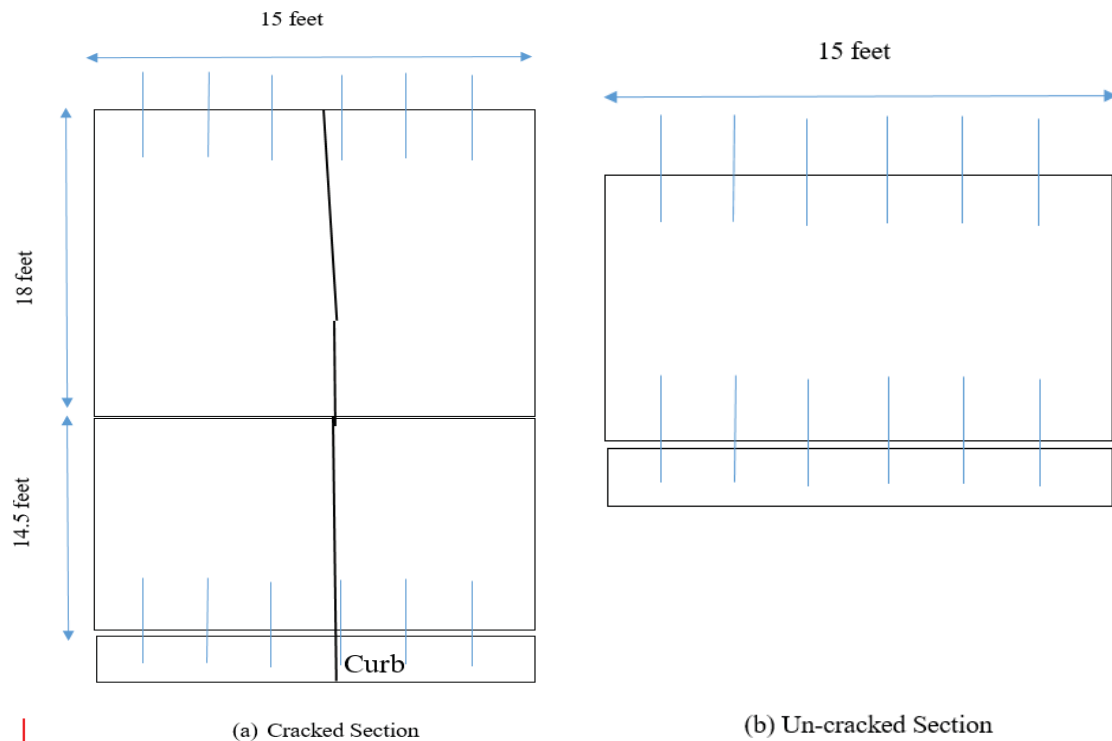
Discussion: The dowel bar spacing was 0.30 m (1 ft) consistently with length around 0.61 m (2 ft). Tie bar spacing was 0.61 m (2 ft) with a variation of ± 0.08 m (3 in.). The schematics of the tie bar location in the cracked and uncracked panel sections are shown below in Figure 107. No reinforcement misalignment was found. The longitudinal joint between lanes for the cracked slab section did not have any tie bars present.

Figure 107: Tie bar location in the inspected panels at Gregory Drive.
Units of the plot are in feet, 3.28 ft = 1 m.
