ULTRASONIC IMAGING FOR CONCRETE INFRASTRUCTURE CONDITION ASSESSMENT AND QUALITY ASSURANCE

Research Report No. FHWA-ICT-17-007

A report of the findings of
ICT PROJECT R27-146
Ultrasonic Imaging for Concrete Infrastructure
Condition Assessment and Quality Assurance

Illinois Center for Transportation
April 2017

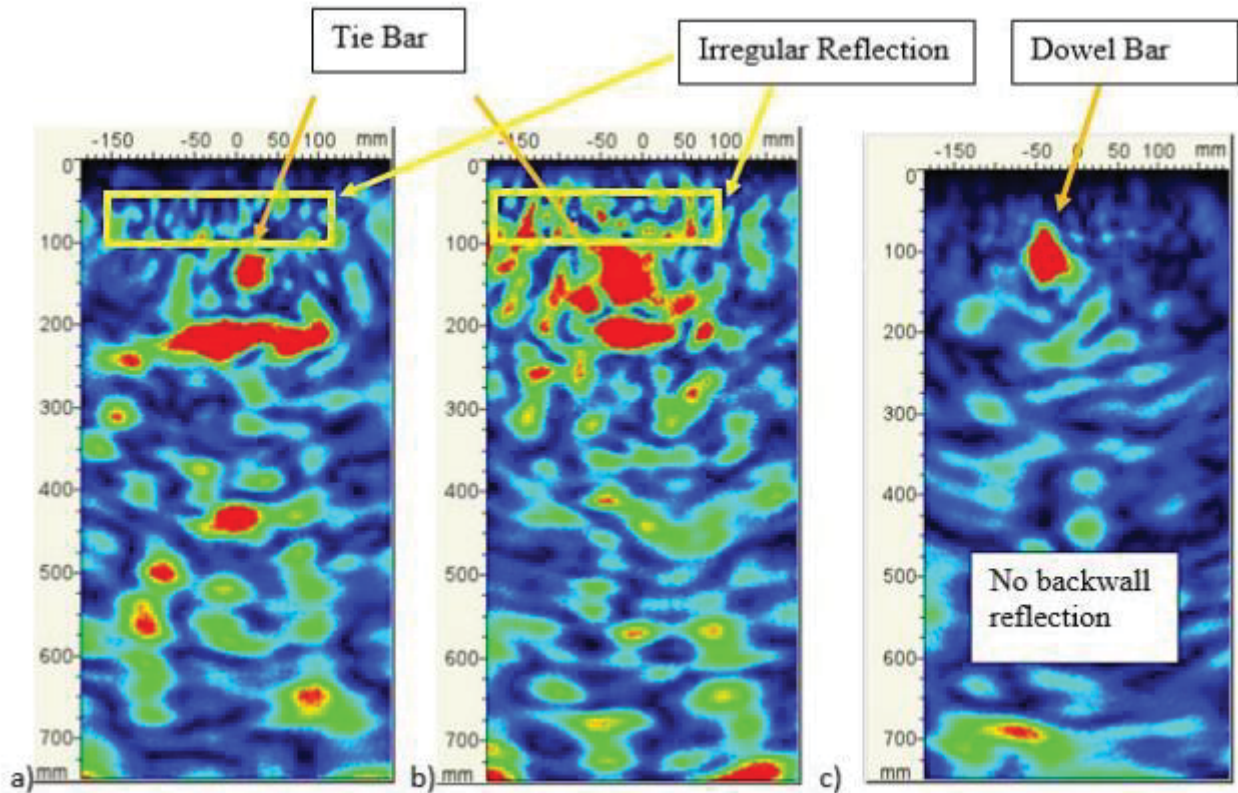
Result: On Fourth Street, Lane A panels had slab depth of 0.25 m (10 in.), while the Lane B panels were found to be 0.20 m (8 in.) deep, as shown in Figure 109. For the Lane B, tie bar and dowel bar depths were estimated about 0.14 m (5.5 in.) and 0.10 m (4 in.), respectively. In Lane A panel, tie bar and dowel bars were found at 0.16 m (6.5 in.) and 0.12 m (4.7 in.) depths, respectively, as shown in Figure 108. Multiple scans were found to have irregular wave reflections as shown in Figure 109. The scattered reflections at locations denote the presence of regions with highly different impedance than concrete. However, as MIRA is only an exploratory device, further tests would be needed to ascertain the cause for these multiple wave reflection.

Figure 109: Fourth Street B-scans with different intensities of wave scattering.
Engineering judgment is needed to estimate the design features in scattered B-scans.
Units of the plot are in millimeters, 1 in. = 25.4 mm.

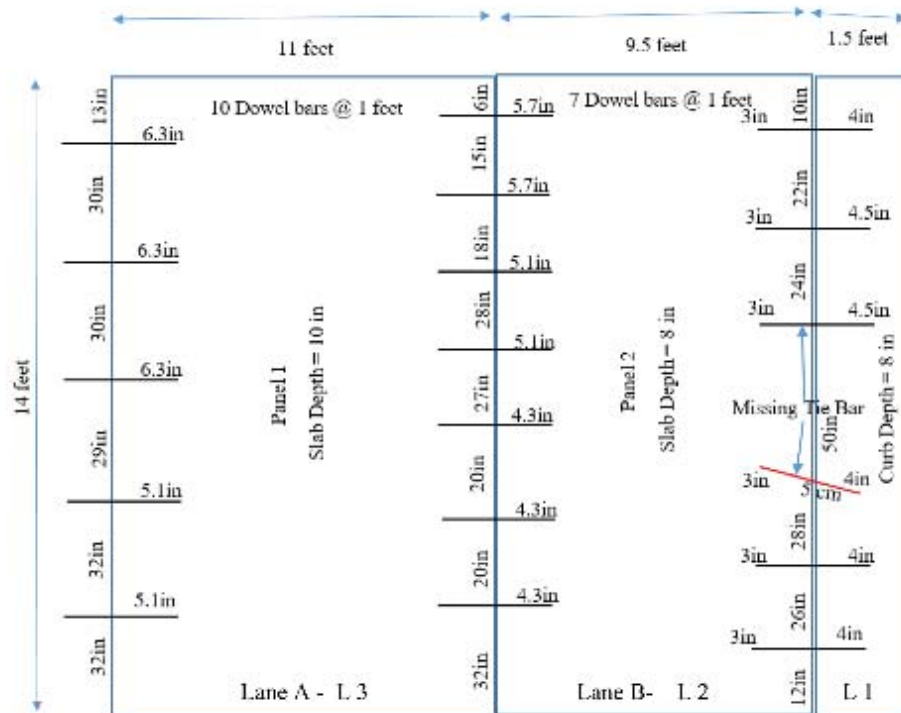
The schematics of the tie bar location in inspected section are shown in Figure 110. The variations in the tie bar depth and spacing are indicated, and the horizontally misaligned tie bars are highlighted in red.

Figure 110: Spatial configuration of the tie bars in the inspected panels on South Fourth Street. Unit conversions: 3.28 ft = 1 m, 1 in. = 0.025 m.
