ENHANCED CULVERT INSPECTIONS BEST PRACTICES

Guidebook

Author: Doug Youngblood, CDM Smith
Report Number: 2017-16
Date Published: June 2017

1. Report No. MN/RC 2017-16		2.		3. Recipients Accession No.	
4. Title and Subtitle Enhanced Culvert Inspections – Best Practices Guidebook				5. Report Date June 2017

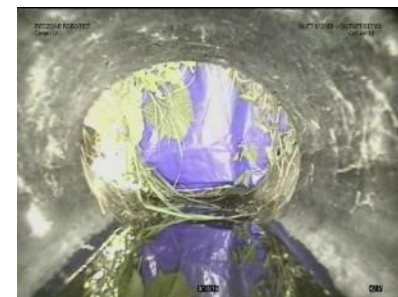
1. The contractor reviewed site information to identify traffic controls requirements.
2. When on site, the contractor assessed light in the culverts. If the sun impacted video quality, the contractor hung a tarp over the culvert outlet and used the camera’s on-board lighting (**Figure 6**).

Figure 6 – A tarp was hung at the culvert’s outlet to control camera lighting.

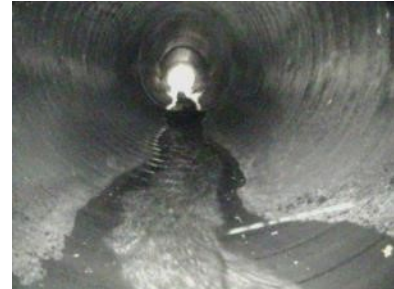
- CCTV Video** – The contractor recorded 638 lf of high definition CCTV video (Figure 8). Video was provided as 10 *.mpeg files. The quality of this video was excellent. The camera operator was PACP certified; this is advantageous because the operator is required to attend a nationally certified inspection recertification class every 3 years. The contractor used best practices for obtaining video and thoroughly documented defects observed in the culvert.

Figure 8 – Inspection video for culvert ID 36918

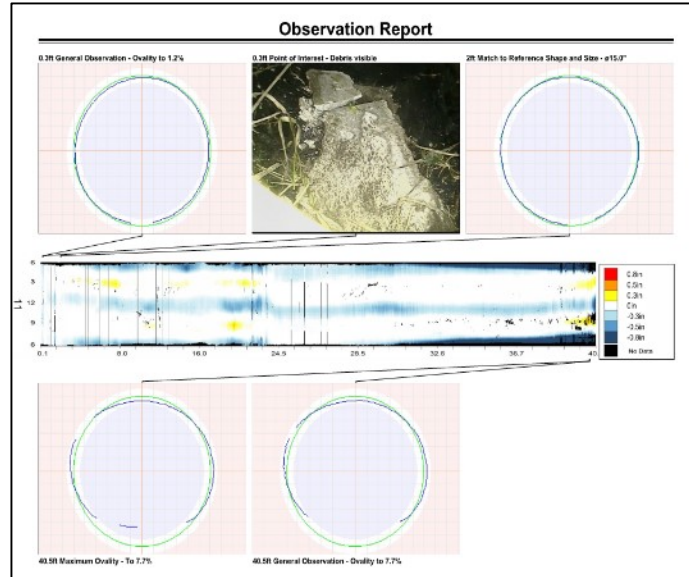
The laser ring measured a culvert’s percent deflection from perfect circularity (**Figure 10**).

Figure 10 – Ovality report for Culvert ID 613189
