Design Considerations for Embankment Protection During Road Overtopping Events

Jeffrey D. G. Marr, Principal Investigator

St. Anthony Falls Laboratory

Final Report 2017-21

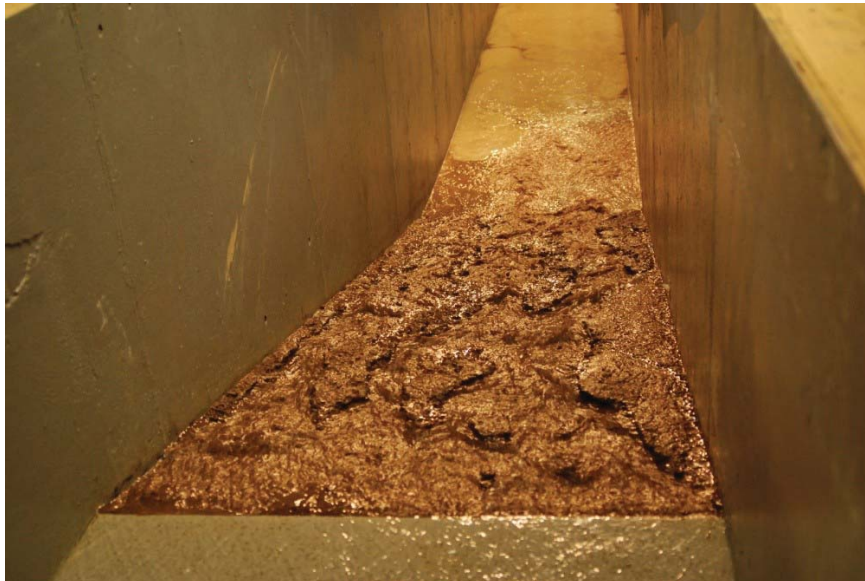
Figure 4.2. 4H:1V Slope mid-run with prevalent channels of flow looking downstream. Less than two minutes of run time.

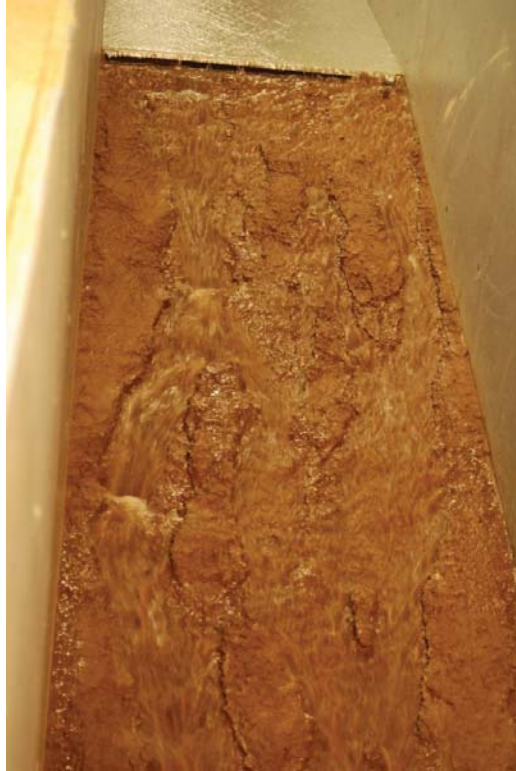
Erosion occurred immediately across entire slope. Preferential flow paths were quickly established then deepened by repeated flows. Concentrated erosion occurred immediately downstream of the fixed edge of the “shoulder”, eventually funneling all flow into the deepest preferential path, forming a pattern of cyclic steps, which are similar to pools and chutes, migrating upstream. If the shoulder were not fixed in place, it would most likely have undermined and collapsed.

Figure 4.3. Mid-run 4H:1V slope looking upstream. Flow channelized on slope with trough forming on the transition from shoulder to slope.

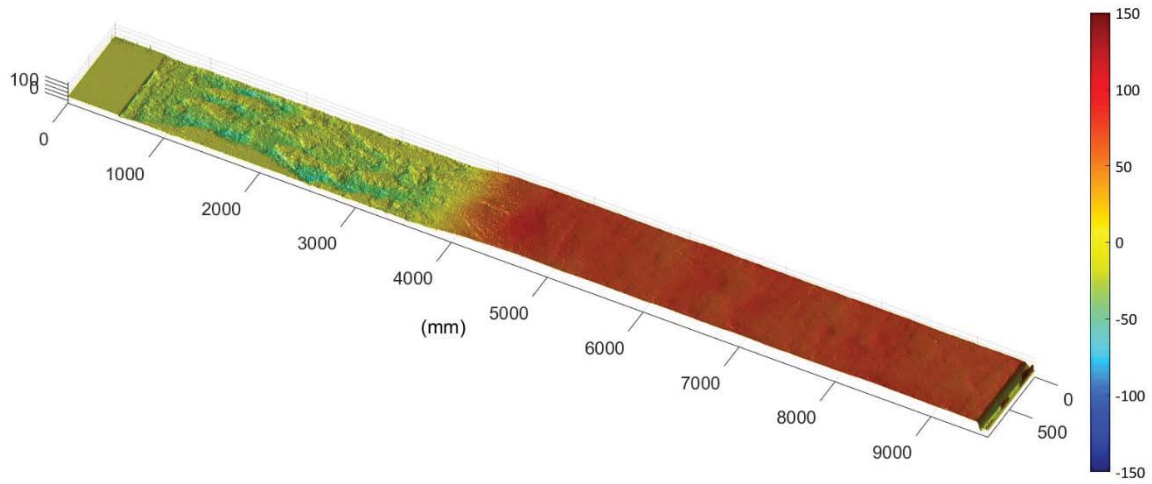
Figure 4.5 Topographic difference plot from zero to two minutes of run time, showing prominent channels being carved on slope. Elevation units are in millimeters.

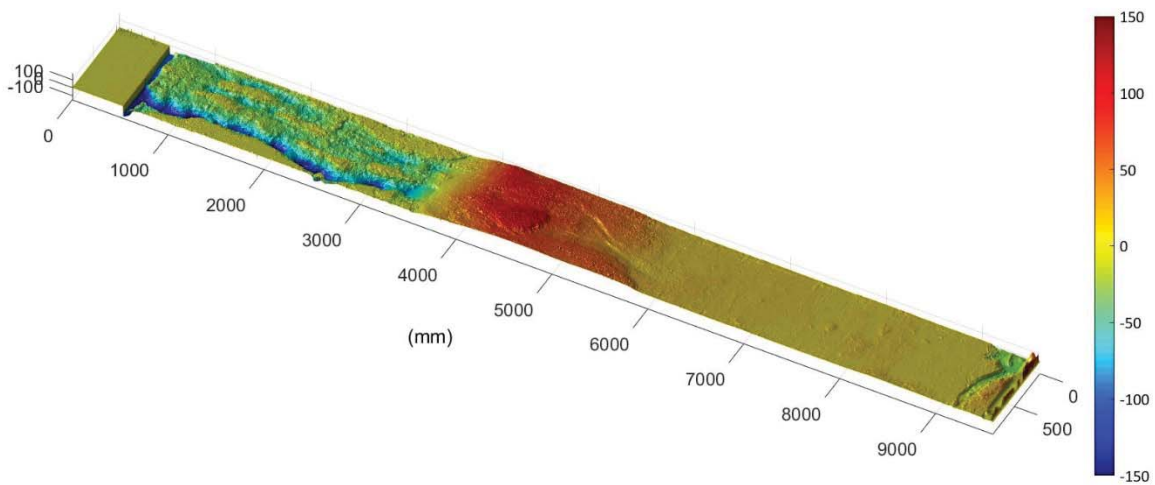
Figure 4.6 Topographic difference plot from zero to eight minutes of run time. Note scour and trough formation at upstream transition from shoulder to slope and primary channel of erosion.

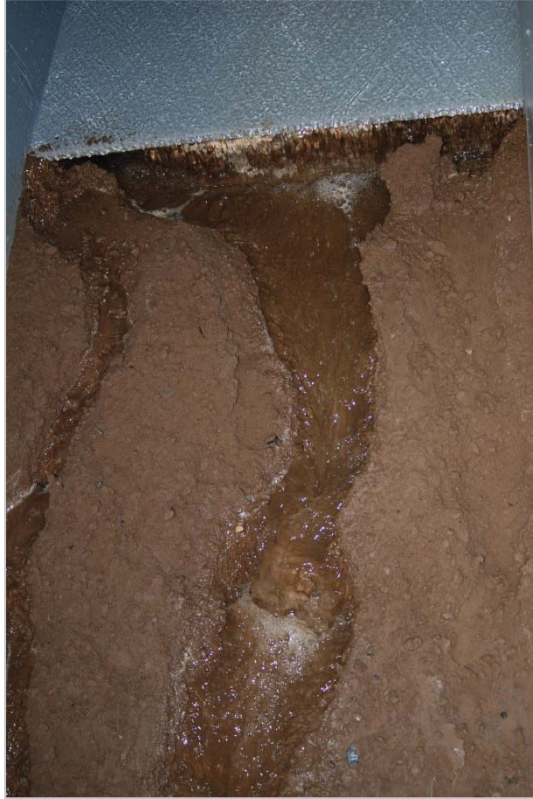
This slope's failure was similar to the 4H:1V slope except that the erosion occurred less rapidly and did not erode as deep into the slope. A trough formed immediately downstream of the shoulder and fed into carved channels that wove down the slope. On the lower half of the slope, several flow paths recombined and erosion was shallower and more prevalent as opposed to one deep prominent channel.

Figure 4.9. Channelized flow and separation from the edge of the shoulder forming trough at the transition.

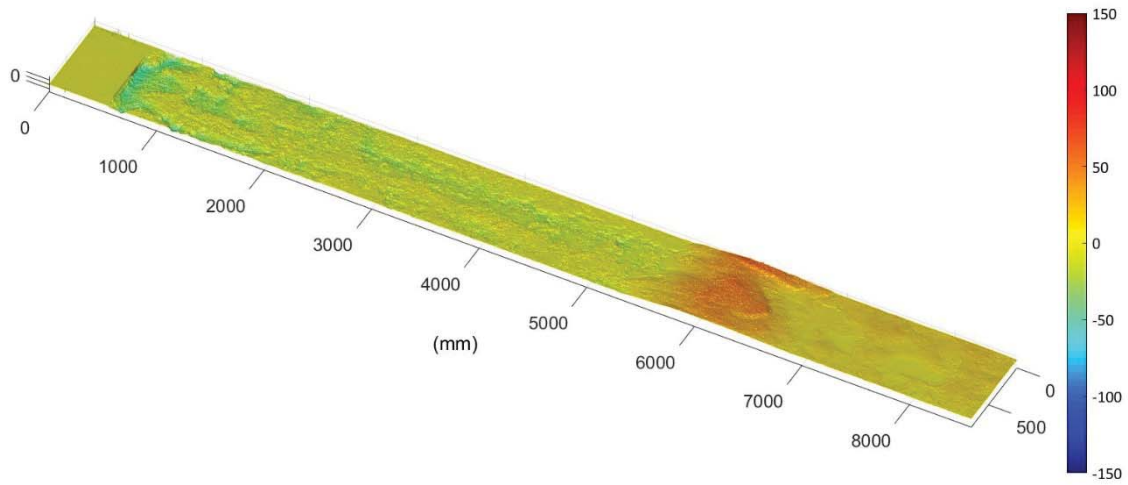
Figure 4.11. Topographic difference plot from zero to two minutes of run time. Note the large area of erosion immediately after the shoulder and channels downslope of it.

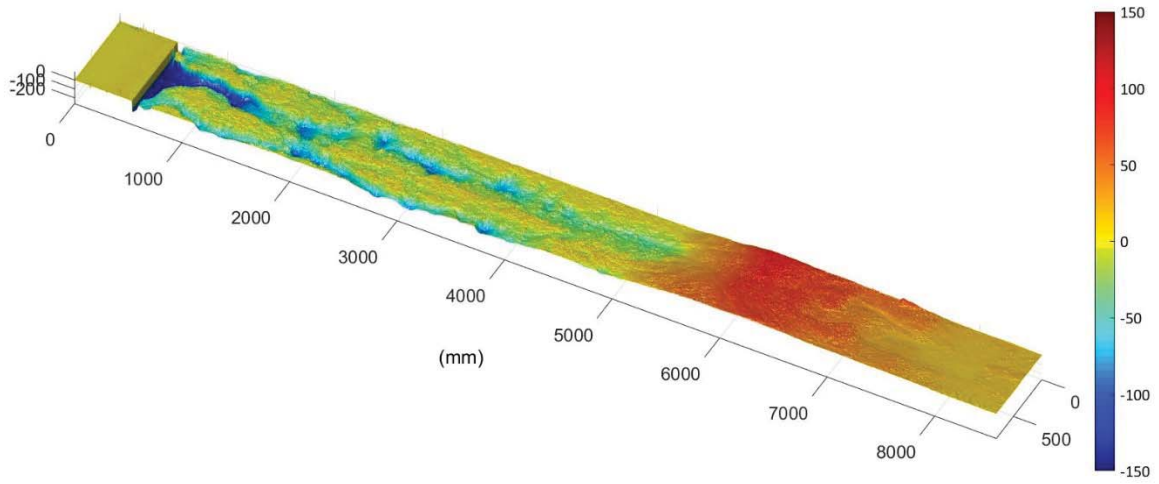
Figure 4.12. Topographic difference plot from zero to 10 minutes of run time. Only ten minutes of run time has undermined the shoulder.

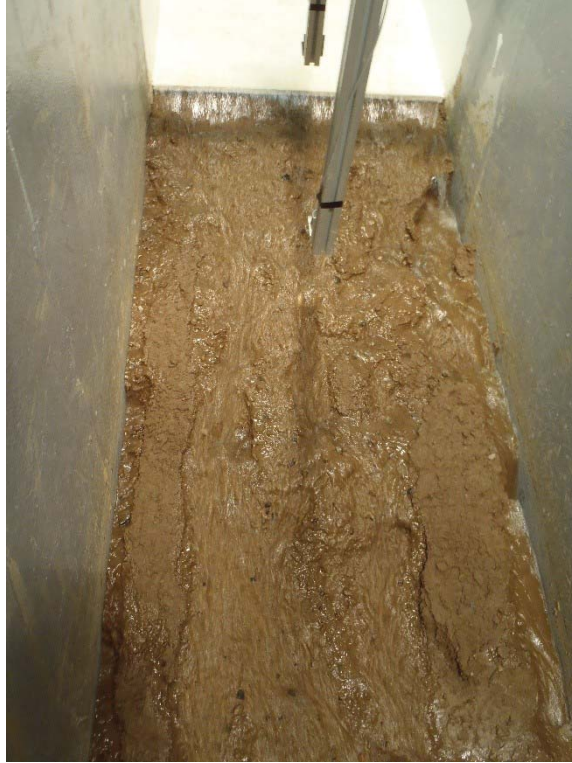
Figure 4.15. Looking upstream after approximately 25 minutes of run time. Channels and depressions forming, no trough or main channel forming.

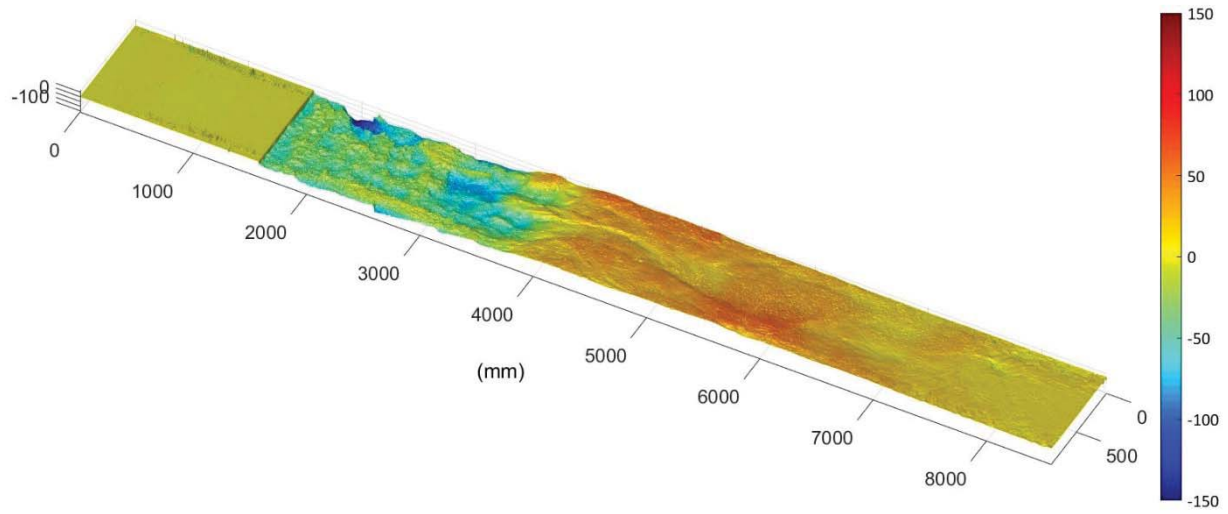
Figure 4.18. Topographic difference plot from two to 22 minutes of run time. Slope now has channels but not as definitive as other runs of bare soil, no primary channel on slope was eroded.

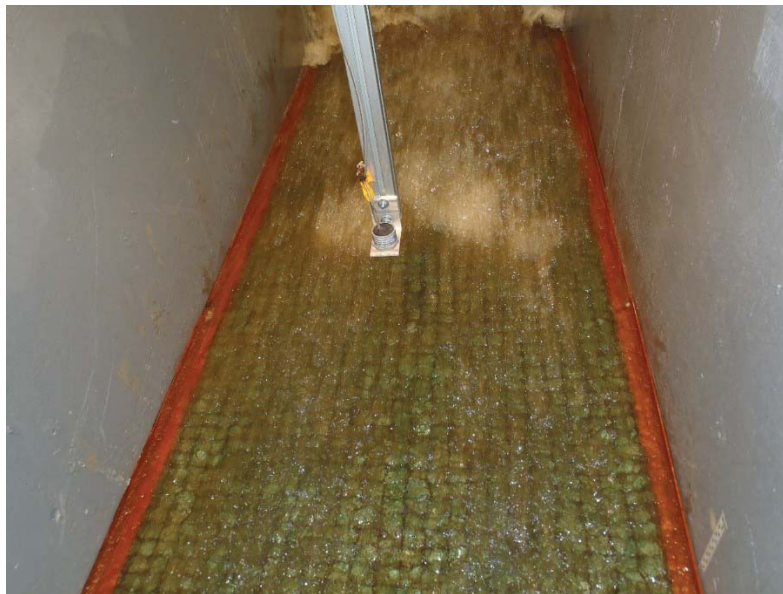
The first flow increments were uneventful with little noticeable erosion occurring. Water flowed both on top of the geogrid and through the erosion control blanket. At the end of the third flow step, some visible erosion occurred directly downstream of the shoulder. On the fourth flow step, an erosional scour hole formed just over half way down the slope, with a corresponding depositional mound clearly forming immediately downstream. Both features gradually grew in size and moved slightly upstream, until a large failure occurred within less than five minutes of the start time. Soil from an erosional trench, extending from the road shoulder to 2/3 of the way down the slope, was excavated and was partially retained by the geogrid and erosion control blanket creating a mound just upstream of the toe. On the upper part of the slope the geogrid spanned across the eroded region, while on the lower part of the slope the geogrid protruded upward over the soil mound.

Figure 4.21. Start of erosion about $\frac{1}{2}$ way down the slope indicated by the depression leading to a mound that aerated the flow in the center of the flume. Looking downslope from shoulder at mound and hydraulic jump.

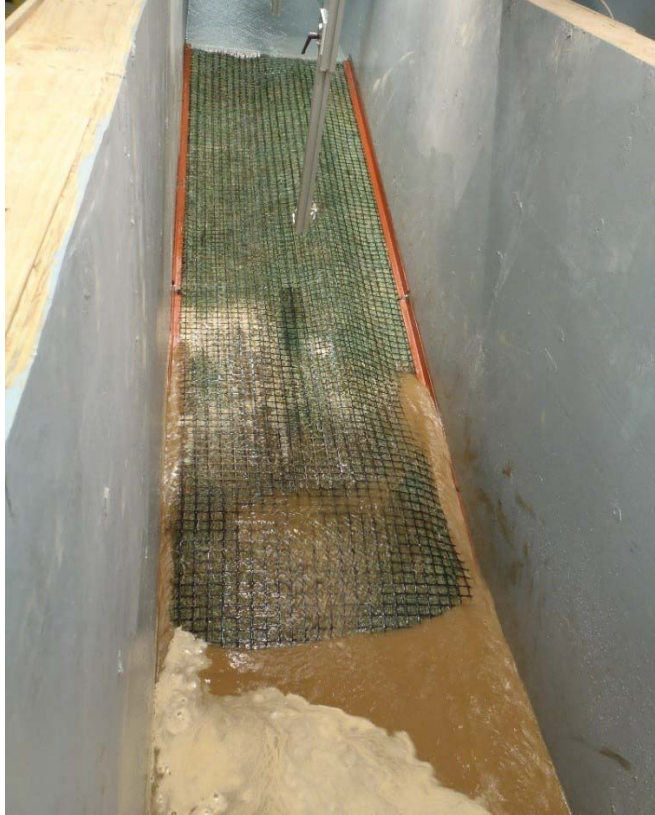
We observed a large amount of erosion on the right side of the embankment slope. The left edge opposite the erosional area remained intact. A large depositional mound just upstream of the toe of the slope could be a result of the soil that eroded and traveled under the ECB. Burying the ECB at the toe of the slope could have helped to reduce erosion. The erosion that took place along the river-right edge of the flume was unobservable from the surface during the flow event due to the bridging of the stabilization material.

Figure 4.22. Post flow erosion after 2.7cfs testing. Note the mound near bottom of slope and depression along the left side of the flume looking upstream. Sediment rich water on slope and in tail water indicating erosion occurring on the slope under the ECB.

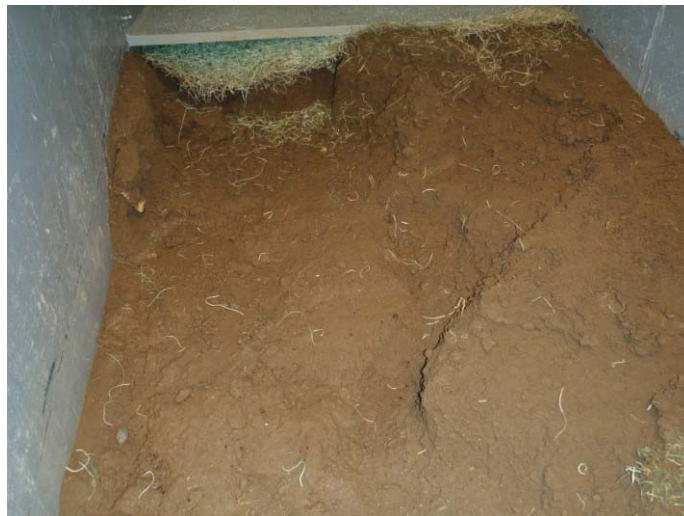
Figure 4.23. Slope with the shoulder at the top of the photo after ECB was removed post-testing. Note the undermining of shoulder and extensive erosion not seen with ECB still in place on previous photos.

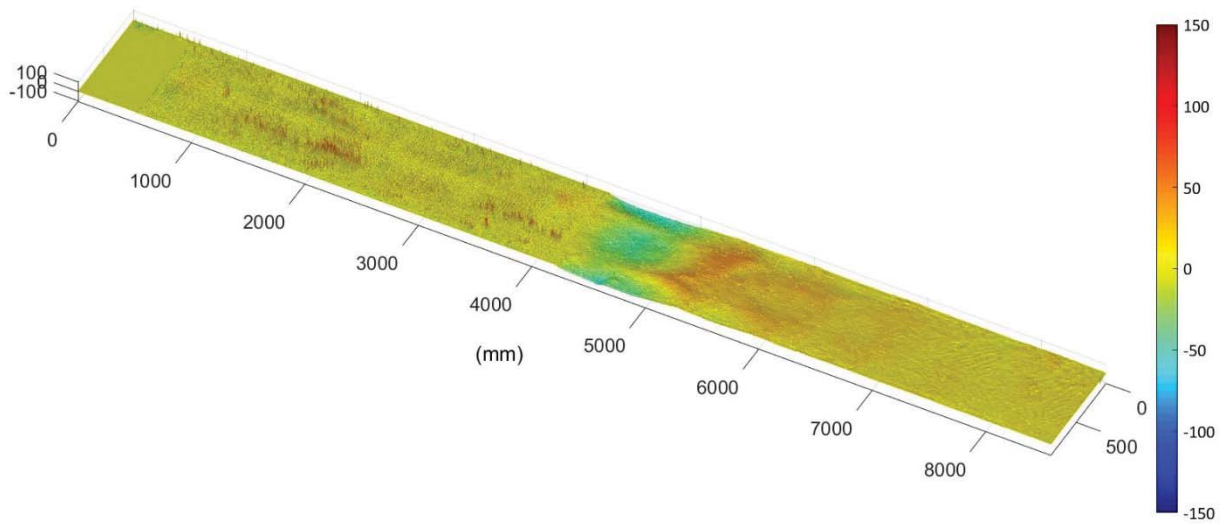
Figure 4.25. Topographic difference plot from zero to 1.5 hours of run time. Minimal erosion on the slope shown here with a depression after the toe of the slope.

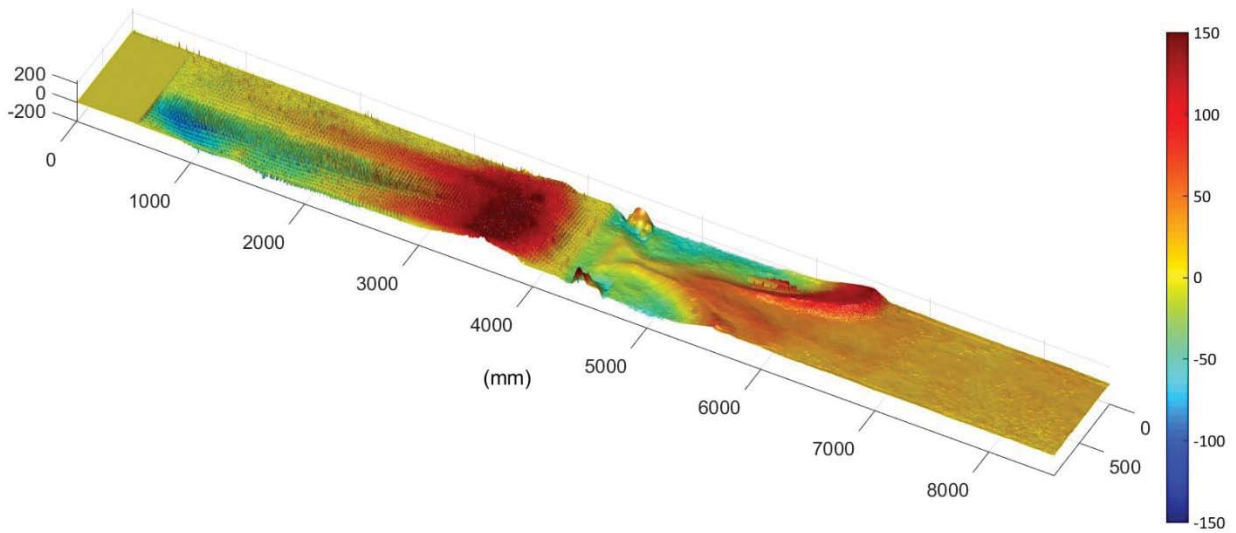
Figure 4.26. Topographic difference plot from zero to 1.93 hours minutes of run time. Note large area of erosion on the edge of the slope with soil deposition at the toe of the slope under the ECB.

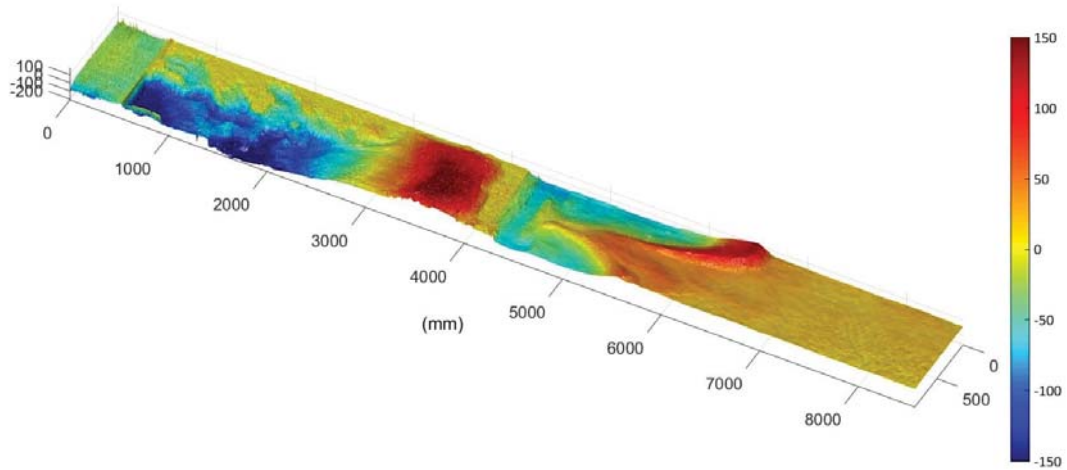
Figure 4.27. Topographic difference plot of bare soil before testing to 1.93 hours of run time with ECB removed. Removing the ECB reveals the extent of erosion that was occurring beneath the ECB.

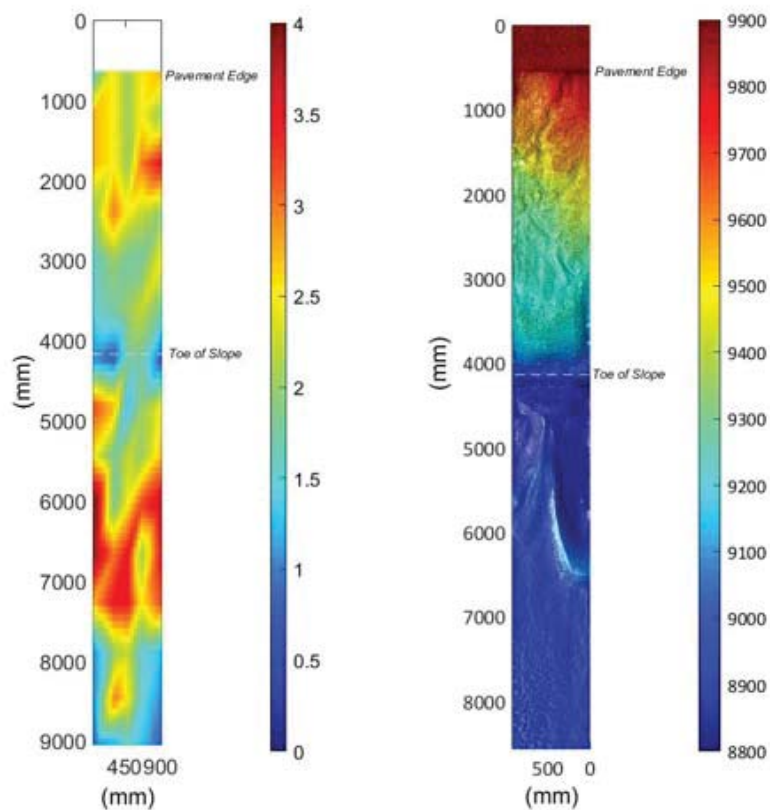
Figure 4.28. (Left) Aerial view of interpolated compaction data on slope. The vertical axis is distance in millimeters from mid-shoulder. Compaction is presented in units of tons per square foot. White area is the shoulder. The color bar on the right of the figure gives color range for compaction values. (Right). Aerial view of scanned slope after eight minutes of run time and ECB was removed showing large depression and channels near pavement edge.

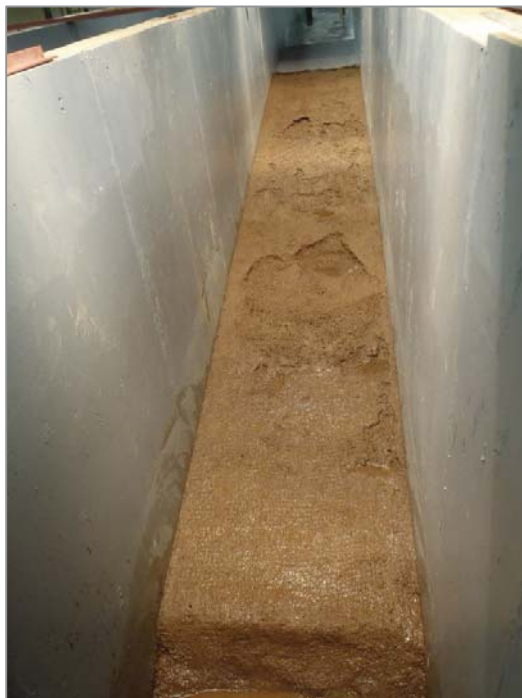
Similar to the 4H:1V slope “quick” test, there was little erosion during the first initial hours of run time. Through subsequent runs, aerially extensive but shallow erosion increased. Between 10 and 12 hours a small dip and mound was formed on the lower portion of the slope. This zone of erosion grew gradually until the test ended at 16 hours. The test was ended based on calculation of greater than 0.5 inches of soil loss. When the geogrid and erosion control blanket were peeled back, several other shallower areas of erosion were revealed.

Figure 4.32. Looking upstream at bare soil post run with treatment removed showing different locations of erosion on the slope.

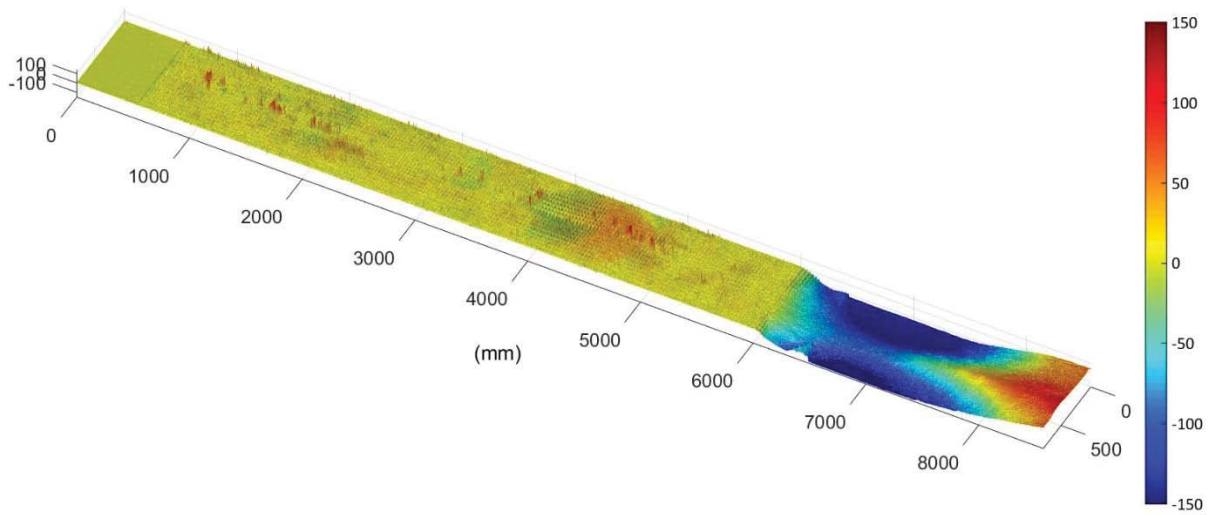
Figure 4.34. Topographic difference plot from zero to 16 hours of run time. Showing a depression and elevated mound $\frac{3}{4}$ of the way down the slope from the shoulder. Smaller depressions are also on the upper $\frac{1}{4}$ of the slope and at mid-slope

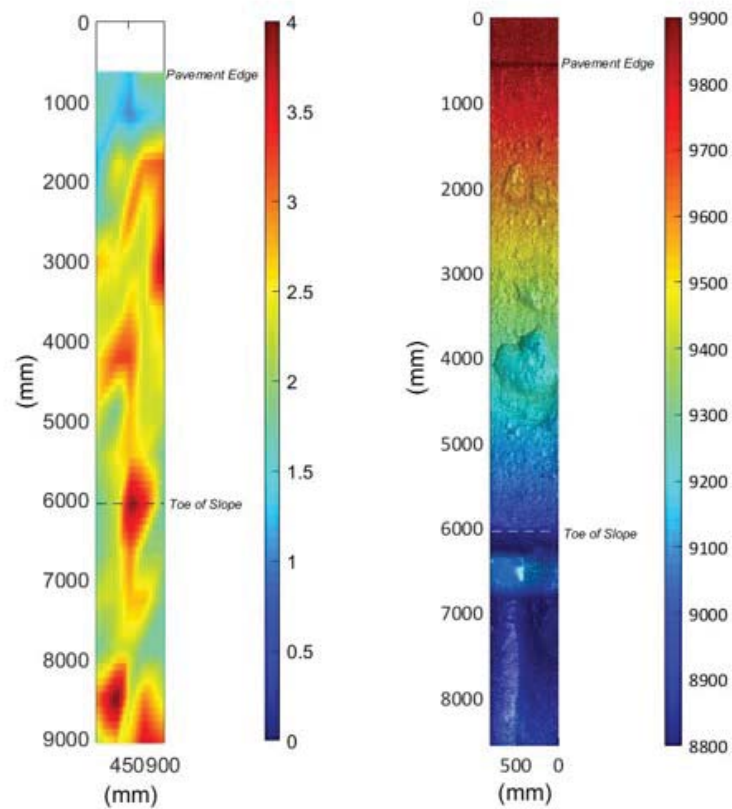
Figure 4.36. (Left). Aerial view of interpolated compaction data on slope. The vertical axis is distance in millimeters from mid-shoulder. Compaction is presented in units of tons per square foot. (Right). Aerial view of final bare soil scanned after the stabilization material was removed from the slope.

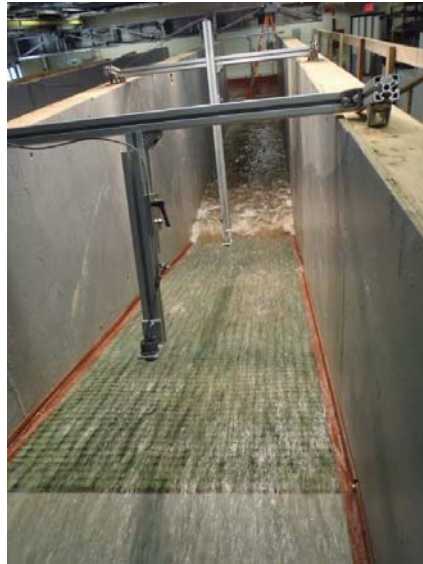
Almost immediately after the first flow began, erosion initiated just downstream of the shoulder resulting in flow penetrating beneath the geogrid and erosion control blanket. Water was turned off after 30 minutes. Erosion near the shoulder transition was similar to that of bare soil tests characterized by a scour hole immediately downstream of the shoulder.

Figure 4.37. Looking downstream at slope with indications of immediate erosion by murky tail-water during the first test.

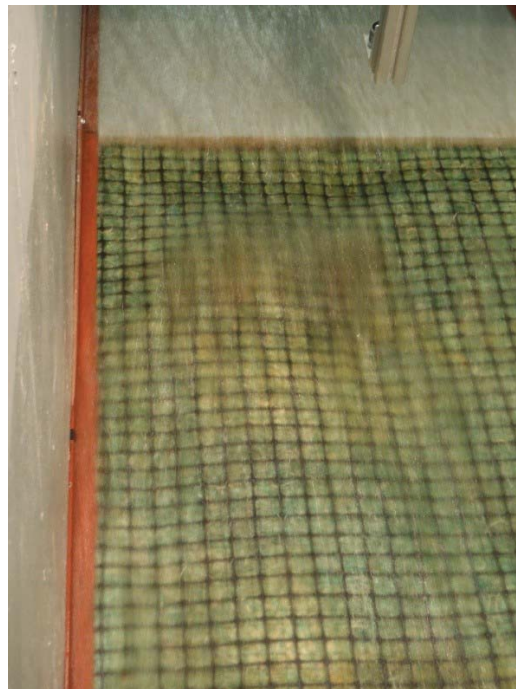
Figure 4.38. Close up of shoulder and slope transition looking upstream. Note the large depression immediately after the shoulder and mound of soil just downstream.

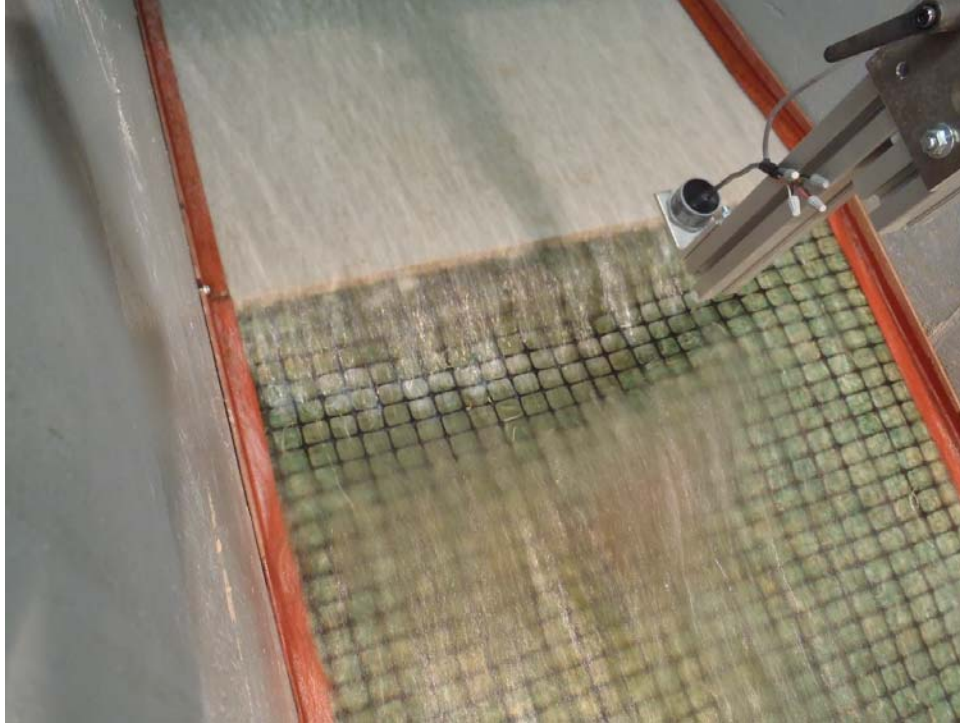
Figure 4.39. After only a few more minutes of run time the erosion has expanded to nearly the entire width of the transition from shoulder to slope.

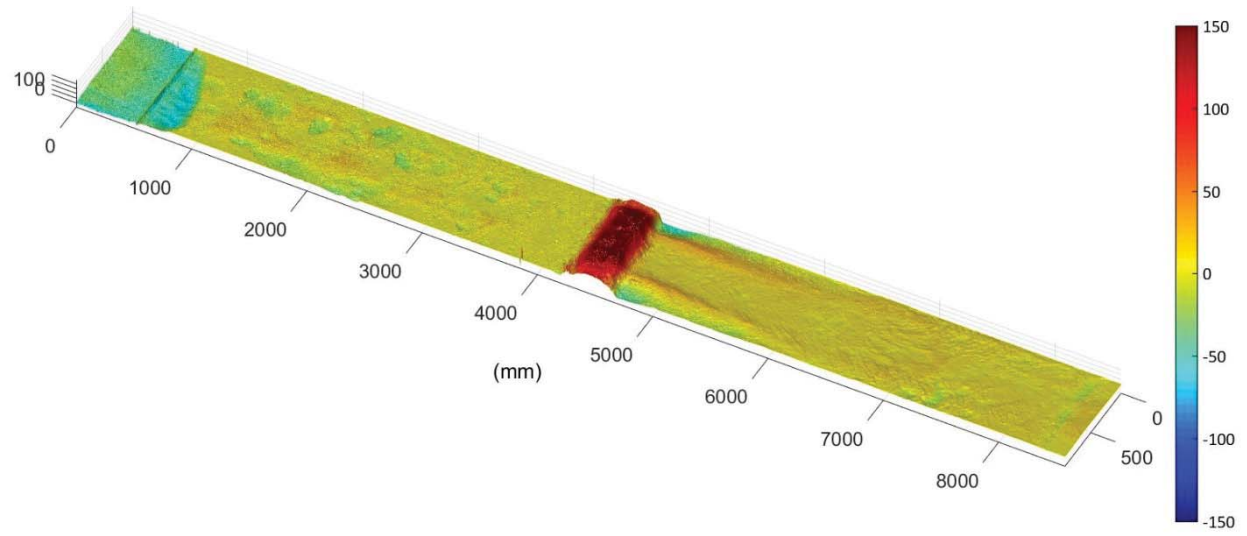
Figure 4.42. Topographic difference plot of initial bare soil vs. final bare soil after 30 minutes of testing. The large deposition at toe of slope is the ECB flipped over onto flat area, and not actually soil deposition.

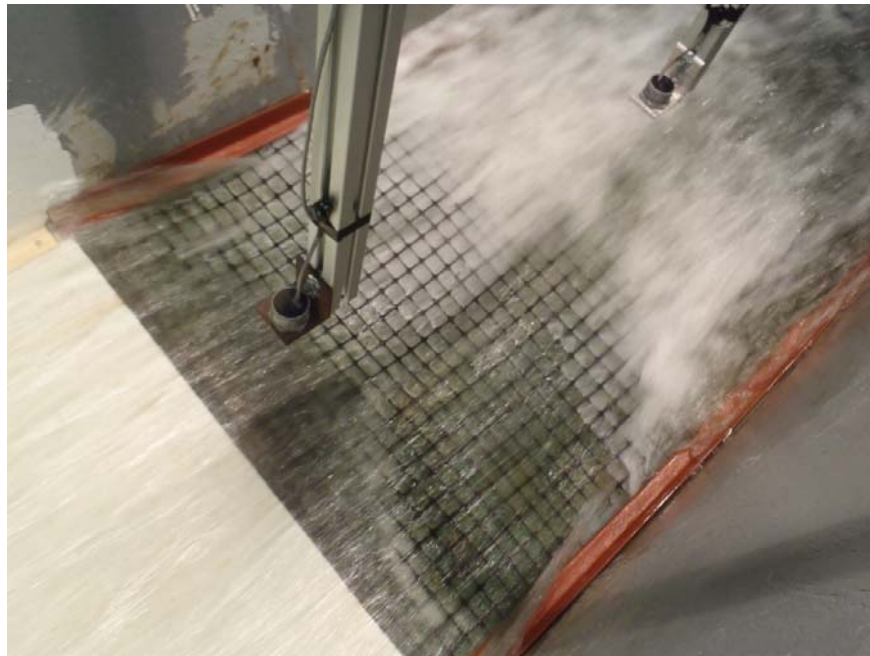
Similar to the 4H:1V “quick” test, the bulk of the erosion occurred near the top of the slope. The erosion and resulting mound extended across the width of the flume. Although the upstream eroded face was quite steep and the erosion was deep, the simulated paved edge was not undermined.

Figure 4.47. Looking downstream from shoulder near the end of the 4-6 hour run. Note the widespread area of erosion and flow separation from the shoulder hitting an angle where the deepest area of erosion is located.

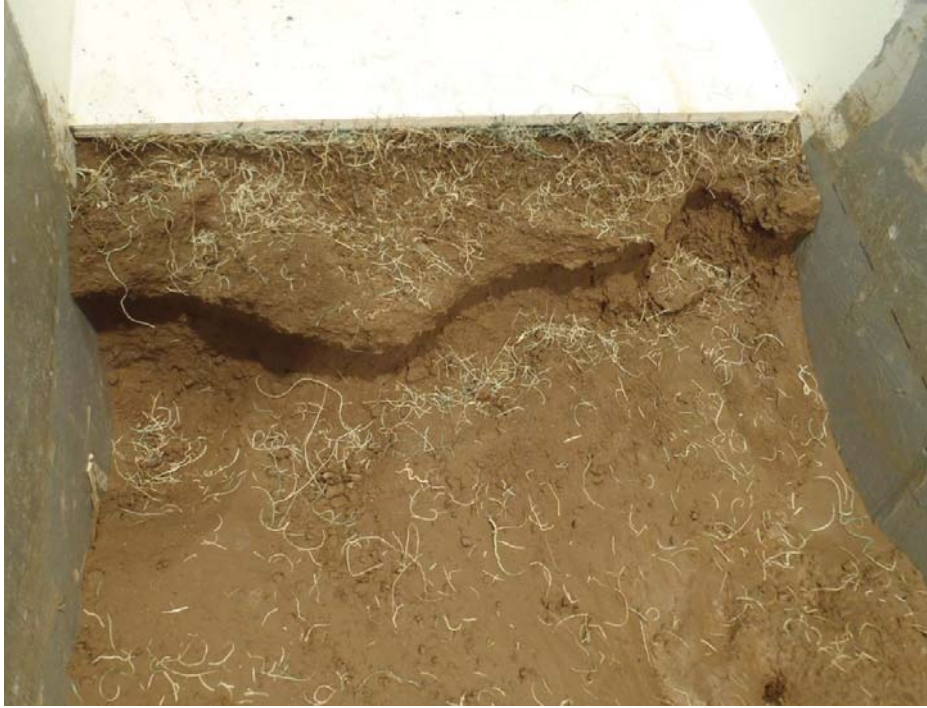
Figure 4.48. Looking upstream at shoulder and slope after stabilization material was removed. Note the remaining soil that was not undermined but close to it after 6 hours of run time.

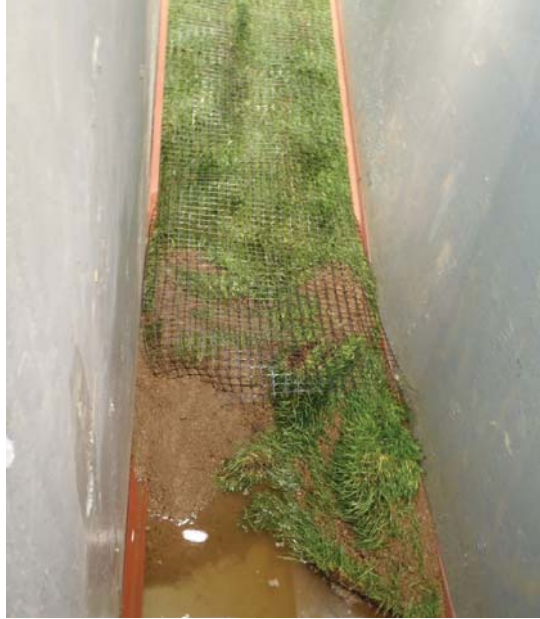
Although the sod did not root, it remained alive through the test and exhibited some growth. In this test, a progressive failure began at the flat run-out area and moved upstream. Sod pieces on the flat run-out area were washed away and soil was eroded to the floor. The soil beneath the sod at the toe of the slope was undermined, though the sod flexed to partly cover the eroding soil surface. Above the obvious eroded area, the soil was completely intact.

Figure 4.56. Looking upstream at toe of slope. Erosion beginning at toe of slope, undermining sod and washing some pieces away. Erosion working up the slope from run-out area.

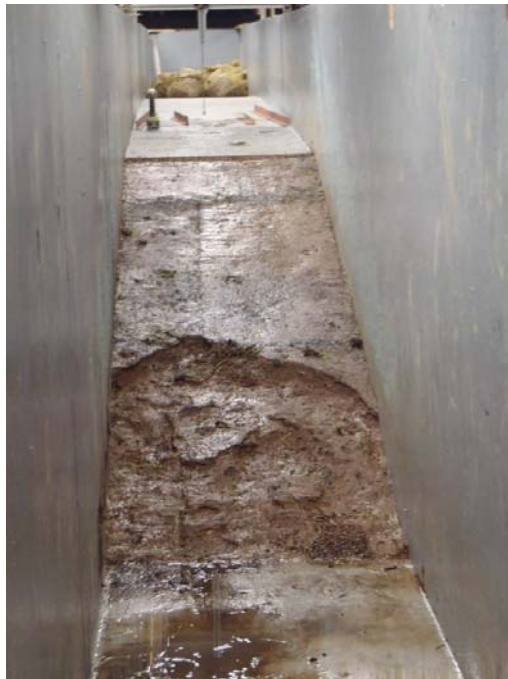
Figure 4.57. Looking upstream from run-out area. Stabilization material removed showing the extent of the erosion starting at the toe of the slope and working up towards the shoulder.

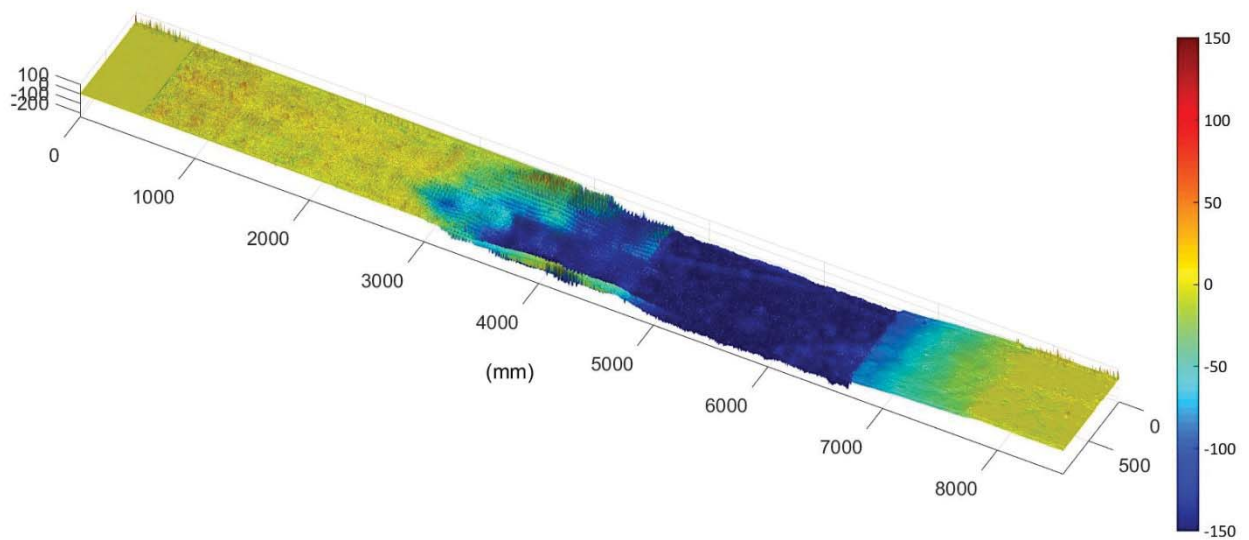
Figure 4.60. Topographic difference plot from zero to 4.5 hours of run time. Note the unchanged upper slope and erosion at the bottom of the slope.

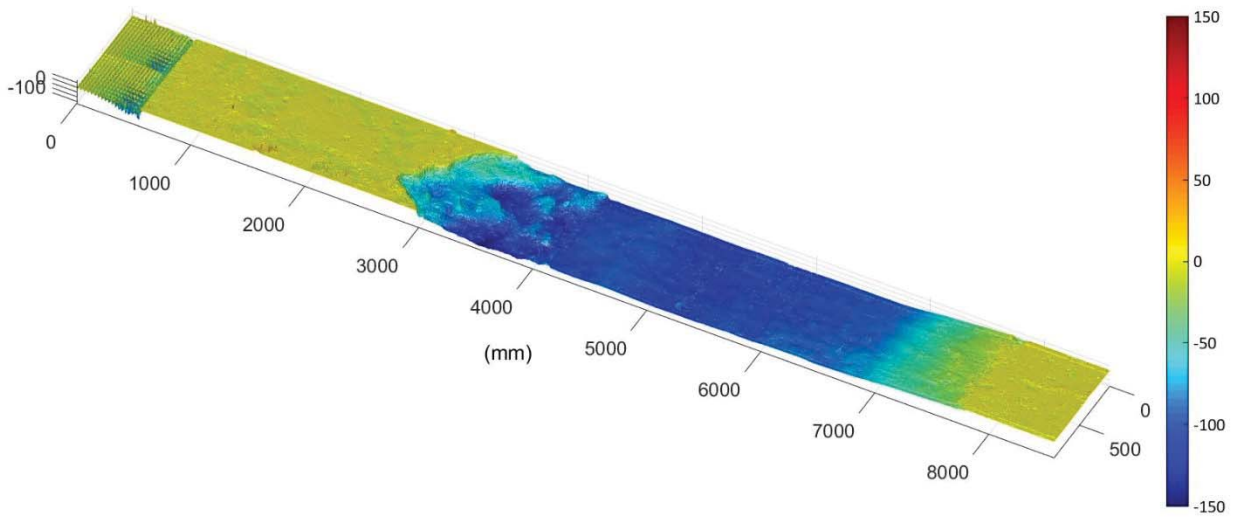
Figure 4.61. Topographic difference plot of initial bare soil vs. final bare soil after 4.5 hours of run time. Upper slope to approximately 2500mm downslope still intact.

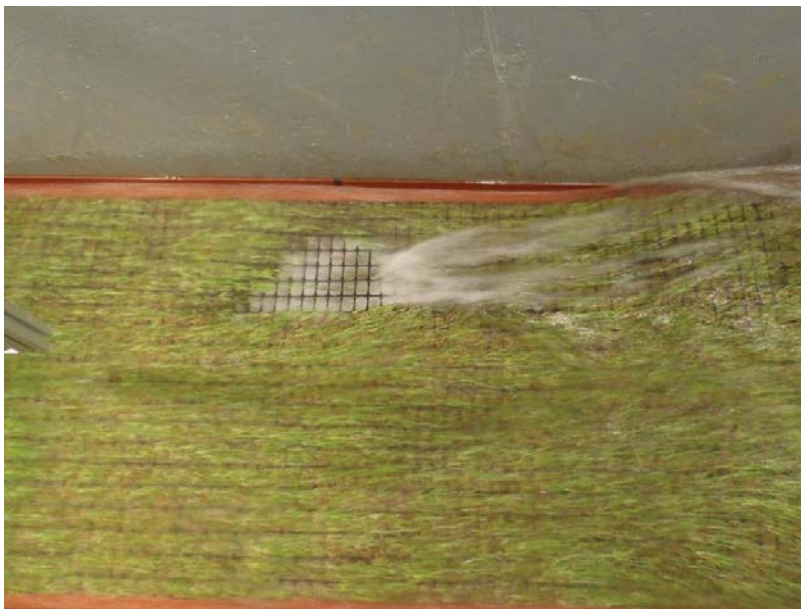
In contrast to the 4H:1V “quick” test, the slope first began to erode at a butt joint between sod pieces about halfway down the slope after more than two hours. This erosion was relatively localized until the flow step increase, when it expanded greatly. Similar to the 4H:1V “quick” test, soil eroded from beneath the sod before the sod washed away. At the end of the test a small section of sod near the top of the slope was still intact, as well as the soil beneath.

Figure 4.64. Aerial view of the slope just past halfway down the slope a large depression formed quickly at the seam of two pieces of sod just minutes before the end of the 2-4 hours testing time.

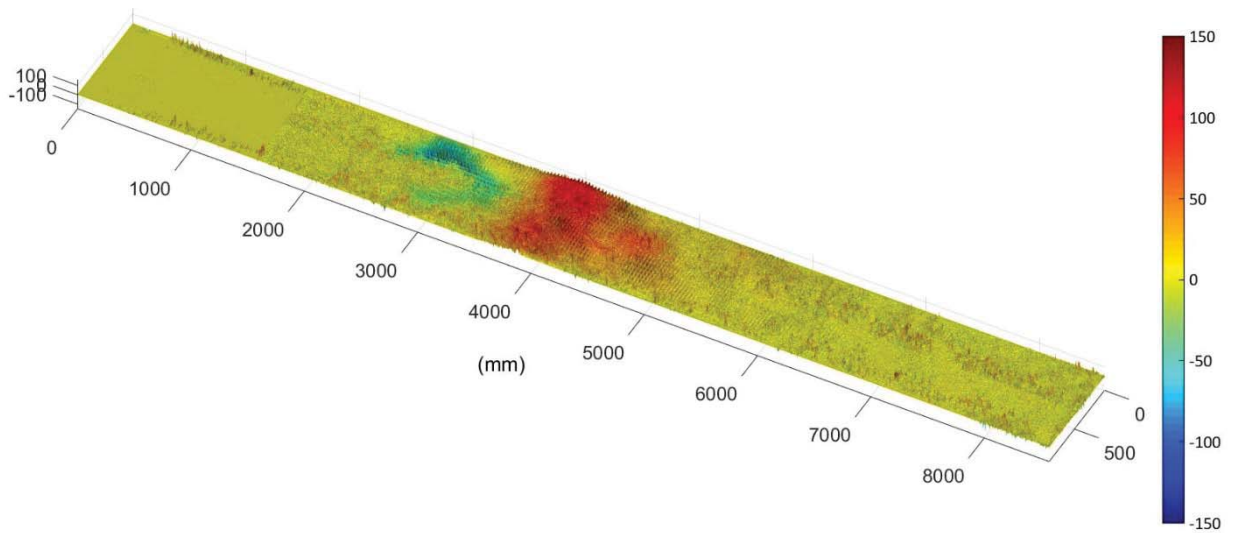
Figure 4.69. Topographic difference plot from zero to four hours of testing time. Note the large deposition at the toe of the slope and depression upslope of it.

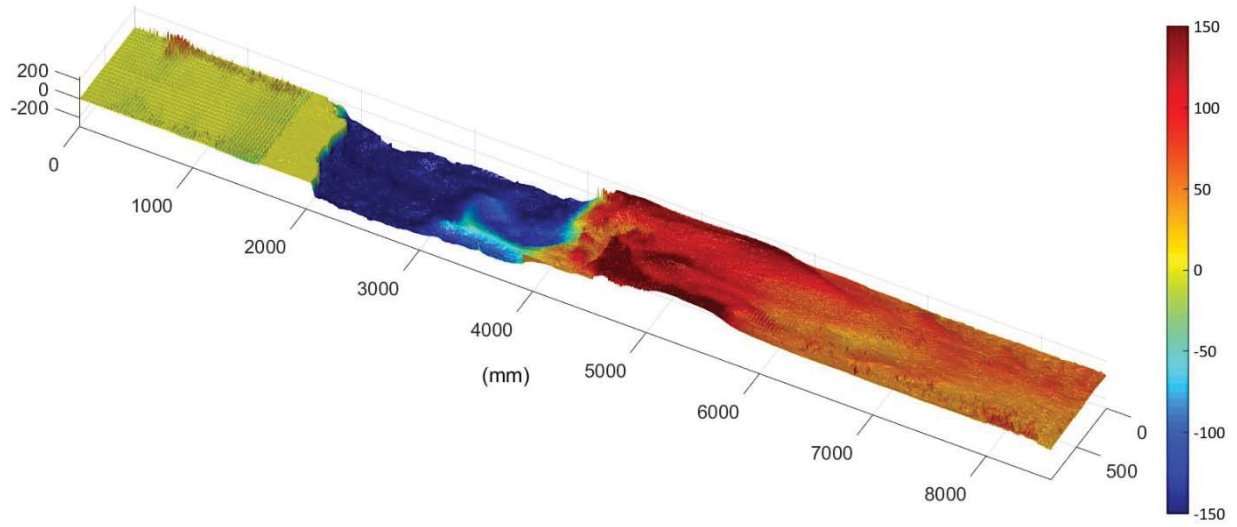
Figure 4.70. Topographic difference plot of initial bare soil vs. final bare soil after 9.5 hours of run time. The upstream slope is still intact. Note that the positive elevation on pavement section is the geogrid that has been flipped back over the surface.

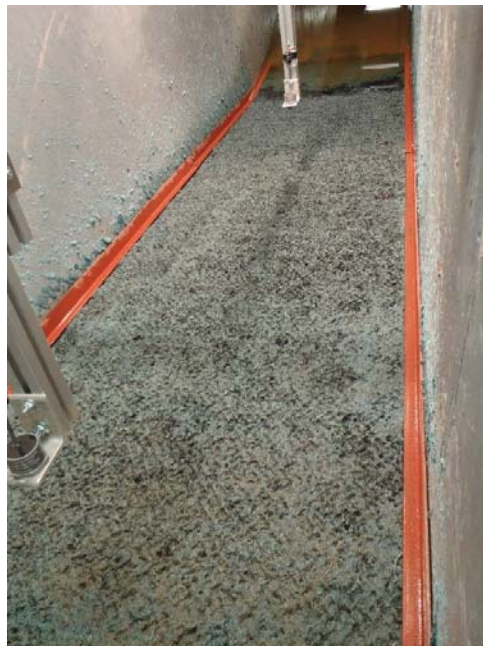
Figure 4.73. View from upstream after 1 hour of run time, note that some of the FRM has been washed away from the surface of the TRM.

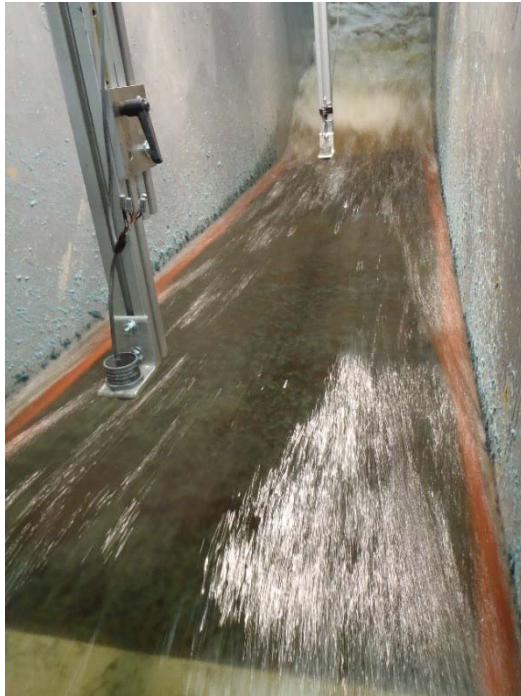
Although the FRM was fully integrated into the TRM it was progressively washed away exposing the TRM mat beneath. Erosion started in the lower third of the slope and slowly migrated upslope. Some soil was deposited beneath the TRM immediately upstream of toe of the slope. Other than several other isolated pockets of erosion the remainder of the slope was essentially free of erosion.

Figure 4.74. View from upstream during 2.5-3.0 hour run. Note that most of the FRM has been washed away at this point.

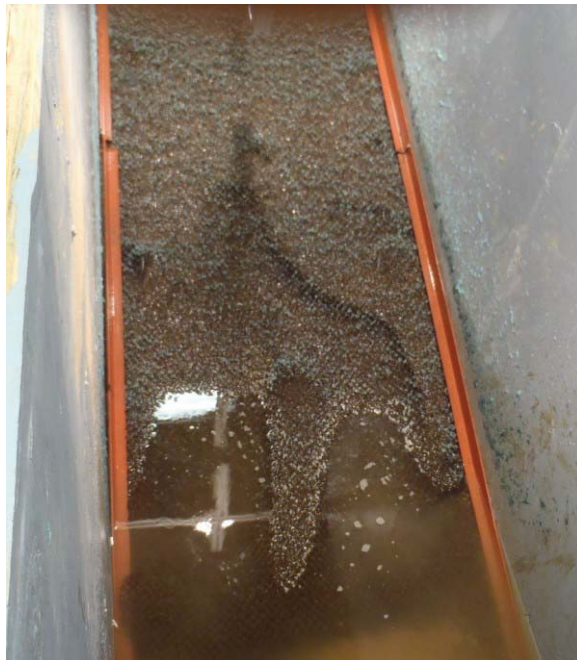
Figure 4.75. View from downstream after 3.5 hours of run time. Erosion working up the slope from the toe under the TRM.

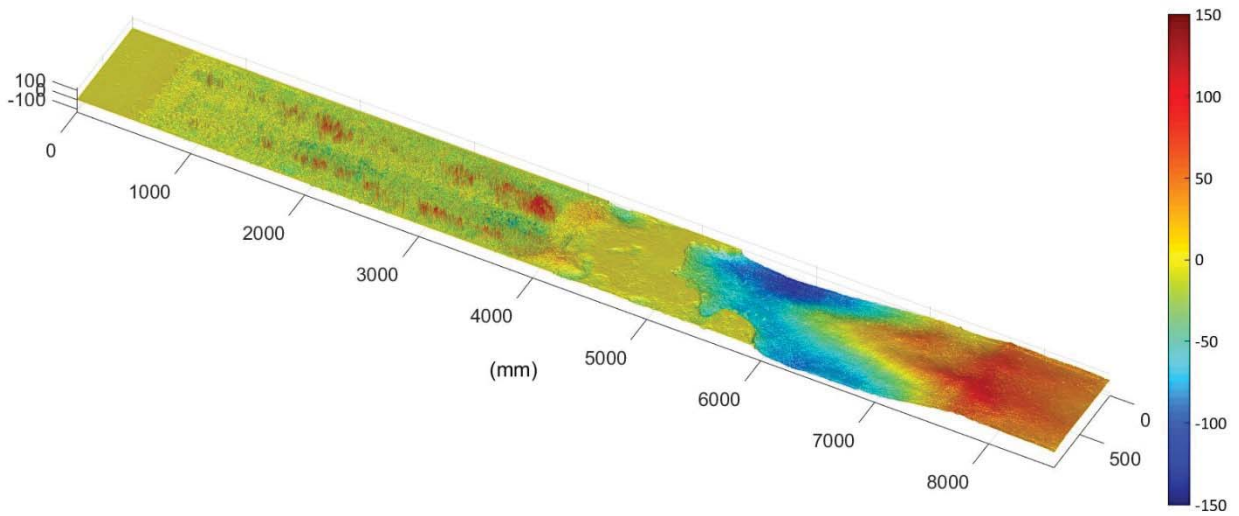
Figure 4.78. Topographic difference plot from zero to 2.5 hours of run time. Erosion and deposition occurring at the toe of the slope.

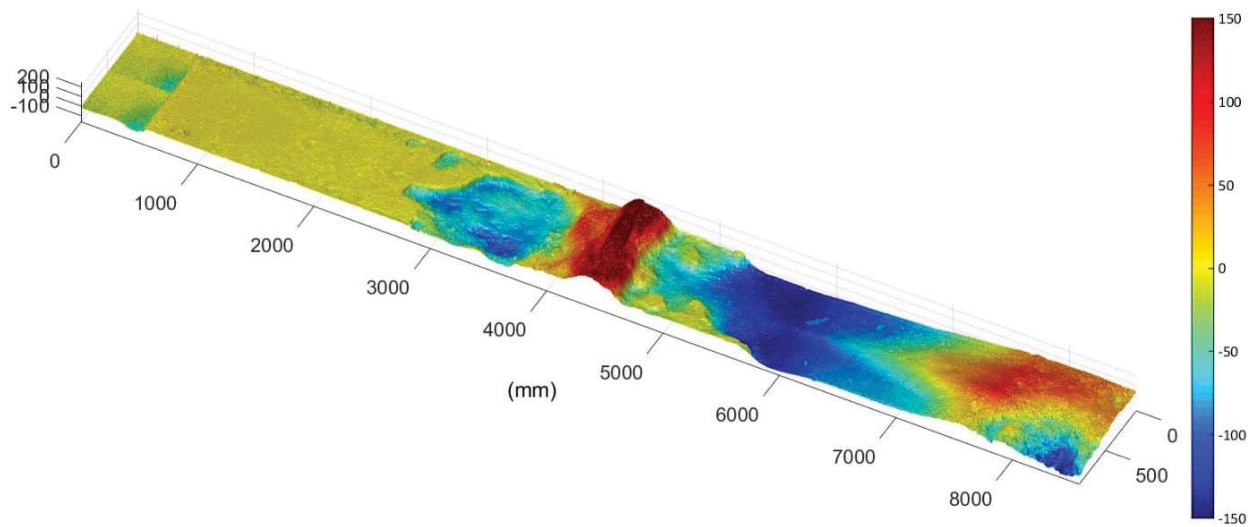
Figure 4.80. Topographic difference plot from initial bare soil vs. final bare soil after 3.5 hours of run time. Substantial erosion near the toe of the slope. The large depositional area at 4300 mm is the TRM after being flipped onto the flat run-out area.

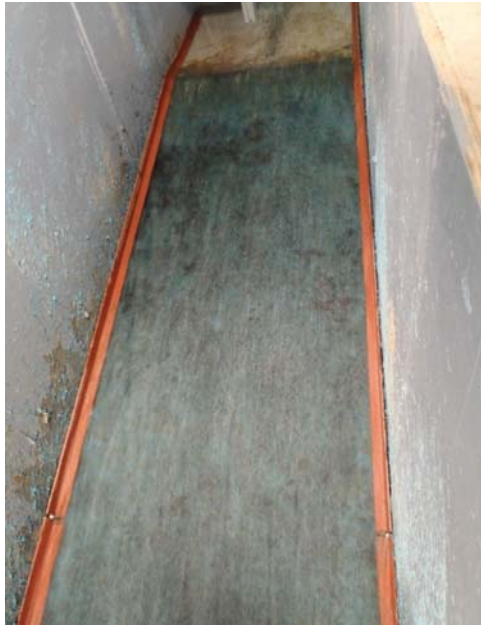
Figure 4.82. View from downstream during 0-2 hour run. Minimal erosion noticed. FRM is being washed away while TRM is remaining stapled to the slope.
