Design Considerations for Embankment Protection During Road Overtopping Events

Jeffrey D. G. Marr, Principal Investigator

St. Anthony Falls Laboratory

Final Report 2017-21

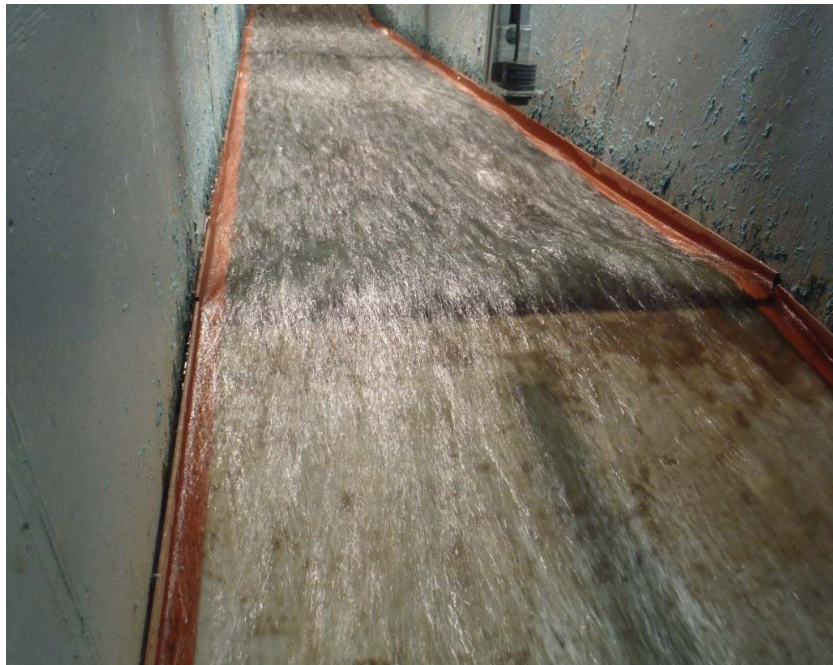
Figure 4.83. View from upstream during 2-4 hour run. Noticeable depression after shoulder along right edge of slope. More of the FRM is being removed from testing.

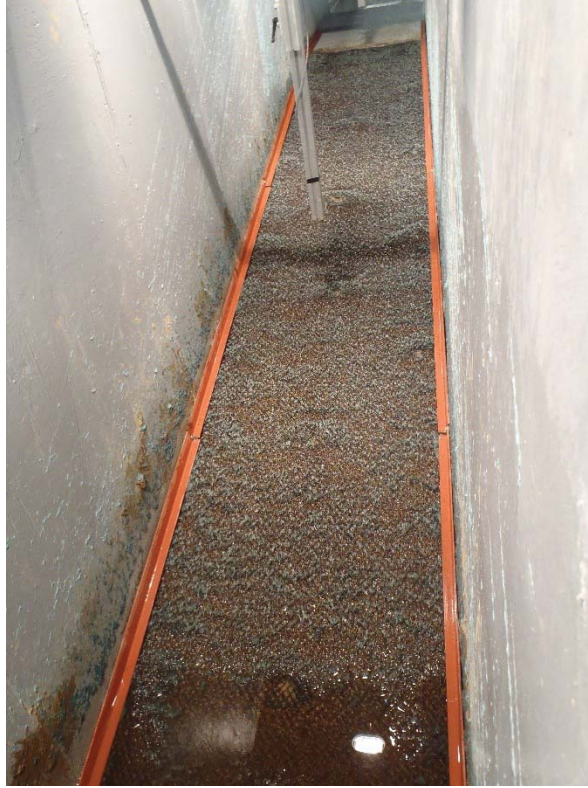
Figure 4.84. View looking upstream after six hours of run time. Almost all of the FRM has been washed away and the depression near the shoulder has gotten deeper.

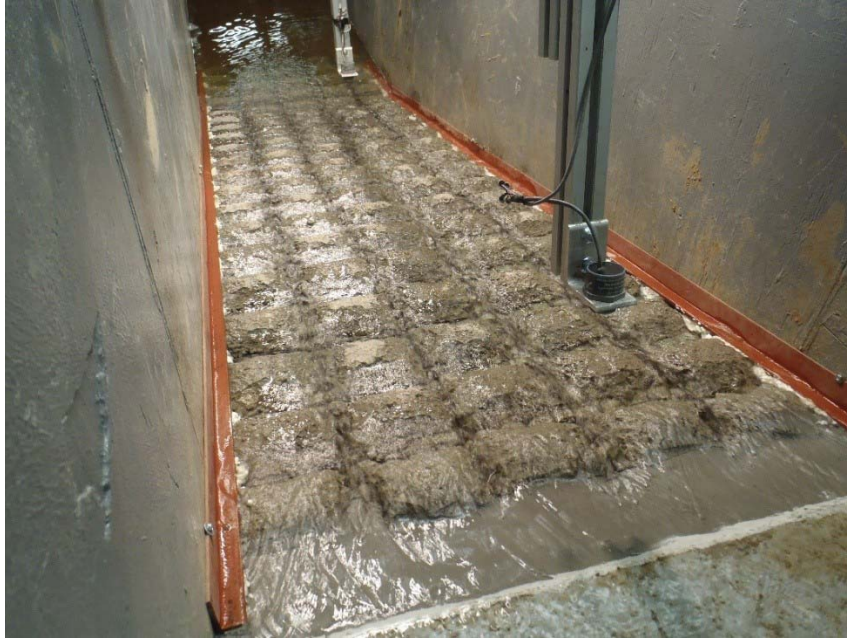
Figure 4.91. Image from Run 1 with discharge set at $0.9 \text{ ft}^3/\text{s}$. There was no noticeable erosion over entire 30 min run.

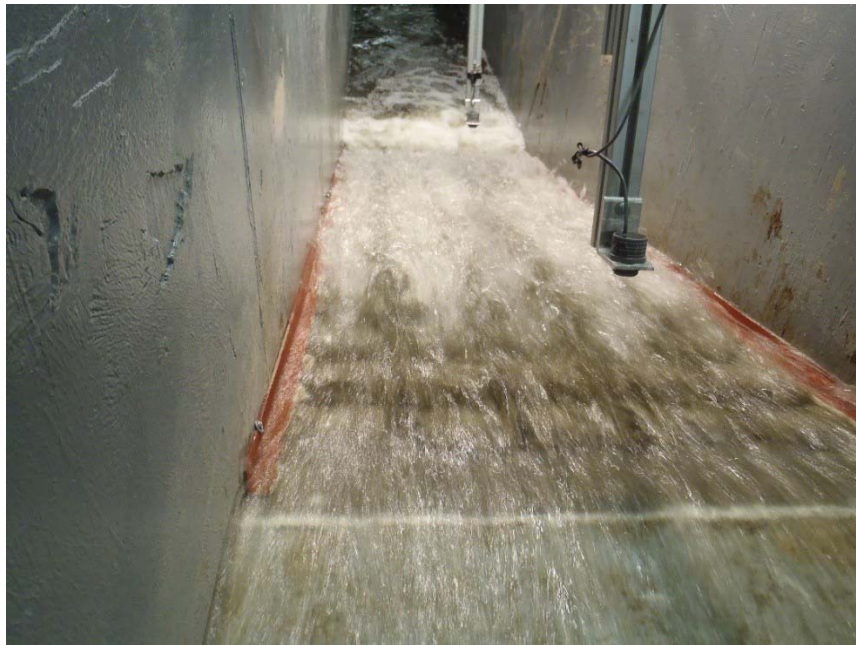
Figure 4.92. View looking downstream from the shoulder during 1 to 1.5 hour run with flow of $2 \text{ ft}^3/\text{s}$ and overtopping depth of 3 inches. The flow was aerated and very turbulent.

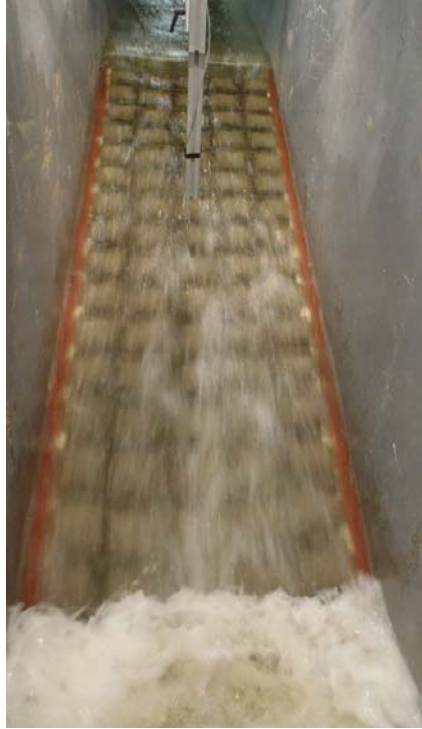
The first two runs, 0.4-inches and 3 inches of overtopping, resulted in only minor erosion. During the third run, a small scour hole and depositional mound became noticeable about 66% of the way down the slope. This void grew in size and at about 1.5 hours a second scour hole and depositional mound was observed downstream of the first. The experiment was then ended.

Figure 4.93. Looking upstream at slope near end of 1.5 hour run. Aeration near mid-slope and erosion/deposition areas stepping down the slope.

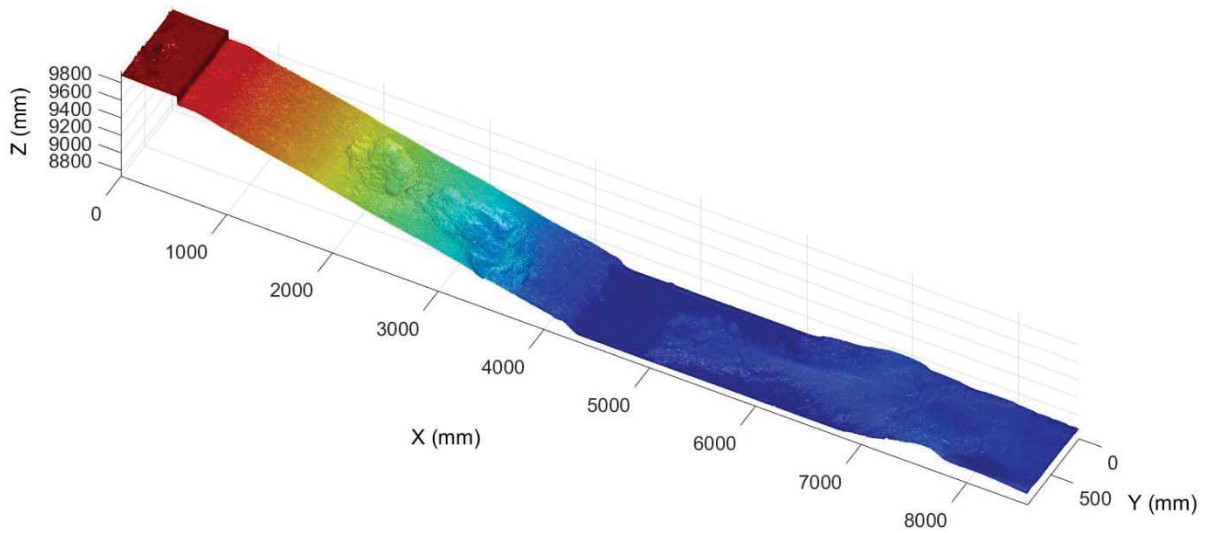
Figure 4.96. Scan of the final bare soil after the Flexamat® was removed. Two large depressions are shown here, similar to what is seen in the difference plot of zero vs 1.5 hours of run time, but more prevalent when seen without the Flexamat® covering it.

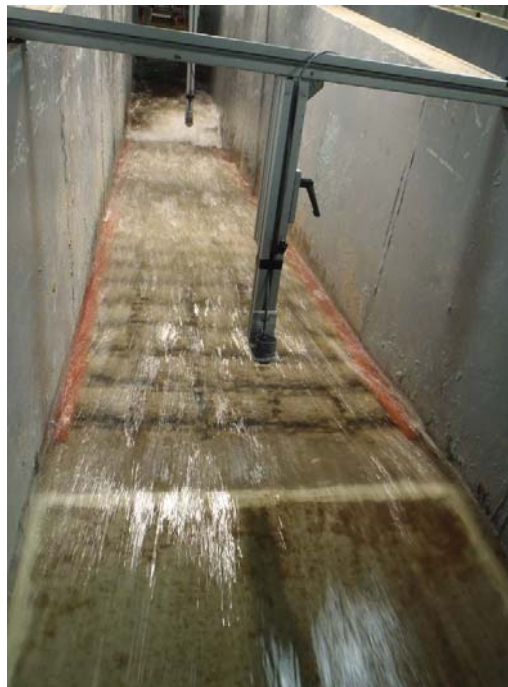
Figure 4.99. View from shoulder looking downstream during 10-12 hour run. No noticeable erosion on the slope.

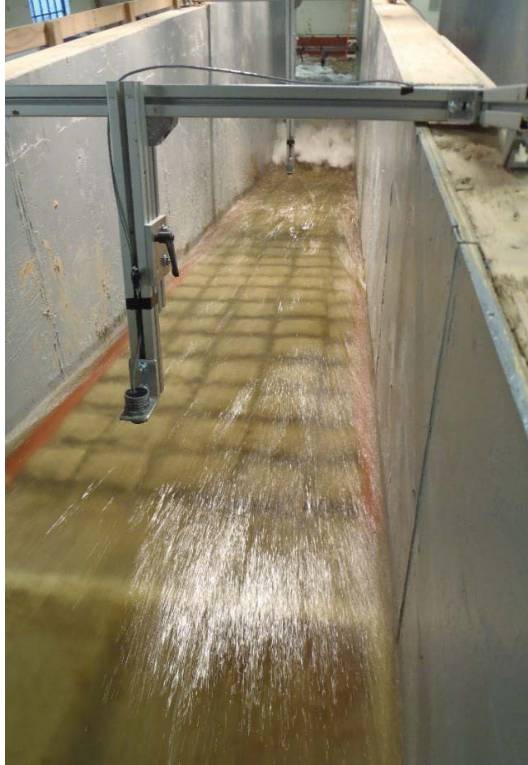
Figure 4.100. View from shoulder looking downstream during 22-24 hour run. No noticeable erosion, smooth water surface to about mid-slope.

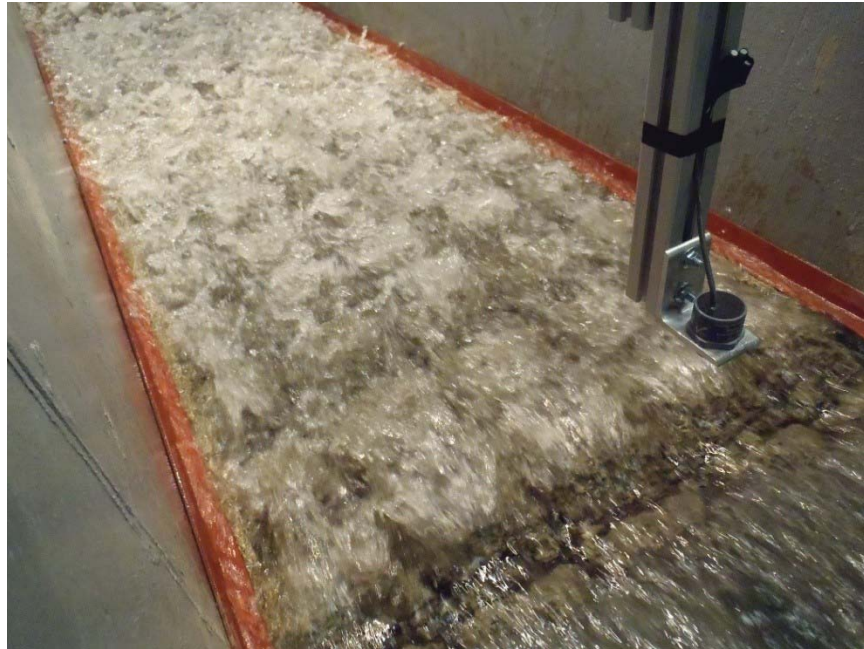
Figure 4.105. View from shoulder looking downstream during first two hour run. Highly turbulent flow but no noticeable erosion on slope.

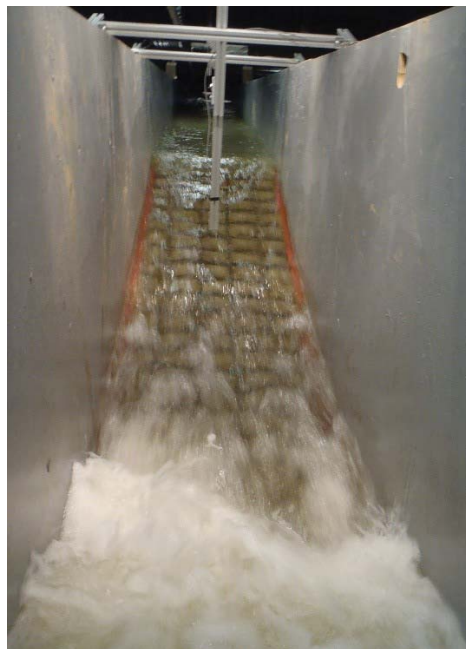
As with previous tests with this technique, the water surface is very turbulent and aerated during low flow state (Figure 4.106). It is not clear if this hydraulic condition initiates the erosion process. The topographic scan data showed erosion forming mid-slope after 4 hours of run time and fairly low discharge. The run was continued for 25.3 hours total and discharge was increased. During this period, the extent and depth of erosion continued under the mat. The mat did not wash out but was held in place however soil was able to erode and wash away from underneath the mat. The erosion scour and deposition was observed to translate downslope during the test.

Figure 4.106. View from downstream looking up at slope during 24.35 to 25.33 hour run. Mid-slope mound has been eroded and flat upper slope has stabilized and new mound at toe of slope is causing aeration.

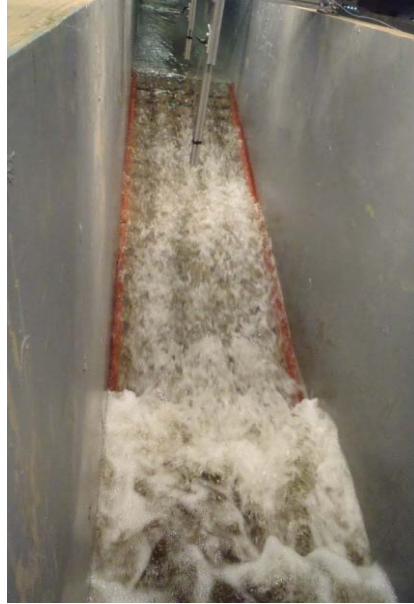
Figure 4.107. View from downstream looking up at slope during 4-6 hour run. Note the depression and subsequent aggradation at mid-slope causing aeration.

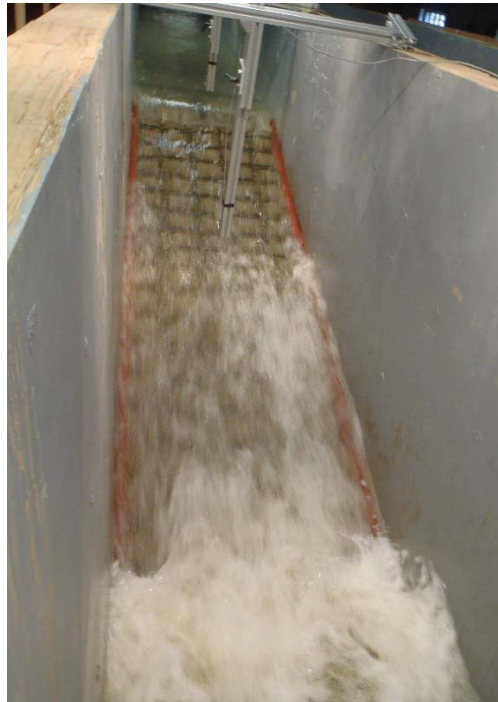
Figure 4.108. View from downstream looking up at slope during 17.25-20.25 hour run. The slope did not drastically change over 10 hours of run time from the first sign of erosion.

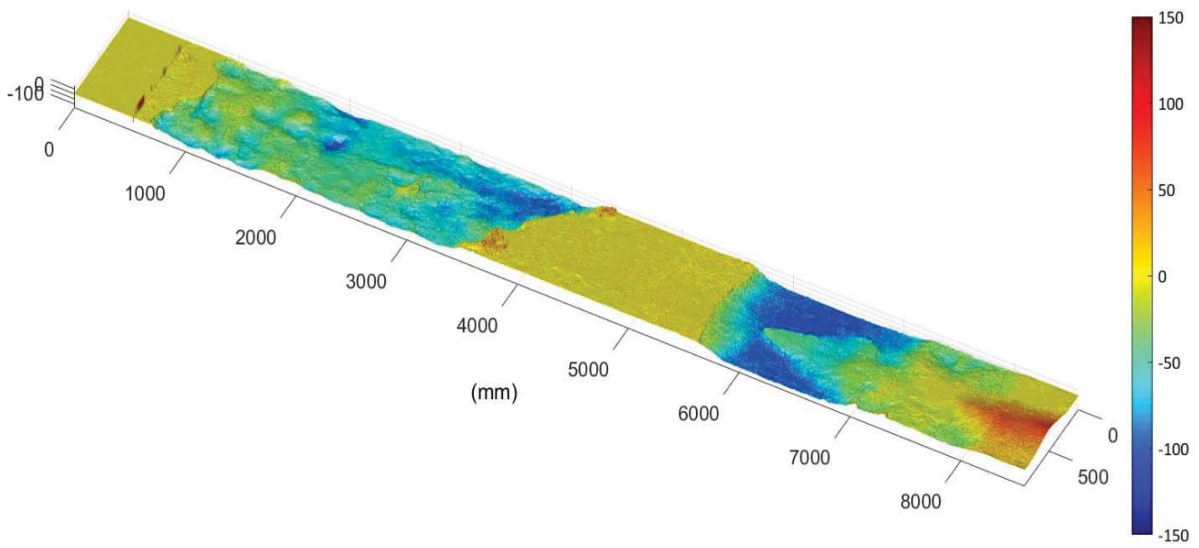
Figure 4.113. Topographic difference plot from initial bare soil vs. final bare soil after 25.33 hours of run time. Note the similarity to the previous figure in the location of the depression and the intact portion of the soil near the shoulder-slope transition.

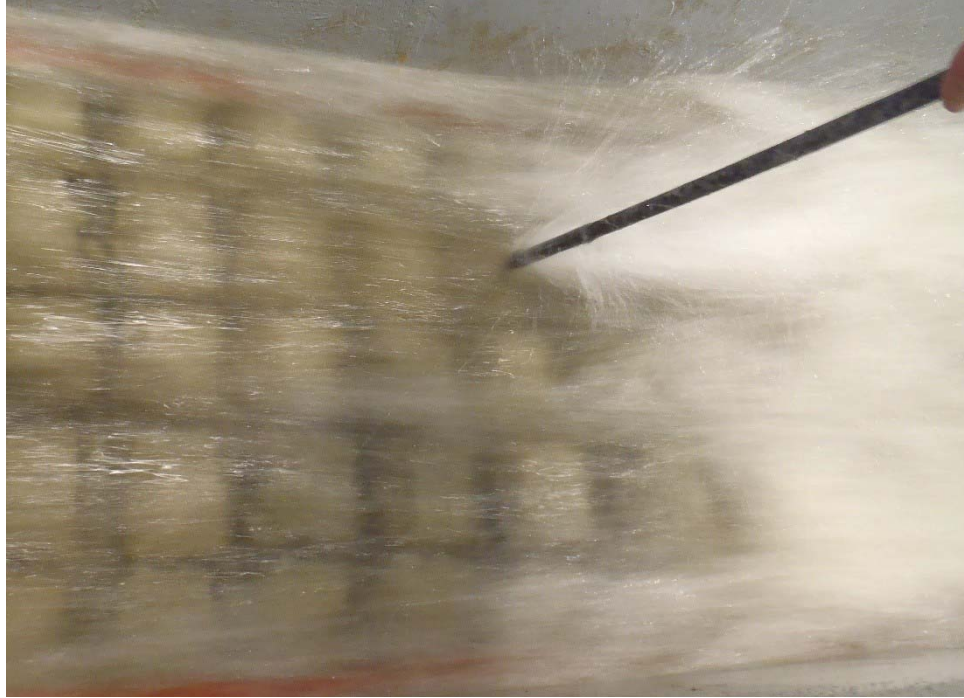
A similar lack of contact event occurred on the second 4H:1V test of the flexible concrete geogrid mat (Figure 6.2). The concrete mat separated from the slope surface despite the weight of the concrete block grid. There were no staples fastening the flexible concrete geogrid mat because it was assumed that the weight of the material would hold it against the slope surface. At a high flow of 0.72-ft over the crest, the velocity was fast enough to create uplift and the soil beneath was exposed and eroded near the toe of the slope.

Figure 6.2. Flexible concrete geogrid mat tested on the 4H:1V slope at 9.90 ft³/s and approximately 25 hours of run time. Concrete blocks may be pushed down with a probe rod 3-4 inches before touching the slope surface $\frac{3}{4}$ of the way down the slope.

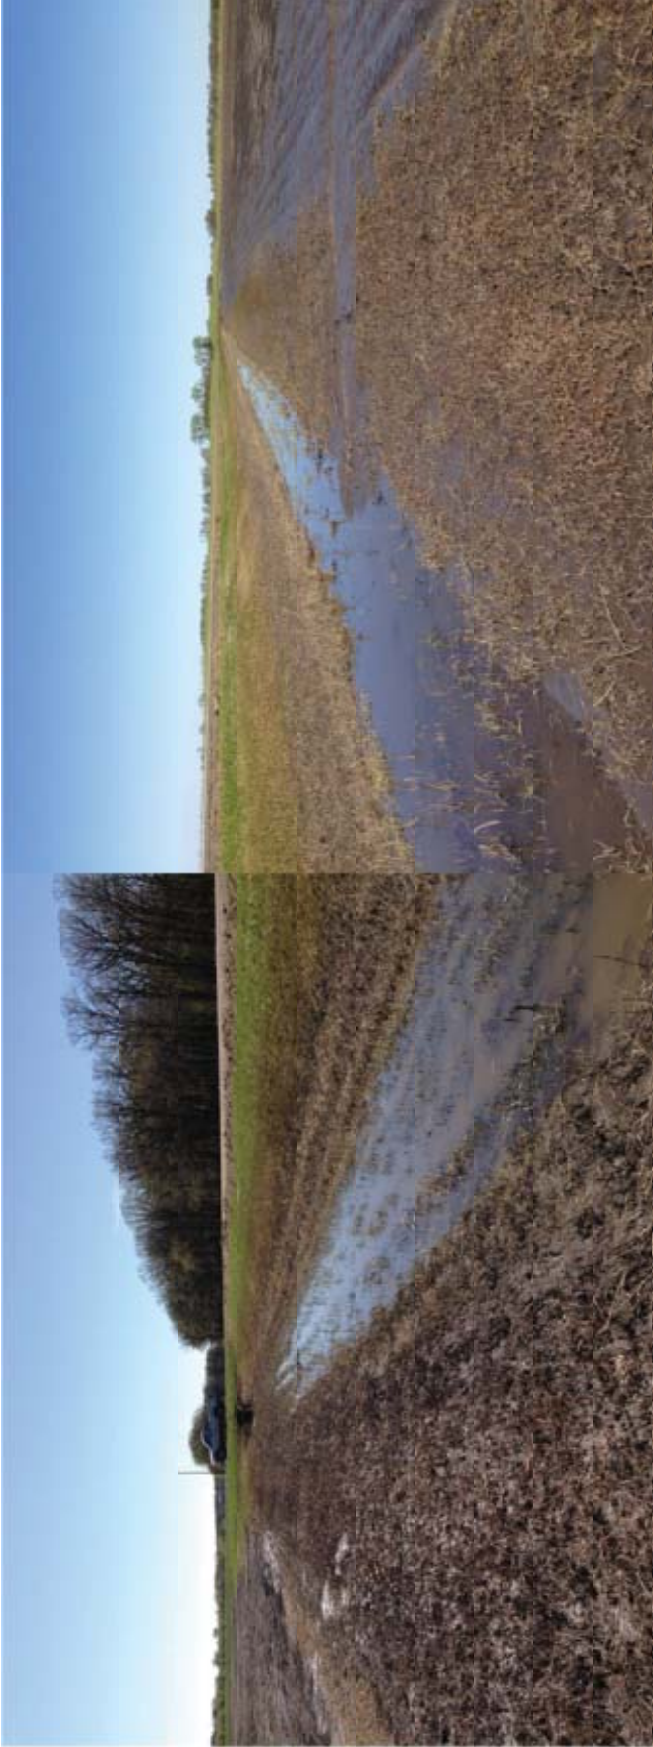
The site was inspected for damage once the flood water receded. Figures 6 and 7 show the site condition on May 23, 2013. There was no significant erosion noted.

UPSTREAM LOOKING EAST

UPSTREAM LOOKING WEST

Figure 6. Inspection – May 23, 2013 at the Marshall County Site

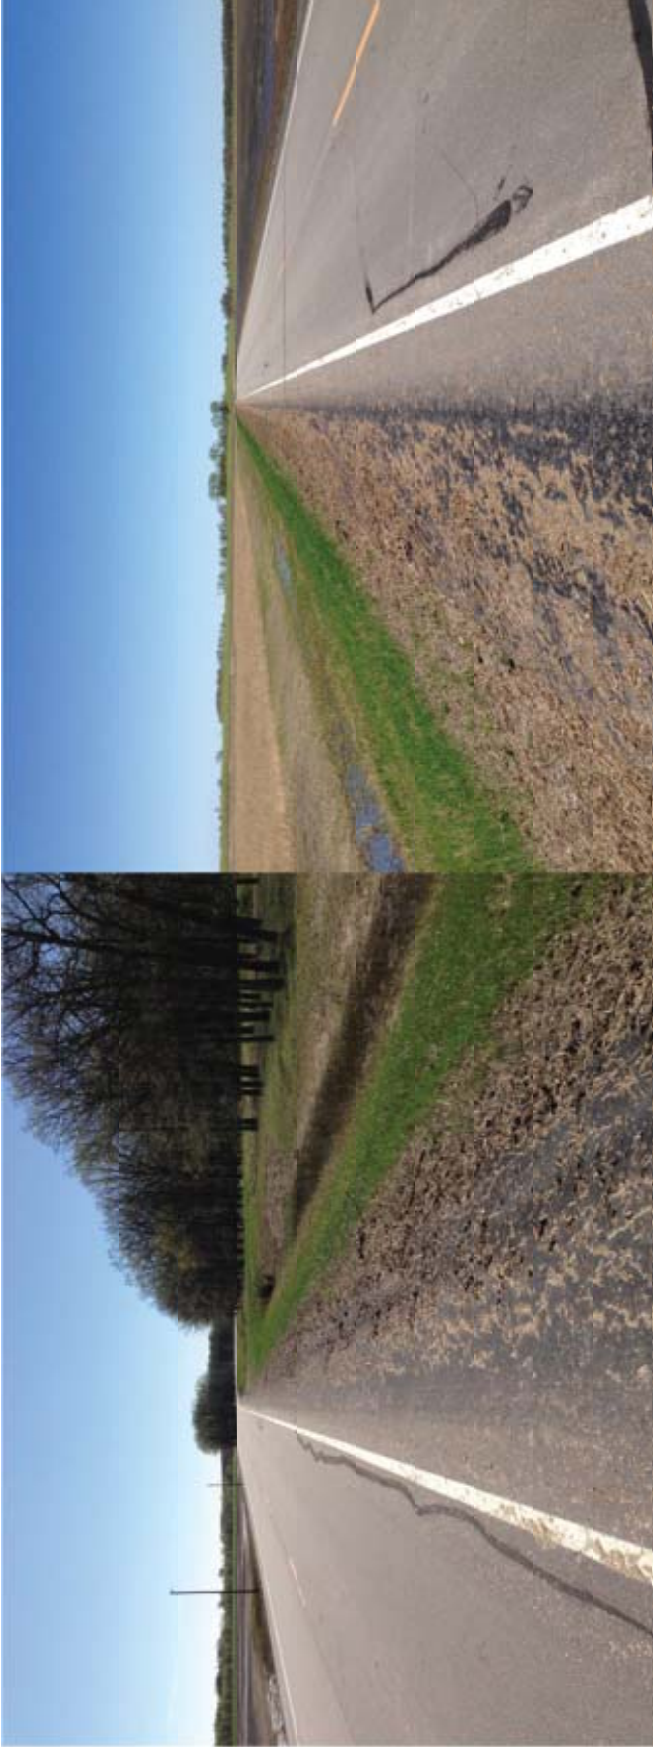
DOWNSTREAM LOOKING EAST

DOWNSTREAM LOOKING WEST

Figure 7. Inspection – May 23, 2013 at the Marshall County Site

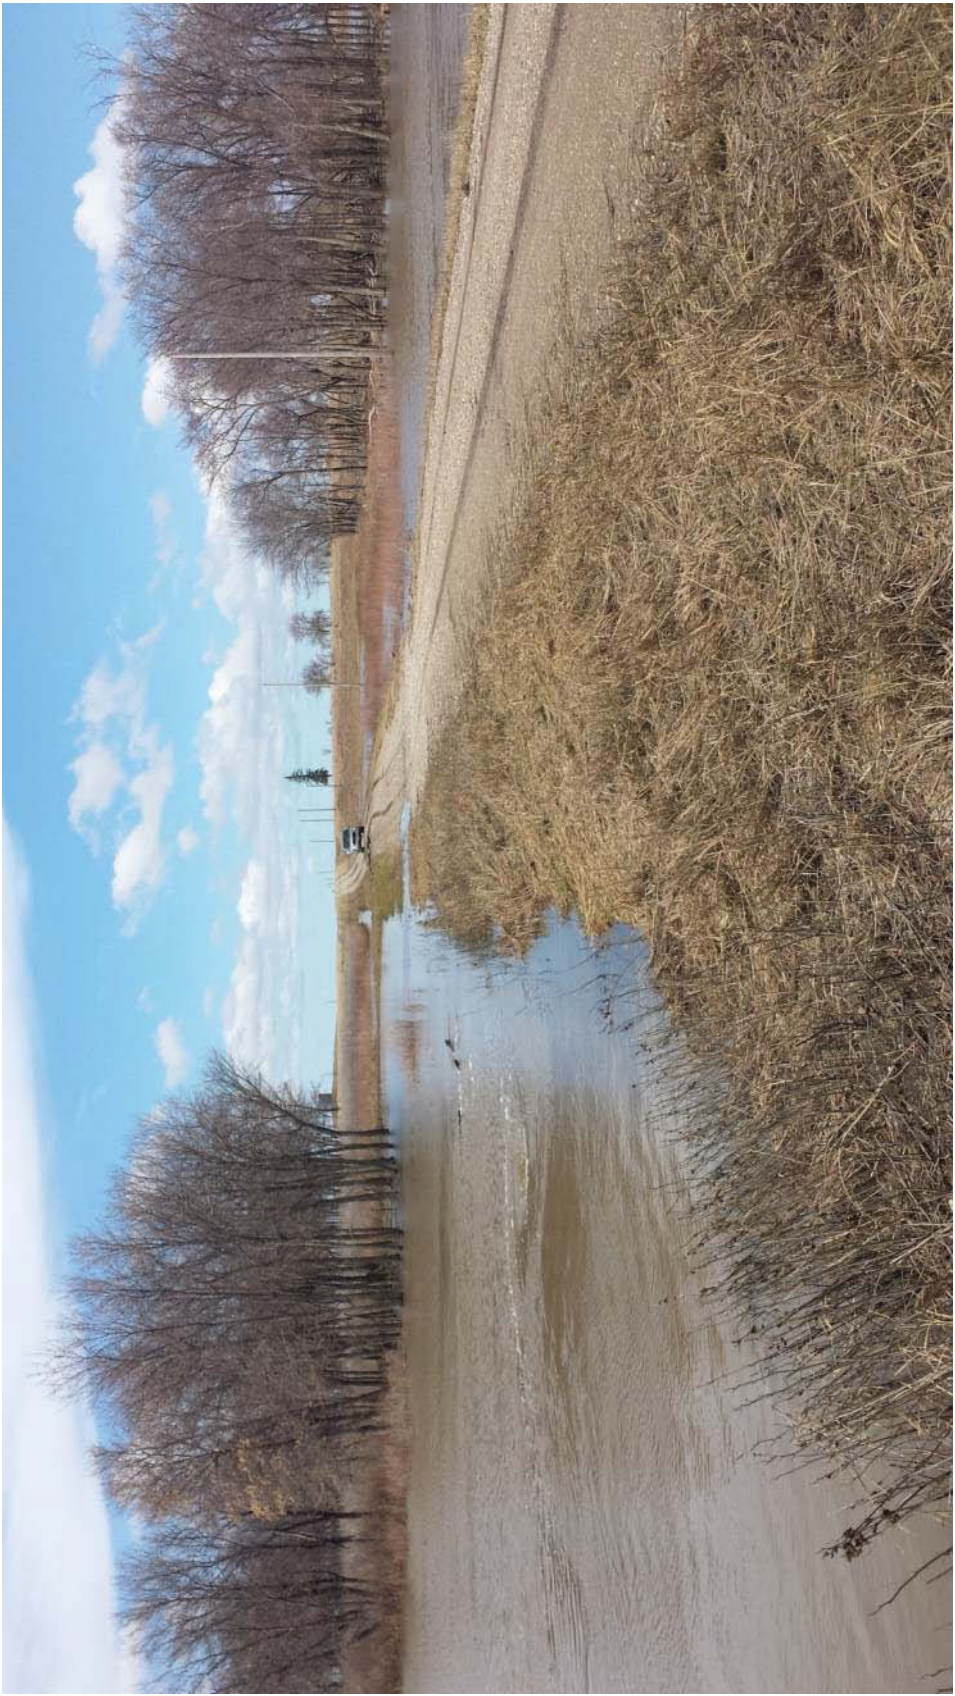
Location 4 Looking west at the upstream shoulder, post-flooding condition

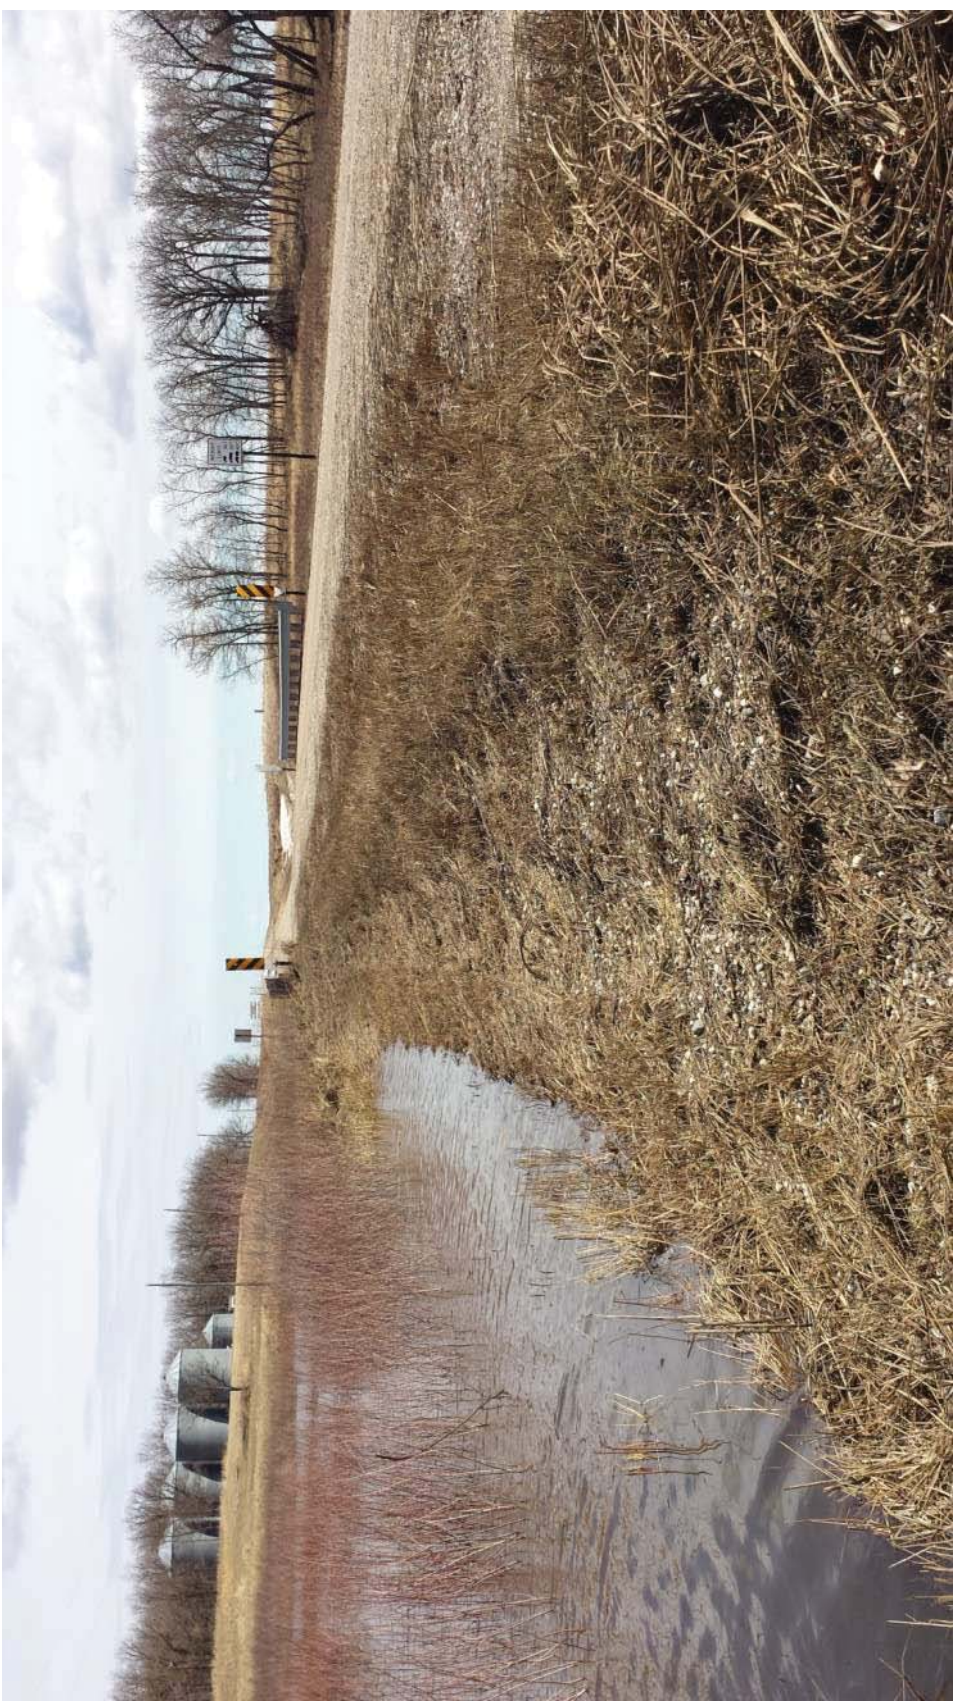
Location 5 Looking east at the upstream shoulder, post-flooding condition

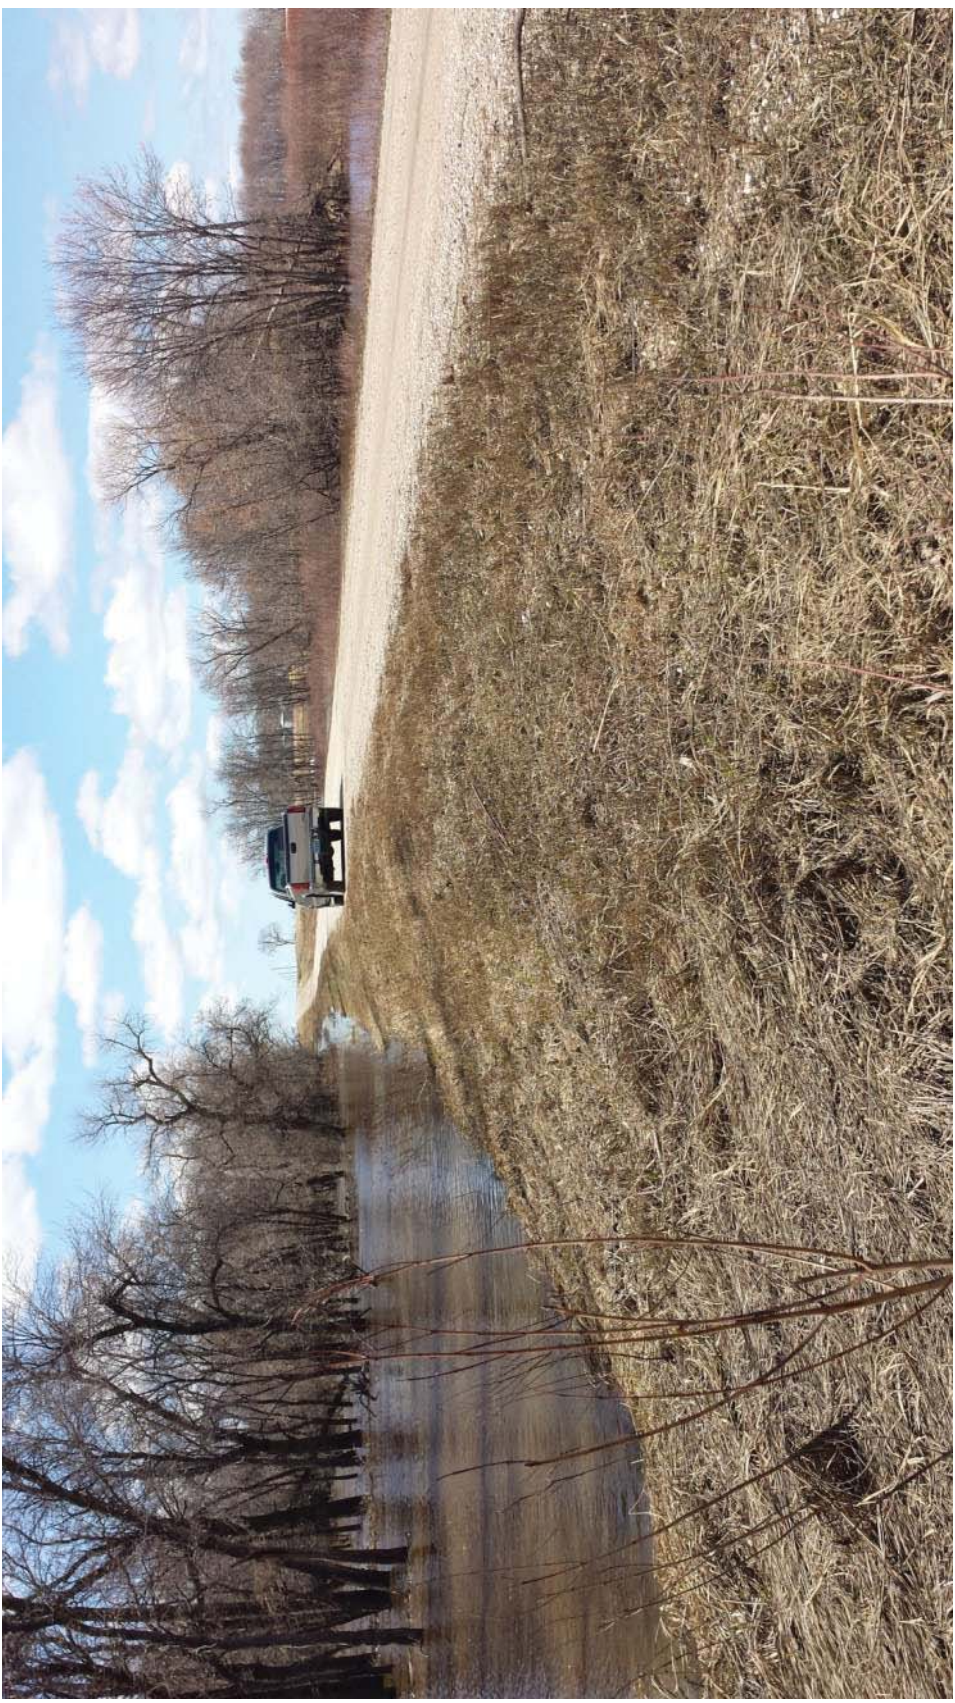
Location 5 looking west at the downstream shoulder, post-flooding condition

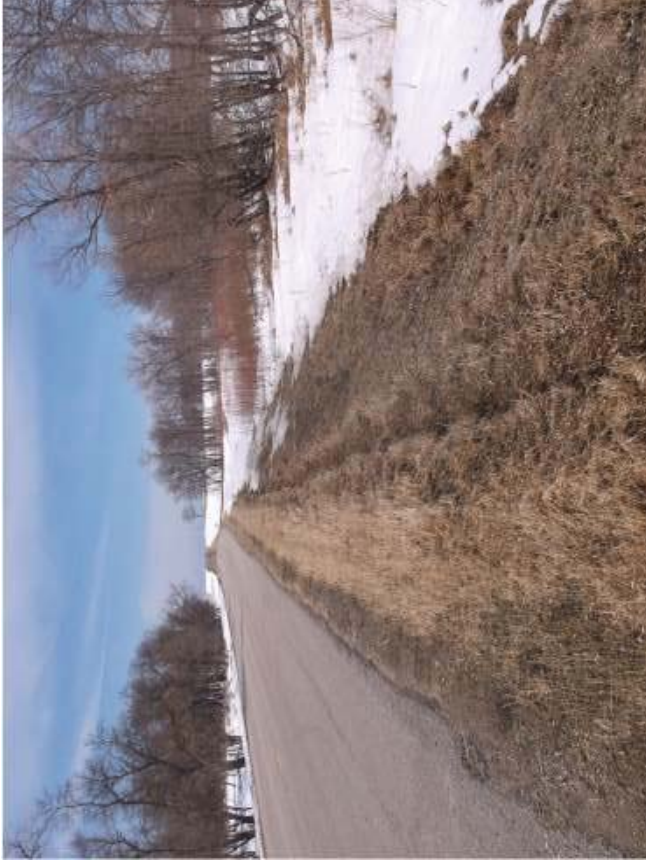
Existing Shoulder Conditions in Kittson County
