Comprehensive Field Evaluation of Asphalt Patching Methods and Development of Simple Decision Trees and a Best Practices Manual

Department of Civil Engineering
University of Minnesota Duluth

June 2017

Research Project
Final Report 2017-25

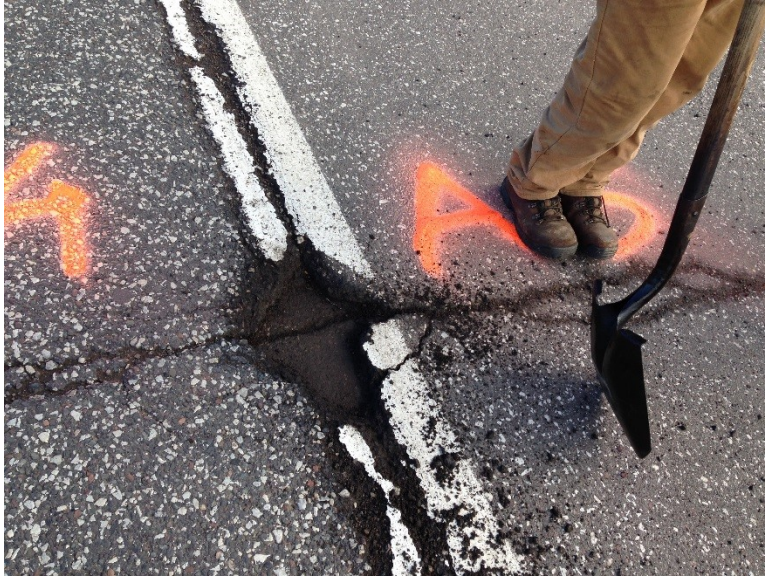
Figure 3.5 Pothole A-5 prior to Patching (After Cleaning).

Pothole A-5: This pothole was located along the shoulder joint. The pothole lies along an existing longitudinal crack in the overlay with a reflective transverse crack crossing through the pothole as shown in Figure 3.5. The pothole was prepped using compressed air. The size of the pothole was 17.5 inches x 13 inches x 1.5 inches.

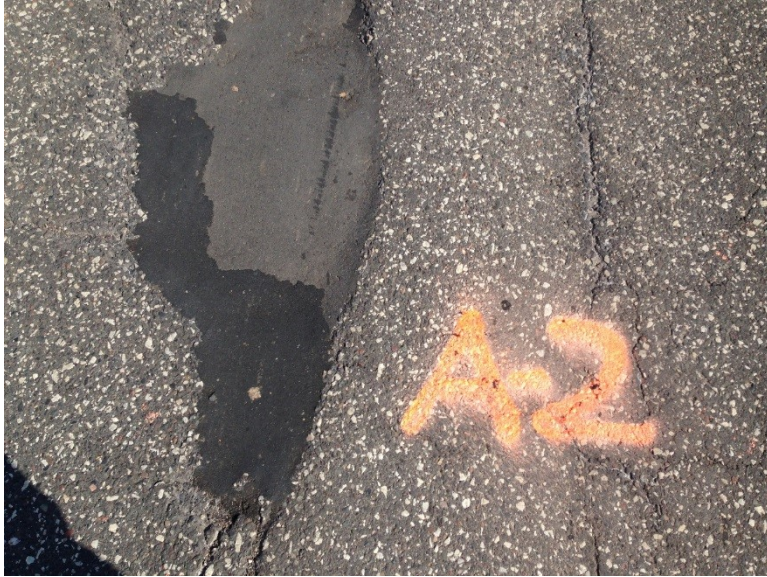
Figure 3.11 Pothole A-2 (3 Days after Patching).

Figure 3.11 through Figure 3.20 provide some photographs of the patches taken at different times to demonstrate how cold mix patches aged over time. It appears that the largest change had occurred within the first three days after patching installation while the cold mix material was still compressing under self-weight and traffic loads. Loose material around the patch edges was also removed during this time. Minimal material was removed after the initial three days.

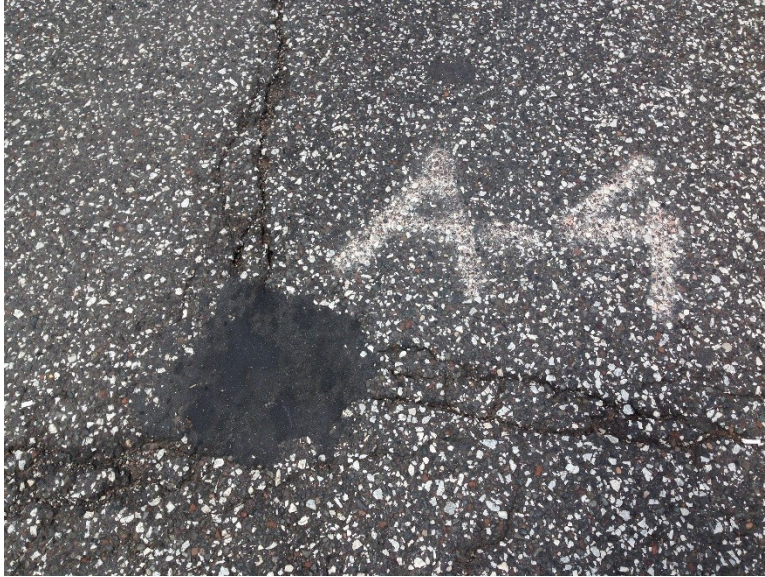
Figure 3.22 Image Used for A-4 Retention Calculation (7/9/14).

Pothole A-4: Two different site visit dates were used to calculate the retention of material. The dates of comparison are April 29, 2014 (Figure 3.21) and July 9, 2014 (Figure 3.22). During that 71 day time span, the patch lost was approximately 13% of its surface area. The material lost was mostly extra patch material overlaying the existing road. The entire pothole was still patched and protected from moisture.

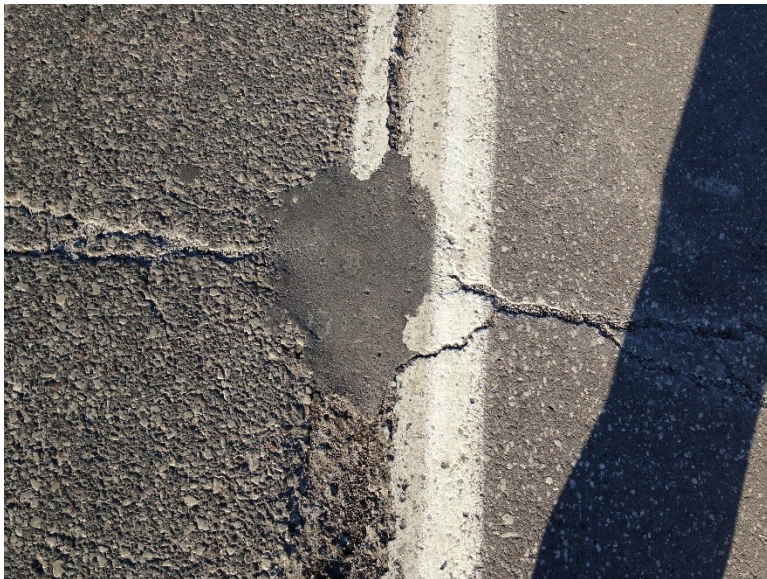
Figure 3.24 Image Used for A-5 Retention Calculation (12/4/14).

Pothole A-5: Three different site visit dates were used to calculate the retention of material. The dates of comparison are April 29, 2014 (Figure 3.23), July 9, 2014, and December 4, 2014 (Figure 3.24). Over time this patch lost a bit of material at the bottom. The total amount of material lost from April 29 to December 4 (219 days) was 17%.

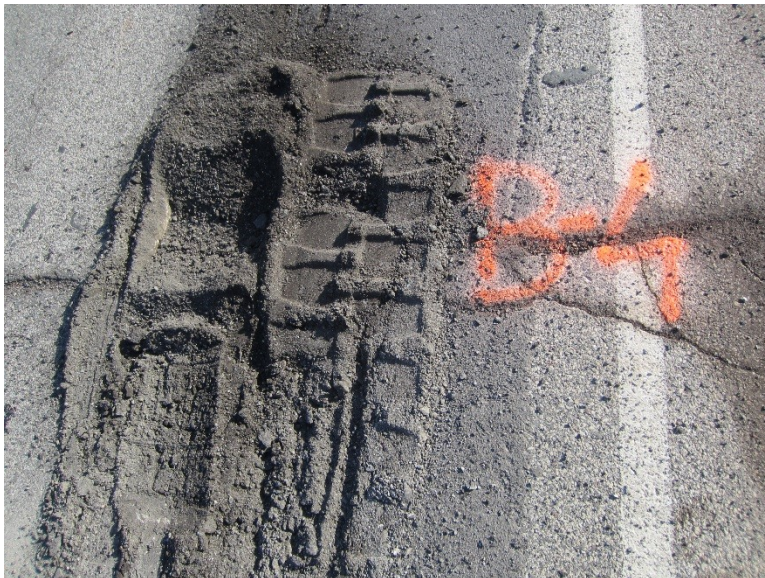
Figure 3.28 Pothole B-4 with Milling Debris Still in Place.

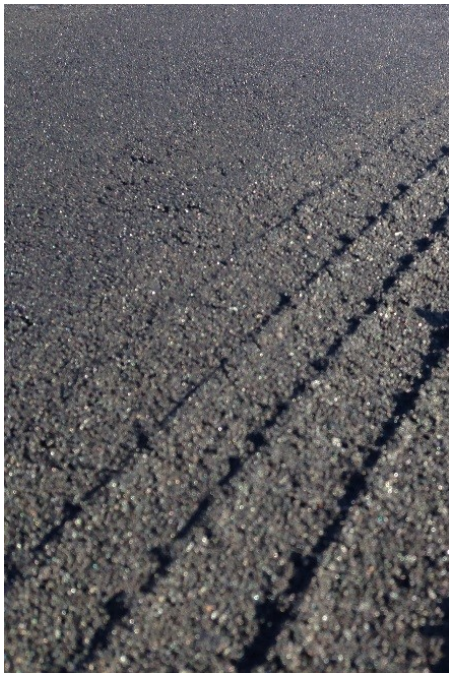
Figure 3.33 Settlement (Dishing) of Pothole B-2 an Hour after Compaction.

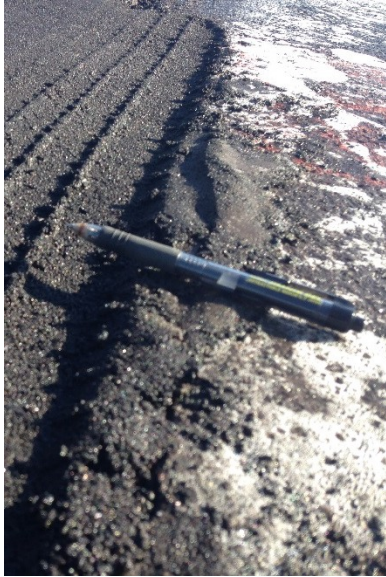
The cold mix patches at Site-B performed similar to Site-A. One difference at this site was the existence of significant dishing. After compaction, the potholes were flush with the roadway, however within the first hour several of the potholes had settled below the roadway surface. The depressed material is along the right edge of the crack. Pothole B-2 which suffered the most dishing was about ½ inch below the roadway surface within an hour (Figure 3.38).

The reason for this depression was due to the depth of the patch filled. Cold mix has a small aggregate size paired with a slow curing asphalt binder. These two factors prevent the patch material from forming a stiff structure. When the pothole depth is too large, like Pothole B-2, the patch material cannot support itself. This did not occur at Site-A, because all potholes had a depth less than two inches. Dishing is common in these patches along the edges due to the inability for hand compactor machinery to properly compact along the interface. The compactor rests on the existing roadway during the compaction process preventing a complete compaction along the patch interface. Over time this area compresses under self-weight and creates the dished area shown in Figure 3.38 through Figure 3.41. After three days the patches appeared to reach their steady state compaction level. Minimal material was lost after those three days.

Figure 3.38 Settlement (Dishing) of Pothole B-2 an Hour after Compaction.

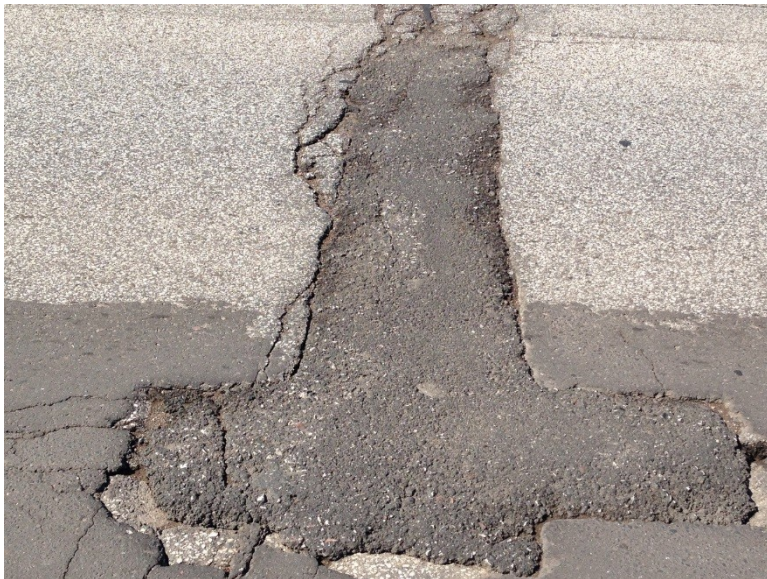
Figure 3.44 Pothole B-5 (146 Days after Patching).

An insignificant amount of additional oil was mixed into the millings to help rejuvenate the mix. For this mix 1.5 gallons of asphalt oil was added to approximately 1000 pounds of mill tailings. The result was a patch material that aged and oxidized at a rapid rate. This aging is visually apparent over time as shown in the Figure 3.42 to Figure 3.48. Raveling was a common distress due to the aged binder and significant material was lost along the edge and surface of the patches over time.

The placement of patch material actually facilitated further damage to the roadway. The damage occurring appears similar to pumping action that is common with concrete panels. As traffic loads travel across the patch area there is not an efficient load transfer causing vertical movement of the patch material. This movement ejects water and fine material from underneath the patch and abrades the adjacent roadway. Comparing Figure 3.43 and Figure 3.44 illustrates that damage to the roadway in Patch B-5. Figure 3.47 provides a close view of this deterioration in Patch B-6.

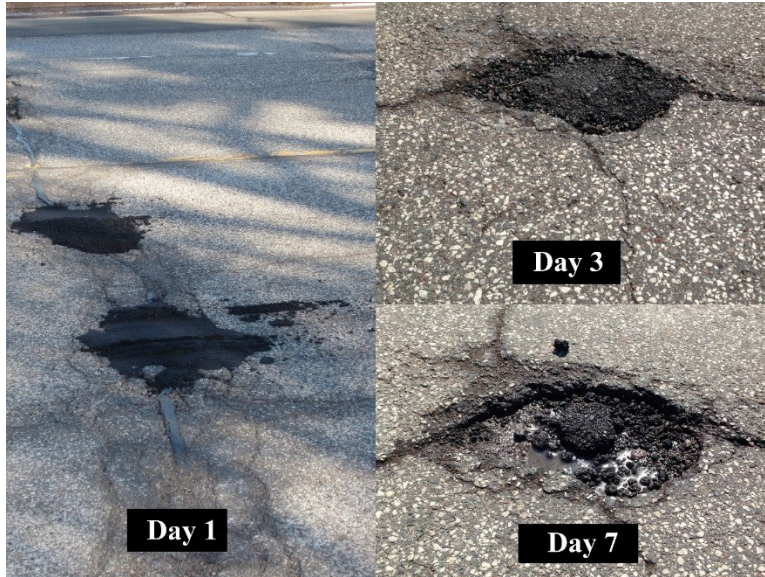
The importance of compaction is shown below in Figure 3.48. Extra hot recycled material was placed in smaller potholes in the wheel path. The potholes were not prepped before patching material was placed, and the material was only compacted under live traffic. As shown in Figure 3.48, the material was removed from the pothole after seven days. This serves as evidence that proper pothole preparation and patching material compaction can be the difference between a successful patch and a waste of resources. The last site visit conducted on December 4, 2014 (237 days after installation) showed that patches were affected by the first few uses of snow plows in the winter months.

Figure 3.48 Uncompacted Hot Recycled Material in Wheel Path.

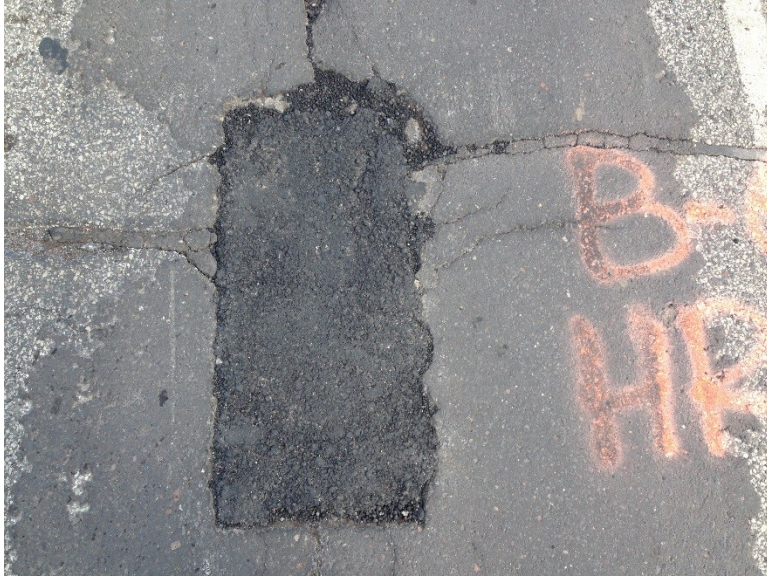
Two different site visit dates were used to calculate the retention of hot recycler material. The dates of comparison are April 14, 2014 (Figure 3.49) and July 9, 2014 (Figure 3.50). Unlike the two cold mix patches from Site-A, this patch lost a significant amount of material over time. The dry material previously discussed broke down over time and was removed from the pothole area. During this time (86 days) 19% of the patch material was lost. This percent only accounts for the material lost around the edge of the patch. The figures show that some material was also lost due to surface raveling.

Figure 3.49 Image Used for B-6 Retention Calculation (4/14/14).

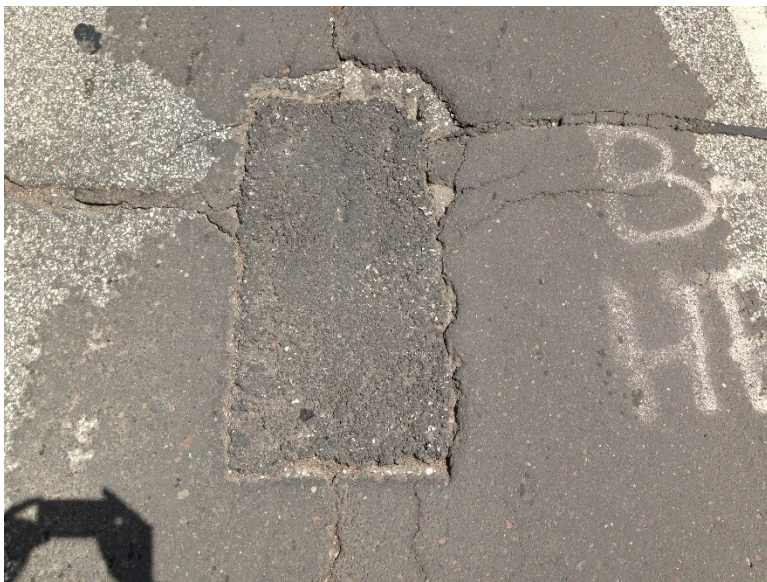
Figure 3.50 Image Used for B-6 Retention Calculation (7/9/14).

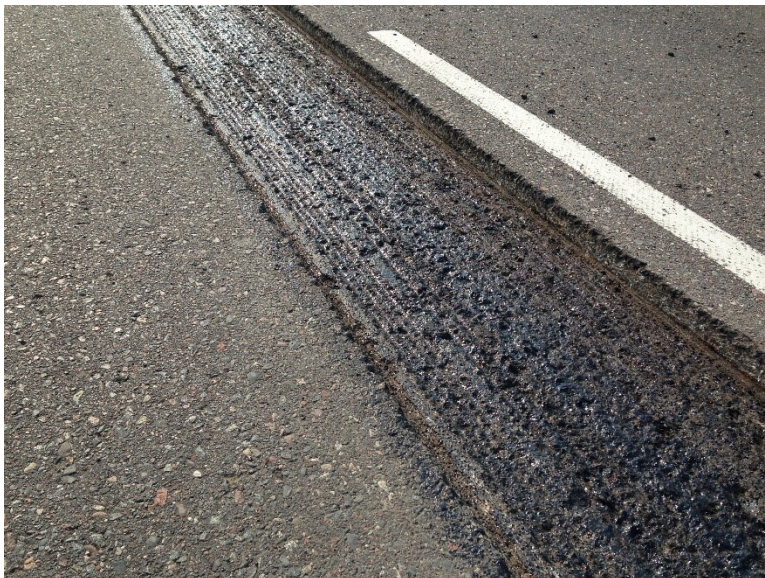
Figure 3.57 Milled Trench.

As shown in Figure 3.57 and Figure 3.58, one issue with the mill and fill operation in Site D was the tacking process used: (i) insufficient amounts of tack was applied to the milled trench and (ii) trucks placing HMA needed to place the truck's wheels into the trench in order to line up where the HMA was discharged. This led to the dirt and debris from truck wheels into the trench which covered some of the tack. Also tack stuck to the truck wheels at many locations further reduced the amount of effective tack. Without a sufficient tack coating, a strong bond at the interface of the patch will not occur, leading to possible delamination or freeze-thaw damage due to water infiltration. Figure 3.63 through Figure 3.65 provide three photographs of the patched locations taken 35 days after the installation of the patching. The patch interface at that time is shown below in Figure 3.66. Improper compaction may also lead to dished areas where hydroplaning and icy surfaces can occur.

- Complete coverage of the patch area with an approved tack material is recommended.
- When the HMA delivery vehicle drives directly in the milled area, debris from the tires covers the tack material rendering it non-functional. This should be avoided if at all possible.
- Compaction should be as thorough as possible to ensure patch longevity. Vibratory steel rollers should be employed to achieve this.

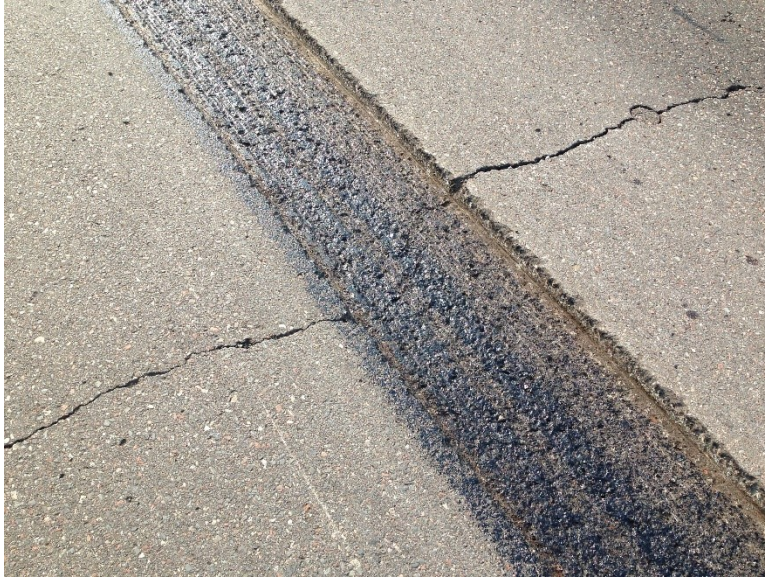
Figure 3.58 Milled Trench with Transverse Crack (Pothole D-3 Location).

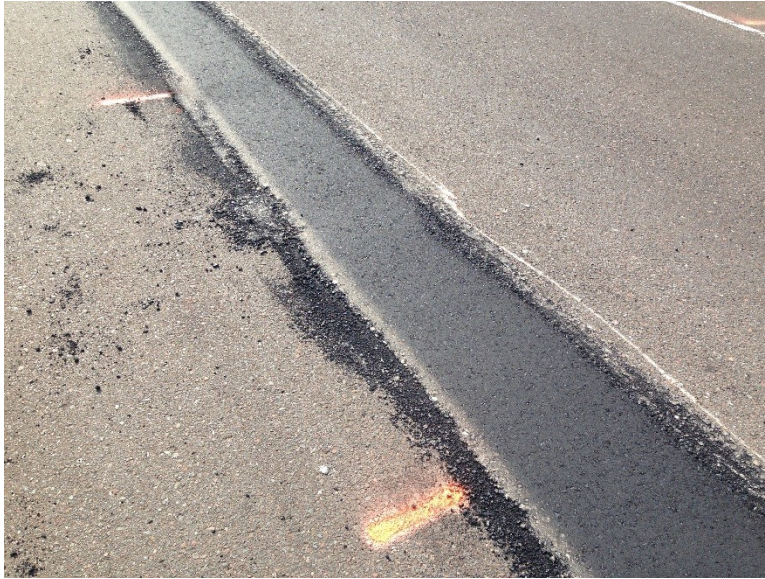
At this site all three patch samples were provided with the same milling and preparation, however, the quality of asphalt placement varied between the samples. Excess material was placed along some areas of the patch. During compaction the excess material was pushed outside of the pothole area. The

difference between excess material placement (Figure 3.59) and proper placement (Figure 3.60) is illustrated below. Placing the proper amount of material leaves a much cleaner looking product as well as reduces the amount of waste material. Figure 3.61 Shows finished patching work at Pothole D-3.

Figure 3.59 Pothole D-1 after Compaction (Excess Fill Material on Roadway).

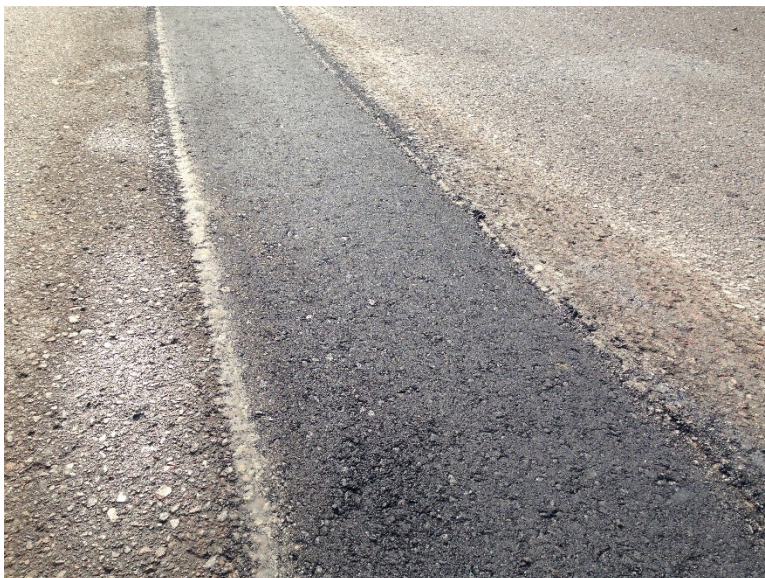
Figure 3.60 Pothole D-2 with Clean Compaction.

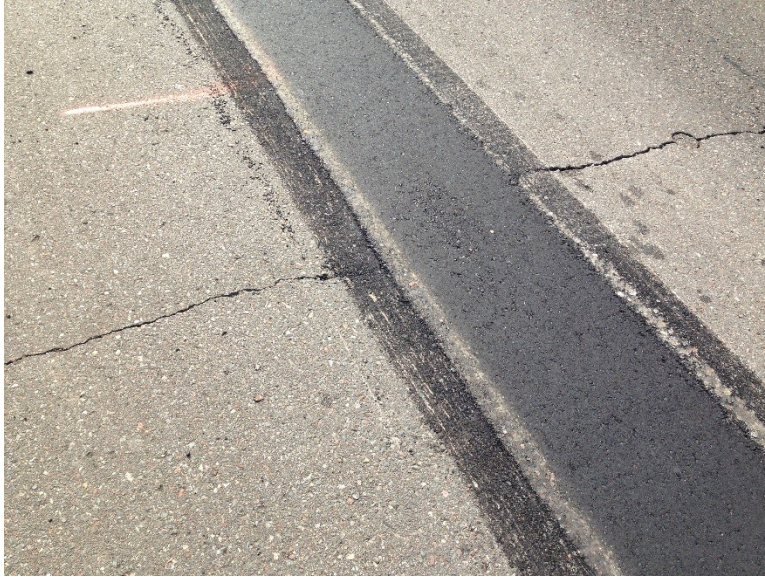
Figure 3.61 Pothole D-3 with Clean Compaction.

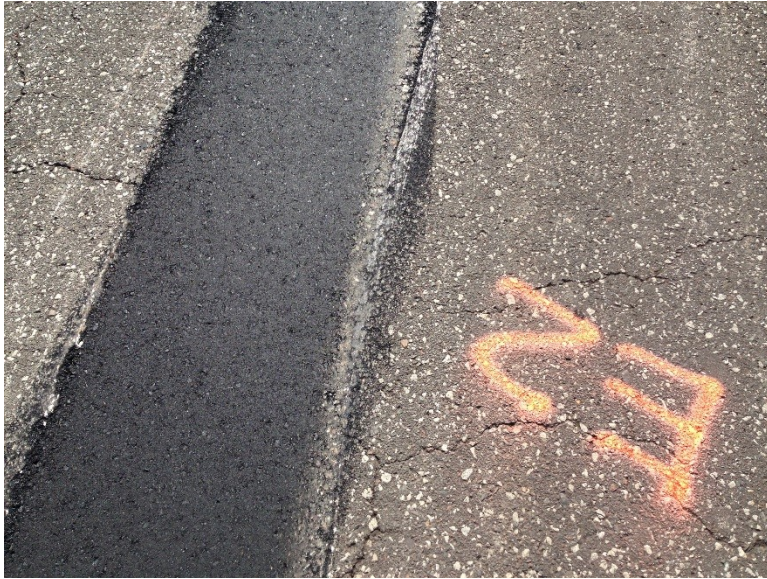
Pothole E-2: This pothole was located in the non-wheel path of the passing lane. The pothole lied along a large longitudinal crack. This crack was along the joint between the driving and passing lane. The pothole was prepped with a milling machine. The size of the milled pothole was 121 inches x 20 inches x 2 inches. Several smaller transverse cracks existed and ran into the milled trench.

Figure 3.73 Pothole E-2 after Compaction.

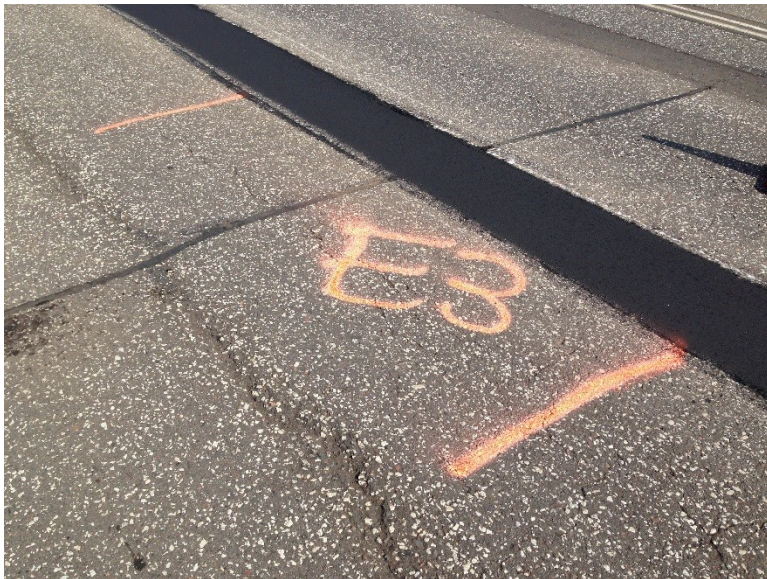
Pothole E-3: This pothole was located in the non-wheel path of the passing lane. The pothole lies along a large longitudinal crack. This crack is along the joint between the driving and passing lane. The pothole was prepped with a milling machine. The size of the milled pothole was 108 inches x 20 inches x 2 inches. Several smaller transverse cracks and one larger sealed transverse crack existed and ran into the milled trench.

Figure 3.74 Pothole E-3 after Compaction.

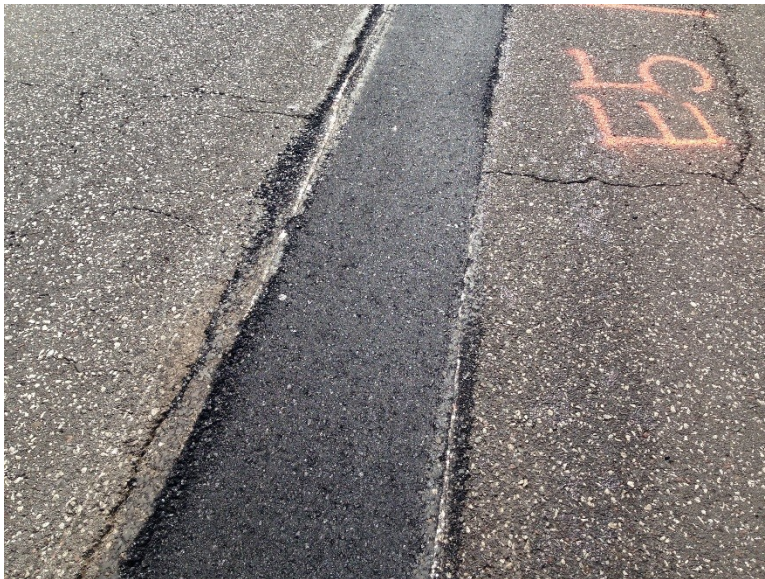
Pothole E-5: This pothole was located in the non-wheel path of the passing lane. The pothole was located along a large longitudinal crack. This crack was along the joint between the driving lane and passing lane. The pothole was prepped with a milling machine. The size of the milled pothole was 121 inches x 20 inches x 2 inches. Several medium sized transverse cracks existed and ran into the milled trench.

Figure 3.76 Pothole E-5 after Compaction.

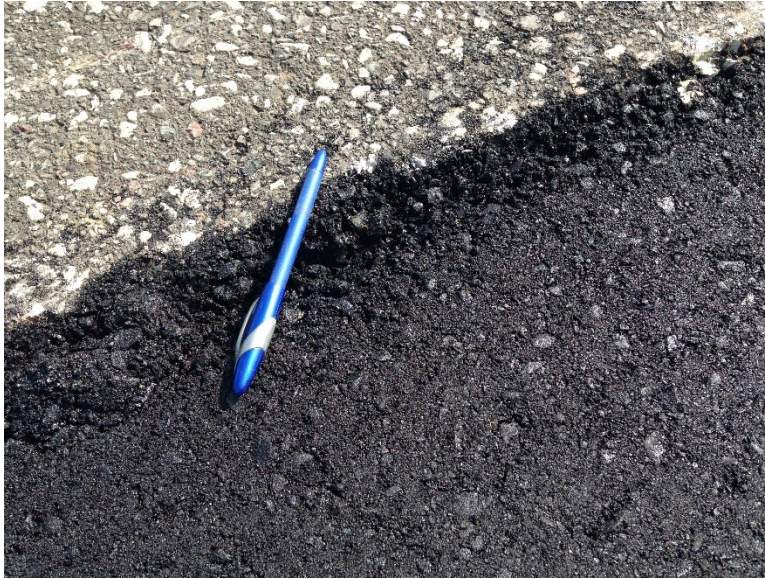
The lack of compaction issue near the interface of the pothole and roadway discussed above in Site D section also existed at this site. The issue however was more prevalent and also included some raveled material right after compaction (Figure 3.77).

Figure 3.77 Lack of Compaction and Material near Interface of Patch Material and Roadway.

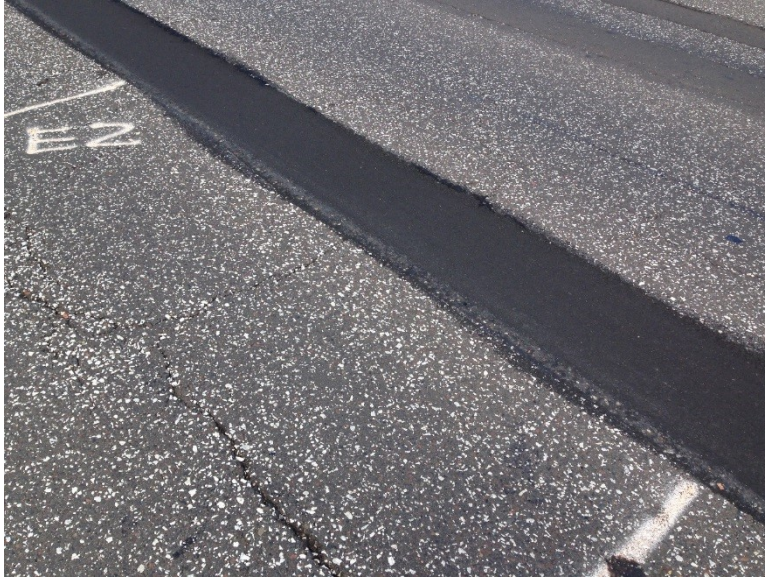
Figure 3.78 Pothole E-2 (28 Days after Patching).

Figure 3.78 through Figure 3.85 provide a visual of how HMA mill and fill patches aged over time at Site E. This site illustrated the importance of proper patching method identification as well as the need for quality workmanship during the patching process. At this site, it was common to see longitudinal cracks parallel to the patch (Figure 3.81 and Figure 3.83). For patch work to be successful, it is imperative that maintenance is performed with quality workmanship. An example of poor workmanship is shown in Figure 3.80 where proper compaction was not applied near the edge of the patch. A final site visit for

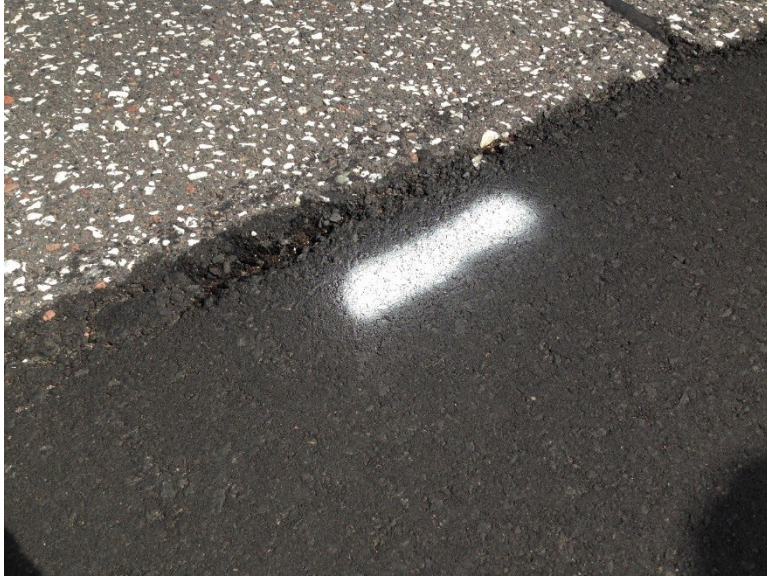
Figure 3.80 Poorly Compacted Interface (28 Days after Patching).

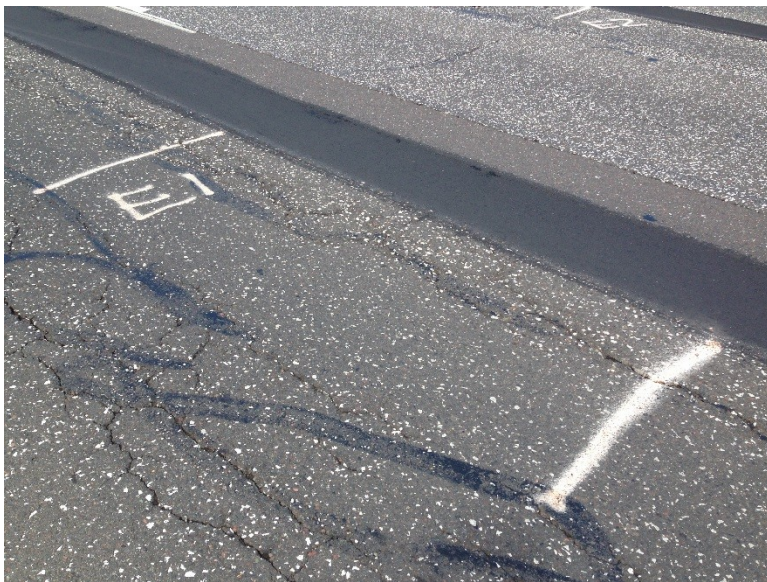
Figure 3.81 Patch E-1 Parallel to Existing Distresses (28 Days after Patching).

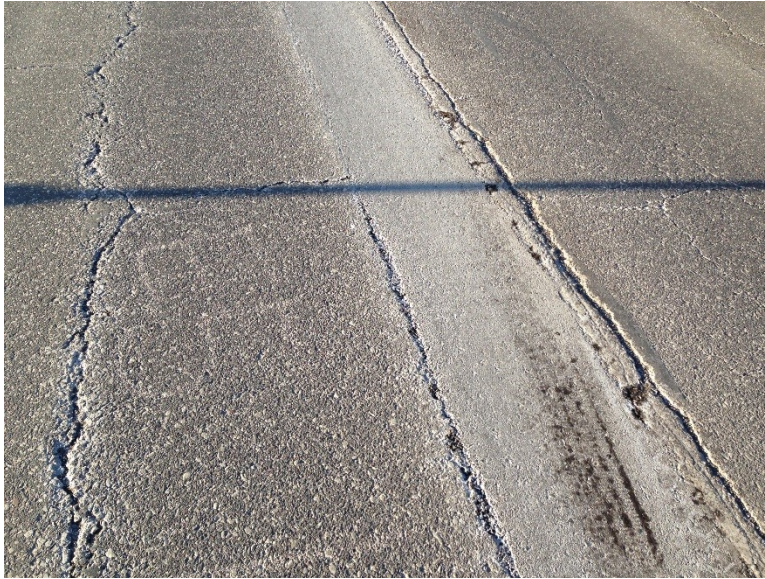
the year was made on December 4, 2014. Figure 3.82 to Figure 3.85 show that a significant amount of damage had occurred to the patch material including cracks and raveling along the patch interface.

Figure 3.84 Pothole E-5 (119 Days after Installation).

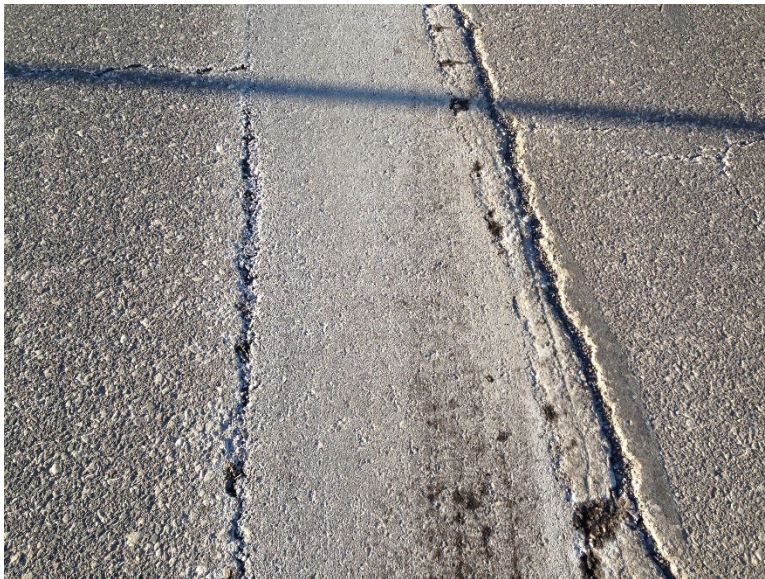
Figure 3.85 Close View of Distresses on Pothole E-5 (119 Days after Installation).

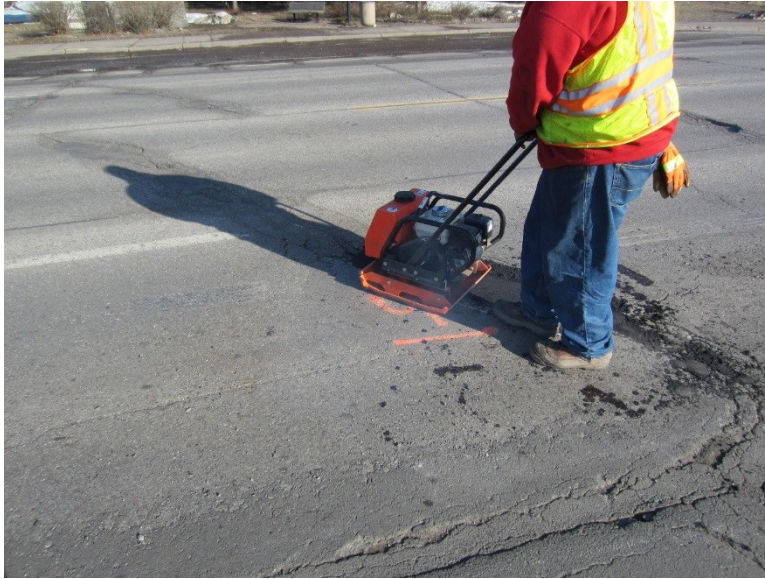
Figure B4: Cold Mix Step 4.

Step 4: Material is compacted using either shovels (Site A) or handheld compactors (Site B).

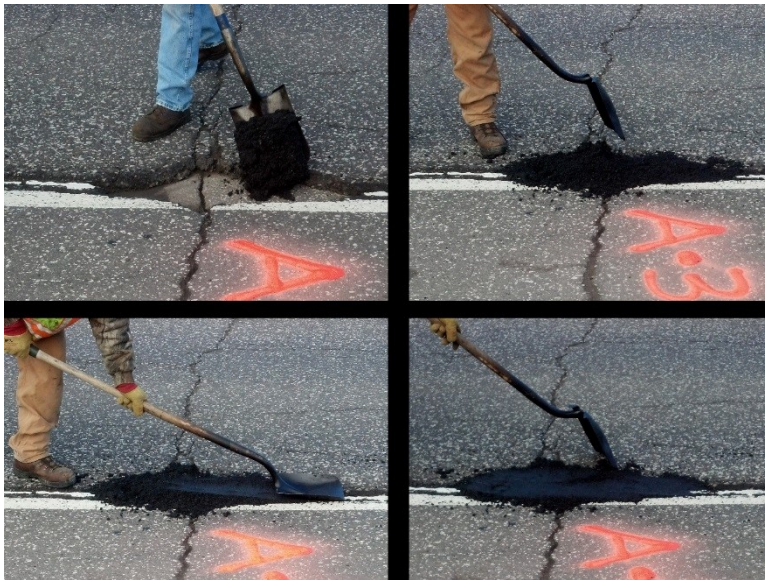
Figure B5: Cold Mix Placement and Compaction Using Only a Shovel.

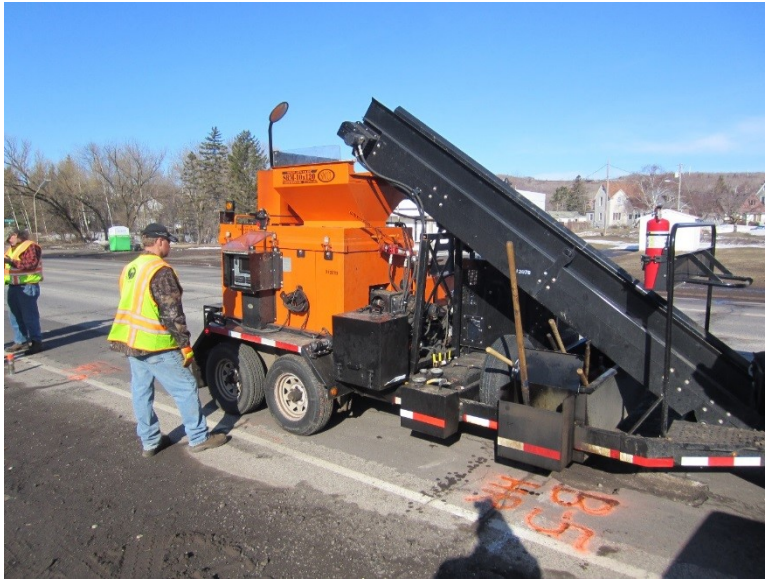
Figure B6: Hot Recycler Step 3.

Step 3: Heating recycled material for placement. Recycled material is placed into the Stepp SRM 10-120 Asphalt Recycler and heated to 300°F.

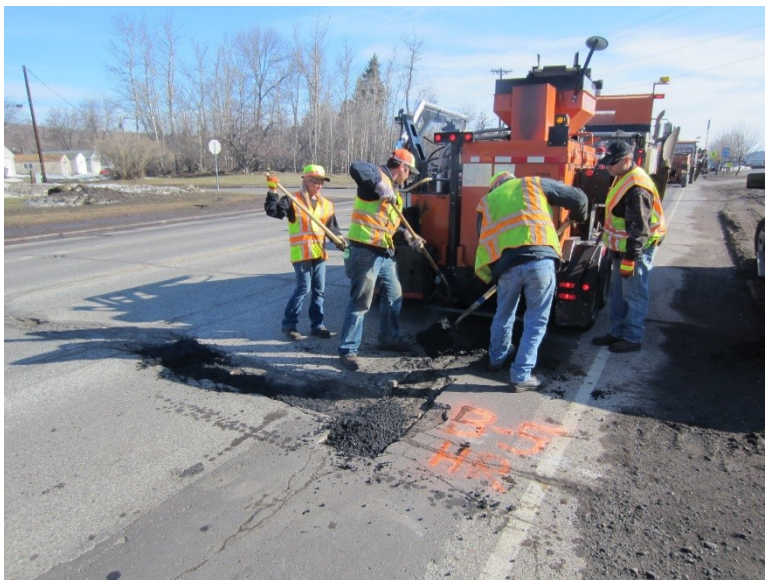
Figure B7: Hot Recycler Step 4.

Step 4: Heat material is placed into the pothole.

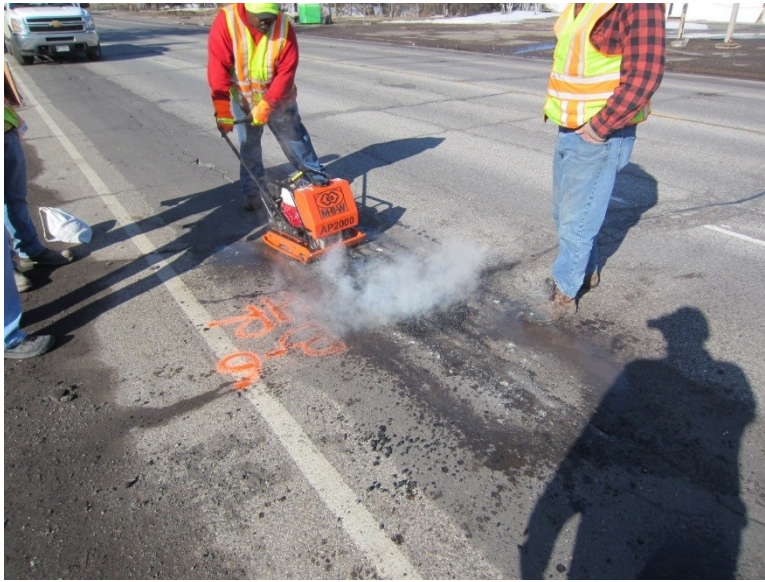
Figure B8: Hot Recycler Step 5.

Step 5: Material is compacted using hand held compactor.

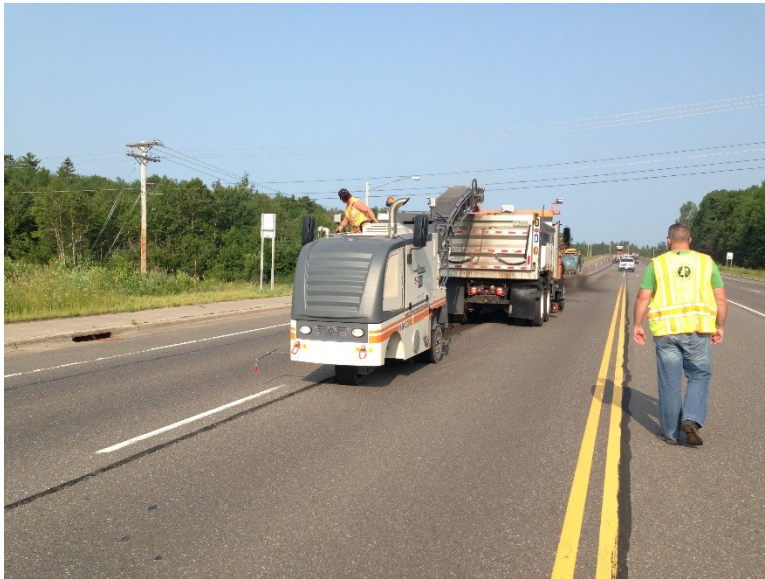
Figure B9: Mill and Fill Step 1.

Step 1: Milling machine mills out Trench along distressed area.

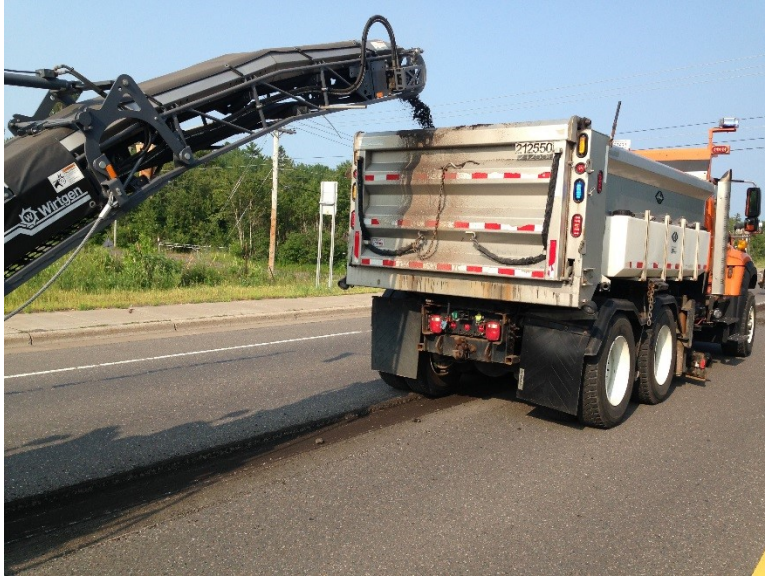
Figure B10: Milled Material is placed in a Truck to be Hauled Away.

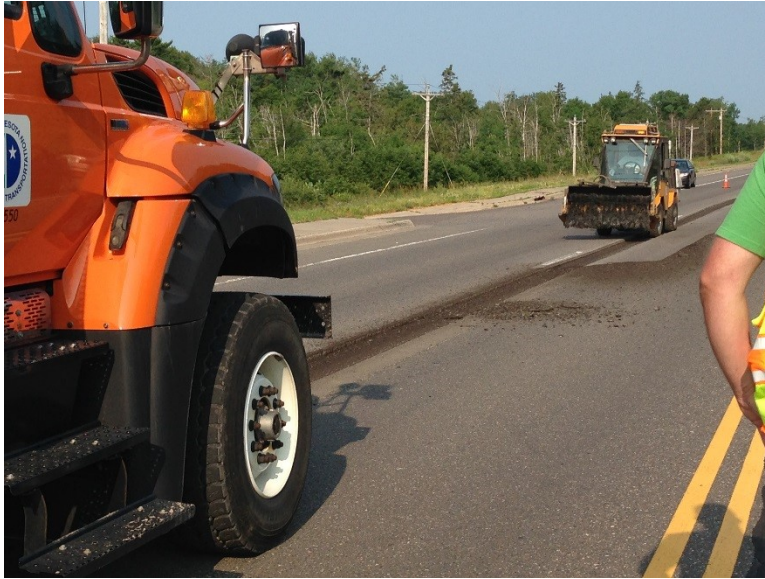
Figure B11: Mill and Fill Step 2.

Step 2: Trench is swept clean of remaining debris.

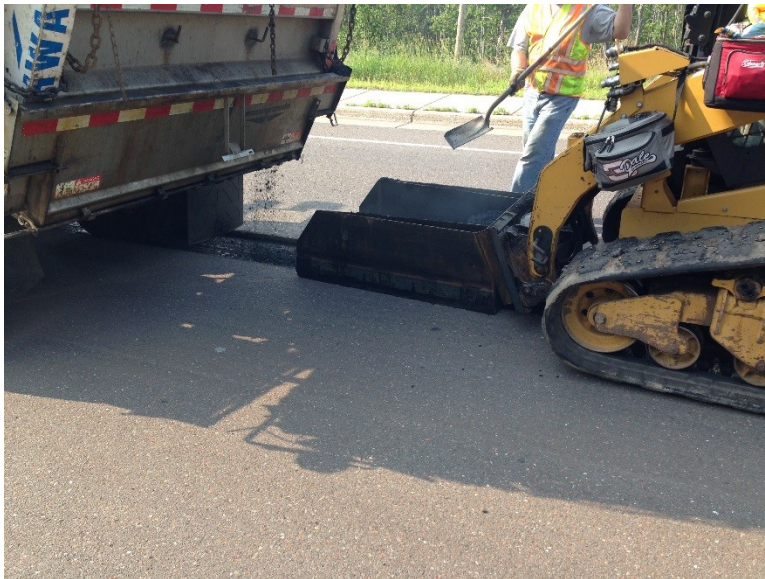
Figure B12: Mill and Fill Step 3.

Step 3: Windrows of fill material are placed in the milled trench and leveled out by a skidsteer.

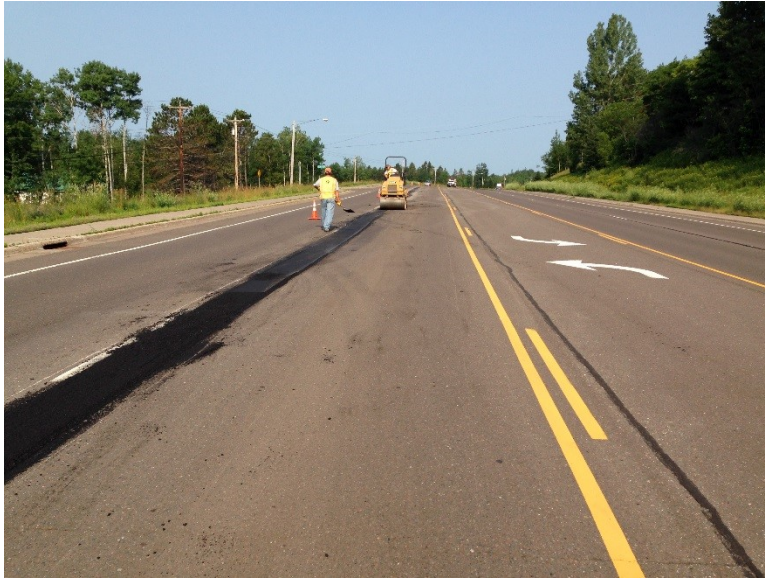
Figure B13: Mill and Fill Step 4.

Step 4: A steel drum roller compacts the fill material to complete the patch.
