# **Phased Array Ultrasonic Steel Corrosion Mapping for Bridges and Ancillary Structures**

**Barritt Lovelace, Principal Investigator**  
Collins Engineers, Inc.

**August 2017**

Research Project  
Final Report 2017-33

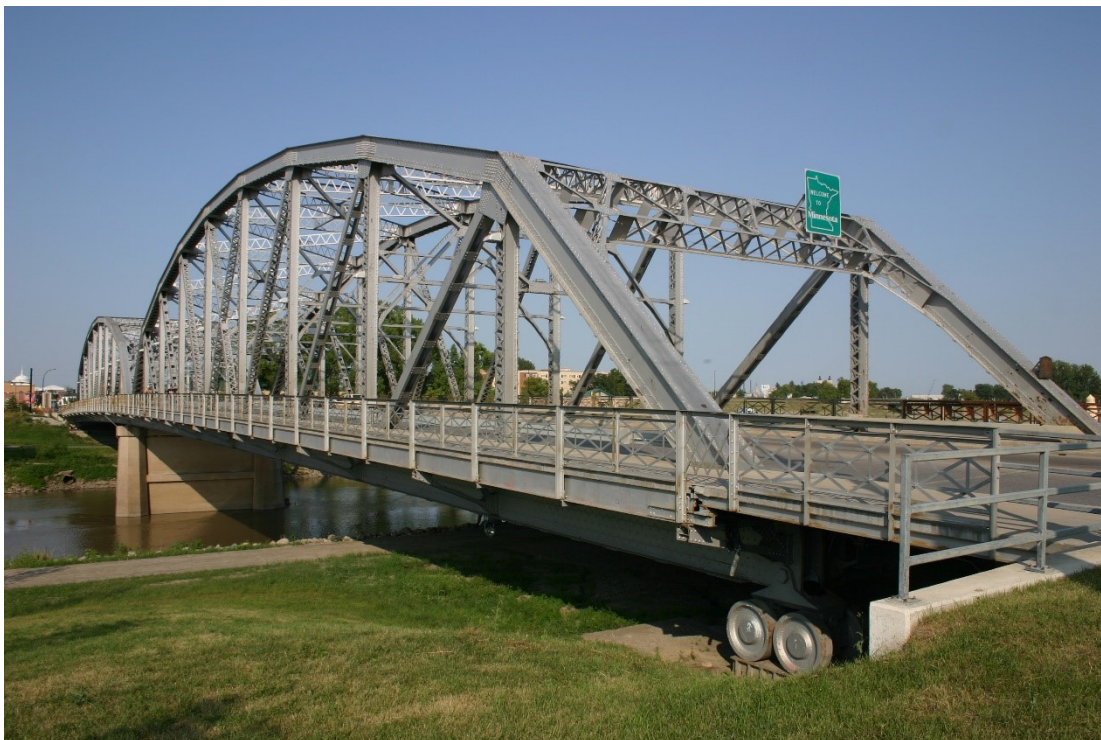
Figure 4.1 Sorlie Bridge Overall Photo.

As part of this research study and the fracture critical bridge inspection corrosion measurements were taken at the bottom flange of a floor beam at a horizontal gusset plate. Three C-Scans were performed and are shown below. The C-Scans show the thickness of the member at various locations. The colors

on the scan represent different thicknesses as depicted on the scale to the right. The white areas depict missing data from the scan.

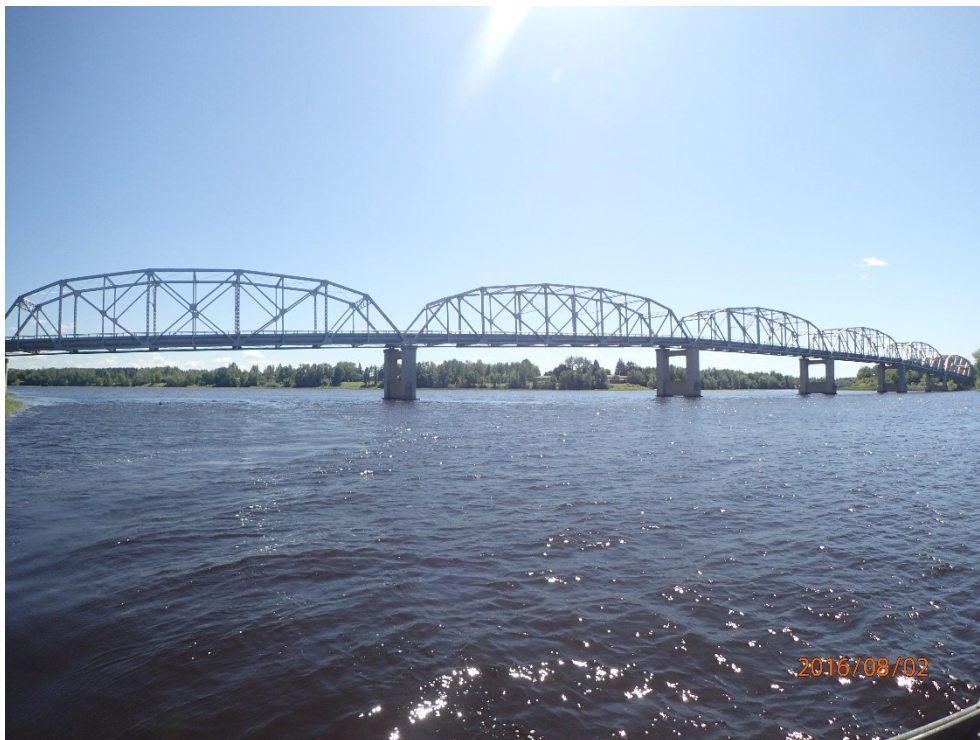
Figure 4.5 Baudette Bridge Overall Photo.

As part of this research study a stringer splice plate was scanned with the Phased Array Ultrasonic System to map the corrosion of the steel member. Two scans were performed and are shown below.

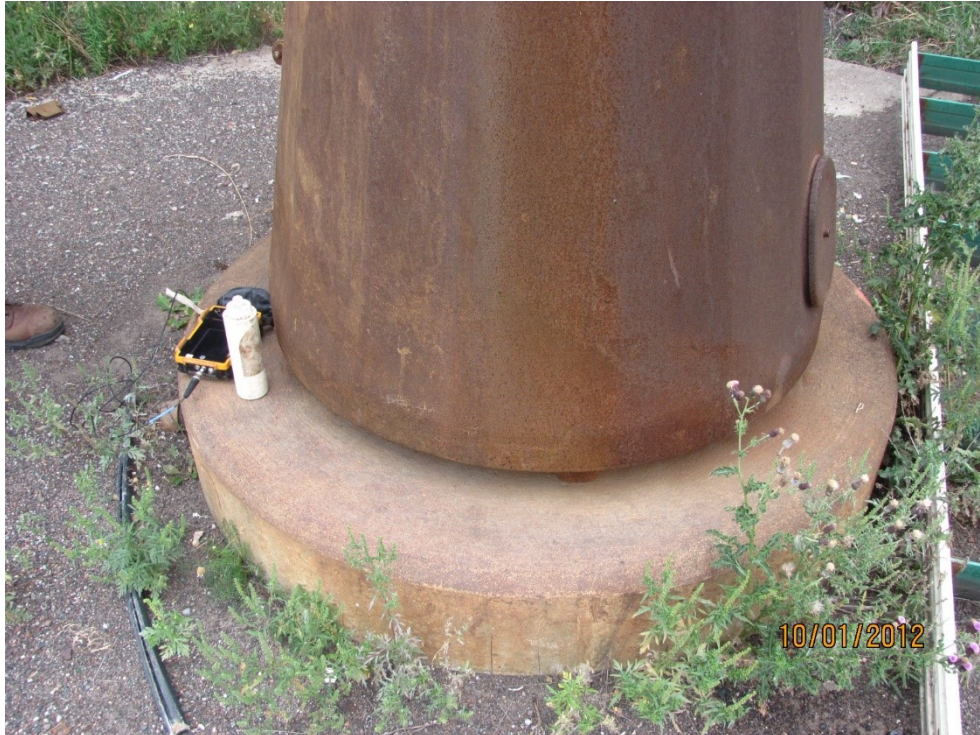
Figure 4.8 Duluth High Mast Light Base Photo.

High mast lights are critical structures on the MnDOT transportation system. High mast lights include a foundation, base plate with anchor rods, tower and luminaire. A high mast light in Duluth, MN with known corrosion issues near the base was chosen to be included in the study to evaluate PUAT's effectiveness on ancillary structures.

As part of this research study the base of the high mast light was scanned with the Phased Array Ultrasonic Testing System to map the corrosion. The resulting scan is shown below.

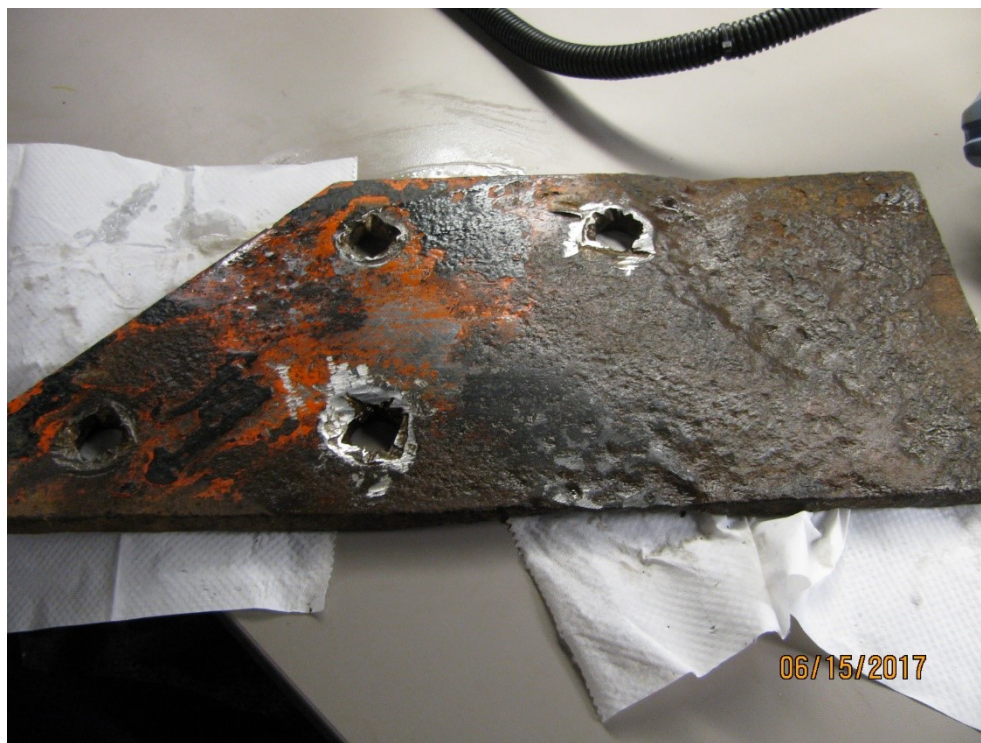
Figure 4.11 Silverdale Bridge Test Specimen.

As part of this research study corrosion scanning was performed on the Silverdale Bridge Test Specimen. The results of the scan are shown below.
