Continued Field Evaluation of Precutting for Maintaining Asphalt Concrete Pavements with Thermal Cracking

August 2017

INE/AUTC 17.17

FHWA-AK-RD-4000(155)

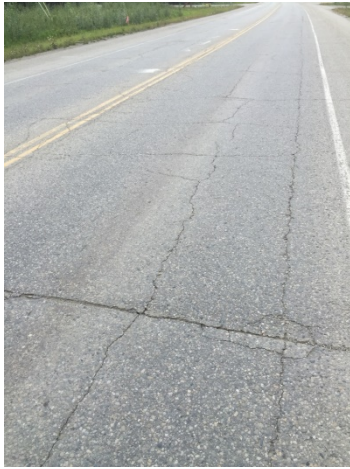
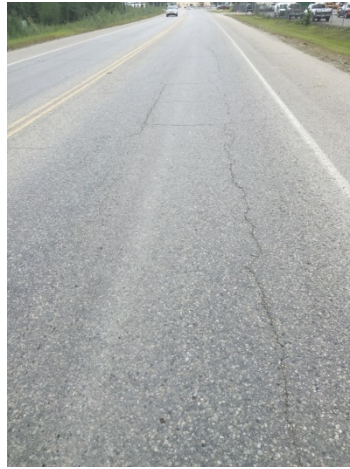
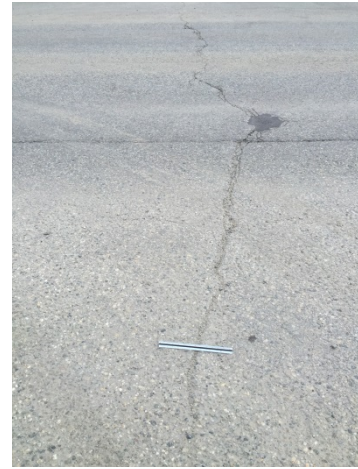
Figure 4.1 Field observations of 32-year old Phillips Field Road, Fairbanks, Alaska

After 32 years of service, even the active precuts showed acceptable appearance (Figure 4.1e). Better appearance of the inactive precut was also observed (Figure 4.1d). In contrast, the natural crack (Figure 4.1c) offered a broken and crooked appearance, which is unpredictable and more difficult to maintain. The driving public and state agencies would tend to prefer the “nicely designed” precuts rather than broken natural cracks. The long-term, regular appearance of pavement surfaces is considered important. For Portland cement concrete road pavements, sidewalks, etc., use of expansion joints and regularly spaced scoring has long been the standard way of controlling appearance and damage severity due to inevitable thermal cracking. Therefore, the precut technique for asphalt concrete can be considered “successful” for its effectiveness in controlling the locations of many more natural cracks that could have developed.

Several small potholes were observed where longitudinal cracks and precuts intersected (Figure 4.1f). The observation about potholes was consistent with Minnesota's experience of precutting asphalt pavement (Janisch and Turgeon 1996). Their report indicated that "a cupped depression developed approximately 5–7 years after implementation of precuts." However, the small potholes that accumulated over 30+ years on Phillips Field Road required minimal patching and did not significantly influence ride quality.

In summary, the Phillips Field Road precut site was 32 years old, but its general driving condition was found to be good. Potholes needed to be maintained, but all the cracks, including transverse cracks, active precuts, longitudinal cracks, and block cracks seemed not to deteriorate the pavement condition significantly.

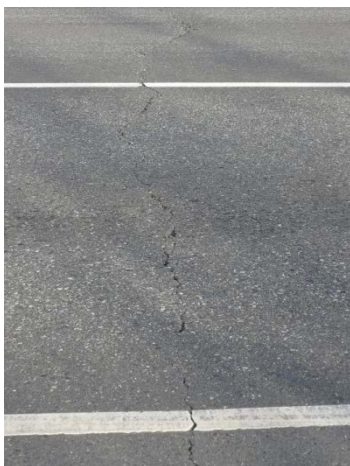
Figure 4.3 Select field survey photos in 2013 and 2014 (Liu et al. 2015)

The details of the field surveys (Figure 4.2) conducted in 2013 and 2014 can be found in a previous project report (Liu et al. 2015). Figure 4.3 presents select survey photos of observed natural cracks, and both non-active precut and active precut cracks.
