REPORT OF THE CIVIL AERONAUTICS BOARD

Of the investigation of an accident involving aircraft of United States registry NC 1946 which occurred near Las Vegas, Nevada, on January 16, 1942.

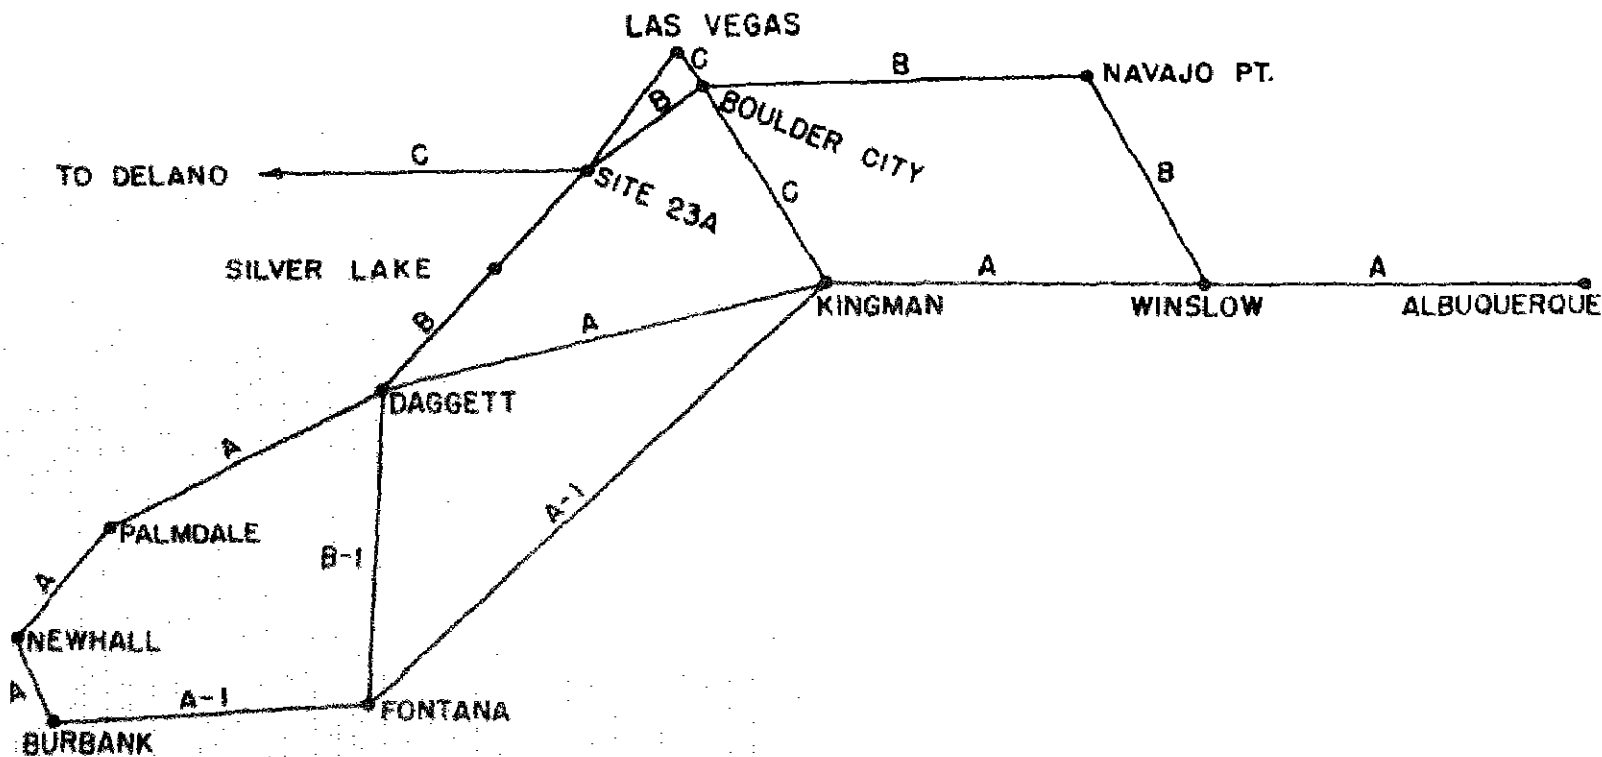
SKETCH SHOWING TWA'S ROUTES BETWEEN  
ALBUQUERQUE, NEW MEXICO AND BURBANK, CALIFORNIA

8. The airplane was flown between Las Vegas, Nevada, and the point of impact on a course which was improper for the route involved.

11. Due to emergency conditions resulting from the war, only one beacon between Las Vegas, Nevada, and Silver Lake, California, was operating.
