CIVIL AERONAUTICS BOARD

ACCIDENT INVESTIGATION REPORT

MIAMI AIRLINE, INC.—ELIZABETH, NEW JERSEY, DECEMBER 16, 1951**THE ACCIDENT**

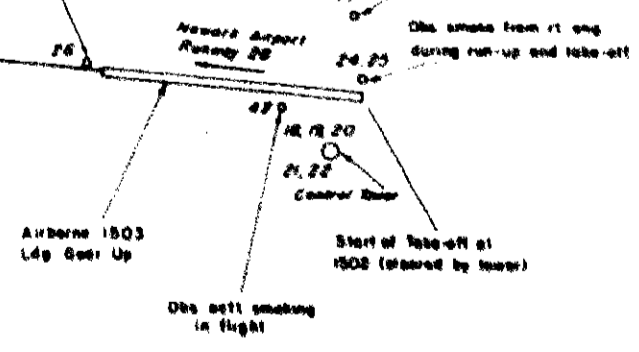
PLAN VIEW

Obs. aft overhead - flame rt eng - as aft passed over rt wing 'folded up' - aft. dropped - fell direct down out of sight

Note:
 O Wreckage along flight path - See wreckage distances chart Exhibit 41A
 O Area 1, 2, 3, 4 Witness location - See Exhibit 41A
 See Exhibit 40C

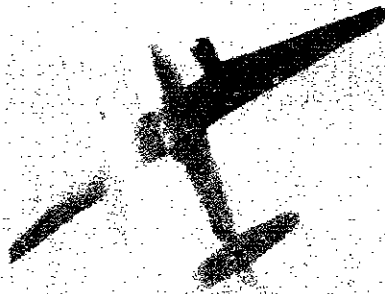
POINT OF CRASH 1509
 AREA 3 AREA 4
