## CIVIL AERONAUTICS BOARD

**ACCIDENT INVESTIGATION REPORT**

NORTHEAST AIRLINES, INC., DC-6A, N 34954,  
RIKERS ISLAND, NEW YORK, FEBRUARY 1, 1957

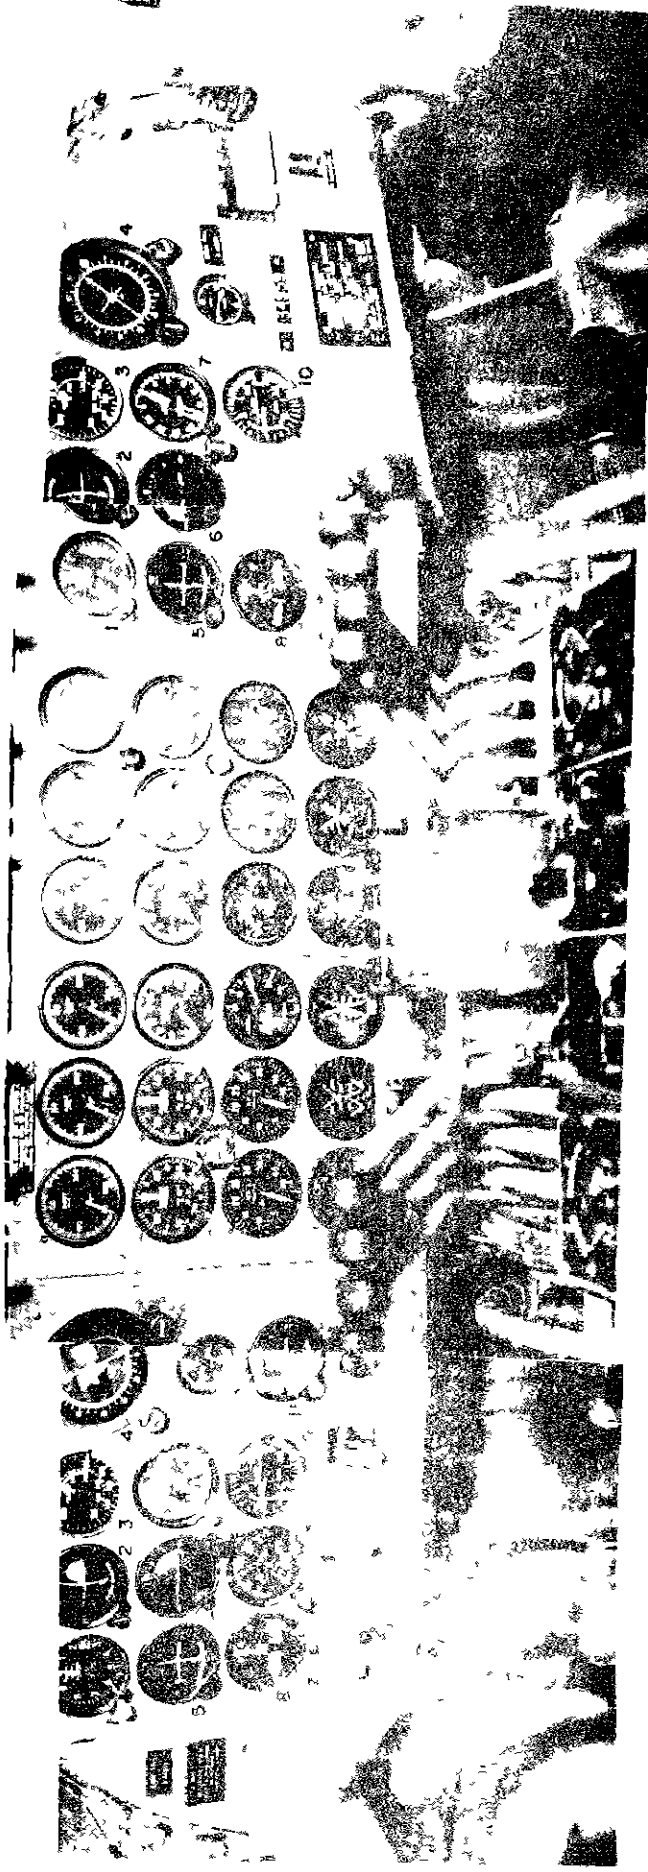
ATTACHMENT B

The cockpit of N 34954 was equipped with both electrical and pitot static flight instruments. With the exception of the C-2A Gyrosyn compass and one cross-pointer indicator, the instrumentation was identical on the pilot's and copilot's panels. Captain Marsh testified that, with the exception of a turn from 40 toward 45 degrees, no turns were made during the flight and that no indication of a turn or bank was displayed on any of the flight instruments. Both pilots testified that there was no warning of any instrument failure. Assuming that there had been a failure of a directional instrument and that the indicator either remained in a fixed position or assumed a rotational motion, the perceptibility of a turn not evident in that instrument would be evident on other instruments as would a turn to follow a rotating directional indication. Similarly, a failure of an attitude instrument and any attempt to follow an erroneous reading would be revealed by other attitude and directional instruments.

There is no evidence that any such irregularities did occur and there appears to be no reason why the radical departure from course would not be displayed on the instrument panel. Based on this and other facts of record the Board can only conclude that Captain Marsh either did not properly observe his flight instruments or failed to refer to the proper instruments in his control of the flight.
