**Federal Railroad
Administration**

Passenger/Freight Train Collision

September 12, 2008, Chatsworth, CA:

Main Report

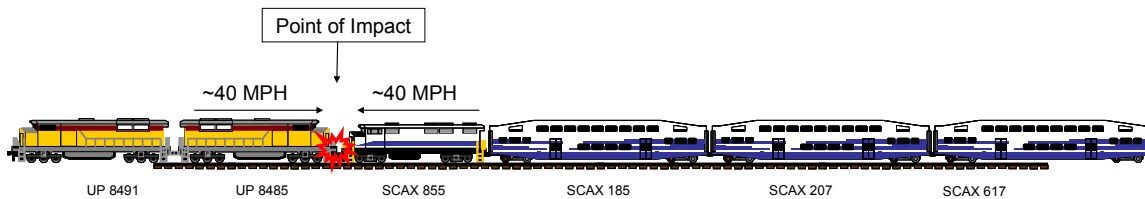
2.1 Initial Contact

The locomotives come together, initiating contact at the coupler knuckles. The draft gears compress, bottom out, and overload the draft gear pockets on each locomotive. On the freight locomotive, the coupler shank fractures and the draft gear pocket deforms downward. The pilot fractures and tears away. On the passenger locomotive, the coupler and draft gear pocket fracture off completely from the locomotive underframe. Next, the locomotive end structures come together. Though the front faces of the colliding trains are not symmetrical, the anti-climber devices still engage and effectively lock the two locomotives together vertically. There is little evidence of vertical motion at the colliding interface.

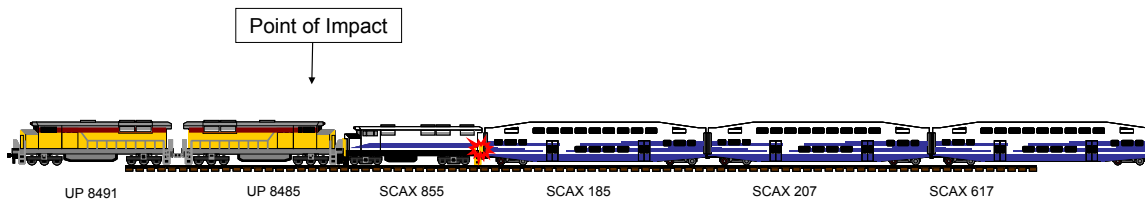
2.2 ~0.03 Seconds: Locomotives Begin to Crush and First Passenger Car Begins to Decelerate

At about 0.03 seconds, the passenger locomotive is crushed by about 2 feet and the main structure cripples. The front portion of the locomotive is vaulted back and up and intrudes into the operator's volume. The first passenger car makes hard contact with the rear of the passenger locomotive. The first passenger car (#185) begins to decelerate. There will be about a 0.05 second delay before the second passenger car (#207) begins to decelerate.

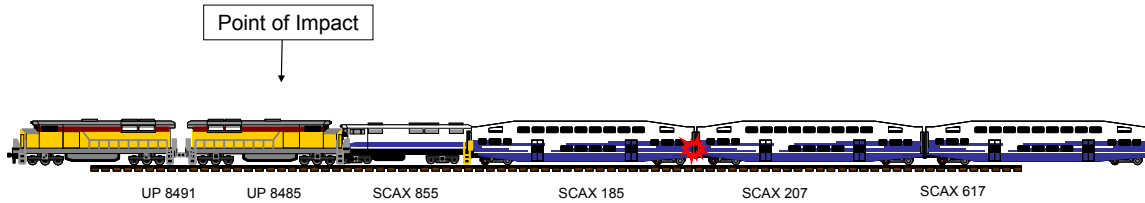
2.3 ~0.10 Seconds: Passenger Locomotive Continues to Crush and Second Passenger Car Decelerates

At about 0.1 seconds the passenger locomotive is crushed another 6 feet (at this time, 8 feet in total). The passenger locomotive's lead truck rotates back and the truck attachments, which connect the truck to the car, fail. As the collision pulse moves back through the train, the second passenger car makes hard contact with the first passenger car and begins to decelerate.

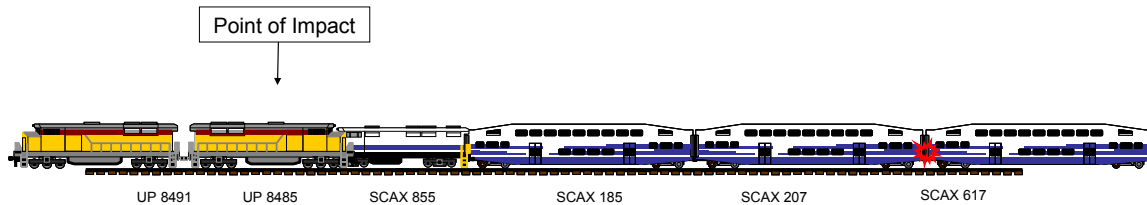
2.4 ~0.15 Seconds: Passenger Locomotive Continues to Crush, First Passenger Car Cripples and Third Passenger Car Decelerates

At about 0.15 seconds the passenger locomotive front end is crushed by about 10 feet. The lead truck impacts the adjacent fuel tank. The impact punctures the tank and the fuel tank detaches from the carbody underframe. The first passenger car is crushed by about one foot and the underframe starts to cripple at the front end gooseneck. The trailing cab car begins to decelerate.

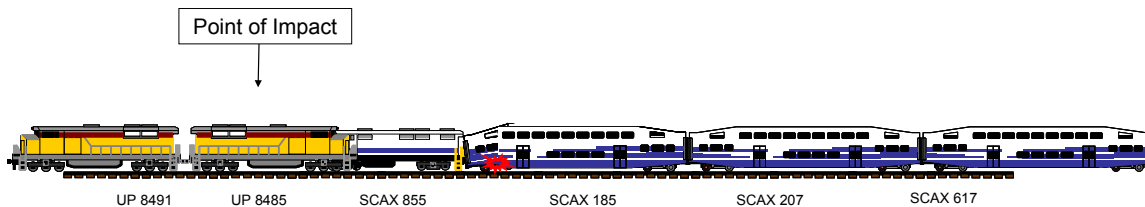
2.5 ~0.25 Seconds: First Passenger Car Catastrophically Fails at Gooseneck

At around 0.25 seconds the passenger locomotive front end has finished crushing, about 15 feet in total. The passenger locomotive has finished decelerating and begins to reverse direction as it is pushed by the momentum of the freight train. The gooseneck of the first passenger car catastrophically fails at ~3.5 feet of crush. The car breaks into two pieces and the front portion pitches upward and begins to plunge back through the middle portion of the multi-level car (the structural damage to the first passenger car is summarized in Section 4 and described in detail in Appendix A.2.1). The trailing cars in the passenger train finish running into each other and from this point on act essentially as a single mass, decelerating at a steady rate of about 0.5 g.

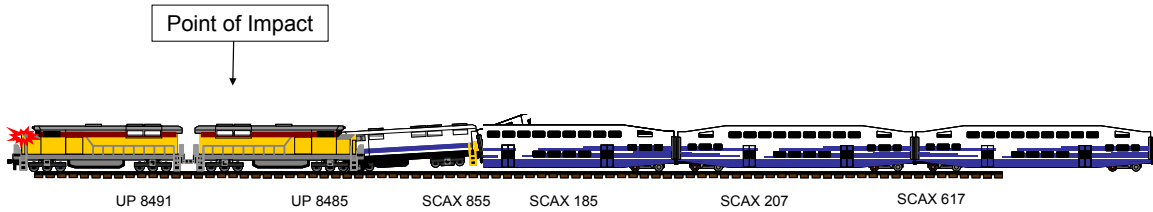
2.6 ~0.4 Seconds: Freight Cars Begin to Pile Up and First Passenger Car Continues to Crush

At about 0.4 seconds, the first freight car behind the second rear-facing freight locomotive overrides and crushes the operator's compartment. The freight cars successively pile up in a large scale sawtooth buckle mode. The detached front portion of the first passenger car has plunged about 10 feet deeper into the middle portion and continues to move backward, peeling open the roof and side walls.

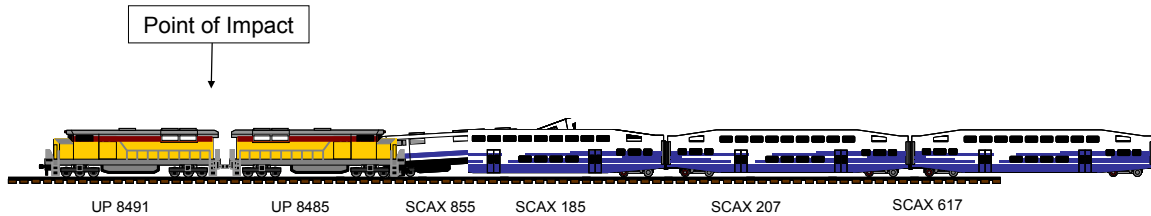
2.7 ~0.75 Seconds: Second and Third Passenger Cars Change Direction of Travel

At about 0.75 seconds the passenger train has finished decelerating and begins moving in the opposite direction. The first passenger car has crushed a total of about 30 feet.

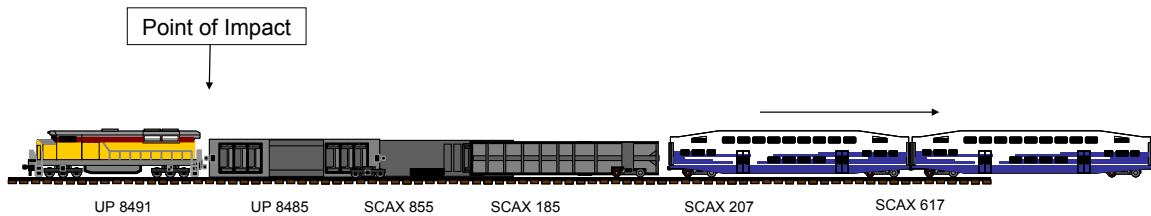
2.8 ~1.25 Seconds: First Passenger Car Crush Complete; Lead Locomotives and First Passenger Car Roll; Second and Third Passenger Cars Separate

The front portion of the first passenger car has plunged back into the middle portion of the car by 44 feet, stopping just before the lower level rear doors, as described in Section 4 and in Appendix B.3.1. The lead freight locomotive, the passenger locomotive and first passenger car roll and the coupled connections to adjacent cars fail. The second and third passenger cars reverse direction, rolling back what is roughly estimated to be between 80 and 100 feet.

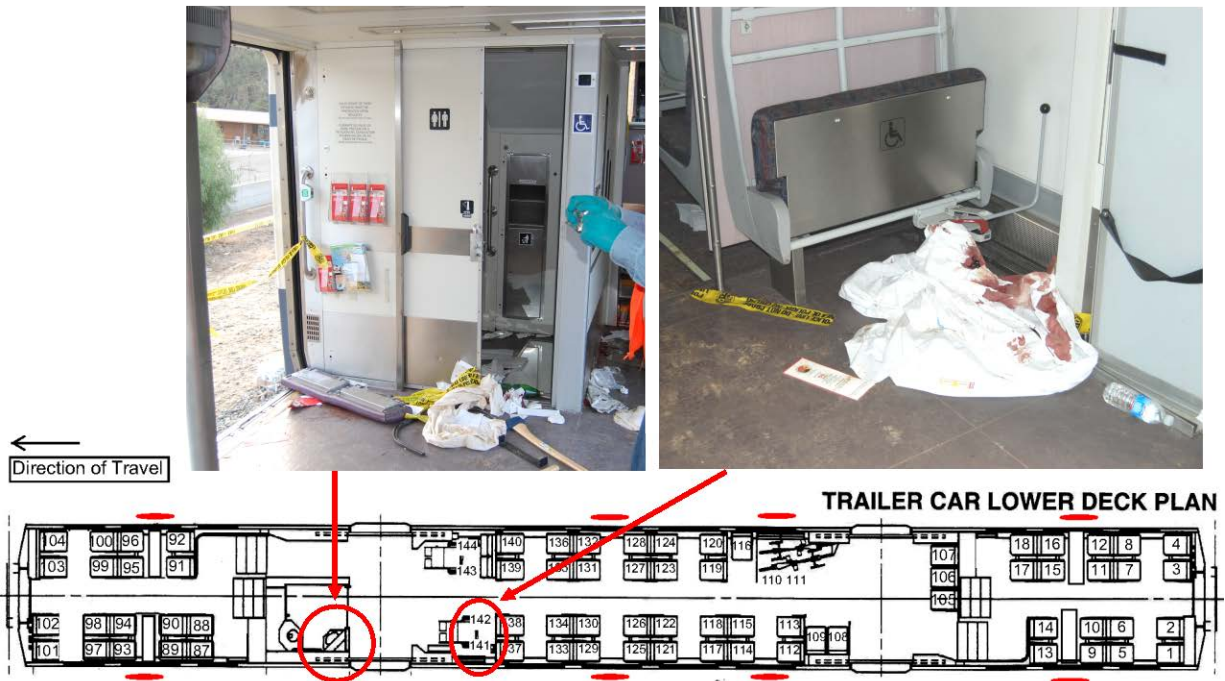
Interviewed Passenger #7 was seated on the flip-down seat on the left side of Car #207 and impacted the bulkhead about 10 feet away (see Figure 10). This passenger suffered serious injuries, including four fractured ribs, four fractured vertebrae, fractured tibia, fractured forearm, and a fractured finger. This increased severity of the injuries to these passengers was likely caused by an extremely high SIV and very rigid impact surfaces, i.e., the stairs and the bulkhead wall.

Figure 10. Forward Stepwell, Lower Level to Mezzanine Level, and Lower Level Fold-down Seat, Car #207

Figure 10 shows the bulkhead wall, which is next to the bathroom door, and the fold-down seat where Passenger #7 was likely initially located.

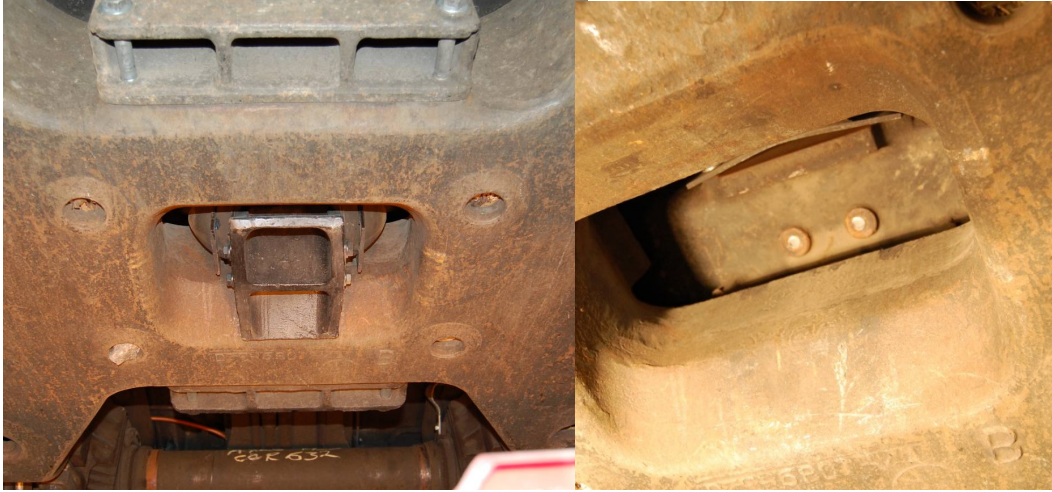
Figure A.2.1-15. Intact Truck Retention Mechanism

For perspective, Figure A.2.1-15 provides visual comparisons showing on the left, the intact truck retention mechanism, and on the right, the bolts after an impact in which the truck retention mechanism failed.

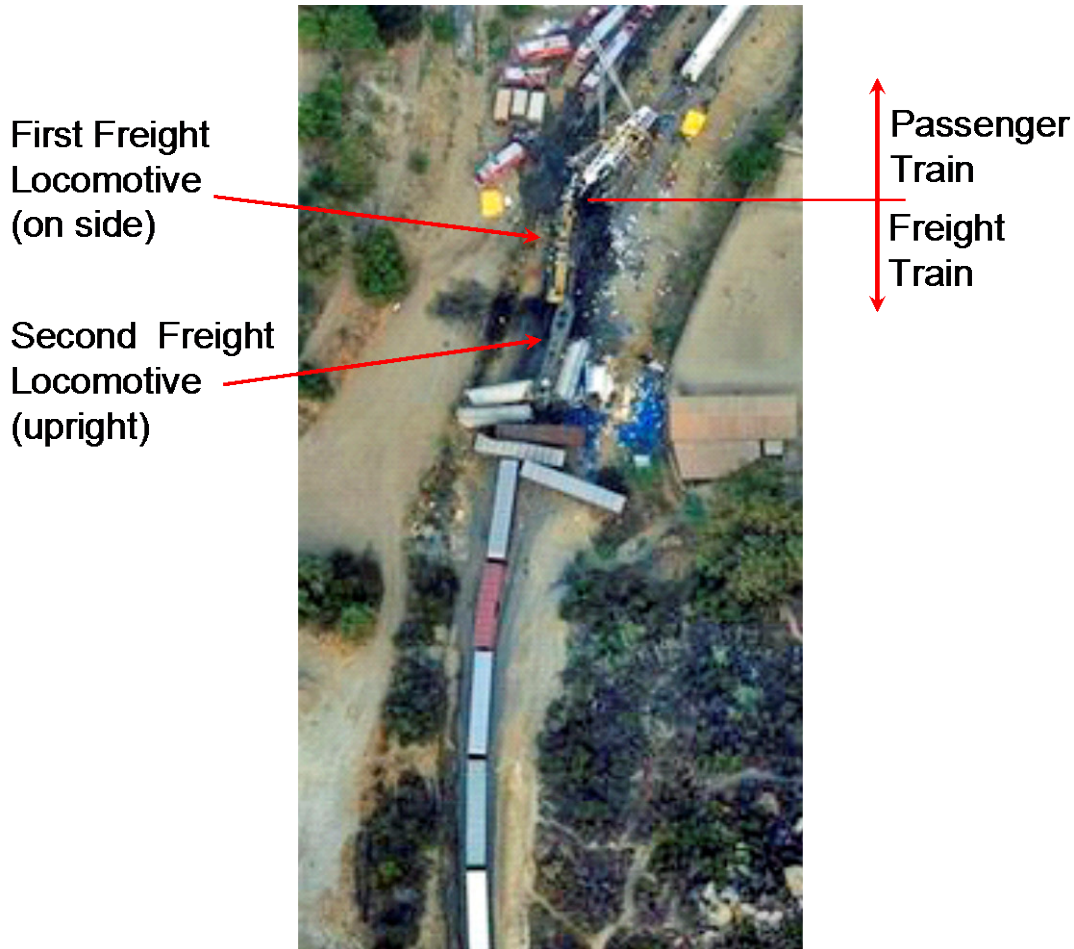
Figure A.2.2-1. Aerial View of Freight and Passenger Equipment

The underframes of the freight equipment all remained essentially intact. The principal damage to the lead locomotive affected the ancillary structures on the front end—the draft gear housing, the plow, the breast plate, and the short hood. In the second locomotive, a portion of the roof peeled back, likely caused by an impact with an empty covered hopper car. Seven trailing freight cars stacked up sideways against the trailing end of the trailing freight locomotive, and consequently received damage to their superstructures. Behind the sideways freight equipment, three freight cars derailed but remained upright. These cars received fairly minor damage. The trailing seven freight cars remained upright and on the track, and did not appear to be damaged. Table A.2.2-1 summarizes the structural damage to the freight locomotives and cars.

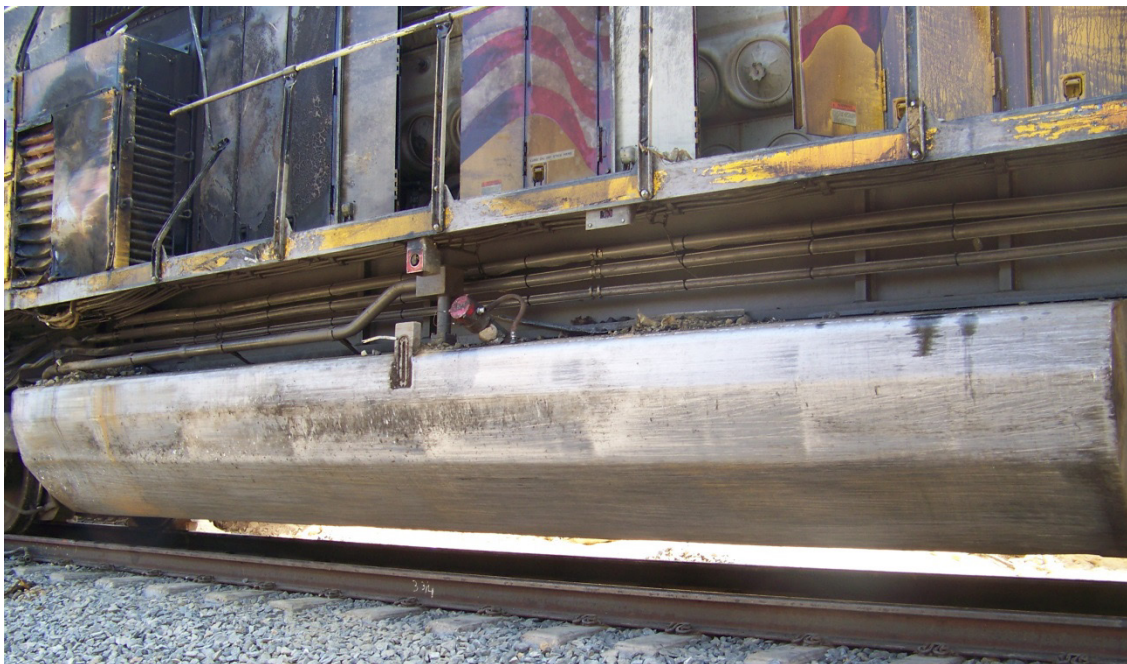
Figure A.2.2-3. Left Side of Lead Freight Locomotive

Figure A.2.2-3 shows that the right side of the locomotive has little damage. The underframe is essentially intact, and both trucks and the fuel tank remained attached.

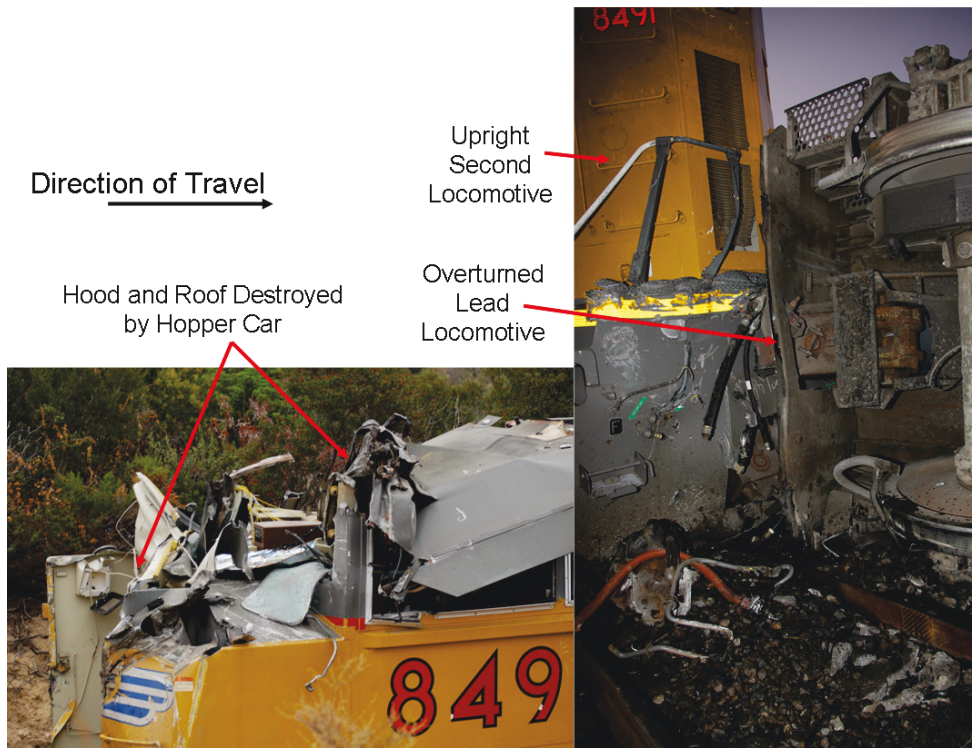
Figure A.2.2-5. Second Freight Locomotive Structural Damage

The photos in Figure A.2.2-5 depict the damage to the second freight locomotive inflicted by the hopper car and the damage caused by the interaction between the first and second freight locomotives.

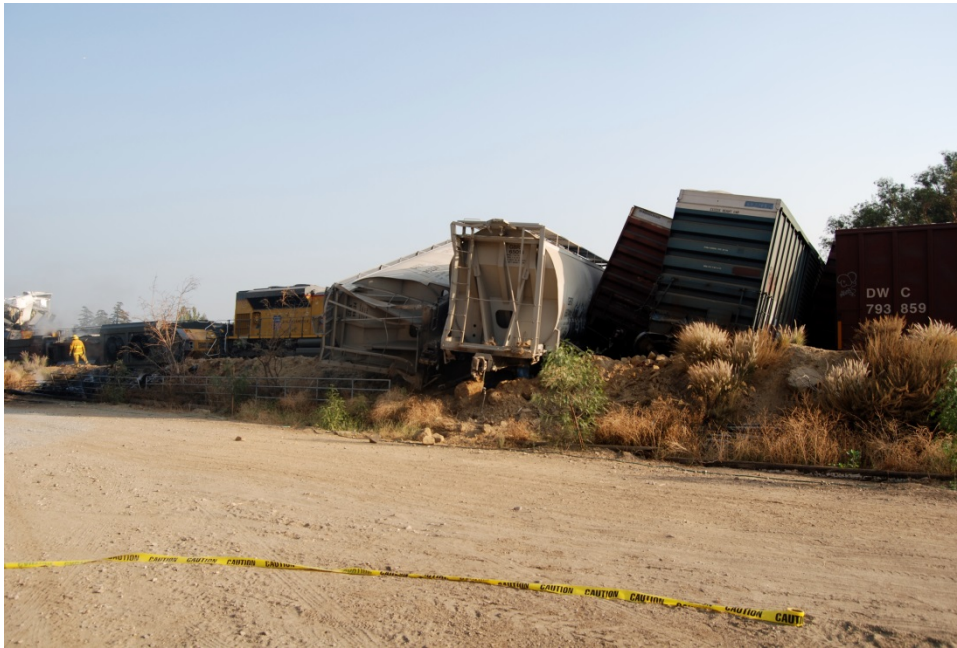
Figure A.2.2-7. Derailed Freight Cars

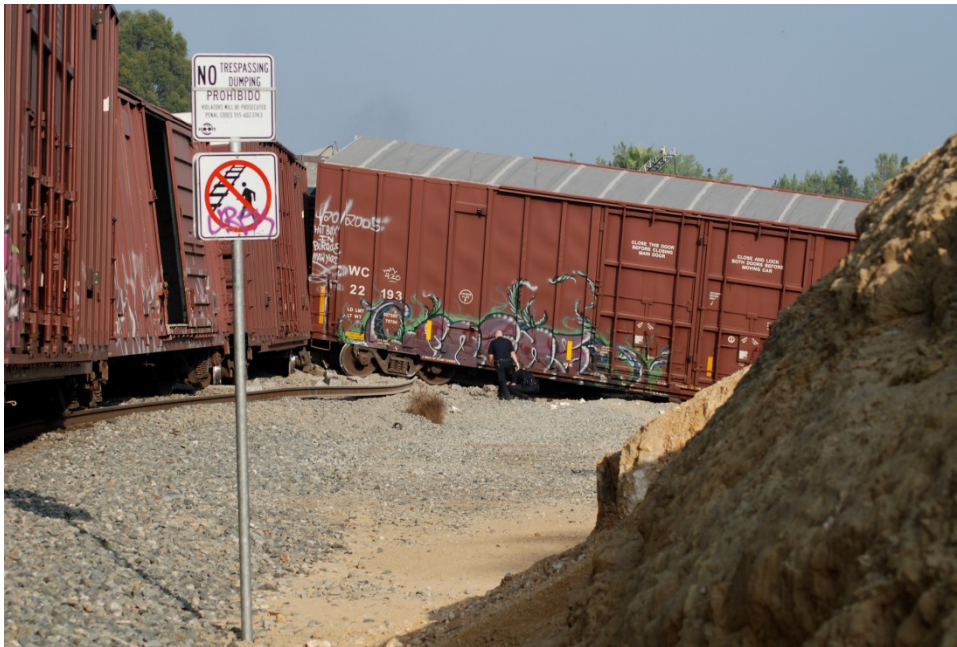
Figure A.2.2-8. Displaced Rail and Derailed Freight Cars

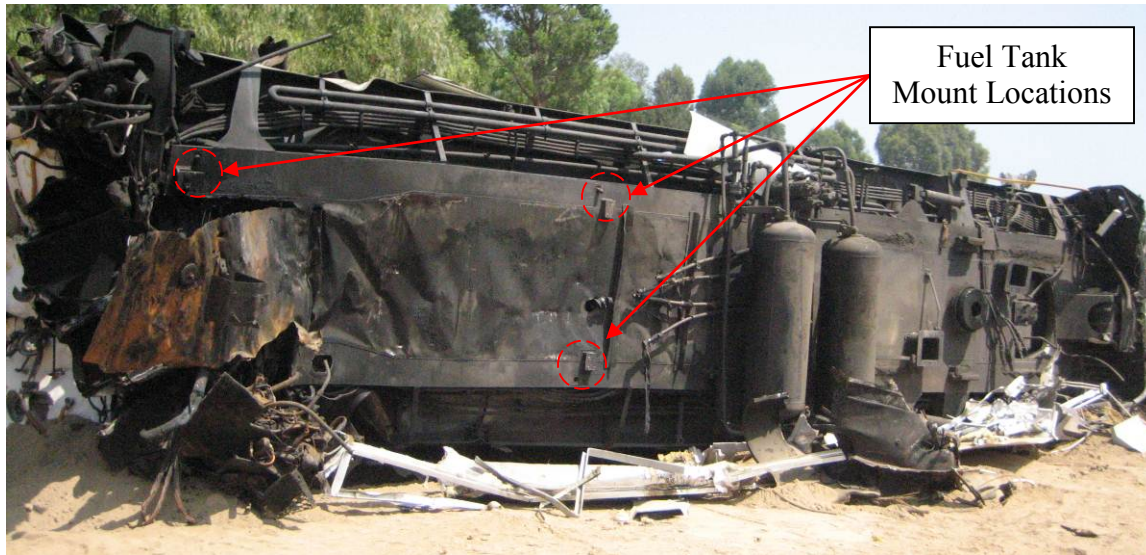
Figure A.3-6. Passenger Locomotive Underframe, After Locomotive Moved by Rescue and Recovery Crew

Prior to the crashworthiness team's arrival on scene, the freight locomotive and the passenger locomotive were moved as part of the rescue and recovery operations. As a result of this move, portions of the damaged passenger locomotive underframe were disturbed, including the center plate from the lead truck. Figure A.3-6 is a photograph of the underframe of the locomotive after it was moved from its post-accident location. Three fuel tank attachment locations are highlighted in this photograph. Two of these three locations include fractured mounting bolts still in their holes.

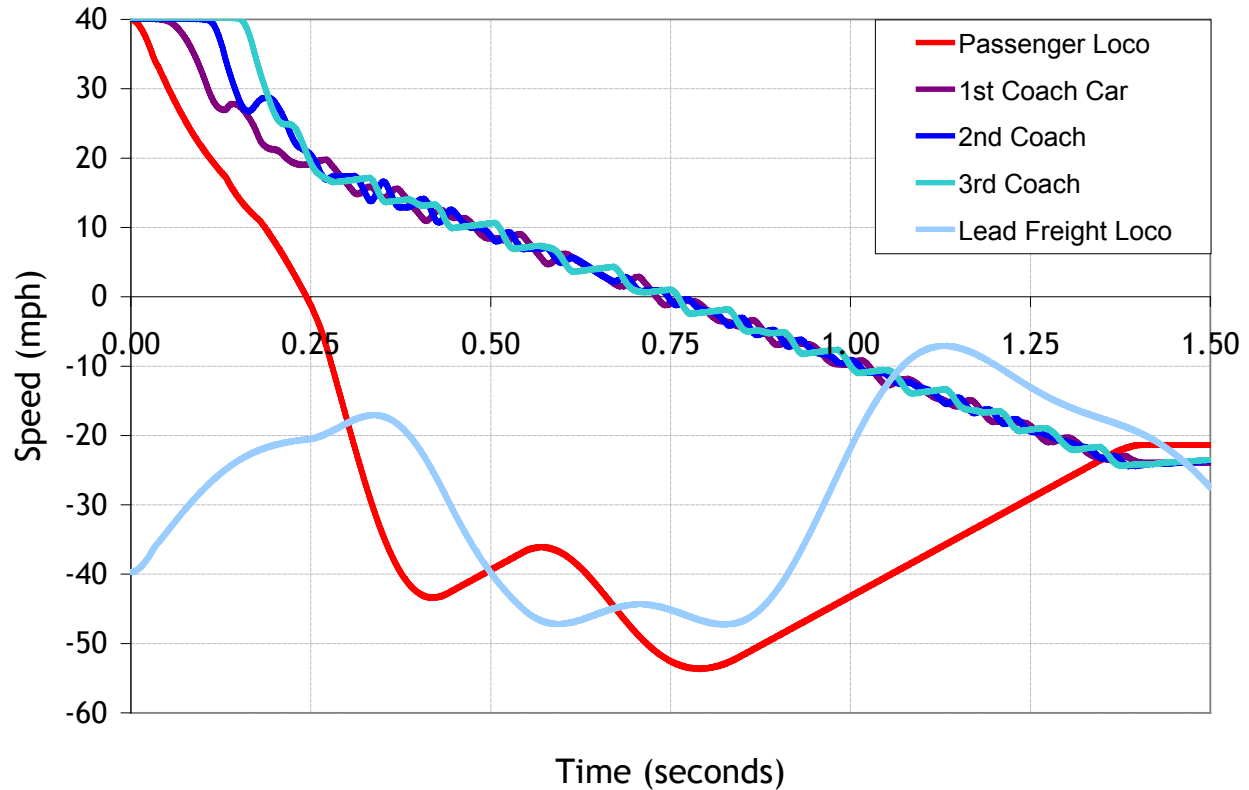
Figure A.4-4. Velocity-Time Histories for Each Vehicle Starting at the Time of Impact

Figure A.4-4 shows the velocity-time history of the passenger train and the first locomotive in the freight train. The two trains were traveling toward each other, with a closing speed³ of about 80 mph. In the first 0.05 seconds after the impact, the passenger locomotive slowed to about 30 mph, a rate of approximately 7.3 gs.⁴ There is about a 0.05-second delay before the following passenger cars begin to decelerate. The passenger train then decelerates at a rate of about 1.8 gs. The approximate timing of the simulation collision event correlates to timing estimated from reviewing the onboard locomotive cameras, as described in Appendix A.5.

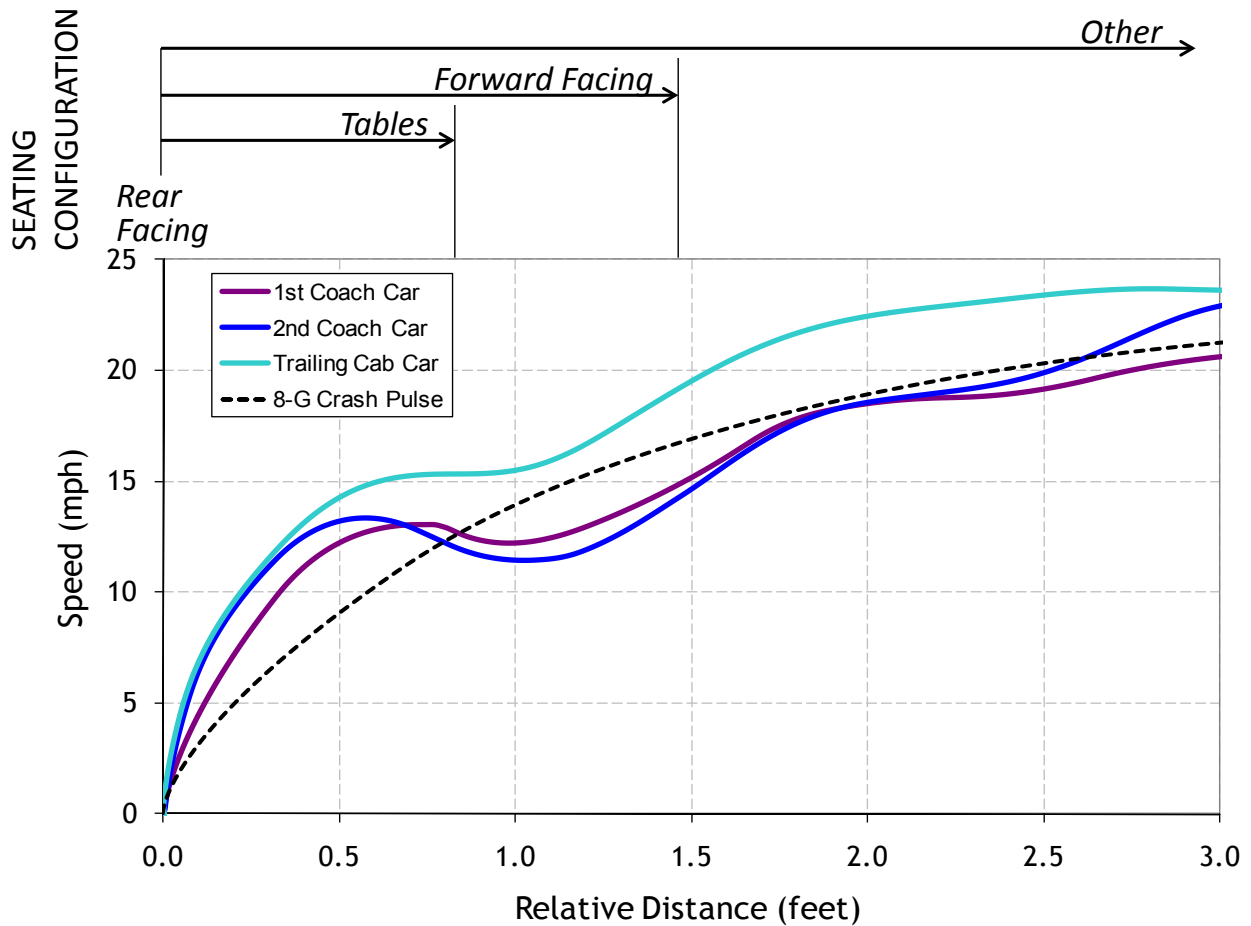
Figure A.4-5. Secondary Impact Velocities for Each Occupied Vehicle

Figure A.4-5 shows the SIVs for the passenger train. The horizontal axis at the bottom of the plot represents the distance travelled for an occupant in free flight with respect to the carbody (which varies with seating configuration as shown at the top of the plot). The vertical axis represents the velocity of an occupant in free flight, also with respect to the carbody. The first 0.3 seconds of the gross motions in Figure A.4-4 are used to plot the relevant SIV data for this accident. For comparison, the SIV plot associated with the 8-g crash pulse (used for passenger seat crashworthiness testing) is also plotted in the graph.

passengers seated at forward-facing or facing seats without tables, the high end estimate of the SIVs was 21-24 mph. The results show that the last coach experiences a high deceleration, resulting in a more severe secondary impact. For passengers who are not compartmentalized, large travel distances correlate to an even higher SIV. In this accident, two fatalities were caused by long travel distances in the interior resulting in fatal impact with the interior.

These results correlate to the evidence of interior damage of the third passenger car, described in Appendix B.3.

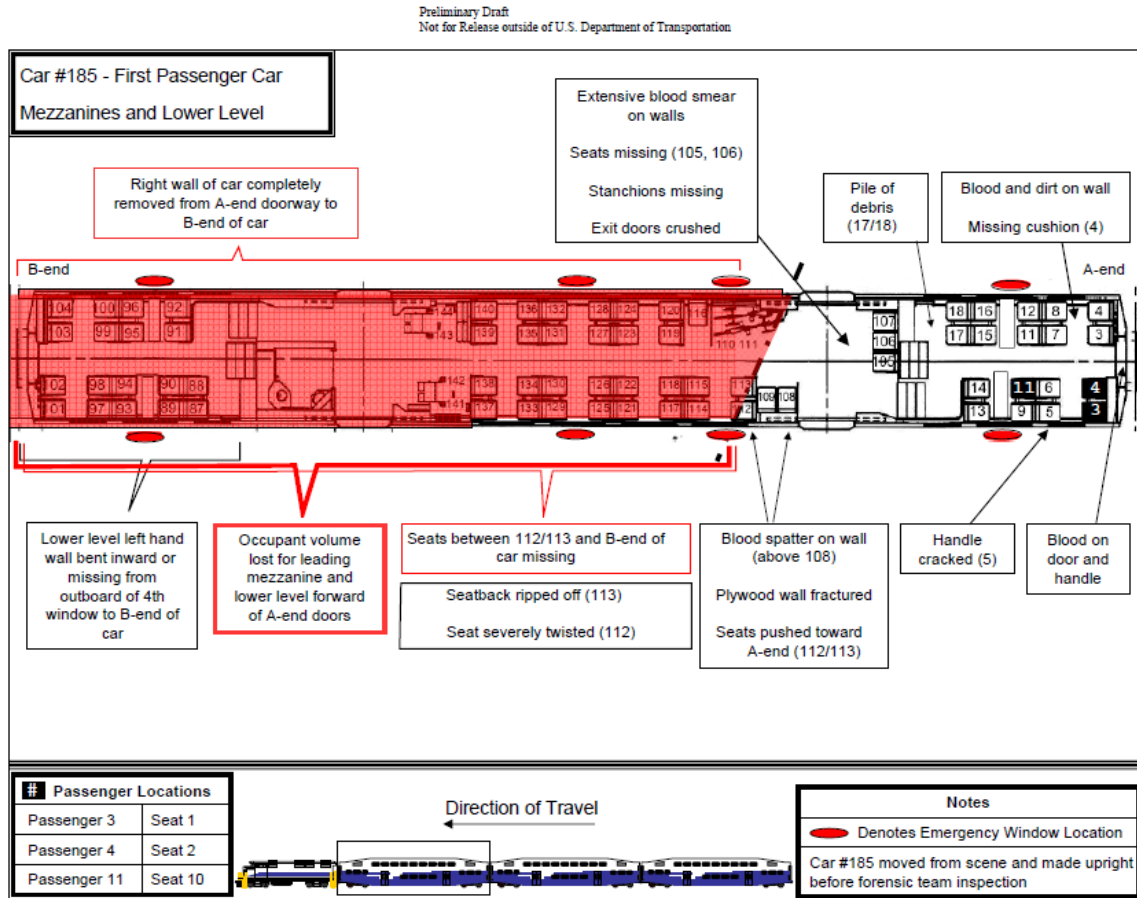
B.3-1

Car #185 – First Passenger Car

Mezzanines and Lower Level

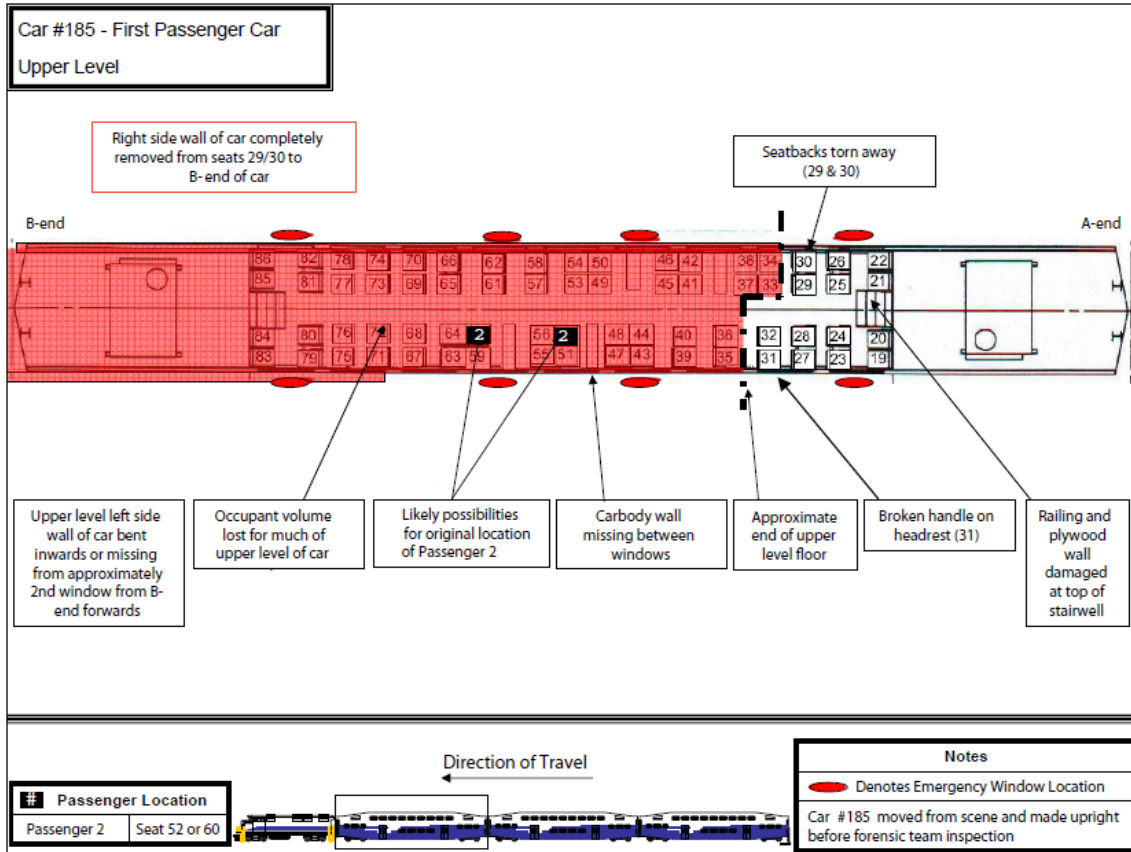
B.3-2

Upper Level

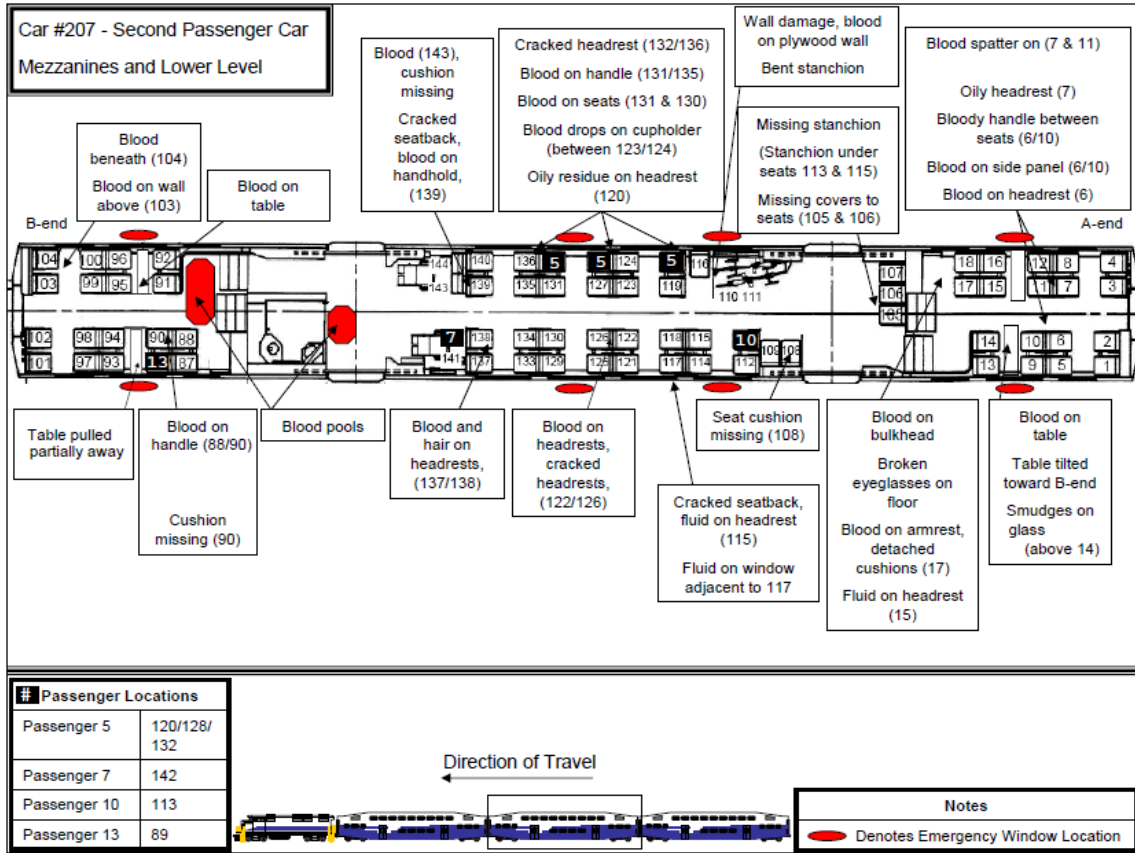
B.3-3

Car #207 – Second Passenger Car

Mezzanines and Lower Level

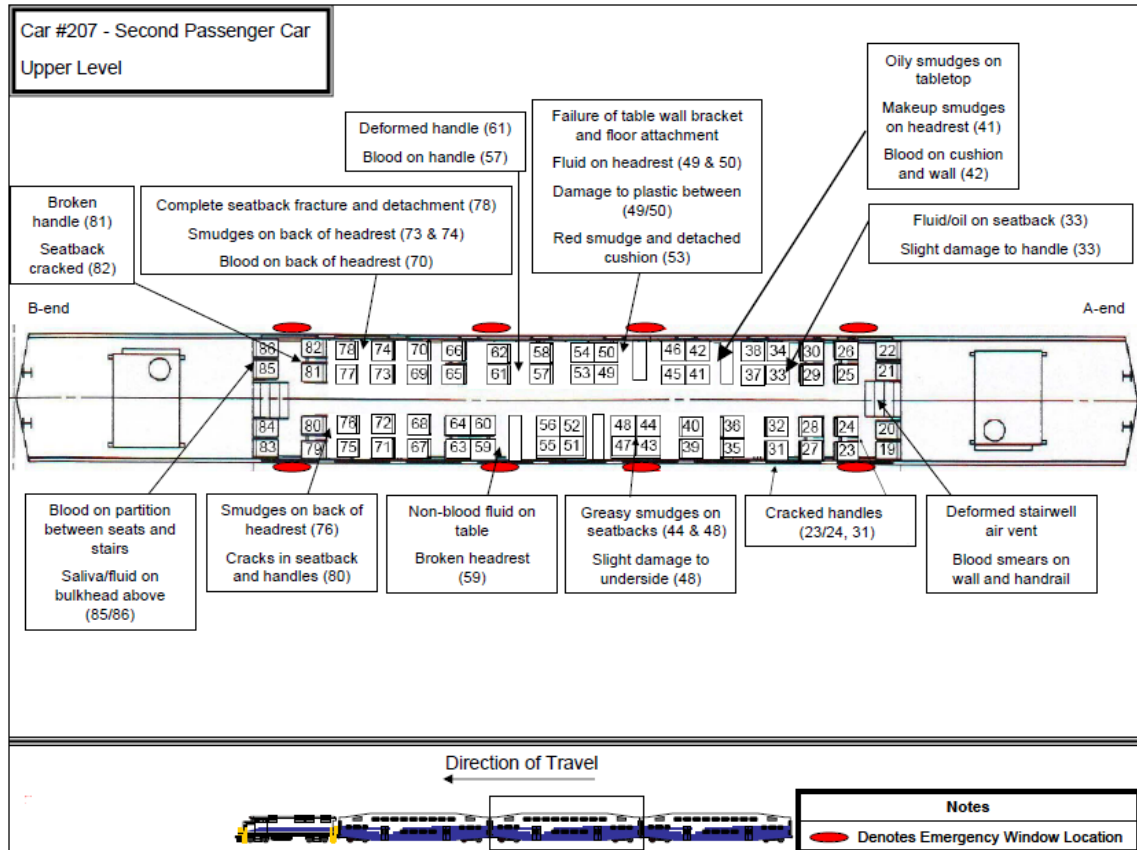
B.3-4

Upper Level

Passenger Locations

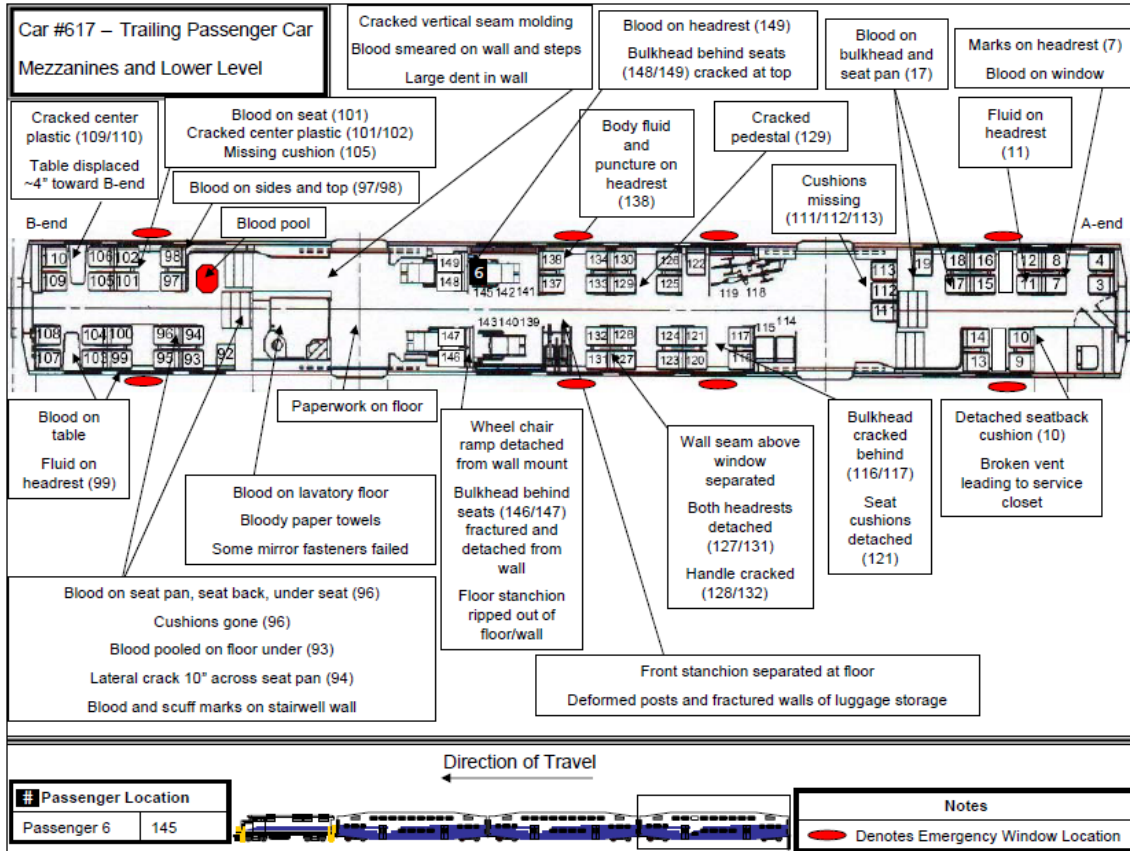
B.3-5

Mezzanines and Lower Level
