EVALUATION OF FLOORPAN TEARING AND CABLE SPLICES FOR CABLE BARRIER SYSTEMS

MIDWEST ROADSIDE SAFETY FACILITY

MwRSF Research Report No. TRP-03-324-17

May 16, 2017

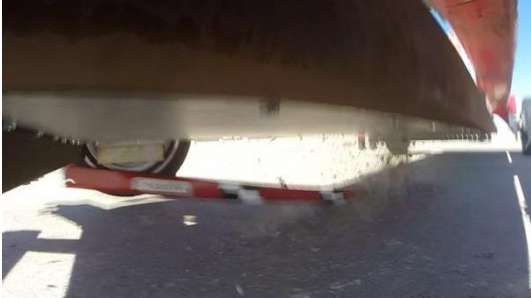
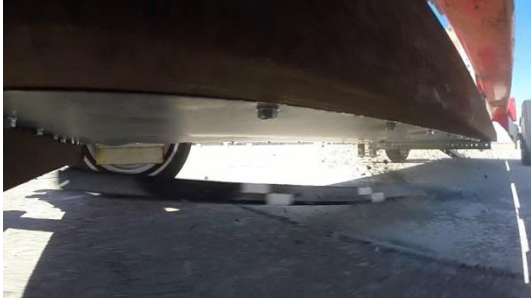
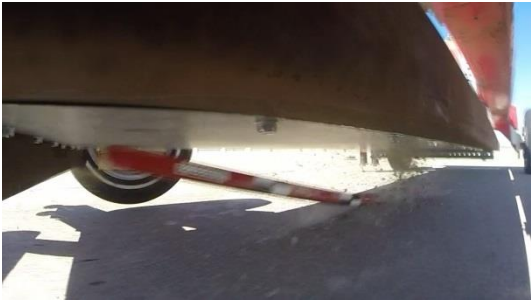
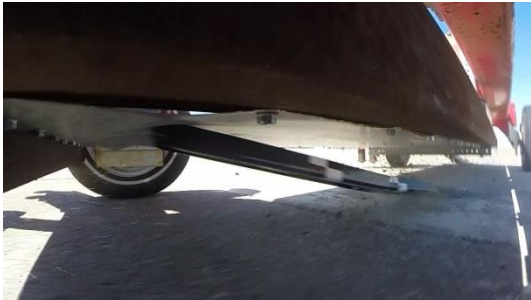
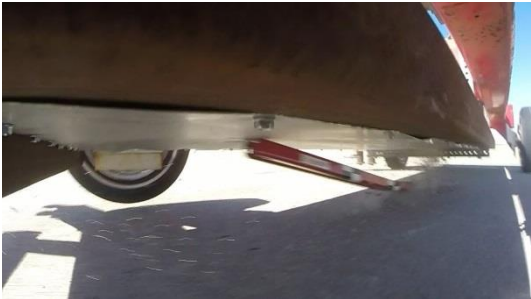
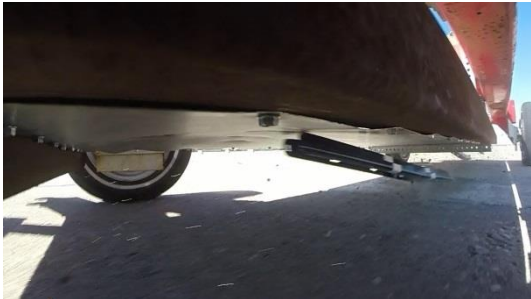
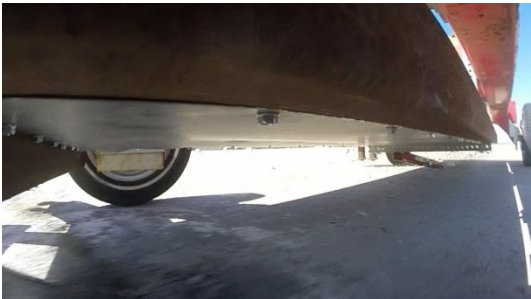
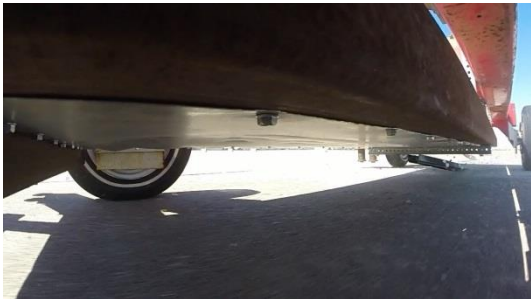
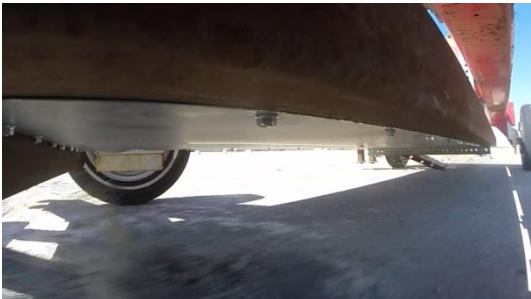
Figure 28. Time-Sequential and Post Damage Photographs, Test No. MWFPF-2

Test no. MWPF2-2 provided very similar results as compared to full-scale crash testing. The elastic response of the overridden posts applied a vertical contact force to the simulated floorpan. Tears observed in the simulated floorpan were all caused by the free edges of the posts and were similar in length and opening width to those found in the test vehicles of test nos. MWP-6 and MWP-7. Additionally, creases running the length of the simulated floorpan were formed from contact with both edges the posts. Therefore, the bogie testing setup was thought to accurately replicate the floorpan damage observed in full-scale test nos. MWP-6 and MWP-7. The same test setup was utilized in the remaining bogie tests to evaluate various tearing mitigation methods.

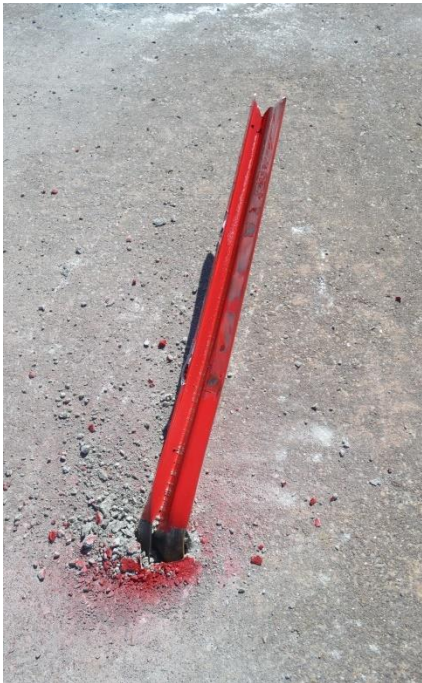
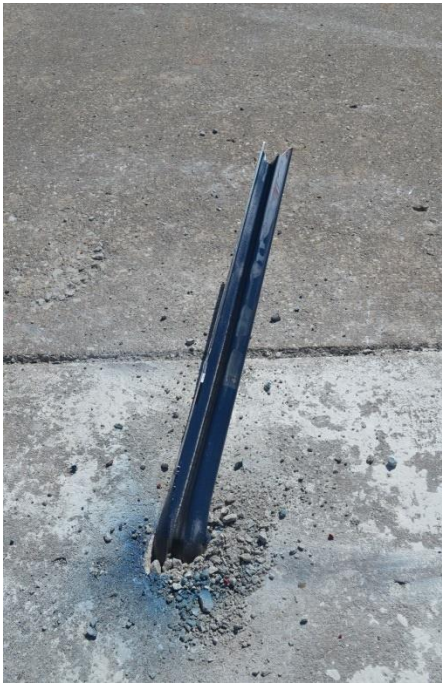
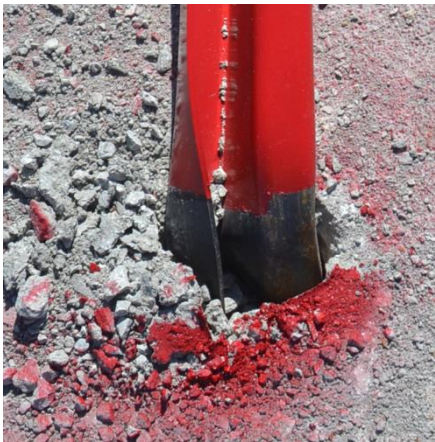
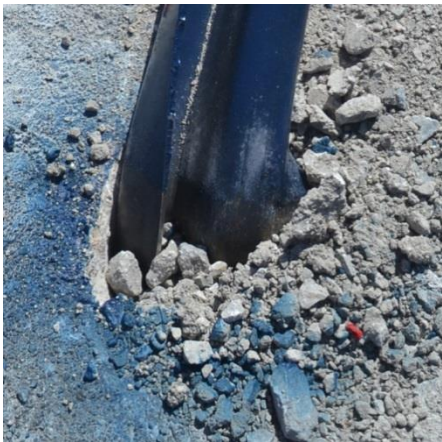
The posts were bent plastically near the groundline, and contact marks were found on the top half of the post along the free edge and impact side face of the post, as shown in Figure 28. Damage to the simulated floorpan included creasing and tearing due to contact from the top corners of both posts, as shown in Figure 29. Two tears were found in both the front and rear bays of the simulated floorpan. These tears corresponded to the location of initial contact between the free edges of the posts and the floorpan as the posts passed the crossbeams and rebounded upward. The largest tear was 5 in. (127 mm) long and had a maximum width of ½ in. (13 mm). Creases in the simulated floorpan were found extending from the tears toward the rear of the bogie. Approximately 3 in. (76 mm) to the right of the tears and creases caused by the free edges, additional creases caused by the continuous edges of the posts were present on the floorpan. All tears and creases observed on the simulated floorpan were measured and are summarized in Table 5.

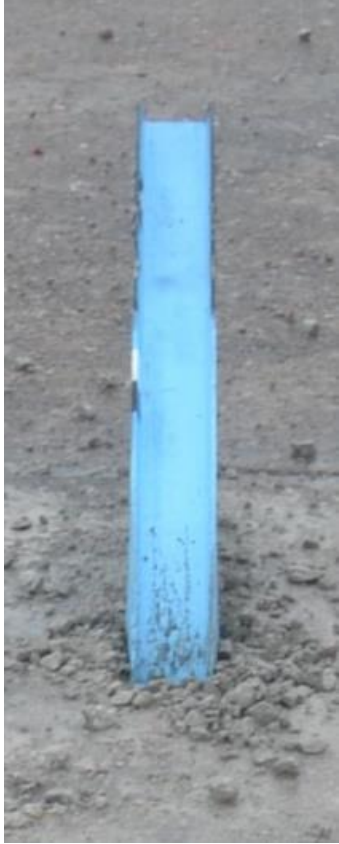
Figure 38. Time-Sequential and Post Damage Photographs, Test No. MWPF5-5

The posts were bent plastically near the groundline, and contact marks were present on both edges of the posts, as shown in Figure 38. Damage to the simulated floorpan included tearing and creasing due to contact with the top corners of both posts, as shown in Figure 39. Four tears were found in both the front and rear bays of the simulated floorpan corresponding to the location of initial contact between the posts and the floorpan as the posts passed the crossbeams and rebounded upward. The largest of these initial tears was 6½ in. (165 mm) long and had a maximum width of ¼ in. (6 mm). Continued contact with one of the posts resulted in two additional tears in the front bay measuring 16 in. (406 mm) and 13 in. (330 mm) in length. The shorter height of the posts appeared to cause higher restoration forces, which led to these additional tears. Creases were also found in the simulated floorpan extending from the initial tears toward the rear of the bogie. All of the tears and creases observed on the simulated floorpan were measured and are summarized in Table 8.

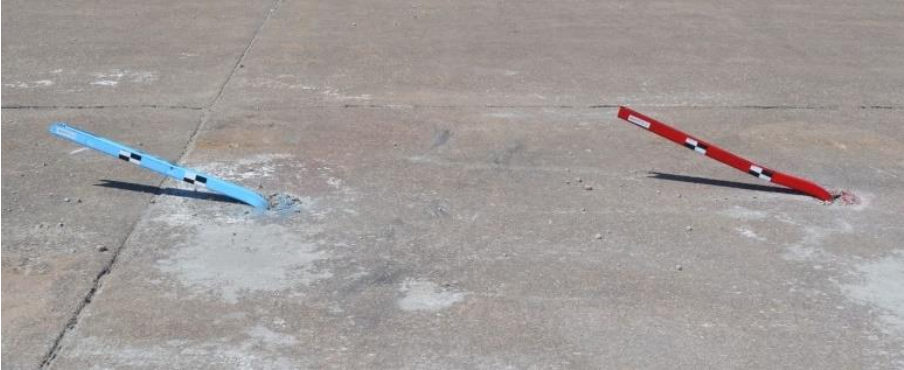
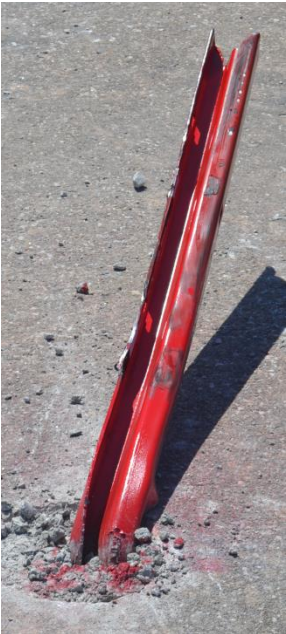
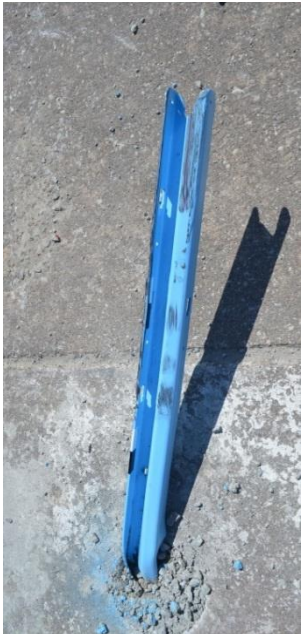
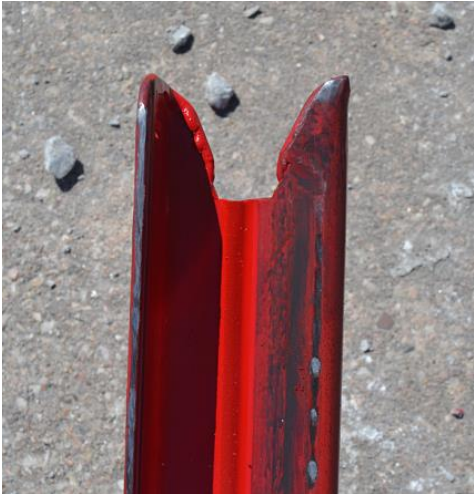
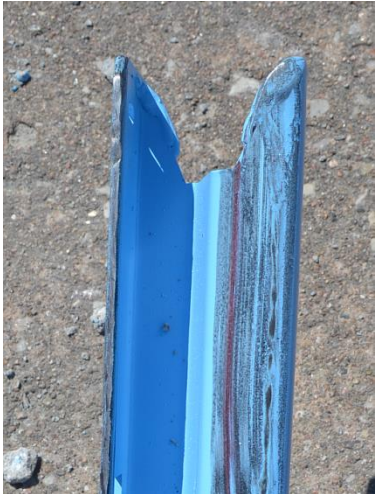
Figure 42. Time-Sequential and Post Damage Photographs, Test No. MWPPF-6

The posts were bent plastically near the groundline, and contact marks were found on the top half of the post along the free edge and impact side face of the post, as shown in Figure 42. Damage to the simulated floorpan included creasing and tearing due to contact from the top corners of both posts, as shown in Figure 43. Two tears were found in both the front and rear bays of the simulated floorpan. These tears corresponded to the location of initial contact between the free edges of the posts and the floorpan as the posts passed the crossbeams and rebounded upward. The largest tear was 12¾ in. (324 mm) long and had a maximum width of ½ in. (13 mm). Creases in the simulated floorpan were found extending from the tears toward the rear of the bogie. Additional creases caused by the continuous edges of the posts were present in the floorpan, approximately 3 in. (76 mm) to the right of the tears and creases caused by the free edges of the post. All tears and creases observed on the simulated floorpan were measured and are summarized in Table 9.

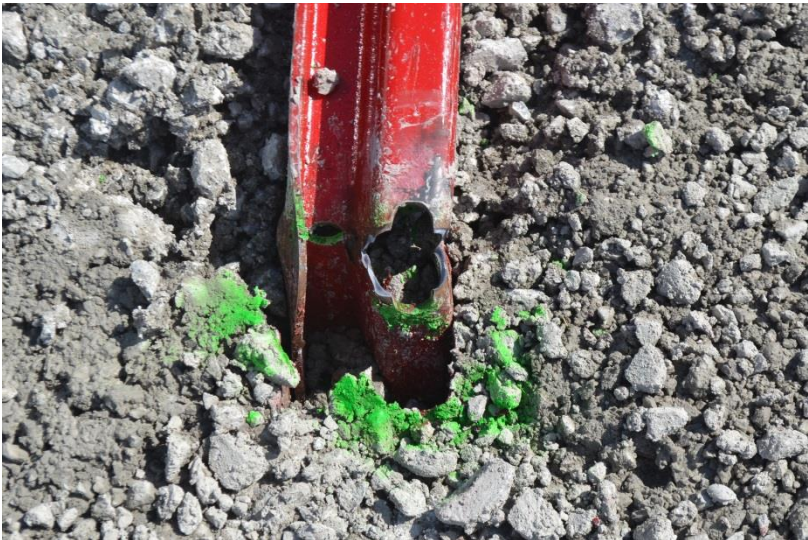
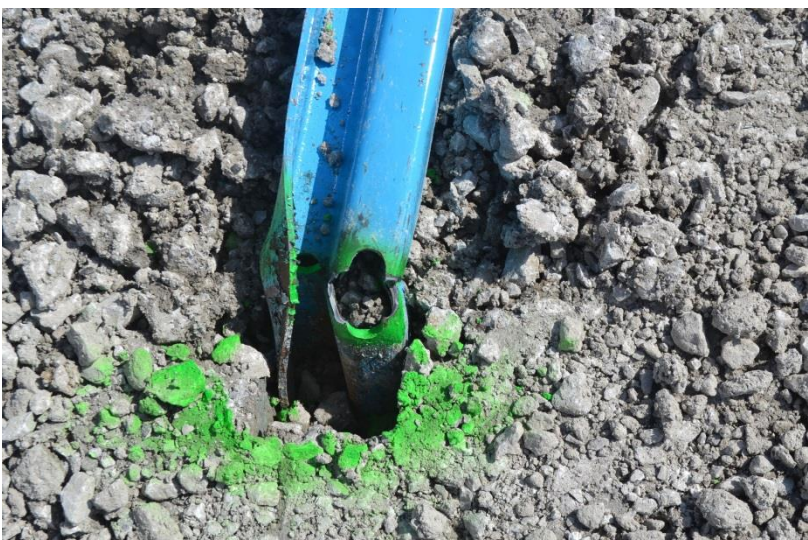
Figure 45. Time-Sequential and Post Damage Photographs, Test No. MWPF7-7

The posts were bent plastically near the groundline, and tearing was present in both posts, as shown in Figure 45. The tears initiated from the weakening holes on the impact side of the posts and extended into the webs and adjacent flanges. The posts displaced approximately 1 in. (25 mm) through the soil at the groundline. Contact marks were found on the top half of the post along the free edge and impact side face of the post. Damage to the simulated floorpan included scrapes and creases, but no tearing. Four creases were found in both the front and rear bays of the simulated floorpan, as shown in Figure 46. The two creases in each bay resulted from contact with the free edges of the posts and extended nearly the entire length of the bogie vehicle. The creases resulting from contact with the continuous edges of the posts were limited to less than 6 in. (152 mm). All creases observed on the simulated floorpan were measured and summarized in Table 10.

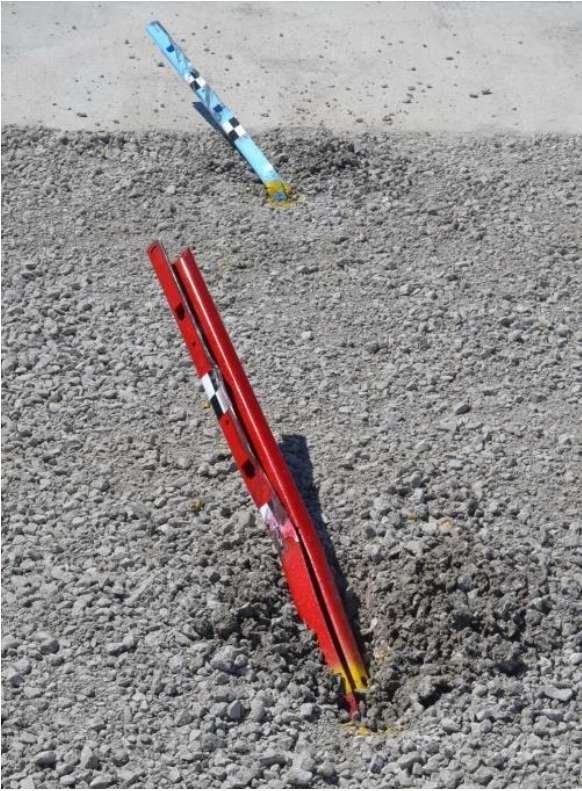
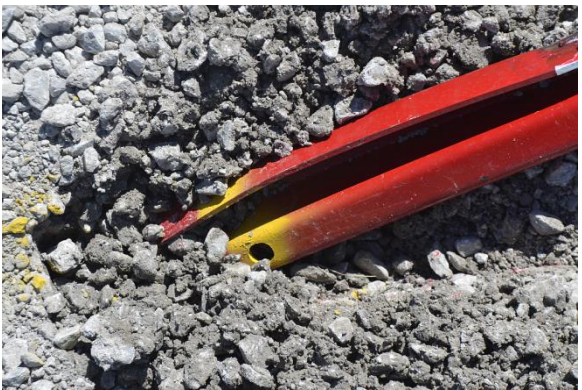
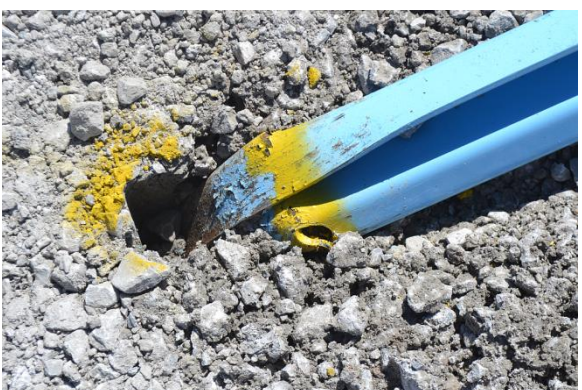
Figure 48. Time-Sequential and Post Damage Photographs, Test No. MWFPF-8

The posts were bent plastically near groundline, and contact marks were found along the top half of the post, as shown in Figure 48. No tearing was observed in the post around the weakening holes. The posts displaced 2 to 3 in. (51 to 76 mm) through the soil at the groundline. Damage to the simulated floorpan included tears and creases, as shown in Figure 49. Tears were found in the front and rear bays corresponding to contact from the free edge of the first post. Each bay had an initial tear near the crossbeam, the largest of which was 10¾ in. (273 mm) long with a maximum opening width of ⅝ in. (16 mm). Creasing followed these tears and eventually led to secondary tears measuring 25 in. (635 mm) and 18½ in. (470 mm). The free edge of the second post left a prominent crease along the front bay of the simulated floorpan and a short crease on the rear bay before sliding to the side of the bogie and losing contact with the floorpan. Due to the orientation angle of the post, the continuous edges left only minor creases in the floorpan. All tears and creases observed on the simulated floorpan were measured and are summarized in Table 11.

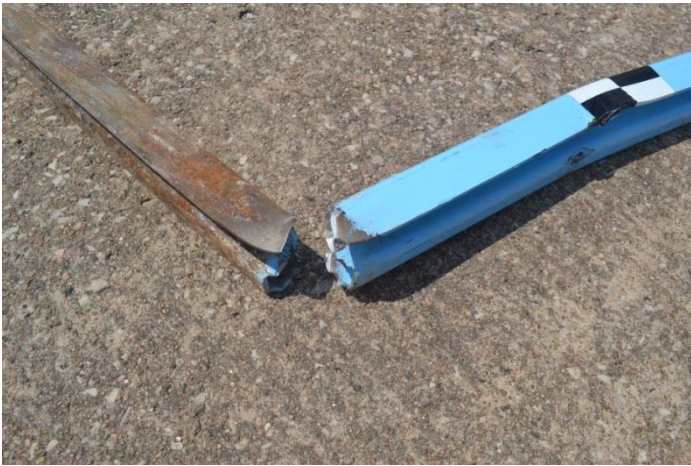
Both posts had ruptured at the groundline, as shown in Figure 55. Tearing was initiated around the weakening slots on the impact side of the posts and continued through the entire cross section. The simulated floorpan was undamaged as the posts never contacted the undercarriage of the bogie vehicle.

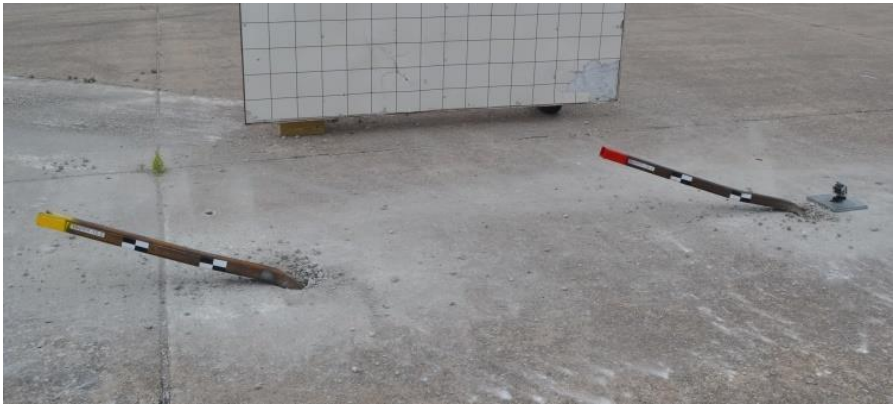
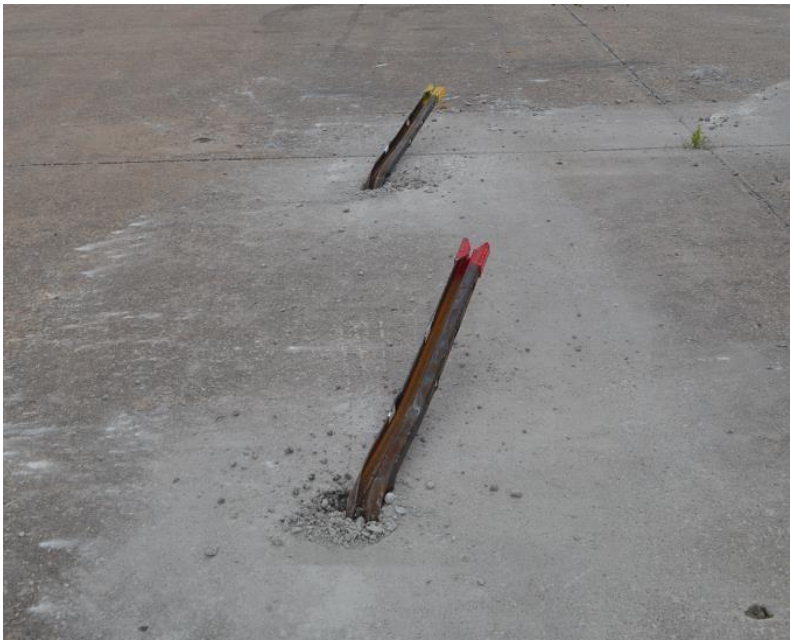
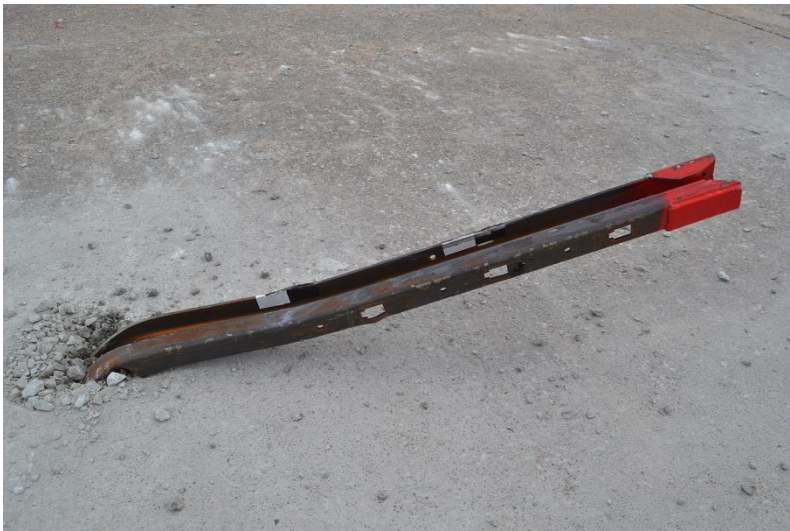
Figure 58. Time-Sequential and Post Damage Photographs, Test No. MWPPF-13

The posts were bent plastically near the groundline, and contact marks were found along the impact side of the posts, as shown in Figure 58. Damage to the simulated floorpan included tearing and creasing due to contact from the top corners of both posts, as shown in Figure 59. Two tears were found in both the front and rear bays of the simulated floorpan. These tears corresponded to the location of initial contact between the continuous edges of the posts and the floorpan as the posts passed the crossbeams and rebounded upward. The largest tear was 3 in. (76 mm) long and had a maximum width of ¼ in. (6 mm). Creases in the simulated floorpan were found along the entire length of the simulated floorpan. All tears and creases observed on the simulated floorpan were measured and are summarized in Table 12.

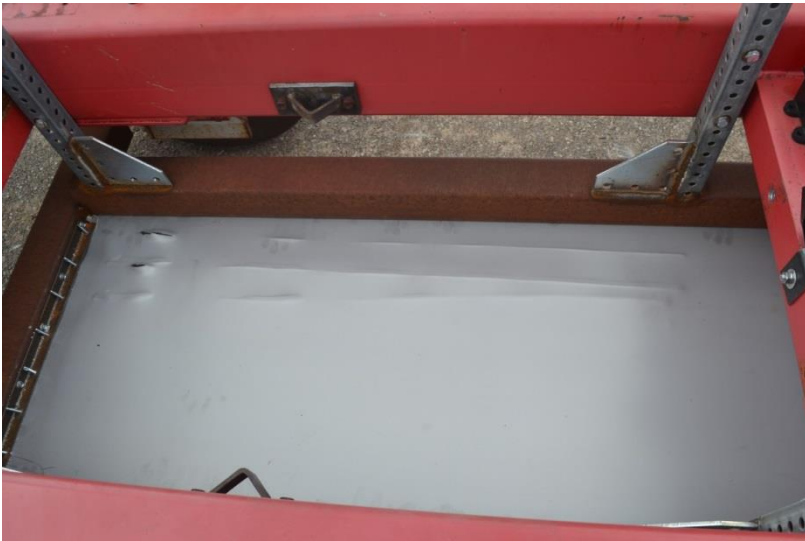
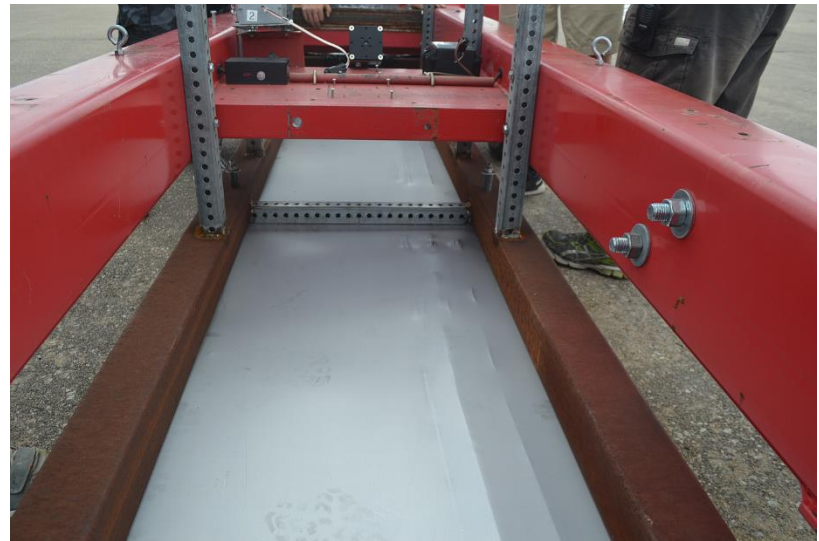
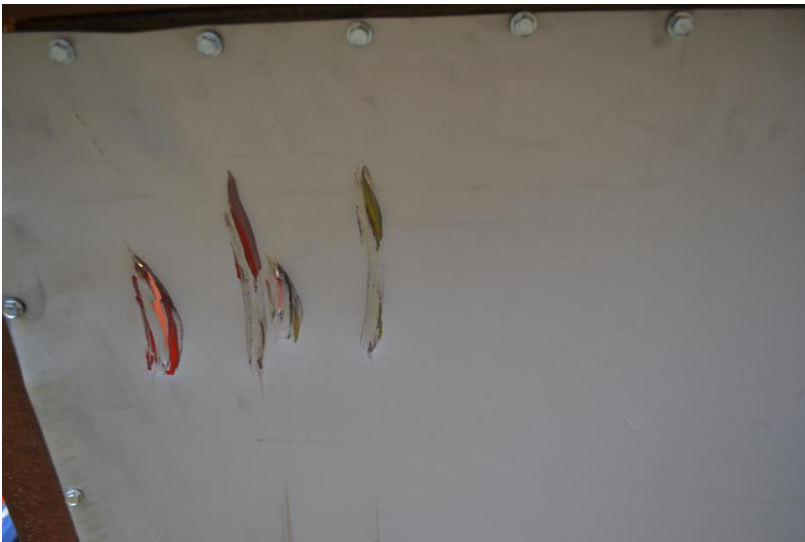
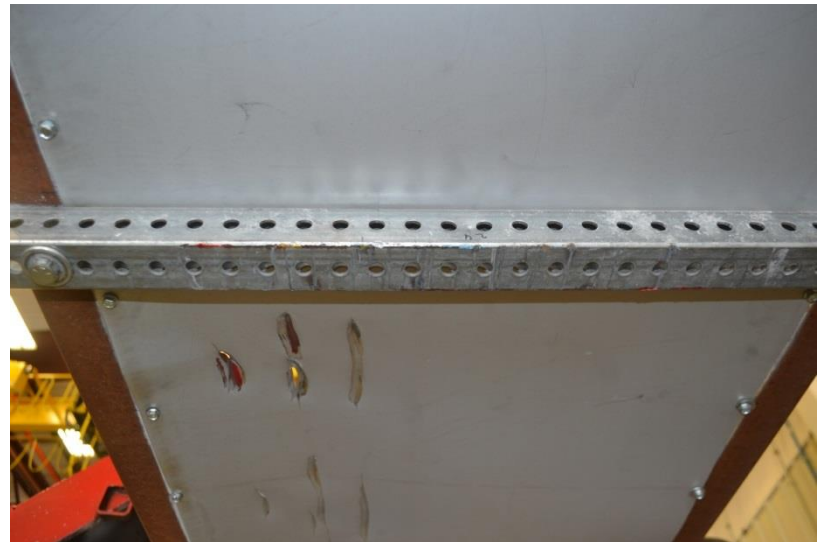
Figure 59. Simulated Floorpan Damage, Test No. MWPFPP-13

Figure 60, the lack of a radius at this location resulted in a sharp corner exposed to contact with an impacting vehicle. Further, these sharp corners were responsible for all four tears observed in the simulated floorpan. The protected free-edge sides of the posts caused only creasing in the simulated floorpan. Thus, the steel plate edge protector may have actually prevented tearing if the posts had been fabricated correctly.

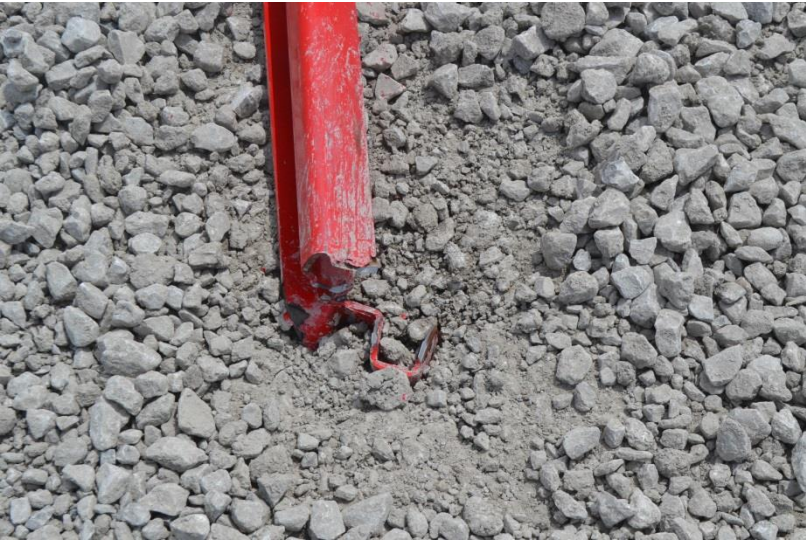
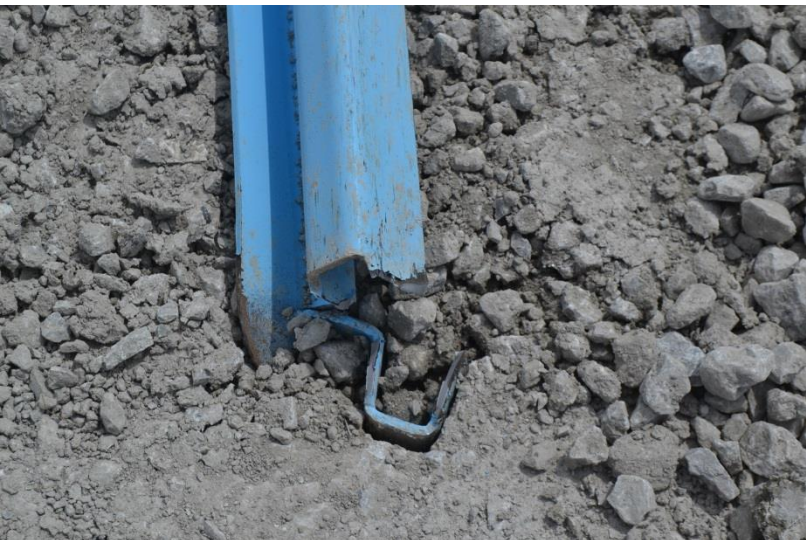
Figure 64. Time-Sequential and Post Damage Photographs, Test No. MWFPF-15

The posts were completely bent over, and tearing was present in both posts, as shown in Figure 64. The tears initiated from the weakening slots on the impact side of the posts and extended through the adjacent flanges and the webs. Only the opposite-side flanges of the posts were still intact and held the posts together. The posts displaced approximately $\frac{1}{2}$ in. (13 mm) through the soil at groundline. The simulated floorpan was undamaged as the posts never contacted the undercarriage of the bogie vehicle.

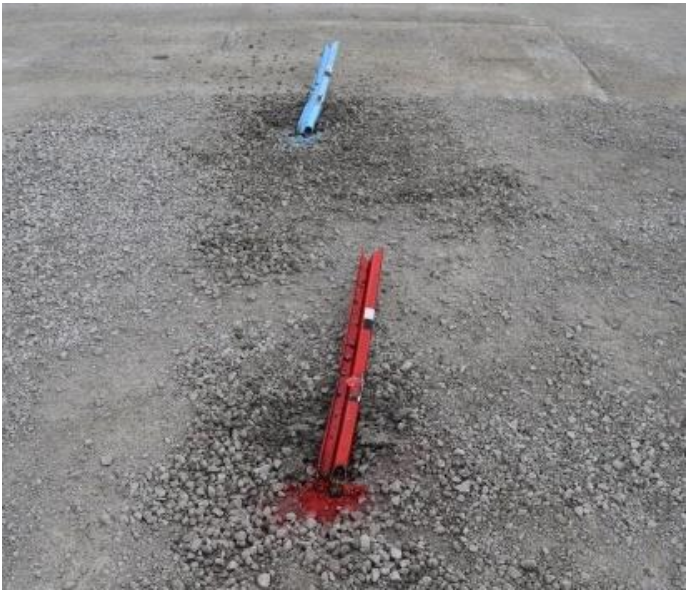
Figure 66. Time-Sequential and Post Damage Photographs, Test No. MWFPF-18

The posts were bent plastically near the groundline, and tearing was present in both posts, as shown in Figure 66. The tears initiated from the weakening holes on the impact side of the posts and extended into the webs and adjacent flanges. Additional tearing was found on the opposite side flange of the first post. The posts displaced approximately 1 1/2 in. (38 mm) through the soil at the groundline. Damage to the simulated floorpan included scrapes and creases, but no tearing. Two creases were found in both the front and rear bays of the simulated floorpan, as shown in Figure 67. Only one of the creases extended past the region of initial contact. All creases observed on the simulated floorpan were measured and are summarized in Table 13.

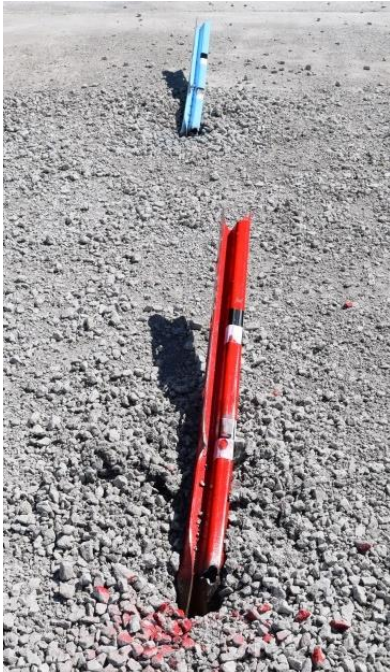
Figure 69. Time-Sequential and Post Damage Photographs, Test No. MWFPF-21

The posts were bent plastically near the groundline, and tearing was present in both posts, as shown in Figure 69. The tears initiated from the weakening holes on the impact side of the posts and extended into the webs and adjacent flanges. The posts displaced approximately 1½ in. (38 mm) through the soil at the groundline. Damage to the simulated floorpan included scrapes and creases, but no tearing. Three creases were found in both the front and rear bays of the simulated floorpan, as shown in Figure 70. Creases resulting from contact with free edges extended along the length of the simulated floorpan. Creases formed from contact with continuous edges were limited to only the area of initial contact. All creases observed on the simulated floorpan were measured and are summarized in Table 14.
