FINAL REPORT

Evaluation and Validation of Aboveground Techniques for Coating Condition Assessment

CC TECHNOLOGIES, INC GREGORY RUSCHAU, PH.D. ANGEL KOWALSKI

FEBRUARY 28, 2006

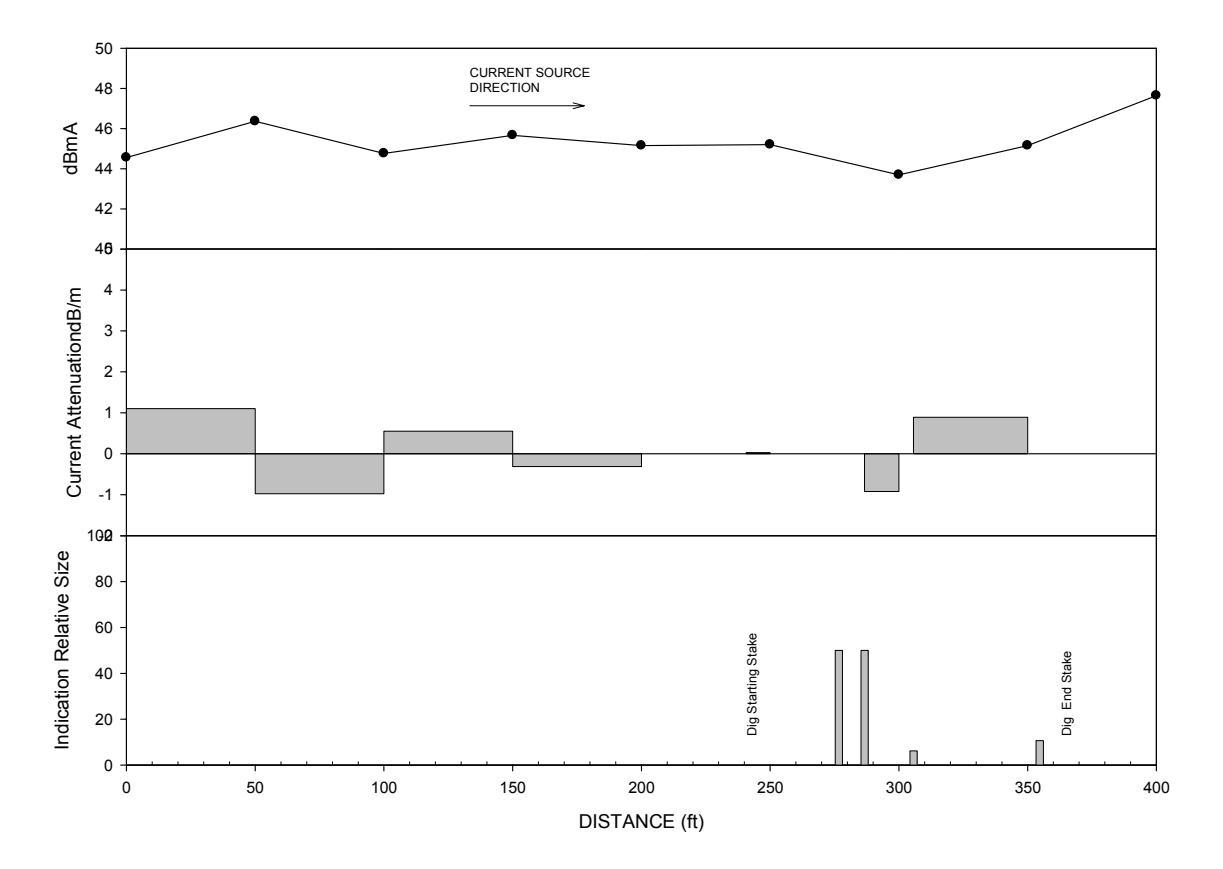
survey procedure manual). When readings are taken at a closer spacing, the current attenuation data may show inconsistency as current magnitude variations with distance are within the same range of the equipment precision. The current attenuation results in Figure 3 vary randomly from negative to positive values with no valid interpretation other than the presence of a perturbed magnetic field. Additionally the magnetic field could be affected by the current flow through the damaged coating or distorted by other elements such as an abrupt change in pipe depth or a bend.

Figure 3: Current Attenuation results obtained with PCM tool calculating attenuation from current readings at 50 ft intervals

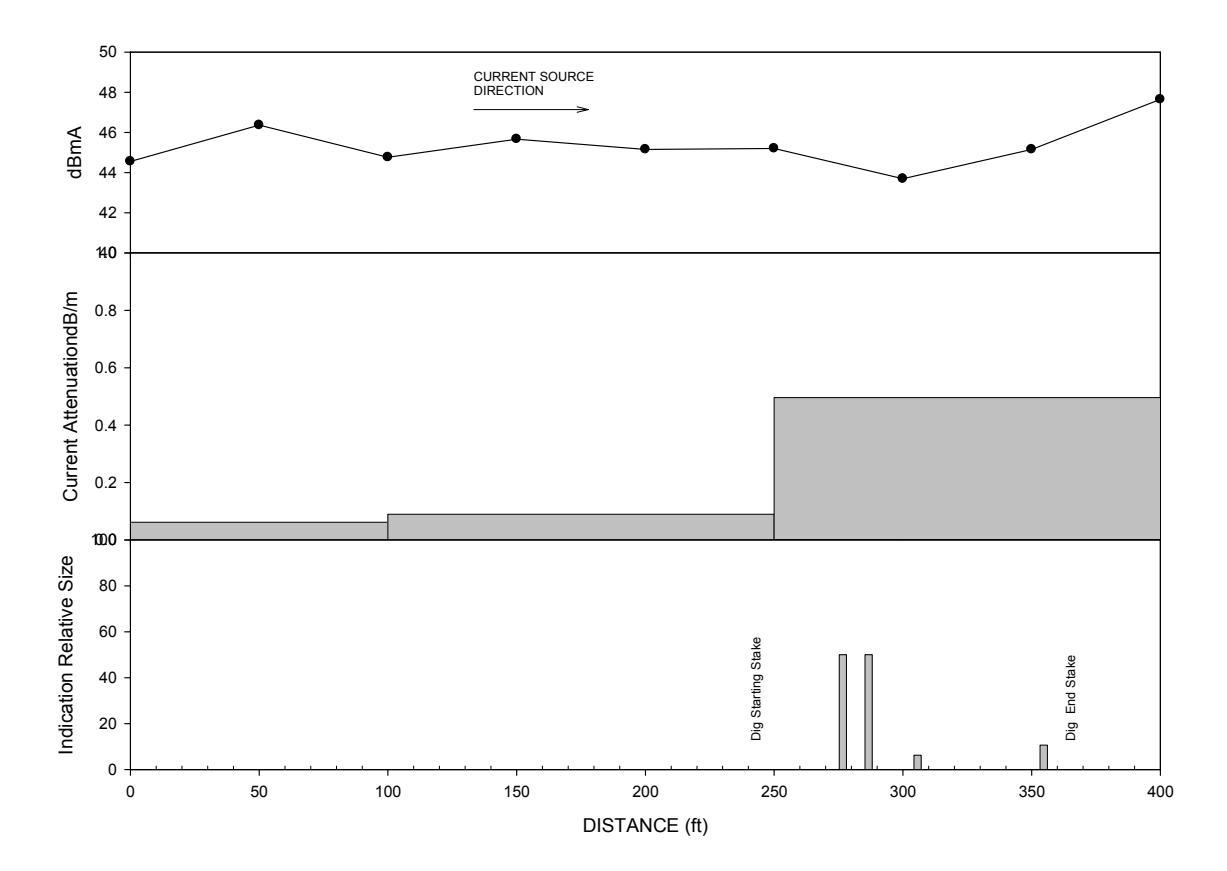
After analyzing the data shown above and using current readings at 150 ft spacing to calculate current attenuation values a more consistent curve was obtained and is presented in Figure 4.

Figure 4: Current Attenuation results obtained with PCM tool calculating attenuation from current readings at 150 ft intervals

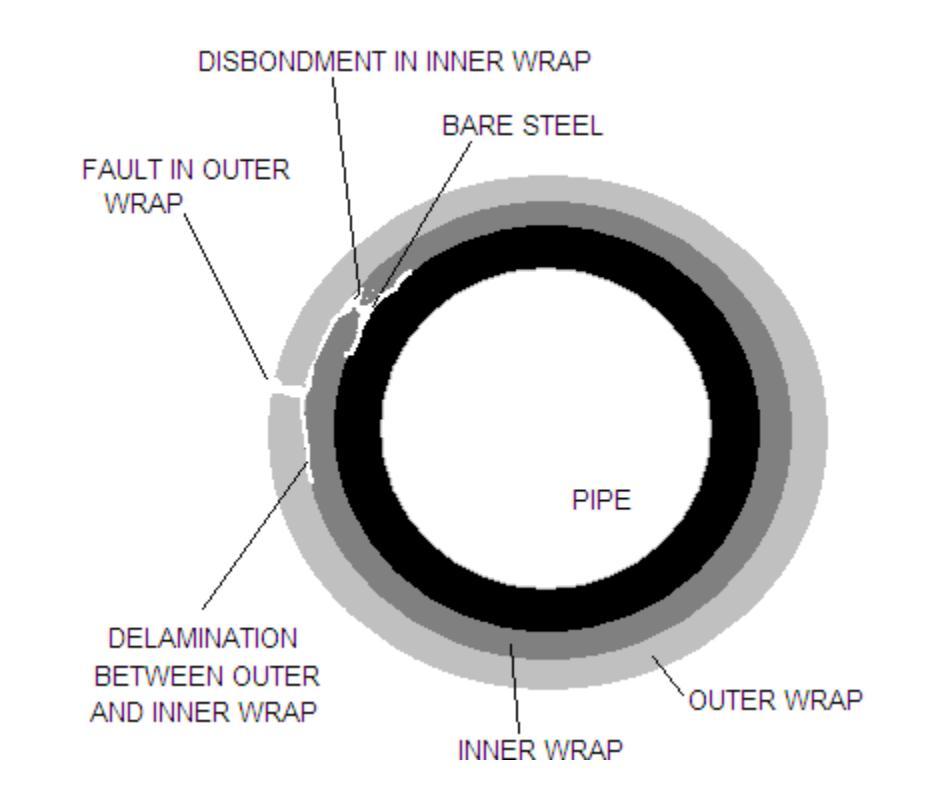
The use of a holiday detector during the visual examinations likely would not have produced any different results, because the bare steel area was not directly exposed to the soil, as shown schematically in Figure 50.

Figure 50: Representation of common coating fault in double layer wrap (asphalt enamel and coal tar enamel) systems

Groundwater took a tortuous path to reach the steel, and unless the groundwaters were still present during the visual examination, the electrical conductive pathway

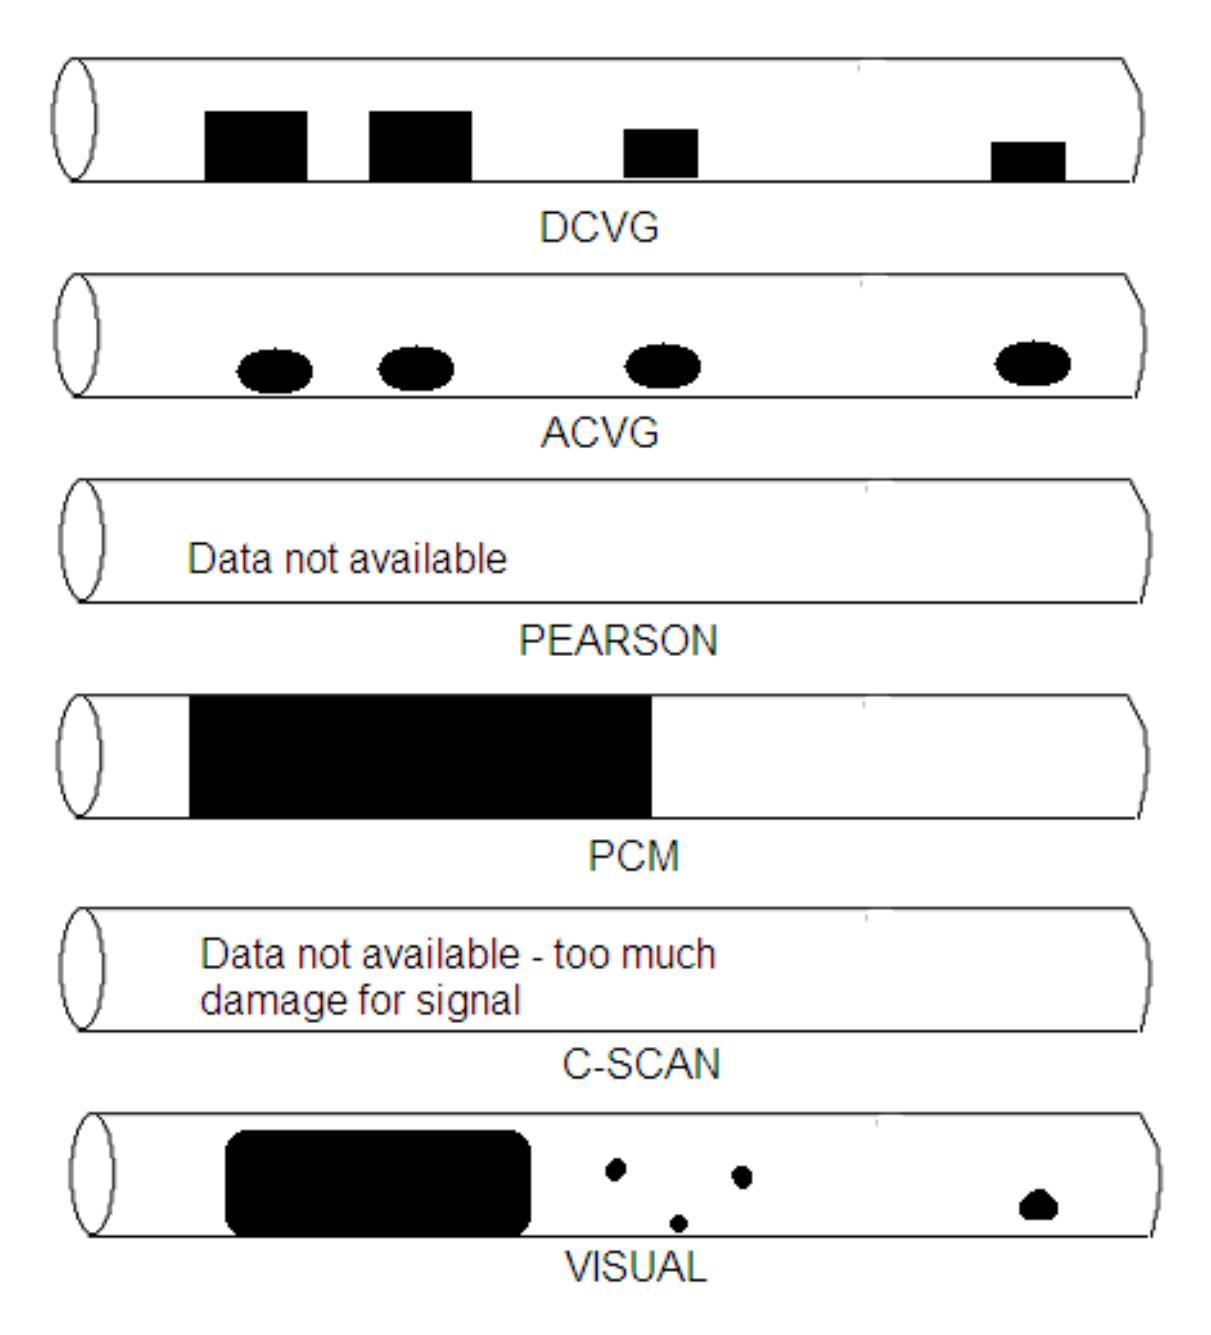
PCM appeared to be appropriate for large areas of disbondment, such as that shown in Figure 51. The DCVG and ACVG signals for these regions appeared to indicate several defects rather than the one large disbonded area that was present. Beyond this example, PCM provided only non-specific data at uncertain locations along the pipe. Observing PCM results on Test Sites 2a and 2b suggests that 50 ft spacing for current readings generated inconsistent current attenuation data and thus did not pin point individual coating indications.

Figure 51: Comparison of techniques from Site 1. The black areas represent either the size of the coating fault (from surveys) or the area of exposed steel (from visual exam).

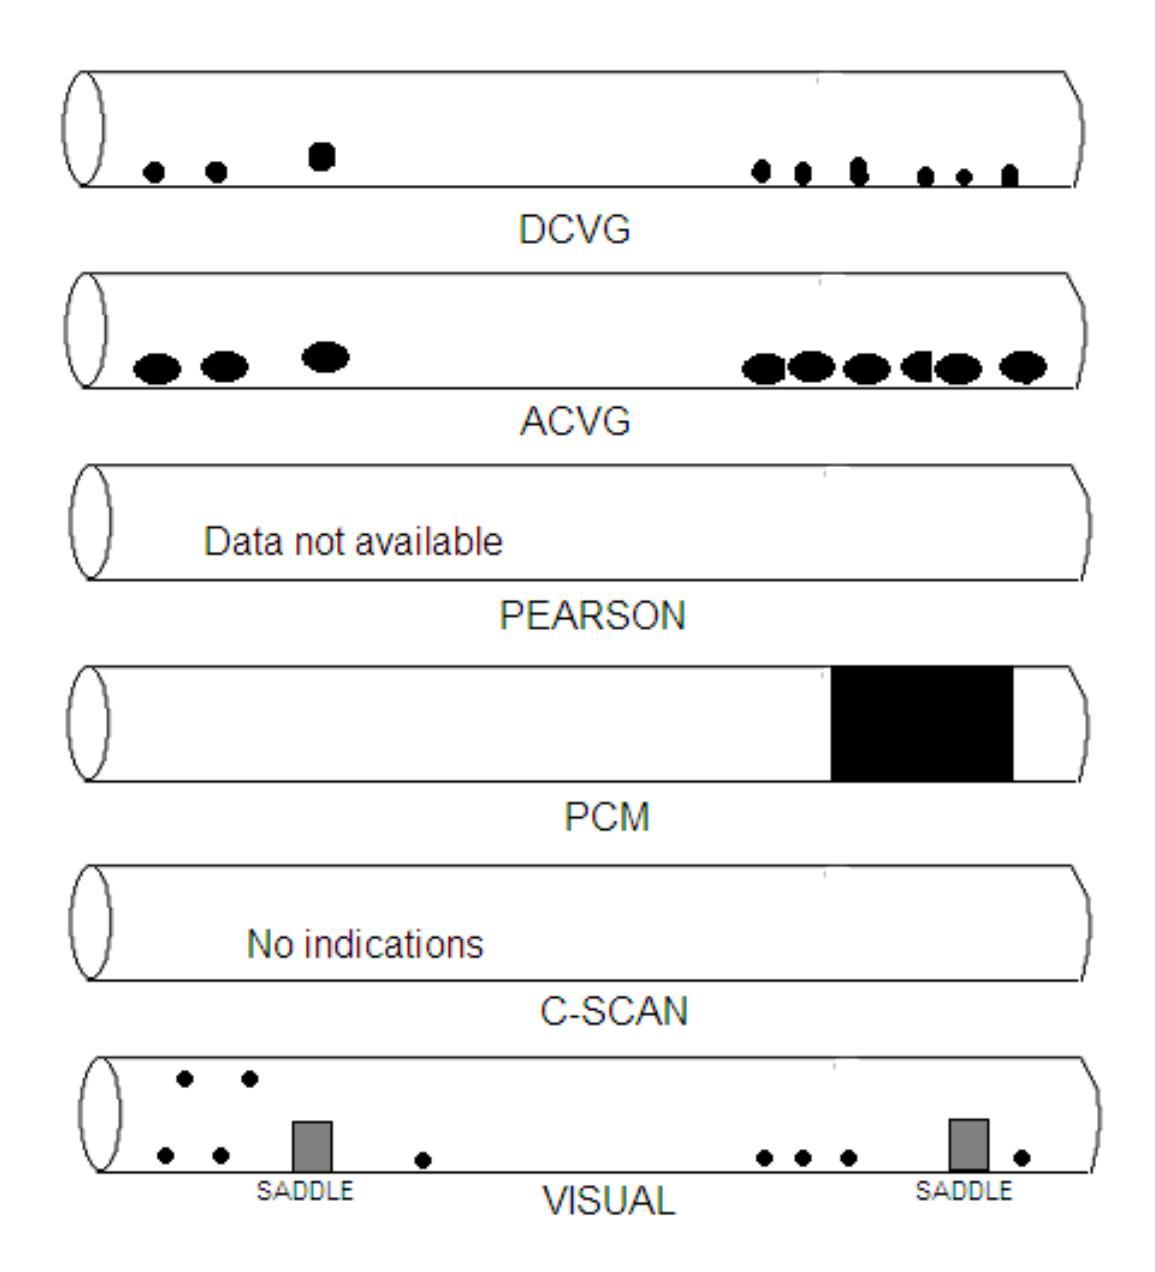
Figure 52: Comparison of techniques from Site 2a. The black areas represent either the size of the coating fault (from surveys) or the area of exposed steel (from visual exam).

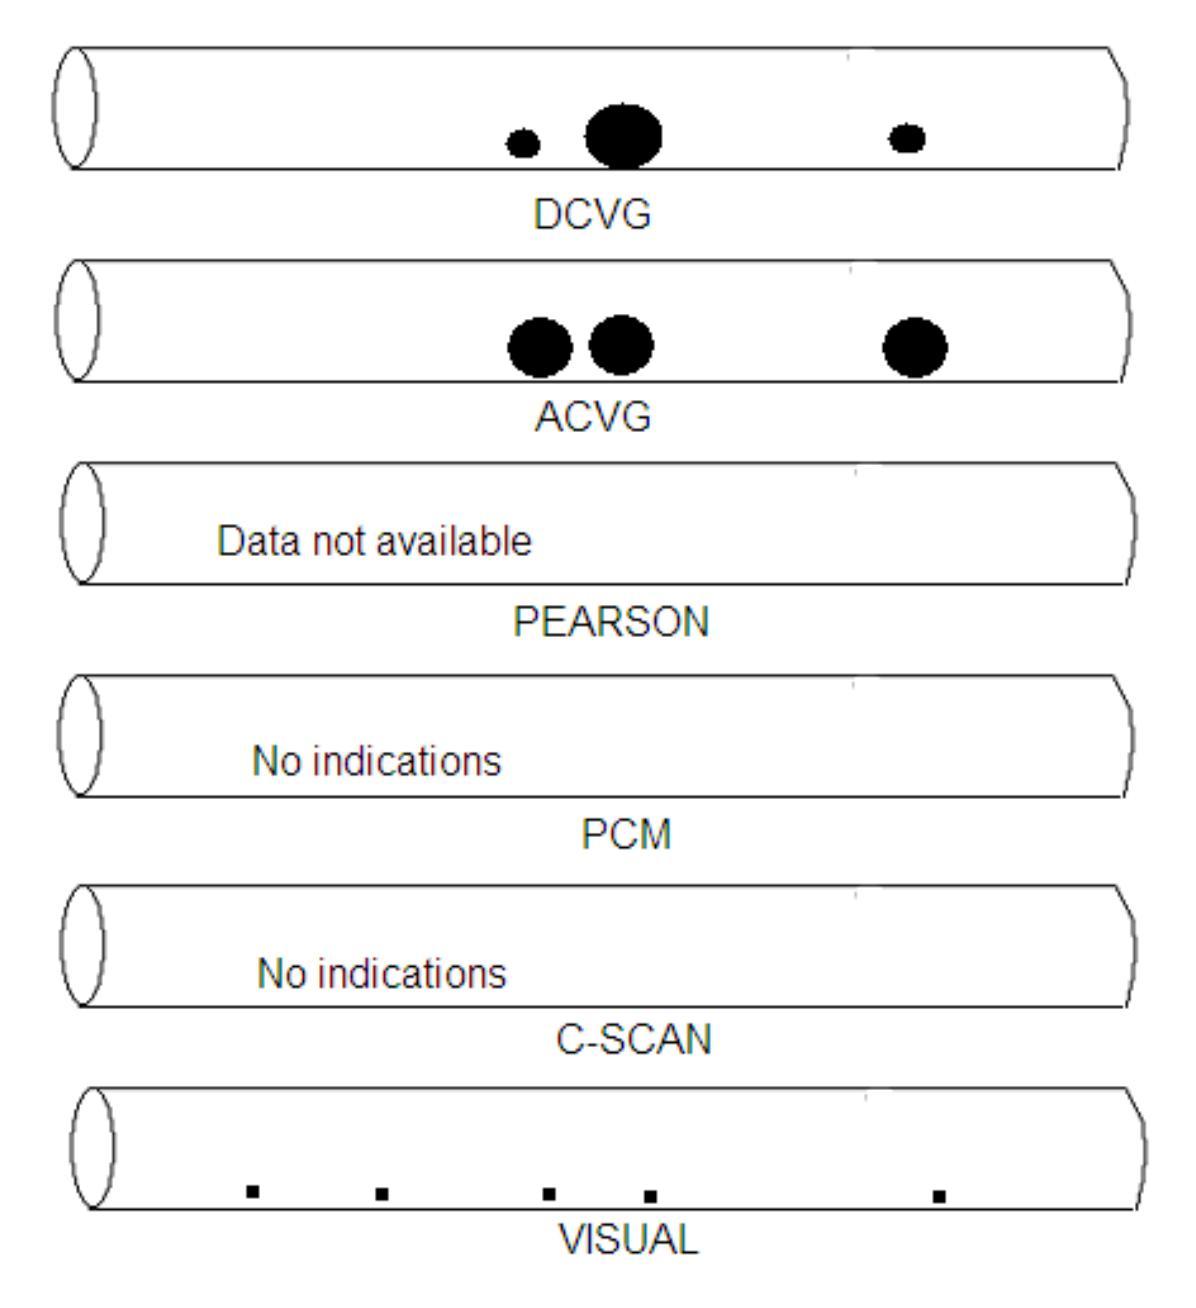
Figure 53: Comparison of techniques from Site 2b. The black areas represent either the size of the coating fault (from surveys) or the area of exposed steel (from visual exam).

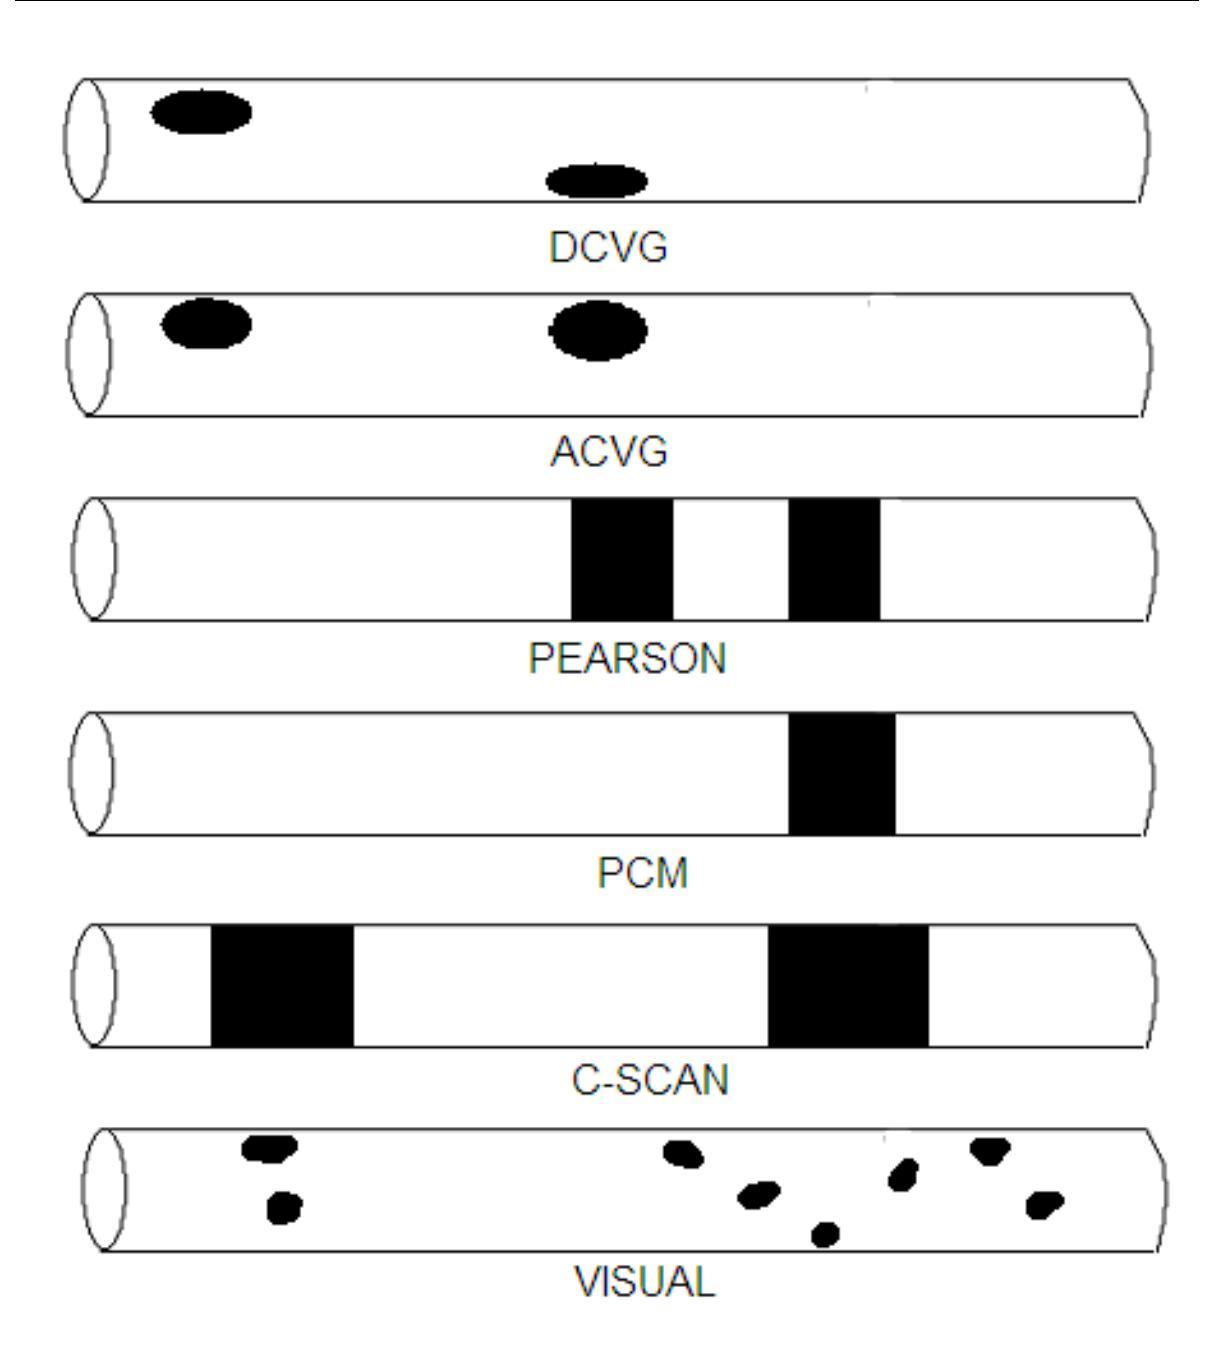
Also, the current attenuation values (mB/m) obtained by PCM and C-Scan tools did not coincide with observed coating condition and no consistent relationship could be established. However, on test Site 3a (Figure 54) the PCM survey reported 2 indications not reported by the other tools that were validated during excavation. On this Test Site C-Scan on close interval current mode also reported an indication not reported by the other tools and was validated during excavation.

Figure 54: Comparison of techniques from Site 3a. The black areas represent either the size of the coating fault (from surveys) or the area of exposed steel (from visual exam).

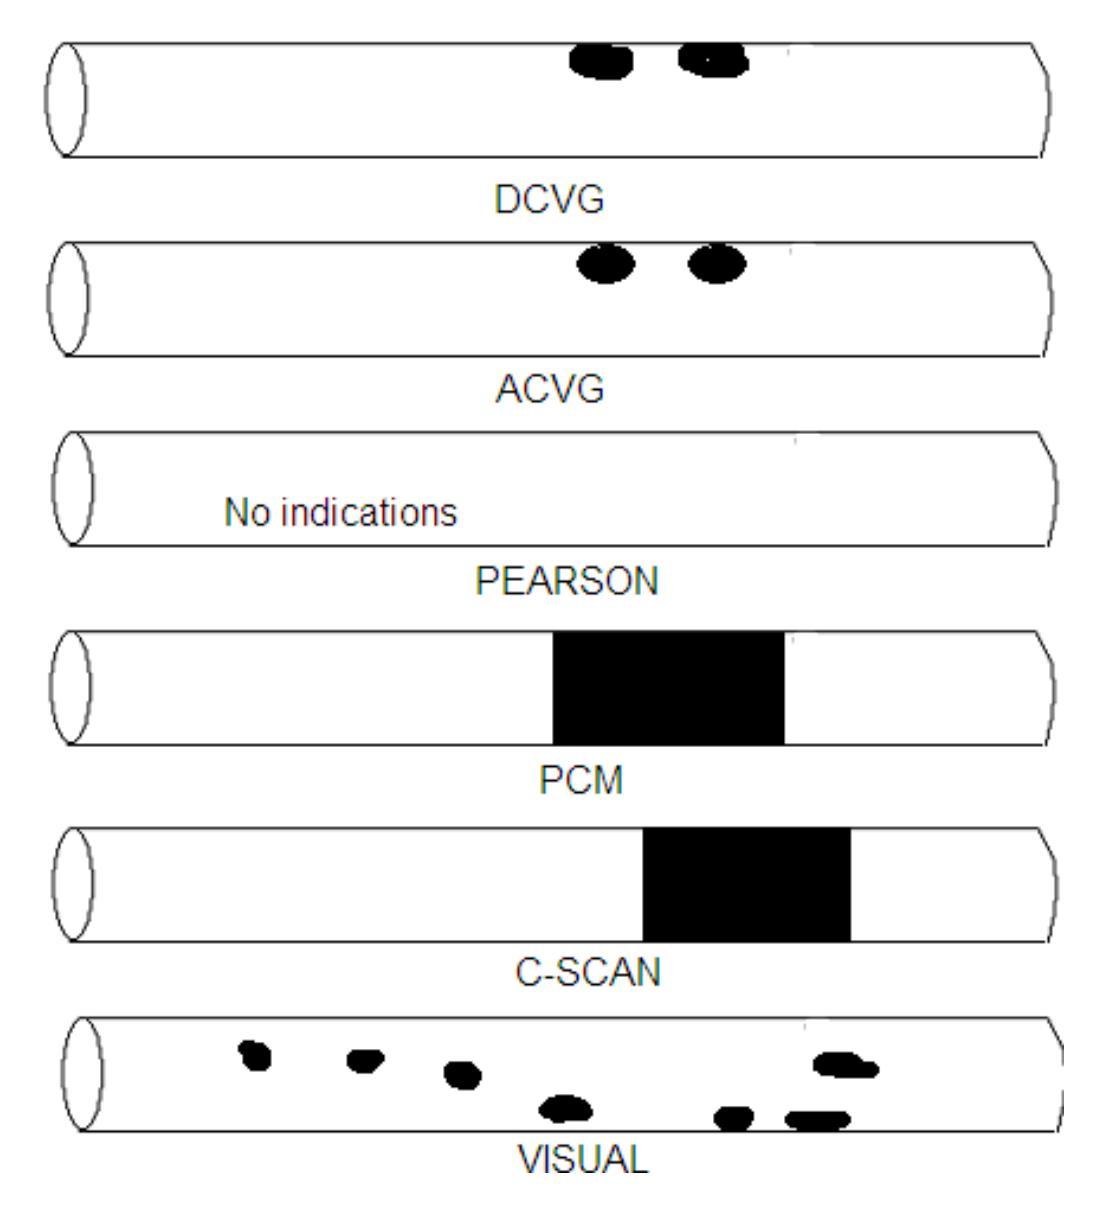
Figure 55: Comparison of techniques from Site 3b. The black areas represent either the size of the coating fault (from surveys) or the area of exposed steel (from visual exam).

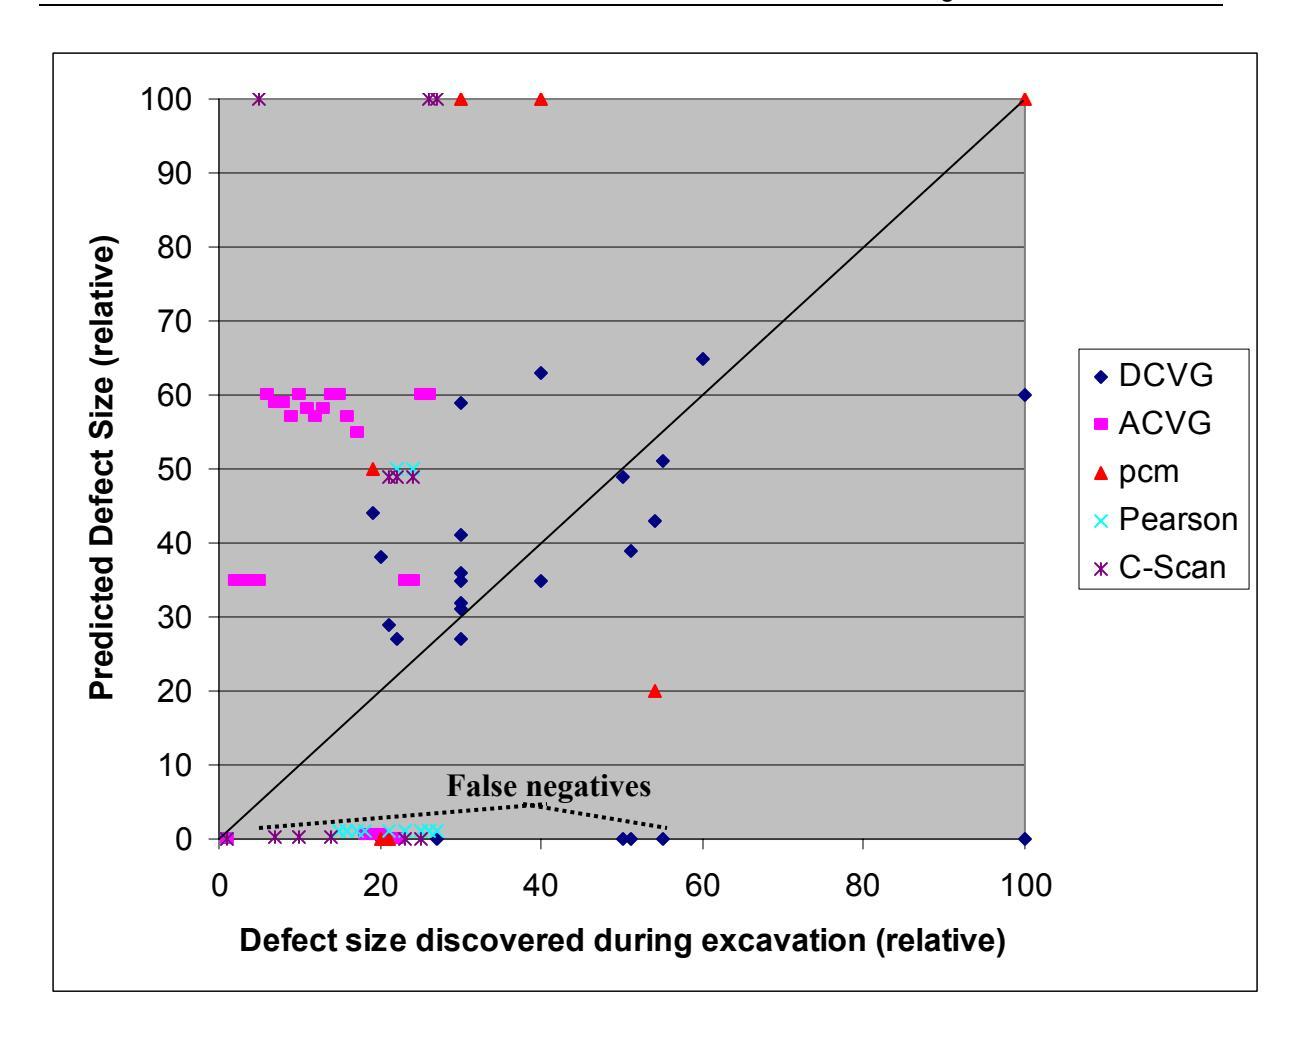
Figure 56 shows the relative performance of each technique from a sizing/locating perspective. From this graph the accuracy of DCVG appeared to be the highest. ACVG tended to overestimate the size of most of the defects, and also did not differentiate size as well. The current attenuation techniques, PCM and C-scan, were "all-or-nothing" indicators which essentially indicated either intact coating or poor coating, with little in between.

Figure 56: Graphic comparison of the performance of each technique with respect to defect sizing (points close to 45° line indicate high degree of accuracy).
