# Forensic Study of Early Failures with Unbonded Concrete Overlays

*Prepared by:*  
Shad Sargand, Roger Green, Junqing Zhu, and Issam Khoury

*Prepared for:*  
The Ohio Department of Transportation,  
Office of Statewide Planning & Research

*November 2017*  
*Final Report*

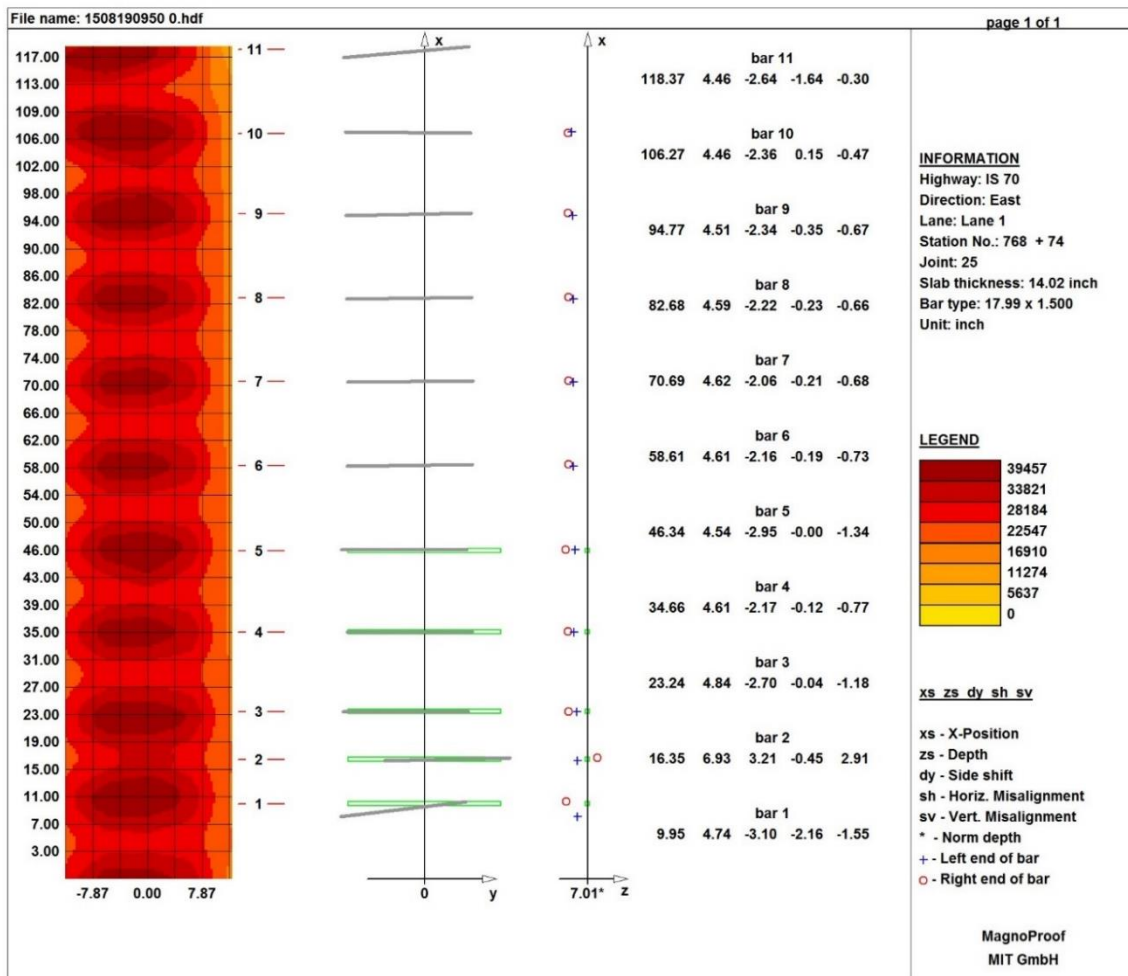
Figure 10 shows a sample MITScan reading from a joint on I-70 EB. The bar locations are noted by dark red spots at the left, and these are resolved into the positions marked to their right, which graphically indicates the orientation of each bar and deviation from design placement. Note in the figure one red spot is at the bottom, below where  $x=0$ , indicating a bar outside the scan zone, probably due to not being able to operate the apparatus along the inside edge of the lane due to the presence of traffic control and moving traffic in the adjoining lane. The detected bars are numbered 1 through 11, though there should be 12. Furthermore, Bar 2 appears to be located at a midpoint between two dark spots, and may be a spurious reading. The section of the figure to the left of the raw scan represents the resolving of the magnetic readings into dowel bar locations, including indications of various types of misalignment. For example Bar 1 and Bar 11 are clearly rotated. Bars 1, 3, 4, and 5 have longitudinal translation, as indicated by the green outlines. Vertical displacements are noted on the z-x graph that is the third section of the figure, with the plus signs (circles) indicating the vertical (z) position of the left (right) end of each bar.

**Figure 10 Sample MITScan reading from Joint 25 on I70 EB. Bar locations are denoted by dark red spots in at the left, and these are recsolved into the positions marked to their right, which graphically indicates the oreintation of each bar and deviation from design placement.**

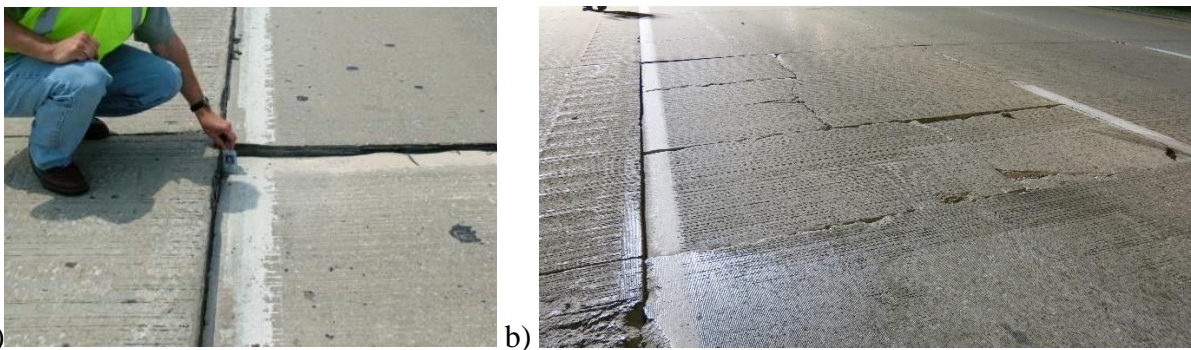
In the eastbound direction, various distresses were found including patching, faulting, transverse cracking, corner breaks and joint spalling. Figure 18 shows pictures of faulting and a transverse crack on I-70 eastbound. An eastbound segment consisting of 26 slabs was selected for more thorough inspection; 20 of the 26 slabs exhibited distress. Three had been replaced recently with concrete repairs. Only three were still in good condition. The westbound direction appeared to suffer relatively less damage, and less distress was observed. Figure 19a) shows a corner break and Figure 19b) shows joint spalling found on westbound direction. In the selected westbound section, only two joints out of 15 showed signs of distress. The distress map in Figure 20 illustrates the locations and types of distresses found in the selected distressed section and in the other direction.

**Figure 18 a) MAD-70 EB faulting (ODOT photo June 25, 2008); b) MAD-70 EB transverse cracking (April 22, 2015)**

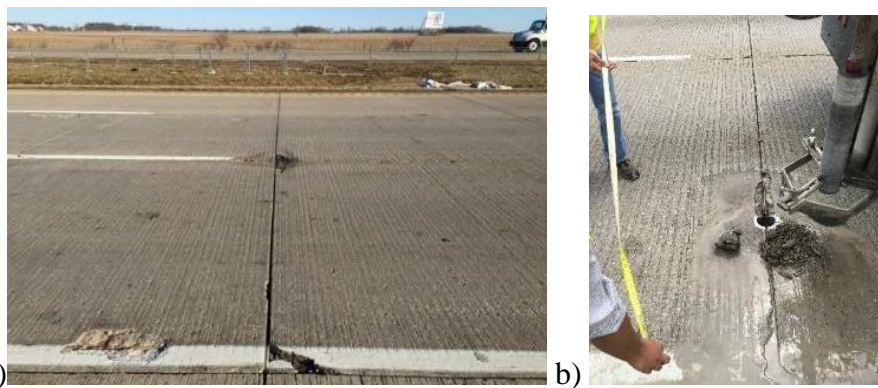
**Figure 19 a) MAD-70 WB corner breaks (March 30, 2015); b) MAD-70 WB joint spalling at bottom of picture, filled with water (August 19, 2015)**

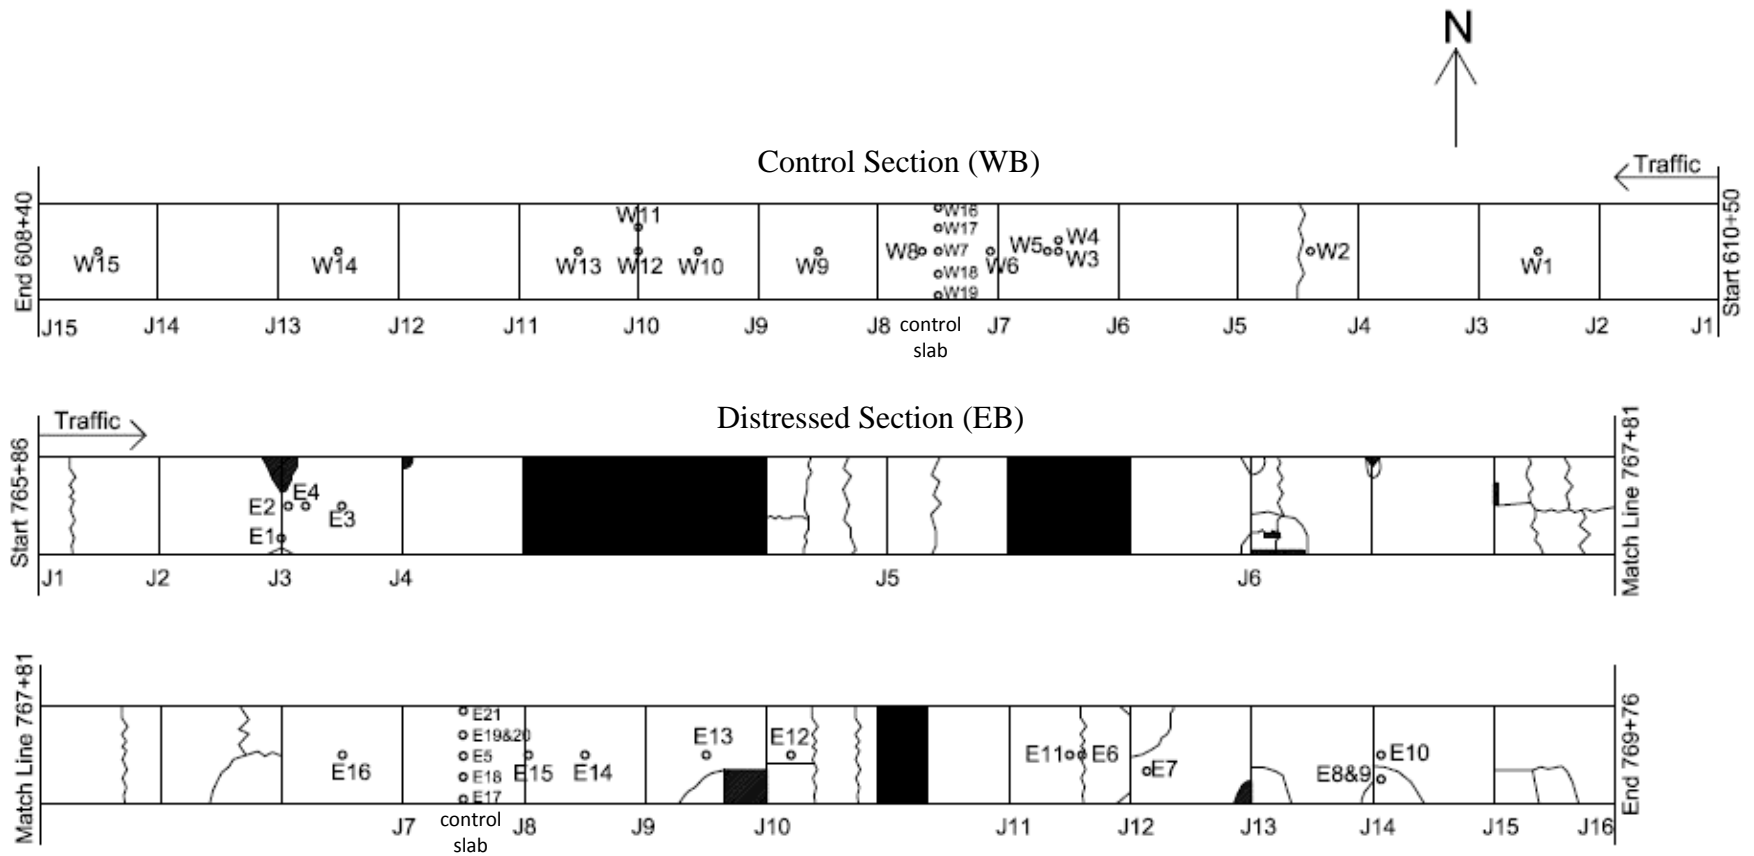
**Figure 20 Distress Map and Coring plan on MAD-70. Numbered joints were scanned by the MITScanner.**

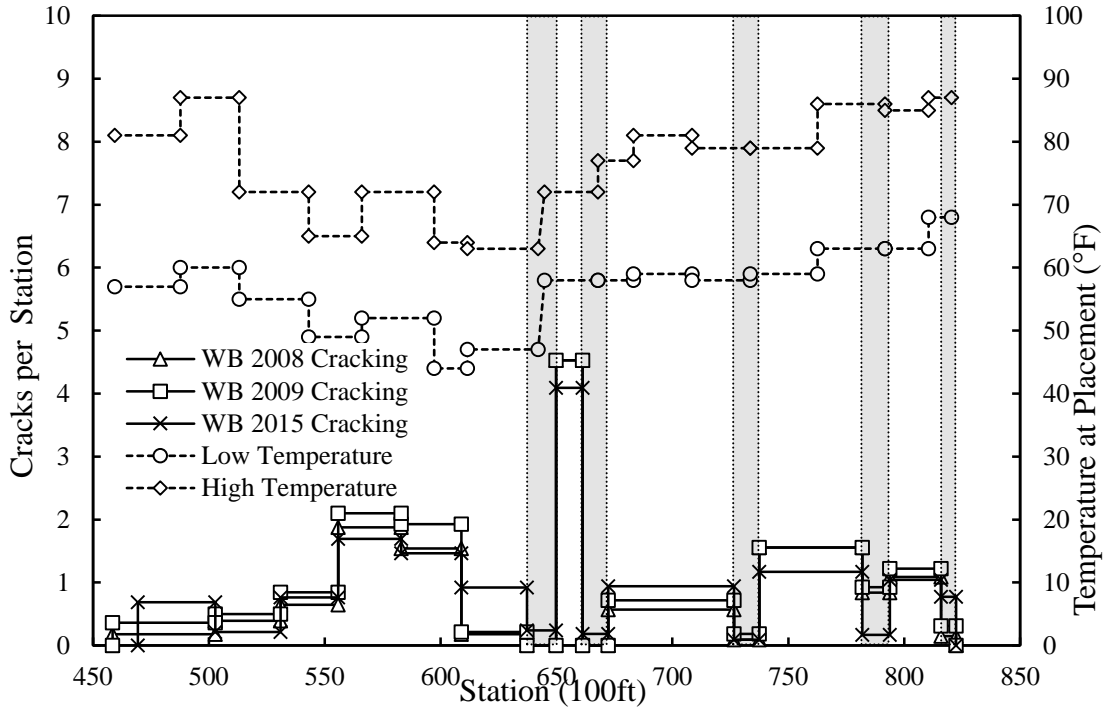
Distress surveys were conducted by ODOT in 2008 and 2009 along the whole length of MAD-70 UBCO sections. Cracks per station were calculated and plotted over the length of the project in Figure 21 and Figure 22. Replacement of cracked slabs between 2009 and 2015 was responsible for the decreased amount of cracking shown in the figures. High and low temperatures during construction were added to the graphs to determine if temperature or temperature differential had an effect on cracking. Temperature and temperature differential have effects on early age (first 3 days) cracking, and the extent of the cracking be predicted using HIPERPAV. However, as seen in Figure 21 and Figure 22, a direct relationship is not apparent between long term cracking and temperature at time of construction. Shaded areas are full-depth concrete pavement segments. From the graph, it can be seen the number of cracks per station increased from 2008 to 2009. This suggests the pavement was still deteriorating. As seen in Figure 20, there is no direct relationship between placement minimum/maximum temperature and cracking. However, other factors, in combination with temperature, such as wetting the bond breaker surface prior to overlay placement, affect the stress development and strength gain, and are included in the discussion of the HIPERPAV analysis. Comparing eastbound with westbound direction, it can be seen the eastbound direction experienced much more cracking than the westbound direction. Comparing the UBCO section with the full-depth reconstruction section, it can be seen that the UBCO section had more cracks.

Figure 21 MAD-70 Westbound cracking plot (100 ft = 30.5 m).

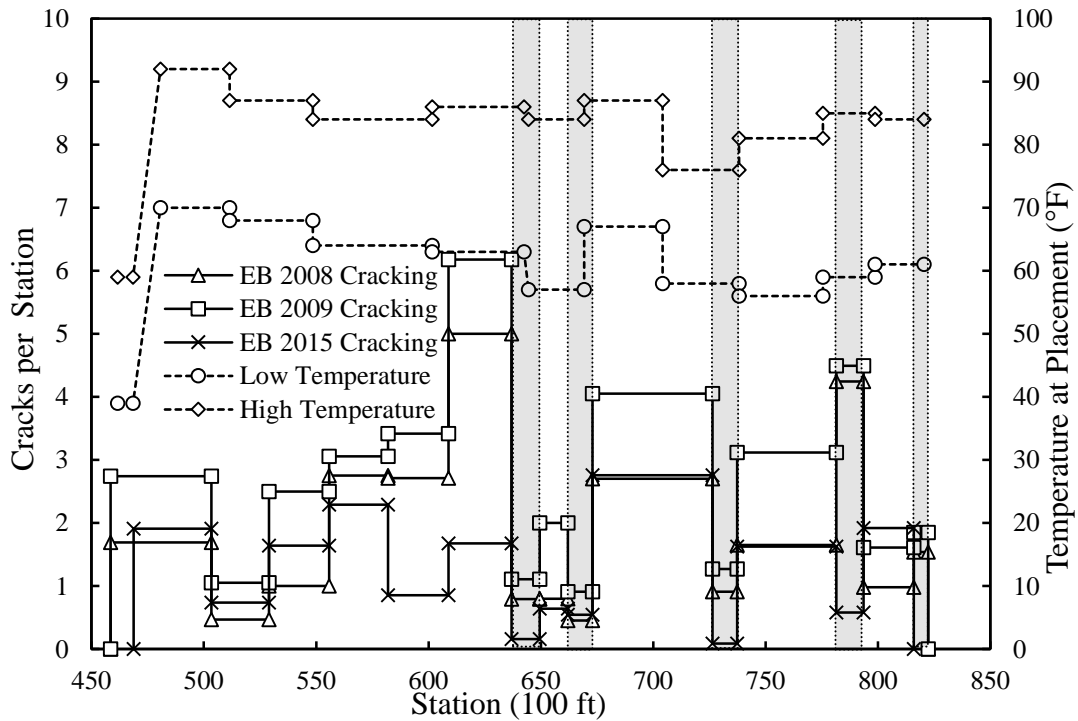
Figure 22 MAD-70 Eastbound cracking plot (100 ft = 30.5 m).

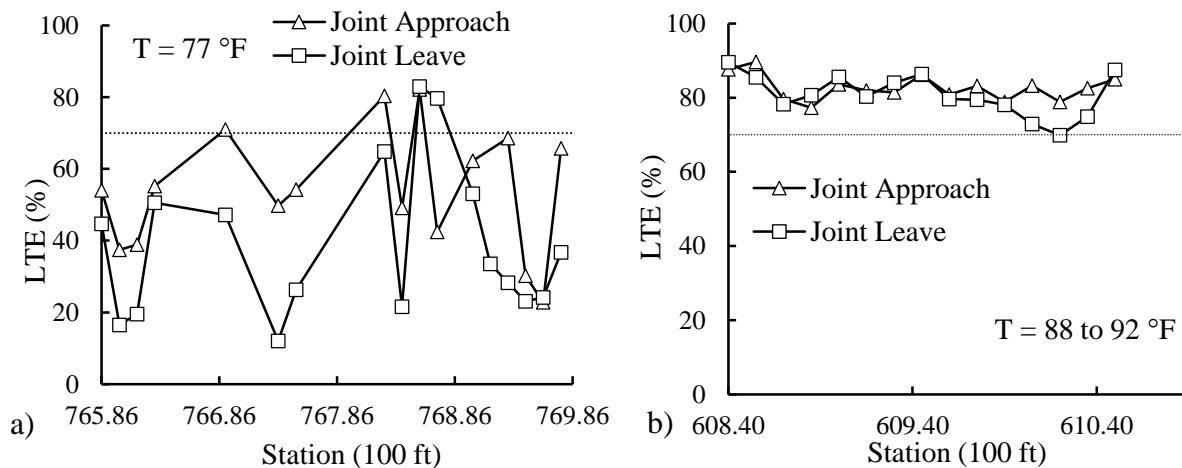
**Figure 30 a) MAD-70 EB distressed section Load Transfer Efficiency; b) MAD-70 WB control section Load Transfer Efficiency (100 ft = 30.5 m). (T = pavement surface temperature)**

Figure 30 shows the load transfer efficiency (LTE) results of selected test sections. LTE is generally poor on the eastbound distressed section of MAD-70. Most distressed section joints have LTE less than 70% and the variation is large from joint to joint; in some joints the LTE is less than 20%. This indicates the dowels are ineffective. The westbound control section joints showed satisfactory LTE; only one joint had LTE at 70% or less. The temperature during testing in both directions was high and slab expansion would have tended to lead to joint interlock, which would improve LTE, thus the joints with low LTE would be expected to perform even worse at lower temperatures.

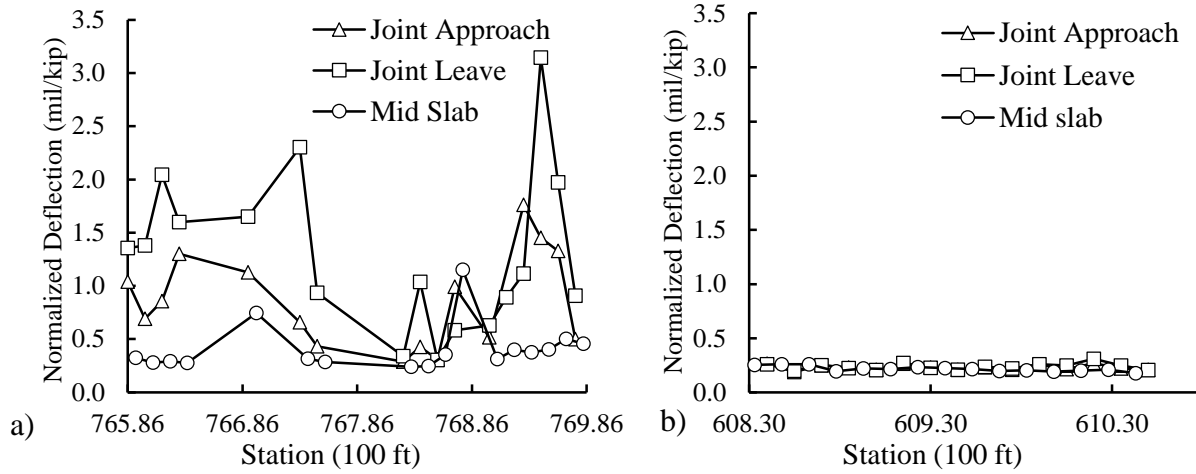
**Figure 31 a) MAD-70 EB distressed section Normalized Deflections; b) MAD-70 WB control section Normalized Deflections (1 mil/kip = 5.71 mm/MN, 100 ft = 30.5 m).**

Figure 31 shows the normalized deflection results of the selected sections. Eastbound MAD-70 distressed section showed high normalized joint deflections, as great as 3.7 mil/kip (21 mm/MN), with a lot of variation from joint to joint. Deflections on the joint leave position are relatively

higher than that on the joint approach position. The MAD-70 westbound control section showed small and uniform joint deflections, most below 0.25 mil/kip (1.43 mm/MN).

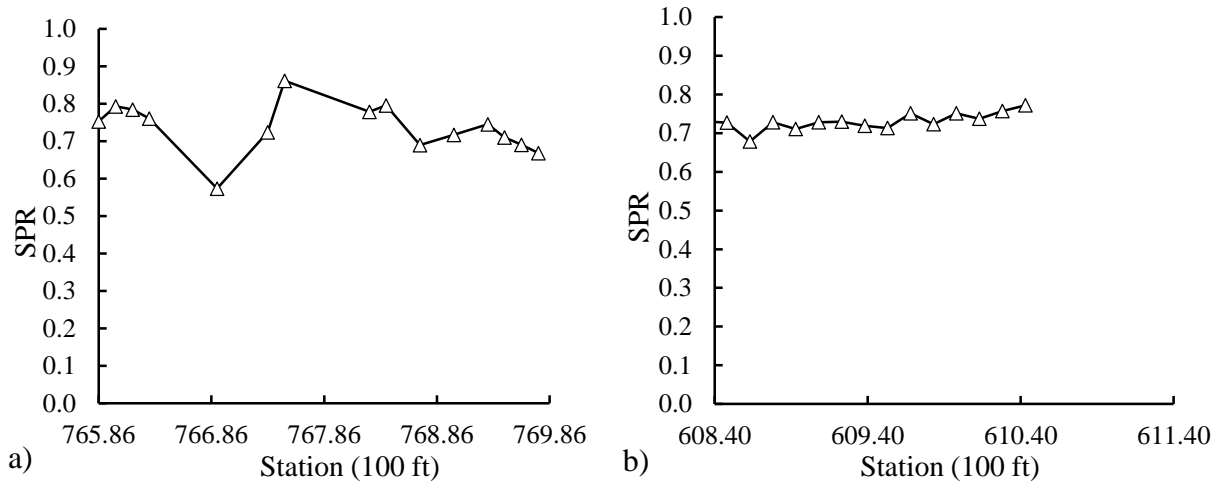
**Figure 33 a) MAD-70 EB distressed section Mid-slab Spreadability; b) MAD-70 WB control section Mid-slab Spreadability (100 ft = 30.5 m).**

Figure 32 presents the Joint Support Ratio (JSR) results and Figure 33 presents mid-slab spreadability (SPR) results. For MAD-70 EB distressed section direction, JSR values are significantly greater than 1, which indicates joint support condition is unbalanced; the joint leave side has much greater deflection than the joint approach side. This indicates voids under joint leave side. This is consistent with distresses found on the leave side, as shown in Figure 18. Joint 6, 14, and 15 with high JSR values all had large corner break slab on the leave side. All JSR values on westbound control section of MAD-70 are close to 1, which means equal joint support condition on both sides of joints. Mid-slab SPR values are variable in the eastbound direction distressed section, while SPR values on westbound direction control section are uniform and close to 0.75. This indicates a lower level of deterioration than on the distressed section, consistent with observations of pavement condition.

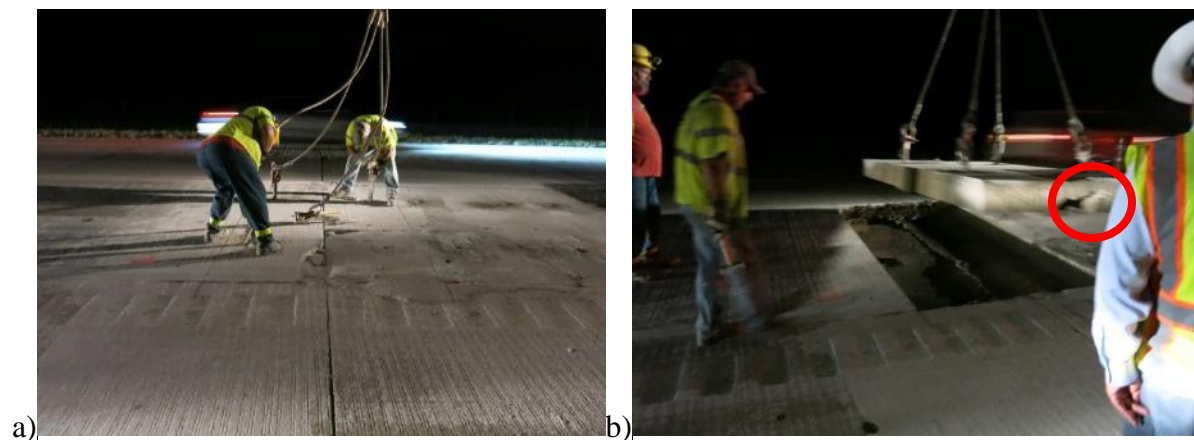
Some deteriorated joints and slabs on MAD-70 were repaired on April and September 2015. During the repair work on the eastbound forensic section, on September 15, 2015, the Ohio University research team was in the field to document the condition underneath the overlay slabs. A joint repair slab with 3 ft (0.92m) on either side of a transverse joint was lifted out as shown in Figure 34. Distress in the segment included joint spalling and corner breakage with settlement. In Figure 34b), it can be seen clearly in the circled area that the bottom half of concrete near the joint remained in the hole. Figure 35 shows the state of the bondbreaker layer beneath the segment. In Figure 35a), a ridge of concrete chunks was left on the bondbreaker after the segment had been removed. This confirms the tenting distress found during coring. On near right side of Figure 35b), the bondbreaker was in poor condition, which was due to water retained from lack of drainage as evidenced by the presence of saw slurry. Other observations made during slab removal include:

**Figure 34 a) Segment being prepared for removal, September 15, 2015; b) Segment being lifted. Circled area shows gap where missing concrete remained in hole.**

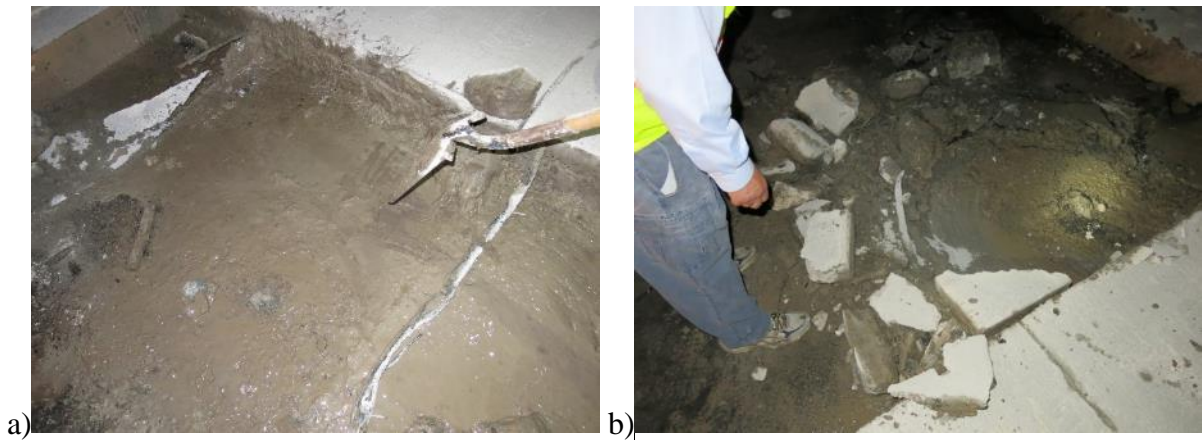
- Excessive water was found trapped in the asphalt bondbreaker layer at multiple locations, for example as shown in Figure 36a).
- Some bondbreaker material was soft and deteriorated as seen in Figure 36b).
- “Tenting” distress was found at some joints.
- There was no evidence the joints or cracks in the underlying concrete pavement were reflecting into the unbonded overlay. The underlying concrete pavement base appeared to be complete and smooth.

**Figure 36 a) Water trapped in the bondbreaker layer; b) Deteriorated bondbreaker**

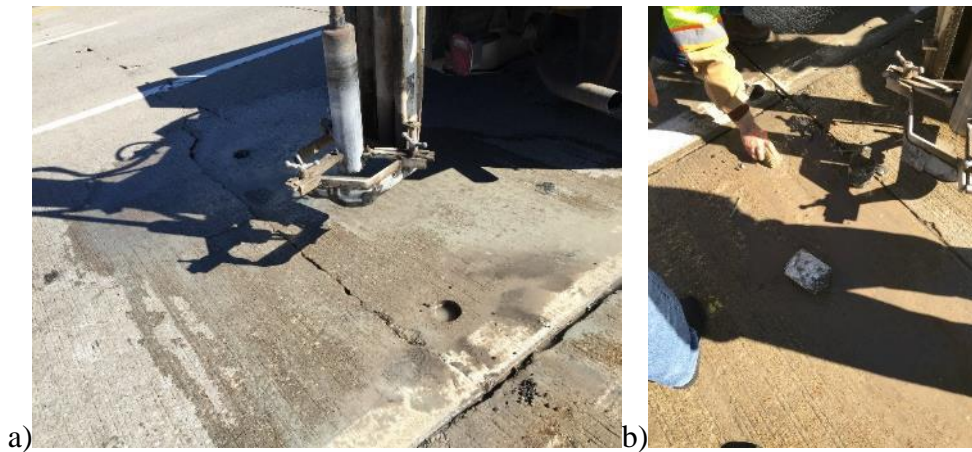
**Figure 38 Core holes retaining water.**

Water drained very slowly from the core holes on both sections, as seen in Figure 38, indicating a lack of drainage for water entering the pavement through the joints. It is likely this water saturated the asphalt bondbreaker near joints and cracks. The cores sent to Purdue were taken from a failed joint with tenting distress, a good joint, at mid-slab from a segment of three slabs with no cracks, and from a slab with a mid-slab crack.

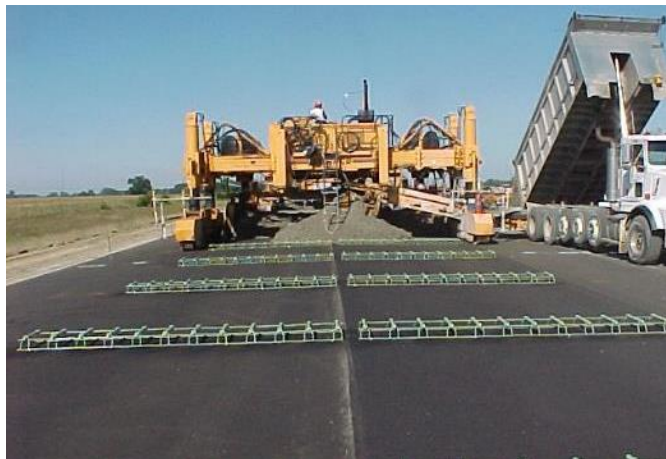
Figure 39 is a photograph taken during construction of the MAD-70 overlay in 1999 showing the bondbreaker surface was dry when concrete was placed, contrary to specification, which requires wetting measures. The dry surface can produce stress due to differential moisture levels in the slab [National Concrete Pavement Technology Center, 2006]

**Figure 39 Concrete overlay being placed on a dry bondbreaker surface on MAD-70 in 1999.**

Figure 39, a photograph taken during construction, shows that no wetting measure taken on that particular day of construction. It is not known on how many days the wetting measure was skipped. Based on the HIPERPAV analysis, it is obvious concrete placed on a moist base cures much faster and is stronger in the first 72 hours, and is less likely to crack, than concrete placed on a dry base.

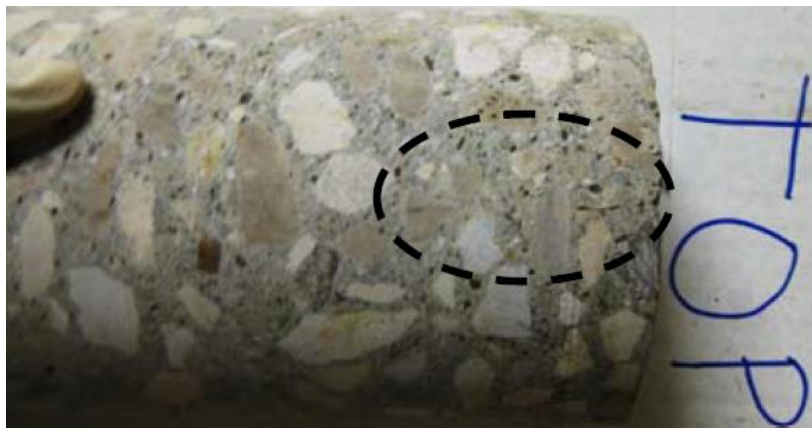
- Bondbreaker was found in all core holes, including those at joints, and at an average thickness of 1.9 in (48 mm) they were 46% thicker than in the eastbound direction, which averaged 1.3 in (33 mm). Table 7 in next section presents the thickness results. Only one joint had bondbreaker that was damaged but in the hole the bondbreaker felt solid.
- Only two joints out of 15 showed any signs of distress. The worst one was cored. The core collected in the wheel path had deteriorated to aggregate and concrete fragments typical of tenting. A core on the transverse joint broke and also showed signs of tenting (Figure 19b).
- A core was collected at a small crack which verified the presence of top down cracking, shown in Figure 40.

**Figure 40 Top-down hairline crack on core W4 from MAD-70 westbound. Photo from report by Dr. Jan Olek of Purdue University.**

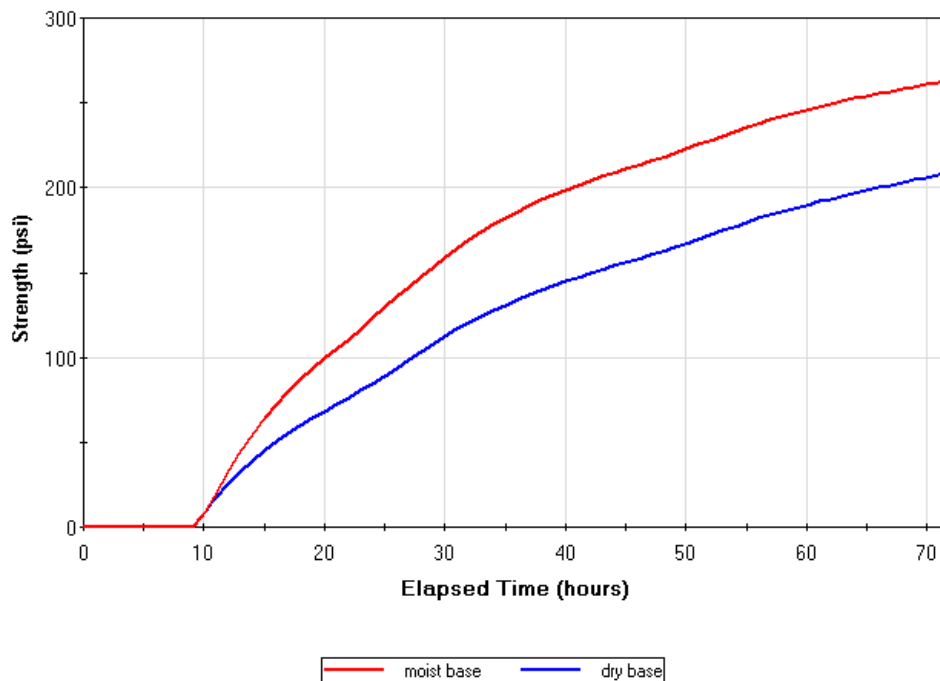
**Figure 44 Strength versus elapsed time in HIPERPAV, MAD-70 overlay August 31, 1999.**

A comparison was made between moist and dry base to see the effect of wetting the base before placing concrete. Figure 44 shows comparison of concrete strength development placed on August 31, 1999. The simulation indicated the concrete on moist base cured much faster than concrete on dry base. The tensile strength at 72 hours is 263.4 psi (1.816 MPa) for concrete on moist base and 209.4 psi (1.444 MPa) for concrete on dry base. Figure 49 shows the crack risk plot. In the dry case, the stress to strength ratio exceeds 100% at about 16 hours, indicating crack formation. The stress-strength ratio of the concrete on moist base stays below 75%. Figure 46 and Figure 47 show the concrete strength and crack risk, respectively, computed for concrete placed on May 12, 2000, during the next construction season. There is a similar discrepancy in tensile strength at 72 hours with 230.0 psi (1.586 MPa) for concrete on moist base and 182.3 psi (1.257 MPa) for concrete on a dry base. In Figure 47, the dry base stress to strength ratio breaks 100% at about 15 hours, while the moist base case tops out at about 85%.

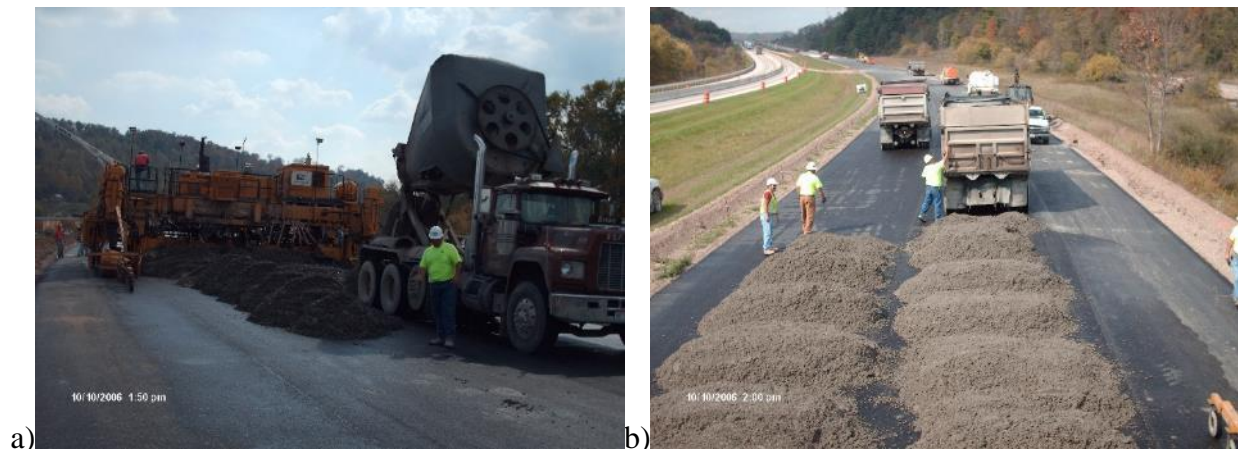
**Figure 50 Wetting the bondbreaker before placing concrete. Photos dated Oct. 10, 2006.**

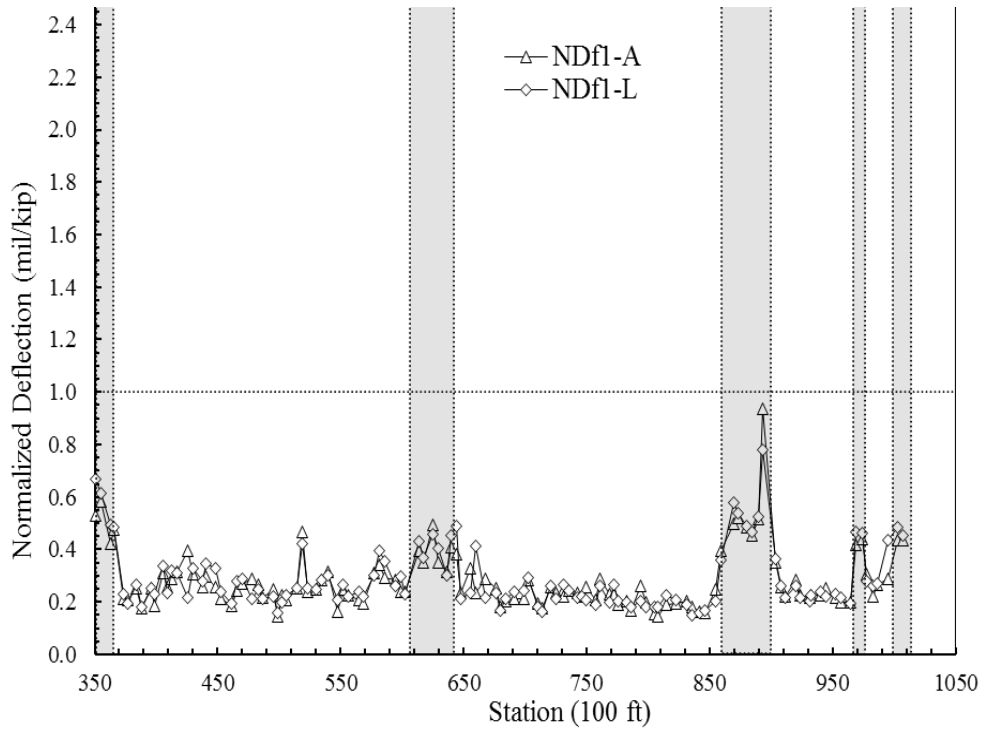
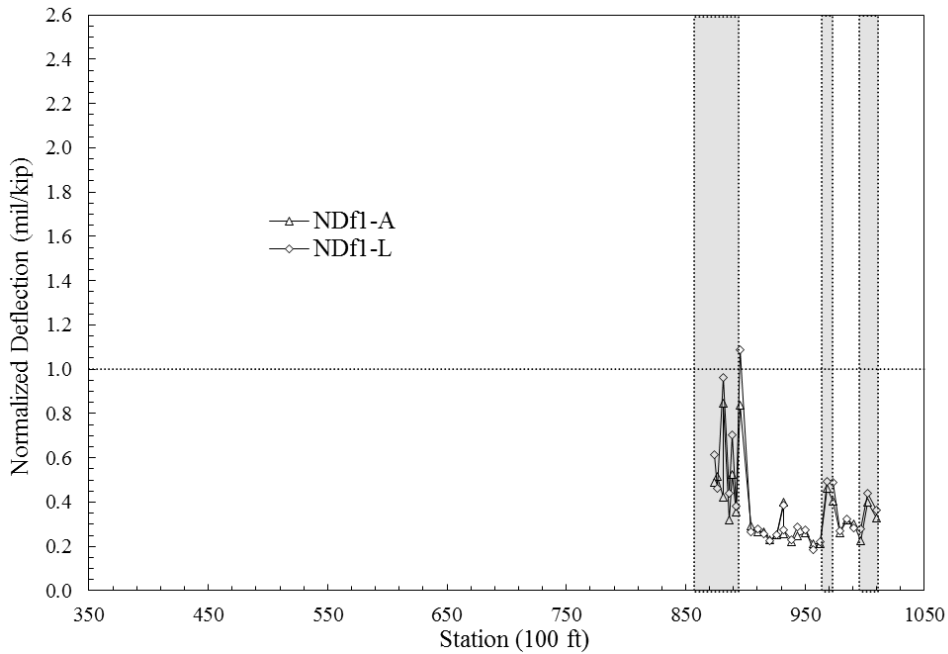
deflections are mostly less than 0.4 mil/kip (2.3 mm/MN), and the variation is very small along the whole length. A majority of the LTE values for the unbonded overlay were less than 70%.

**Figure 54 I-77 northbound normalized joint deflections (1 mil/kip = 5.71 mm/MN, 100 ft = 30.5 m)**

**Figure 55 I-77 southbound normalized joint deflections (1 mil/kip = 5.71 mm/MN, 100 ft = 30.5 m)**

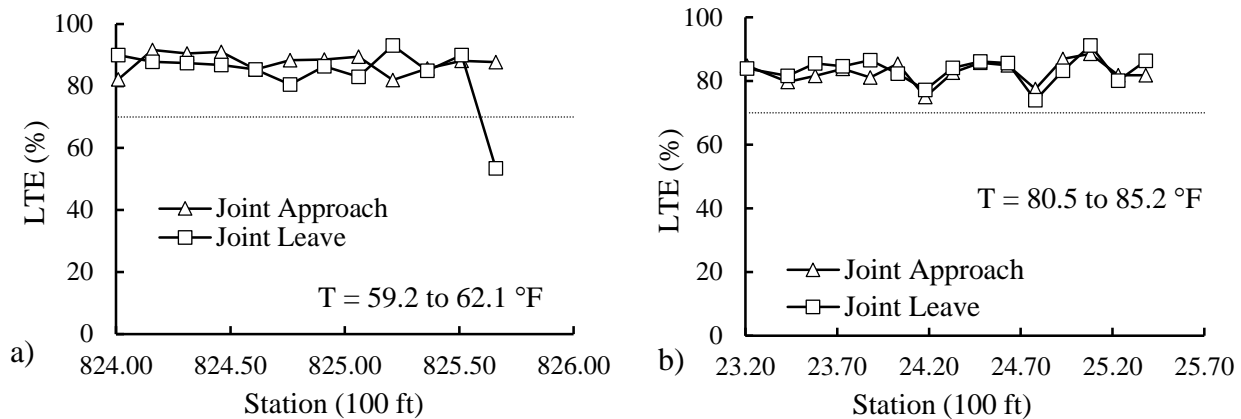
**Figure 59 a) I-77 NB control section Load Transfer Efficiency; b) I-77 SB distressed section Load Transfer Efficiency (100 ft = 30.5 m). (T = pavement surface temperature)**

Figure 59 shows the LTE results of the selected damaged and control sections. The LTE results are generally good on both sections, above 70% with one exception on the control side. Figure 60 shows the normalized deflections of the selected sections. I-77 control and distressed sections showed small and uniform joint deflections, most of which are below 0.25 mil/kip. Figure 61 and Figure 62 respectively present the JSR and SPR results of selected control and distressed sections.

High LTE of joints in the distressed section in the southbound direction may include contributions from temperature-induced horizontal compressive stress in the concrete pavement pushing slabs together and creating aggregate interlock or increased friction. Coring verified the previous evaluation of joint condition. For example, the last joint in the control section in the northbound direction was cored and found to have a horizontal crack at the dowel bar level.

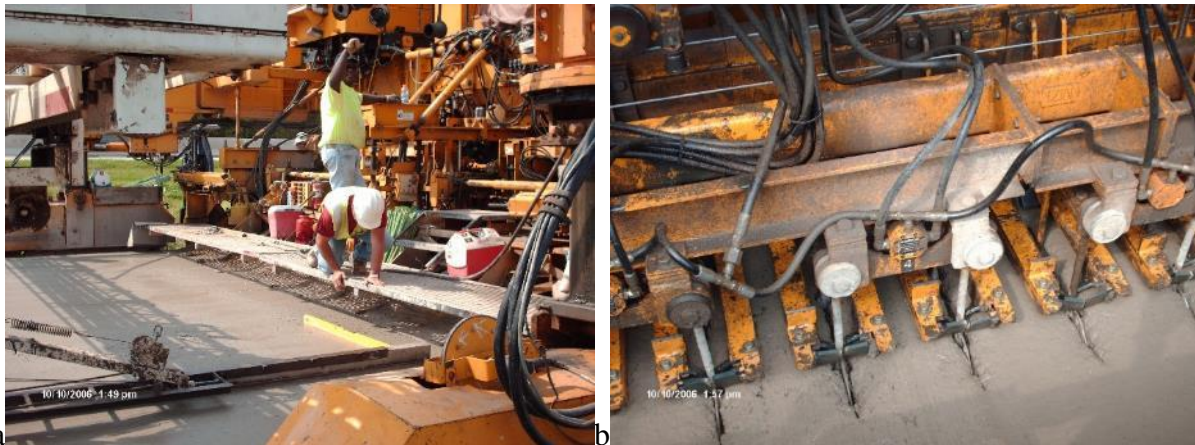
Figure 63 has photos taken during the construction of WAS/NOB-77. As shown in the photos, a dowel bar inserter (DBI) was used; dowel bar baskets were used in the construction of MAD-70. The use of dowel bar inserter may have contributed to the misalignment of dowel bars in WAS/NOB-77 sections. The other concern associated with the inserter is the adequacy of consolidation of concrete over the inserted bars, resulting in segregation of aggregate. This is a result of the insertion process, which involves the inserter vibrating the bar while pushing it into the concrete. The vibrations have the effect of pushing larger pieces of aggregate down or to the

side of the bar, so that the concrete that fills the hole over the bar tends to have smaller aggregate and a greater probability of entrapped air voids forming within the concrete or as a gap between the top of the dowel bar and the concrete. As a result, the material properties of the concrete above the dowel bar may differ from that below the bar, for example the strength and modulus, as reported by Larson, Vanikar, and Forster [1993]. Over the long term, the concrete near the dowel bars can then be subject to vertical longitudinal cracking, horizontal cracking, and defects associated with the air voids in the concrete and/or directly above the dowel bar.

**Figure 63 Pictures of DBI used in construction of WAS/NOB-77. Photos dated October 10, 2006.**

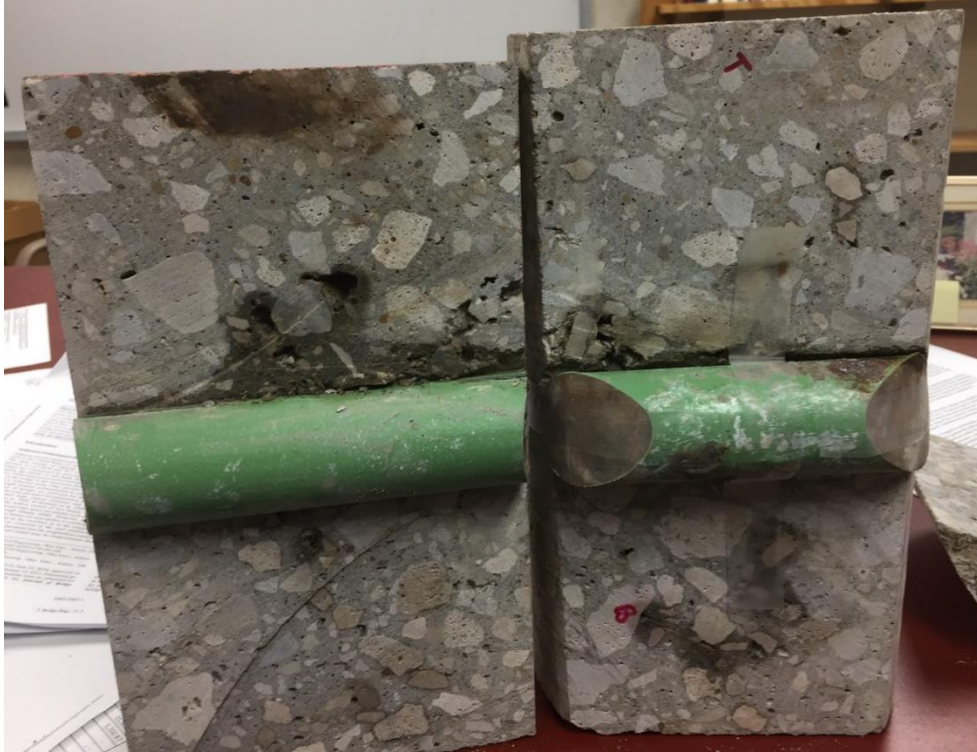
**Figure 67 Two tangential cores collected at a joint on WAY-30, after sawing in half.**

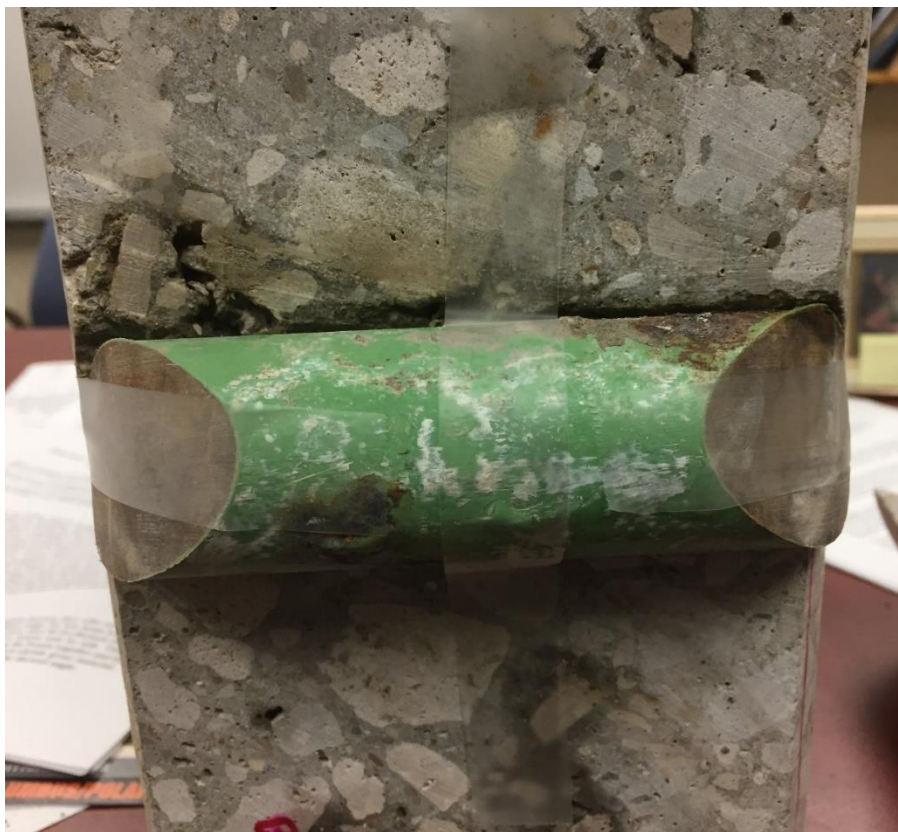
**Figure 68 Close-up of tangential core from WAY-30 showing space above dowel bar and some entrapped air voids. Note that the dowel bar is held in place with clear adhesive tape.**

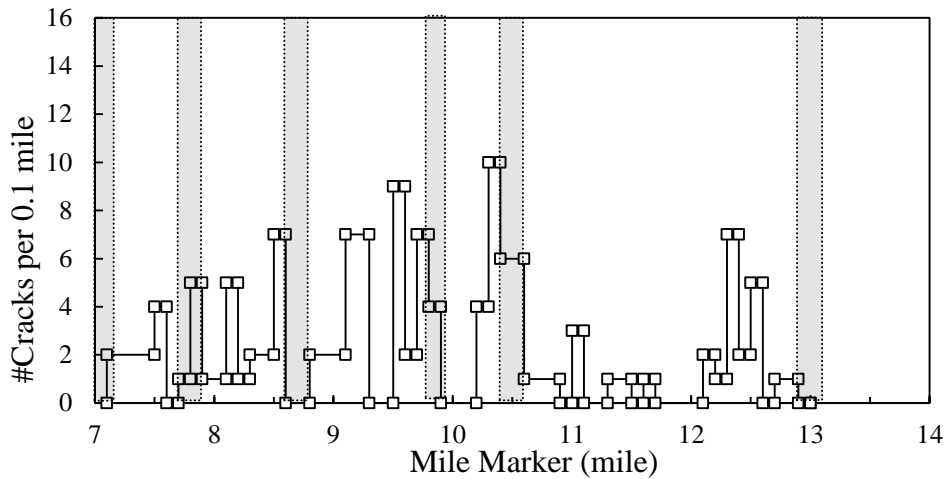
**Figure 78 LAK-90 EB cracking plot (1 mi = 1.61 km)**

The distress survey of I-90 was conducted by reviewing PathWeb images provided by ODOT from their most recent survey on July 28, 2014. The number of cracks per every 0.1 mile (0.16 km) was counted by reviewing the images, such as Figure 5 and the numbers were plotted with respect to mile marker; the results are shown in Figure 78 and Figure 79 for eastbound and westbound directions, respectively. Shaded areas indicate full-depth concrete pavement sections (PCC thickness=13 in (330 mm)). As can be seen from the plot, on the eastbound direction, the maximum amount of cracks occurred between Mile Marker 10.3 and 10.4 with the value of 10 cracks per 0.1 mi (0.16 km). On the westbound direction, the maximum amount of cracks occurred between Mile Marker 12.3 and 12.4 with the value of 14 cracks per 0.1 mi (0.16 km).

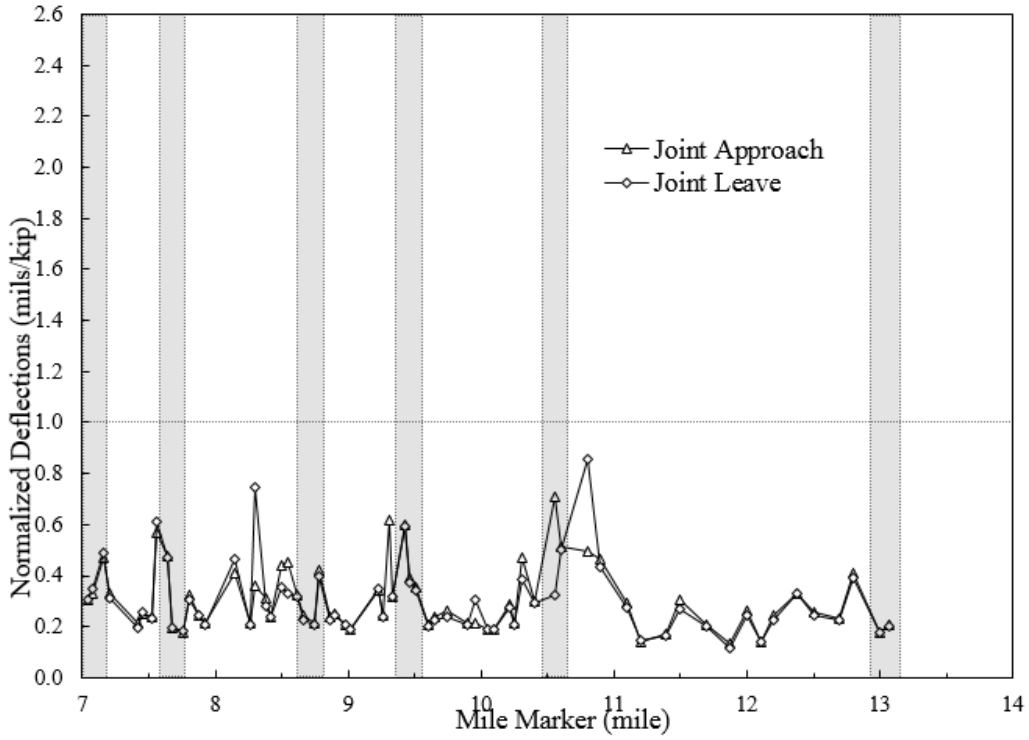
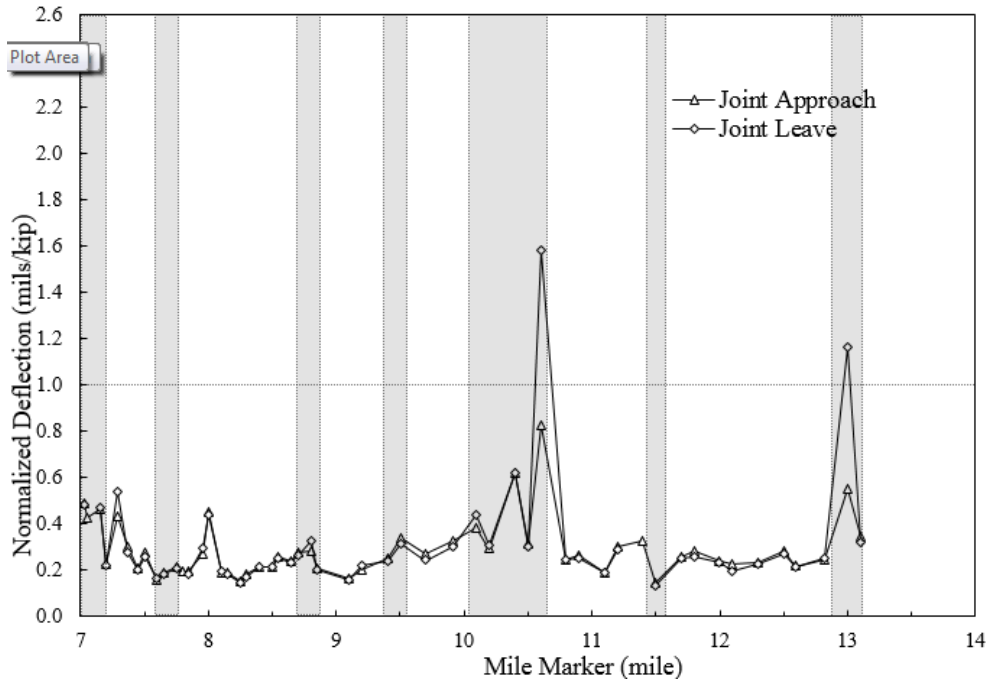
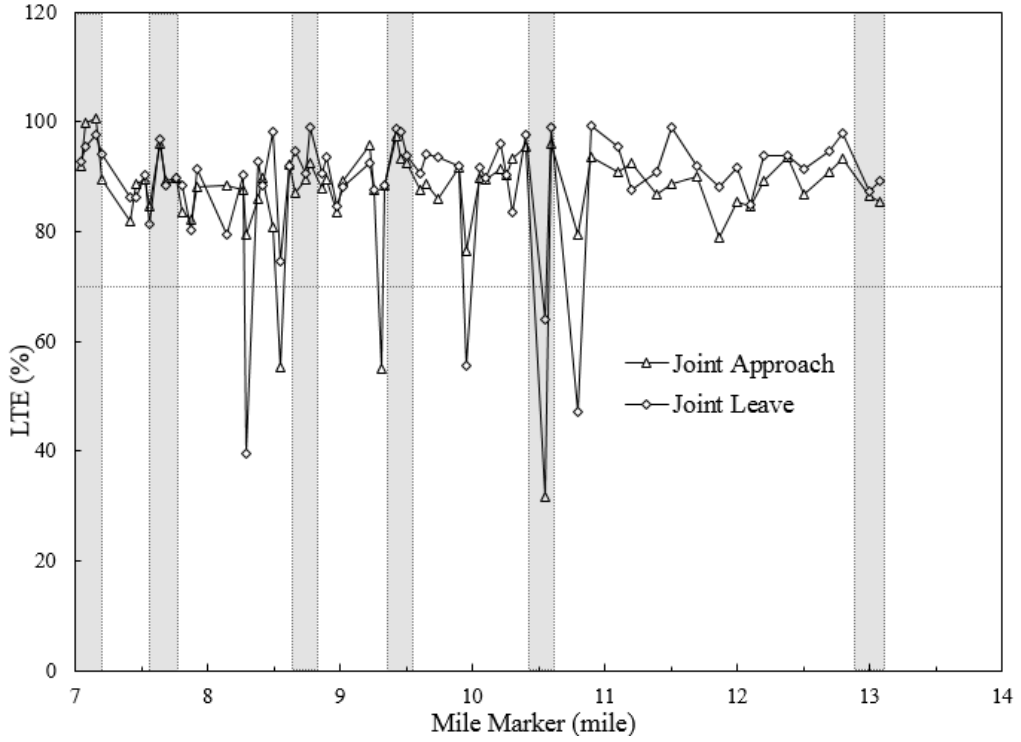
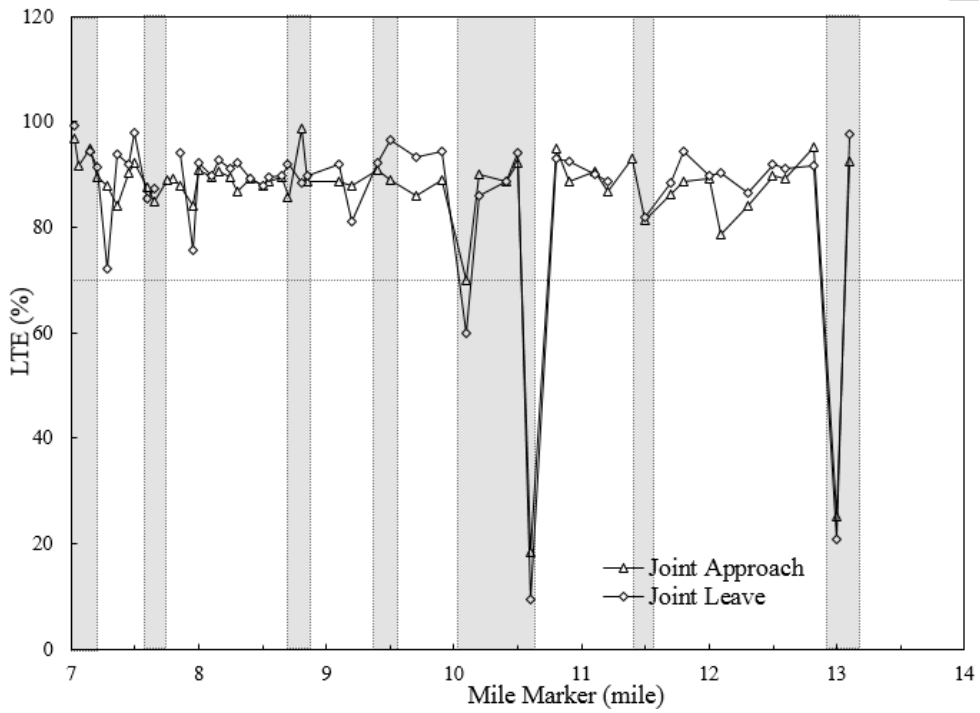
Initial FWD measurements were made on LAK-90 on June 15, 2016. Figure 80 and Figure 81 present the normalized joint deflections ( $NDf_1$ ) of the LAK-90 UBCO sections. LTE results are shown in Figure 82 and Figure 83. The shaded areas indicate full-depth concrete pavement sections. Overall, the normalized joint deflections are below 1 mil/kip, except for joint-leave deflection at mile marker 10.602 and joint-leave deflection at 12.998 on the westbound direction, which are 1.578 mils/kip and 1.164 mils/kip. These two locations are full-depth concrete. In the LTE plots, these two joints had very low LTE values of 9.5% and 20.9% on joint leave position. The rest joints of westbound direction had LTE values above 80% with a few exceptions which are between 80% and 60%. On the eastbound direction, LTE values were above 80% mostly also with a few exceptions as low as 31.9% at mile marker 10.552.

**Figure 80 LAK-90 Eastbound Normalized Joint Deflection (1 mil/kip = 5.71 mm/MN; 1 mi = 1.61 km)**

**Figure 81 LAK-90 Westbound Normalized Joint Deflection (1 mil/kip = 5.71 mm/MN; 1 mi = 1.61 km).**

**Figure 82 LAK-90 Eastbound Load Transfer Efficiency (1 mi = 1.61 km)**

**Figure 83 LAK-90 Westbound Load Transfer Efficiency (1 mi = 1.61 km)**
