# Forensic Study of Early Failures with Unbonded Concrete Overlays

*Prepared by:*  
Shad Sargand, Roger Green, Junqing Zhu, and Issam Khoury

*Prepared for:*  
The Ohio Department of Transportation,  
Office of Statewide Planning & Research

*November 2017*  
*Final Report*

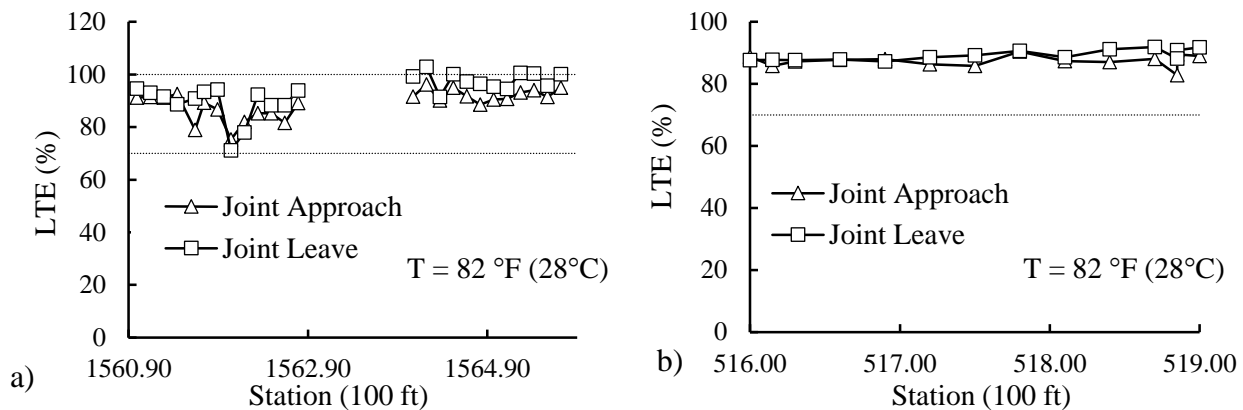
Figure 84 presents the LTE results on the selected sections. In the distressed section, LTE values are mostly above 80% with a few exceptions that were below 80%. These points are consistent with joint distress/repair shown on Figure 89. The segment from station 1564+00 to 1565+90 in the distressed section is full-depth concrete pavement. This section had LTE values over 100%. In the control section, all LTE values are near 90%, which indicates good load transfer.

**Figure 84 a) LAK-90 EB distressed section Load Transfer Efficiency; b) LAK-90 WB control section Load Transfer Efficiency (100 ft = 30.5 m) (T = pavement surface temperature).**

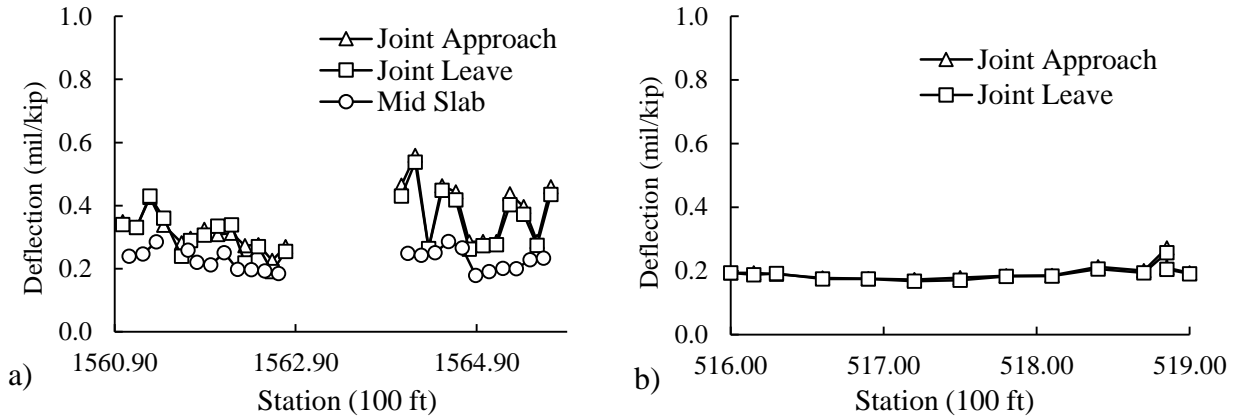
Figure 85 presents the normalized deflections on selected sections. In the distressed section, deflections are generally between 0.2 mil/kip (1.14 mm/MN) and 0.4 mil/kip (2.28 mm/MN) with variations from joint to joint. The full-depth section in the distressed section have higher deflections. In the control section, all deflections are near 0.2 mil/kip (1.14 mm/MN) with much lower variation. Figure 86 presents the Joint Support Ratio (JSR) results, which are close to 1 for both distressed and control sections. Figure 87 presents the spreadability (SPR) results. SPR values are all close to 80%, which indicates good spreadability overall. In summary, based on deflection data, pavement structure was not the cause of the distresses.

**Figure 85 a) LAK-90 EB distressed section Normalized Deflection; b) LAK-90 WB control section Normalized Deflection (1 mil/kip = 5.71 mm/MN, 100 ft = 30.5 m).**

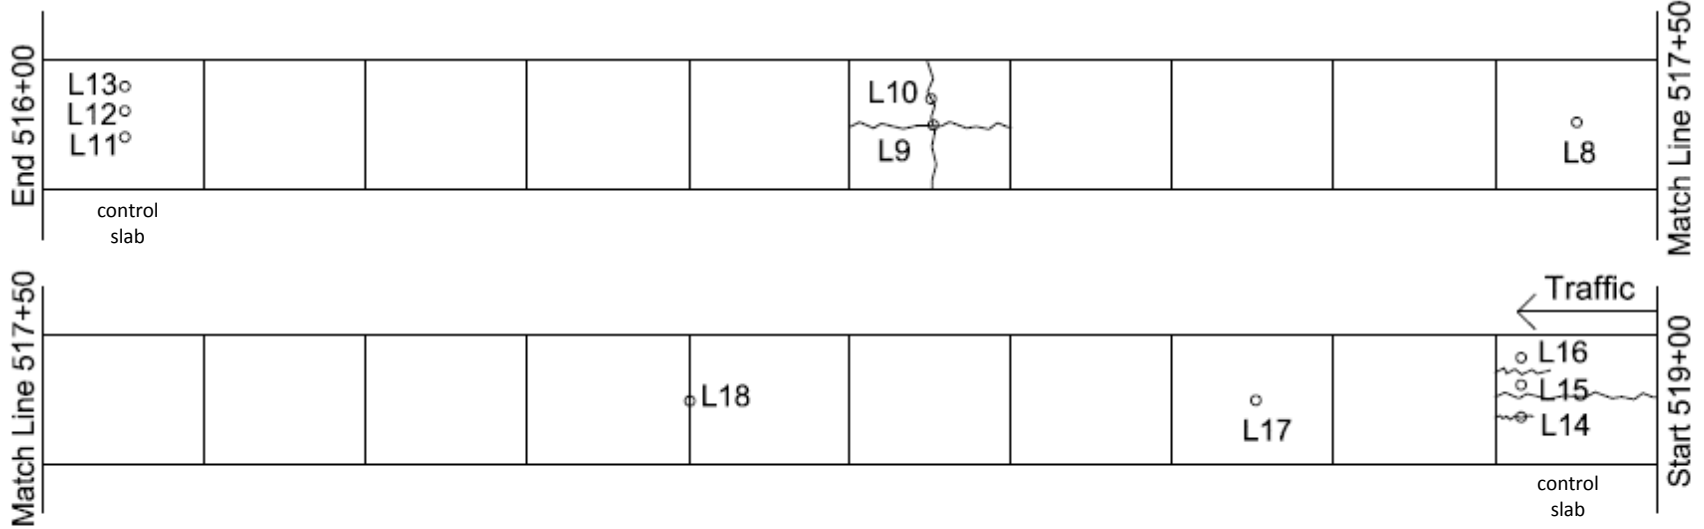
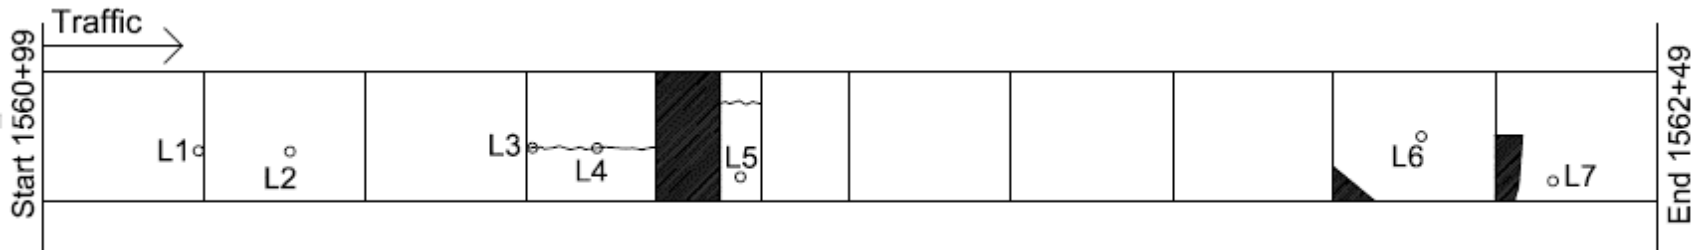
Figure 89 Distress Map and Coring plan on LAK-90.

Cores L1 and L4 from the distressed eastbound lane and Cores L9 and L18 from the control westbound lane were used for petrographic analysis. Location of the cores can be determined by looking at Figure 89 above. Core L1 was used for specific gravity and coarse slag aggregate analyses, the latter also including Core L18. Results are summarized in Table 25. Findings from the SEM analysis of the cores are presented below from the subcontractor report by Dr. Jan Olek of Purdue University:

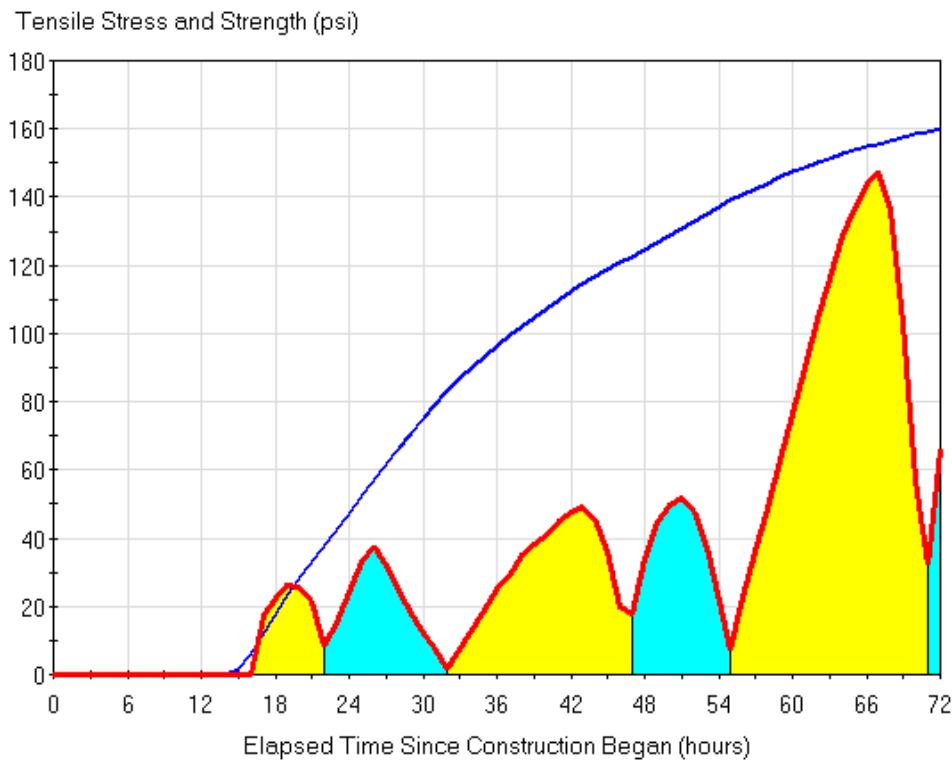
shows high stress on the top surface of concrete and green region shows high stress on the bottom surface. It can be seen that stress on the top surface begins to exceed strength at 5 am. Figure 93 directly compares tensile strength development with and without slag cement in the mix for cement placed on Oct. 10, 2006. At 72 hours, the PCC tensile strength is 217.3 psi (1.50 MPa) without slag cement, and 160.3 psi (1.11 MPa) with the slag cement. Figure 94 shows the stress to strength ratio for the same date; the slag cement crosses the 100% line, indicating failure, about 16 hours after placement.

**Figure 92 PCC Tensile strength and stress development after construction on LAK-90, October 10, 2006 (1 psi = 6.89 kPa).**

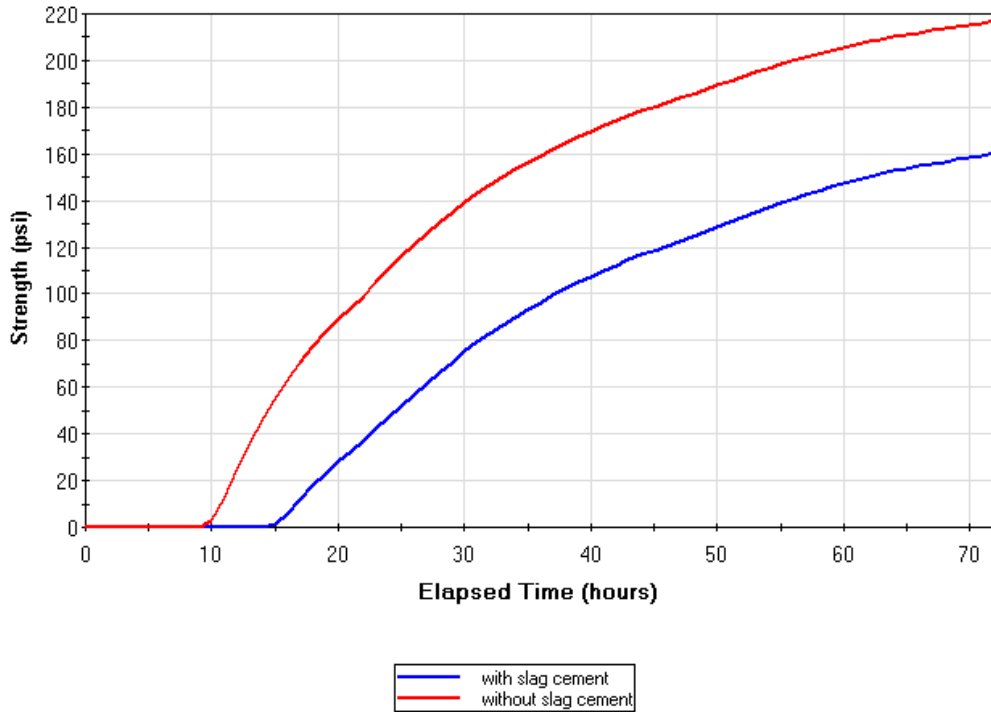
**Figure 93 Early stage PCC tensile strength development comparison from HIPERPAV, LAK-70 overlay with and without slag cement, October 10, 2006 (1 psi = 6.89 kPa).**

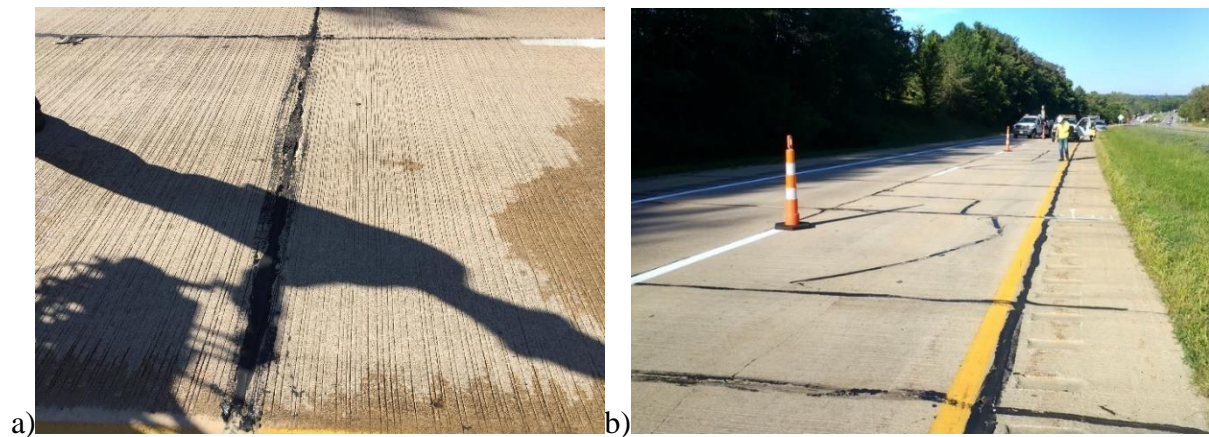
The ASD-30 site was visited on July 8, 2016, and some photographs showing the state of the pavement were taken, such as the minor joint spalling and longitudinal cracking shown in Figure 97.

**Figure 97 Pavement distress observed on ASD-30, July 8, 2016: a) Joint spalling; b) Longitudinal cracking**

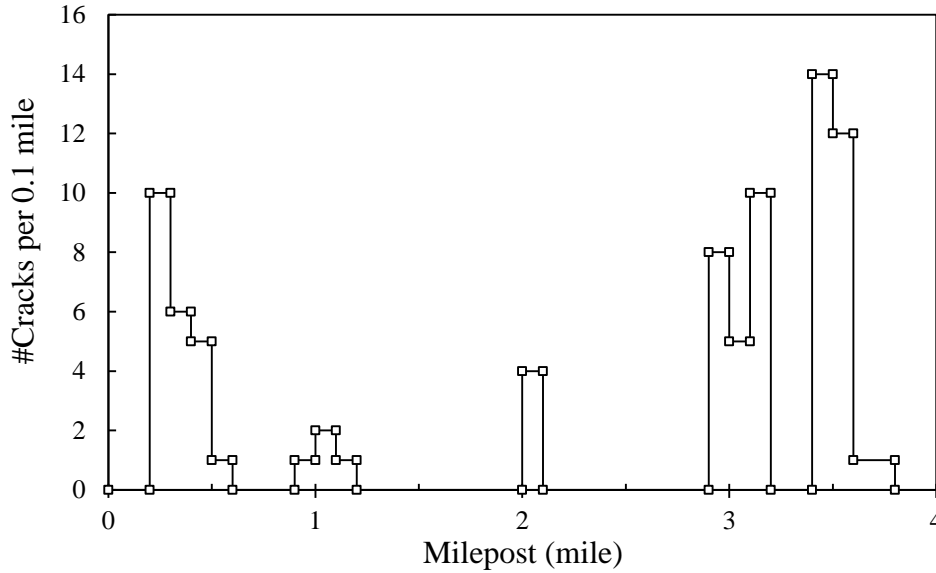
**Figure 98 ASD-30 Eastbound Passing Lane Cracking Plot (1 mile = 1.6 km)**

A distress survey using PathWeb images was conducted. The latest data available on PathWeb for ASD-30 are from August 2014. Some of the images were blurred and Google Street View was used to for assistance in counting cracks. The images of ASD-30 on Google Street View were collected from August 2013. Based on the survey, the eastbound passing lane experienced more distresses, including longitudinal cracking and joint failure. Westbound appeared to be in good condition overall. Figure 98 presents the cracking statistics of eastbound passing lane. Cracks per 0.1 mile (0.16 km) were counted and plotted with respect to milepost.

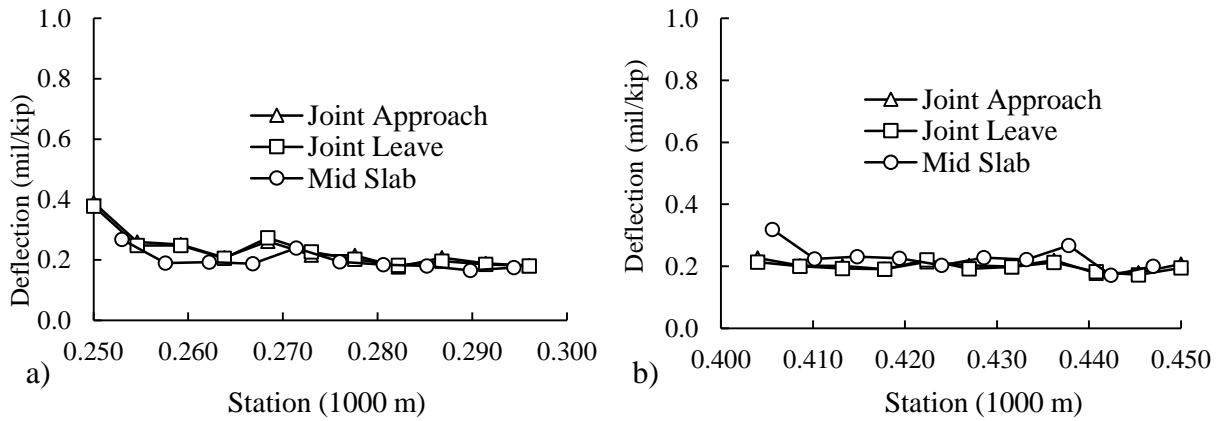
**Figure 100 ASD-30 Normalized Deflections a) Eastbound; b) Westbound (1 mil/kip = 5.71 mm/MN, 1000 m = 3281 ft).**

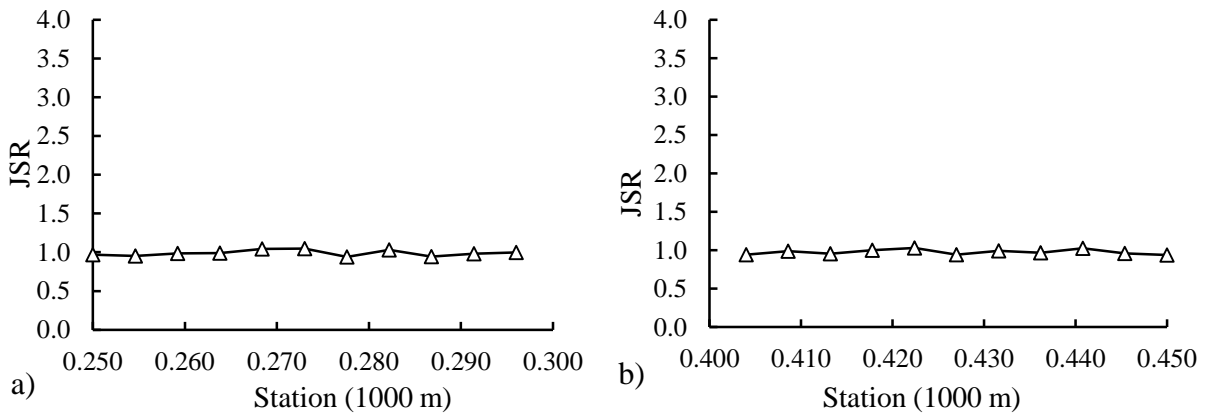
**Figure 101 ASD-30 Joint Support Ratio a) Eastbound; b) Westbound (1000 m = 3281 ft).**

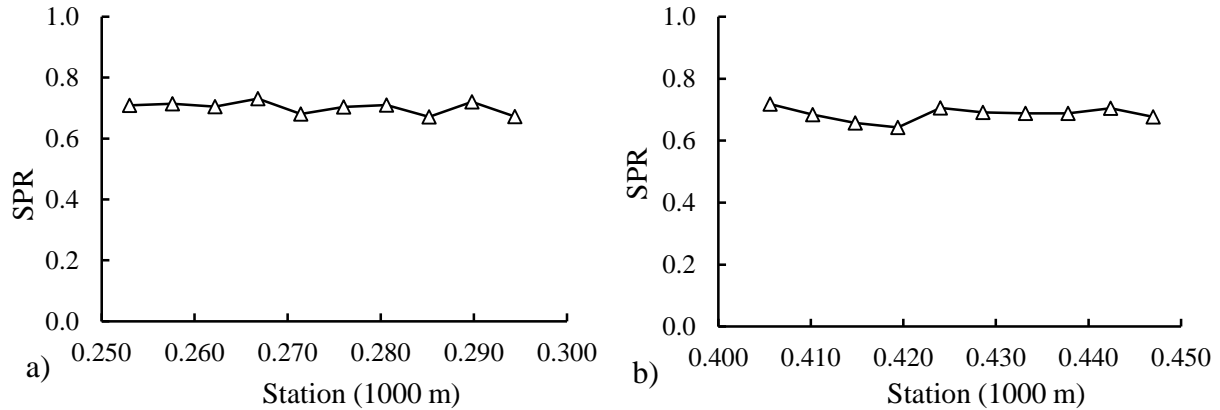
**Figure 102 ASD-30 Mid-slab Spreadability a) Eastbound; b) Westbound (1000 m = 3281 ft).**

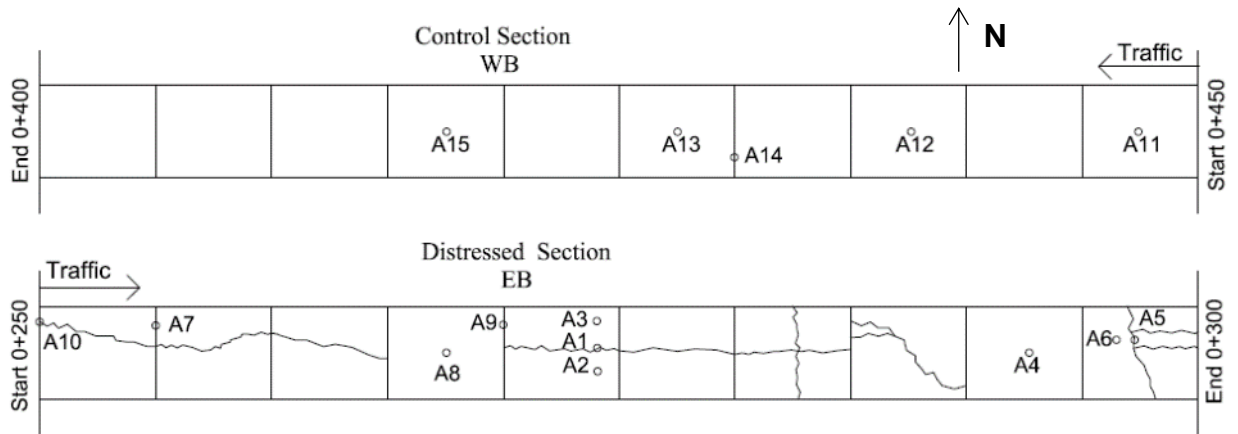
Figure 103 presents the distress survey and coring plan on ASD-30 in both directions. Coring occurred on September 20, 2016. A horizontal crack at dowel level was found in one of the core holes, shown in Figure 104.

**Figure 103 Distress map and coring plan on ASD-30. Note section numbers are in meters (1 m = 1.094 yd = 3.28 ft)**

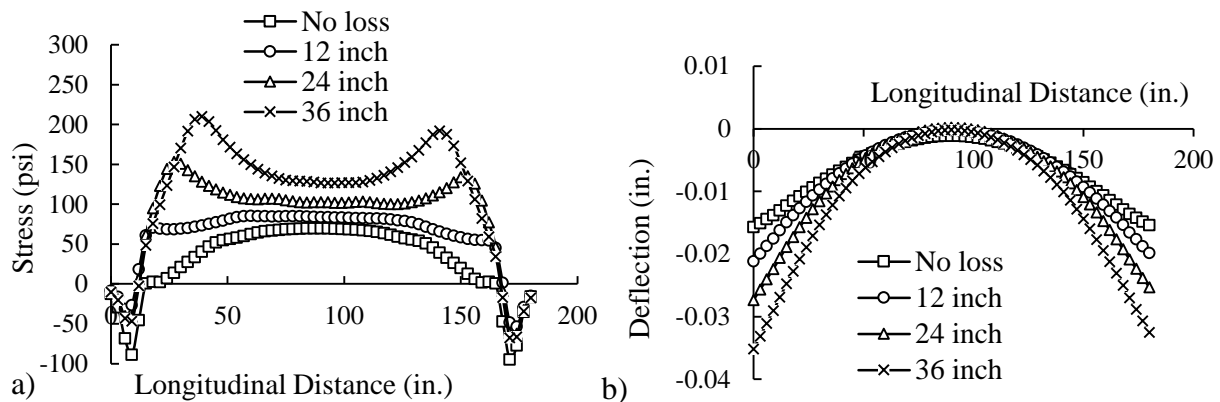
Figure 116 and Figure 117 present the maximum principal stress distribution and vertical deflection along Line 1 and Line 2 with only wheel loads. Stress along Line 1 and Line 2 increased with more loss of support. Maximum stress reaches 210 psi (1447 kPa) with 36-in (0.91 m) loss of support compared with 69 psi (475 kPa) with no loss of support. Deflections along Line 1 increased at the edges with more loss of support and remained nearly unchanged in the middle. The difference of deflections along Line 2 is relatively small. The slab is moving upwards near the longitudinal edge and is moving downwards near the center.

**Figure 116 Case 1 (W) a) Maximum principal stress along Line 1; b) Deflection along Line 1. Line 1 is parallel to traffic. (1 in = 25.4 mm; 1 psi = 6.9 kPa)**

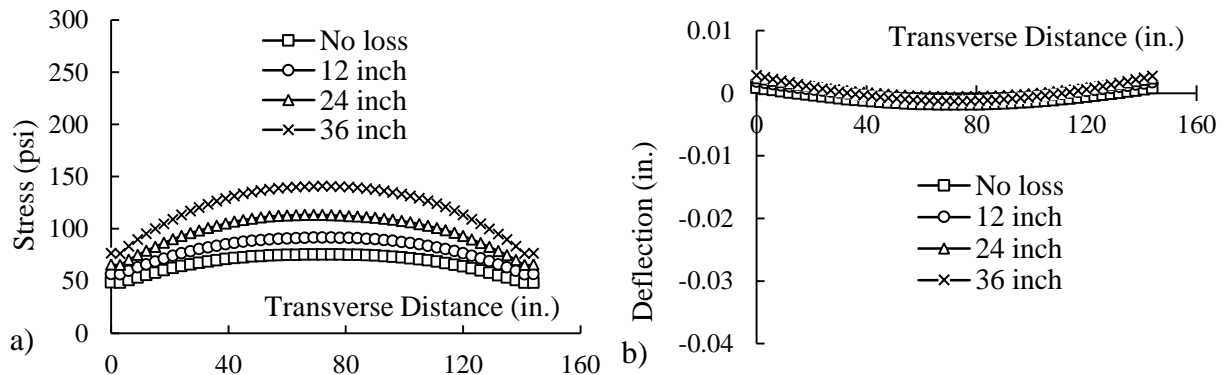
**Figure 117 Case 1 (W) a) Maximum principal stress along Line 2; b) Deflection along Line 2. Line 2 is transverse to traffic. (1 in = 25.4 mm; 1 psi = 6.9 kPa)**

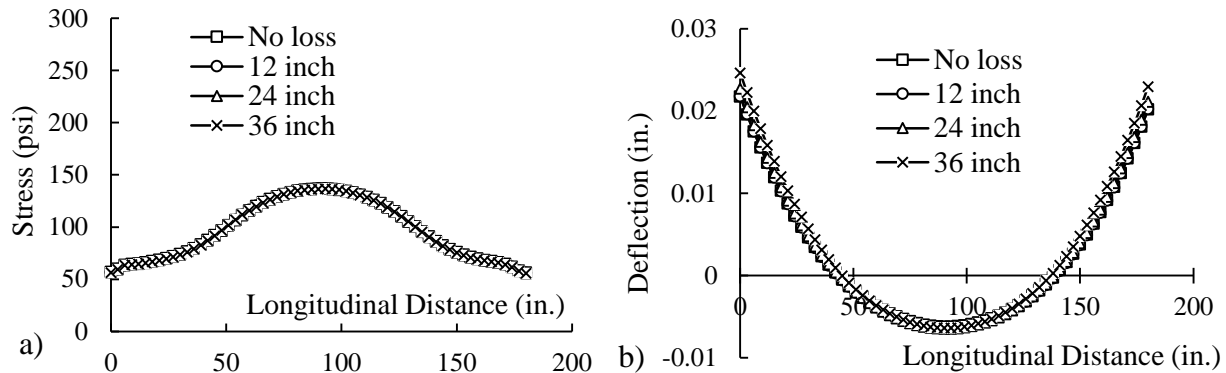
Figure 118 and Figure 119 present the maximum principal stress distribution and vertical deflection along Line 1 and Line 2 with only negative temperature gradient. Generally, the loss of materials under the joints had no or very little effect in this case. Stresses and deflections remained unchanged along both Line 1 and Line 2 with or without loss of support. This can be explained by

**Figure 118 Case 1 (T) a) Maximum principal stress along Line 1; b) Deflection along Line 1. Line 1 is parallel to traffic. (1 in = 25.4 mm; 1 psi = 6.9 kPa)**

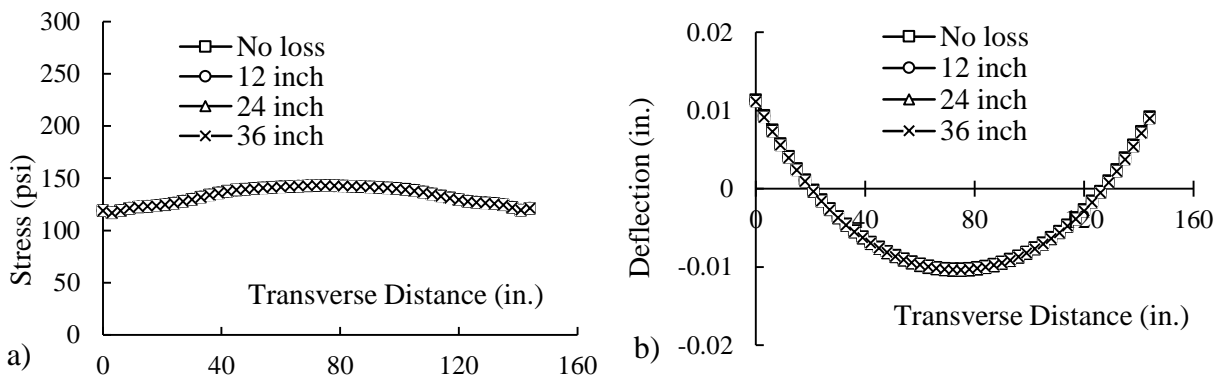
**Figure 119 Case 1 (T) a) Maximum principal stress along Line 2; b) Deflection along Line 2. Line 2 is transverse to traffic. (1 in = 25.4 mm; 1 psi = 6.9 kPa)**

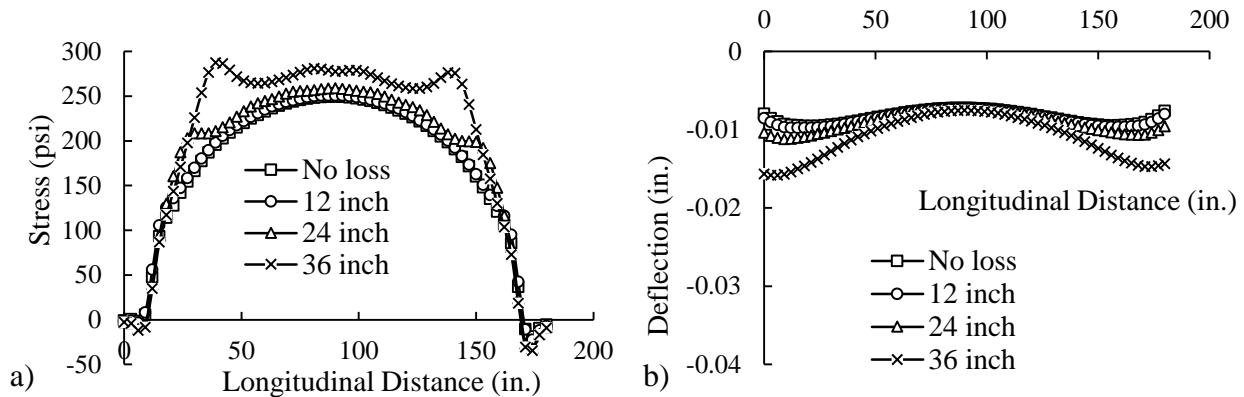
Figure 120 and Figure 121 present the maximum principal stress distribution and vertical deflections along Line 1 and Line 2. From Figure 120a), it can be seen that stress in the middle of the slab increased with more loss of support. The stress increased rapidly near the 36 in (0.91 m) position of Line 1 to 276.3 psi (1905 kPa). The surface of the slab between 36 in (0.91 m) to 144 in (3.66 m) position along Line 1 is under great tension due to loss of support. The stress distribution of 12 in (0.305 m) and 24 in (0.61 m) loss of support is analogous but less obvious. Deflections along Line 1 also increased with more loss of support. The maximum deflection increased from 0.0057 in (0.145 mm) to 0.0158 in (0.401 mm). Stress along Line 2 increased with more loss of support. The stress in the middle of the slab increased from 261.1 psi (1800 kPa) with no loss of support to 294.2 psi (2028 kPa) with 36 in (0.91 m) loss of support. Deflection along Line 2 generally remained unchanged with or without loss of support.

**Figure 120 Case 1 (T+W) a) Maximum principal stress along Line 1; b) Deflection along Line 1. Line 1 is parallel to traffic. (1 in = 25.4 mm; 1 psi = 6.9 kPa)**

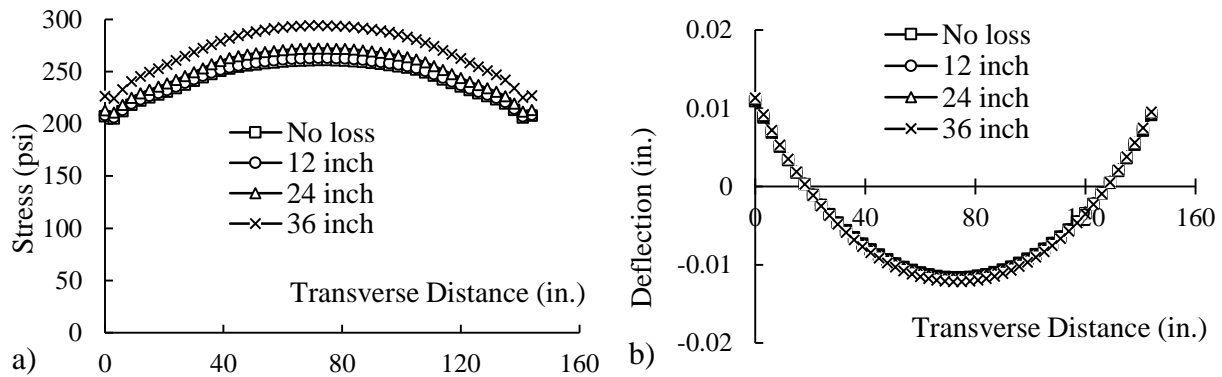
**Figure 121 Case 1 (T+W) a) Maximum principal stress along Line 2; b) Deflection along Line 2. Line 2 is transverse to traffic. (1 in = 25.4 mm; 1 psi = 6.9 kPa)**

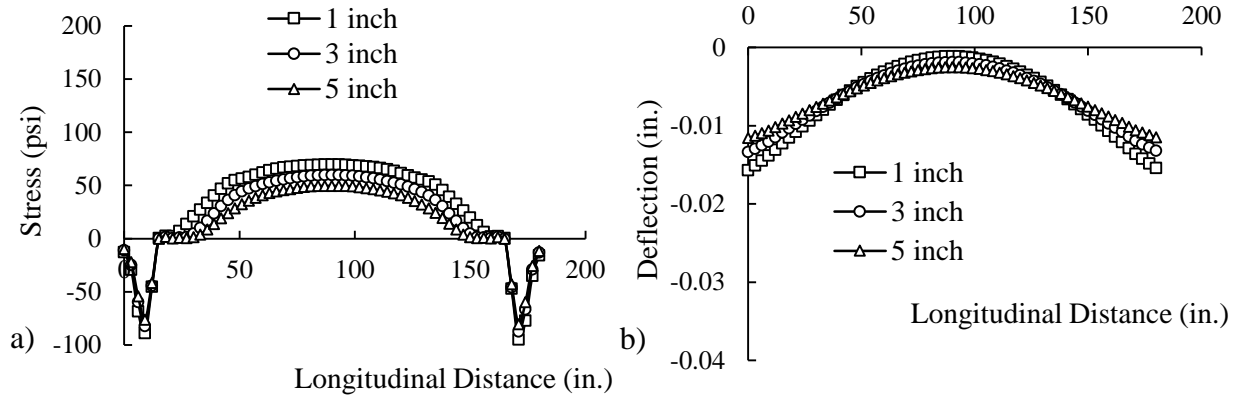
Figure 122 presents the maximum principal stress distribution and deflection along Line 1 due to wheel loading only. Figure 123 presents the stress and deflection along Line 2. As can be seen, stresses along Line 1 and Line 2 decrease with thicker AC bondbreaker. The vertical deflections along Line 1 are negative, indicating the slab is pressed into the bondbreaker. The slab on the 1 in (25 mm) thick bondbreaker shows the most deflection at the ends and the least negative deflection in the center, indicating the most bending of the slab, while the 5 in (127 mm) bondbreaker yields the least bending distortion of the slab.

**Figure 122 Case 2 (W) a) Maximum principal stress along Line 1; b) Deflection along Line 1. Line 1 is parallel to traffic. (1 in = 25.4 mm; 1 psi = 6.9 kPa)**

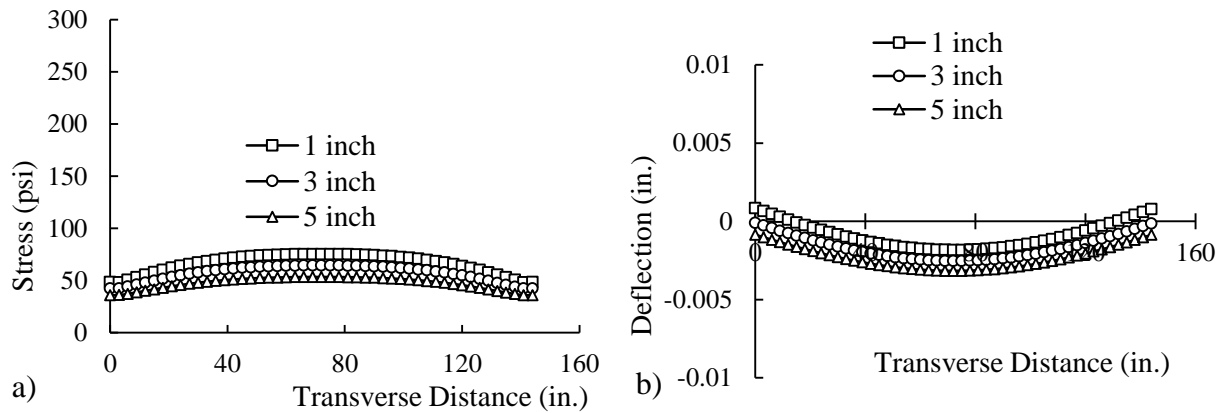
**Figure 123 Case 2 (W) a) Maximum principal stress along Line 2; b) Deflection along Line 2. Line 2 is transverse to traffic. (1 in = 25.4 mm; 1 psi = 6.9 kPa)**

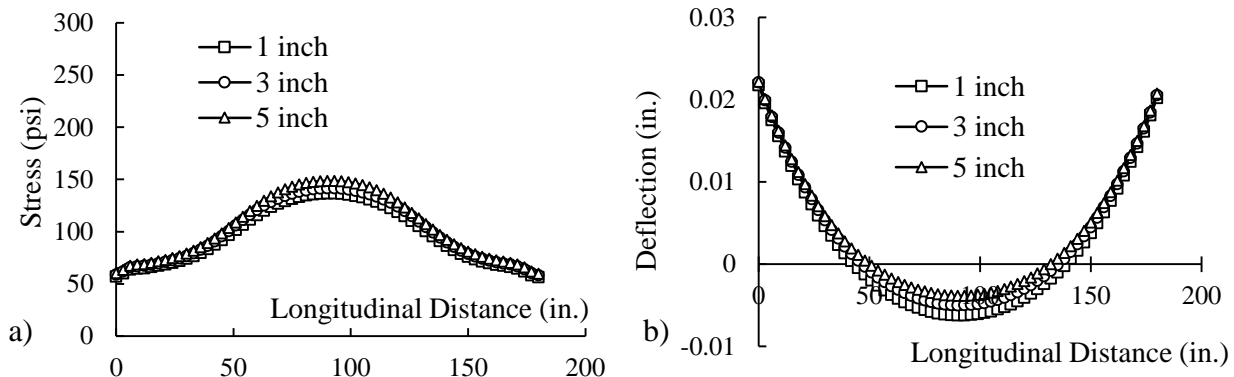
Figure 124 and Figure 125 present the maximum principal stress distribution and deflections along Line 1 and Line 2. As can be seen, the negative temperature gradient causes the slab to curl upwards. The edges and corners of the slab lost contact with the bondbreaker. The maximum stress along Line 1 and Line 2 increases with thicker bondbreaker. This difference is greater in the middle of the slab, while in the edges the difference is less. The deflections, however, decrease with thicker bondbreaker. Similarly, the difference is greater in the middle of the slab.

**Figure 124 Case 2 (T) a) Maximal principal stress along Line 1; b) Deflection along Line 1. Line 1 is parallel to traffic. (1 in = 25.4 mm; 1 psi = 6.9 kPa)**

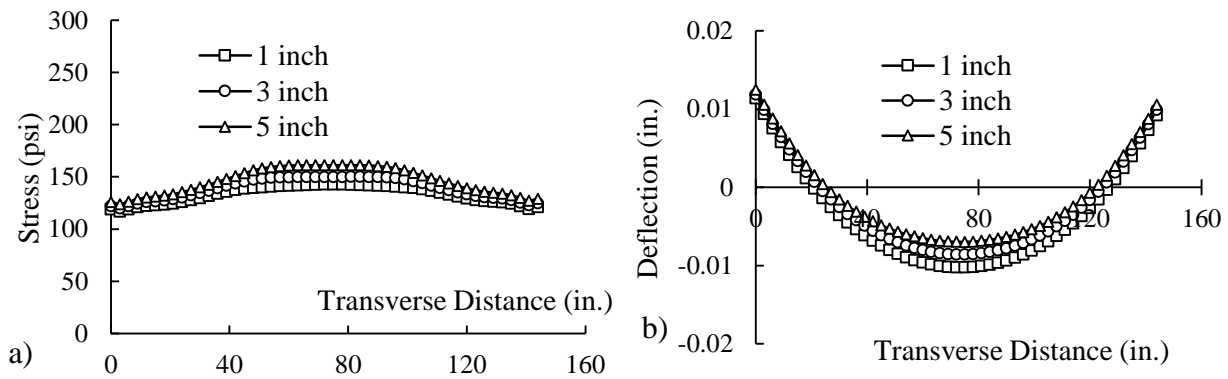
**Figure 125 Case 2 (T) a) Maximum principal stress along Line 2; b) Deflection along Line 2. Line 2 is transverse to traffic. (1 in = 25.4 mm; 1 psi = 6.9 kPa)**

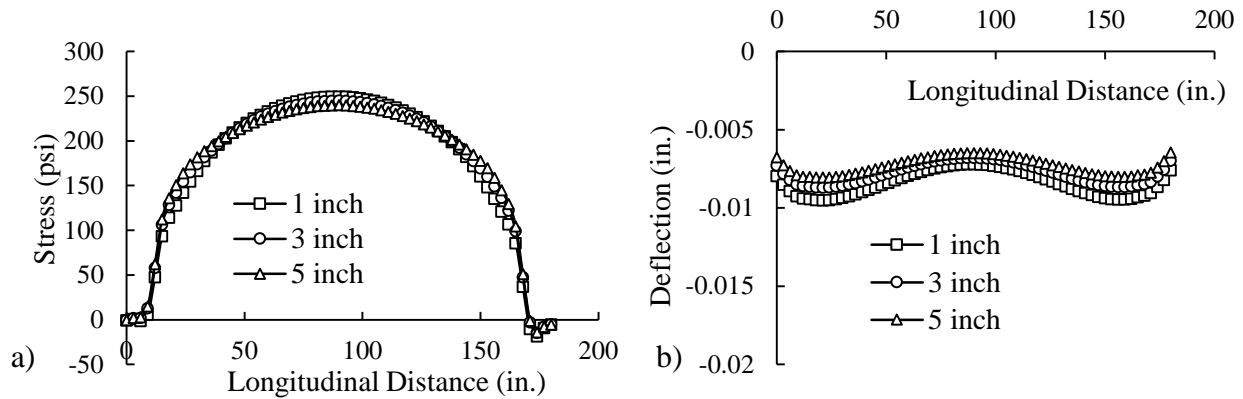
Figure 126 presents the maximum principal stress distribution and deflections along Line 1 due to negative temperature and wheel loading. Figure 127 presents the stress and deflections along Line 2. The difference of stress along Line 1 is very small. The model with thicker bondbreaker has slightly lower stress in the middle of the slab. Stress along Line 2 decreases with thicker bondbreaker. Deflections along Line 1 and Line 2 decrease with thicker bondbreaker thickness.

**Figure 126 Case 2 (T+W) a) Maximum principal stress along Line 1; b) Deflection along Line 1. Line 1 is parallel to traffic. (1 in = 25.4 mm; 1 psi = 6.9 kPa)**

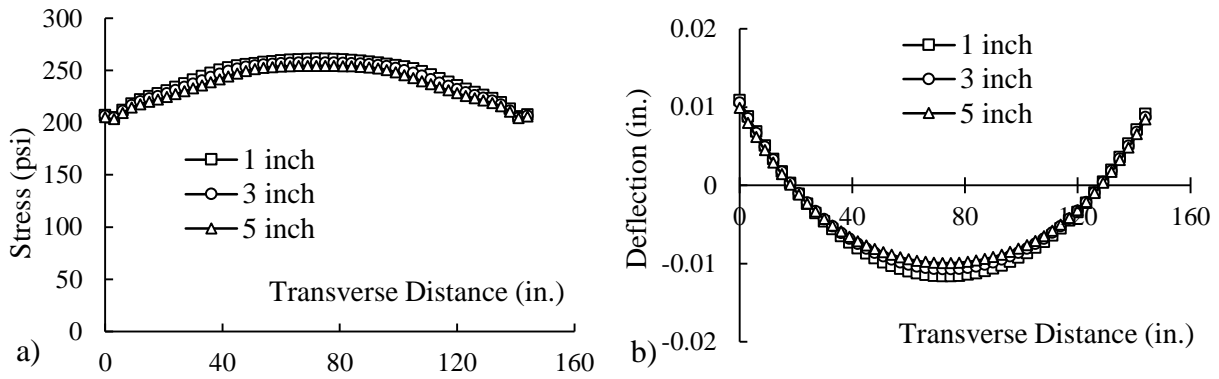
**Figure 127 Case 2 (T+W) a) Maximum principal stress along Line 2; b) Deflection along Line 2. Line 2 is transverse to traffic. (1 in = 25.4 mm; 1 psi = 6.9 kPa)**

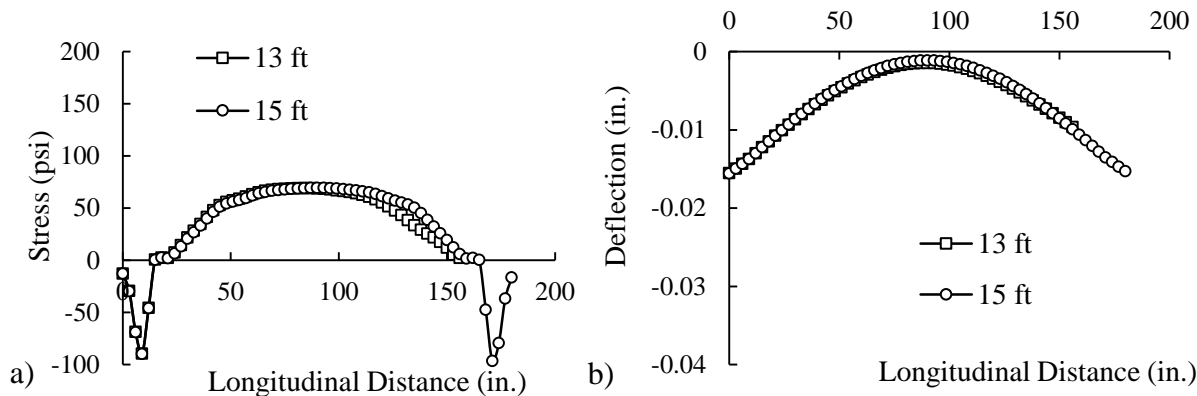
Figure 129 and Figure 130 present the maximum principal stress distribution and deflections along Line 1 and Line 2 due to wheel loading only. It can be seen from the plots that stress didn't change much along Line 1 and Line 2. Deflections along Line 1 remained unchanged from 15 ft (4.6 m) to 13 ft (4.0 m) joint spacing. Deflections along Line 2 decreased from 15 ft (4.6 m) to 13 ft (4.0 m) joint spacing, but the difference is very small.

**Figure 129 Case 3 (W) a) Maximum principal stress along Line 1; b) Deflection along Line 1. Line 1 is parallel to traffic. (1 in = 25.4 mm; 1 psi = 6.9 kPa)**

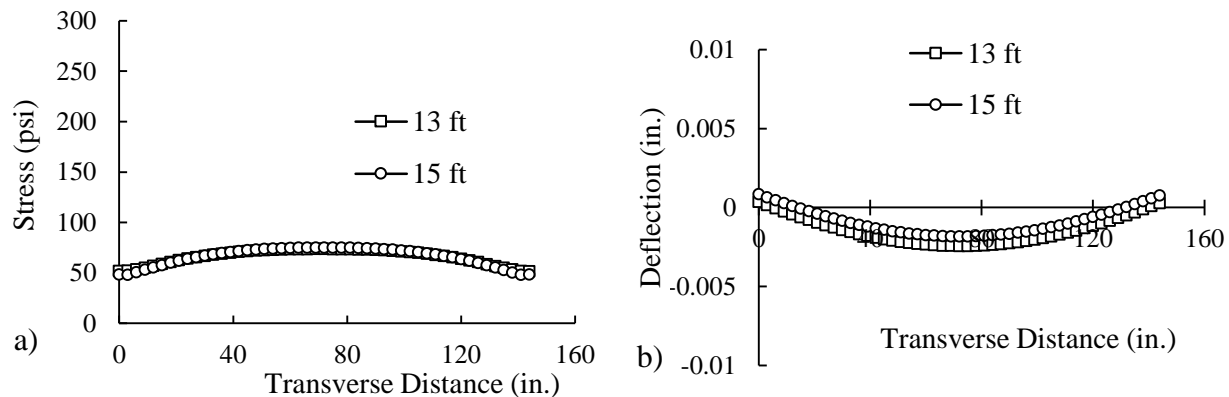
**Figure 130 Case 3 (W) a) Maximum principal stress along Line 2; b) Deflection along Line 2. Line 2 is transverse to traffic. (1 in = 25.4 mm; 1 psi = 6.9 kPa)**

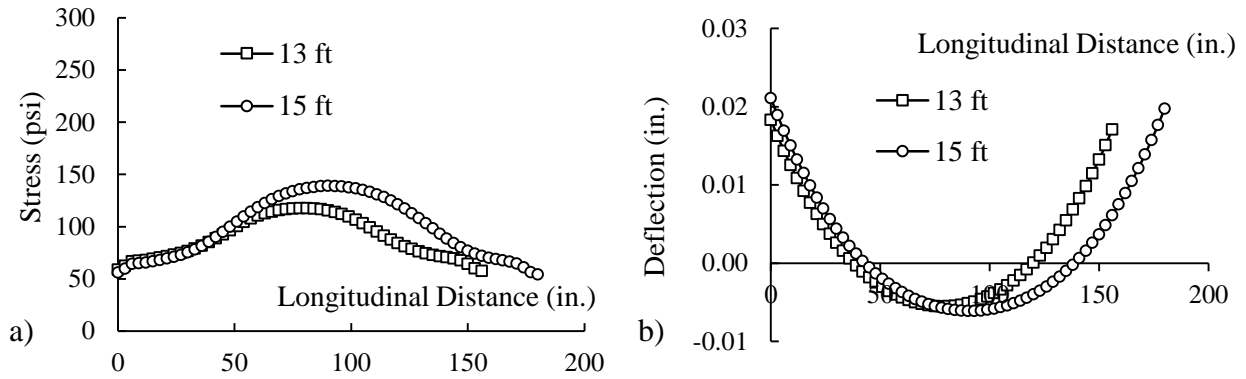
Figure 131 and Figure 132 present the maximum principal stress distribution and deflections along Line 1 and Line 2 due to negative temperature only. It can be seen from the plots that the deflections didn't change much due to different joint spacing. Stress along Line 2 and middle of Line 1 decreased with smaller joint spacing.

**Figure 131 Case 3 (T) a) Maximum principal stress along Line 1; b) Deflection along Line 1. Line 1 is parallel to traffic. (1 in = 25.4 mm; 1 psi = 6.9 kPa)**

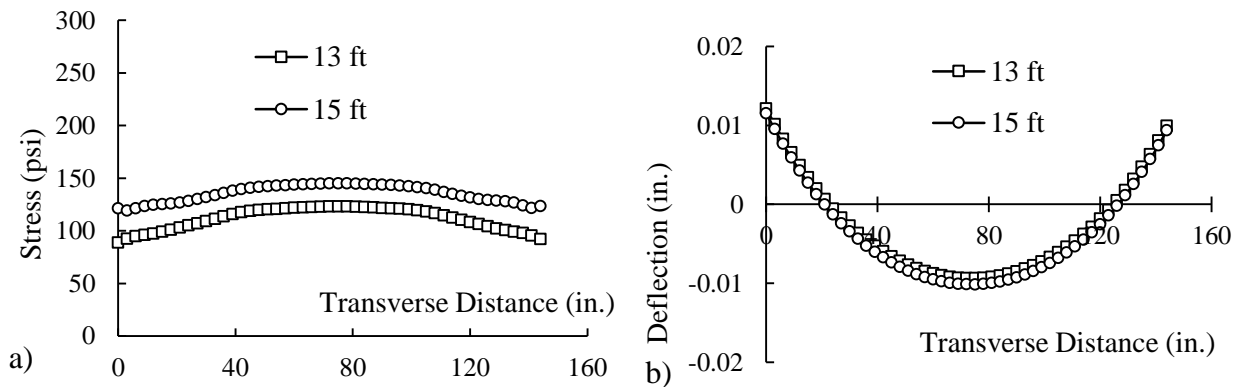
**Figure 132 Case 3 (T) a) Maximum principal stress along Line 2; b) Deflection along Line 2. Line 2 is transverse to traffic. (1 in = 25.4 mm; 1 psi = 6.9 kPa)**

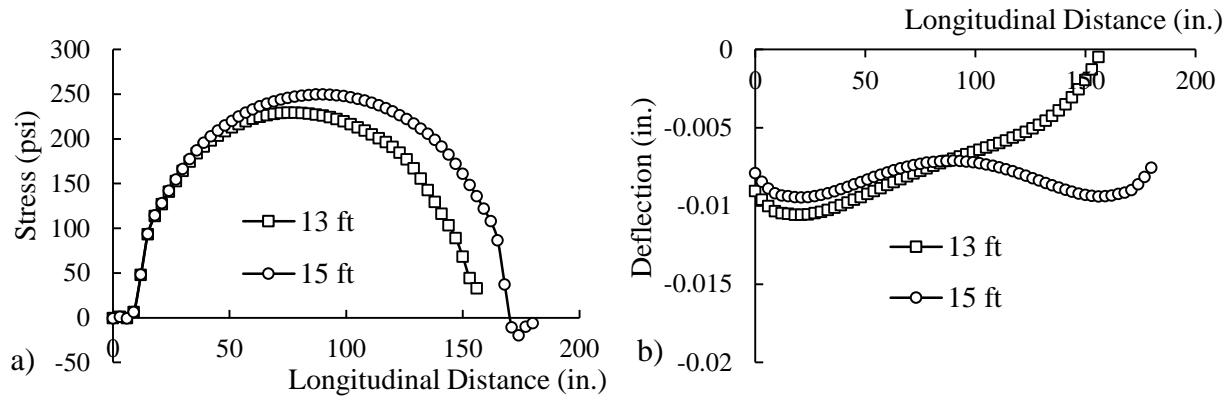
Figure 133 and Figure 134 present the maximum principal stress distribution and deflections along Line 1 and Line 2 due to negative temperature with wheel loading. The stress decreased with shorter joint spacing. Deflection along line 1 increased with shorter joint spacing on the loaded side of the slab. On the other side of the slab, however, deflection dropped significantly with 13 ft (4.0 m) joint spacing.

**Figure 133 Case 3 (T+W) a) Maximum principal stress along Line 1; b) Deflection along Line 1. Line 1 is parallel to traffic. (1 in = 25.4 mm; 1 psi = 6.9 kPa)**

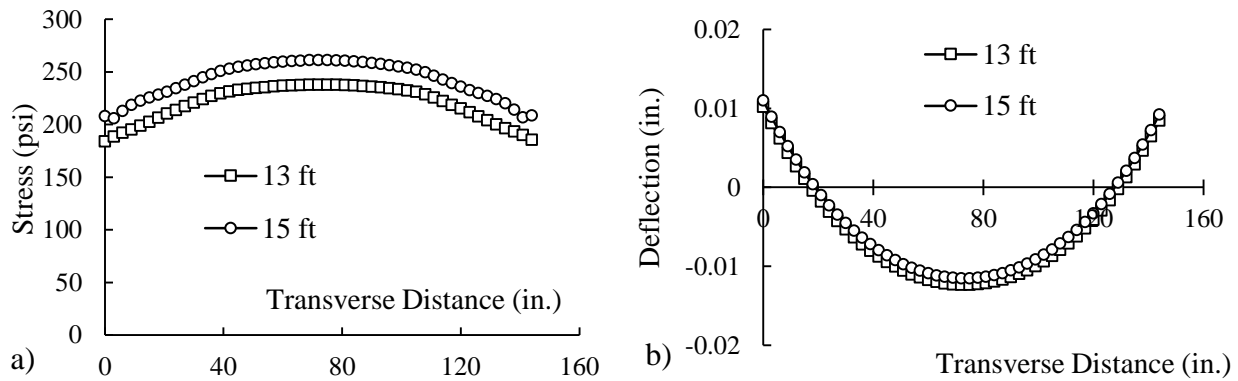
**Figure 134 Case 3 (T+W) a) Maximum principal stress along Line 2; b) Deflection along Line 2. Line 2 is transverse to traffic. (1 in = 25.4 mm; 1 psi = 6.9 kPa)**

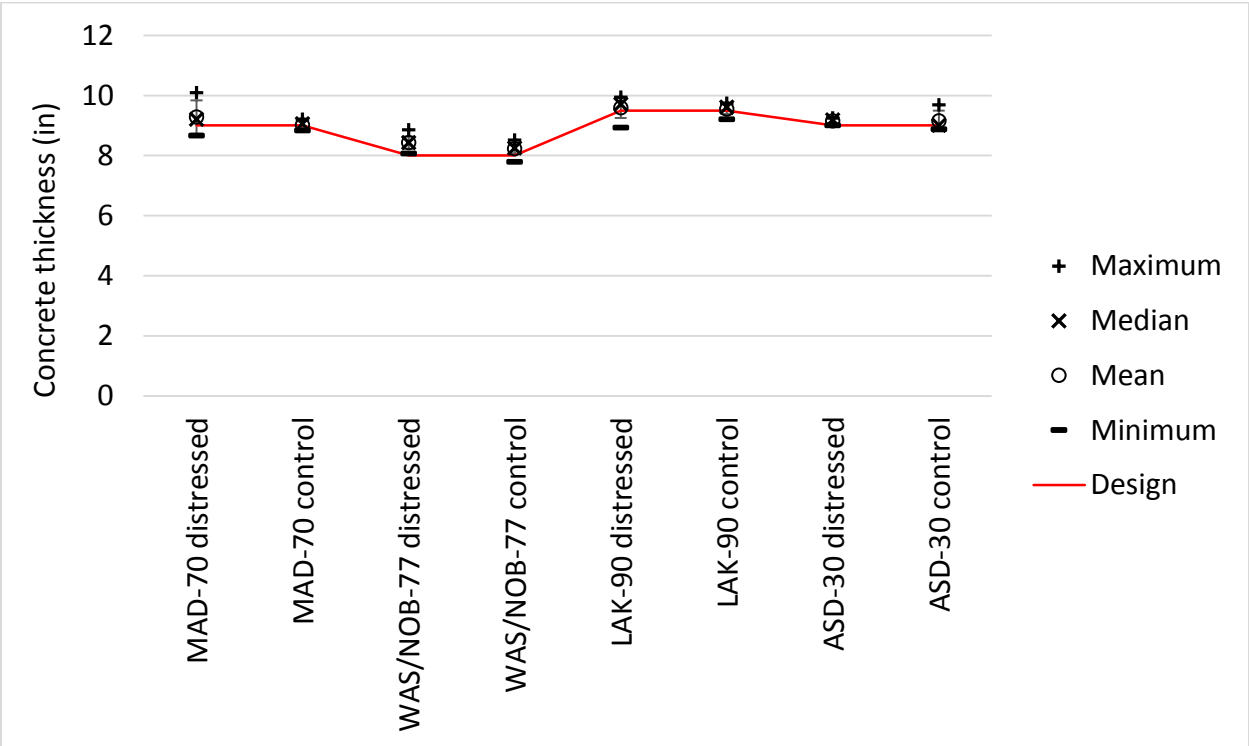
The thicknesses of the PCC overlays for each project, based on statistics compiled from the measurements of all cores, are plotted in Figure 136, along with design thicknesses. The measured thicknesses are each close to the design value, though MAD-70 distressed section shows a greater variability in the measurements than the other sections, particularly the MAD-70 control section. The thickness design was not found to be an issue for any of the overlay projects.

Figure 136 PCC Overlay thicknesses of each project compared to design values (1 in =25.4 mm).

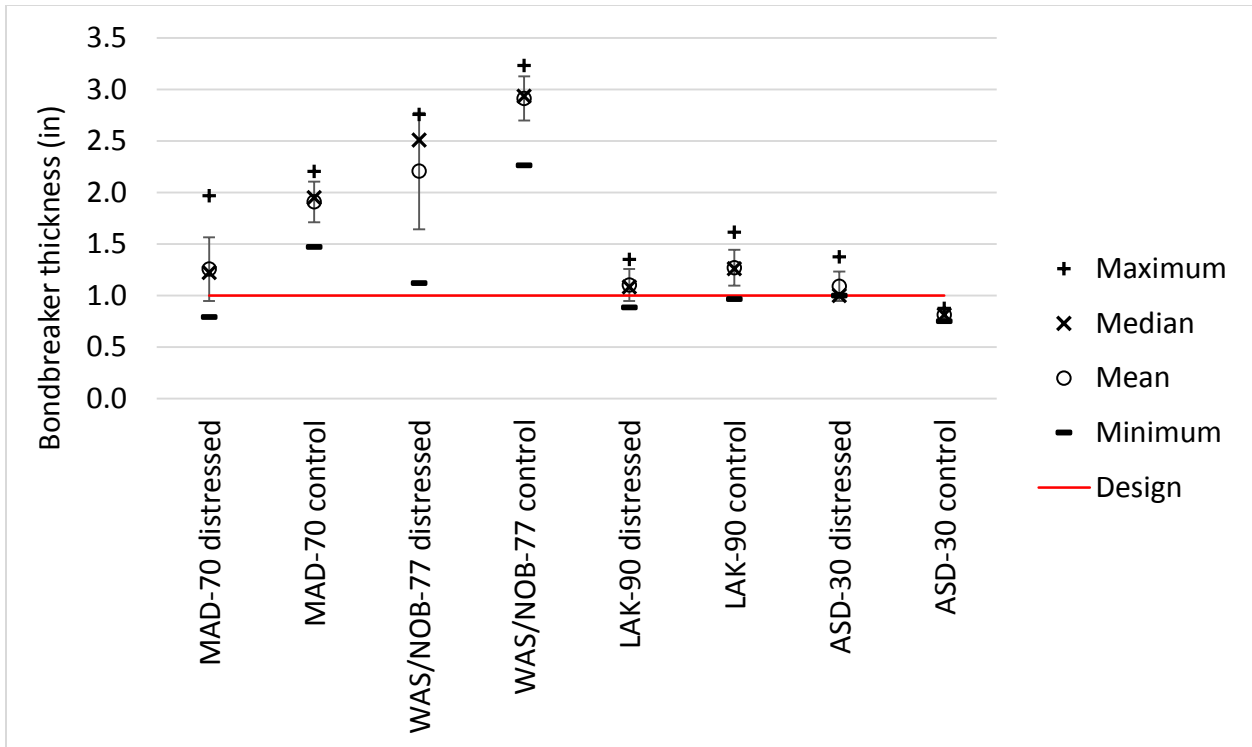
The thicknesses of the AC bondbreaker layers are given in Figure 137. The design thickness was 1 in (25 mm) for each project, but the MAD-70 Westbound and WAS/NOB-77 bondbreaker thicknesses are far greater than the design values, with the control sections being thicker than the distressed sections.

Figure 137 Bondbreaker thicknesses of each project compared to design values (1 in =25.4 mm).

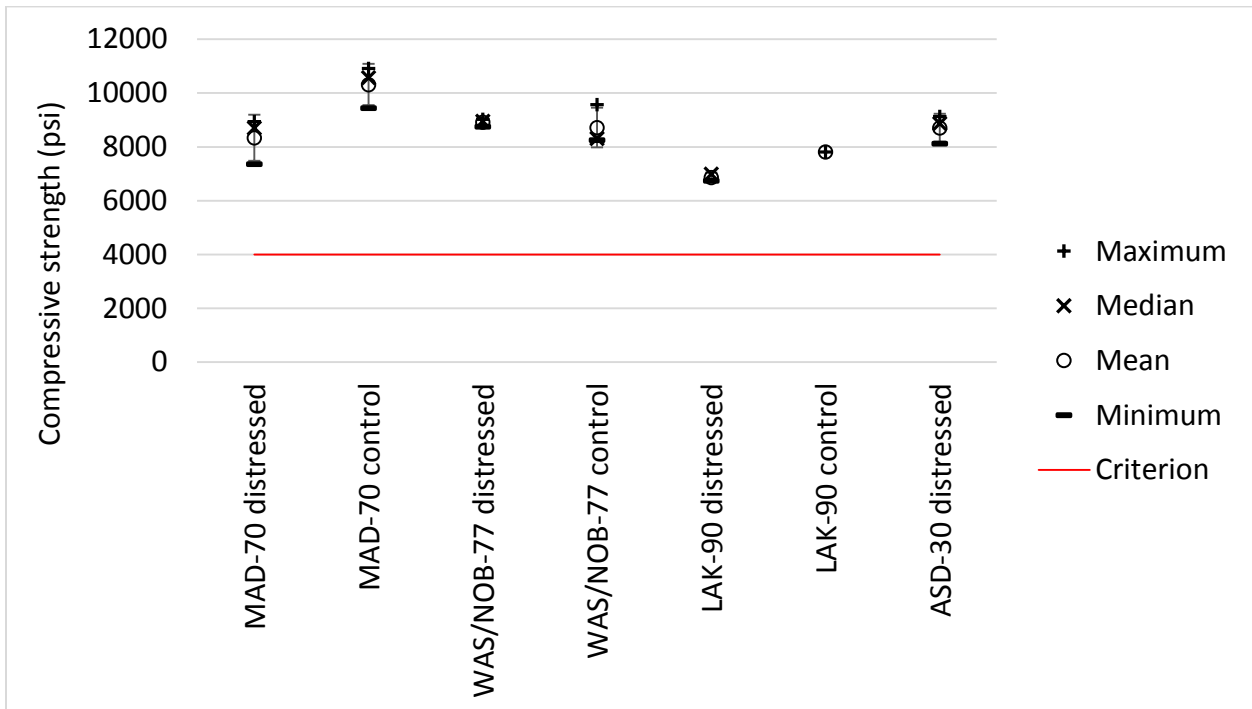
The compressive and tensile strength of the PCC layer in each section is given in Figure 138 and Figure 139, respectively. In all cases, these strengths exceed the ODOT design criteria indicated by the red line. The elastic modulus (*E*) values are plotted in Figure 140; only WAS/NOB-77 meets the current ODOT criterion of 5 million psi (34.5 GPa), while the others fall short by up to about 20%, except MAD-70 distressed, which at 2.8 million psi (19.3 GPa) is 44% below the ODOT criterion. Note that only one specimen was measured from each section on MAD-70 and WAS/NOB-77, and only one specimen for the sites LAK-90 and ASD-30, with LAK-90 control and ASD-30 distressed sections not included. The coefficient of thermal expansion values for each site are plotted in Figure 141, representing three values for each section except LAK-90 distressed and ASD-30 distressed, which were not measured.

Figure 138 Compressive strength of PCC overlay for each project (1000 psi = 6.89 MPa).
