# Forensic Study of Early Failures with Unbonded Concrete Overlays

*Prepared by:*  
Shad Sargand, Roger Green, Junqing Zhu, and Issam Khoury

*Prepared for:*  
The Ohio Department of Transportation,  
Office of Statewide Planning & Research

*November 2017*  
*Final Report*

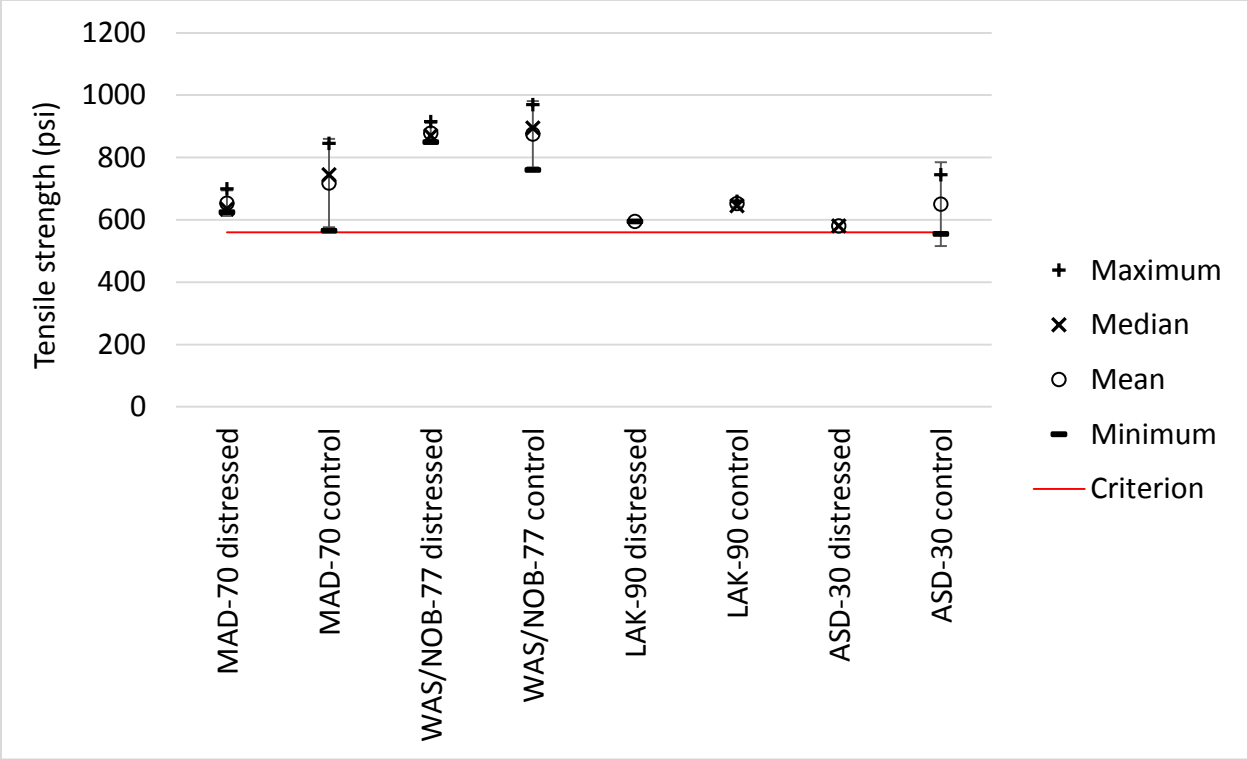
The compressive and tensile strength of the PCC layer in each section is given in Figure 138 and Figure 139, respectively. In all cases, these strengths exceed the ODOT design criteria indicated by the red line. The elastic modulus (*E*) values are plotted in Figure 140; only WAS/NOB-77 meets the current ODOT criterion of 5 million psi (34.5 GPa), while the others fall short by up to about 20%, except MAD-70 distressed, which at 2.8 million psi (19.3 GPa) is 44% below the ODOT criterion. Note that only one specimen was measured from each section on MAD-70 and WAS/NOB-77, and only one specimen for the sites LAK-90 and ASD-30, with LAK-90 control and ASD-30 distressed sections not included. The coefficient of thermal expansion values for each site are plotted in Figure 141, representing three values for each section except LAK-90 distressed and ASD-30 distressed, which were not measured.

Figure 139 Tensile strength of PCC overlay for each project (1000 psi = 6.89 MPa).

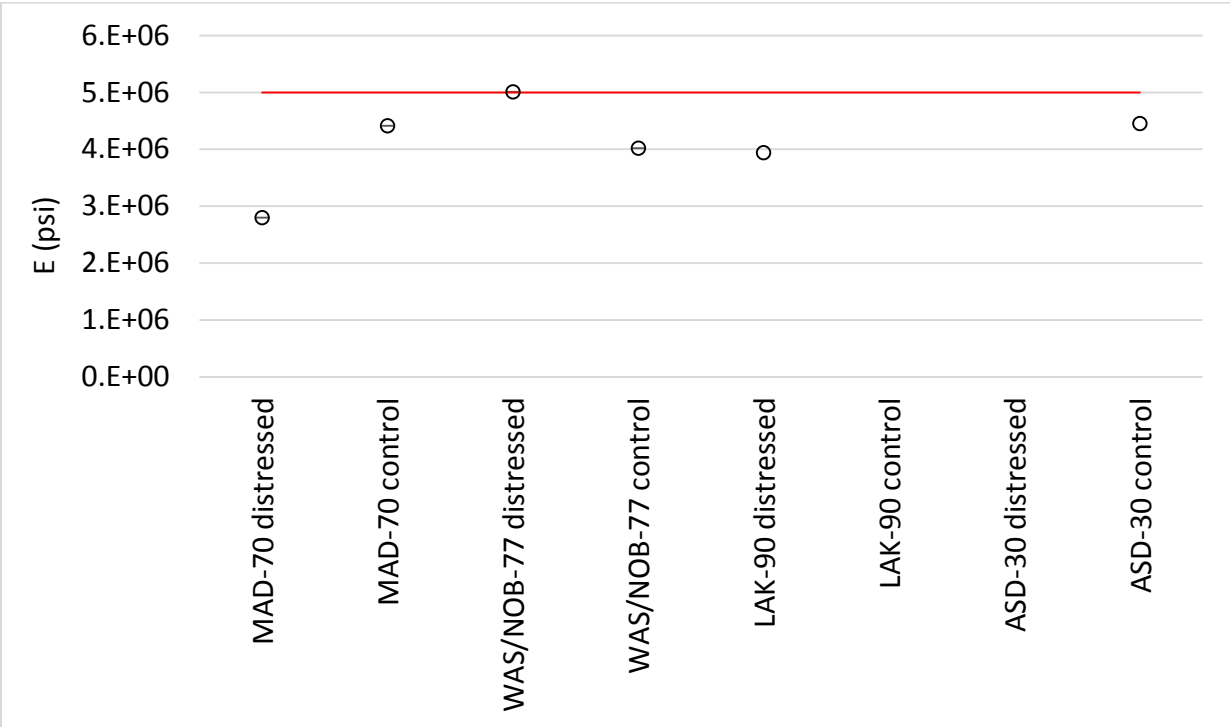
Figure 140 Elastic modulus (E) of PCC overlay for each project (1E+06 psi = 6.89 GPa). Note this parameter was not measured for LAK-90 control or ASD-30 distressed sections.

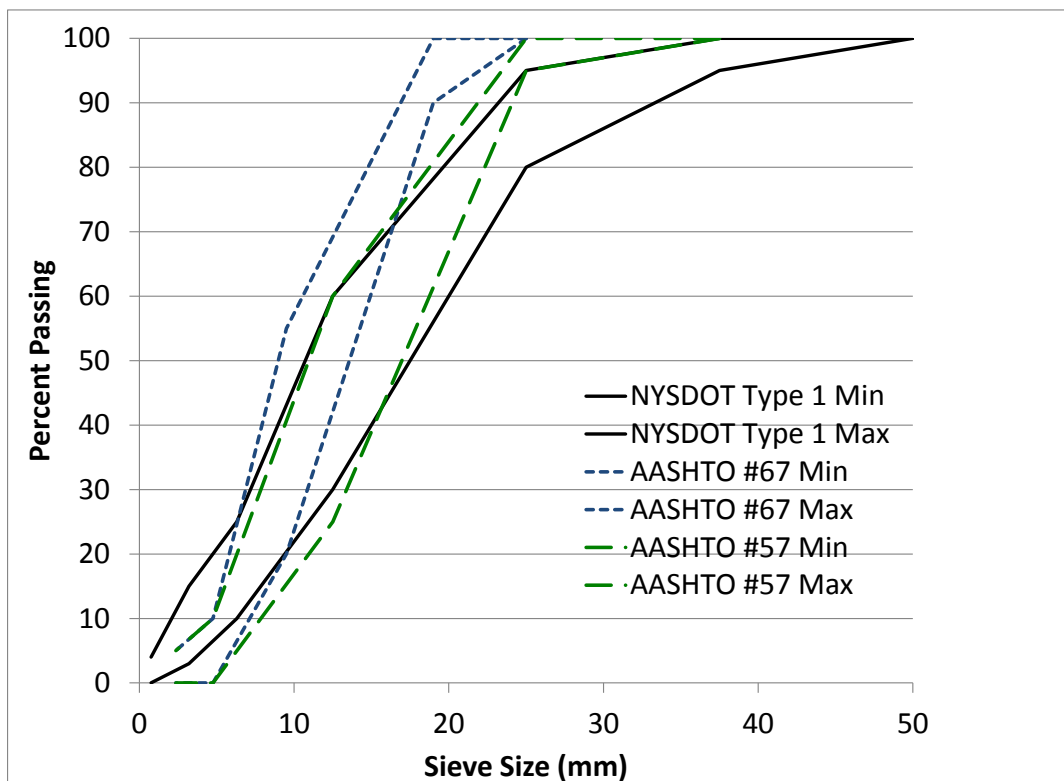
The now inactive ODOT CMS Item 308, Asphalt Treated Free Draining Base (ATFDB) is similar to the permeable base used on the NYSDOT I-86 project discussed in Chapter 2 of this report. Figure 142 shows a comparison of the aggregate gradations permitted for Item 308, which can be either AASHTO #57 or AASHTO #67 at the discretion of the contractor, and the gradation used on I-86, NYSDOT Type 1. The ODOT mix could be a finer gradation with a smaller top size. The ODOT specification requires an asphalt content between 1.5% and 3.5% whereas the NYSDOT requires an asphalt content between 2.0% and 4.0%. Should ODOT chose to use a permeable asphalt bondbreaker, it is recommended the Department evaluate their Item 308 specification, make revisions as needed, and reactivate.

**Figure 142. Comparison of aggregate gradations for former ODOT CMS Item 308, which can be either AASHTO #67 or AASHTO #57, and NYSDOT Type 1 aggregate used on I-86 in New York. (25.4 mm = 1 in).**
