# Pilot Construction Project for Granular Shoulder Stabilization

**Final Report  
September 2013**

**Sponsored by**  
Iowa Highway Research Board  
(IHRB Project TR-634)  
Iowa Department of Transportation  
(InTrans Project 11-405)

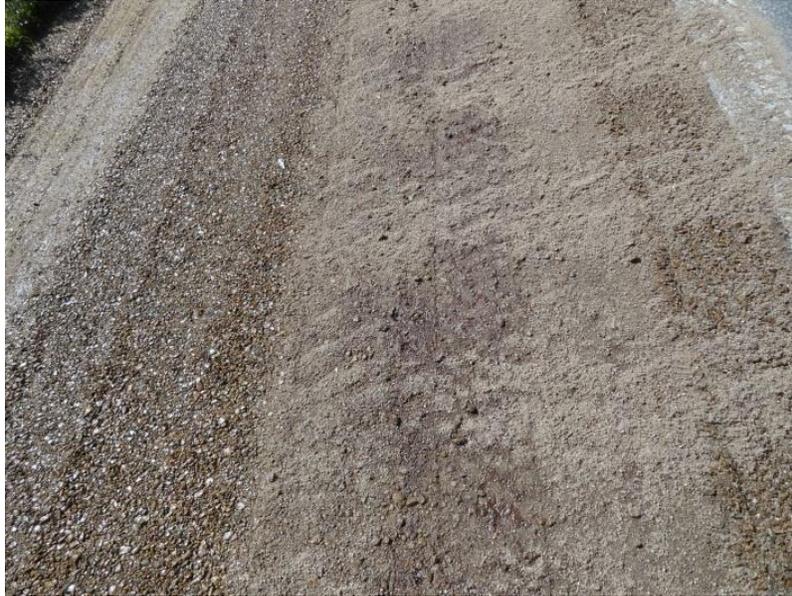
**Figure 11. Soapstock and sand applied to recycled asphalt paving materials**

In one place, recycled asphalt paving material was newly spread on the shoulder. After the soapstock and sand was applied to it, the mixed material looked much like dense-graded aggregate, with a noticeably greater amount of fine particles (Figure 11).

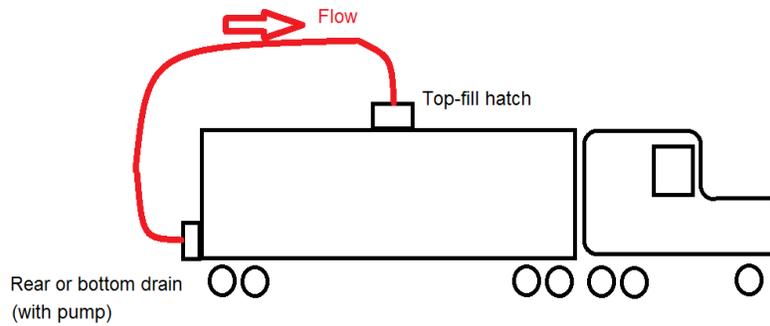
One action drew researchers' attention when Boer used the plastic pipe and pump to recirculate soapstock from the bottom to the top of the storage tank (Figure 17). The day before this action, the treatment showed inconsistent results between the morning and afternoon work session, which was believed to be a consequence of soapstock segregation. According to Boer, material with low viscosity tends to settle to the bottom, while material with high viscosity tends to flow to the top. After the soapstock was circulated, its viscosity was more consistent, so it could be distributed evenly and provide better performance.

**Figure 17. Recirculating soapstock to provide more consistent density (Harris 2011)**

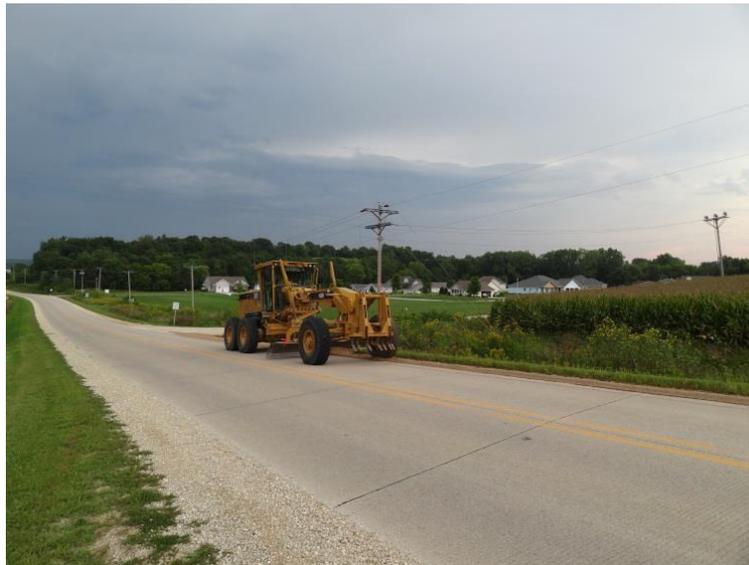
**Figure 18. Grader bladed over the shoulder applied with sand**

While applying soapstock onto Fayette County Road (CR) W-51, the county maintenance crew developed an alternate method for placing sand over the soapstock. A county truck placed sand on the white line by using an edge rut chute. Then, the motor grader bladed sand over the surface on which the soapstock was applied (Figure 18).

This procedure worked well for places where the shoulder surface was lower than the pavement, but not for places where the shoulder surface was higher than the pavement. The newly-applied soapstock on higher shoulder surfaces was scraped off the shoulder by the motor grader blade.

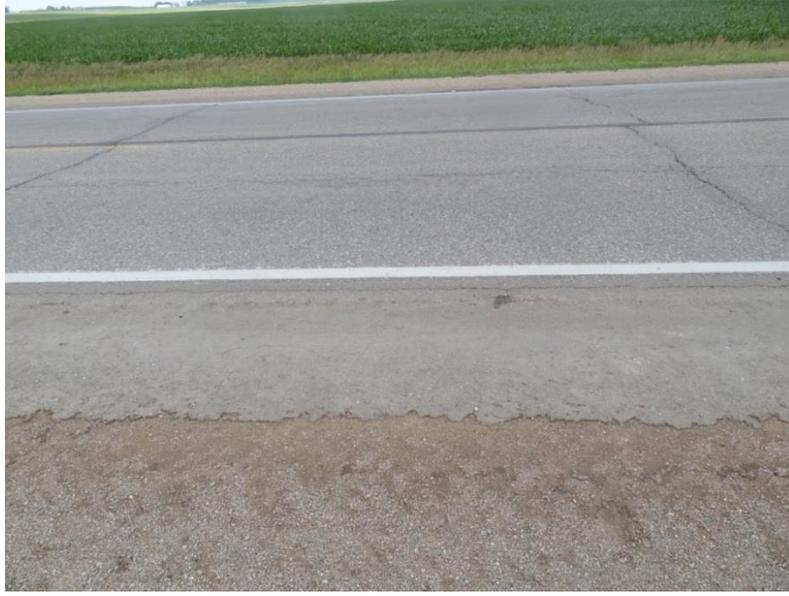
**Figure 21. Eastbound shoulder of US 18 near Garner, Iowa**

Figure 20 provides an example of good shoulder performance for this area. This shows a section of the US 169 shoulder adjacent to the SB lane just south of Algona, where a thin layer of soapstock remained firmly on the shoulder. Another example is shown in Figure 21. The shoulder section was on US 18 near Garner with a thicker layer of soapstock on surface.

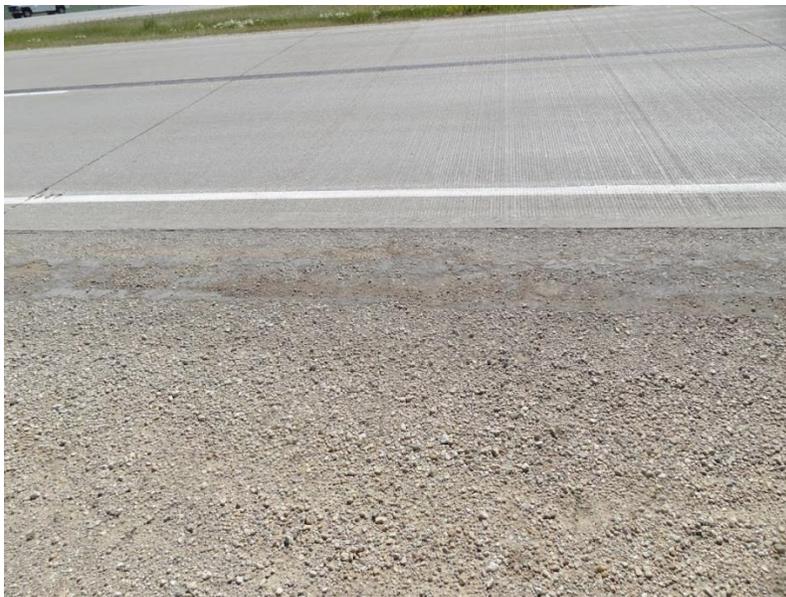
**Figure 25. Southbound outside shoulder of US 63 near Denver, Iowa**

Figure 24 provides an example of good shoulder performance for this area. This shows a shoulder section of IA 3 on adjacent to the EB lanes just east of Waverly, where a thick layer of soapstock remained firmly on the shoulder. Another example is shown in Figure 25. This shoulder section was on US 63 near Denver, where soapstock had penetrated into the shoulder and could not be seen easily.

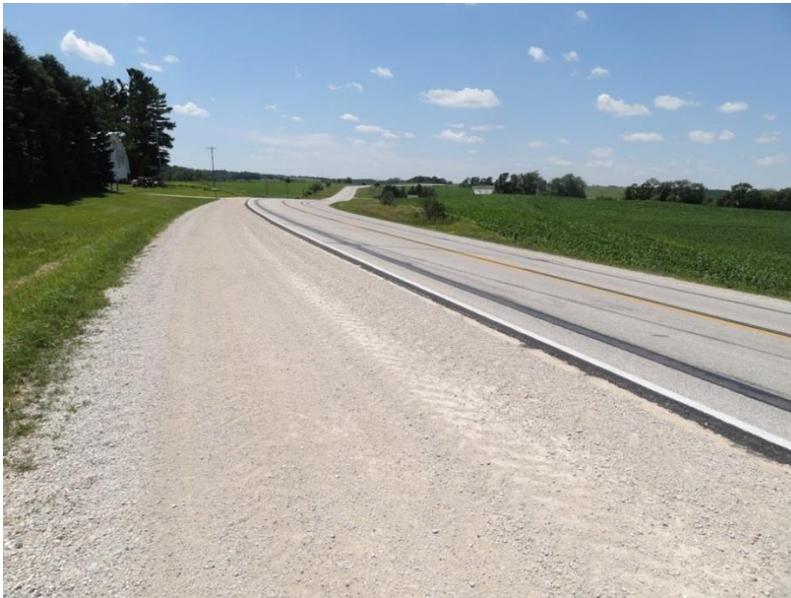
**Figure 29. Shoulder of US 18 on eastbound west of Clermont, Iowa**

Figure 28 shows one shoulder section of US 18 EB east of West Union. Although the shoulder had been regraded, the hard surface resulting from the soapstock could still be observed. Another example is shown in Figure 29. The shoulder was also along US 18, west of Clermont, where the whole section was regraded with new gravel.
