Longitudinal Joint Repair Best Practices for the Ohio Department of Transportation

Keeping Ohio's Pavement Joints Zipped Up

July 2017

Final Report

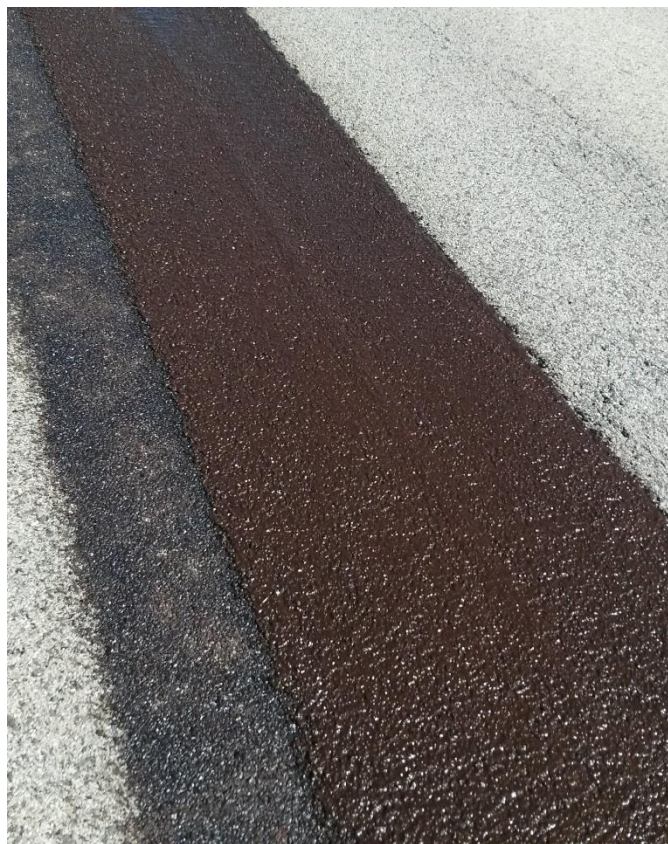
Micro surfacing has become an accepted repair technique for longitudinal joint repair in Illinois. As shown in figure 12, the micro surfacing is typically applied to the 18 inches centered on the joint. The repair technique requires removal of raised pavement markings and thermoplastic prior to application. If the joint has significant deterioration, a two-lift micro surfacing is used with the first layer of materials being applied only within the deteriorated joint, and the second layer extending 9 inches on each side. The treatment also requires re-installing striping and grooves for RPMs. The prices are typically higher for first projects, but the price is expected to fall as the required equipment is purchased by more contractors.

Figure 12. Micro surface seal applied over a LJ in Illinois (Illinois DOT).

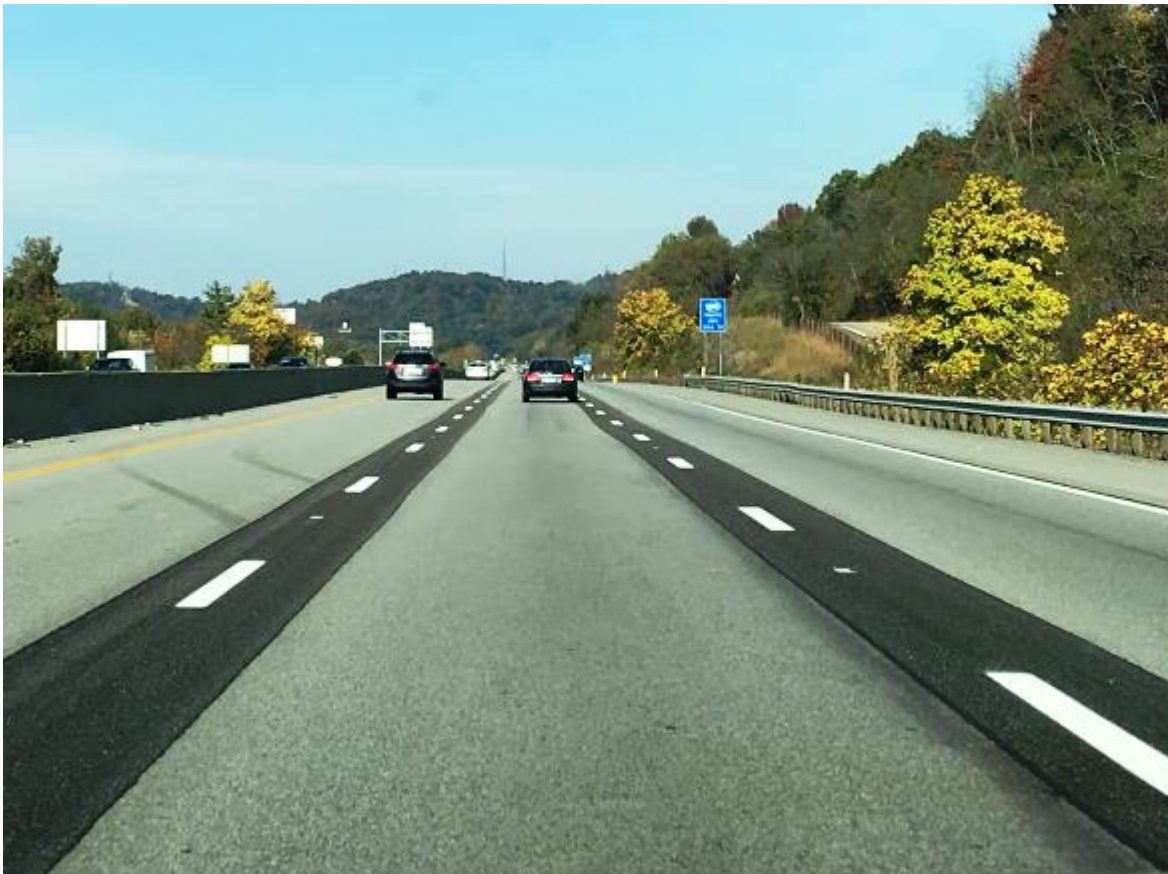
Like Illinois, West Virginia DOT has used micro surface as a preventive maintenance treatment for LJ distress. Travis Walbeck, WVDOT State Pavement Engineer, plans further use of the treatment after having completed two successful applications since 2015. In one section, the treatment was placed on medium severity cracks with secondary cracking and some of the cracks reflected through within a year. However, when the distress severity is low, the treatment has shown promise. Figure 14 illustrates the WVDOT use of the product 4 months after placement on I 64 near Dunbar.

Figure 14. Micro surfacing placed over two adjacent LJs on I 64 near Dunbar (WVDOT).

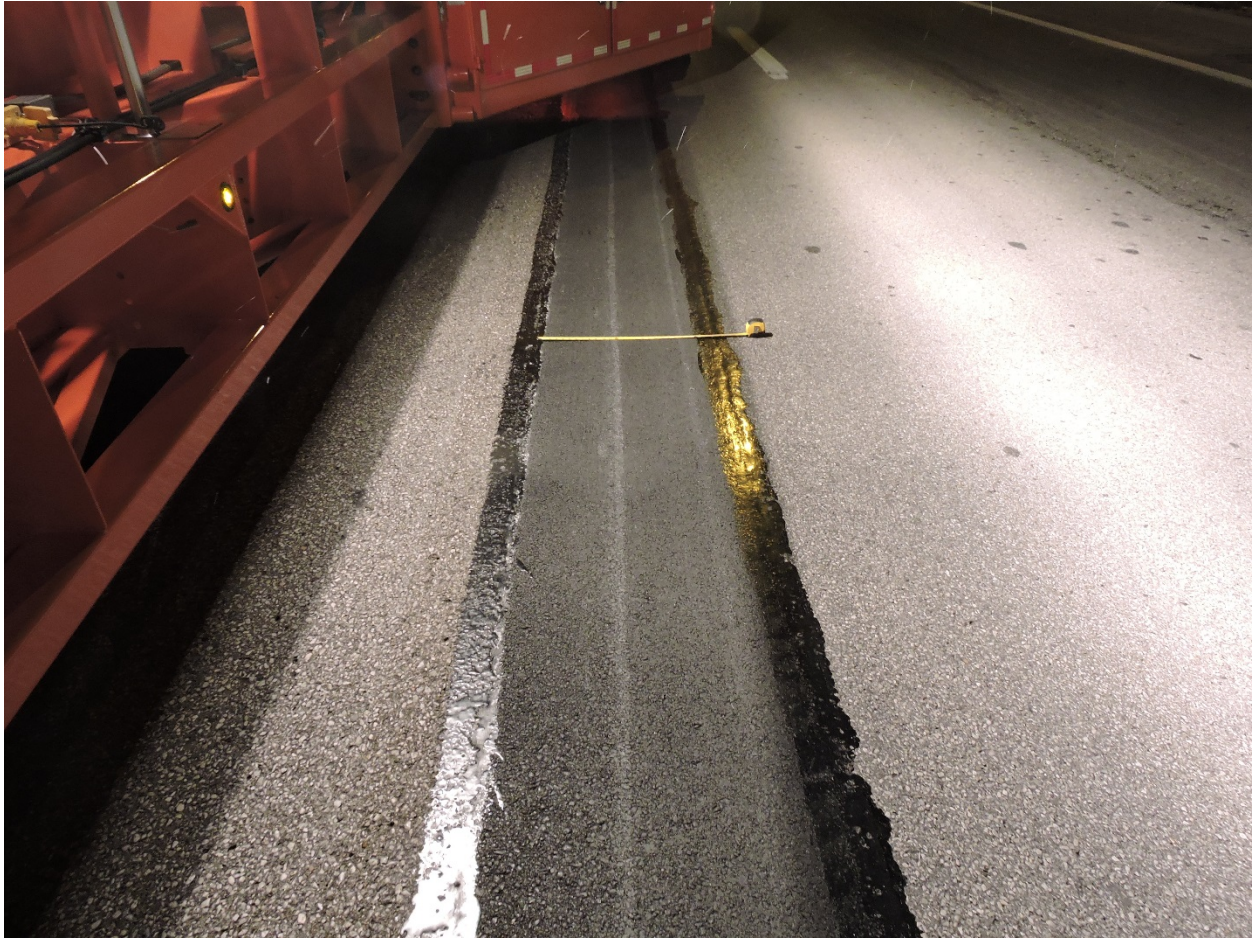
Figure 1-1. Typical section of the 2' slot paving.

This section consists of approx. 24" slot paving for the longitudinal joint within the middle lane for I-70 westbound (see Figure 1-1). The slot paving in this section lies within the wheel path of the middle travel lane. The repair is 4' from the nearest pavement markings. The condition of the repair asphalt remains in good condition with only minor surface wearing and no visible cracking. The AC bands were in good condition, however, very minor wearing of the AC band shows aggregate beginning to show through band (see Figure 1-2). There is only very minor secondary cracking near the repair joint. Secondary cracking is sporadic and only occurring in the original pavement. These cracks would be considered low severity per ODOT PCR Manual. Despite being in the wheel path, the repair overall is showing very little mounding or rutting and generally conforms to the sloping of the existing roadway. According to ODOT maintenance personnel, no compaction testing was done during placement of the asphalt.

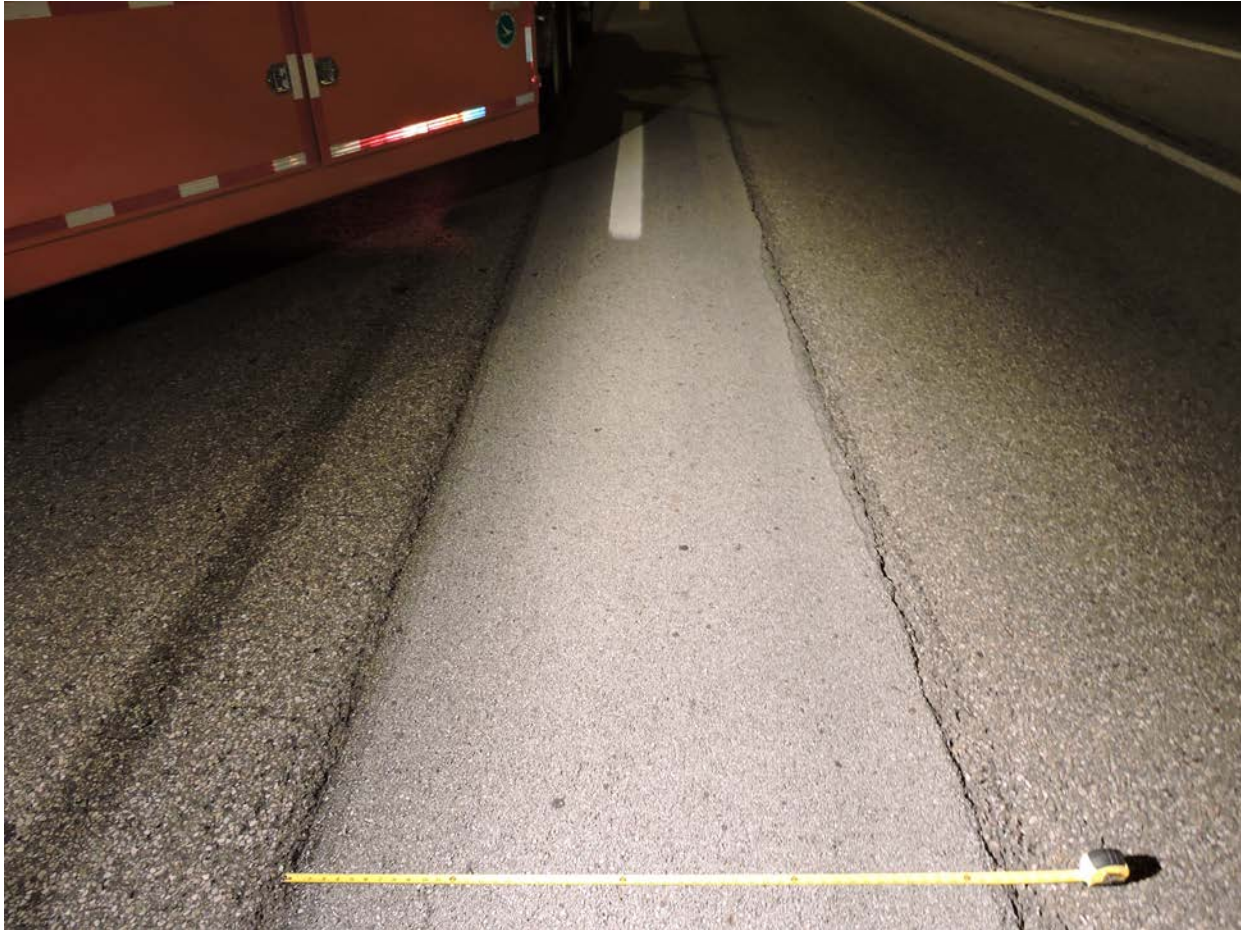
Figure 2-1. Typical section of the 4' slot paving.

This section consists of approx. 48" slot paving repair for longitudinal joints. The repair is centered on the pavement markings for both longitudinal joints within the traveling lanes (see Figure 2-1). The asphalt within the repair is consistently showing moderate wearing as aggregate is being to be exposed. Overall the asphalt in the repair area is showing minimal deterioration. The AC band has been nearly 100% removed. There is evidence that the band was in place at one time. Low- to medium-severity cracking (1/2" to 1") is occurring at the edge of the repair on both sides of the repair (see Figure 2-2). There are also low- to medium-severity secondary cracking (1/4") and deterioration on the original non-repaired asphalt (see Figure 2-3). There was no compaction testing performed onsite at time of placement according to ODOT maintenance personnel. The repair exhibited slight rutting at the edges of the repair. These areas are near the wheel path of the two adjacent traveling lanes.

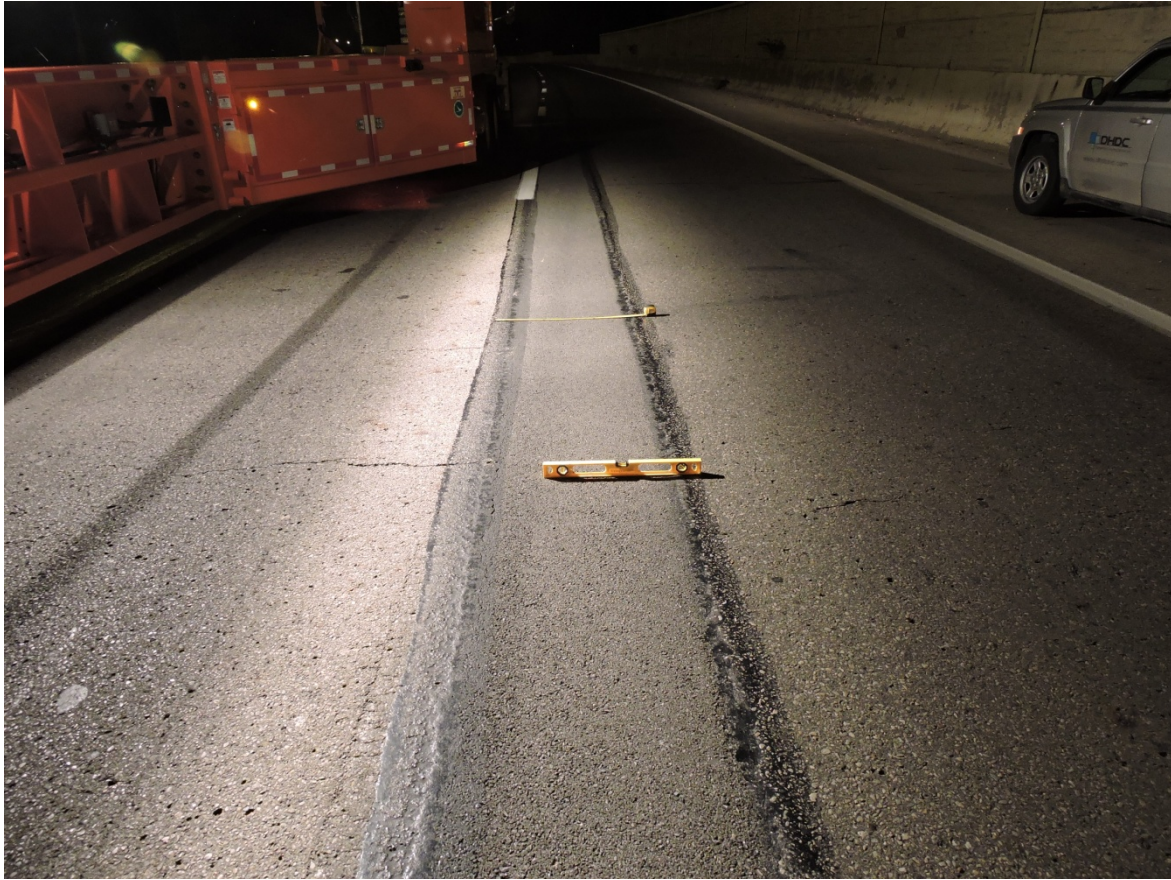
Figure 3-1. Typical section of the 3' slot paving.

This section consists of approx. 36" slot paving for both longitudinal joints within the 3 travel lanes for the Collector/Distributor Road from I270 south to Easton Way. The slot paving for the inside lane had one edge aligning with the pavement markings with the other edge extending into the wheel path of the inside lane (see Figure 3-1). The condition of the asphalt remains in good condition with only minor surface wearing and no visible cracking. The AC bands were in fair condition, though still present, aggregate is beginning to show as the band wears, more particularly on the edge within the wheel path (see Figure 3-2). The edge within the wheel path is showing minor cracking in periodic locations. However, the edge within the pavement markings generally has continuous cracking forming through the AC band to the surface (see Figure 3-3). These cracks would be considered low severity per ODOT PCR Manual. The repair overall is showing very little mounding or rutting and generally conforms to the sloping of the existing roadway. According to ODOT maintenance personnel no compaction testing was done during placement of the asphalt.

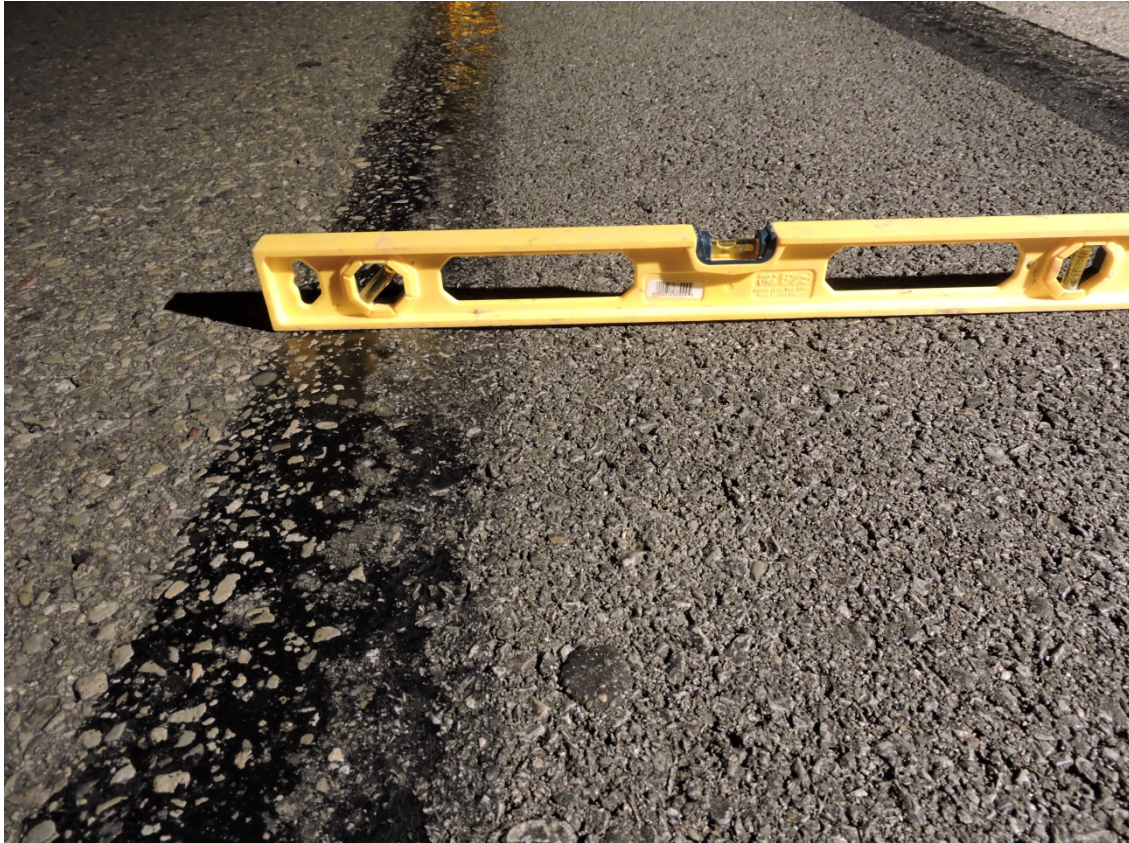
Figure 3-2. Typical AC band within wheel path (band on left within wheel path).

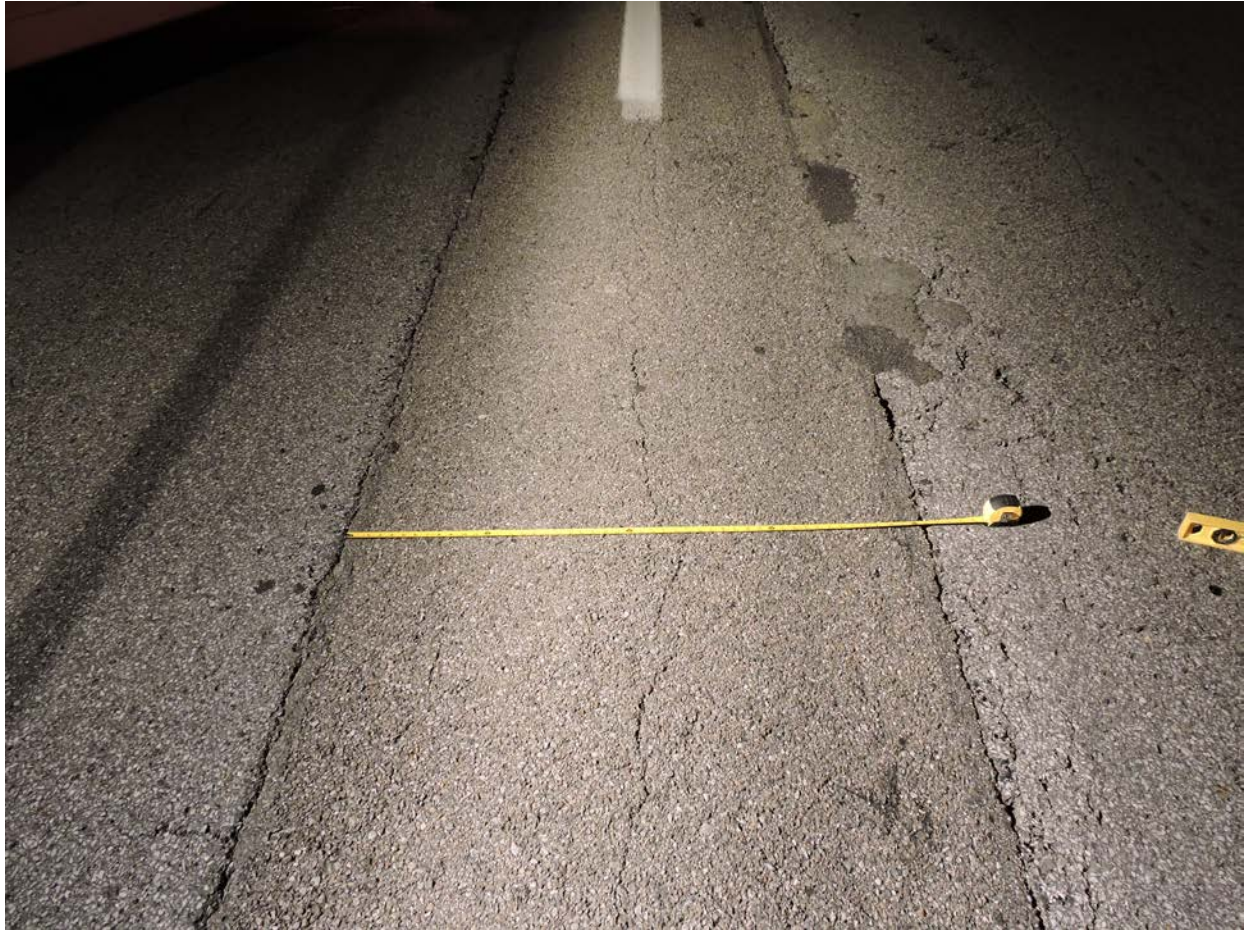
This section consists of approx. 48" slot paving repair for longitudinal joints. The repair is centered on the pavement markings for both longitudinal joints within the traveling lanes (see Figure 4-1). The asphalt within the repair is consistently showing moderate wearing with approx. ¼" longitudinal cracking through the center of the repair, presumably where the original longitudinal joint existed (see Figure 4-2). The AC band has been nearly 100% removed. There is evidence that the band was in place at one time. Low- to medium-severity cracking (1/2" to 1") is occurring at the edge of the repair on both sides (see Figure 3-3). There are also low- to medium-severity secondary cracking (1/4" to 1/2") particularly to the north edge of the repair area within the original asphalt (see Figure 3-4). Some areas have separated significantly enough that the area required patching. There was no compaction testing performed onsite at time of placement according to ODOT maintenance personnel. The repair exhibited slight rutting at the edges of the repair. These areas are within the wheel path of the two adjacent traveling lanes.

Figure 4-1. Typical section of the 4' slot paving.

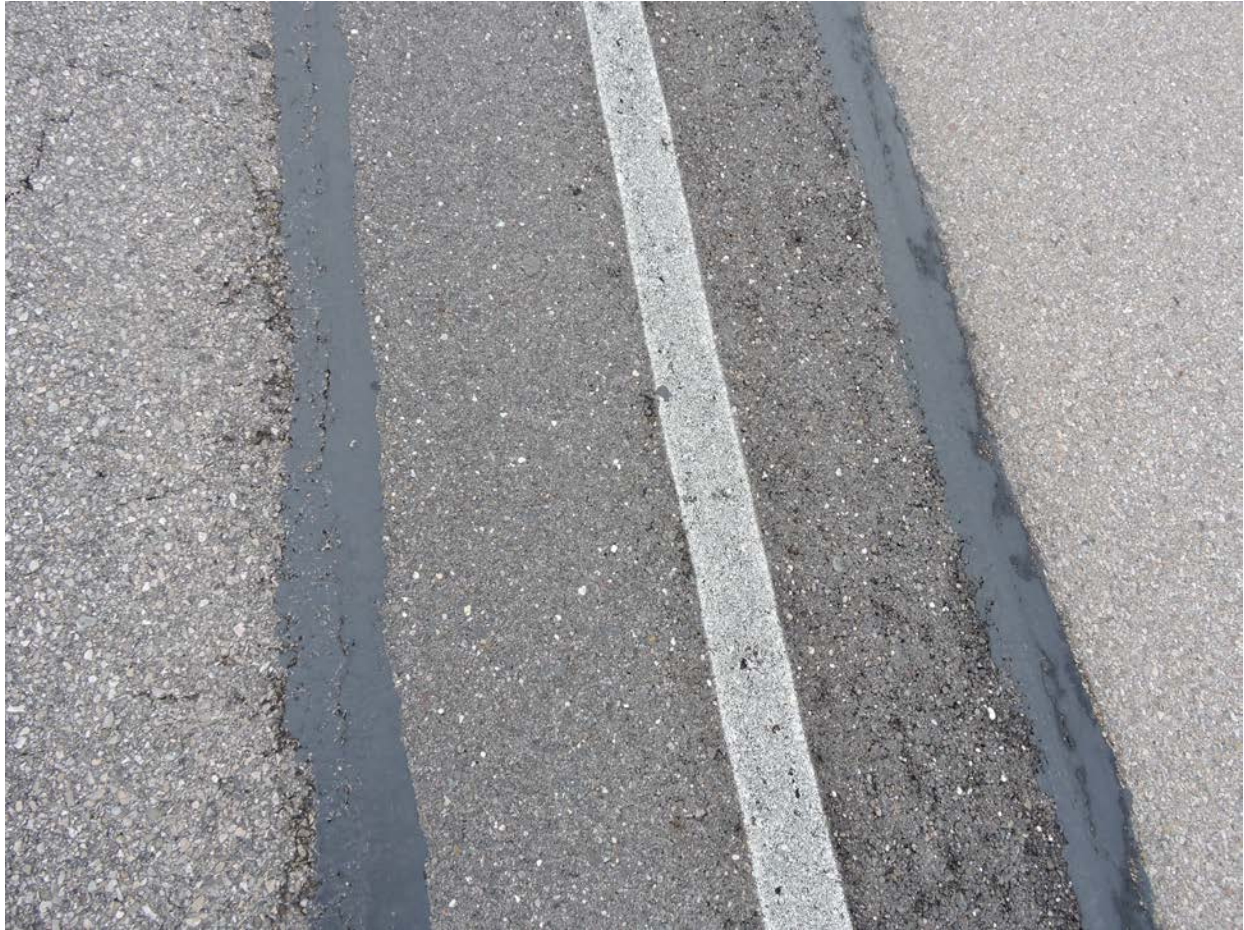
This section has longitudinal joint repair between the two travel lanes on I-77 in Guernsey County. The repair is 2 inch depth, 2 foot width, slot paving for the longitudinal joint between the two travel lanes (see Figure 5-1). Overall the asphalt within the repair area remains in tack however in some areas the original joint is beginning to form on the repair area itself. These areas were evident from rain event the previous day as they remain saturated as the majority of the remaining pavement has dried. The AC band remains intact in appropriate condition; however the joint between the original pavement and the repair area is beginning to show through as the AC band begins to separate slightly (see Figure 5-2). Secondary cracking is beginning to form, more so on the inside travel lane. The cracking is running perpendicular to the repair area, and is roughly 1/4" in width. Generally speaking, the repair area is flush with the existing pavement area; however, there are sections that exhibit slight mounding up to 1/4" over a two foot area.

Figure 5-2. Typical slot pave section inside lane to the left.

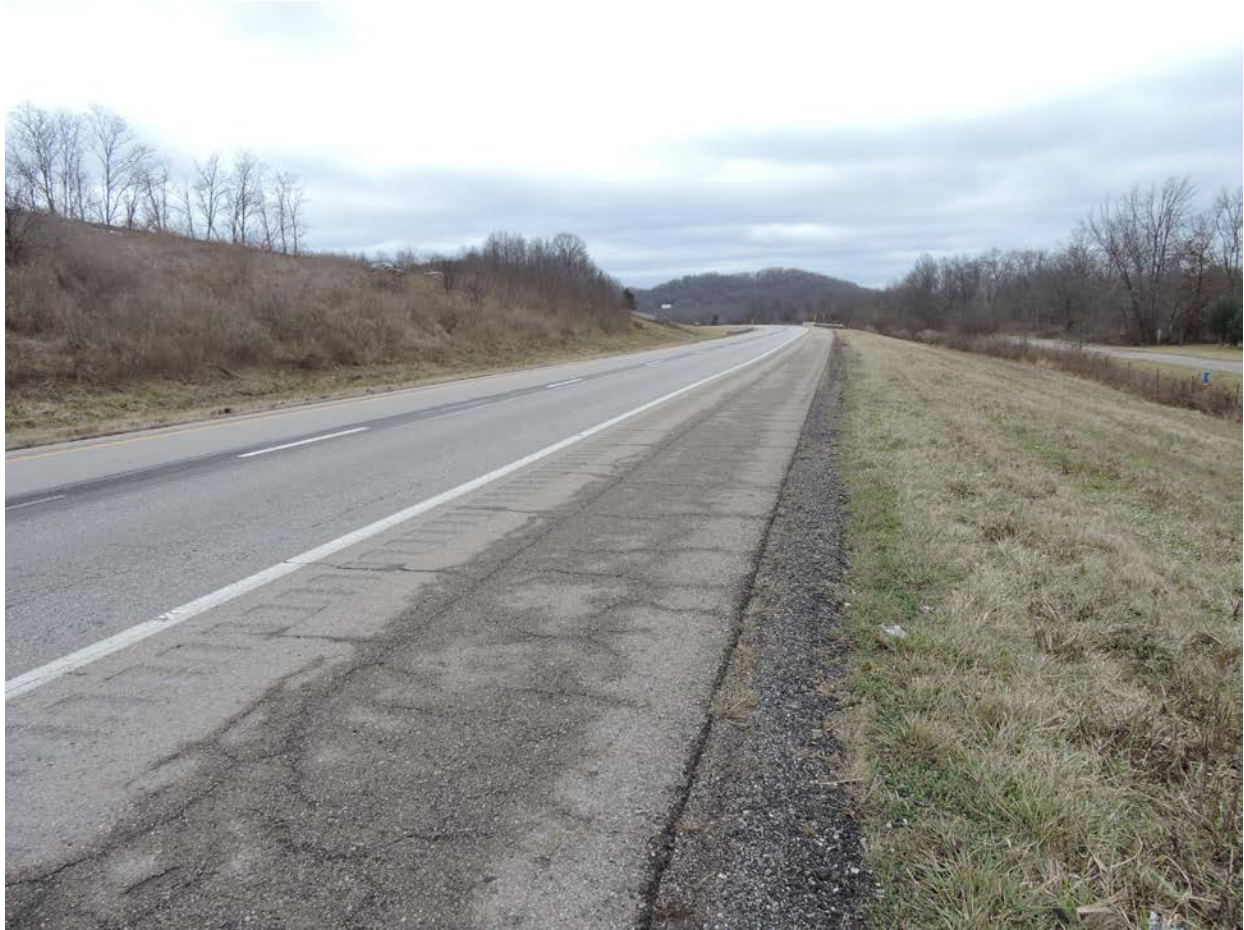
Figure 5-3. Section of 2' slot paving.

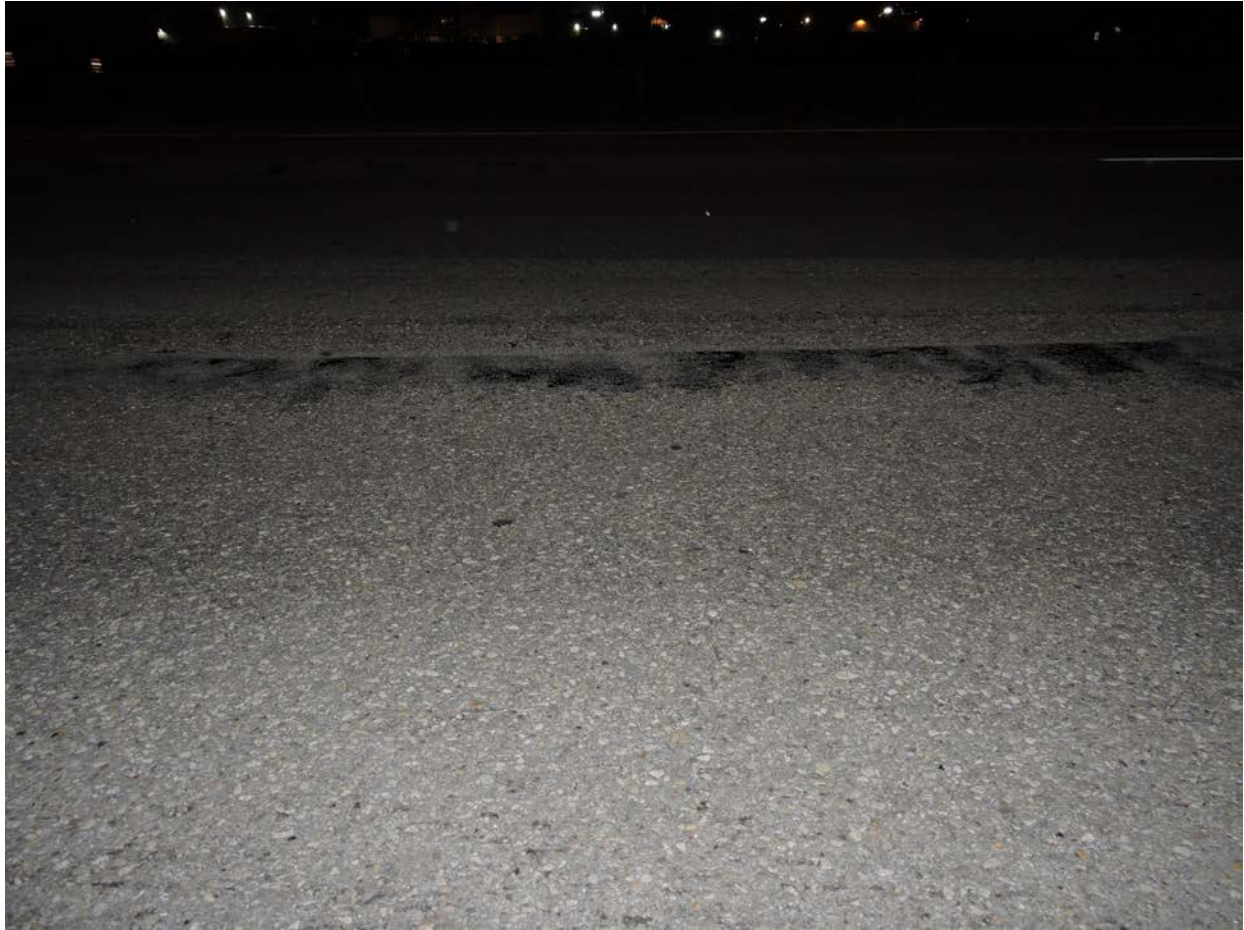
This section consists of approx. 8”to 12” spray patching of longitudinal joint within the pavement markings for I-270. The patching was done outside of the wheel path but within the pavement markings of the travel lanes (see Figure 6-1). The patched area was between lanes 2 and 3. The longitudinal joint between lanes 1 and 2 was patch with asphalt (see Figure 6-3). The condition of the repair patch remains in good condition, with the patch showing little to no distress (see Figure 6-2). The repair area did not show areas that exhibited secondary cracking within the non repaired pavement. This was consistent throughout the patching areas. The patching material did consistently exhibit a slight mounding of the material throughout, roughly ¼” to ½” over the original pavement. This spray patch section was installed by ODOT personnel.

Figure 6-1. Typical section with spray patching.

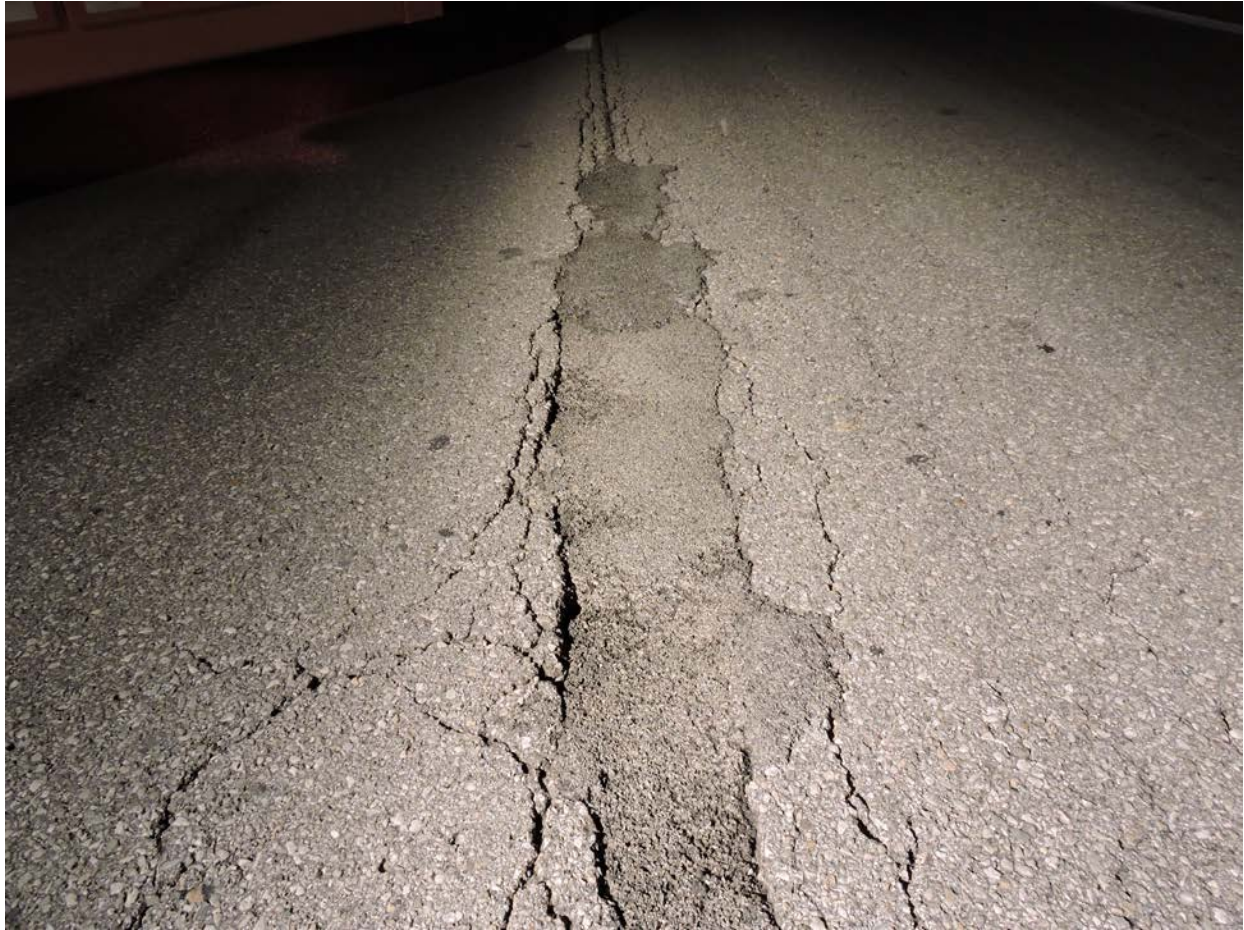
Figure 6-3. Longitudinal joint treated with asphalt patching.

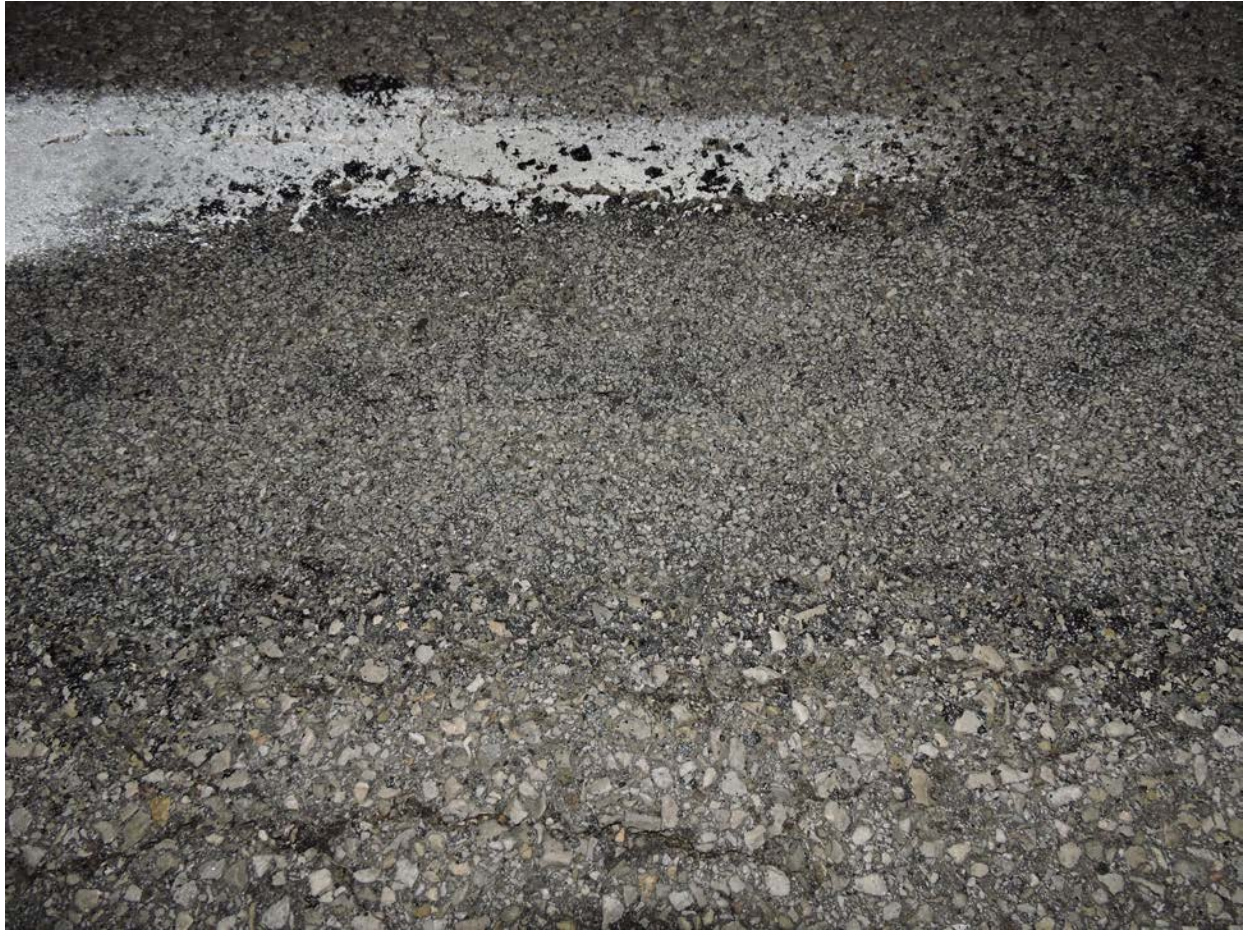
This section consists of approx. 8" spray patching of longitudinal joint within the pavement markings for I-270. The patching was done outside of the wheel path but within the pavement markings of the travel lanes (see Figure 7-1). The condition of the repair patch remains in good condition, however, the patch is beginning to show signs of distress with possible separation forming within the patching material itself (see Figure 7-2). The repair area did show areas that exhibited secondary cracking within the non repaired pavement. These cracks would be considered low severity per ODOT PCR Manual. The secondary cracking was not consistent throughout the patching areas. An estimate of 30% to 40% linear feet of patching exhibited the secondary cracking (see Figure 7-3). The patching material did consistently exhibit a mounding of the material throughout, roughly 1/2" to 3/4" over the original pavement. This spray patch section was installed by ODOT personnel.

Figure 7-1. Typical section with spray patching.

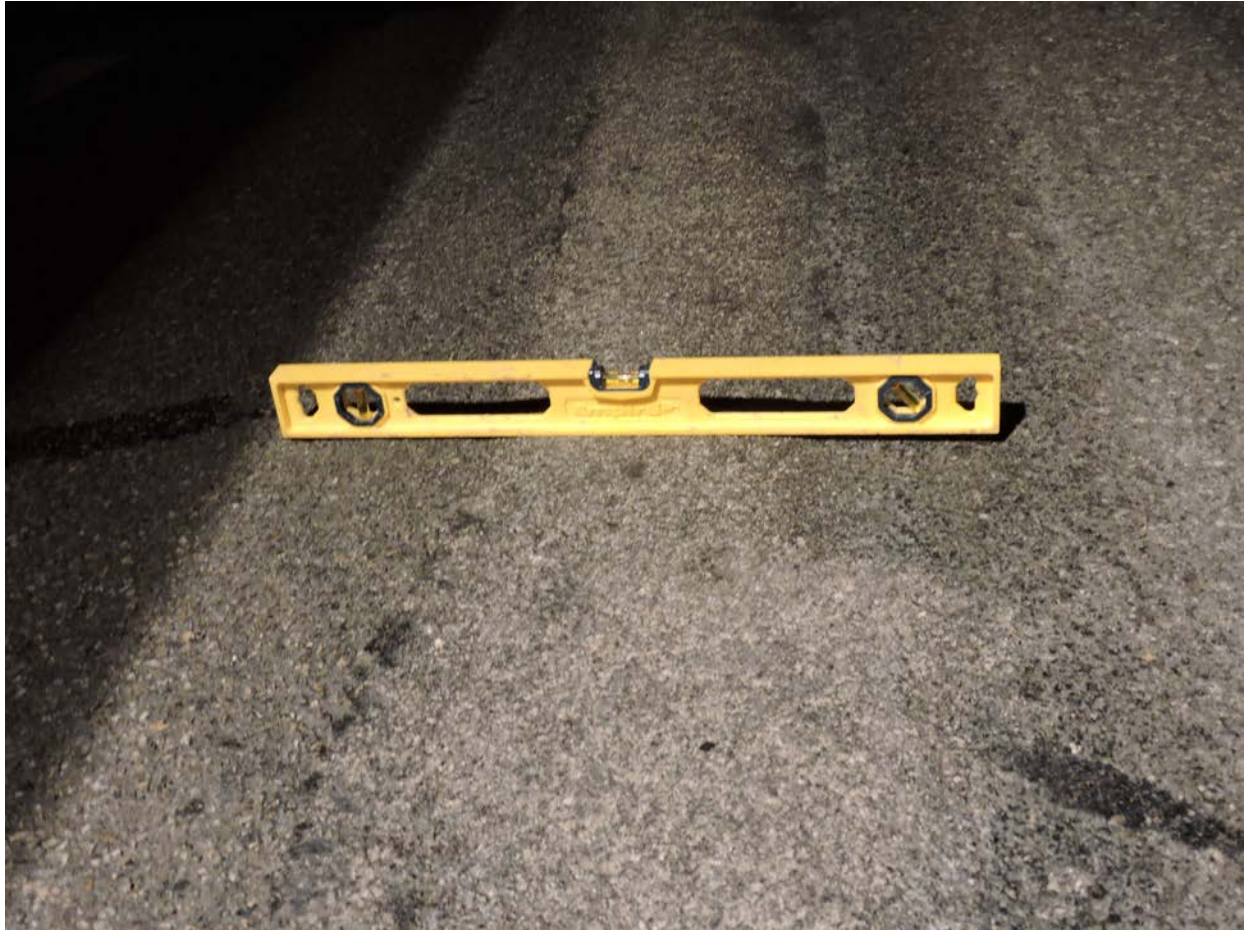
This section consists of approx. 12" to 18" wide with extremes 24" wide of spray patching of longitudinal joint within the pavement markings for I-270. The patching was done outside of the wheel path but within the pavement markings of the travel lanes (see Figure 8-1). The condition of the repair patch remains in good condition, exhibiting very minimal distress in infrequent areas (see Figure 8-2). The repair area generally did not show signs of secondary cracking. There is some cracking running perpendicular into the repair, however this cracking pattern is not limited to occurring in just the repair area, they exist in areas where spray patching was not done as well (see Figure 8-3). These cracks would be considered low severity per ODOT PCR Manual. The patching material did consistently exhibit a mounding of the material throughout, roughly 1/2" to 3/4" with an extreme of 1" over the original pavement (see Figure 8-4). This spray patch section was installed by Premier Patching, Inc., which was a subcontractor to Igel Construction.

Figure 8-1. Typical section with spray patching.

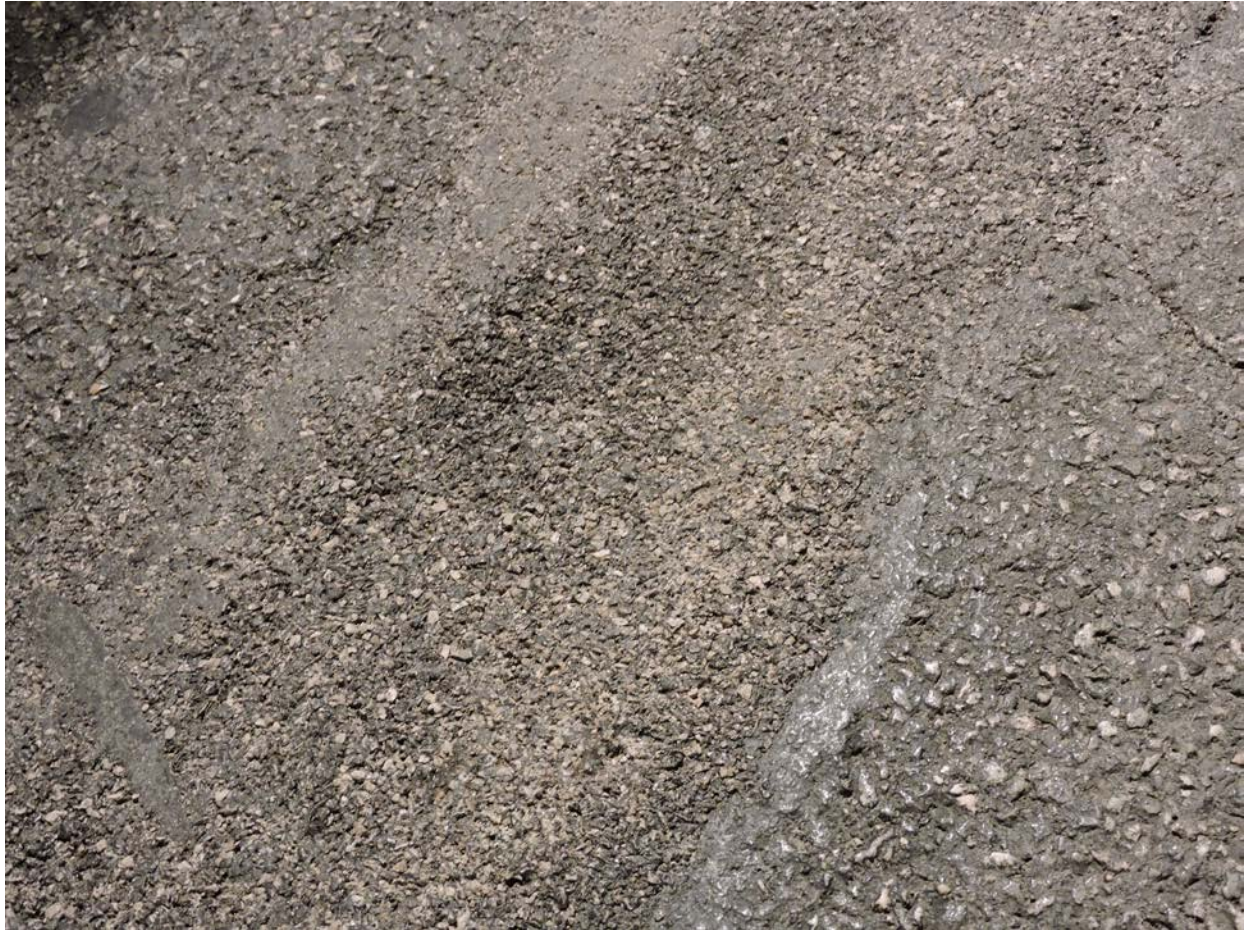
Figure 8-2. Typical spray patch condition.

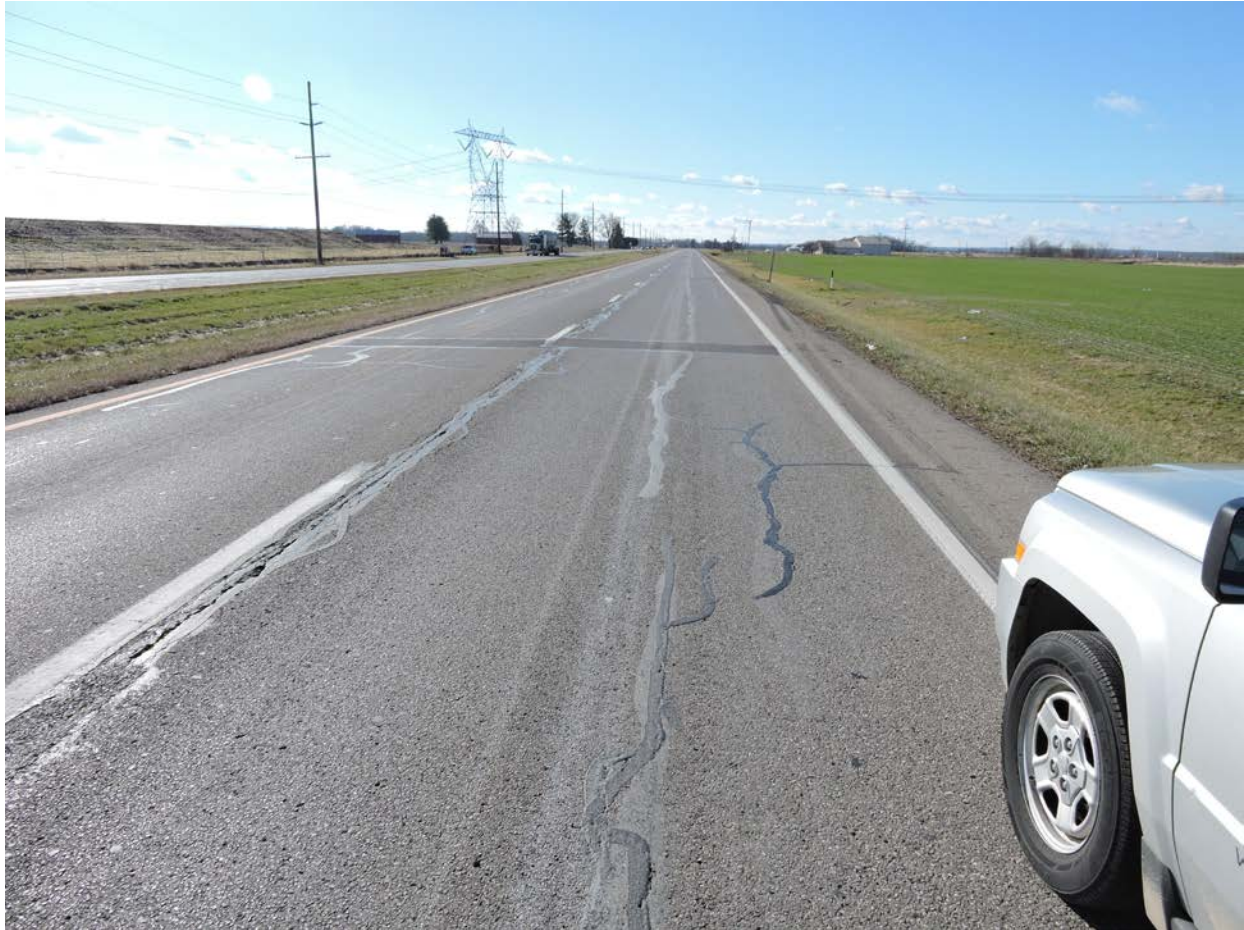
This section consists of approx. 8" wide spray patching of longitudinal joint within the pavement markings for US 23. The patching was done outside of the wheel path but within the pavement markings of the travel lanes (see Figure 9-1). The area has also been heavily crack sealed. The spray patch is currently in poor condition. The spray patch is breaking up in sections and exhibiting cracking within the patch itself (see Figure 9-3). There are areas that the spray patch has degraded a significant amount, some much so that little evidence of the patch remains. There are distinct signs of secondary cracking running parallel to the spray patch. Cracks can exceed ½" width in some sections. Many of these areas have been crack sealed. Generally speaking, the repair area is flush with the existing pavement however there are sections the exhibit slight "mounding" of the patch work. This spray patch section was installed by ODOT personnel.

Figure 9-1. Section of roadway with spray patch and misc. crack sealing.

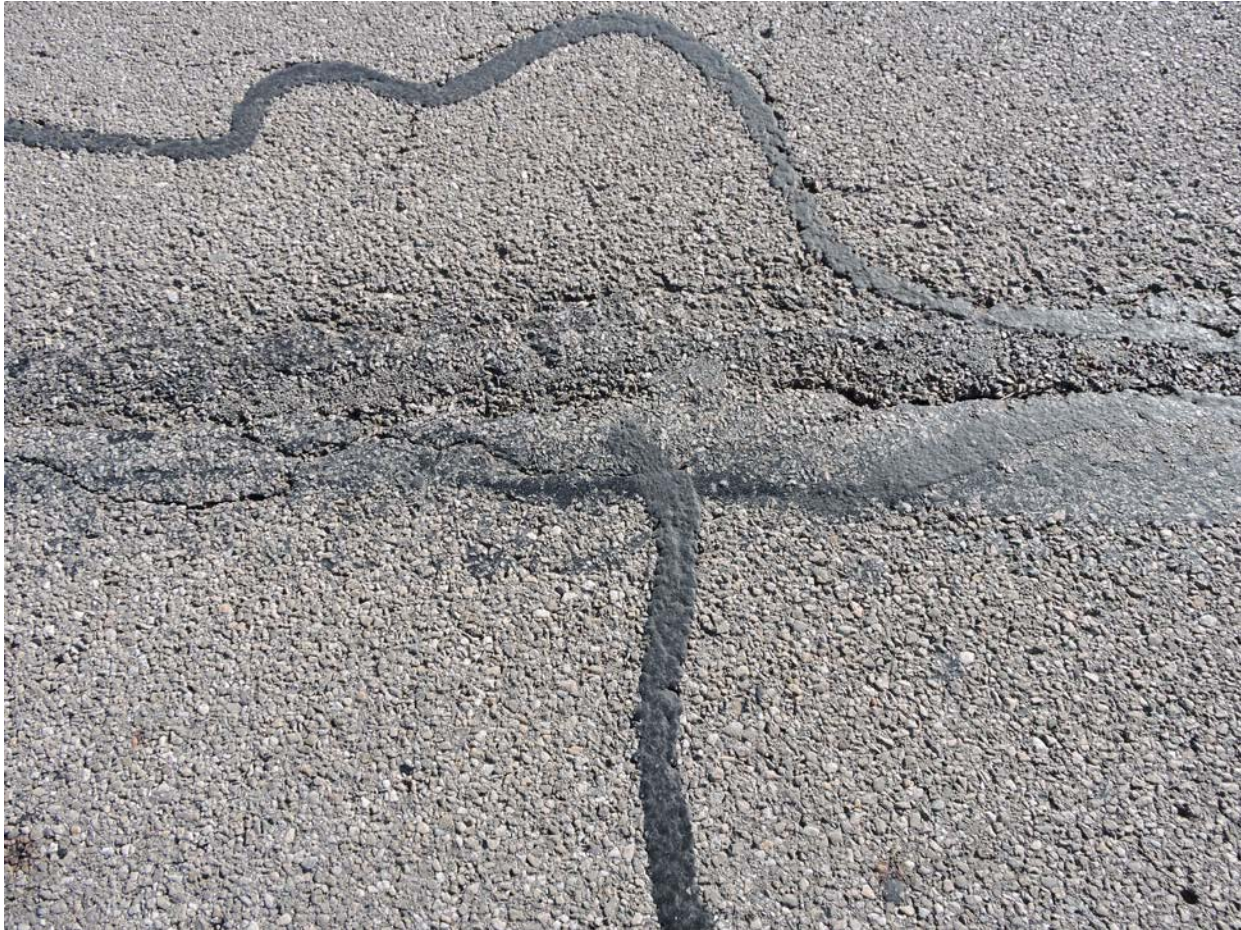
Figure 9-2. Typical spray patch condition.

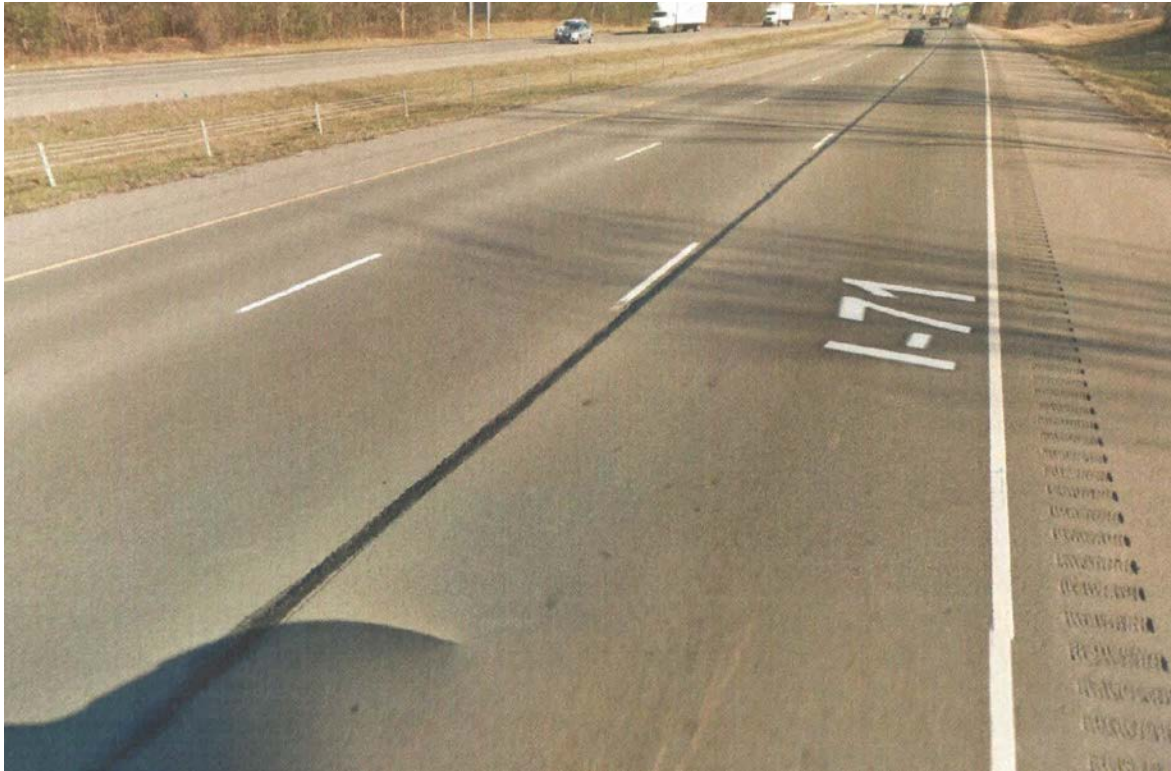
Figure 12-1. Typical crack sealing section.
