"CAPTIVE COLUMN" CRASH TESTS

March 1981
Final Report

1. Report No. FHWA/ RD-81/501		2. Government Accession No.		3. Recipient's Catalog No.	
4. Title and Subtitle "Captive Column" Crash Tests Crash Testing of a Light Standard Luminaire Pole.				5. Report Date March 1981

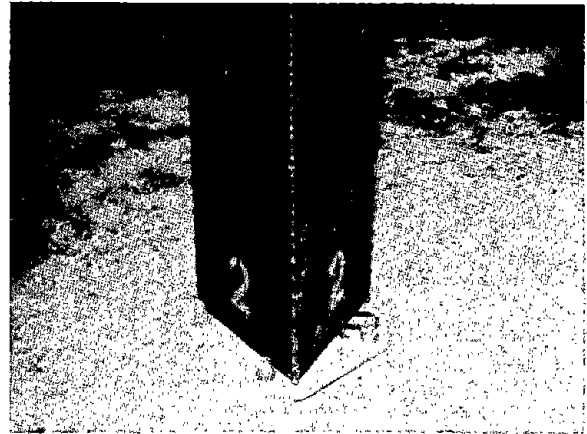
Figure 6. Fixed base attachment to "Captive Column" light standard. This type attachment was used in test runs 2 and 4.

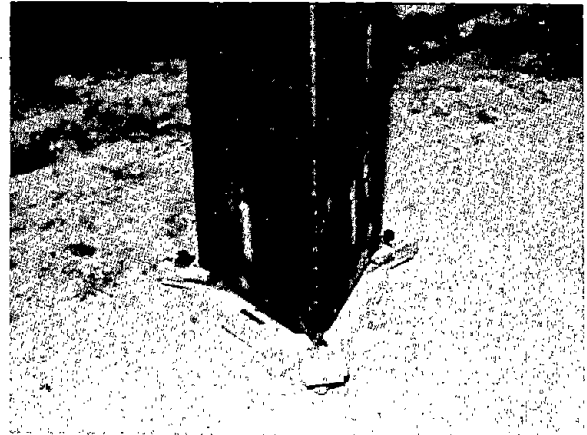
Figure 8. Slip base attached to "Captive Column" light standard. This type attachment was used in test runs 1 and 3.

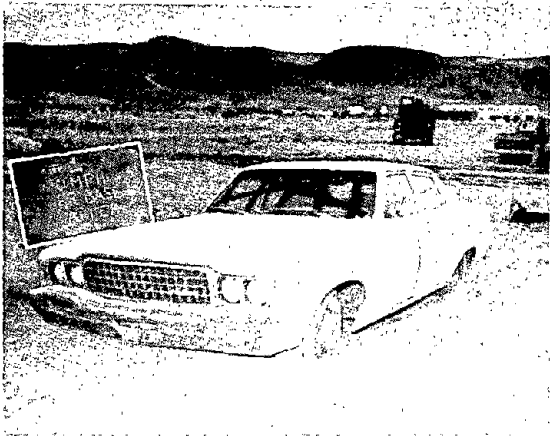
Figure 11. Test vehicle in braking area (sand pit) with fallen standard (right rear), which illustrates relative position to path of vehicle.

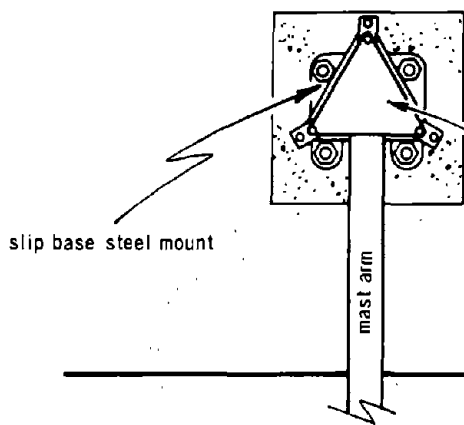
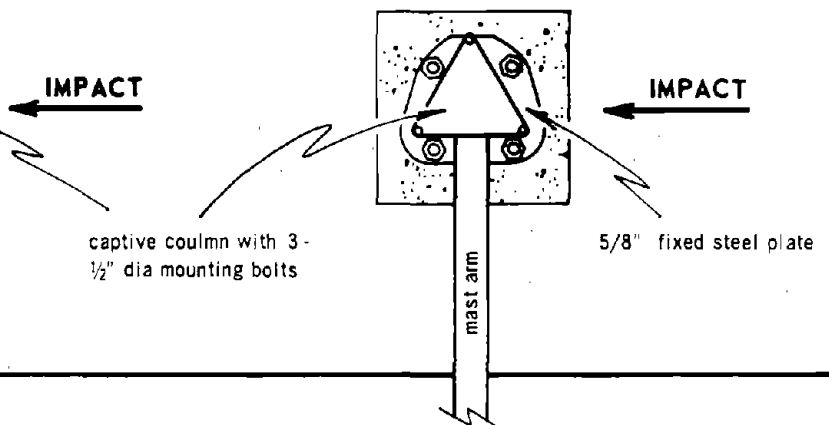
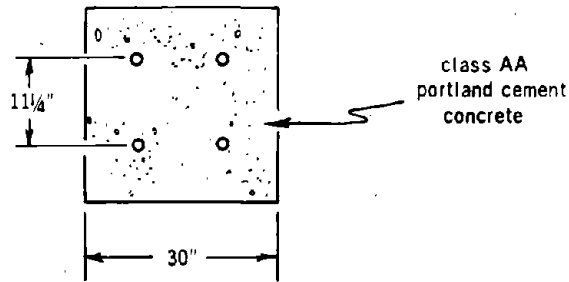
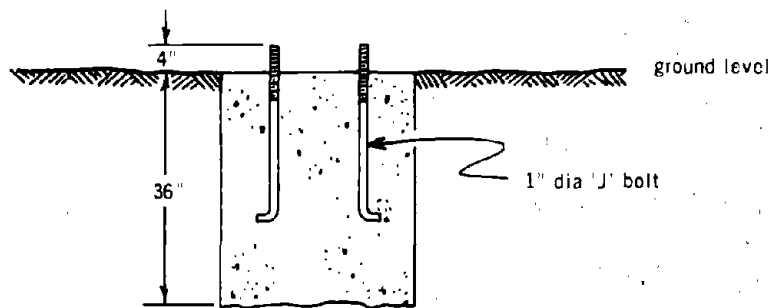
Figure 27. Test foundation and types of column base attachments.

SLIP BASE
(top view)
Test 1 & 3

All captive columns were impacted at same or similar angle.

FIXED BASE
(top view)
Test 2 & 4

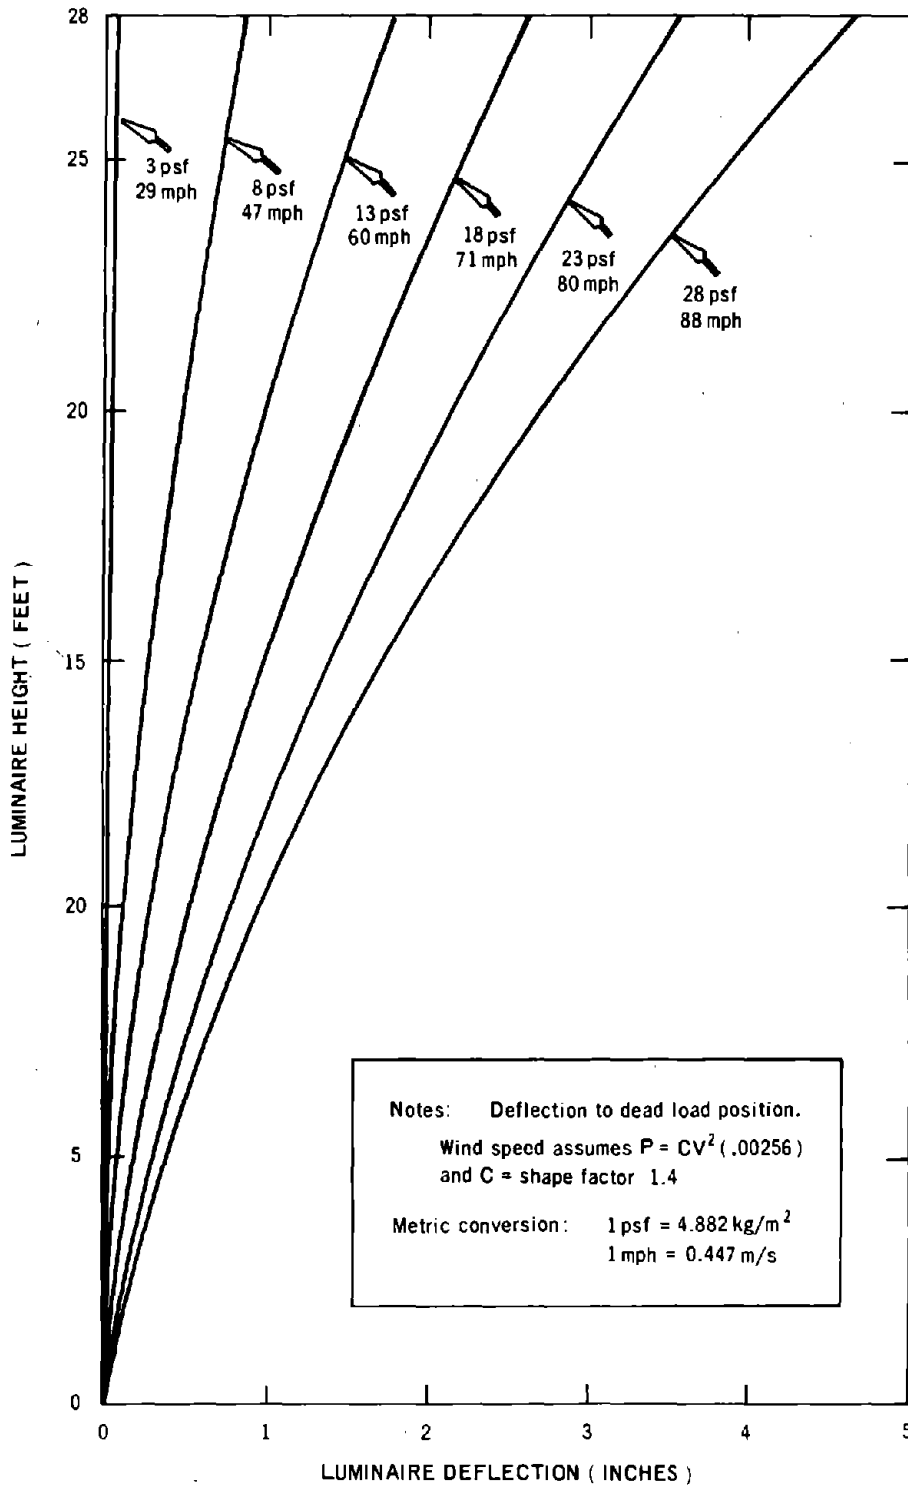
A series of curves showing pole deflection (beyond dead load) vs. pole height are given in Figure 34 for a range of simulated wind velocities. Maximum tip deflection was less than 5 inches

(12.5 cm) for uniform loading simulating 88 mph (39.34 m/s). Even at these wind pressures, the maximum stresses in the main chord elements are less than 50 percent of their yield strength.

Figure 34. Pole deflection vs height for various uniform loads.
 (task order No. 5, light standards)
