Texas Tech University Multidisciplinary Research in Transportation

# **Research on Joint Sealant Materials to Improve Installation and Performance: Final Report**

Research Project 0-6826 Research Report 0-6826-1 http://www.techmrt.ttu.edu/reports.php

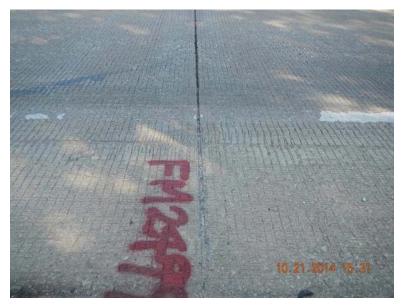
Figure 2.3 Low level of stone intrusion

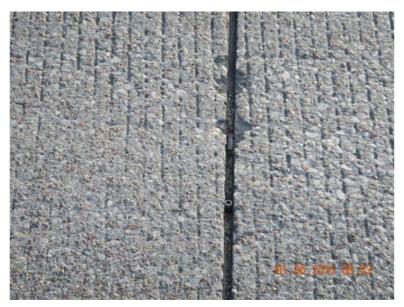
Figure 2.4 Medium level of stone intrusion

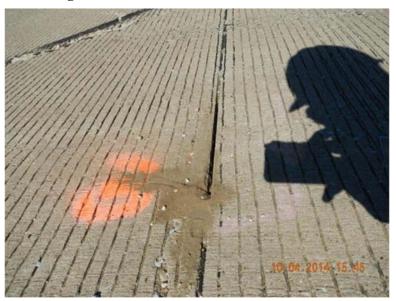
Figure 2.5 High level of stone intrusion

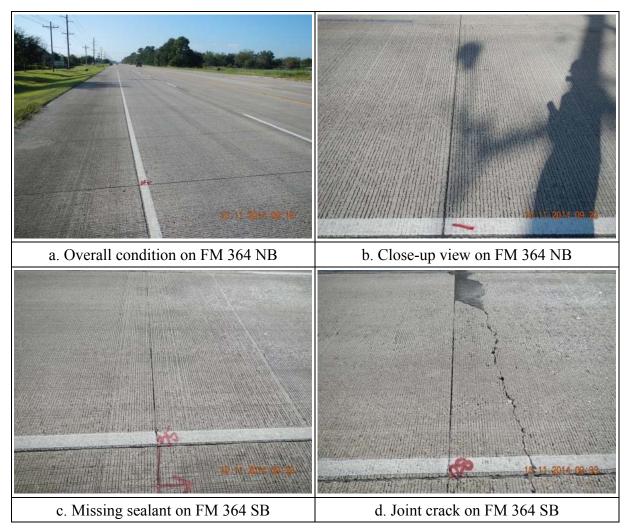
Figure 3.10 Sealant condition on FM 364-BMT [NO. 38]

FM 364 in the Beaumont District was built in 1996 with a 10-in CPCD. The section was surveyed on 11 October, 2014. Figure 3.9 illustrates the typical section from the planset. Even though it can be postulated that the joints in both northbound and southbound lanes must have been installed by the same contractor using the same type of sealant, a significant difference exists in the performance of joints between north and southbound lanes as shown in Figure 3.10. Joint sealant condition on northbound lanes was good as shown in Figures 3.10(a) and (b). On the other hand, as can be seen in Figures 3.10(c) and (d), the condition on southbound lanes was relatively poor. At this point, the cause(s) for this difference in joint sealant condition between northbound and southbound lanes is not known. Figure 3.10(d) illustrates that once the joint movements occur due to faulting or transverse cracks near the joint, sealant adhesion failure could occur, resulting in missing sealant. In other words, it appears that sealant missing is the

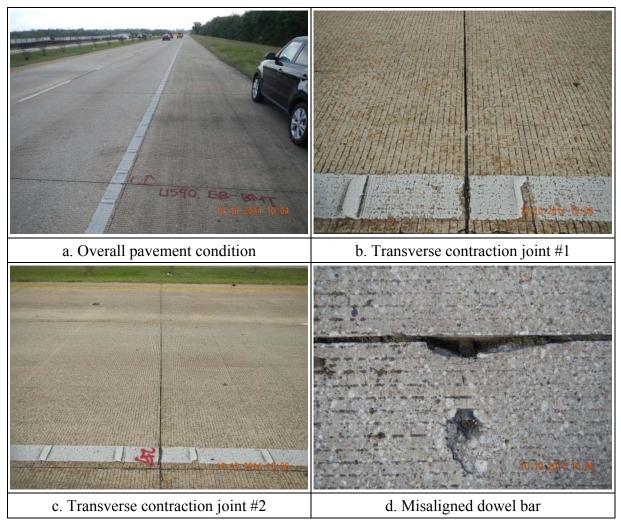
Figure 3.12 Sealant condition on US 90 EB-BMT [NO. 32]

US 90 EB was built in 2000 with a 10-in CPCD. The overall pavement condition including joint condition was very good except for a few missing sealants within the surveyed section. Figure 3.12(a) shows the overall pavement condition. Figures 3.12(b) and (c) show the condition of a typical transverse contraction joint. The misaligned dowel bar was observed as shown in Figure 3.12(d). However, there were no structural distresses observed in the span of 14 years in this area, which implies that one or two misaligned dowel bars may not affect the transverse contraction joint performance in CPCD.

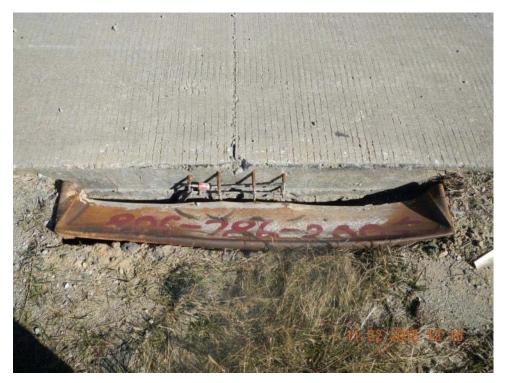
However, the gage protection boxes were destroyed during the full depth repair (FDR) for adjacent CPCD slabs as shown in Figure 4.12. The gage analysis results showed that the protection boxes were broken on April 16, 2015, and data obtained since that point were not reasonable.

Figure 4.12 Destroyed gages during the FDR on SH 288

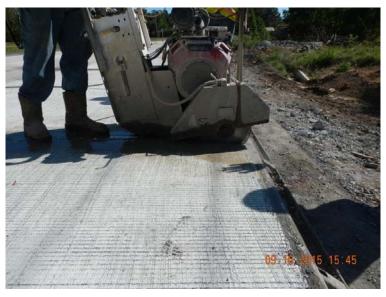
Figure 4.19 shows joint condition after one day of concrete placement, which was September 11, 2015. It shows quite shallow saw cut depth at the edge of the slab. The cut is shallow because the concrete was placed with forms, and the saw cut operation was stopped a few inches away from the form. However, the saw cut depth was adequate through the joint except at the edge of pavement as shown in Figure 4.20. Figure 4.19 shows a crack already developed at the bottom of the saw cut.

Figure 4.20 Sawcut at pavement edge

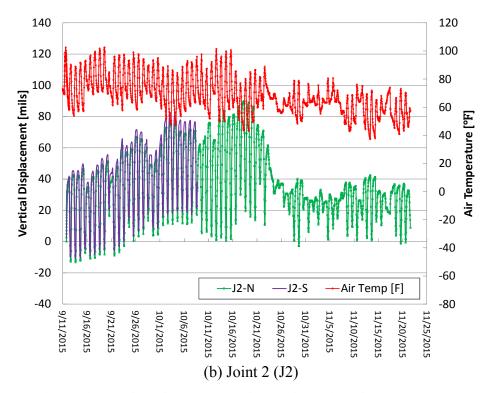
Figure 4.26 Joint displacement in vertical direction on FM 2253

Figure 4.26(a) and (b) illustrate the joint displacements in the vertical direction at Joint 1 and Joint 2, respectively. The joint displacement in the vertical direction increased up to 85 mils within the 42 days age for both Joint 1 and Joint 2, and decreased with temperature drop and swelling effect due to rain after the 42 days of concrete placement, which was on October 23, 2015. Figure 4.27 shows the relative humidity (RH) variation with time. The graph clearly indicates that it was rainy on October 23, 2015, and the RH of air has maintained quite high until November 21, 2015.

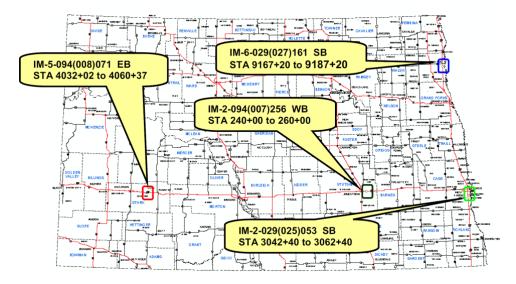
Figure 5.1 Seal/No Seal test location in North Dakota (Dunn et al. 2009)

The North Dakota Department of Transportation (NDDOT) evaluated the practice of unsealed joints in concrete pavements in 2009 (Dunn et al. 2009). The project included test sections (unsealed joints) and controlled sections (sealed joints) at four locations in North Dakota. The design at both test and controlled section was joint width of 1/8-in, saw cut depth of one-third of slab thickness of pavement. Most of the test sections were 2,000 ft long and the control section was 1,000 ft long. Over the 10-year performance, analysis showed a major distress in the form of spalling and corner cracks at joints in unsealed sections. Joints in shoulders were filled with incompressible materials, while joints in driving lanes were free of incompressible materials due to differential air pressure formed by the vacuum of traffic (Dunn et al. 2009).

Figure 5.1 shows the locations of test and control sections in the NDDOT. Based on the research findings, the NDDOT decided to seal joints and use a drainable base layer.

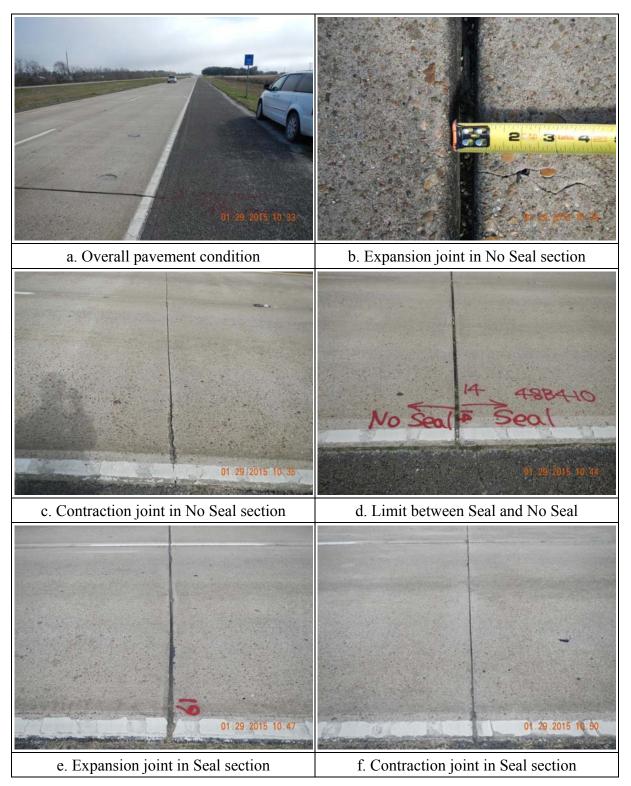
Figure 5.4 Joints conditions on US 90

Field performance survey was conducted on January 29, 2015. A total of 26 expansion joints were investigated; fourteen joints in the unsealed section and twelve joints in sealed section, as shown in Figure 5.4.

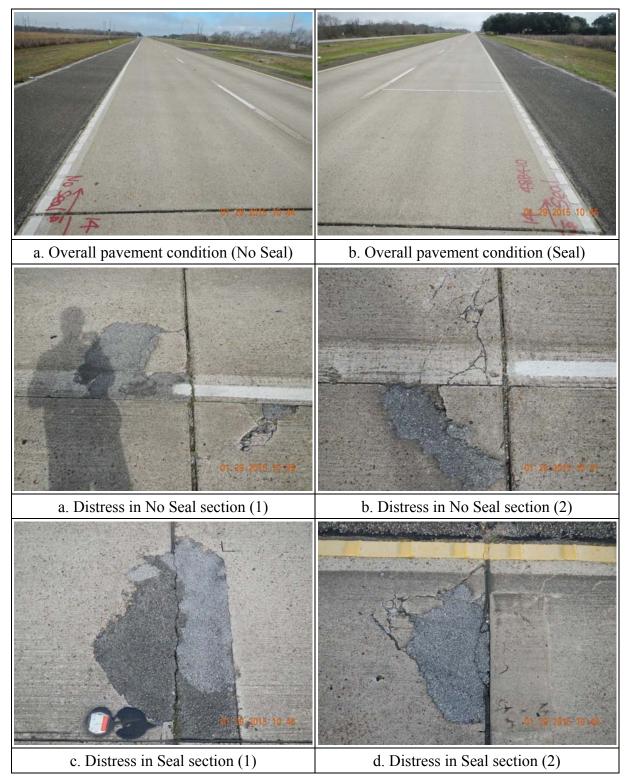
Figure 5.5 Distresses at Sealed and No Sealed sections

Figure 5.5(a) shows the overall pavement condition of both the sealed and unsealed sections. Figures 5.5(b) and (c) show the typical condition of expansion and contraction joints, respectively, in the unsealed section. Overall performance of unsealed joints has been excellent. Figure 5.5(d) shows the expansion joint between the unsealed and sealed sections. Figures 5.5(e) and (f) show the typical condition of expansion and contraction joints, respectively, in the sealed section.
