Construction Report 17-10 Underwater Fiber Reinforced Polymer (FRP) Wrap Experimental Project 1/30/18

Underwater FRP Wrap Experimental Project

Rices Bridge (#2715) over the York River

York, Maine

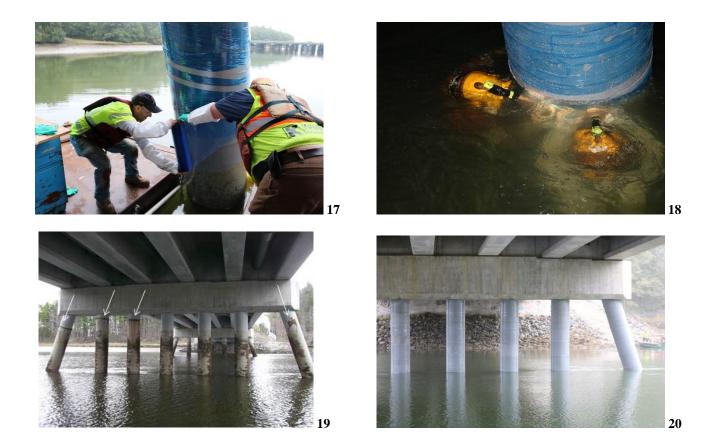
Once the preliminary research was completed, the project took 15 days to complete the 14 piles identified for repair (figures 19 & 20: before & after application). The curing times were significantly less than the 14 days due to the higher water and ambient temperatures. All those involved agreed that it was an easier installation when compared to traditional repair methods. There was less chance of environmental impacts from the process and the containment was easily installed although, the currents in the area did impact positioning of the containment at time. The project used the tides to their advantage as much as possible working up or down the piles with the tides. These advantages, in combination with the significant cost savings, has led MaineDOT to use this on other bridges throughout the State. All projects will be inspected on a regular basis to assess the viability of the FRP wrap as a long-term solution to the premature failure of the FBE coatings on bridge piles.
