NDOT Research Report

Report No: NV-RDT-10-001

# **NON-SACRIFICIAL, ANTI-GRAFFITI COATING 2009 EVALUATION**

**May 2010**

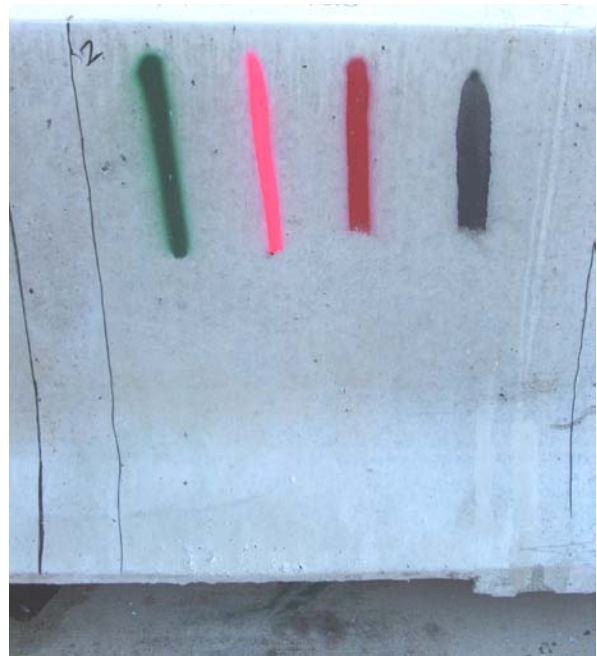
FIGURE 4.2B Removal – Unpainted Panel 2

The representative used several removal agents with unsatisfactory results and thereafter borrowed a removal agent from another vendor. There was a trace amount of paint residue as well as blistering (FIGURE 4.2B).

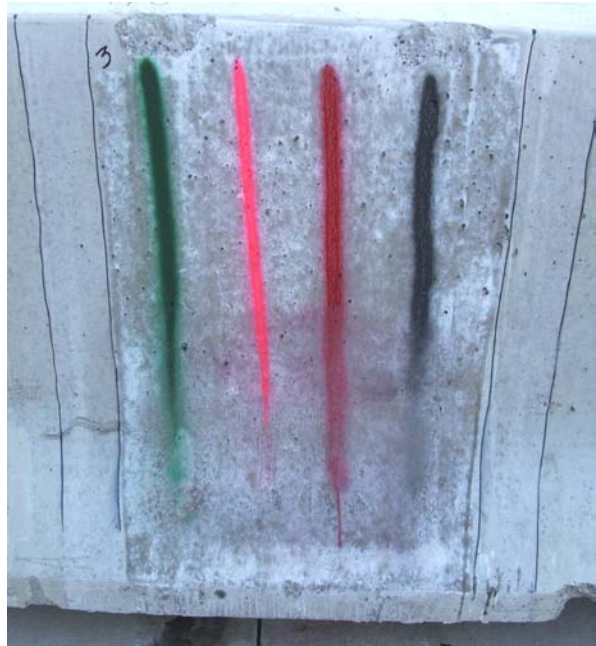
FIGURE 4.3B Removal – Unpainted Panel 3

There was appreciable paint residue and coating discoloration (FIGURE 4.3B).

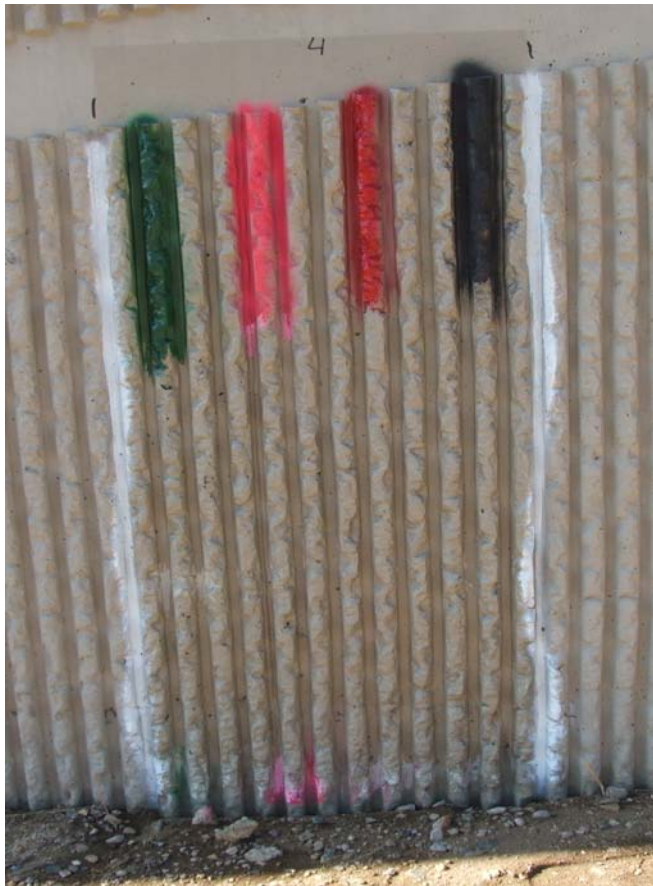
**FIGURE 4.4C Removal - Fractured Fin Facing Panel 4**

There was no reported paint residue. There was a small area where the coating was removed from the substrate. It was debatable as to whether the representative scrubbed the coating off during graffiti removal or if the area was skipped during the coating application (FIGURES 4.4C and 4.4D).

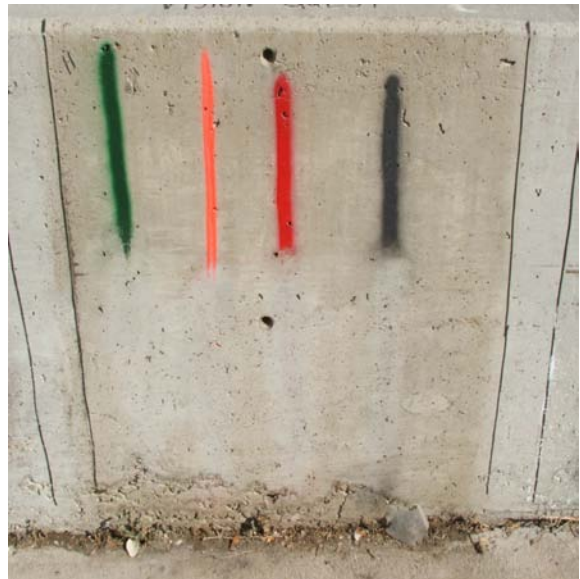
FIGURE 4.11B Removal – Unpainted Panel 11

The coating was removed from several areas and one evaluator mentioned that the remaining coating had discolored (FIGURE 4.11B).

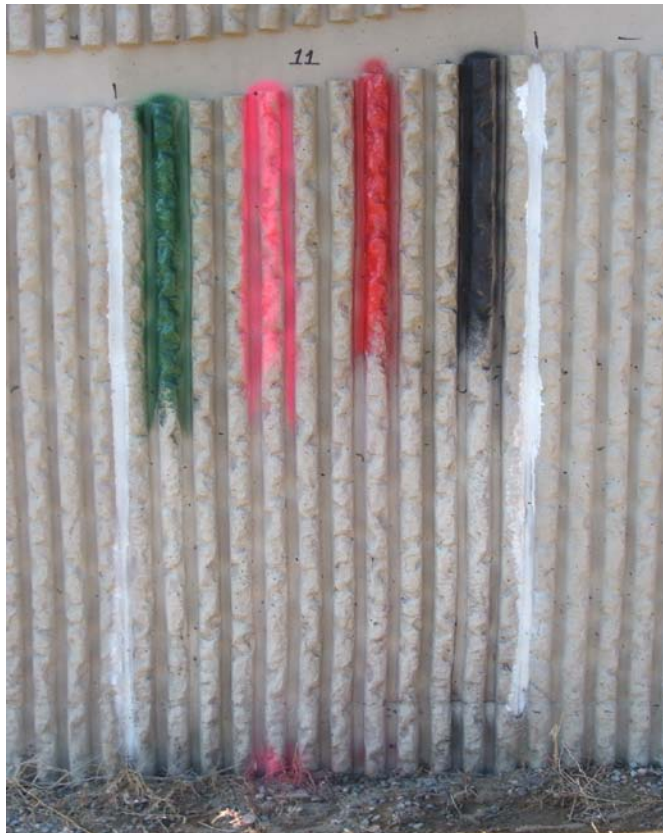
**FIGURE 4.11C Removal - Fractured Fin Facing Panel 11**

The coating system was completely removed from the substrate (FIGURES 4.11C and 4.11D).

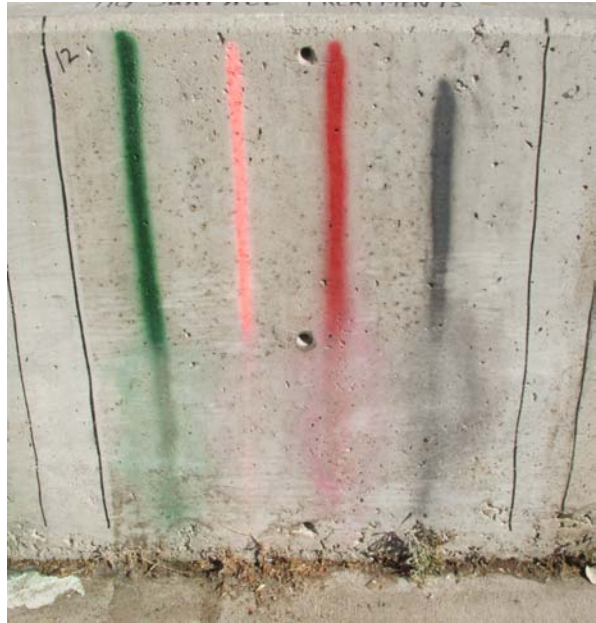
FIGURE 4.12B Removal – Unpainted Panel 12

Residue paint was appreciable for all colors. All evaluators mentioned that coating discoloration was apparent (FIGURE 4.12B).
