**Federal Railroad  
Administration**

## **Passenger/Freight Train Collision**

**September 12, 2008, Chatsworth, CA:**

### **Main Report**

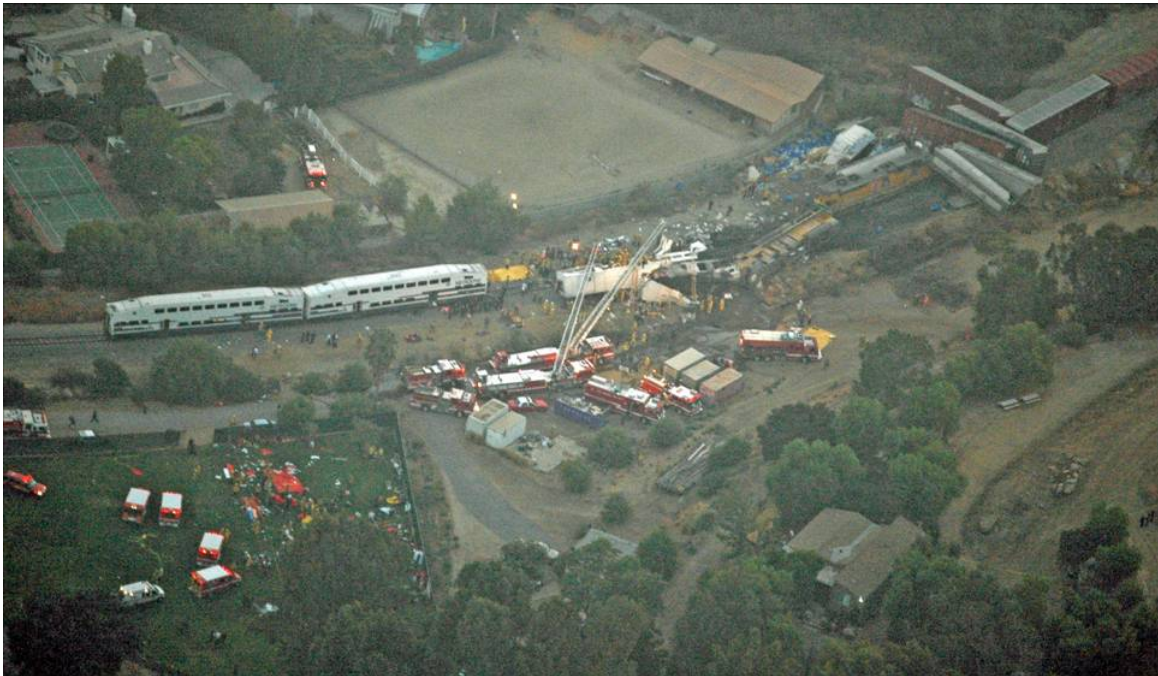
**Figure 2a. Aerial Photograph of Accident (From SCRR)**

Figure 2a is an aerial photograph provided by the Southern California Regional Rail Authority (SCRRA), the authority that governs Metrolink. The photo was taken shortly after the accident occurred. On the left side, the photograph shows the trailing two passenger cars, with little visible damage. In the center, the lead passenger car is shown, with substantial damage. The car is nearly on its side and much of the roof is peeled back. The fans and other roof-mounted equipment on the lead passenger locomotive can be seen adjacent to the sidewall of the lead passenger car. The lead freight locomotive is on its side, while the second freight locomotive is upright toward the upper right-hand side of the photograph. Seven trailing freight cars are stacked up sideways against the trailing end of the trailing freight locomotive. Behind the sideways freight equipment, three freight cars (two of which are visible in Figure 2a) are upright and derailed. The trailing seven freight cars, which are not visible in Figure 2a, remained upright and on the track.

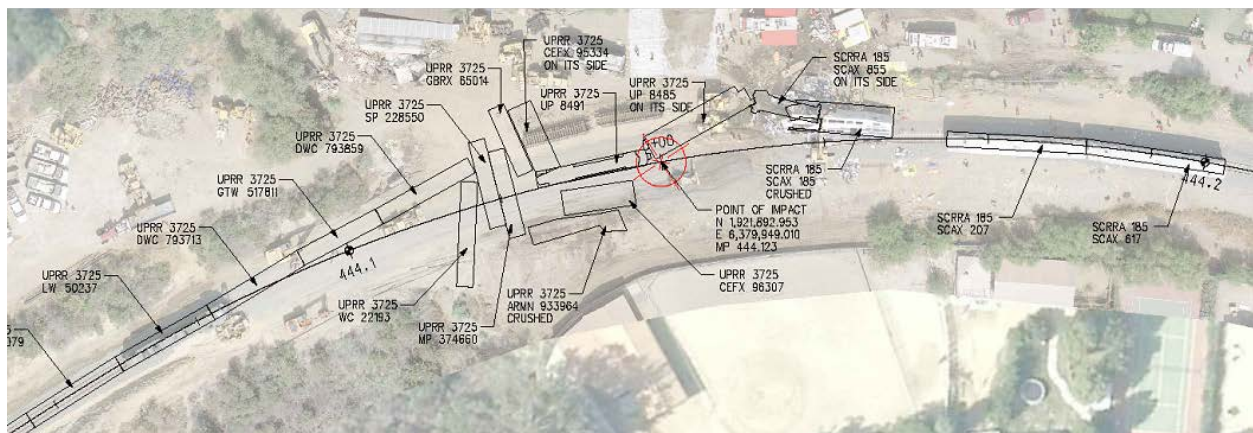
**Figure 2b. Aerial Photograph of Accident, with Equipment Locations (From SCRR)**

Figure 2b shows another aerial photograph, this time from a view looking nearly straight down at the accident. The photograph is annotated with survey locations and the equipment markings. The photograph shows a more complete sketch of the trailing freight equipment, the freight locomotive and at least 10 derailed freight cars.

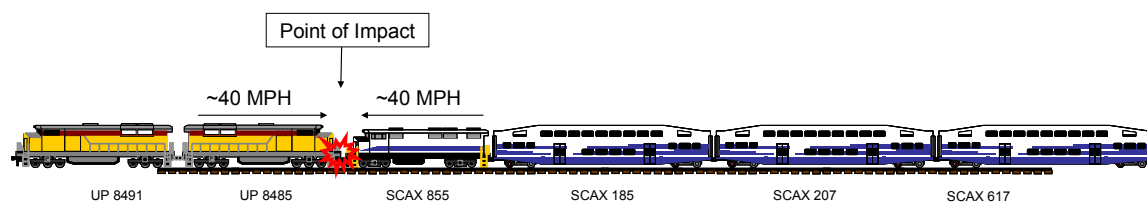
### 2.1 Initial Contact

The locomotives come together, initiating contact at the coupler knuckles. The draft gears compress, bottom out, and overload the draft gear pockets on each locomotive. On the freight locomotive, the coupler shank fractures and the draft gear pocket deforms downward. The pilot fractures and tears away. On the passenger locomotive, the coupler and draft gear pocket fracture off completely from the locomotive underframe. Next, the locomotive end structures come together. Though the front faces of the colliding trains are not symmetrical, the anti-climber devices still engage and effectively lock the two locomotives together vertically. There is little evidence of vertical motion at the colliding interface.

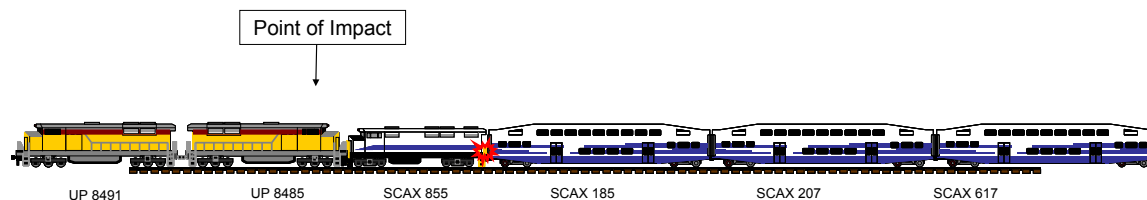
### 2.2 ~0.03 Seconds: Locomotives Begin to Crush and First Passenger Car Begins to Decelerate

At about 0.03 seconds, the passenger locomotive is crushed by about 2 feet and the main structure cripples. The front portion of the locomotive is vaulted back and up and intrudes into the operator's volume. The first passenger car makes hard contact with the rear of the passenger locomotive. The first passenger car (#185) begins to decelerate. There will be about a 0.05 second delay before the second passenger car (#207) begins to decelerate.

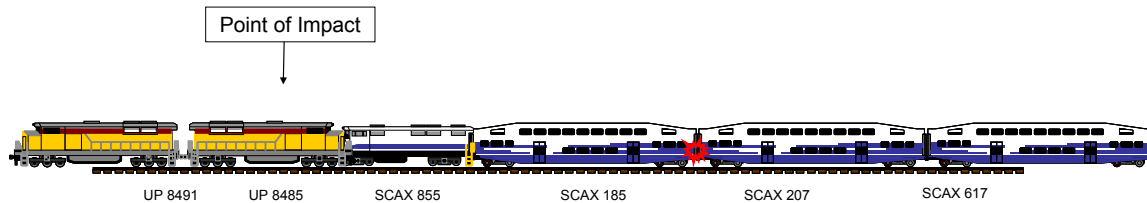
## 2.3 ~0.10 Seconds: Passenger Locomotive Continues to Crush and Second Passenger Car Decelerates

At about 0.1 seconds the passenger locomotive is crushed another 6 feet (at this time, 8 feet in total). The passenger locomotive's lead truck rotates back and the truck attachments, which connect the truck to the car, fail. As the collision pulse moves back through the train, the second passenger car makes hard contact with the first passenger car and begins to decelerate.

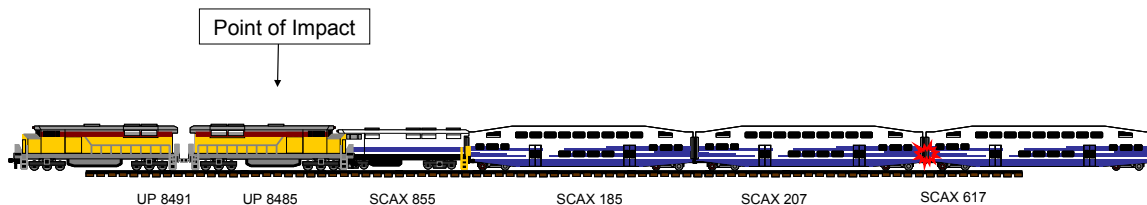
## 2.4 ~0.15 Seconds: Passenger Locomotive Continues to Crush, First Passenger Car Cripples and Third Passenger Car Decelerates

At about 0.15 seconds the passenger locomotive front end is crushed by about 10 feet. The lead truck impacts the adjacent fuel tank. The impact punctures the tank and the fuel tank detaches from the carbody underframe. The first passenger car is crushed by about one foot and the underframe starts to cripple at the front end gooseneck. The trailing cab car begins to decelerate.

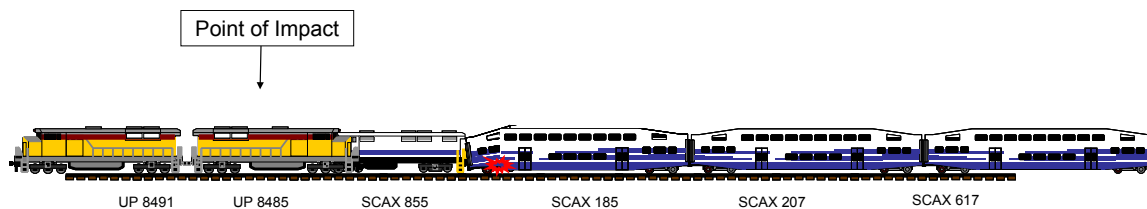
## 2.5 ~0.25 Seconds: First Passenger Car Catastrophically Fails at Gooseneck

At around 0.25 seconds the passenger locomotive front end has finished crushing, about 15 feet in total. The passenger locomotive has finished decelerating and begins to reverse direction as it is pushed by the momentum of the freight train. The gooseneck of the first passenger car catastrophically fails at ~3.5 feet of crush. The car breaks into two pieces and the front portion pitches upward and begins to plunge back through the middle portion of the multi-level car (the structural damage to the first passenger car is summarized in Section 4 and described in detail in Appendix A.2.1). The trailing cars in the passenger train finish running into each other and from this point on act essentially as a single mass, decelerating at a steady rate of about 0.5 g.

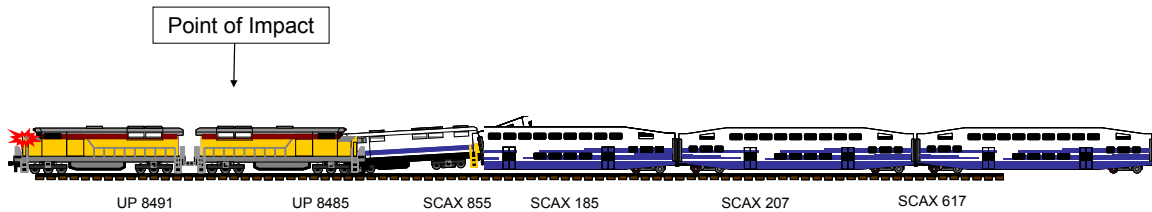
## 2.6 ~0.4 Seconds: Freight Cars Begin to Pile Up and First Passenger Car Continues to Crush

At about 0.4 seconds, the first freight car behind the second rear-facing freight locomotive overrides and crushes the operator's compartment. The freight cars successively pile up in a large scale sawtooth buckle mode. The detached front portion of the first passenger car has plunged about 10 feet deeper into the middle portion and continues to move backward, peeling open the roof and side walls.

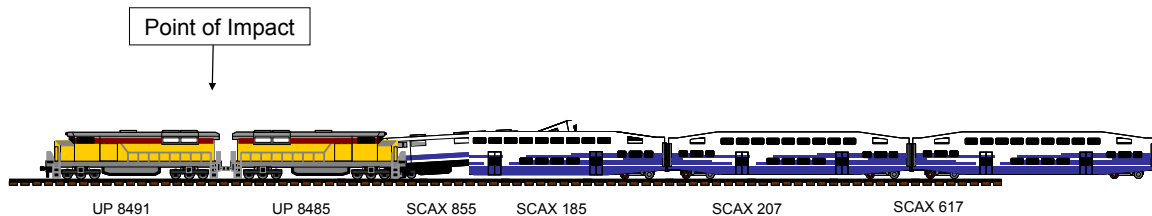
## 2.7 ~0.75 Seconds: Second and Third Passenger Cars Change Direction of Travel

At about 0.75 seconds the passenger train has finished decelerating and begins moving in the opposite direction. The first passenger car has crushed a total of about 30 feet.

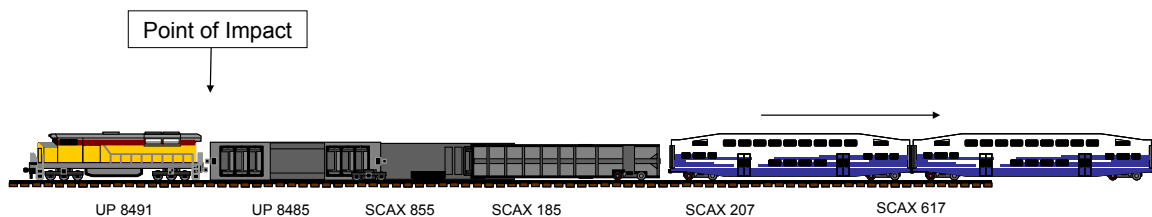
## 2.8 ~1.25 Seconds: First Passenger Car Crush Complete; Lead Locomotives and First Passenger Car Roll; Second and Third Passenger Cars Separate

The front portion of the first passenger car has plunged back into the middle portion of the car by 44 feet, stopping just before the lower level rear doors, as described in Section 4 and in Appendix B.3.1. The lead freight locomotive, the passenger locomotive and first passenger car roll and the coupled connections to adjacent cars fail. The second and third passenger cars reverse direction, rolling back what is roughly estimated to be between 80 and 100 feet.

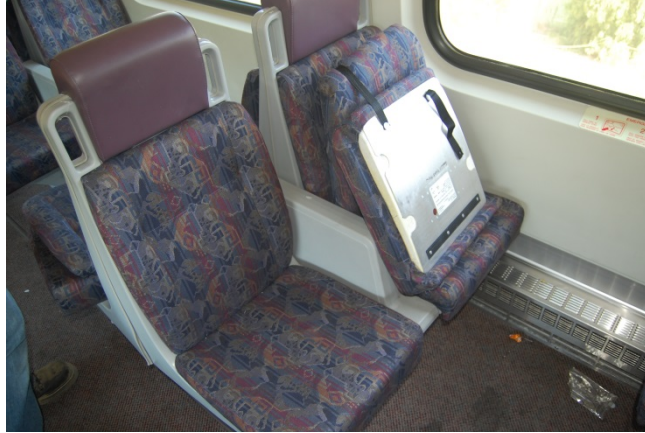
**Figure 6. Rear-Facing Seat**

Based on interior evidence and passenger interviews, the passengers seated in rear-facing seats suffered the least severe injuries as a result of secondary impacts. There was minimal structural damage to seats in consecutive rows of rear-facing seats. In cases where rear-facing seats were damaged in an open bay configuration, the cause was likely due to impacts from occupants seated in the opposite facing seat. As an example of injuries to a rear-facing occupant, Passenger #9, who was seated in a rear-facing seat, spoke of having a headache and aches and pains consistent with a game of football following the accident, but no moderate or severe injuries. This outcome is consistent with dynamic seat analyses and tests that have been conducted previously [3, 4]. The right-hand seat shown in the photograph in Figure 6 is believed to be the initial location of Passenger #9.
