Long-Term Monitoring of Pavement Maintenance Materials Test Sites

PUBLICATION NO. FHWA-RD-98-072

JUNE 1998

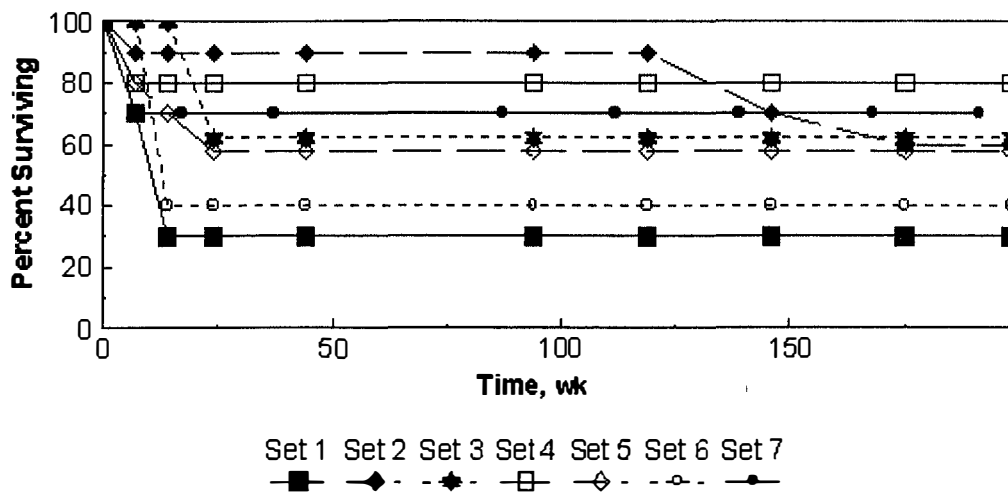
Figure 29. Survival of pothole repairs for control patches-Ontario test site.

One of the reasons that the analysis has concentrated on the differences within the groups is the variability of the performance observed from one set of control patches to the other. Figure 29 illustrates the survival plots for each of the seven sets of control patches placed at the Ontario test site. The percentage surviving after 198 wk varies from 30 to 80 percent, although the materials, placement procedure, and compaction were the same. The most likely source of the variability is differences in the pavement support, drainage, and other in-situ factors, which would have been similar for the rest of the repair types. Comparisons between different patch types at different locations throughout the test site would be irrelevant due to the differences in performance caused by site-specific factors.

Comparison among different sets of control patches within test sites did show differences in survival throughout the same site. An example of these differences can be seen in figure 29 for the control patches at the Ontario test site. These differences indicate that the performance of the control patches was affected by site-specific factors, such as underlying support and drainage, since the material, placement procedure, and compaction effort were the same for each set.
