# Durability Analysis of Aluminized Type 2 Corrugated Metal Pipe

PUBLICATION NO. FHWA-RD-97-140

JANUARY 2000

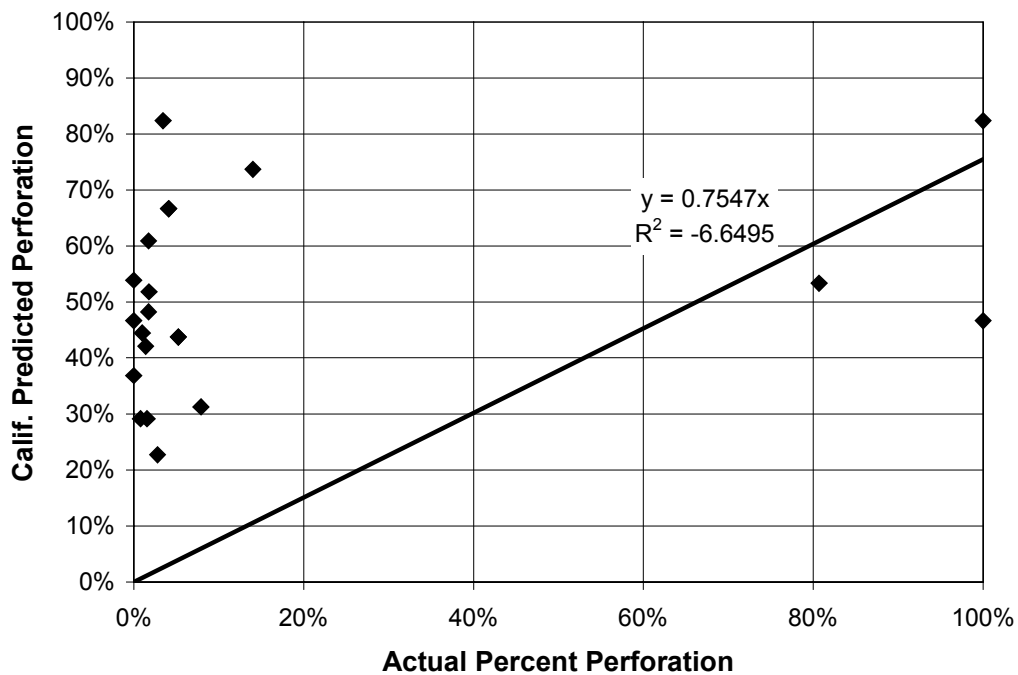
Figure 1 illustrates the “Actual Perforation” compared with the “Percent California Predicted Life” of the 21 Aluminized Type 2 culverts that were part of the field investigations. Notice that the majority of these pipes are performing better than the California Method would predict for a galvanized culvert in the same environment.

In figure 1 there are three “outliers.” Two are points from locations 310.0 and 310.1 from the Natchez Trace Parkway. The previous study labeled these two particular culverts as outliers, due to the presence of a highly aggressive effluent found in the drainage feature. During this investigation, the pH and resistivities measured were considerably higher (more benign) than that measured in the previous study. Some have suggested that the local soil conditions changed over the years. The initial pH of the effluent may have been lowered by soils in a borrow pit within the drainage area. These initial low pH conditions may have dissipated over time.

Figure 1. California Method curve prediction versus actual percent perforation, all Aluminized Type 2.

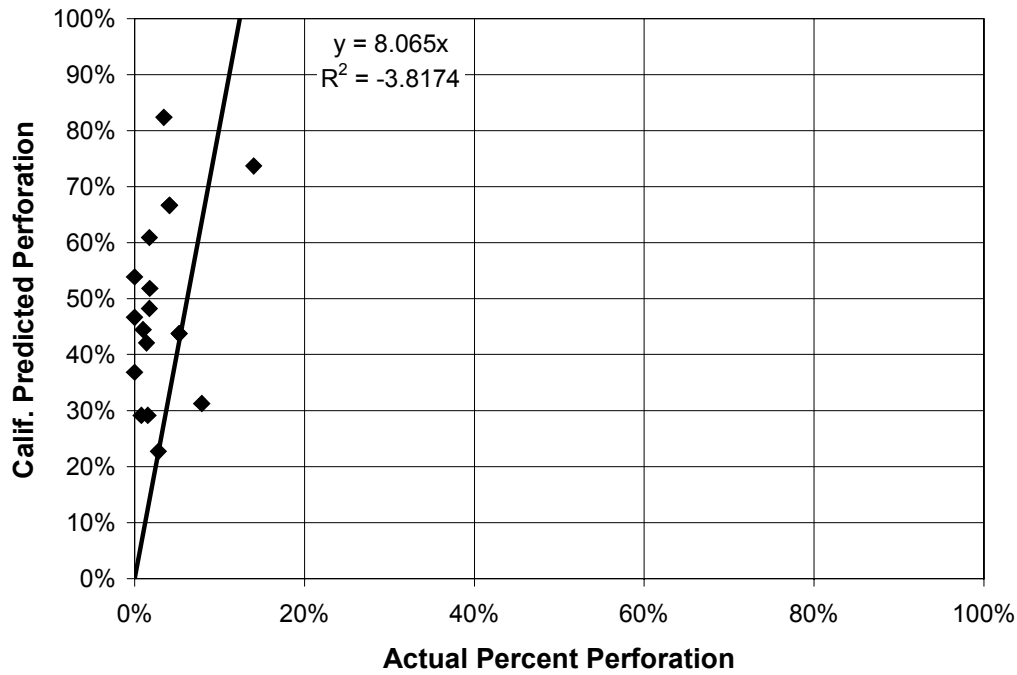
Figure 2. California Method curve prediction versus actual percent perforation, Aluminized Type 2 without outliers.

Figure 2 shows the present data again, but without the outliers. Following a similar analysis, the data show that Aluminized Type 2 is eight times as durable as predicted for galvanized. The same type of analysis was used by the Florida DOT to conclude that Aluminized Type 2 might last 2.9 times longer than the life predicted for galvanized steel. The current analysis (without outliers) appears consistent with the previous work by Potter and the Florida DOT to the extent that it predicts a longer life for Aluminized Type 2 than would be predicted for galvanized steel.

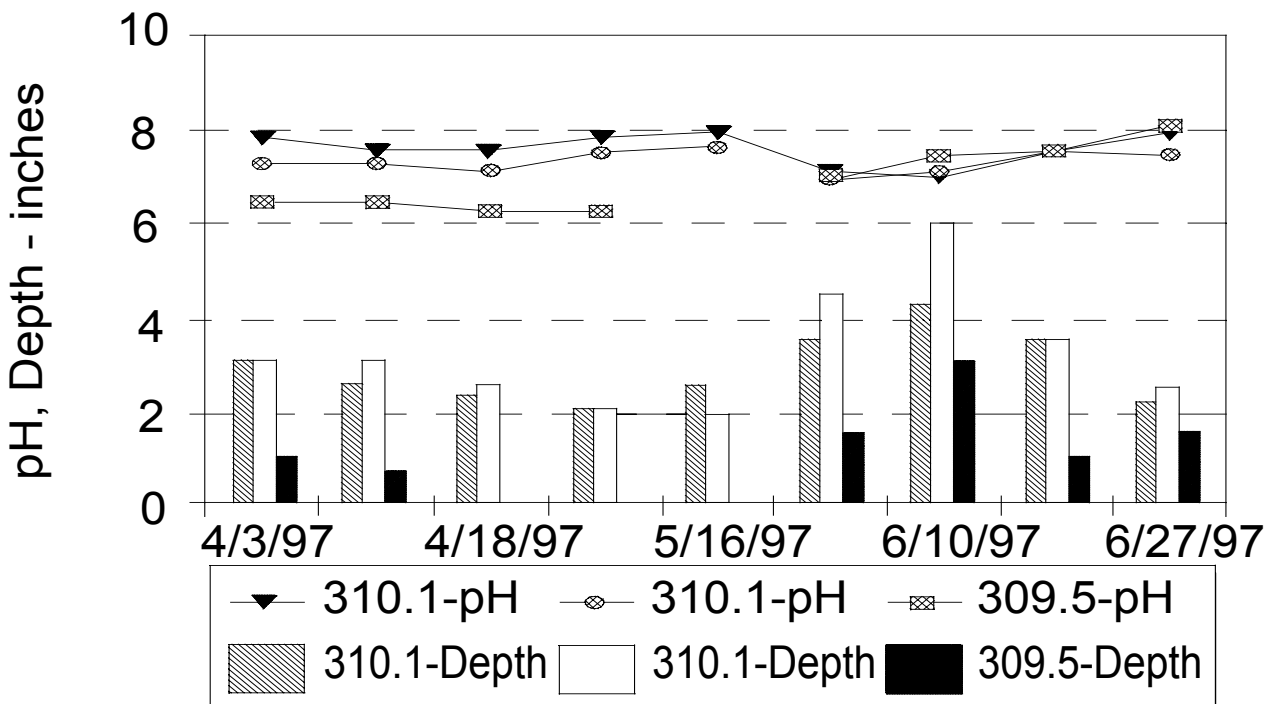
Figure 3. Water level and pH at the three Natchez Trace Parkway pipes with perforation.

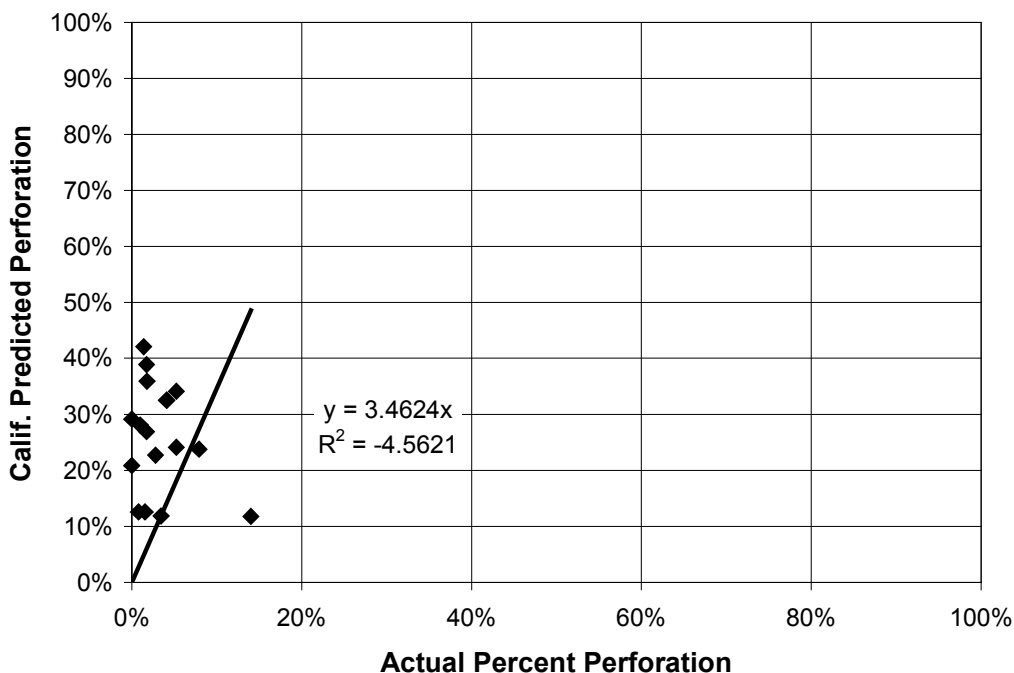
Figure 8 provides the same analysis as figure 2, yet uses the water-side chemistry to predict the California Method life. The correlation is no better. The ratio of actual life to the life predicted for galvanized drops from 8 to 3.5. This is expected because the chemistry of the water side appears less aggressive. A study of the plots in figures 1, 2, and 8 seems to show that, as noted previously, a poor fit is obtained by regression analysis and a better method is needed.

Figure 8. California Method predictions versus actual percent perforation using water-side pH and resistivity.

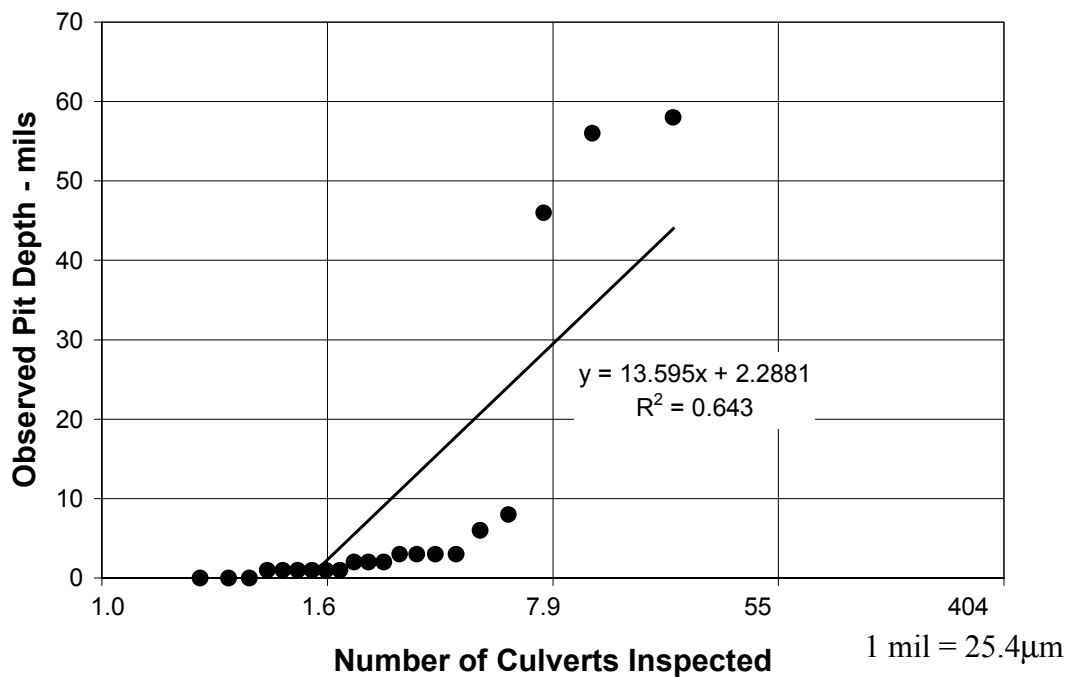
In the current study, we attempted to obtain the maximum pit depth from the invert in each culvert. Figure 9 provides a plot of the data from all of the Aluminized Type 2 sites in this study. Pit depths are the percent perforation times the theoretical thickness for the gauge of culvert.

Figure 9. Extreme-value distribution for all Aluminized Type 2 data in table 1.

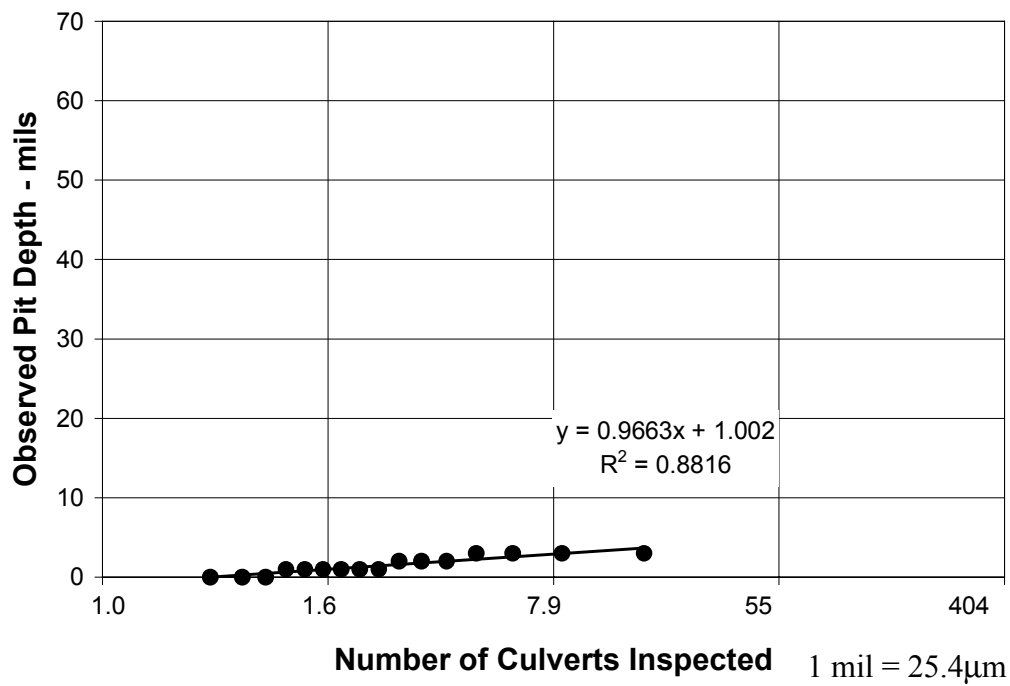
The data suggest at least two modes: a low and high pitting rate. Figures 10 and 11 show these distributions separately. The split between high and low pitting appears to be at about 127µm (5 mils). The samples in this study are between 10 and 17 years old.

Figure 10. Extreme-value distribution for Aluminized Type 2 data in table 1 exhibiting a low pitting mode.

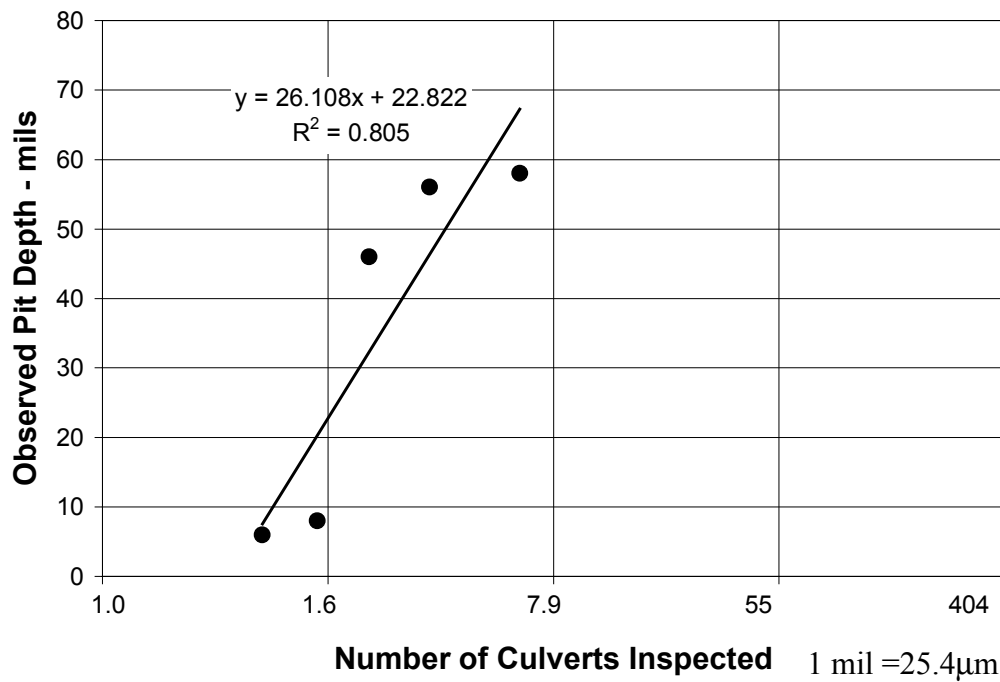
Figure 11. Extreme-value distribution for Aluminized Type 2 data in table 1 exhibiting a high pitting mode.

Each plot has a good correlation coefficient, suggesting that the data fit the model. It is also interesting that the split between low and high pitting mode places more than the three original outliers into a high-pitting rate group. There appear to be six sites (all those with more than 7.5 percent perforation in table 1) experiencing a high pitting rate. Conversely, there are 18 sites with a very low pitting mode.

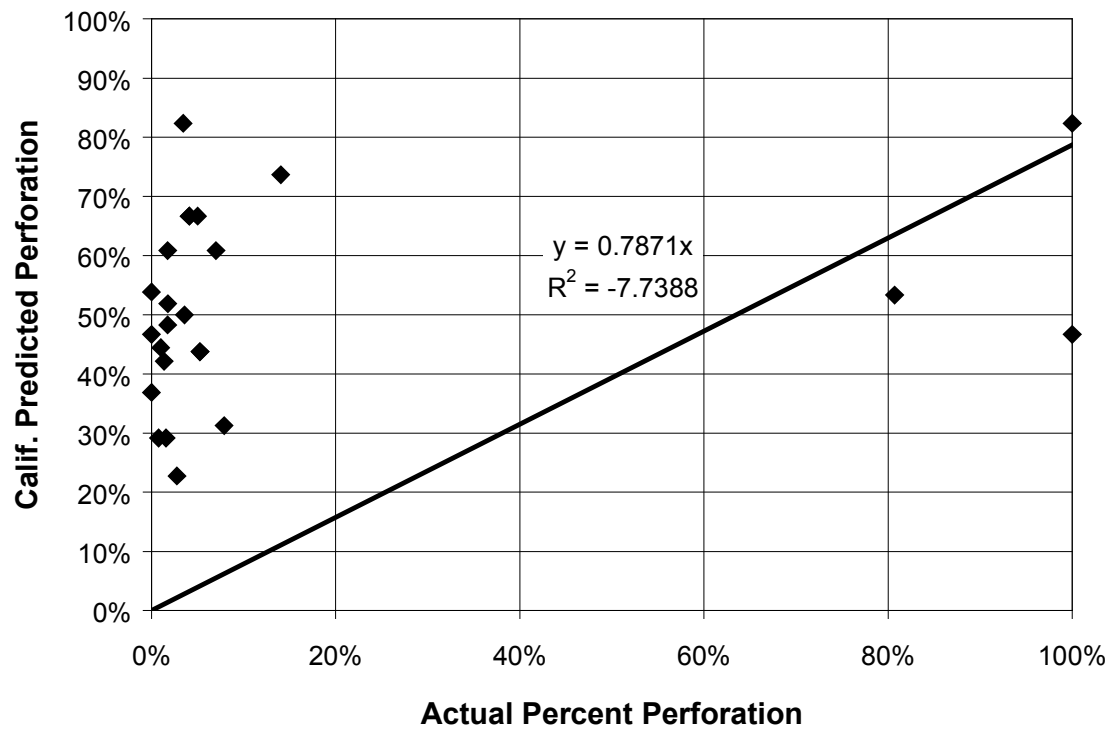
The additional 11 culverts included three Aluminized Type 2 coated culverts. Figure 21 shows the regression analysis described in FHWA-FLP-91-006 with this data added to the 21 discussed in the body of the report (making a total of 24 Aluminized Type 2 coated culverts). The results are not significantly different than discussed in this report – Aluminized Type 2 has an apparent advantage of 8.6 over the California Method's prediction for galvanized pipe. Including the "outliers" reduces the ratio to 0.79. The mode of the extreme value analysis for the pipes exhibiting a low pitting mode is 28.4  $\mu\text{m}$  (1.12 mils). The mode of the extreme value analysis for the pipes exhibiting a high pitting mode is 445  $\mu\text{m}$  (17.5 mils).

**Figure 21. California Method curve prediction versus actual percent perforation, all Aluminized Type 2 in this study.**
