Catastrophic Icefall Hazard Assessment, Avoidance Procedures & Mitigations Strategies - Phase II Site-Specific Studies

February 2018

Alaska Department of Transportation & Public Facilities

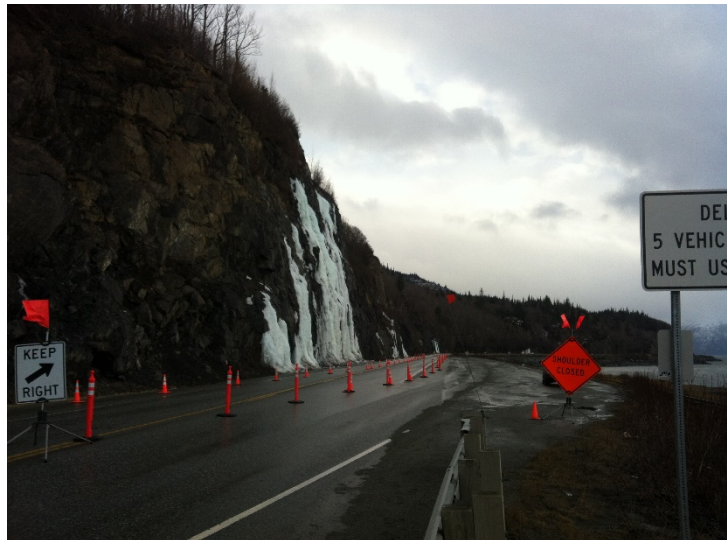
1. Temporary Traffic Modifications – Would be a short-term solution to a perceived imminent icefall impact risk, and one that could be deployed relatively quickly. For example, there is already a temporary traffic diversion and lane closure plan in the area of MP 113 – we saw this implemented after we reported small icefall sloughing events on 20 March 2017, including use of appropriate advance signage. Traffic is slowed down due to the temporary lane changes but this approach afforded an additional lane of offset between northbound traffic and the bottom of the slope. A similar approach could be drafted-up for other locations as-needed based on projected site-specific impact area limits and available space within the roadway section. One down-side to use

Figure 18 – Traffic pattern modification and detour at MP 113.2 area (Photo by Alaska DOT&PF)

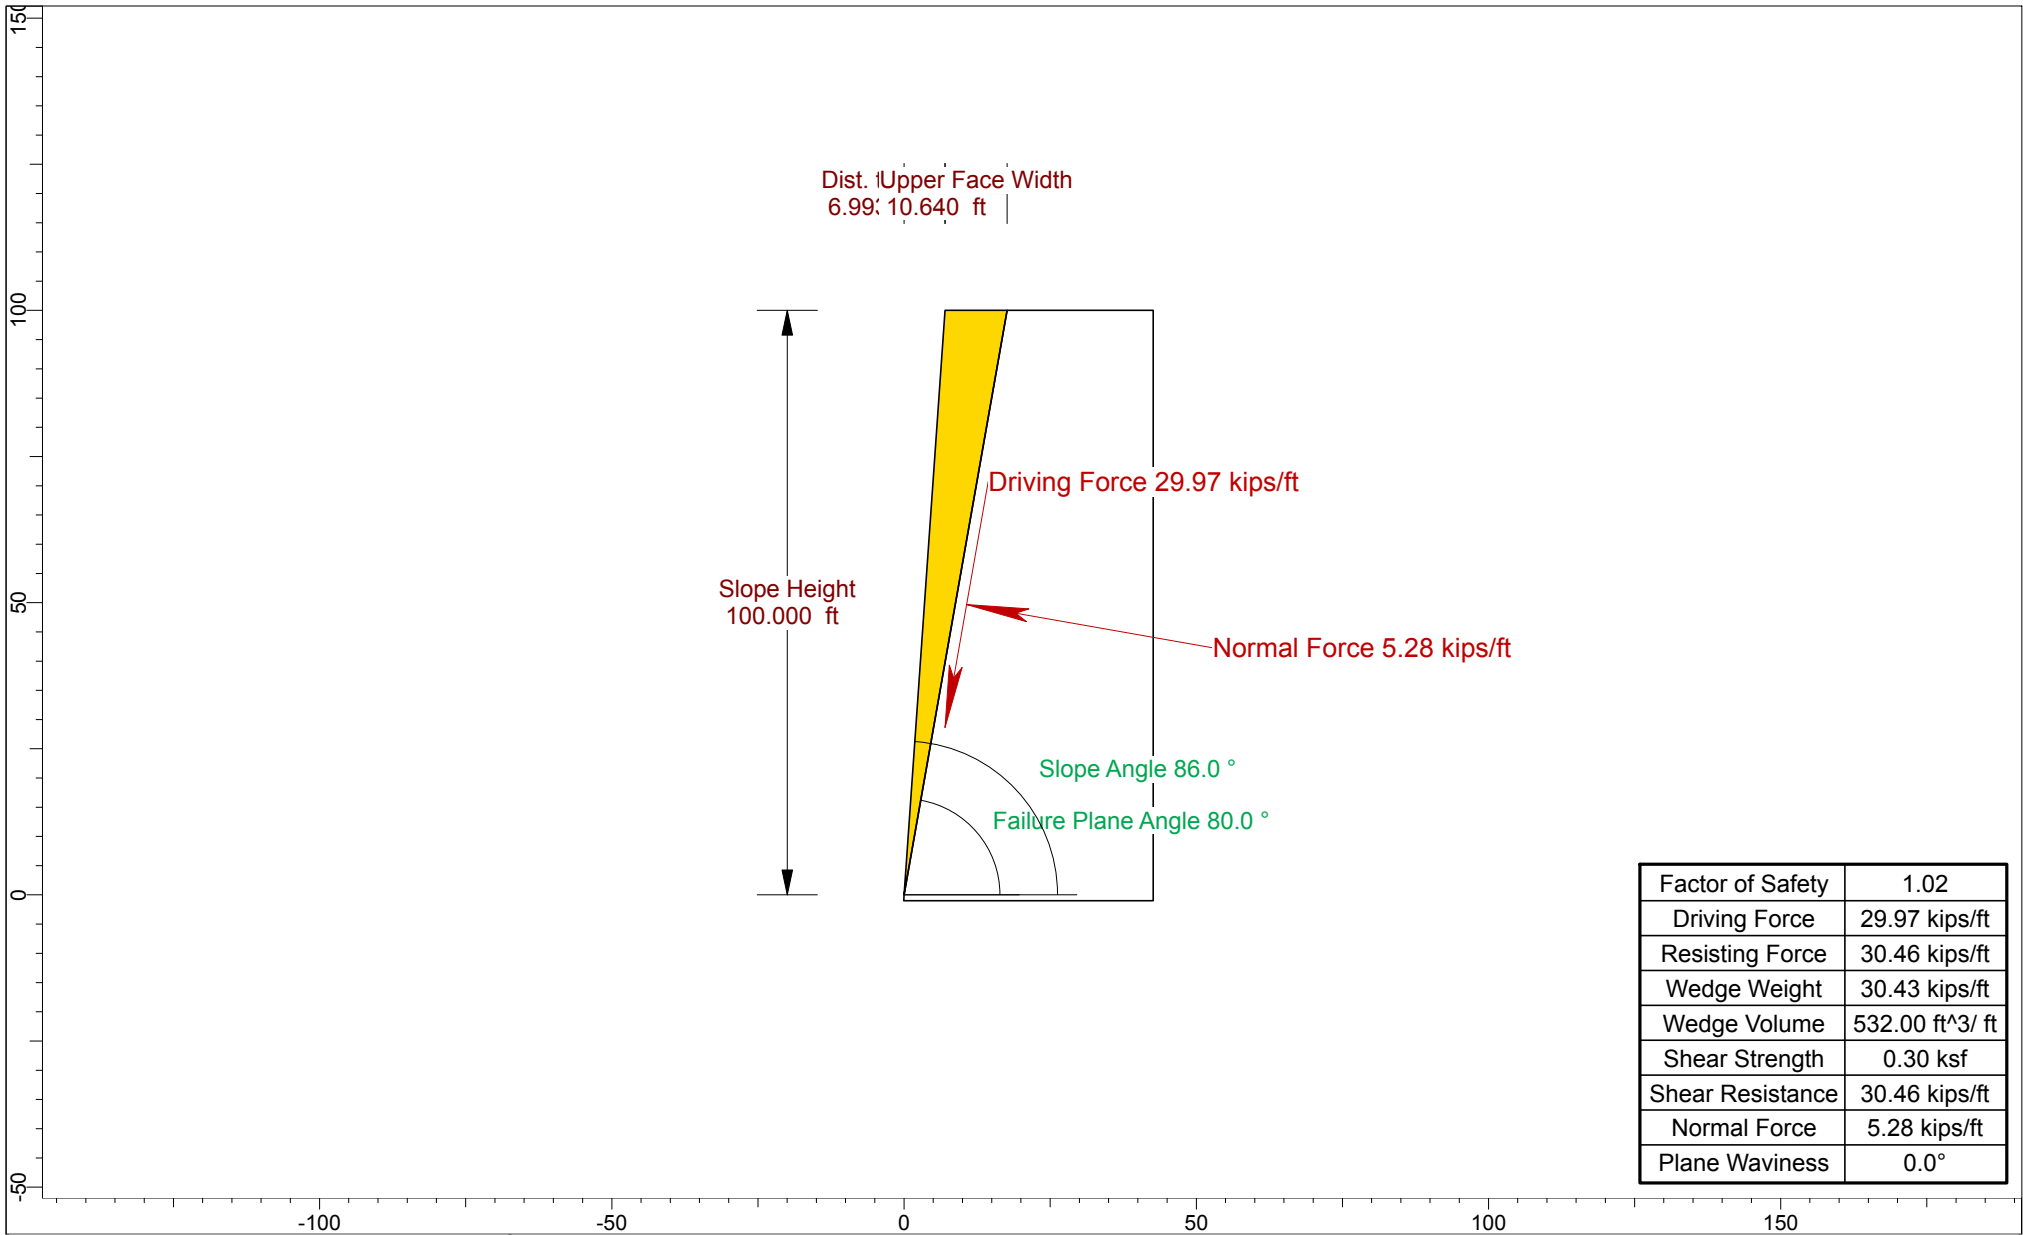
Project		AKDOT&PF - MP 113.2	
	Analysis Description		Icefall Sliding	
	Drawn By	D. Scarpato, P.E.	Company	Scarpotec, Inc.
	Date	1/12/2018, 4:55:24 PM	File Name	RocPlane1

Shear Strength Model Mohr-Coulomb
 Friction Angle 0 °
 Cohesion 0.3 kips/ft²
 Shear Strength 0.3 kips/ft²
 Shear Resistance 30.4628 kips/ft

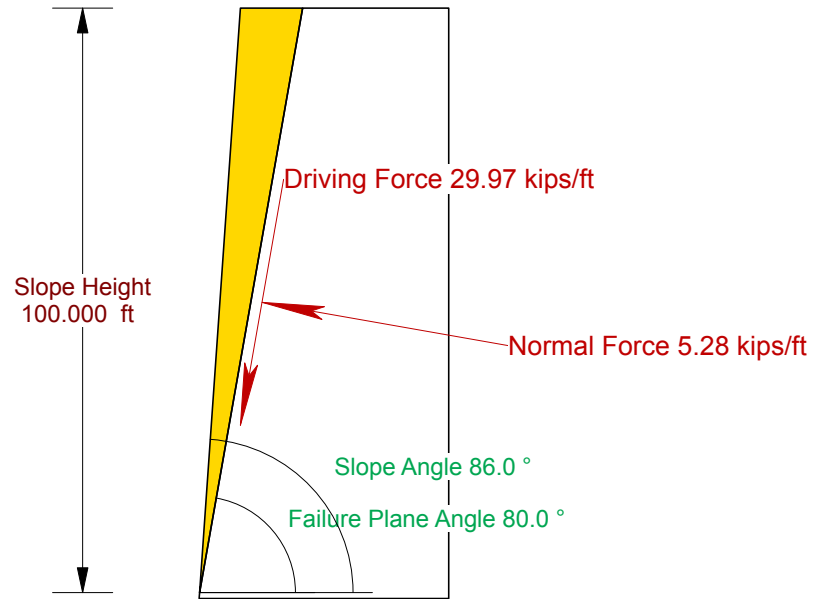
Factor of Safety	36.59
Driving Force	29.97 kips/ft
Resisting Force	1096.66 kips/ft
Wedge Weight	30.43 kips/ft
Wedge Volume	532.00 ft ³ /ft
Shear Strength	10.80 ksf
Shear Resistance	1096.66 kips/ft
Normal Force	5.28 kips/ft
Plane Waviness	0.0°
