Testing and Recommended Practices to Improve Nurse Tank Safety: Phase III

U.S. Department of Transportation
Federal Motor Carrier Safety Administration

July 2018

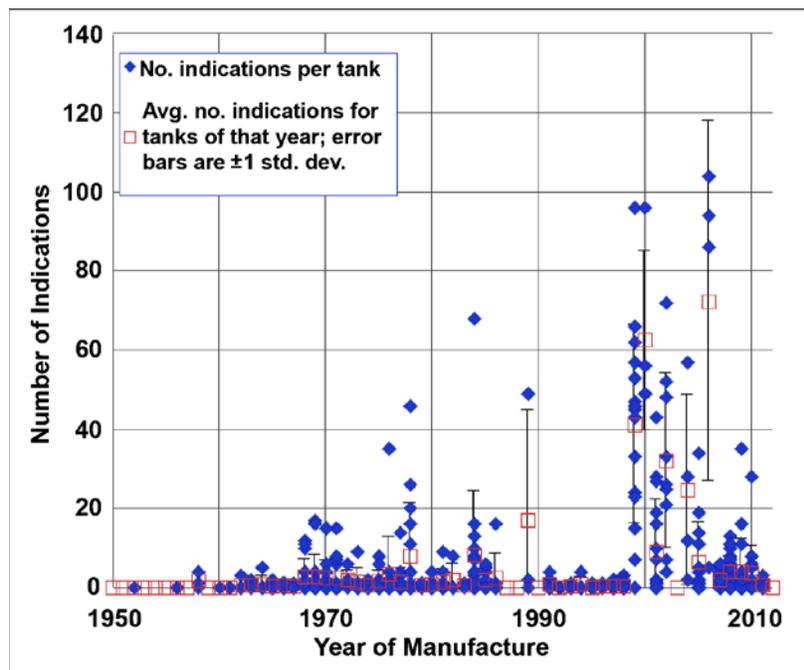
The ultrasound examinations found more perpendicular indications in newer tanks with the thinner steel allowed starting in 1998 than in older tanks with thicker steel. Figure 2 shows the distribution of indications as a function of year of manufacture. Three factors may have raised the count of indications for the newer tanks.

Third, the total absence of full body stress relief annealing treatments (i.e., PWHT) in all tanks manufactured since 1999 (discussed in the following section) means all newer tanks have extremely elevated residual stress in the HAZ from the welding fabrication, which is associated with an increased number of indications.

Figure 2. Scatterplot. Number of indications per tank as a function of year of manufacture.

The effectiveness of PWHT on reducing or eliminating stress corrosion is readily apparent in Figure 2. For tanks tested by this study that were manufactured from 1991 to 1998, 96.8 percent (92 out of 95) were made by Manufacturer C, then a major U.S. tank manufacturer in the Iowa area. That manufacturer's tanks received full-body PWHT. That manufacturer was acquired by manufacturer A in 1999, and as of the date of this research neither of the surviving U.S.

The data show that 74 percent of the indications (2,104 of 2,834) were found in the newer, unannealed, thinner steel tanks manufactured in 1999 or later, even though these tanks comprised only 32 percent of the total tanks tested (168 of 532). Data interpretation may be confounded to some extent by the fact that this cessation of PWHT occurred only 1 year after initiation of thinner tank walls.

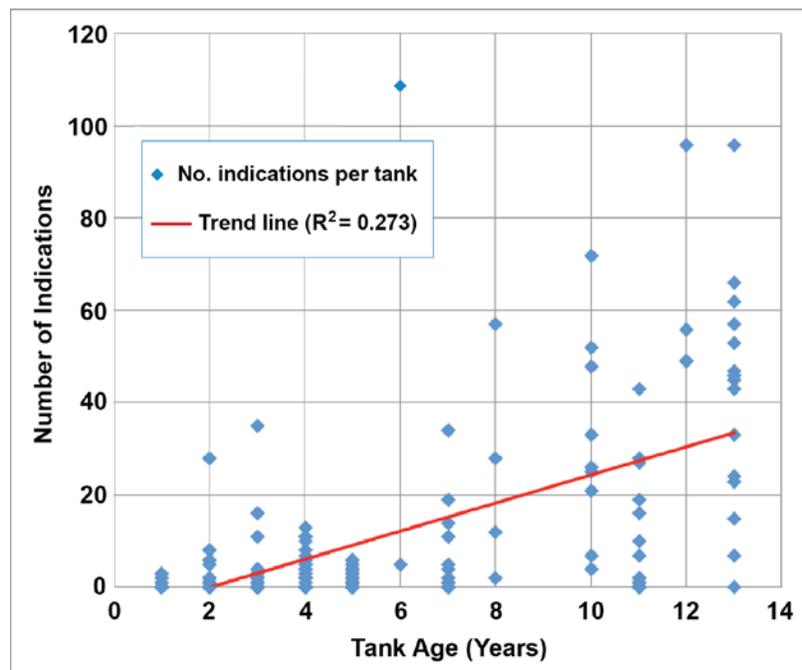
When only tanks manufactured in 1999 or later are considered, the differential effects of decreased wall thickness and discontinuance of PWHT practices are removed/controlled, and the trend one might expect (i.e., more indications in older tanks) does appear somewhat (see Figure 3). The bivariate fit of the data from the 168 tanks shows a less-than-ideal correlation between the number of indications and tank age. The correlation variable describing how closely the line of best fit fits the data (R^2) value of the line on Figure 3 is a bit low, but positive at 0.27.

Figure 3. Scatterplot. Bivariate fit of indication number per tank versus tank age (during the Phase II study in 2012) for tanks manufactured from 1999 to 2011.

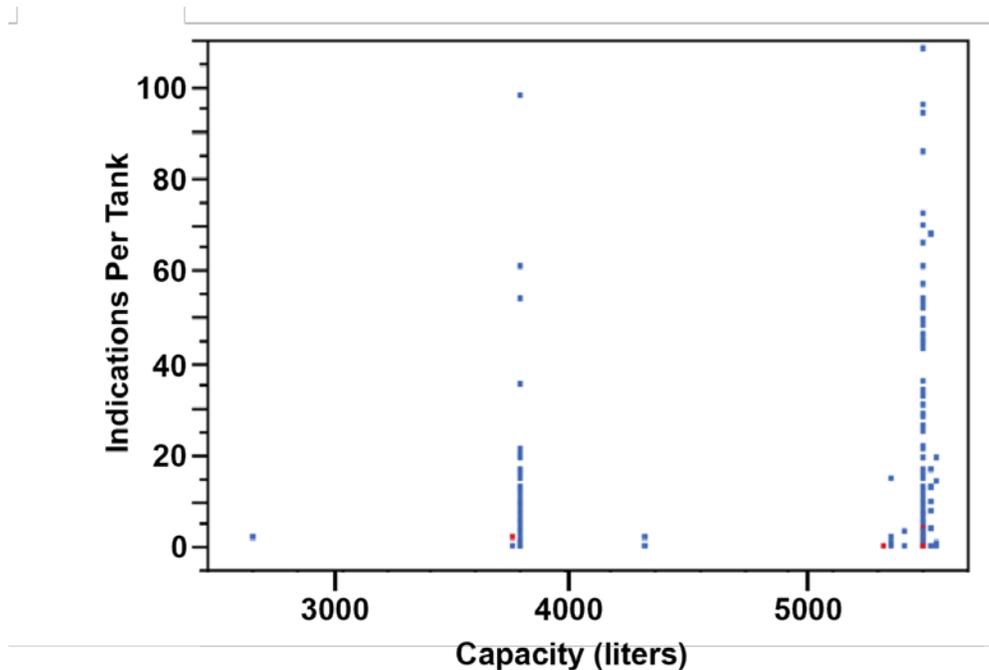
Nearly all tanks inspected in Phase II (and re-examined in Phase III) were either 3,800-liter or 5,500-liter tanks. Figure 4 shows that wide distributions of indication counts were seen for both tank sizes, indicating again that age is not a good indicator of propensity for cracking. In fact, newer unannealed 5,500-liter tanks with thinner shells have a larger number of indications on average than older 3,800-liter tanks with thicker steel.

Figure 4. Graph. Number of indications per tank versus tank capacity.

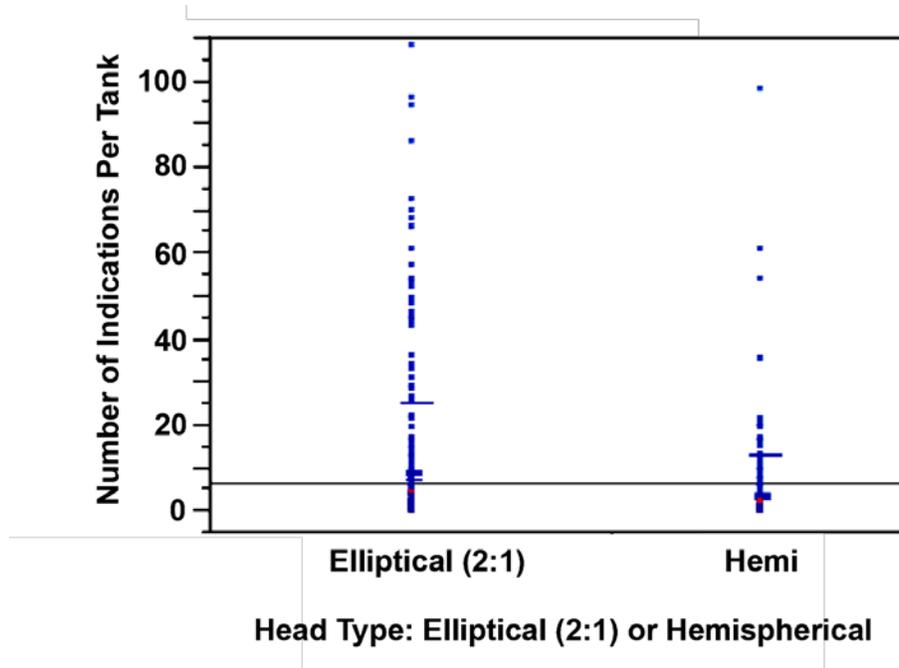
Two types of tank head shapes were found: elliptical and hemispherical. The number of indications per tank for these two populations is plotted in Figure 5. Statistical data is listed in Table 1. Tanks with elliptical-shaped heads had a higher incidence of indications than tanks with hemispherical heads. This is affected by the fact that most newer larger 5,500-liter tanks had elliptical heads, and most of the older 3,800-liter tanks had hemispherical heads. Since the use of newer 5,500-liter tanks is more recent in central Iowa, the majority of the 5,500-liter units tested also had thinner shell walls, and they were not PWHTed. The combination makes elliptically headed tanks appear to have higher numbers of indications. As noted elsewhere, a large proportion of the indications are in the head HAZ.

Figure 5. Graph. Number of indications per tank versus head shape. Horizontal lines indicate the mean number of indications for each head type.

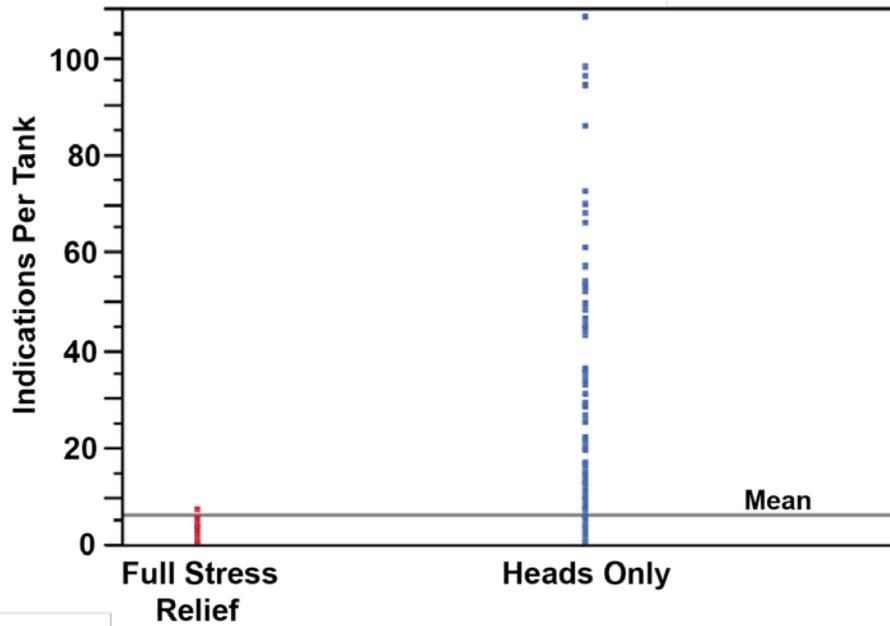
Stress relief annealing (PWHT) of the entire tank had an even stronger influence on the number of indications per tank than did head geometry. The data from the Phase II report provides a comparison of full-body stress relief versus head-only stress relief, shown in Figure 6, with corresponding statistical data in Table 2. None of the tanks that received full-body stress relief had more than 7 indications, while 1 of the tanks that had only the head's stress relieved had 108 indications. (It is important to note that stress-relieved heads are deformed from plate, given a stress-relief anneal, *then* welded to the tank shell. Thus, the subsequent residual stresses created by the welding of the head-to-shell weld seam are not relieved.) The mean number of indications was nearly 10 times less for tanks where the entire tank had been stress relieved after welding than for tanks without full-body stress-relief annealing. This is an order of magnitude of better performance associated with full-body PWHT.

This order of magnitude difference in the number of indications has relevance for policy regarding the desirability of full-body heat treatment post-welding.

Figure 6. Graph. Average number of indications per tank for fully stress-relieved tanks compared to tanks where only the heads were annealed prior to welding the heads to the shell. The mean number of indications per tank (6.3) for the entire population of 532 tanks is marked with a horizontal line.

Note: For tanks that will be given a full-body stress-relief heat treatment after welding, it seems that it would not be necessary to separately heat treat/anneal the heads after they are formed, before they are welded to the shell. Stress relief would be achieved in the heads as well as all the other regions of the tank by the full-body stress-relief anneal performed after all welding has been completed on the tank.

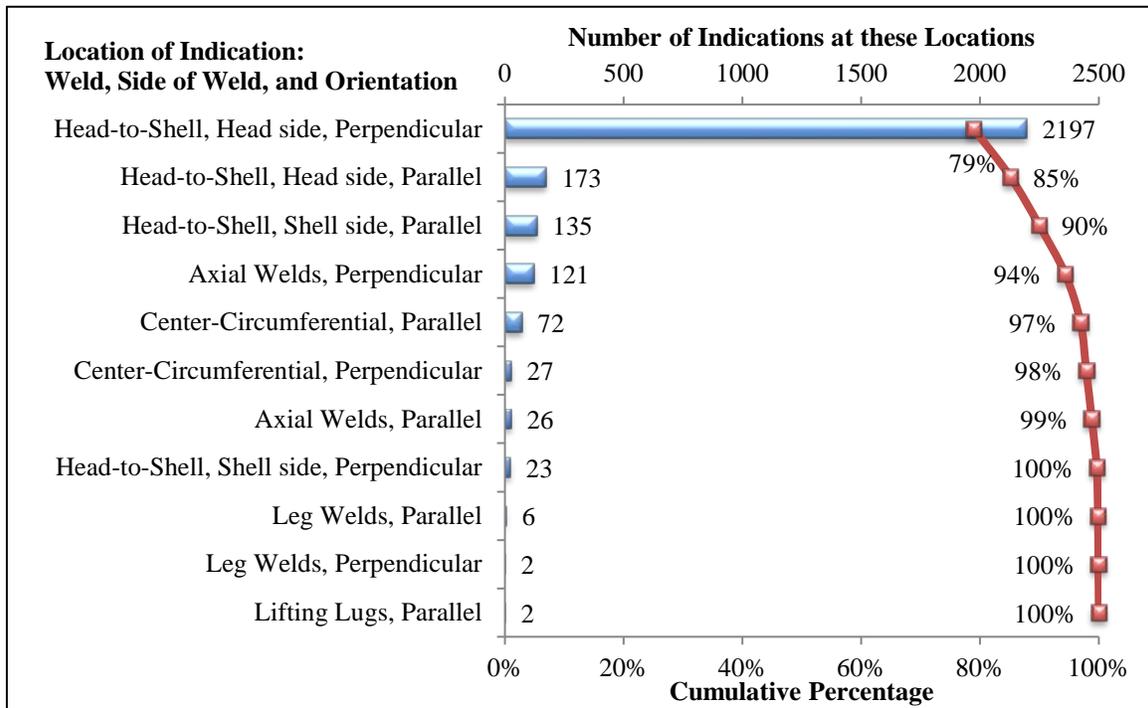
Since HAZ indications pose greater safety concerns than in-weld indications, a Pareto plot (Figure 11) was developed showing the distribution of HAZ indication locations found in the tanks tested with the limited single-beam technology, as well as whether the indication is parallel or perpendicular to the weld. This plot shows what types of indications occur most often and where they are located. Nearly 80 percent of the indications are found at the head-to-shell weld on the head side, perpendicular to the weld.

As noted above, the head side has greater stresses after welding due to elements of its shaping and the type of weld used when joining it to the shell. When a head/cap is placed on the end of the cylinder/shell, the steel at that end cannot expand as freely when heated; the shape of the head/cap prevents this. Although the head/cap itself is also heated at the weld site, the metal that forms the head/cap restricts expansion much more than is expected in a simple hoop section of a shell-to-shell weld. The design and geometry of the shell-to-head weld is also different, providing a larger mass of metal subject to expansion/contraction, which again results in higher residual stresses after welding.

Figure 11. Plot. Location of HAZ indications in a population of 532 nurse tanks.

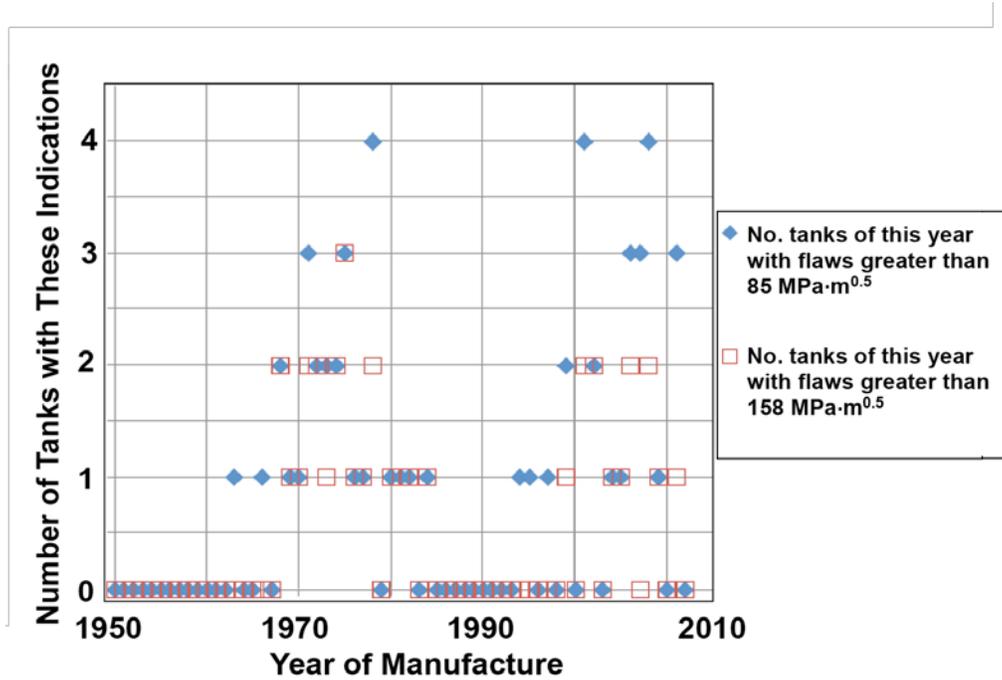
If one assumed a worst case scenario by allowing that the indications recorded in the HAZ did represent through-cracks, then of the 2,784 total indications found in the HAZ, only 93 of them in 55 tanks (10 percent of all tanks) would be of critical length at -70°C , where the stress concentration factor is only 85 Megapascals (MPa) $\cdot\text{m}^{1/2}$. Only 57 indications from 35 tanks (6.5 percent of all tanks) would be of critical length at 20°C , where the stress concentration factor is 158 MPa $\cdot\text{m}^{1/2}$. These results are shown in Figure 12. Note again, this assumes the worst case

Figure 12. Scatterplot. Tanks with critical crack lengths assuming through-cracking exists. An 85 MPa·m^{1/2} flaw is a critical-sized flaw at -70°C, the temperature reached when compressed NH₃ is vented to the atmosphere. A 158 MPa·m^{1/2} flaw is a critical-sized flaw at 20°C.

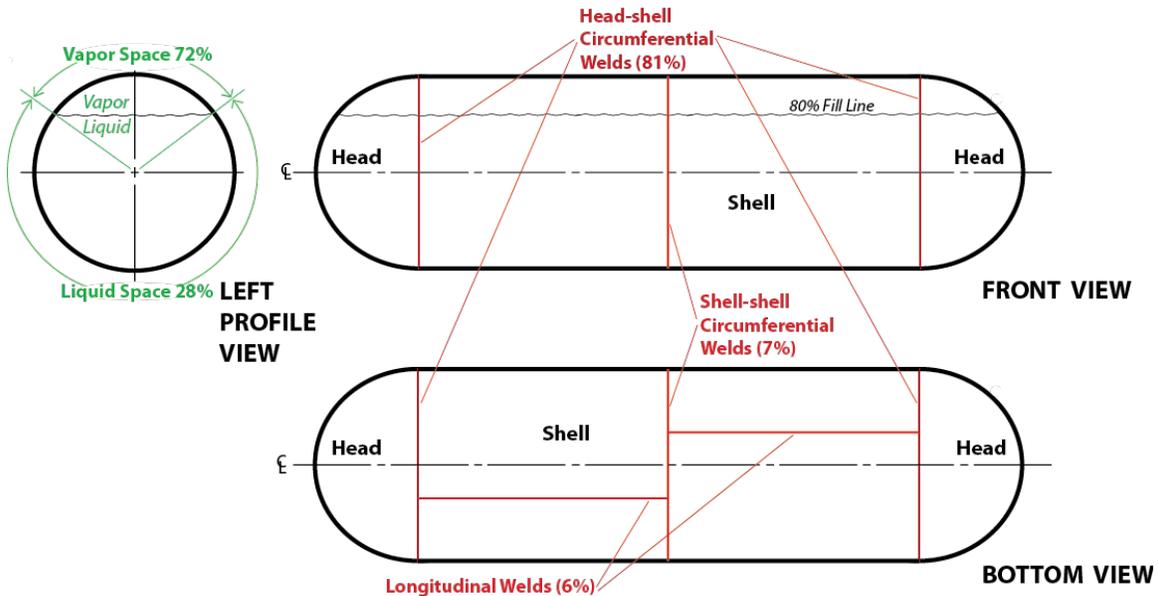
vapor space above the 80 percent fill line, a disproportionately large percentage, since only about one fourth of circumferential weld length lies above the 80 percent fill line. The vapor area is filled with 100 percent corrosive NH_3 vapor, with no water present in the vapor to prevent the SCC, significantly increasing the SCC rate above the 80 percent fill line.

- Only 7 percent of indications were in shell-to-shell circumferential welds, and 6 percent were in longitudinal (girth) welds in the shell.

Figure 14. Schematic. Distribution of indications in nurse tanks.

- There were 168 tanks examined that were manufactured in 1999 or later and thus had no PWHT. They accounted for 74 percent of the indications found in the HAZ, even though those tanks comprised only 32 percent of the total tanks inspected.

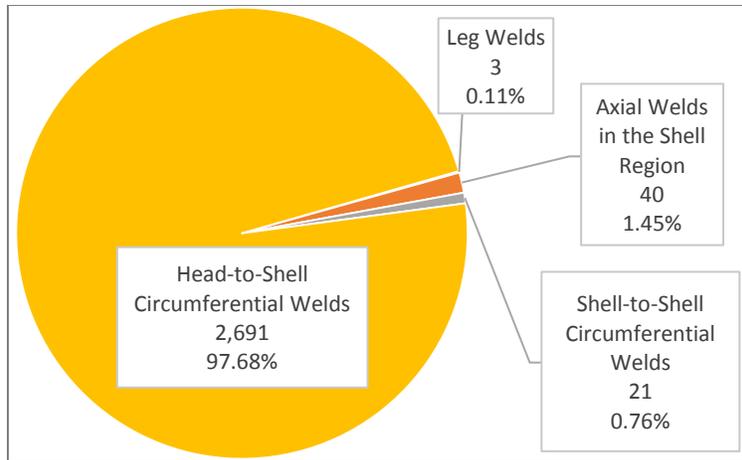
- Only 40 indications were found in axial welds in the tanks' shell region for a similar reason as the limited number of indications in the circumferential shell-to-shell welds.

- Three indications were associated with leg welds, and these likely were not SCCs but fatigue cracks. (This was possible to determine with single-beam technology because leg welds are entirely on the outside of the shell, much like lifting lugs, plus there is no internal metal joint like there is in the shell-to-head or shell-to-shell joints. Thus, even with the limited resolution of single-beam it is possible to distinguish likely-metal-fatigue indications in the continuous steel around a leg weld.)

Figure 16. Chart. Number of indications found in Phase III as a function of location on the tank.

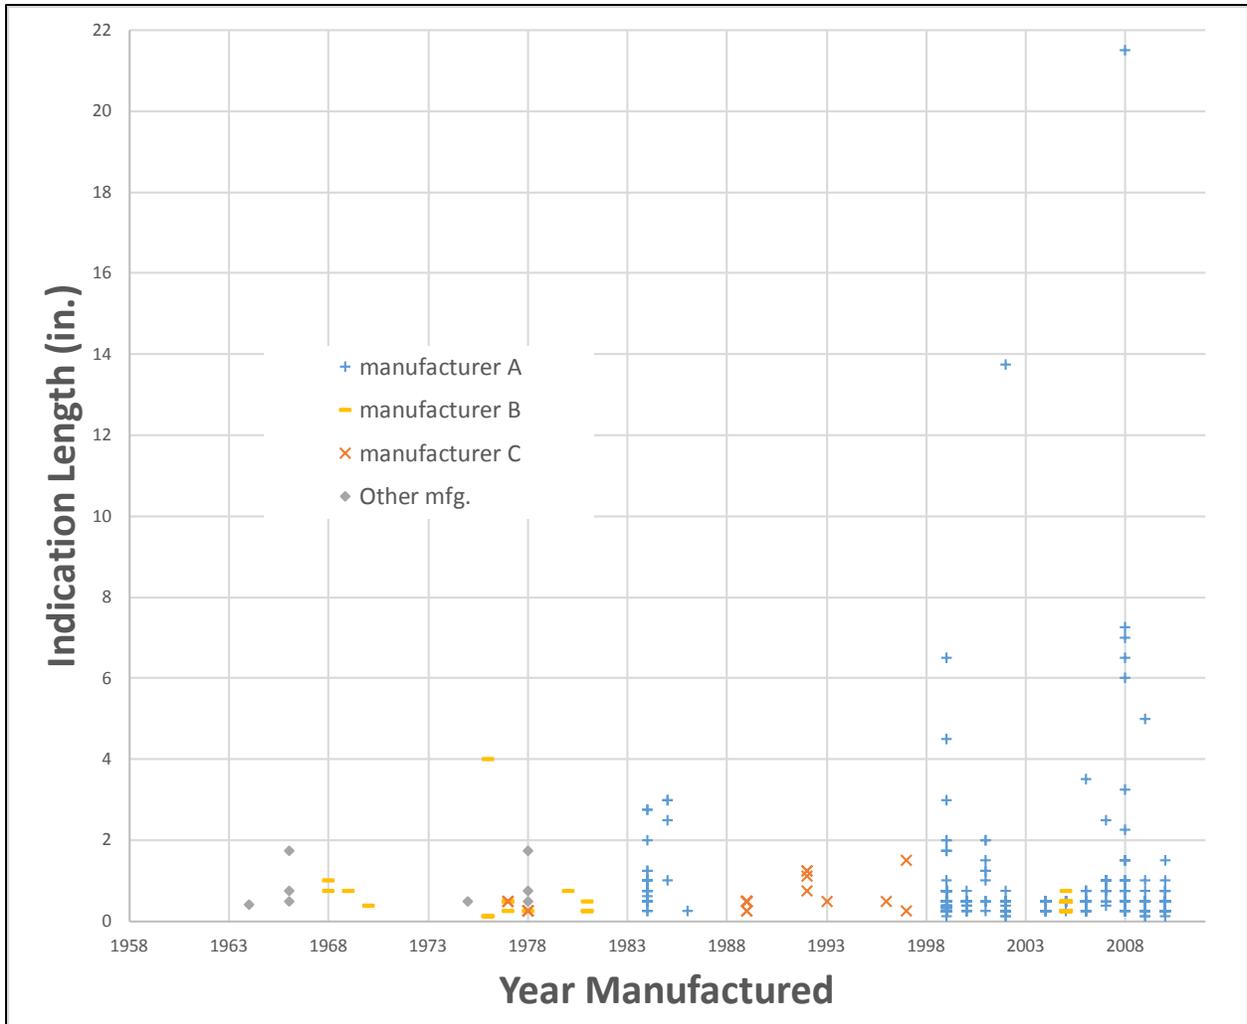
Figure 17 displays the measured length of new indications detected in Phase III as a function of year and company of manufacture. Notice that some indications are extremely long, the largest being greater than 20 inches. Those flaws that were new and long are all ones where the inspectors were looking into the welds (i.e., parallel to a weld).

Figure 17. Scatterplot. Length of new indications found in Phase III as a function of tank’s year of manufacture and tank manufacturer.

indications. It is also of note that the largest indications (see Figure 17) were also found in tanks made by Manufacturer A. However, such an analysis is an over-simplification of the data. Table 6 shows that Manufacturer A accounted for the vast majority of the newer tanks examined in these central Iowa studies (tanks made beginning in 1998 after the ASME specifications were changed in 1997). At the same time, full-body PWHT was discontinued after 1999, because the manufacturer doing so was acquired by another manufacturer.

In general, one can conclude from the data shown in Figure 17 and Figure 18 that newer tanks are showing more new initiations and more growth of existing perpendicular indications over this 3-year period than older tanks. This follows expectations for the size of a perpendicular SCC indication to grow quickly through the HAZ region of high residual stress once initiated, but then the growth of that indication is expected to slow once the indication reaches an area beyond the HAZ with little to no residual stress. It would be logical to expect many of the older tanks to have reached the point where the perpendicular SCC indications have grown to the point beyond the HAZ where there is no residual stress present at the crack tip.

Figure 17 and Figure 18 also point to some possible concerns with tanks manufactured under the revised ASME specification established in 1997 that allows thinner shell steel. It is clear that most of the newer tanks examined in these central Iowa studies (mostly of the 5,500-liter size) showed an increased number of indications and faster indication growth than older tanks present in the sample study. The fact that the majority of tanks in this age range were all manufactured by the same manufacturer is unfortunate, as it prevents making any clear attribution of the cause for both the increased number of indications and the increased indication growth rate to be definitively assigned to the change in ASME specification for shell thickness. However, the percentage of new indications by manufacturer matches with the percentage of post-1999 tanks examined by manufacturer. Thus, it is believed that the change in ASME thickness specification and lack of PWHT are the more probable root causes for the observed results.

There clearly is a need to examine the phased-array technology that has greater resolution and can better differentiate details within such geometries.

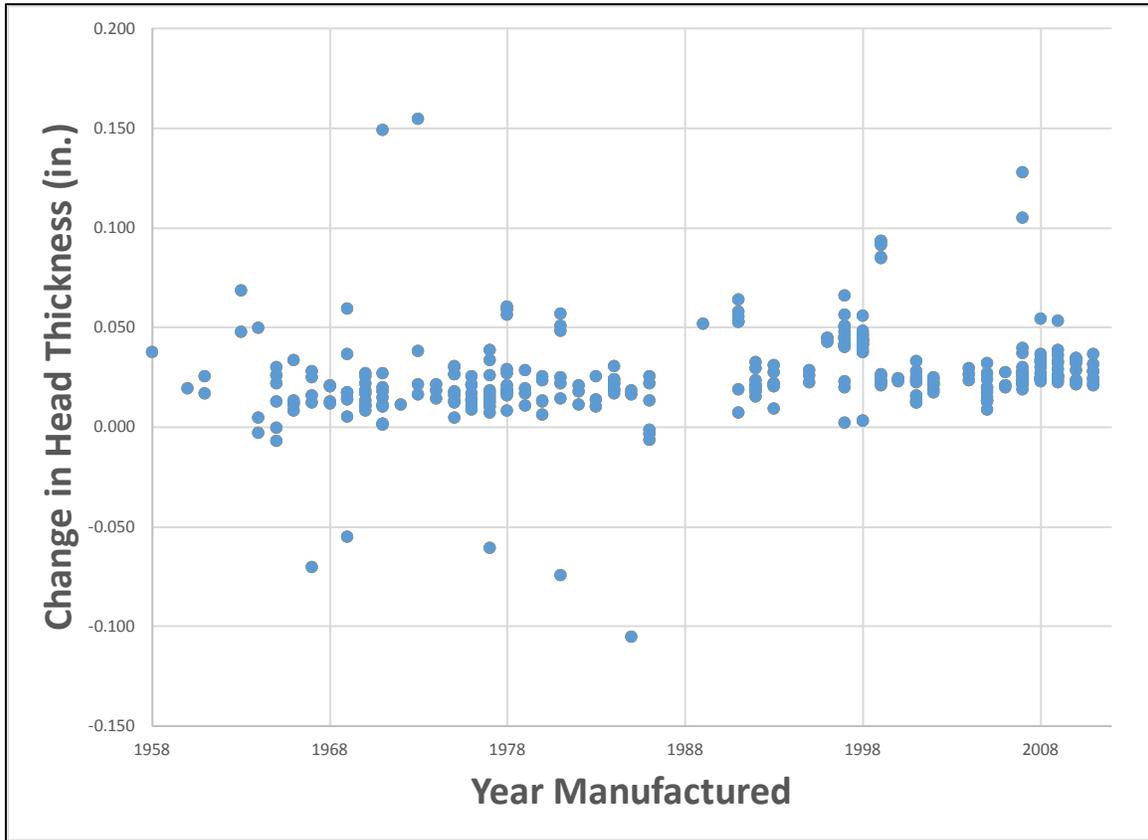
Figure 21. Scatterplot. Plot showing the difference between average head thickness of individual tanks measured in Phase III and their listed ASME data plate head thickness. This only represents tanks with legible values for head thickness. Tanks that measured thinner than the data plate listing are negative.

Measured values of average head thickness were still thicker than the stated ASME plate value in most cases. Tank manufacturers have presumably made most tanks from steel material that was thicker than the value listed on the ASME data plates.

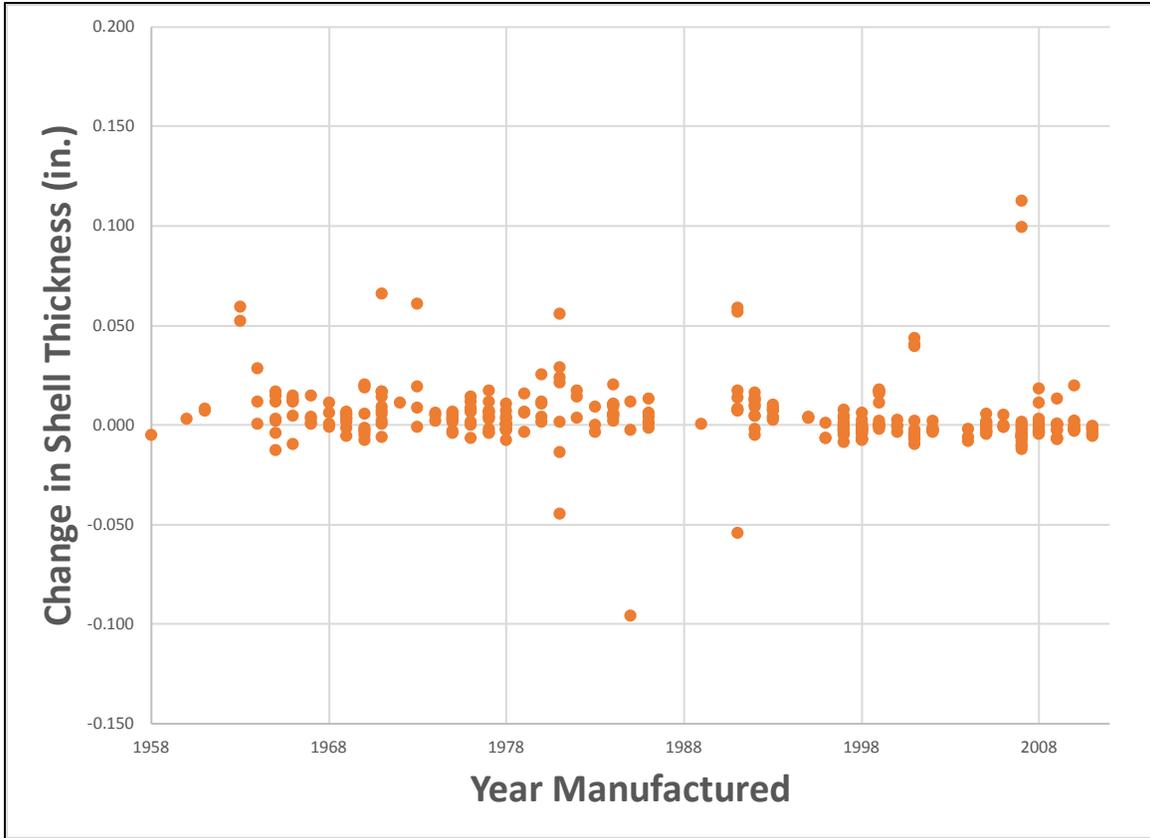
A similar plot is shown in Figure 22, except the values shown correspond to the shell thickness. In this case there are far more tanks where the thickness of the shell is below the stated thickness on the data plate. In fact, approximately one-half of the shells are thinner than what is stated on the data plate. However, they are all within 0.1 inch of the stated value on the data plate.

Figure 22. Scatterplot. Plot showing the difference between average shell thickness on individual tanks measured in Phase III and the listed ASME data plate shell thickness for those tanks. This only represents tanks with legible plate values for shell thickness. Tanks that measured thinner than the data plate listing are negative.

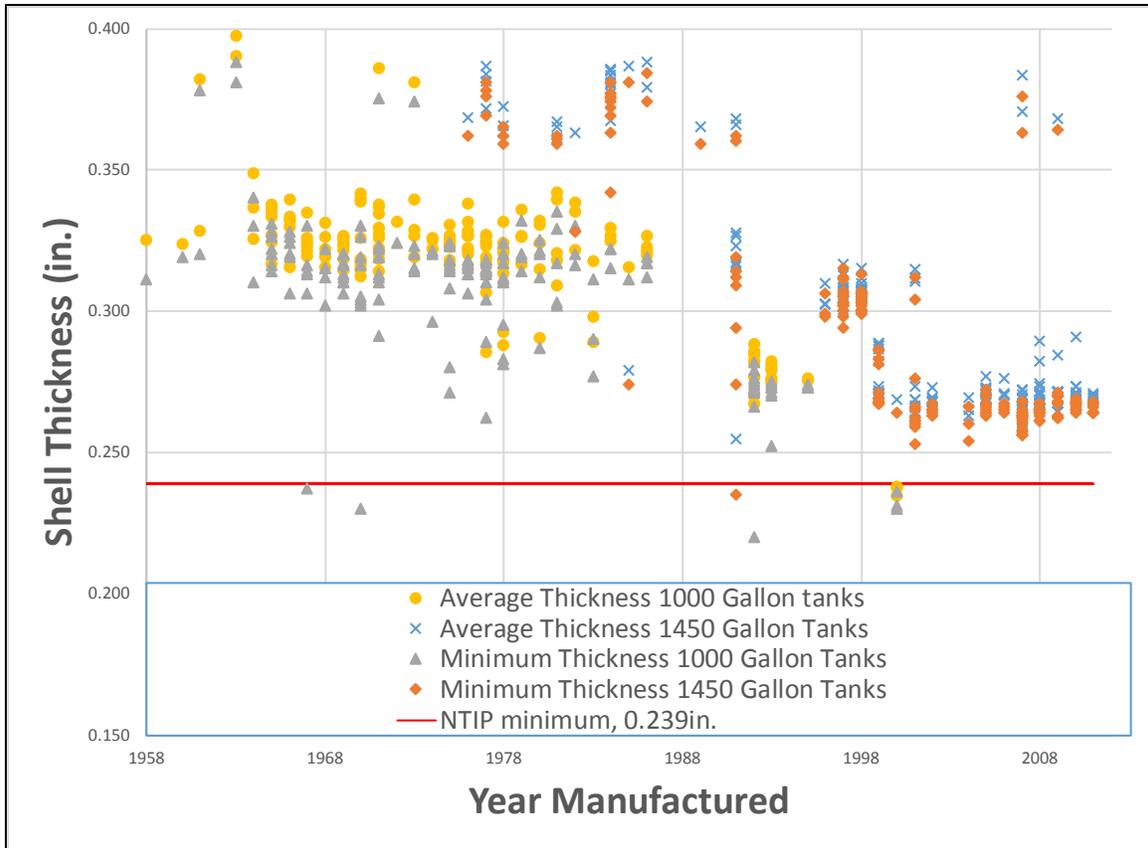
The averages of all the measurements obtained in Phase III for shells and heads are shown in Figure 23 and Figure 24, respectively. The plots show that only a small number of tanks tested have wall thicknesses of concern (i.e., that lie more than 0.1 inch below the stated value on the data plates). It is noted that the shell thickness values are clearly trending towards thinner walls, while the head thicknesses for the most part remain comfortably above the specified minimum thickness. This trend adds credibility to the Phase I and Phase II reports' suggestion that newer tanks are thinner than older tanks. As discussed in Section 2.2.1, this observation is one possible explanation for an increase in indication initiation and growth in newer tanks.

Figure 23. Scatterplot. Plot showing the average and minimum head thicknesses measured on individual tanks. Different approximate tank capacities are indicated by different markers, and any measurements (either average or minimum) that measured thinner than the NTIP minimum values are below the red line.
