# **Valve Integrated Pressure Regulator Examination (DOT DUNS #079807449)**

Report Number:  
**R-WHA-15113-0-A-EX1**

**Mark Toughiry  
Pipeline and Hazardous Materials Safety Administration  
1200 New Jersey Avenue, SE  
East Building, 2nd Floor, Room E21-338  
Washington, DC 20590**

**WHA International, Inc.**

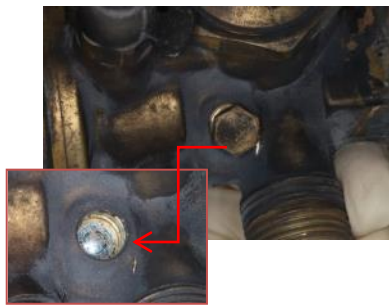
A - Burst Disk and Gasket

- Burst Disk (rupture disc and gasket intact)
- Fill Valve Assembly (inlet filter, poppet, spring, and O-rings intact)
- Pressure Gauge and “Snubber” Orifice (components intact and orifice visibly clean)
- Regulator Assembly (PTFE Seat and O-rings intact; evidence that external combustion products had projected through the regulator atmospheric vent port; but, no evidenced of internal combustion)
- Relief Valve Assembly (valve components, spring, O-rings intact; evidence of external heat affecting the lubricant consistency, but internal combustion patterns not evident)
- Auxiliary Port Assembly (poppet and O-rings intact)
- Flow Head Assembly (components and O-rings intact)
- Shuttle Valve Assembly (components, O-rings, and backup rings intact; evidence of external combustion residue projecting into portions of the shuttle valve, but, no evidence of internal combustion evident)

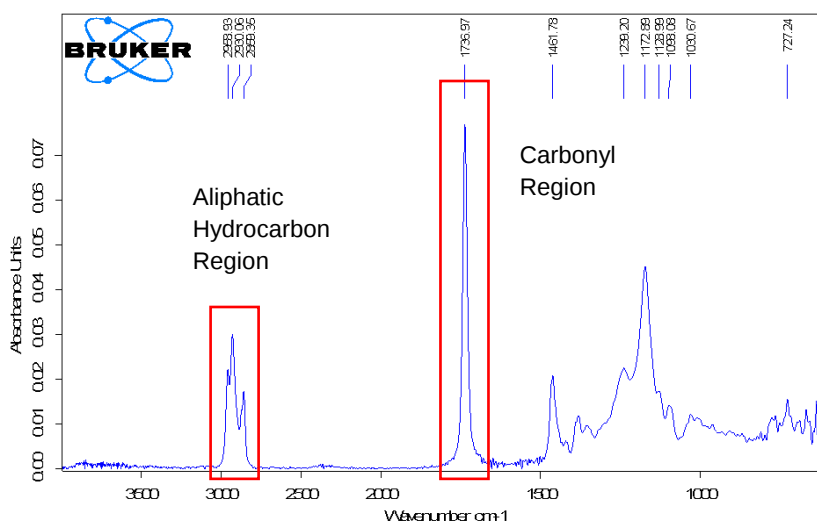
**Figure 16 - Dioctyl Sebacate Characteristic FTIR Spectra**

Some investigations on Grab-n-Go VIPR fires have attributed critical contamination to an EPDM o-ring gland seal that provides the seal between the VIPR and cylinder. In the present investigation, the gland seal o-ring was PTFE and not EPDM. However, these allegations persist. Contamination from EPDM gland seals have been attributed to a plasticizer incorporated into the seal to provide flexibility, primarily Dioctyl Sebacate (DOS), that is alleged to have migrated from the o-ring during service. **Figure 16** shows FTIR spectra for this plasticizer (plasticizer spectra only, not identified with this evidence).

As shown, DOS plasticizers exhibit a characteristic stretch in the aliphatic hydrocarbon region, located between approximately  $2800\text{ cm}^{-1}$  and  $3100\text{ cm}^{-1}$ . DOS also exhibits a characteristic carbonyl stretch at  $1737\text{ cm}^{-1}$ . It is noteworthy that the carbonyls relative absorbance peak amplitude is characteristically greater than the aliphatic hydrocarbons relative peak amplitude.

In contrast to **Figure 16** for DOS (only), the contamination found in the VIPR and cylinder were predominantly aliphatic hydrocarbons inconsistent with only DOS. **Figure 13**, **Figure 14**, and **Figure 15** depict weak carbonyl stretches; however, the ratio of the carbonyls relative absorbance to the hydrocarbons relative absorbance indicates that an unidentified hydrocarbon-based contaminant was predominant in the samples. If the contamination were solely due to DOS, the spectrum would show a larger carbonyl peak as compared to the aliphatic hydrocarbon peak, which was not the case. Therefore, the hydrocarbon-based contaminant observed on the incident components was primarily an unidentified saturated hydrocarbon<sup>3</sup>.

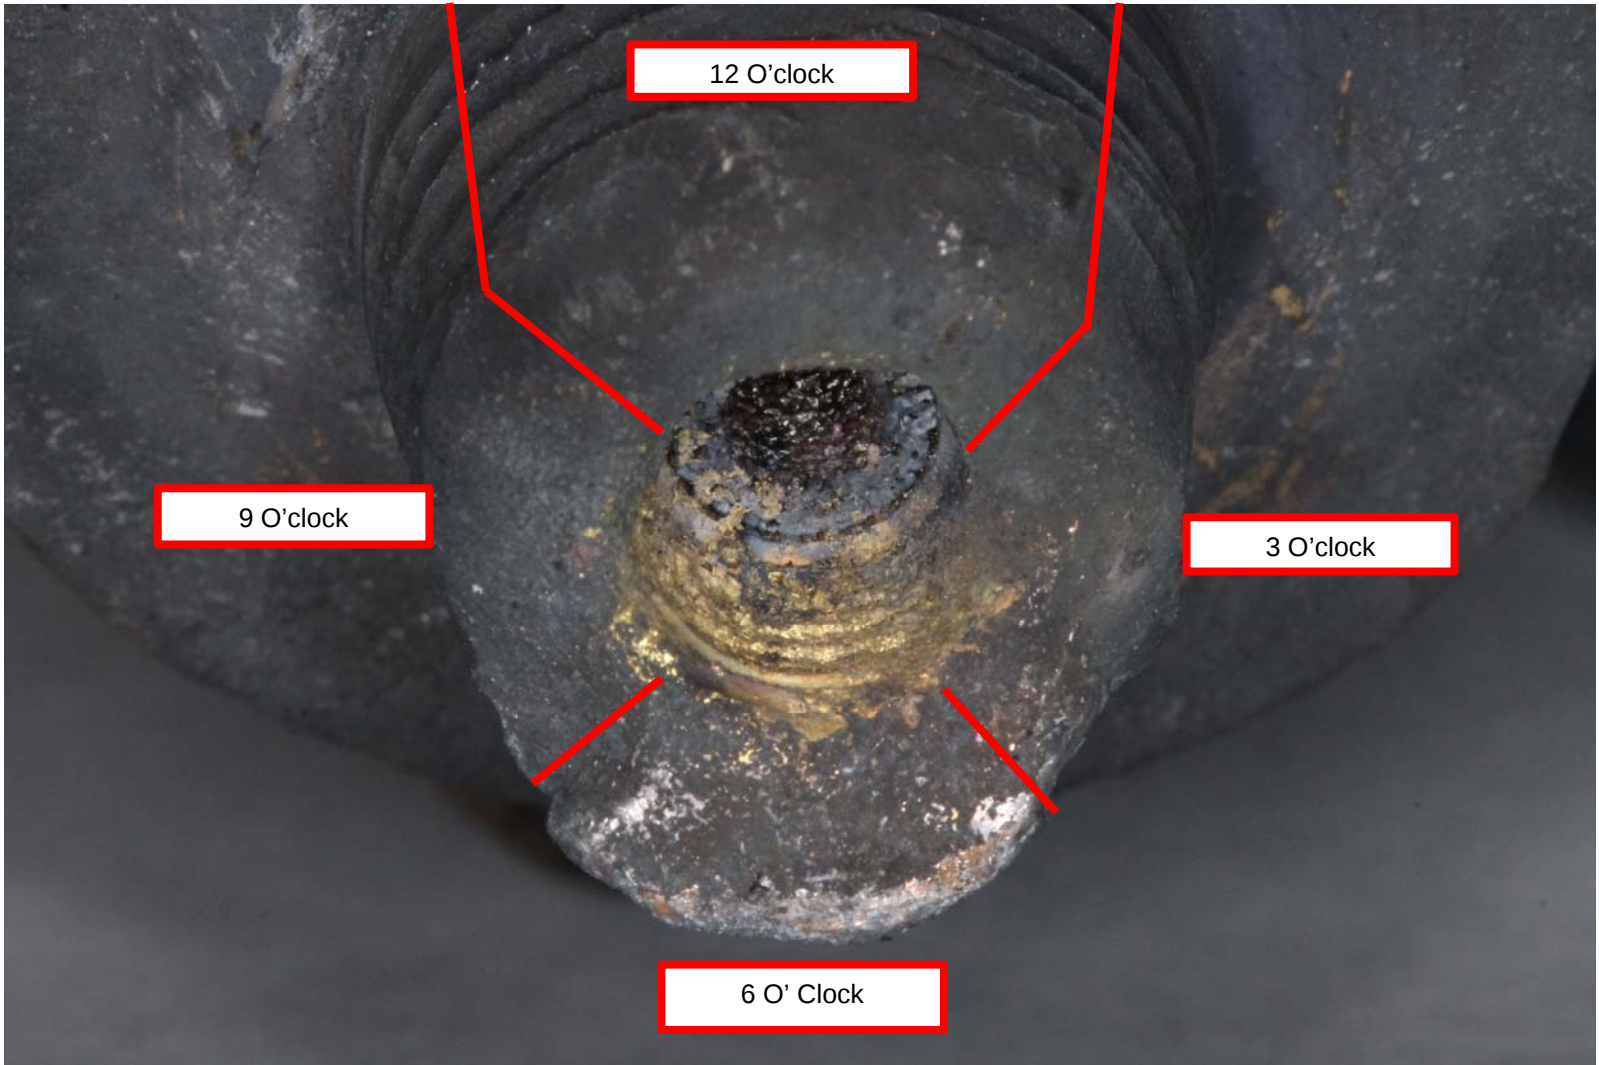
**Figure 2** – EVID-15113-0-A1 Valve Threads (Including Flange) Approximate Area of Analysis (Excludes Face Area

- *Al content was greatest for the 6 o'clock thread position (region of thread that experienced less material loss)*
  - o 12 o'clock position: Al content (~10%) generally consistent throughout thread position from damaged end to flange
  - o 3 o'clock position: Al content generally higher on damaged end (~12%) than flanged end (~6%)
  - o 6 o'clock position: Al content generally increasing from damaged end (~18%) to flanged end (~30%)
  - o 9 o'clock position: Al content (~12%) consistent throughout thread region from damaged end to flange, highest amount of Al (~18%) on thread region near flange

- *Generally more Pb and Mo observed at damaged end of thread positions*
  - o 6 o'clock position observed this trend for Mo but there was no Pb (region of lesser material consumption)

- *C and O typically higher on damaged end of thread (12, 3, 9 o'clock positions)*
  - o Exception was 6 o'clock position where O remains consistent throughout threaded region and C generally higher on damaged end (region of lesser material consumption).

- *Cu content generally consistent throughout each thread region*
  - o Exception positions 3 and 9 where Cu content is generally higher at flanged end (lesser at damaged end)

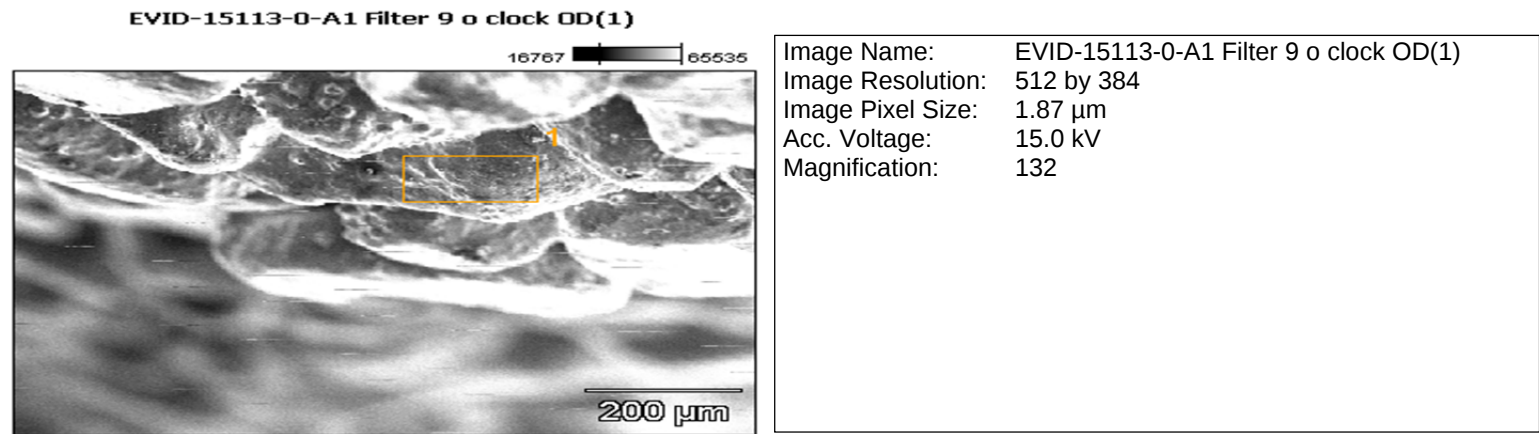
EVID 15113-0-A1 Valve Stem Filter Exterior Near Filter Face Facing Cylinder 9 O'clock Quadrant 4: First Scan Magnified

**Area of analysis uncertain**- Analysis was shot on the outside of the filter at an angle that would have the beam hitting the sample clamp and reflecting into the detector. The sample clamp analysis is included below
