Preventive Maintenance Study - Final Report

WA-RD 871.2

Preventive Maintenance Study

Washington State – Statewide Locations

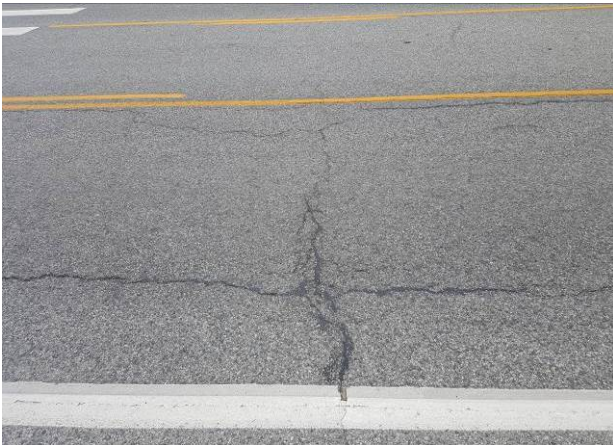
Figure 6. NC2, US2, Good, age 38 months. No spalling or potholes.

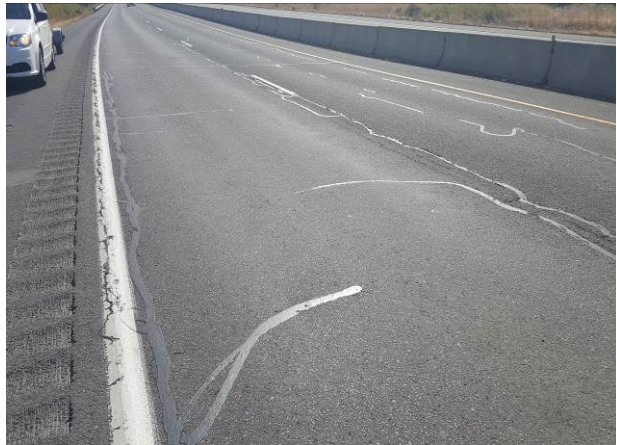
Figure 7. SC1, SR97, Good, age 25 months. No spalling or potholes.

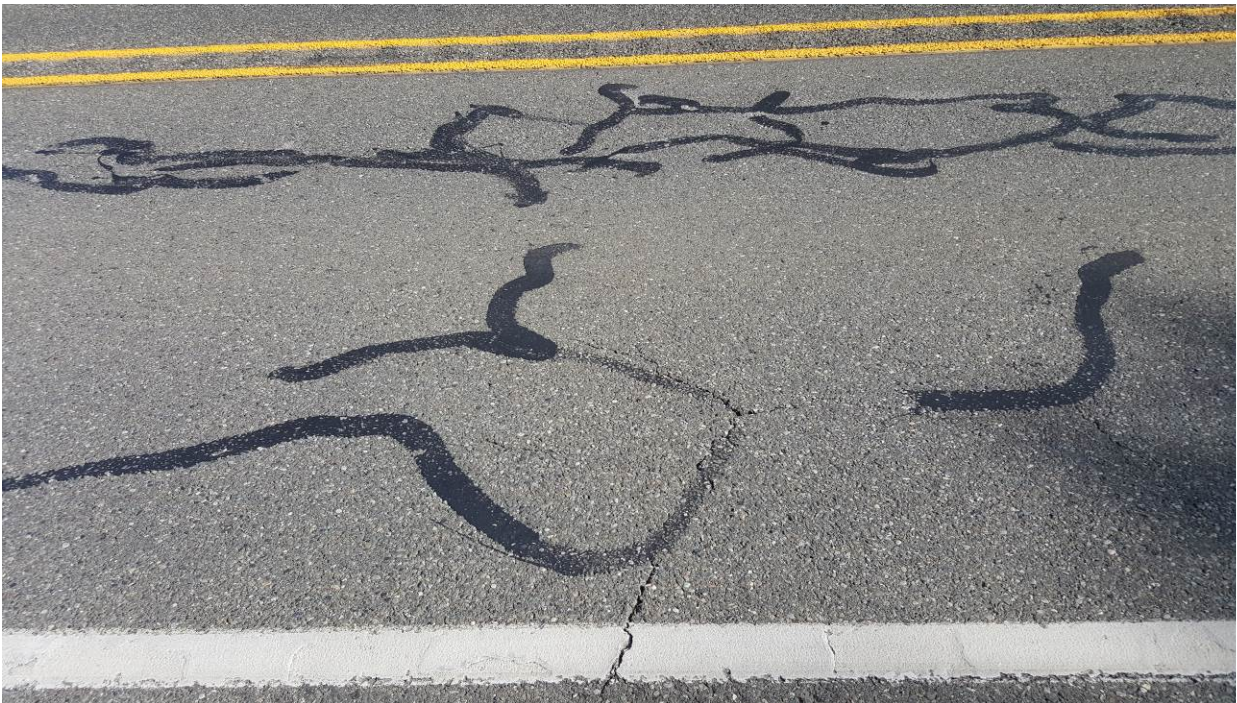
Figure 17. OR1, SR101, three years after installation. There is not much change from year one.

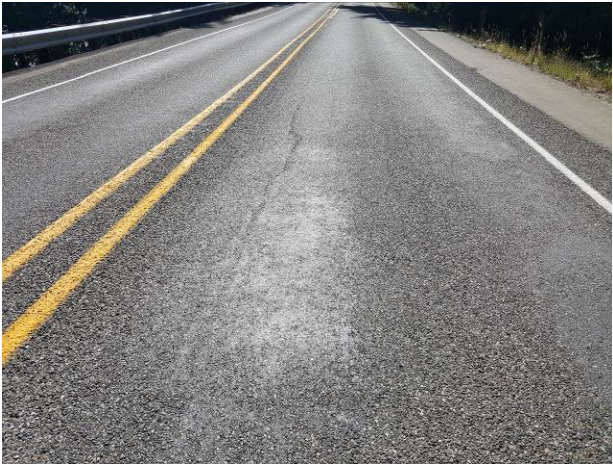
Figure 20. OR1b, SR101, Poor, age 62 months. Longitudinal cracking noted at 21 months. Slight flushing in the wheel paths.

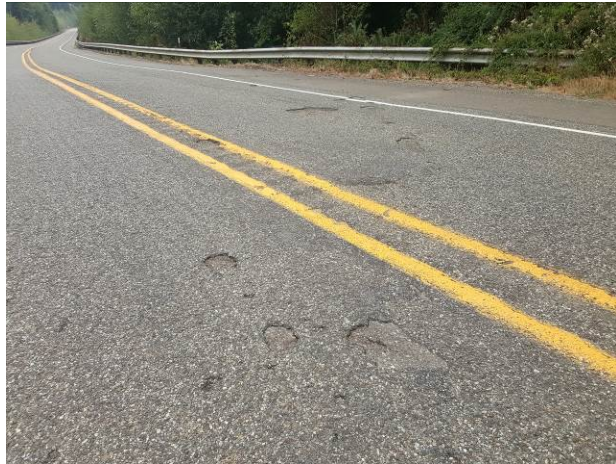
The four full lane chip seal test sites ranged in age from 26 to 62 months at the 2017 inspection. The performance of the full lane chip sealing sites has been disappointing with two of the four sites either flushing in the wheel paths or raveling across the entire lane. Longitudinal cracks that were not sealed prior to the chip seal are reflecting through the chip seals on three of the four sites. Alligator cracking with pumping of fines is present on the fourth site. Most of the chip seals constructed under region wide contracts over many numbers of years have had excellent performance, indicating that the problems on these test sites may be due to materials or workmanship issues. It may also be that the chip seal was placed on a surface with distress not compatible with a chip seal such as delamination (see Figure 21). Figures 20-23 show the condition of the chip seals at the four test sites.

Figure 21. OR3b, SR101, Poor, age 62 months. Delamination and spalling noted.

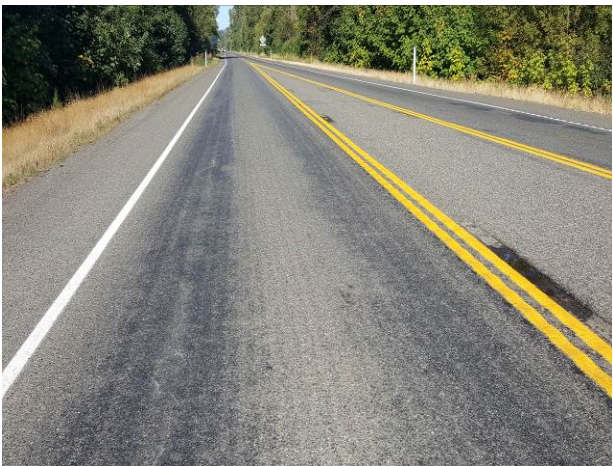
Figure 22. OR16, SR16, Good, age 49 months. Longitudinal cracking and pumping of fines noted at 14 months. Alligator cracking noted at 49 months.

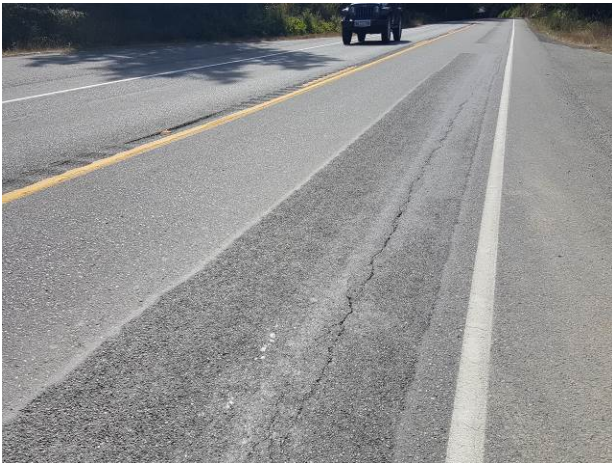
Figure 30. OR12, SR20, Good, age 49 months. Longitudinal reflection crack and flushing noted at 10 months.

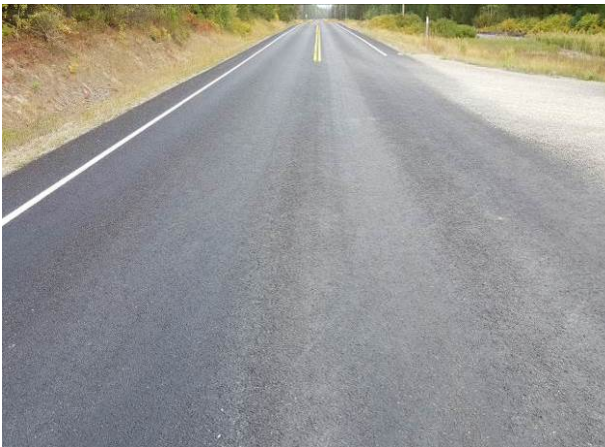
Figure 38. ER7, SR20, Good, age 37 months. BST in 2015, C9728, at the age of 37 months.

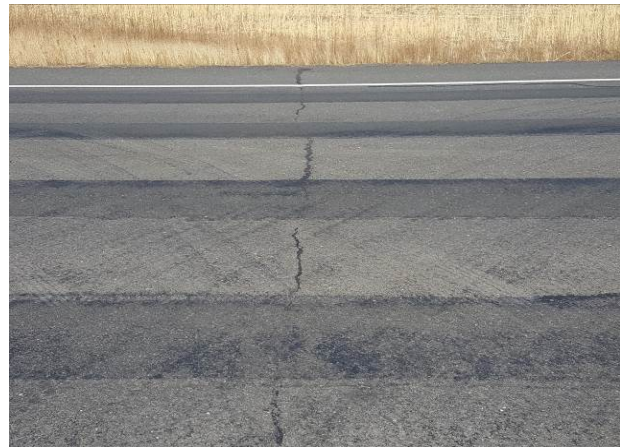
Figure 39. ER10, US2, Good, age 36 months. Cracking noted at 12 months. Loss of aggregate in both wheel paths.

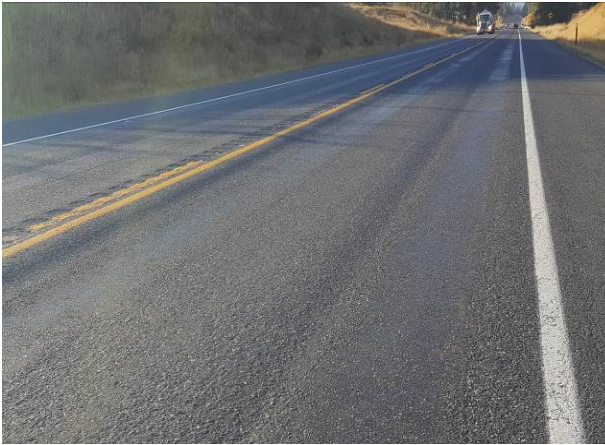
Figure 40. ER15, SR395, Good, age 24 months. Flushing noted in 2017. Transverse reflection cracking noted.

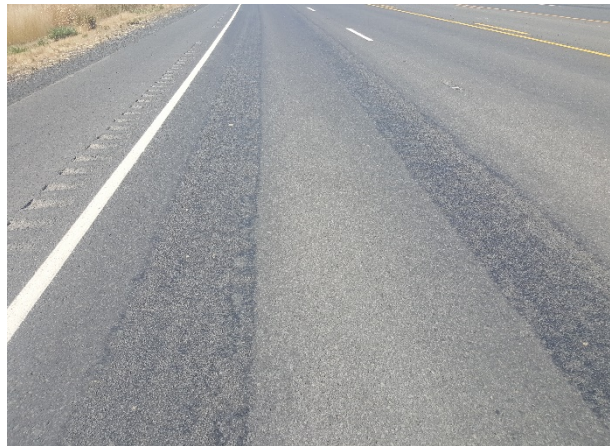
Figure 42. ER40, US270, Good, age 26 months. Loss of chips in both wheel paths.

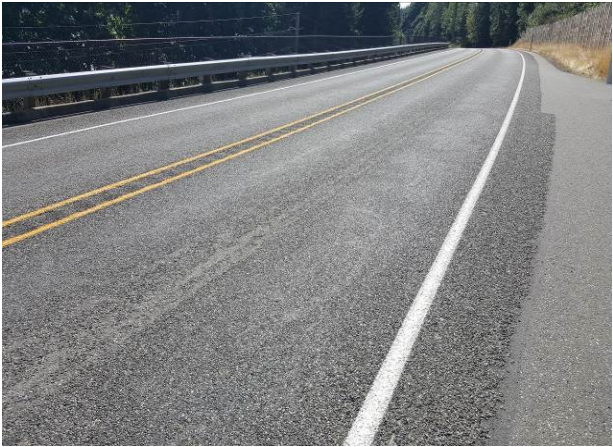
Figure 48. OR1a, SR101, Poor, age 62 months. Underlying crack sealant can be seen as shadowing.

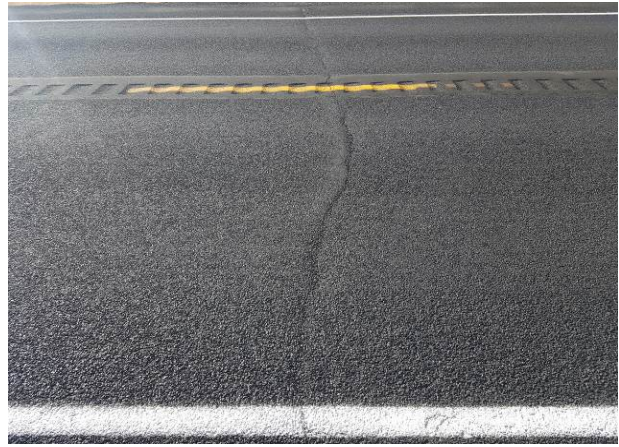
Figure 49. NC1, SR155, Good, age 38 months. Transverse crack locations are depressed and very thin cracks are present.

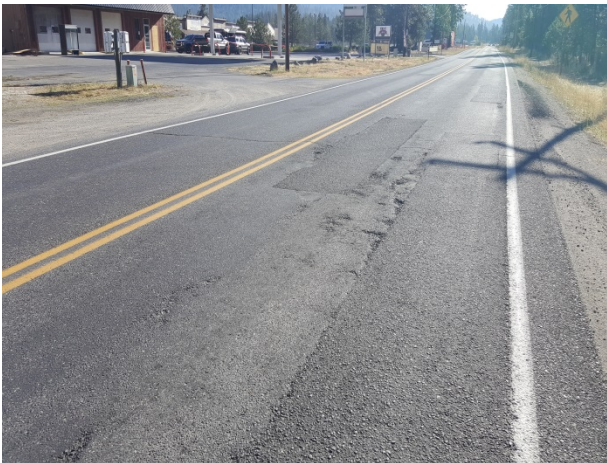
Figure 58. ER3, SR291, Fair, age 62 months. Additional dig outs added in 2015. Transverse reflection crack noted at 10 months after treatment. More dig outs are scheduled for installation in 2017 and a HMA grind/inlay in 2018, C9223.

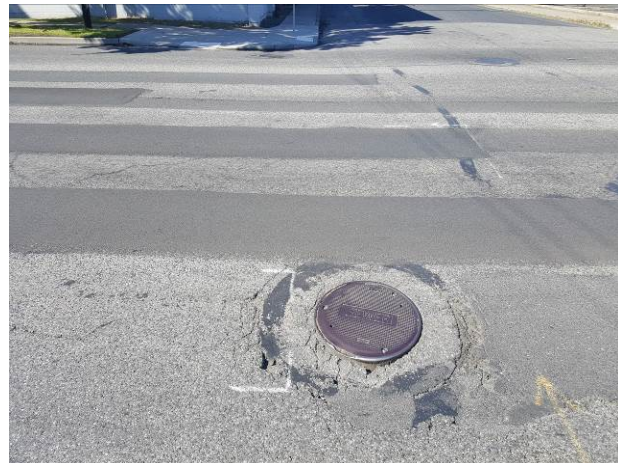
Figure 59. ER4, US2, Fair, age 62 months. Additional dig outs installed in 2013 and 2015. Note different colors of dig out patches done in different years. HMA grind/inlay scheduled in 2018, C9187

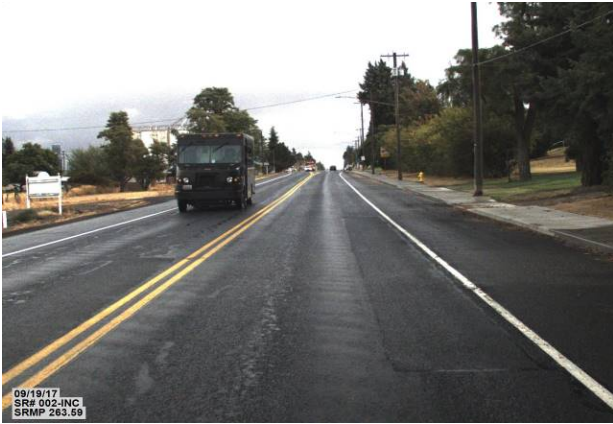
Figure 60. ER5, US2, Poor, age 49 months. Transverse reflection crack at the age of 10 months.

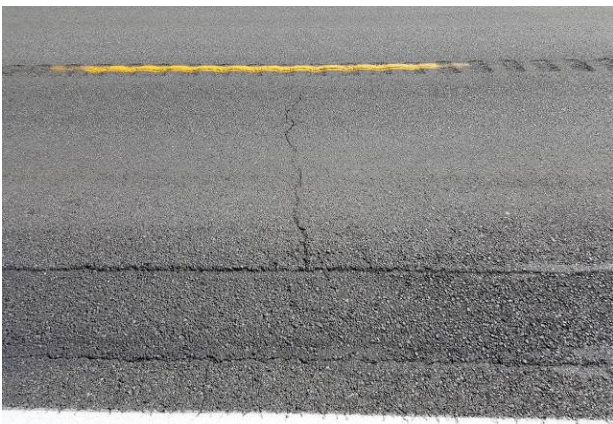
Figure 64. OR11, SR20, Good, age 49 months. Raveling of patch edges noted at 25 months.

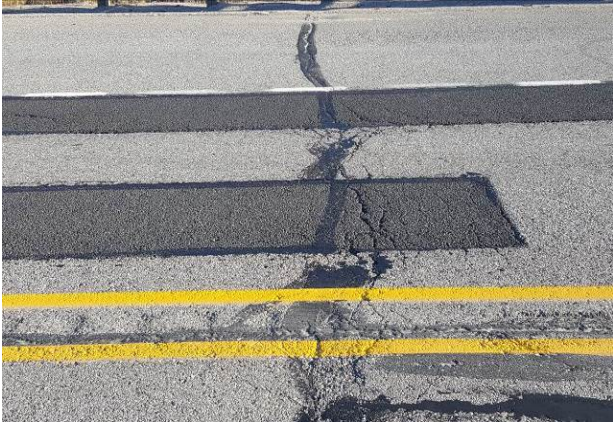
Figure 66. ER9, SR395, Good, age 37 months. Additional dig outs installed in 2015. Transverse reflection cracking noted in 2017.

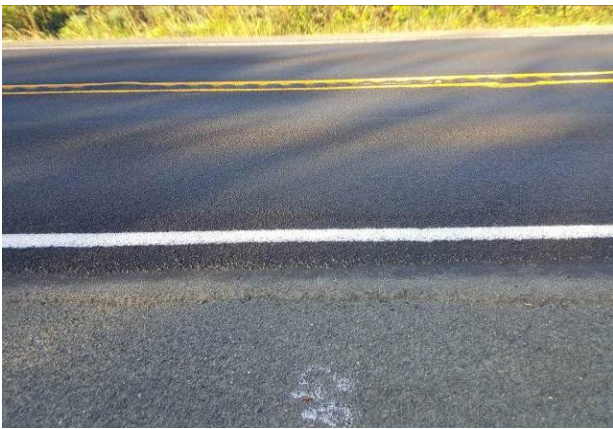
Figure 68. SW5, SR6, Good, are 38 months. More dig outs added in 2015. HMA grind/inlay in 2017, C9087.

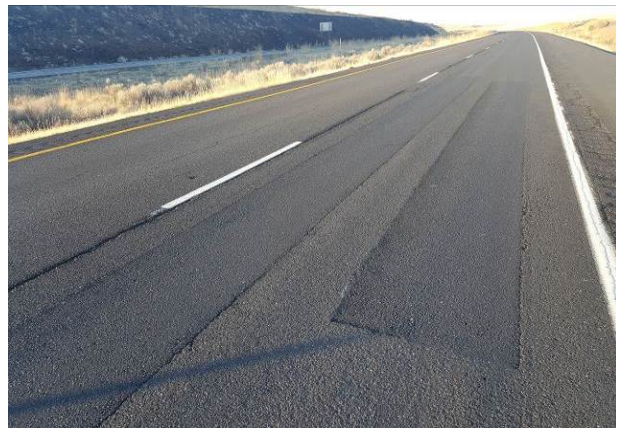
Figure 69. ER17, SR395, Good, age 26 months. Transverse reflection cracking in 2017.

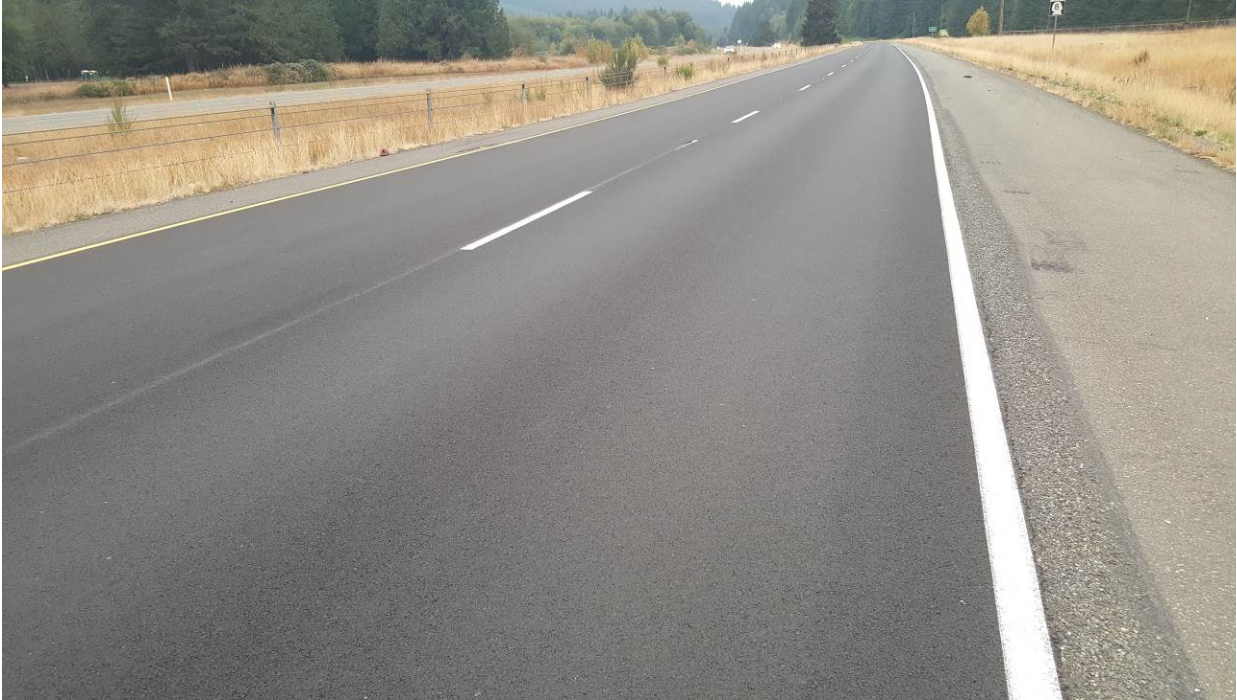
Figure 83. OR2, SR8 five years after installation. HMA grind/inlay in 2017 under Contract 9001.

The dig out patch shown in the photos has not changed in appearance for 62-months except for some slight rutting. The section received an HMA grind/inlay in 2017.

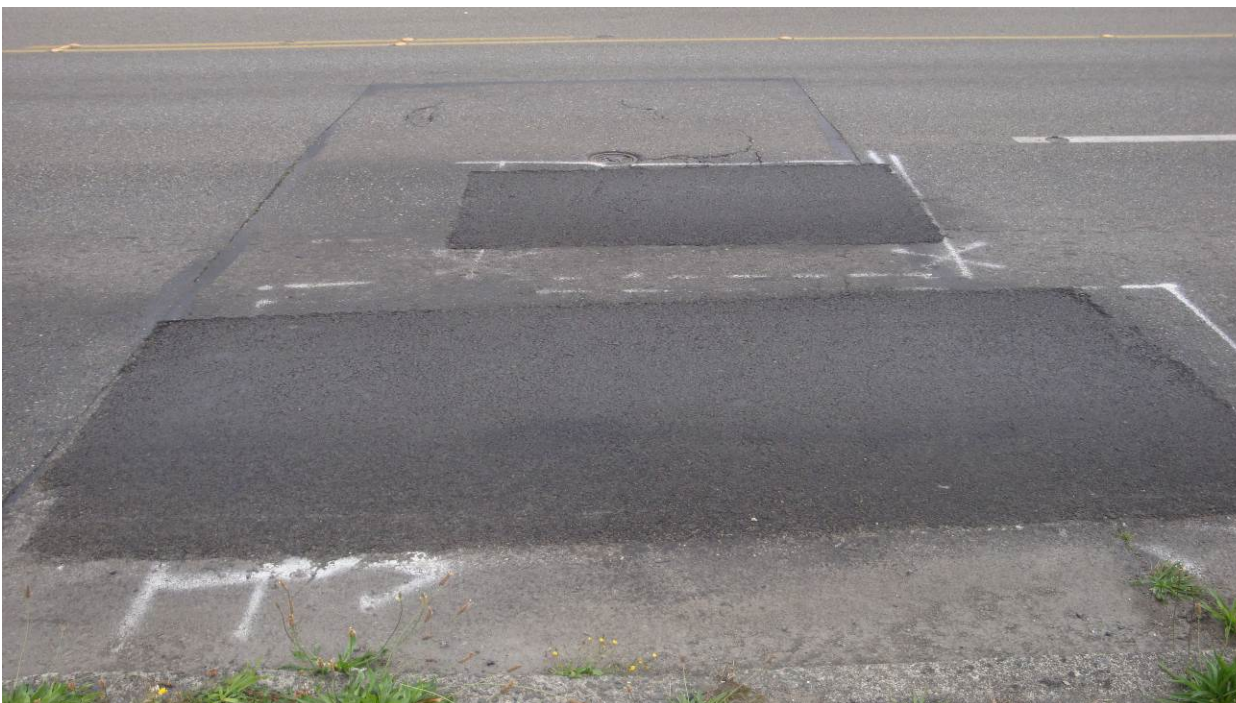
Figure 85. OR5, SR7, immediately after installation in 2013. Dig out patches look good. They appear to be related to utility cuts in original pavement.

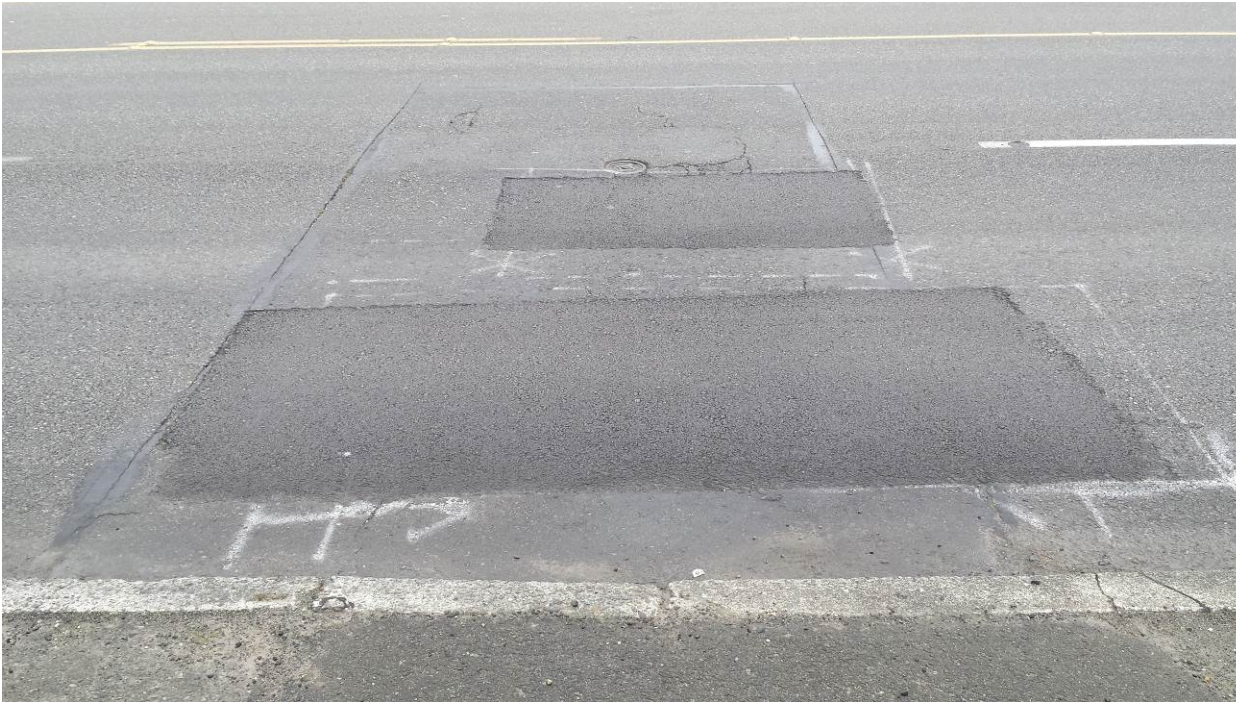
Figure 86. OR5, SR7, one year after installation. No change in the dig out patches.

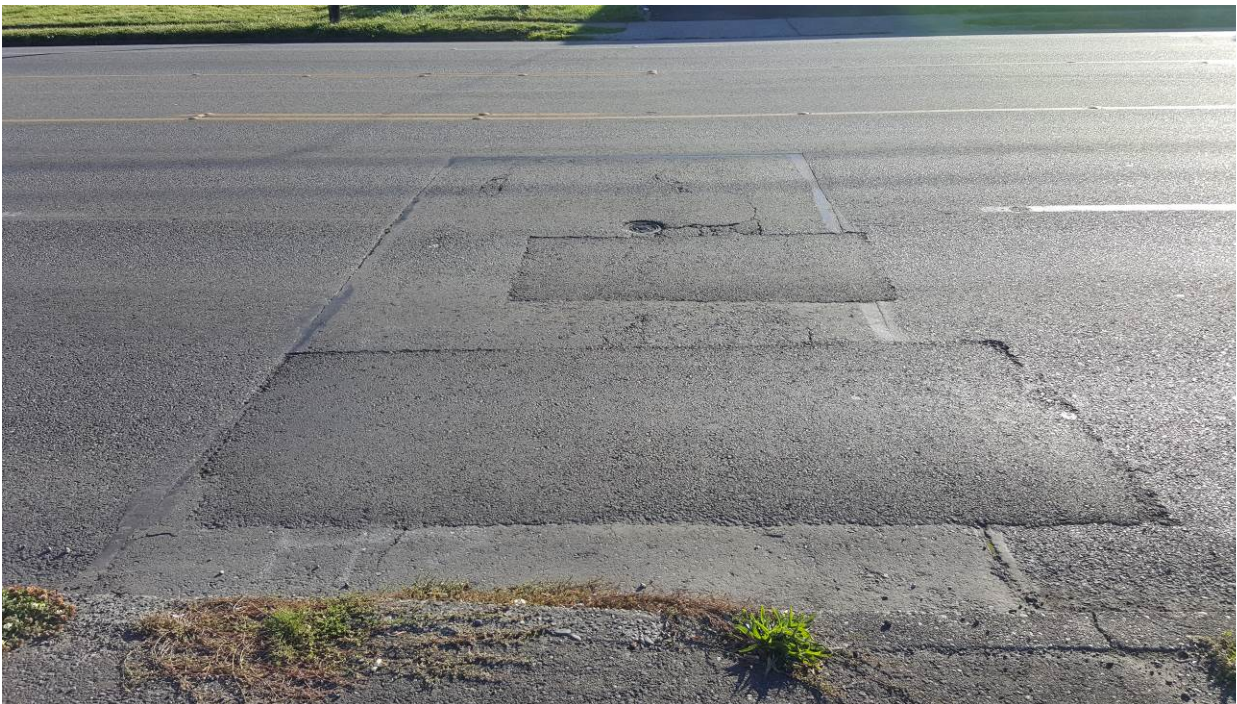
Figure 87. OR5, SR7, two years after installation. No change in the dig out patches.

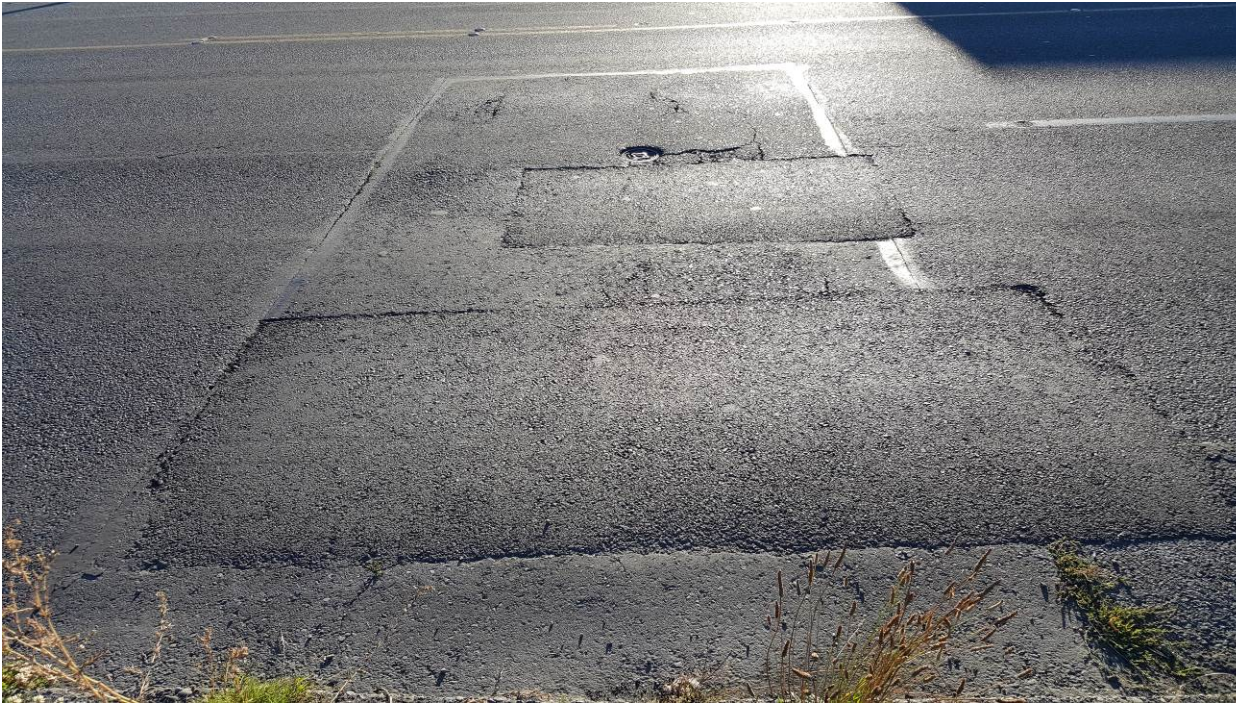
Figure 88. OR5, SR7, three years after installation. No change in the dig out patches.

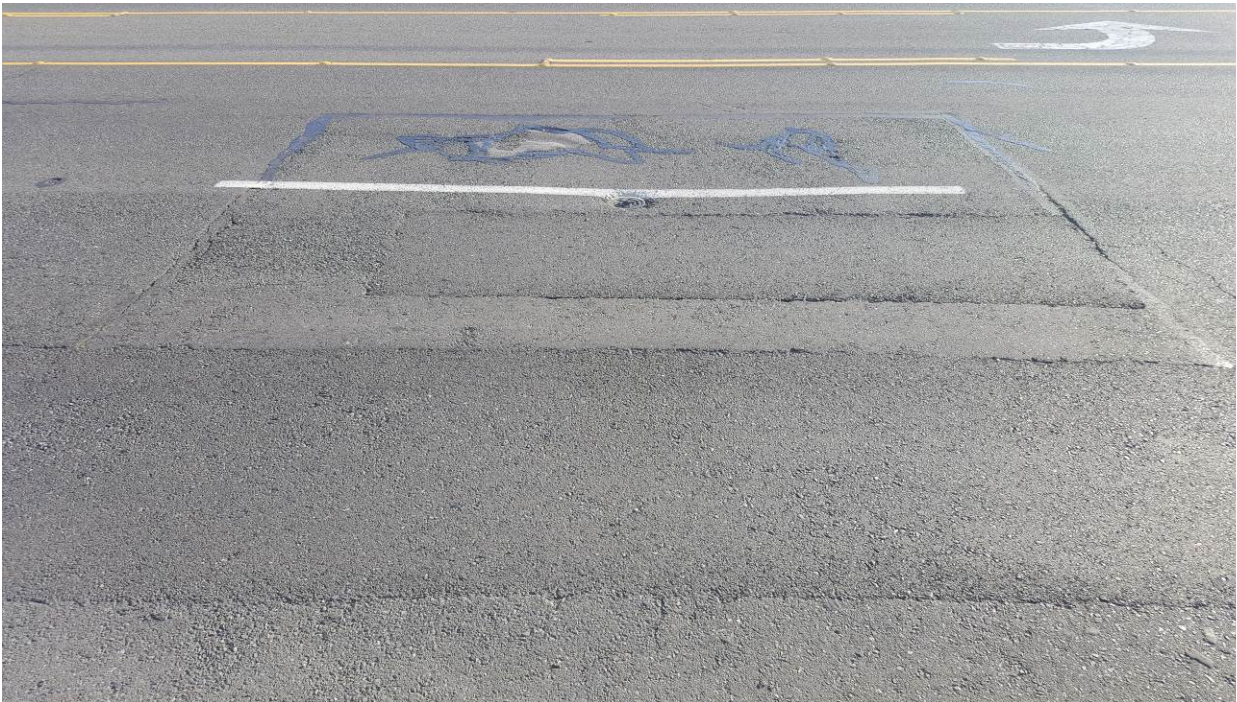
Figure 89. OR5, SR7, four years after installation. No change in the dig out patches. Different location in the same test site.

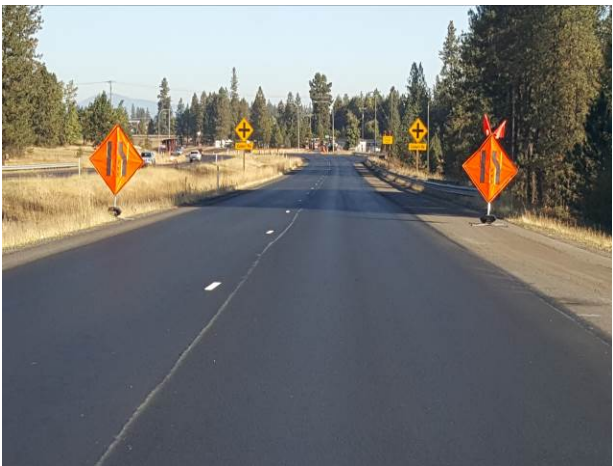
Figure 90. ER1, US2, Poor, 62 months. Additional dig outs and crack sealing done in 2015. HMA grind/inlay in 2017, C9124.

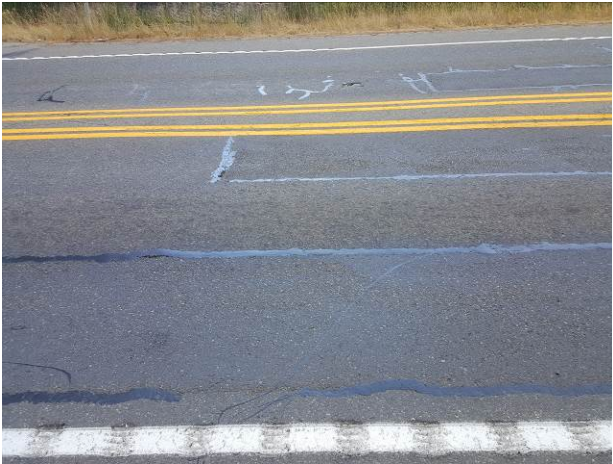
Figure 92. OR27, SR307, Good, age 26 months. Dig out patches and crack sealing in excellent condition.

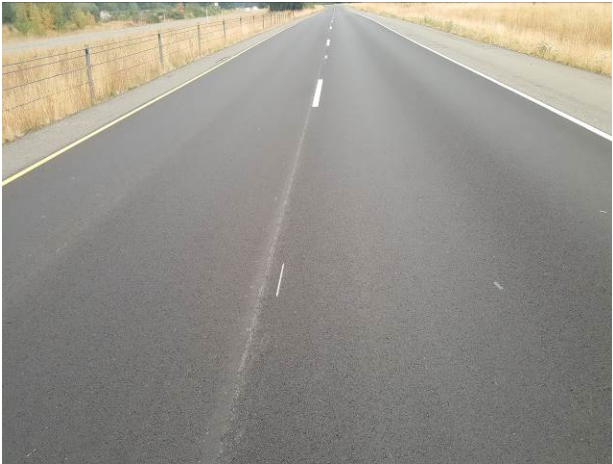
Figure 100. OR2a, SR8, Good, age 62 months. Flushing over the dig out patches. HMA grind/inlay in 2017, C9001.

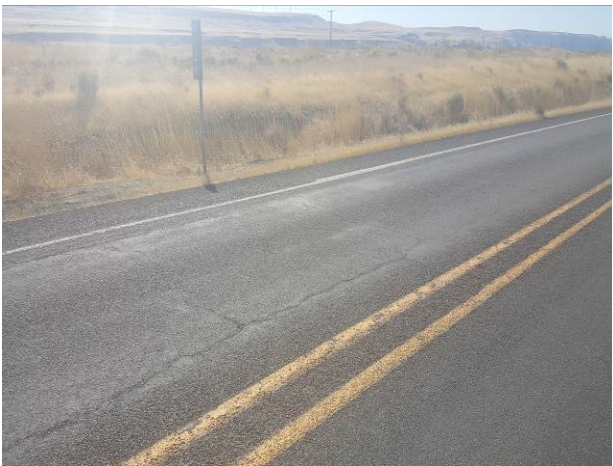
Figure 102. SW1, SR14, Poor, age 62 months. Transverse reflection cracking and flushing noted at 9 months after installation.

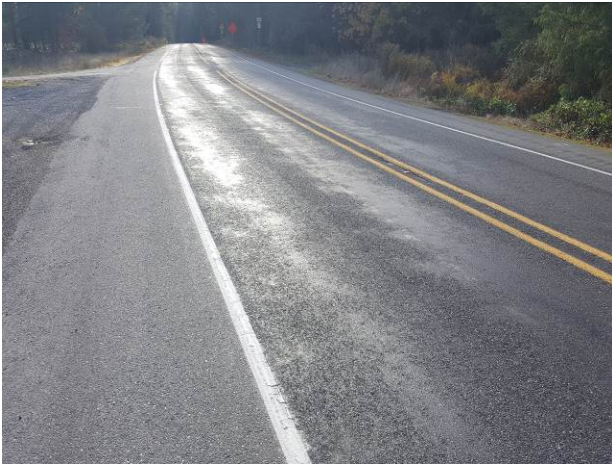
Figure 104. OR14, SR7, Good, age 51 months. Dig out patches flushing through the chip seal at 27 months.

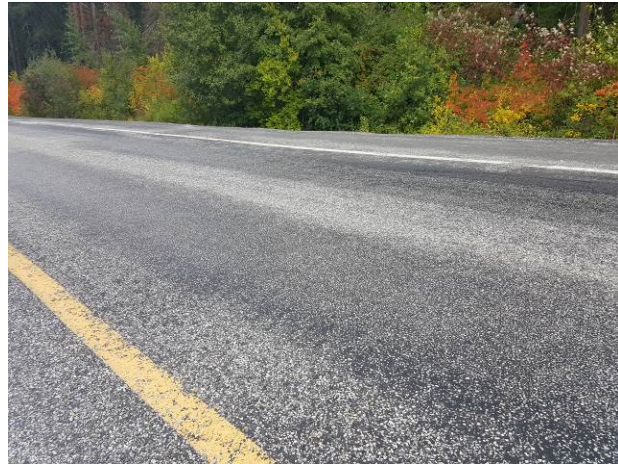
Figure 105. NC3, SR207, Good, age 38 months. Dig out patches flushing through the chip seal after 12 months. This is actually a HBST with 100% embedment in the wheel paths.

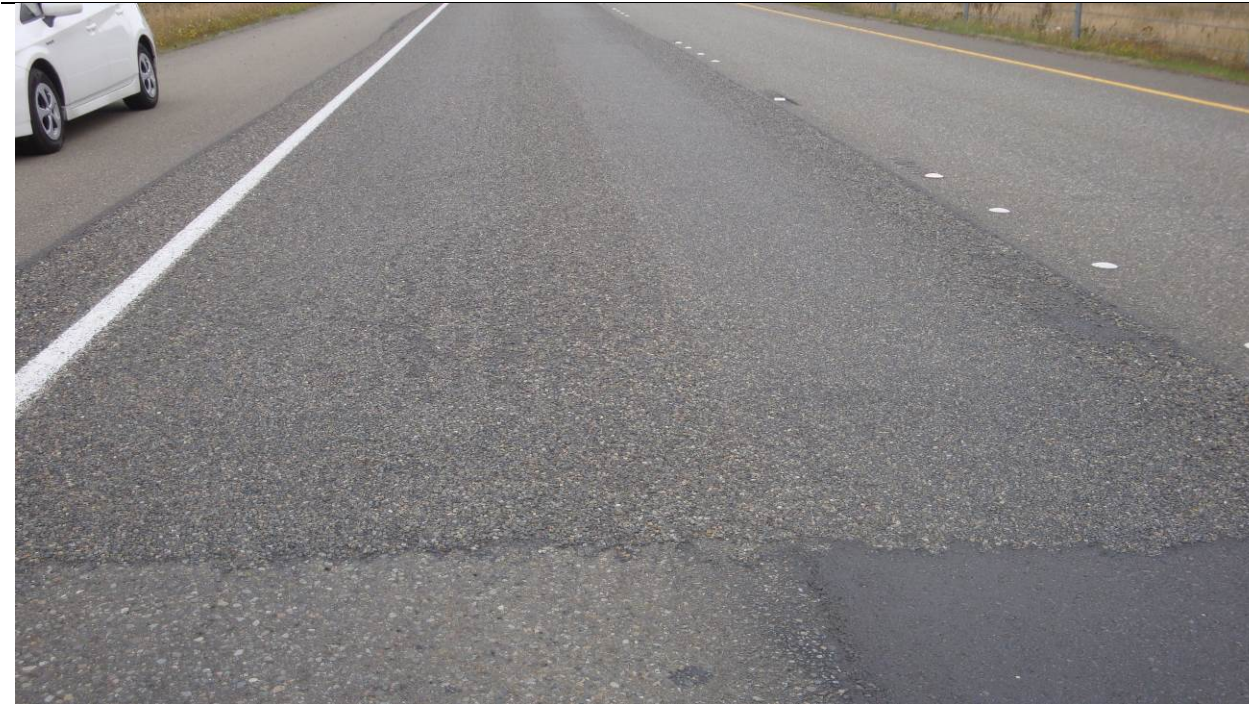
Figure 107. OR2a, SR8, one year after installation. Slight flushing in the wheel paths over the dig out patches.

The type of flushing observed on this site was typical of five of the six sites. The flushing was caused by an excess of asphalt binder that results from a combination of the binder from the patch and the new binder used for the chip seal process. The common practice used to prevent this type of flushing is to wait for a period of time before applying the chip seal. One year is advisable, but shorter periods of time may also work. If there is not sufficient time between the patch and the chip seal, it is recommended to apply a fog seal over the patch prior to the chip seal.

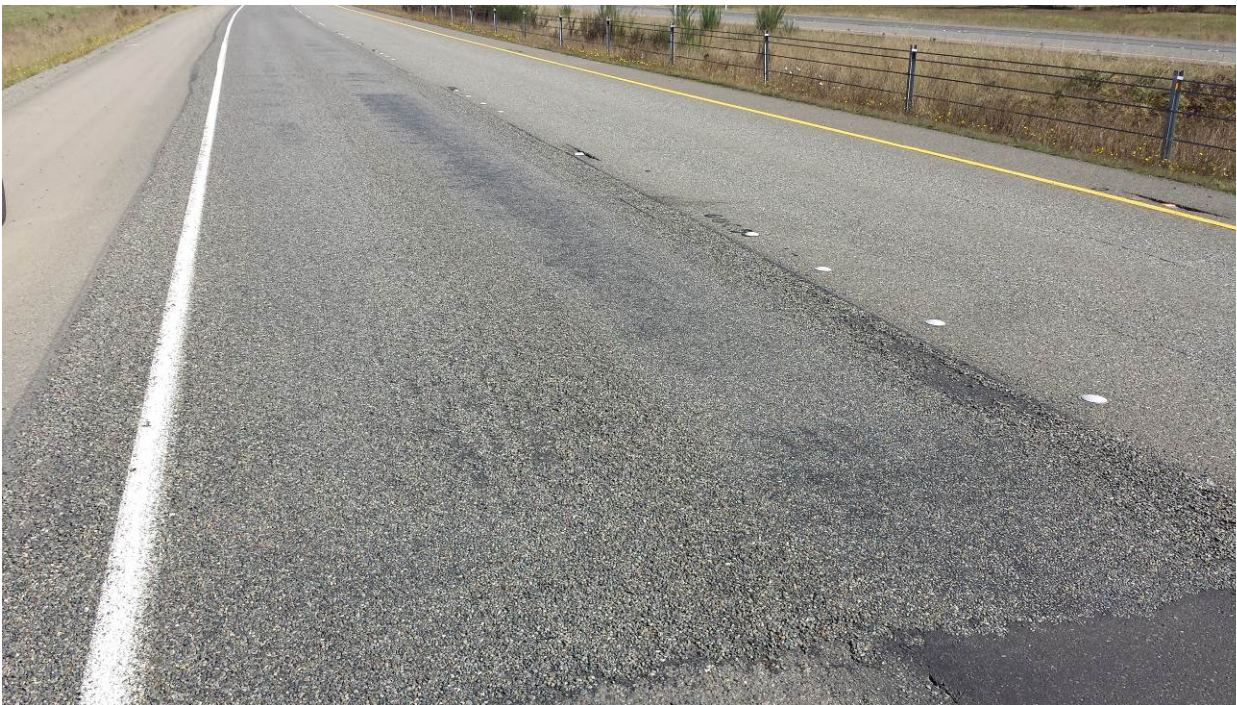
Figure 108. OR2a, SR8, two years after installation. Increased flushing in the wheel paths over the dig out patches.

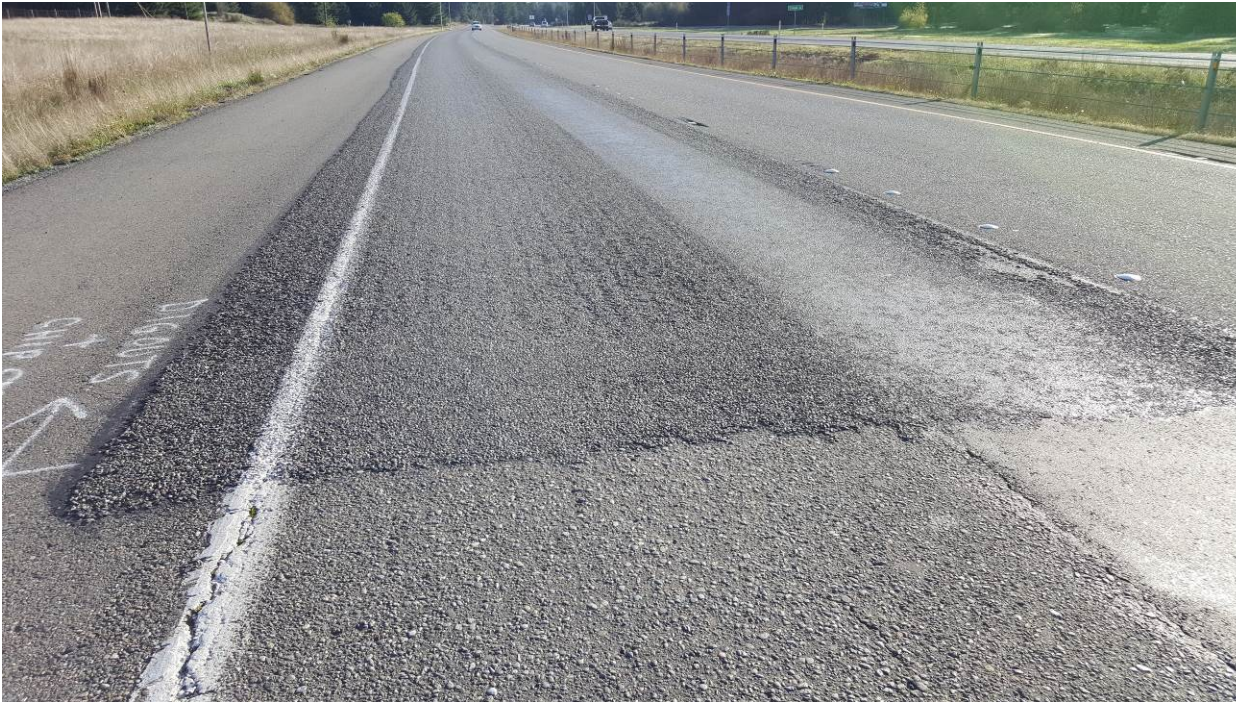
Figure 109. OR2a, SR8, three years after installation. Flushing in the left wheel path throughout the length of the chip seal.

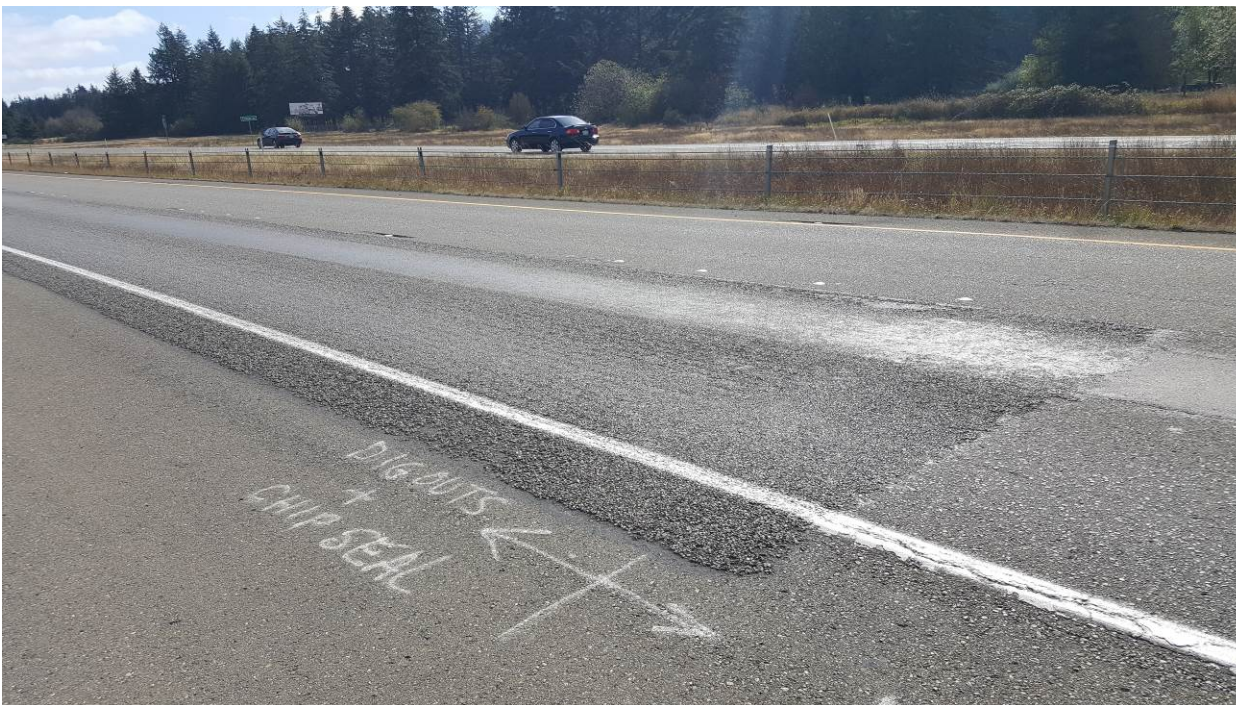
Figure 110. OR2a, SR8, four years after installation. Flushing has remained about the same as in 2015.

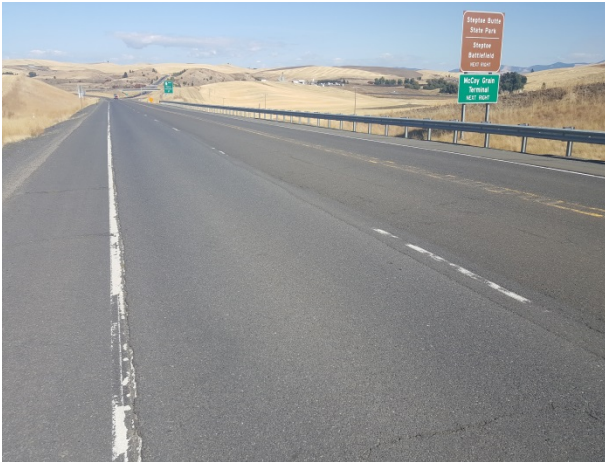
Figure 112. ER8, SR195, Good, are 39 months. Blade patch used to fill wheel path ruts. Additional patches placed in 2017.

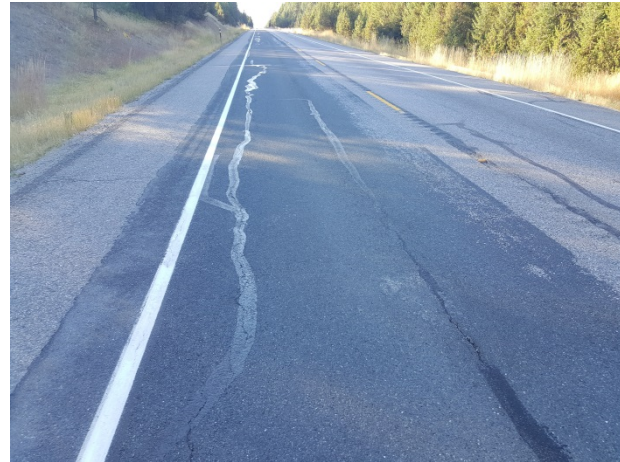
Figure 113. ER9a, SR395, Good, age 37 months. Transverse and longitudinal cracking reflecting through the patch at 13 months.

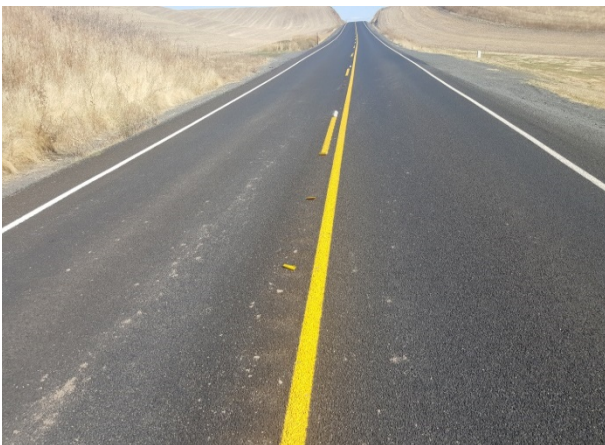
Figure 114. ER20, SR272, Good, age 24 months. Transverse crack reflecting through the patch. HMA grind/inlay in 2017, 9031.

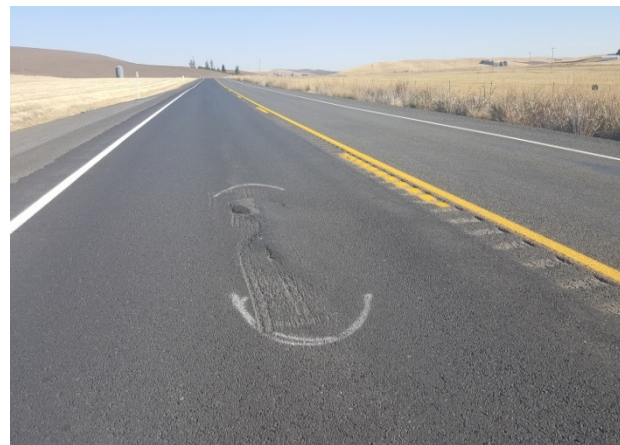
Figure 115. ER26, SR127, Good, age 26 months. Pot hole formed in 2016. Flushing in wheel paths noted in 2017.

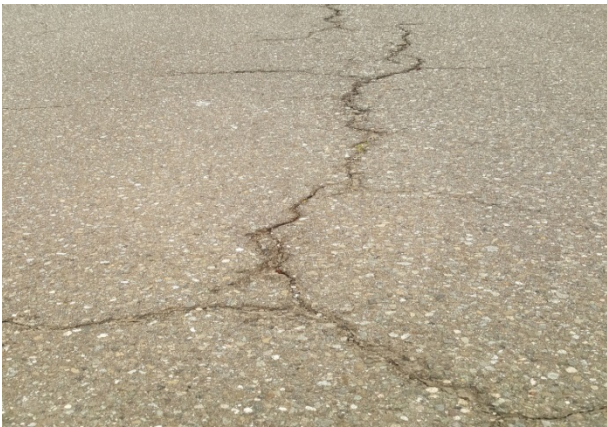
Figure 125. OR3a, SR101, Poor category, age 62 months. No maintenance as of the 2017 inspection.

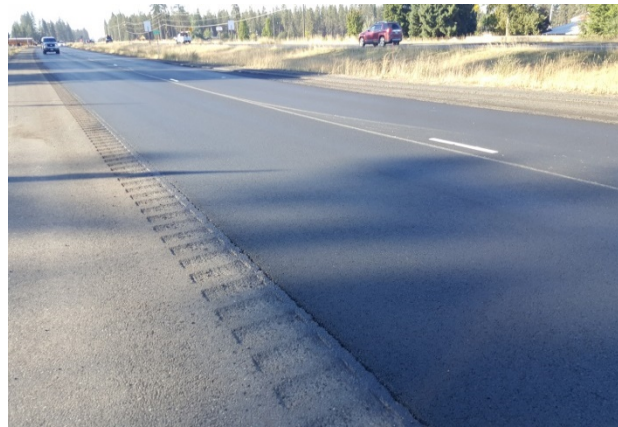
Figure 126. ER1a, US2, Poor category, age 62 months. Dig outs, crack sealing and patching were necessary to preserve the roadway. HMA grind/inlay in 2017, C9124.

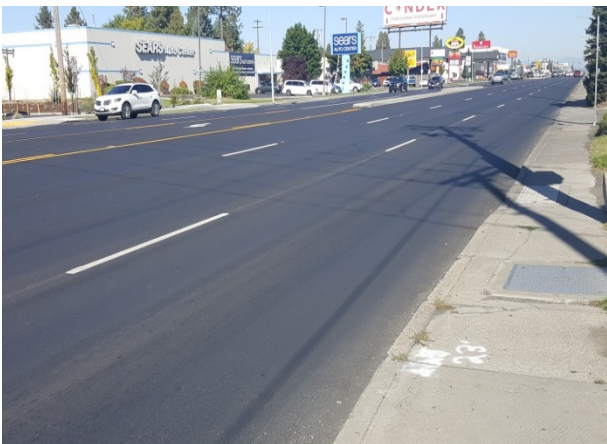
Figure 127. ER2a, US2, Poor category, age 62 months. Dig outs, crack sealing and patching were necessary to preserve the roadway. HMA grind/inlay in 2017, C9063.

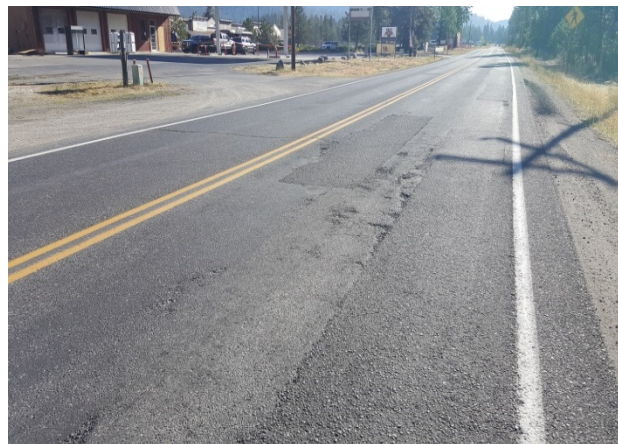
Figure 128. ER3a, SR291, Fair category, 62 months. Dig outs, crack sealing and patching were necessary to preserve the roadway. HMA grind/inlay scheduled in 2018, C9223

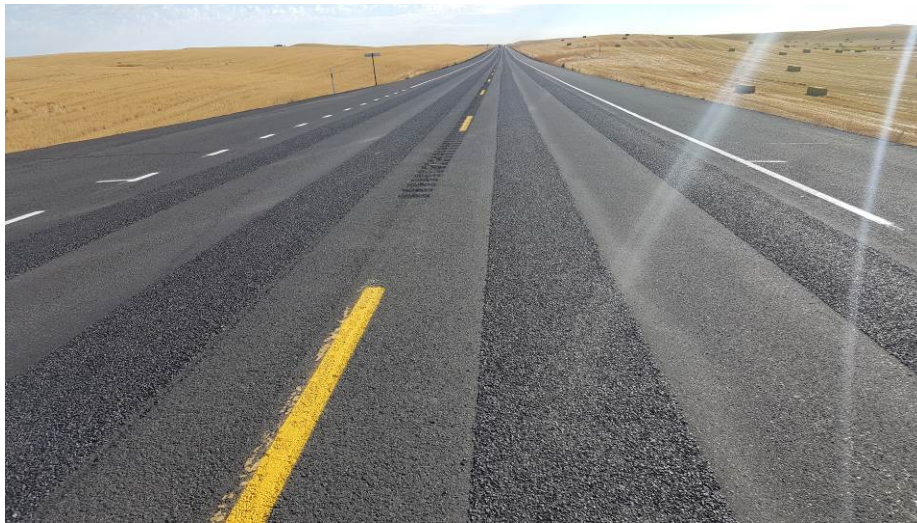
Wheel path chip sealing is a good option when alligator cracking is confined to the wheel paths or when there is rutting in the wheel paths (Figure 140). The Eastern Region used wheel path chip sealing to fill ruts followed by a full lane chip seal in following years.

Figure 140. ER10, wheel path chip seal rut filling on US 2. (September 2016)

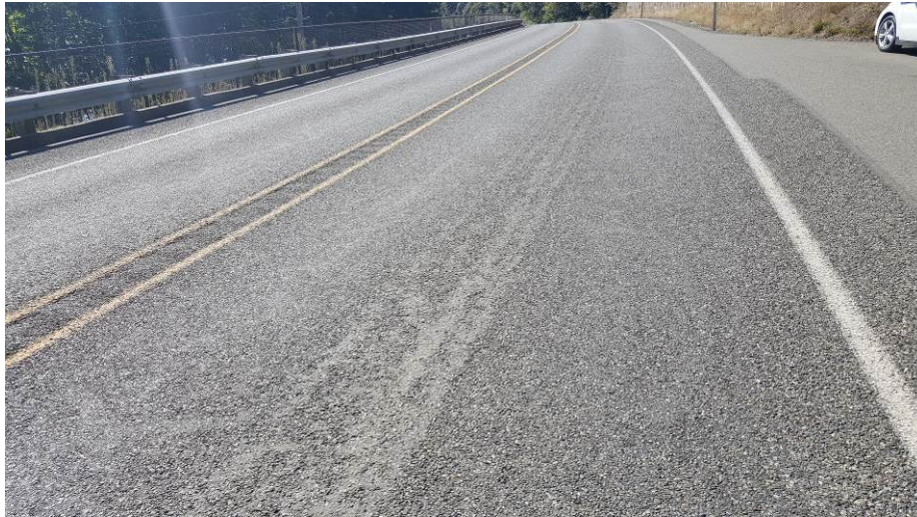
The crack sealing plus chip sealing is the next lowest cost option (Figure 142). It is best used where some of the cracks exceed 1/4 inch in width and some are very fine. Sealing these larger cracks prior to the application of the chip seal will likely prevent the cracks from reflecting through the chip seal. Its use was limited to two test sites, probably due to the higher costs involved. On the Olympic Region test site (OR1a), either crack sealing or chip sealing alone would probably have provided a solution that would have lasted five plus years. The adjacent sections, OR1 and OR1b, which received only crack sealing or chip sealing, respectively, have performed very well. On the North Central site NC1, a special crack sealant was used to seal very wide

Figure 142. OR1a crack sealing plus chip sealing on SR 101.
(September 2016)

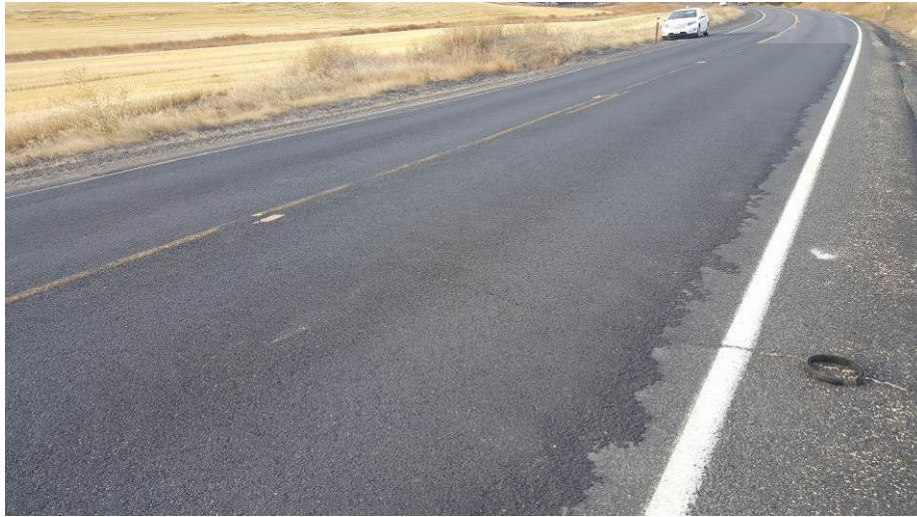
Blade patching is the next least costly treatment (Figure 143). It has limited application for roadways that are out of shape or have large cracks due to movement of the pavement caused by unstable subgrades or other issues. It is generally applied as an emergency stopgap treatment until a more substantial solution such as a mill and fill or full lane chip seal can be applied. The experience has been generally satisfactory, and since other treatments are not an option, it will continue to be used for the previously described pavement issues.

Figure 143. ER20 blade patch on SR 395. (September 2016)

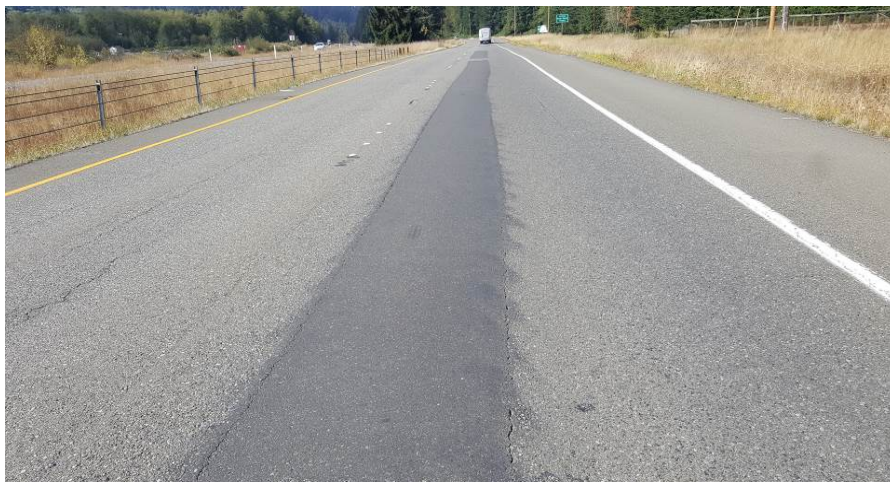
Dig outs are one of the more expensive treatments due to the high cost of equipment, labor and materials required to prepare the holes, fill the holes, and compact the HMA (Figure 144). It is used when the cracks in the wheel path have become wide or alligator cracking has developed and potholes are forming. It is very effective because it removes the entire area of the distressed pavement and replaces it with new HMA. The performance of the dig out patches has been excellent on all of the test sites.

Figure 144. OR2 dig outs on SR 8. (September 2016)
