Preventive Maintenance Study - Final Report

WA-RD 871.2

Preventive Maintenance Study

Washington State – Statewide Locations

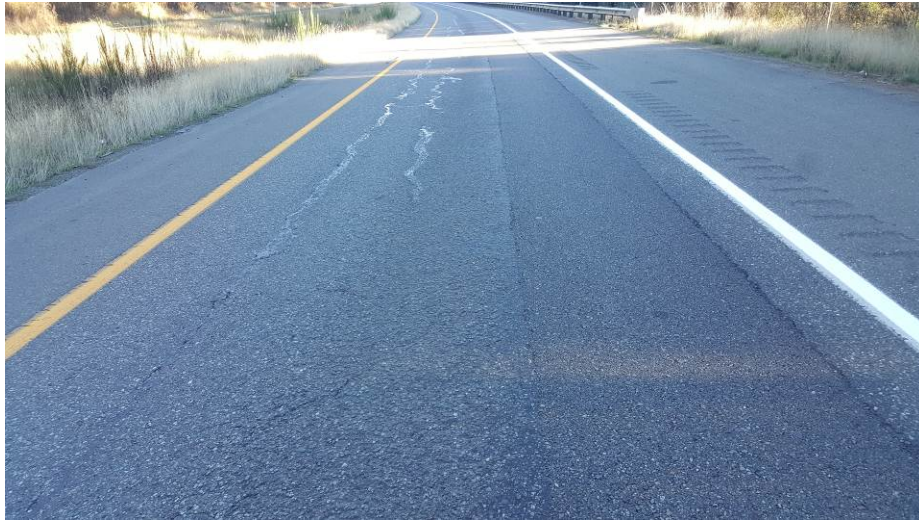
Using a combination of dig outs and crack sealing is a very expensive fix, but may be necessary to fix a pavement with alligator cracking in the wheel paths and longitudinal and transverse cracking throughout (Figure 145). The dig outs plus crack sealing test sites were ones in which the pavement was in such poor condition that the dig outs could not encompass all of the distressed pavement, and as a result, crack sealing was necessary to fill the large cracks between the dig outs.

Figure 145. OR4 dig outs plus crack sealing on SR 3. (September 2016)

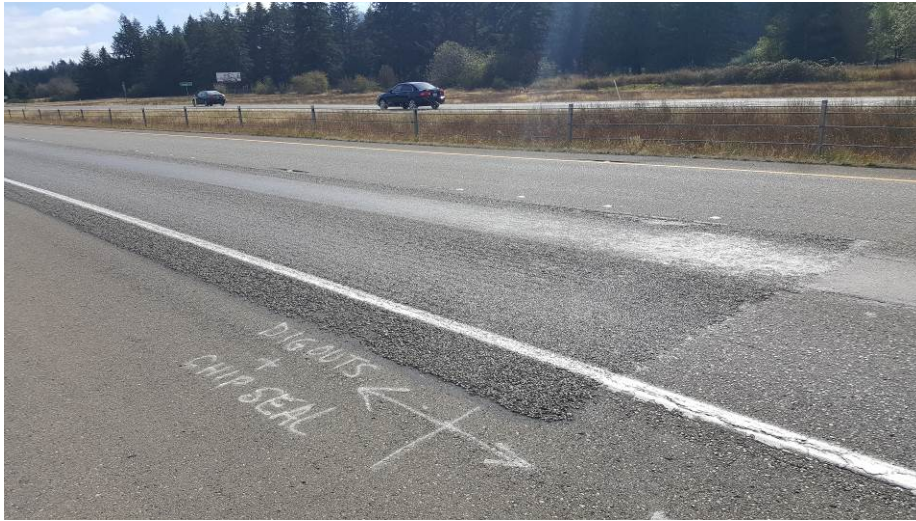
Dig outs plus chip sealing is the most expensive option (Figure 146). Placing a chip seal over newly placed dig out patches is not a good practice due to the strong possibility that the chip seal will flush or could result in chip loss. A solution is to place the chip seal in the next construction season or applying sand to the patches before the chip seal. The flushing conditions on several of the sites could have been avoided by eliminating the chip seal; however, the chip seal serves an additional purpose of providing a better ride over the dig outs.

Figure 146. OR2a dig outs plus chip seal SR 8. (September 2016)
