Final Report

Atlanta's Hotel District: ADA Transition Plan

(A Supplement to STRIDE Project #2012-067S)

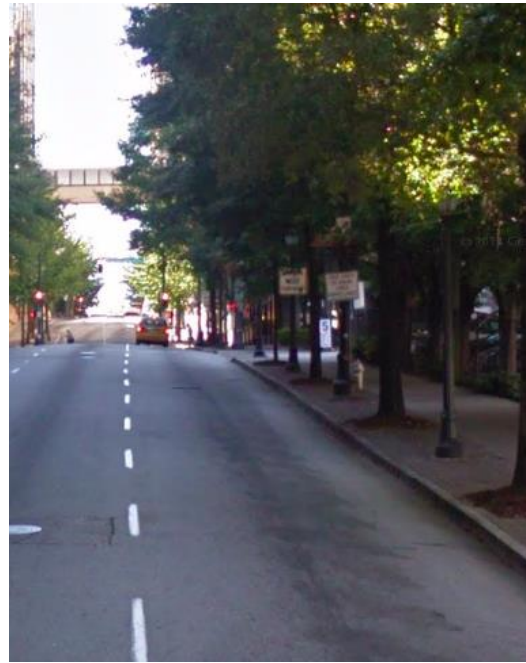
The steepness of John Portman Boulevard and Andrew Young International pose issues in some places. However, the ADA does not require sidewalks to overcome natural road topography. Hence, sidewalk slopes are compliant, but are still not necessarily accessible (see Figure 5). Additionally, some cross slopes in this area have problems, such as those all along Courtland Street and along John Portman Boulevard between Peachtree Street and Peachtree Center Avenue.

Figure 5: Westward View up Andrew Young International Boulevard and Naturally Steep Topography

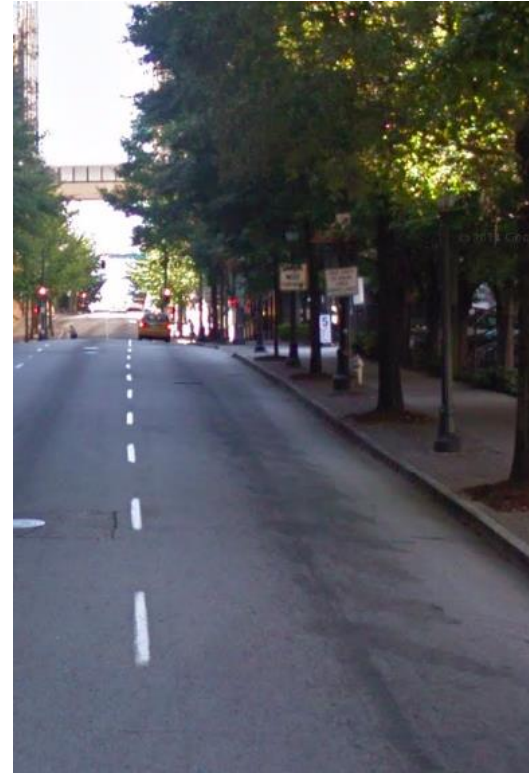
Figure B-6. Example of the naturally steep topography of this area, especially along the east-west streets, such as Andrew Young International Boulevard (shown above)

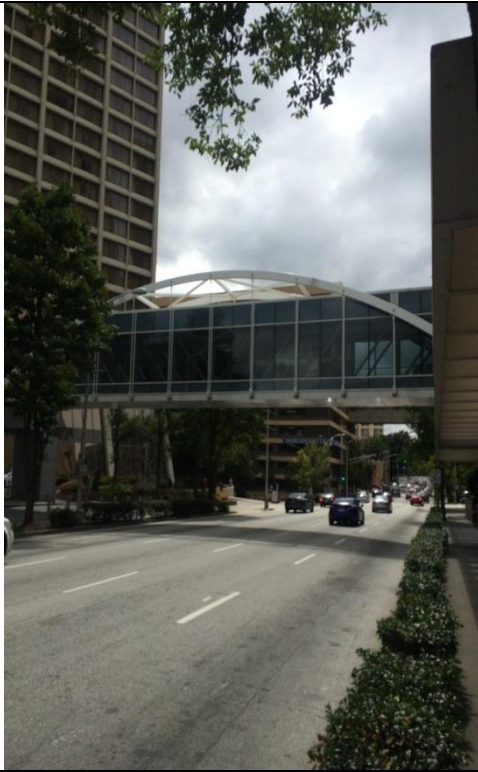
Another accessibility issue in this zone can be found in the sky bridge linking the Hilton to the Atlanta Marriott Marquis (see Figure 8). This route is popular with conventioners, but does not have an automatic door at either access point. While the width of the doors were ADA compliant, guests using wheelchairs or other assistive devices may encounter difficulties operating the manual doors themselves. Automated door openers should be considered at this location given the potential number of users, especially during conventions. The walking surface of the sky bridge was also very smooth, increasing the chances of an individual slipping and falling, especially if the surface is wet. The sky bridge between the Atlanta Marriott Marquis and Hyatt Regency Atlanta has a different type of flooring but also has a moderately-steep slope, measured at 3.7 degrees. While this is also compliant with the ADA running slope requirements, it is still difficult for a person using a wheelchair to move uphill, especially with slow moving pedestrian traffic. Other than the sky bridge issues identified above, accessing the hotels was easy with wide hallways and helpful service staffs to provide direction. Data for this zone and pictorial evidence can be found in Appendices A and B.

Figure B-17. Sky bridge connecting the Atlanta Marriott Marquis to the Atlanta Hilton (left) over Courtland Street NE

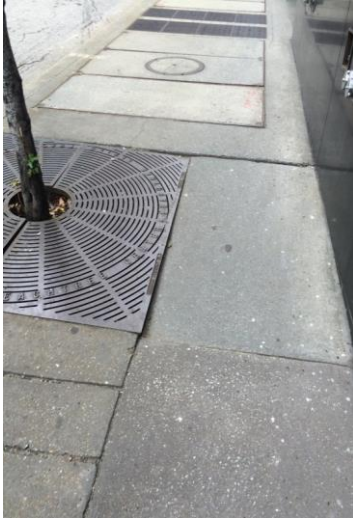
Figure B-23. Disjointed sidewalk slabs on John Portman Boulevard NE on Atlanta Marriott Marquis' southern side. Gaps appear small in the photograph, but present serious issues along most of the tree root covers on this stretch, near the grates, manhole covers, and access slabs. The sidewalk is difficult to traverse in a wheelchair.

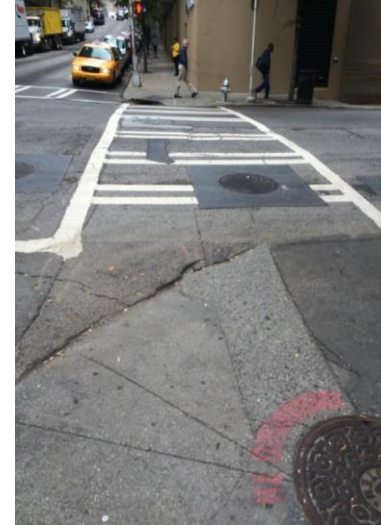
Figure B-24. Wheelchair ramp on the NE corner of John Portman Boulevard NE and Peachtree Center Avenue NE looking west on John Portman towards the Hyatt Regency Atlanta. The wheelchair ramp services neither direction of pedestrian traffic and lacks detectable warning strips. Crosswalks are full of patches, bumps, and potholes. The NW corner ramps in both directions lack warning strips and the connection from the crosswalk to the corner across the street needs to be patched or filled to allow for smoother transition.

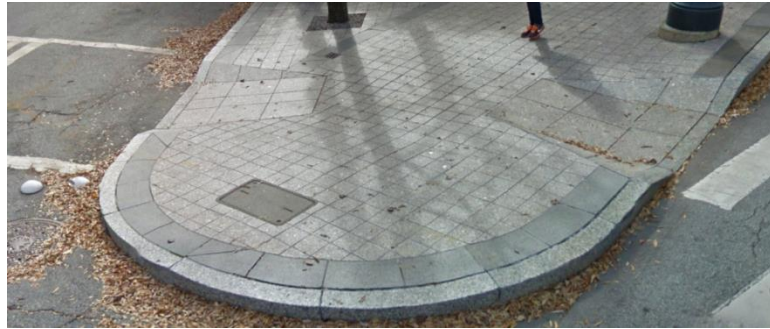
Figure B-49: The median where Peachtree Street and Peachtree Center Avenue merge. Both ramps and sidewalk are made of high quality pavers/tiles and are well constructed. However, neither ramp has detectable warning strips for visually impaired pedestrians.

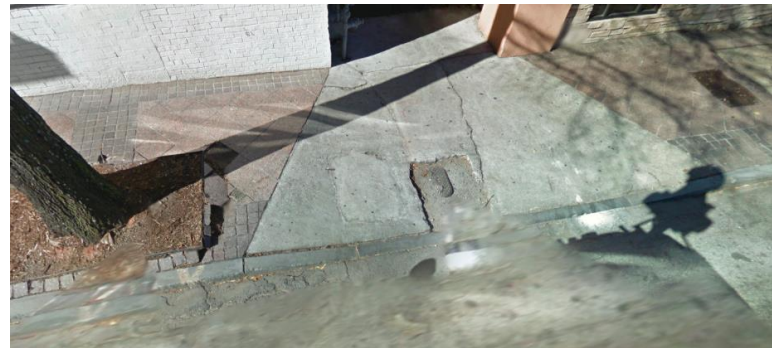
Figure B-52: There is an unexplained ramp leading to the street on the western sidewalk on Peachtree Street, north of its intersection with West Peachtree Street. The sidewalk should be repaired to eliminate this ramp that could lead to confusion for visually impaired pedestrians and a cross-slope hazard. The bricks here should be reset or replaced with concrete to flatten the sidewalk out. The sidewalk here is narrow due to tree placement and could be expanded.

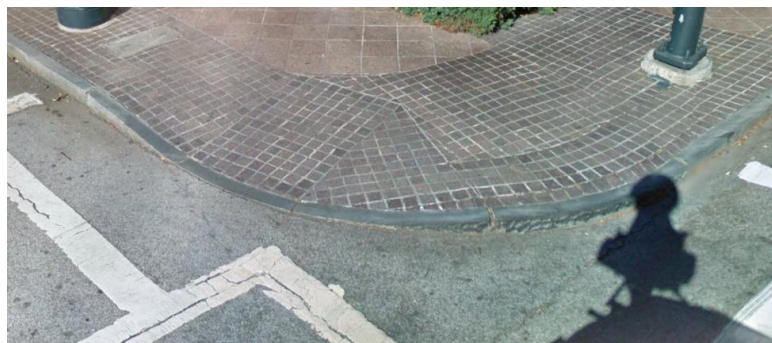
Figure B-53: NW Corner of the intersection of West Peachtree Street and Peachtree Street. The corner is not flush with the crosswalk; there is a noticeable bump to surmount if coming from the east. There are no detectable warning strips present.

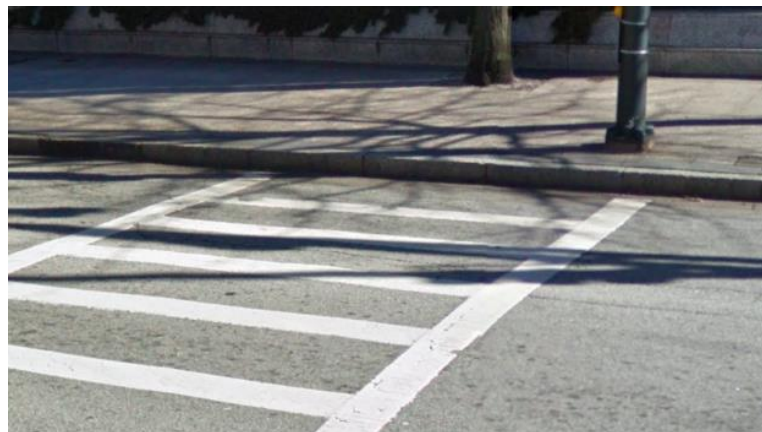
Figure B-54: Across from the NW corner of the intersection of West Peachtree Street and Peachtree Street there is no wheelchair ramp present.

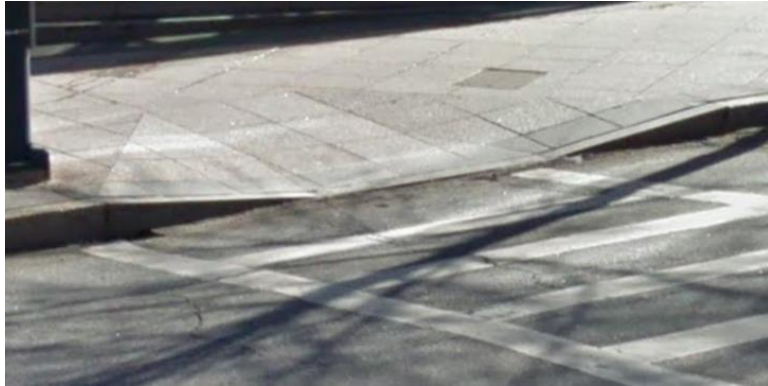
Figure B-55: Across from the SW corner of the intersection of West Peachtree Street and Peachtree Street, the ramp is well constructed and made of quality materials, but there is no detectable warning strip.

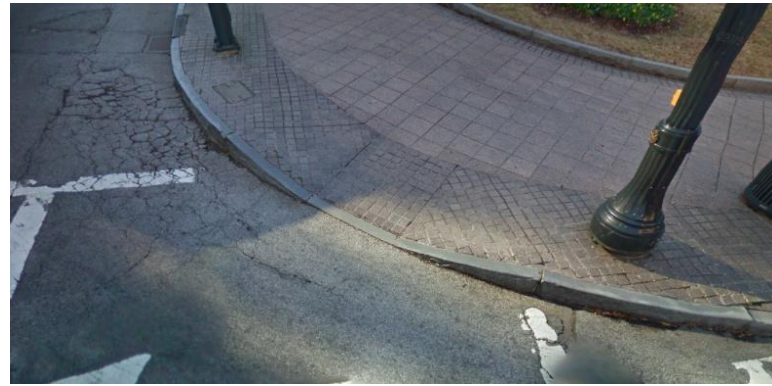
Figure B-56: SW Corner of the intersection of West Peachtree Street and Peachtree Street. The ramp area is too narrow and isn't flush from all directions. There is also no detectable warning strip present.

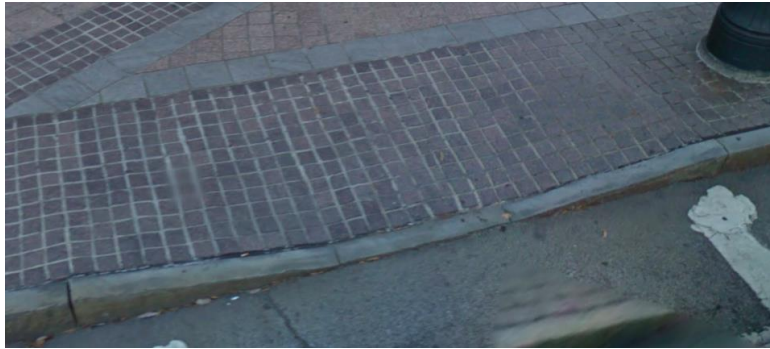
Figure B-57: NW of the intersection of Peachtree Street and Baker Street on the western sidewalk. The ramp lacks a detectable warning strip.

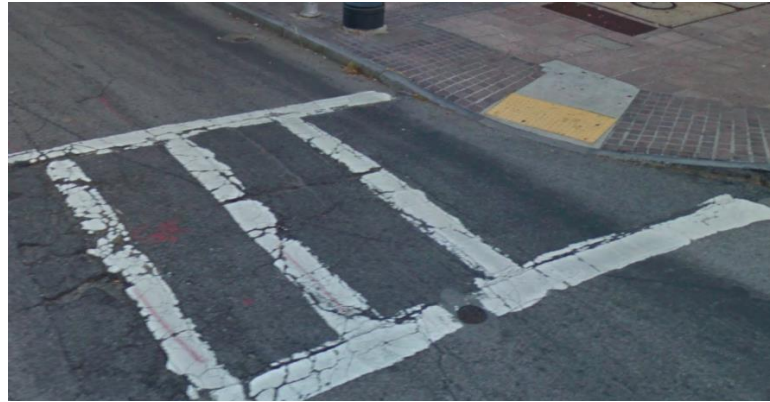
Figure B-58: NW corner of the intersection of Peachtree Street and Baker Street. The crosswalk's asphalt is deteriorating badly. The ramp is mostly compliant, but should be made flush with the crosswalk.

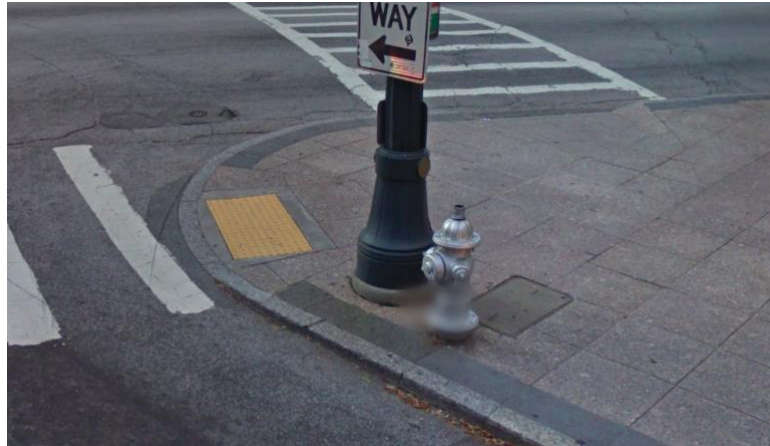
Figure B-59: NE Corner of the intersection of Peachtree Street and Baker Street. The ramp coming from the west lacks a detectable warning strip.

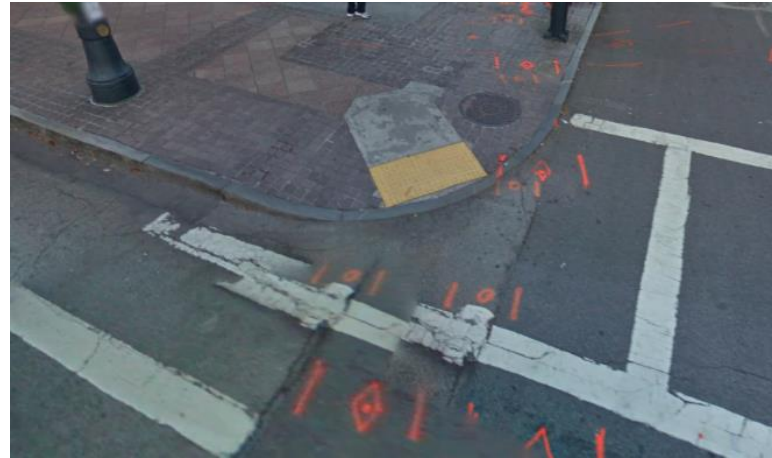
Figure B-60: SW Corner of the intersection of Peachtree Street and Baker Street. The ramp area starts to form into a high curb halfway through the westbound crosswalk and needs to be flush. The detectable warning strip should be extended in a more attractive medium.

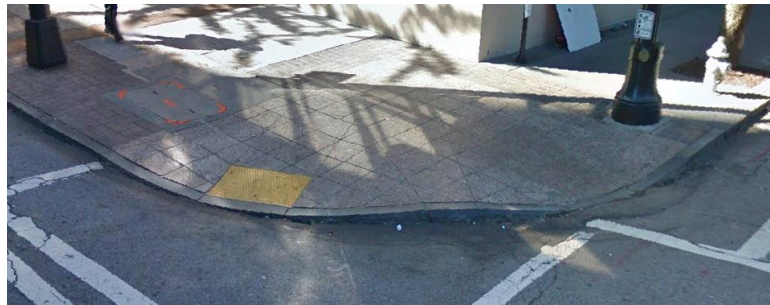
Figure B-61: NW corner of the intersection of Peachtree Center Avenue NE and Andrew Young International Boulevard. The curb is not flush, making wheelchair use of the ramp difficult. There is no detectable warning strip for eastbound pedestrians. The crosswalk transition is rough and uneven.

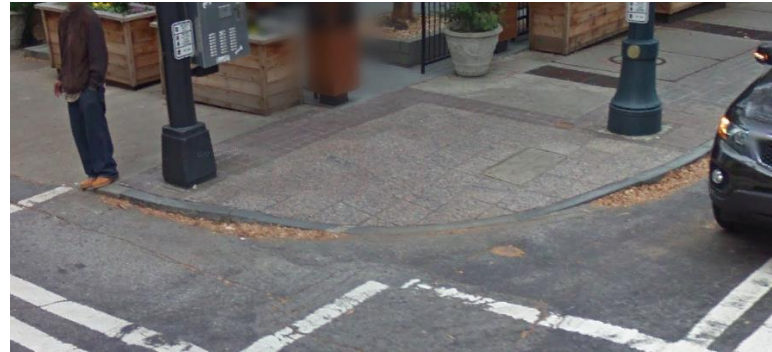
Figure B-62: NE corner of the intersection of Peachtree Center Avenue NE and Andrew Young International Boulevard. The curb begins to rise halfway through each crosswalk. There are no detectable warning strips.

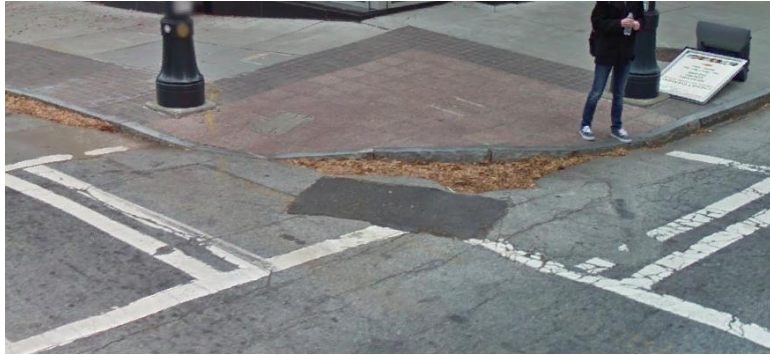
Figure B-63: SW corner of the intersection of Peachtree Center Avenue NE and Andrew Young International Boulevard. The curb height and pavement disjoint makes using the wheelchair ramp nearly impossible. There are no detectable warning strips.

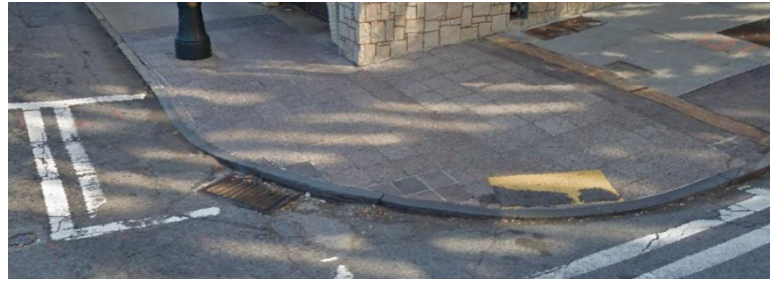
Figure B-64: SE corner of the intersection of Peachtree Center Avenue NE and Andrew Young International Boulevard. The curb height here makes using the wheelchair ramp very difficult. There are no detectable warning strips.
