MID-AMERICA TRANSPORTATION CENTER

Report # MATC-UNL: 100

Safety Investigation and Guidance for Work-Zone Devices in Freight Transportation Systems Subjected to Passenger Car and Truck Impacts with New Crash Standards

2010

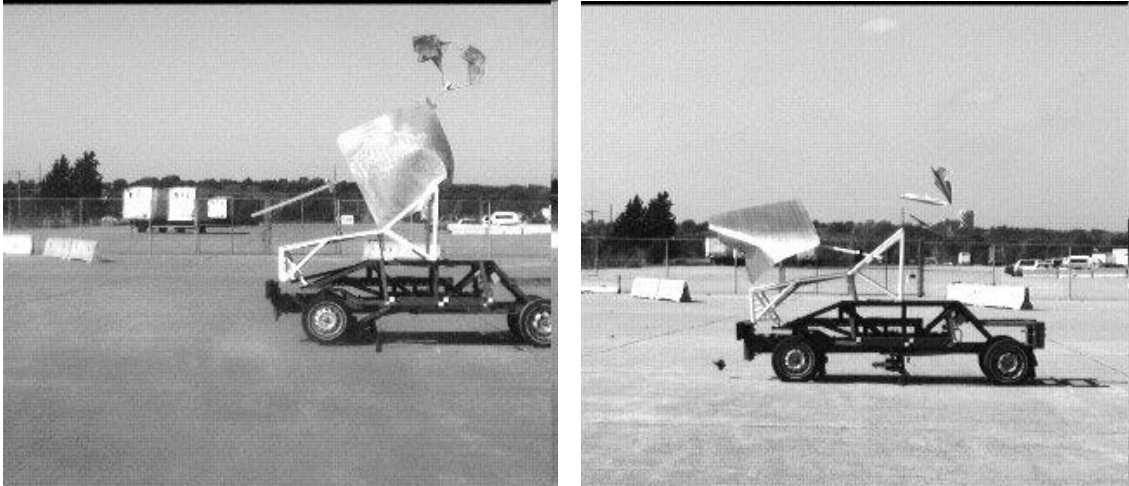
Figure 1. Existing Work-Zone Traffic Control Devices in Simulated Truck Bogie Testing

In 2003, the Dicke Tool Company funded a project at the MwRSF to evaluate the safety performance of NCHRP Report No. 350-accepted work-zone sign support systems for impacts with a ¾-ton pickup truck. These crash tests were performed with a bogie vehicle configured with a frontal profile that replicated the geometry of a 2000P pickup truck. An evaluation of the results from the bogie testing revealed a propensity for some FHWA-accepted, portable sign support systems to impact the windshield region of a simulated pickup truck during high-speed collisions, as shown in Figure 1. Although the bogie vehicle was not configured with an actual glass windshield, the results demonstrated a significant risk for test article penetration through the windshield.

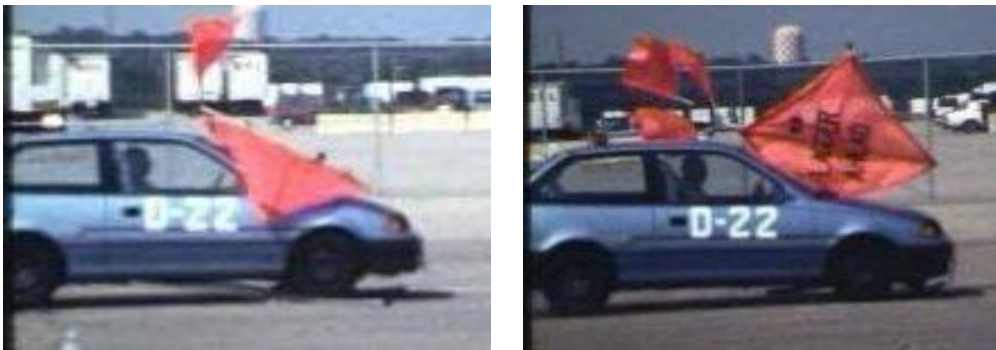
Figure 3. Historical Tests of Low-Mounted Sign Support Systems

Some of the masts that bridged the windshield on the small car, as shown in Figure 3, would likely impact the windshield of a pickup truck as indicated by the previous truck bogie testing shown in Figure 1. Many sign systems that utilized lower mounting heights for sign panels had masts that rotated around the hood. The height of the mast and sign panel controlled where and how the system impacted the small car. These features would affect where the same sign support system would impact a pickup truck. Some sign systems with taller mounting heights for sign panels and those oriented at 90 degrees easily passed over the small car with only slight contact to the roof, as shown in Figure 4. With the additional height and length of the pickup truck, these same sign systems would likely impact the windshield of the pickup truck.

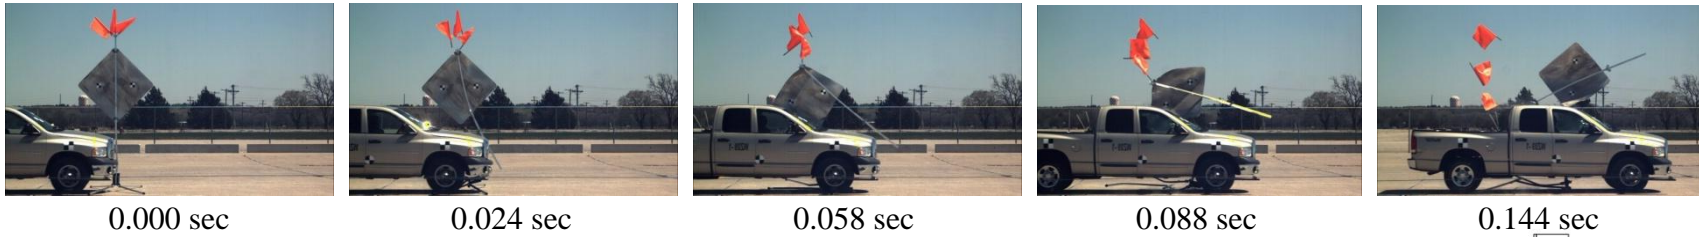
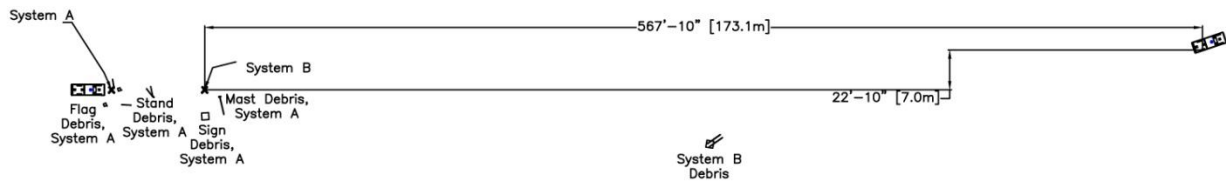
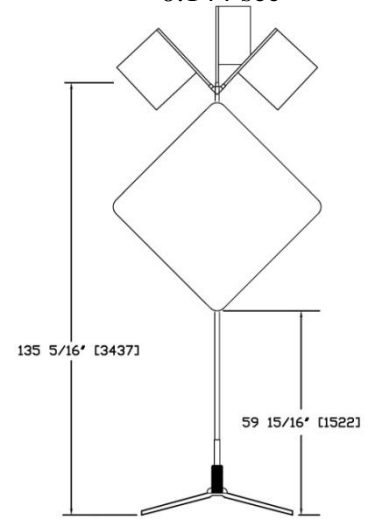
Figure 45. Summary of Test Results and Sequential Photographs, Test No. WZ09-1A

Following test no. WZ09-1, a safety performance evaluation was conducted, and the performance of System No. 1A was determined to be unacceptable according to the MASH criteria. It was deemed unacceptable due to the flag holder penetrating the roof, the sign panel penetrating the windshield, windshield indentation greater than 3 in. (76 mm), and significant windshield cracking. Deformations of, and intrusion into, the occupant compartment did occur as System No. 1A penetrated into the occupant compartment on the right side of the windshield when the corner of the sign panel sliced through the windshield and also when the metal flag holder penetrated the roof into the occupant compartment.

- Test Agency.....MwRSF
- Test Number.....WZ09-1A
- Date4/22/09
- MASH Test Designation Number.....3-72
- Test Article.....Portable Sign Support
 - Height to Bottom of Sign.....59¹⁵/₁₆ in. (1,522 mm)
 - Mast Material.....Aluminum Tubing
- Key Component – X-Footprint Base
 - Length.....125½ in. (3,188 mm)
 - Width.....47½ in. (1,207 mm)
- Key Component – Aluminum Sign Panel
 - Dimension.....48 in. x 48 in. (1,219 mm x 1,219 mm)
 - Thickness.....0.074 in. (1.9 mm)
- Vehicle Make and Model.....2002 Dodge Ram 1500 Quad Cab Pickup
 - Curb.....5,119 lb (2,322 kg)
 - Test Inertial.....4,990 lb (2,263 kg)
 - Gross Static.....5,159 lb (2,340 kg)
- Impact Conditions
 - Speed.....63.4 mph (102.0 km/h)
 - Angle.....90 deg
 - Impact Location.....centerline of mast
- Exit Conditions
 - Angle.....90 deg

- Vehicle Stability.....Satisfactory
- Vehicle Stopping Distance (longitudinal).....567 ft - 6 in. (173.0 m) from Impact B
- Vehicle Stopping Distance (lateral).....22 ft - 10 in. (6.9 m) left of Impact B
- Maximum Angular Displacements (EDR-4)
 - Yaw.....1.20 deg
 - Pitch.....-0.41 deg
 - Roll.....0.84 deg
- Vehicle Damage.....Severe Windshield Damage
 - VDS^[33].....12-FR-1
 - CDC^[34].....12FRAN1
 - Maximum Interior Deformation.....NA
- Test Article Damage.....Moderate

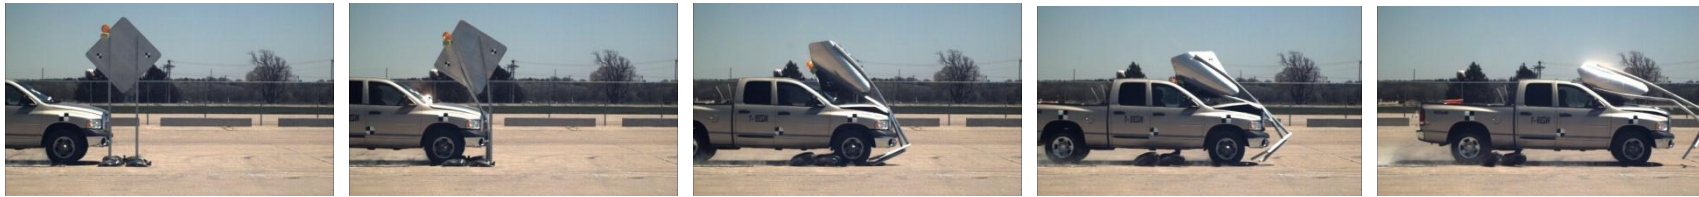
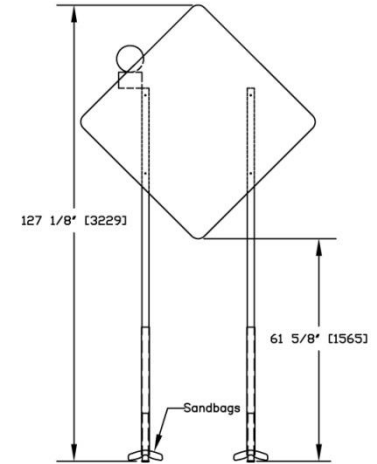
Figure 46. Summary of Test Results and Sequential Photographs, Test No. WZ09-1B

System No. 1B was also determined to be unacceptable according to the MASH criteria due to the light and mast penetrating the windshield, windshield indentation greater than 3 in. (76 mm), and significant windshield cracking, which caused the obstruction of driver visibility and the loss of structure in both glass layers in the windshield. Deformations of, and intrusion into, the occupant compartment did occur as System No. 1B penetrated into the occupant compartment near the upper-center region and upper-left corner of the windshield when the light, mast, and sign panel contacted the windshield. The vehicle's trajectory did not intrude into adjacent traffic lanes.

- Test Agency MwRSF
- Test Number WZ09-1B
- Date 4/22/09
- MASH Test Designation Number 3-72
- Test Article Portable Sign Support
 - Height to Bottom of Sign 61 5/8 in. (1,565 mm)
 - Mast Material Telespar Steel Tubing
- Key Component – H-Footprint Base
 - Length 72 in. (1,829 mm)
 - Width 25 7/16 in. (646 mm)
- Key Component – Aluminum Sign Panel
 - Dimension 48 in. x 48 in. (1,219 mm x 1,219 mm)
 - Thickness 0.075 in. (1.9 mm)
- Key Component – Ballast
 - Weight 4 – 50 lb (22.7 kg) sandbags
- Vehicle Make and Model 2002 Dodge Ram 1500 Pickup
 - Curb 5,119 lb (2,322 kg)
 - Test Inertial 4,990 lb (2,263 kg)
 - Gross Static 5,159 lb (2,340 kg)
- Impact Conditions
 - Speed 62.0 mph (99.8 km/h)
 - Angle 90 deg
 - Impact Location centerline of mast

- Exit Conditions
 - Angle 90 deg
- Vehicle Stability Satisfactory
- Vehicle Stopping Distance (longitudinal) 567 ft - 6 in. (173.0 m) from Impact B
- Vehicle Stopping Distance (lateral) 22 ft - 10 in. (6.9 m) left of Impact B
- Maximum Angular Displacements (EDR-4)
 - Yaw -1.51 deg
 - Pitch -0.34 deg
 - Roll -1.05 deg
- Vehicle Damage Severe Windshield Damage
 - VDS^[33] 12-FL-1
 - CDC^[34] 12FYAN1
 - Maximum Interior Deformation NA
- Test Article Damage Moderate

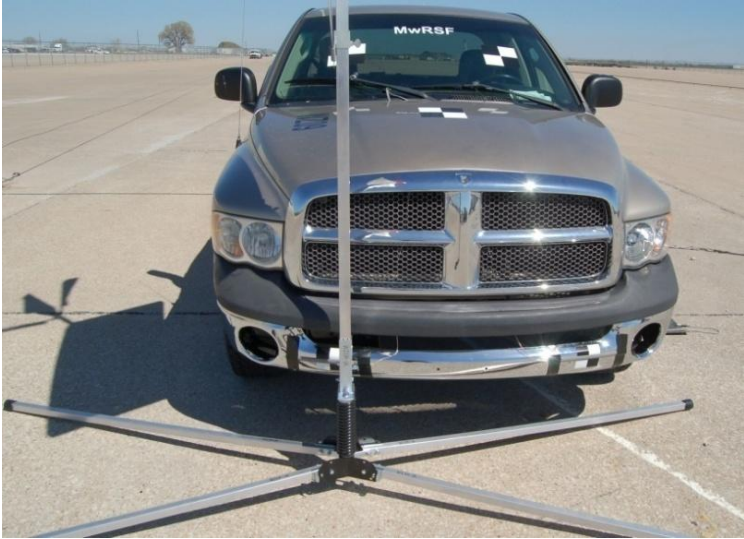
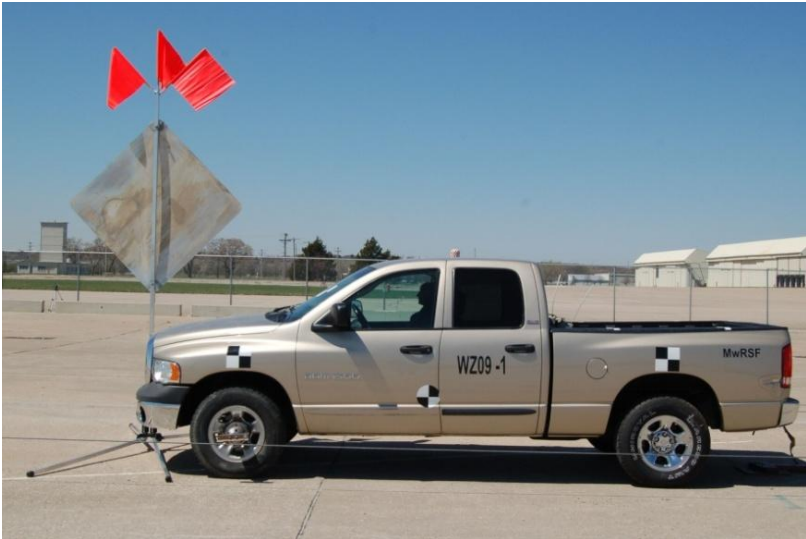
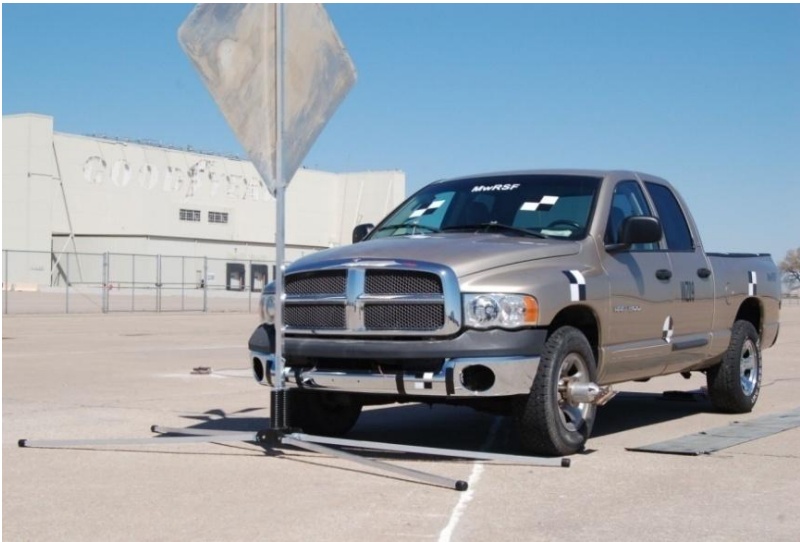
Figure 50. Impact Location, Test No. WZ09-1A

For System No. 1A, initial vehicle impact was to occur with the centerline of the mast 2 in. (51 mm) to the left of the right-side quarter point on the pickup truck's bumper, as shown in Figure 50. The actual point of impact was with the centerline of the mast 5½ in. (140 mm) to the

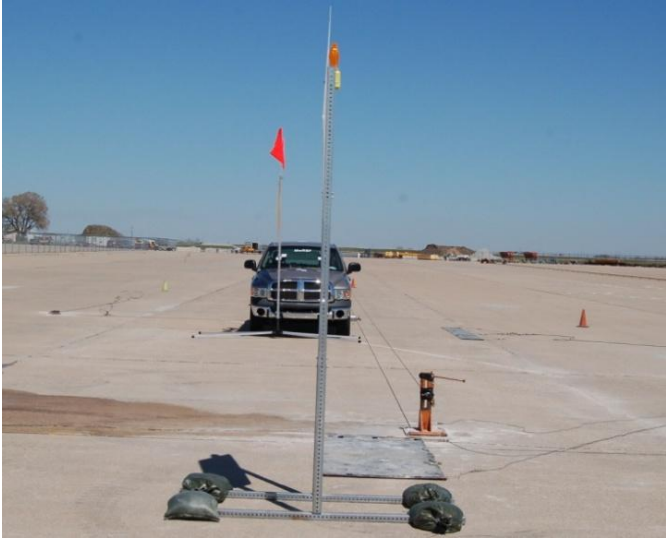
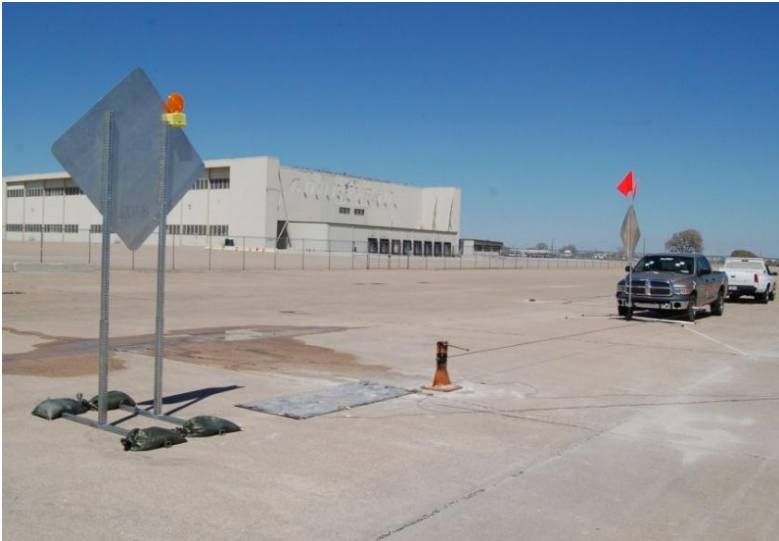
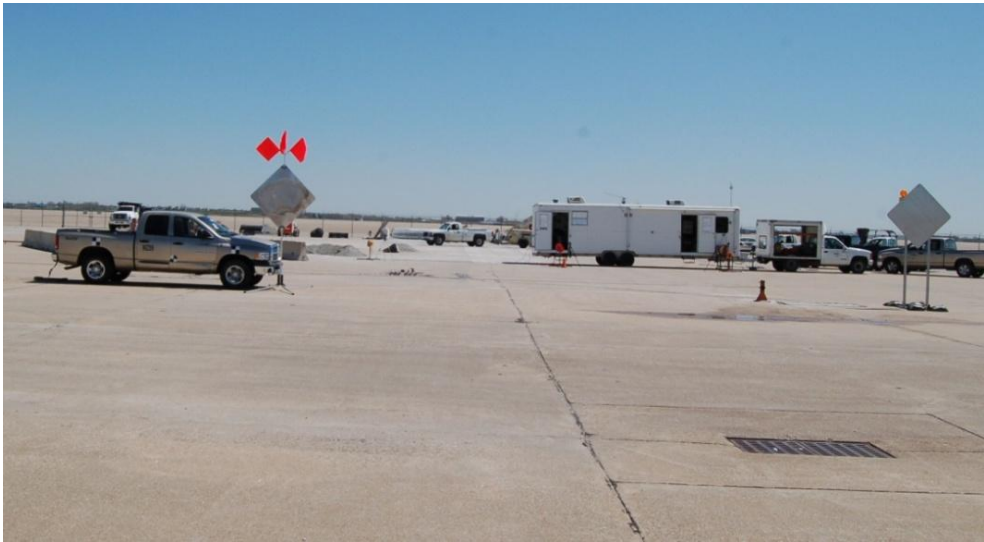
Figure 51. Impact Location, Test No. WZ09-1B

left of the right-side quarter point. For System No. 1B, initial vehicle impact was to occur with the centerline of the impact-side mast 2 in. (51 mm) to the right of the left-side quarter point on the pickup truck’s bumper, as shown in Figure 51. The actual point of impact was with the centerline of the mast 2 in. (51 mm) to the right of the left-side quarter point.

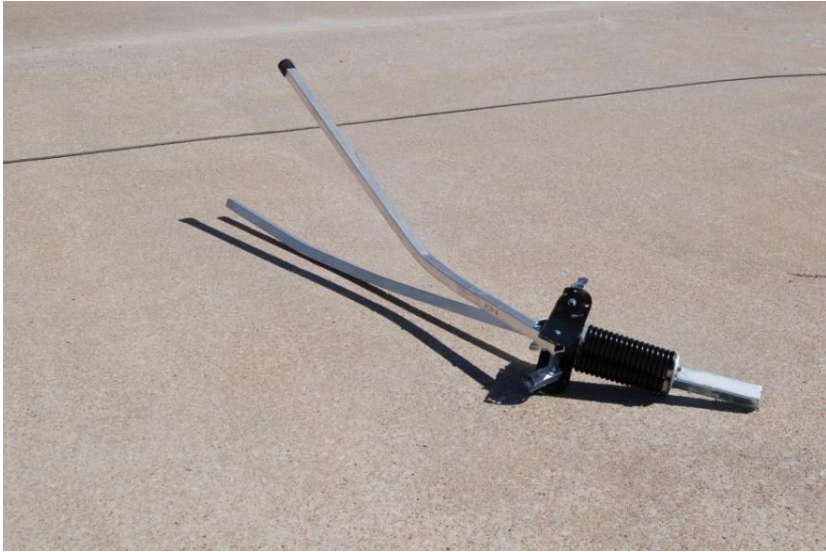
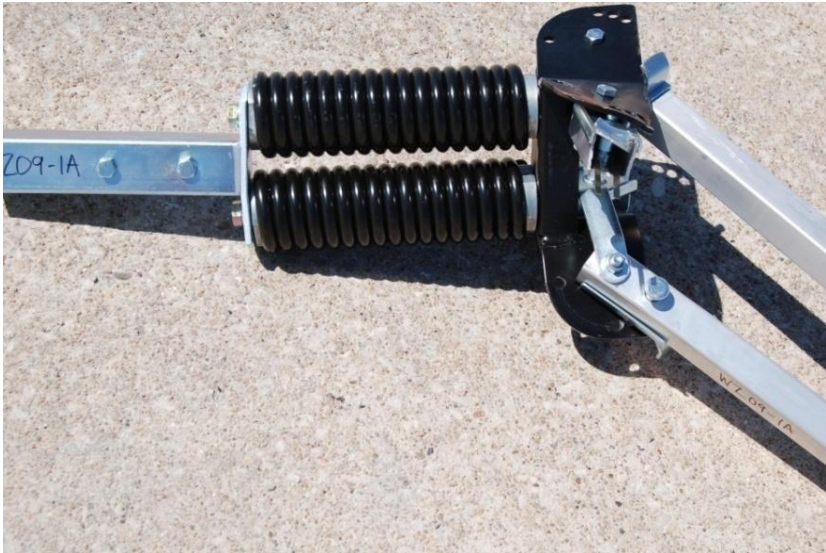
Figure 53. System Damage, Test No. WZ09-1A

Damage to System Nos. 1A and 1B is shown in Figures 53 through 56. System No. 1A encountered severe damage to the sign support stand. Two of the four legs were still attached to the base but were not in their original positions. One of the attached legs was bent moderately, and the other was bent slightly. The other two legs were fractured completely at the leg release/lock mechanism and were slightly bent. The angled base plates attaching the legs were bent, and the plate above the springs was slightly bent. The lower mast was fractured at the breakaway holes. The upper mast was slightly bent. The upper rigid bracket was significantly deformed outwards. All corners of the sign panel were dented and scratched. All three flags were undamaged, and one was located in the bed of the pickup truck.

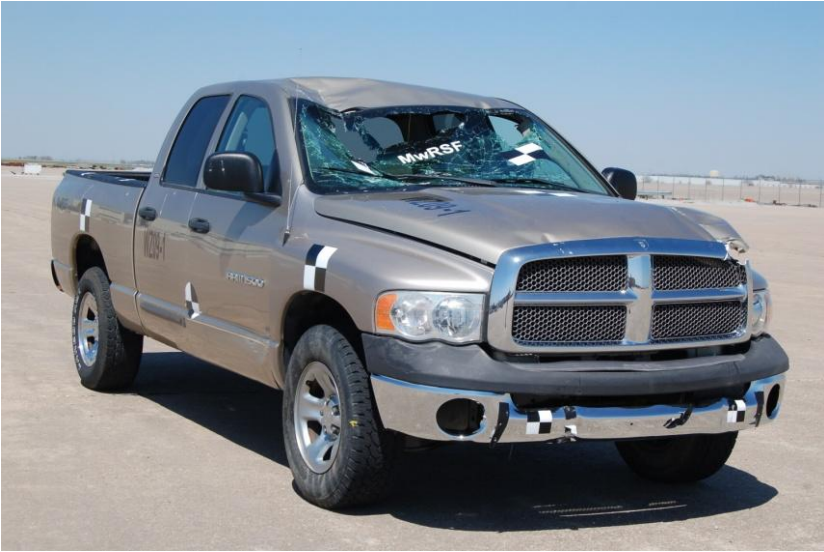
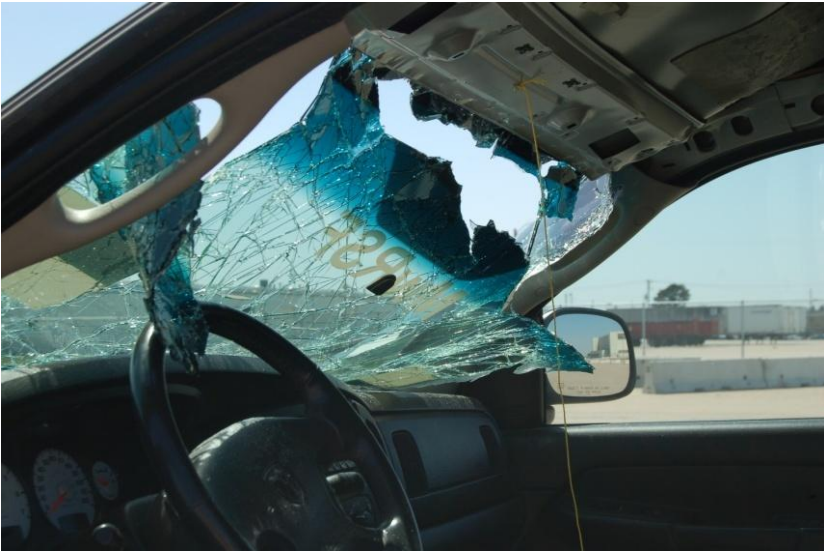
Figure 57. Vehicle Damage, Test No. WZ09-1

Vehicle damage is shown in Figures 57 and 58. The bumper was dented inward where it contacted System Nos. 1A and No. 1B. Small scuffs were found on the plastic bumper on the right side and at both impact locations. The upper-right side of the grill was scratched. The left corner of the grill was broken, and the engine hood sustained a cut at the left-side impact location. The hood was pushed backward and upward at the left-front corner, and the left-front half of the hood was scratched. The windshield was sliced through at the center of the right target where it was contacted by the sign panel from System No. 1A. The upper-center windshield contained a large hole along the roofline where the sign panel of System No. 1B impacted. Another large hole occurred in the upper-left corner of the windshield where the light and mast of System No. 1B impacted. Significant windshield indentation and cracking occurred. The roof was dented and encountered scratches at the right-side impact location. Small dents were found in the front of the roof at the left-side impact location. A small hole was observed in the middle of the roof and slightly off center to the right side where the flag holder of System No. 1B impacted.

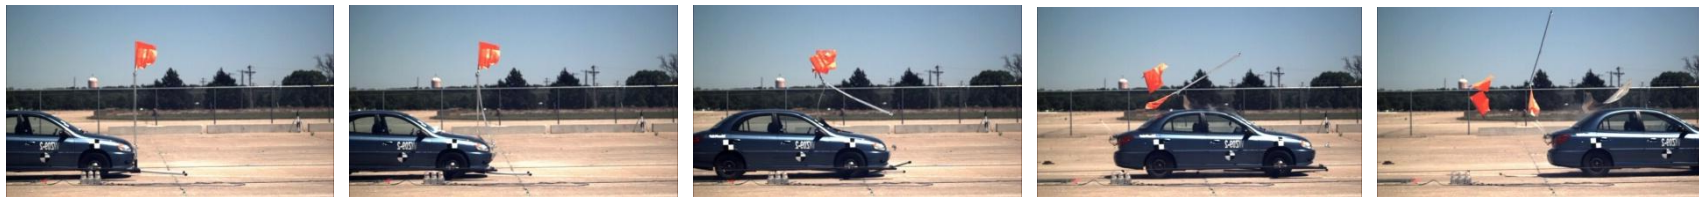
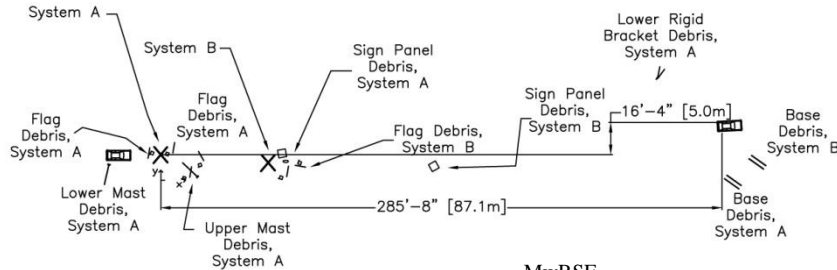
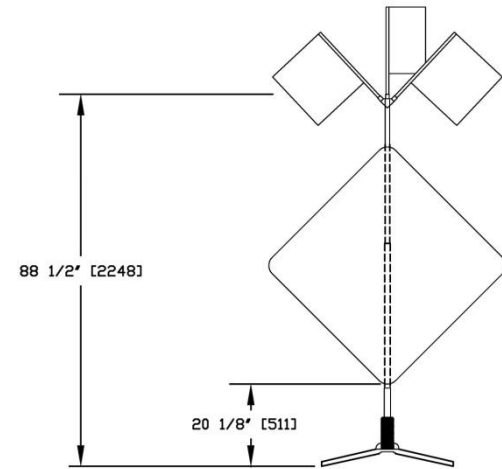
Figure 59. Summary of Test Results and Sequential Photographs, Test No. WZ09-2A

Following test no. WZ09-2, a safety performance evaluation was conducted, and the performance of System No. 2A was determined to be successful according to the MASH criteria. The windshield damage from System Nos. 2A and 2B overlapped at the middle third of the windshield, but the damage to the right third of the windshield was specifically from System No. 2A. A concentrated point of impact from the flash bulb on the lower windshield, and not the test article, occurred in the lower-right corner of the windshield. All other cracking and indentation on the right side of the windshield was from the test article. Detached elements and debris from System No. 2A contacted the windshield, and moderate cracking occurred. A maximum deformation of 2¼ in. (57 mm) occurred on the right side of the windshield, which is below the 3 in. (76 mm) maximum value defined in MASH. There was no penetration of the windshield and no tear in the plastic liner. Moderate windshield cracking also occurred along the upper-right two-thirds of the windshield when the sign panel from System No. 2A released and impacted the windshield, as determined from high-speed video analysis. The cracking appeared to be the same at the upper-middle region of the windshield as well as to the right side. The maximum deformations at the top of the windshield are unknown due to overlapping damage with System No. 2B, but the deformations were less than 3 in. (76 mm). Therefore, the system performance was determined to be acceptable.

- Test Agency MwRSF
- Test Number WZ09-2A
- Date 5/28/09
- MASH Test Designation Number 3-71
- Test Article Portable Sign Support
 - Height to Bottom of Sign 20 1/8 in. (511 mm)
 - Mast Material Aluminum Tubing
- Key Component – X-Footprint Base
 - Length 84 3/4 in. (2,143 mm)
 - Width 32 3/4 in. (832 mm)
- Key Component – Aluminum Sign Panel
 - Dimension 48 in. x 48 in. (1,219 mm x 1,219 mm)
 - Thickness 0.075 in. (1.9 mm)
- Vehicle Make and Model 2002 Kia Rio Sedan
 - Curb 2,309 lb (1,047 kg)
 - Test Inertial 2,404 lb (1,090 kg)
 - Gross Static 2,573 lb (1,167 kg)
- Impact Conditions
 - Speed 64.1 mph (103.2 km/h)
 - Angle 0 deg
 - Impact Location centerline of mast
- Exit Conditions
 - Angle 0 deg

- Vehicle Stability Satisfactory
- Vehicle Stopping Distance (longitudinal) 285 f t- 8 in. (87.1 m) from Impact A
- Vehicle Stopping Distance (lateral) 16 ft - 4 in. (5.0 m) left of Impact A
- Maximum Angular Displacements (DTS)
 - Yaw -2.08 deg
 - Pitch 3.90 deg
 - Roll -1.02 deg
- Vehicle Damage Moderate Windshield Damage
 - VDS^[33] 12-FR-1
 - CDC^[34] 12FZAW1
 - Maximum Interior Deformation NA
- Test Article Damage Severe

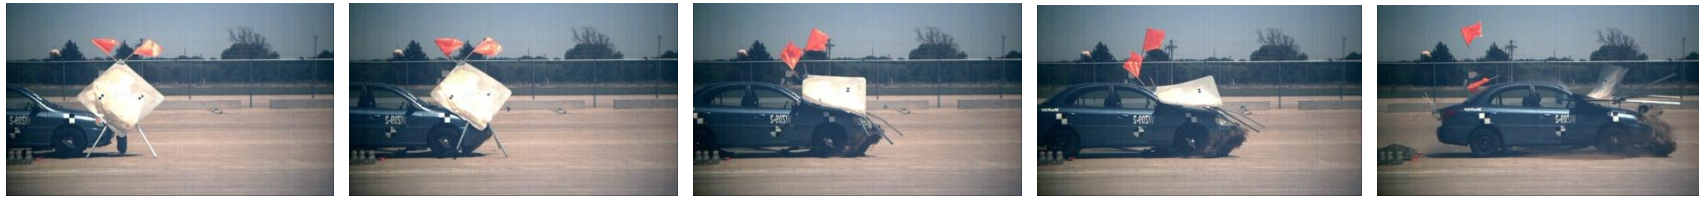
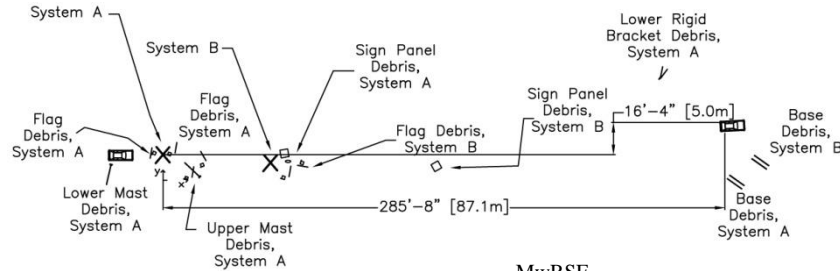
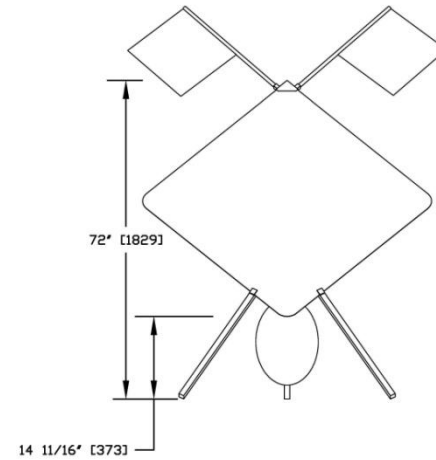
Figure 60. Summary of Test Results and Sequential Photographs, Test No. WZ09-2B

System No. 2B was determined to be unacceptable according to the MASH criteria due to significant windshield cracking, windshield indentation greater than 3 in. (76 mm), and windshield penetration. Deformations of, and intrusion into, the occupant compartment did occur as System No. 2B penetrated into the occupant compartment near the upper-center region of the windshield when the mast contacted the windshield. Even though the mast impacted the top of the windshield, which was already weakened from the impact with System No. 2A, the penetration was significant and was believed to have occurred without the prior damage. The vehicle's trajectory did not intrude into adjacent traffic lanes.

- Test Agency MwRSF
- Test Number WZ09-2B
- Date 5/28/09
- MASH Test Designation Number 3-71
- Test Article Portable Sign Support
 - Height to Bottom of Sign 14¹¹/₁₆ in. (373 mm)
 - Base Material Steel Tubing
- Key Component – Tripod Base
 - Length 56⁵/₁₆ in. (1,430 mm)
 - Width 48³/₄ in. (1,238 mm)
- Key Component – Ballast
 - Weight 50 lb (22.7 kg) sandbag
- Key Component – Aluminum Sign Panel
 - Dimension 48 in. x 48 in. (1,219 mm x 1,219 mm)
 - Thickness 0.080 in. (2.0 mm)
- Vehicle Make and Model 2002 Kia Rio Sedan
 - Curb 2,309 lb (1,047 kg)
 - Test Inertial 2,404 lb (1,090 kg)
 - Gross Static 2,573 lb (1,167 kg)
- Impact Conditions
 - Speed 61.4 mph (98.8 km/h)
 - Angle 90 deg
 - Impact Location centerline of sign panel

- Exit Conditions
 - Angle 90 deg
- Vehicle Stability Satisfactory
- Vehicle Stopping Distance (longitudinal) 285 ft - 8 in. (87.1 m) from Impact A
- Vehicle Stopping Distance (lateral) 16 ft - 4 in. (5.0 m) left of Impact A
- Maximum Angular Displacements (DTS)
 - Yaw 3.06 deg
 - Pitch 2.55 deg
 - Roll 0.89 deg
- Vehicle Damage Severe Windshield Damage
 - VDS^[33] 12-FL-1
 - CDC^[34] 12FYAN1
 - Maximum Interior Deformation NA
- Test Article Damage Moderate

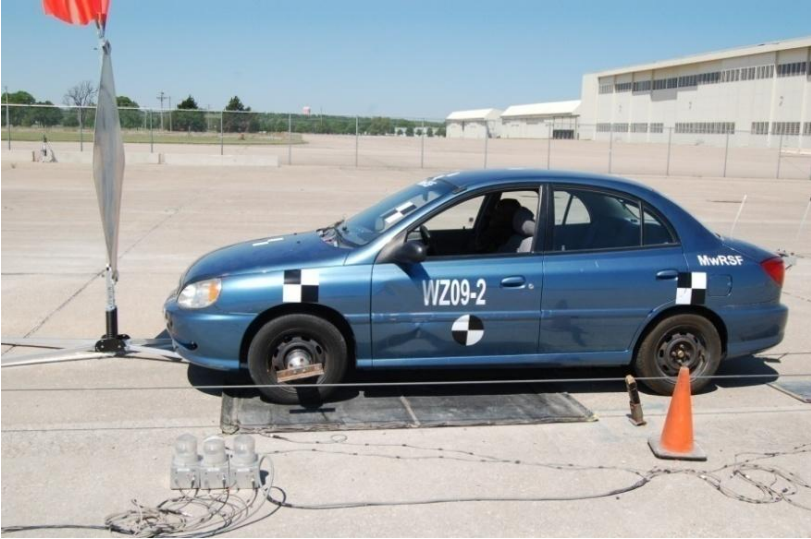
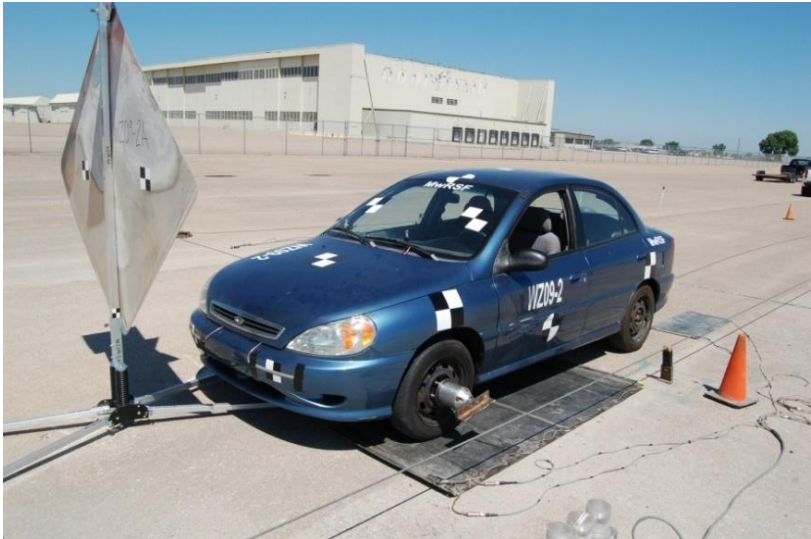
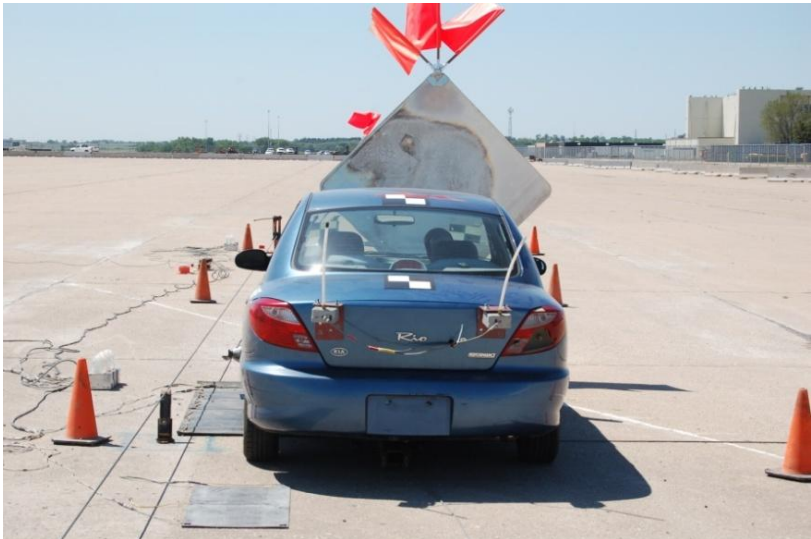
Figure 64. Impact Location, Test No. WZ09-2A

For System No. 2A, initial vehicle impact was to occur with the centerline of the mast at the right-side quarter point on the car's bumper, as shown in Figure 64. The actual point of impact was 3 in. (76 mm) to the left of the right-side quarter point. For System No. 2B, initial

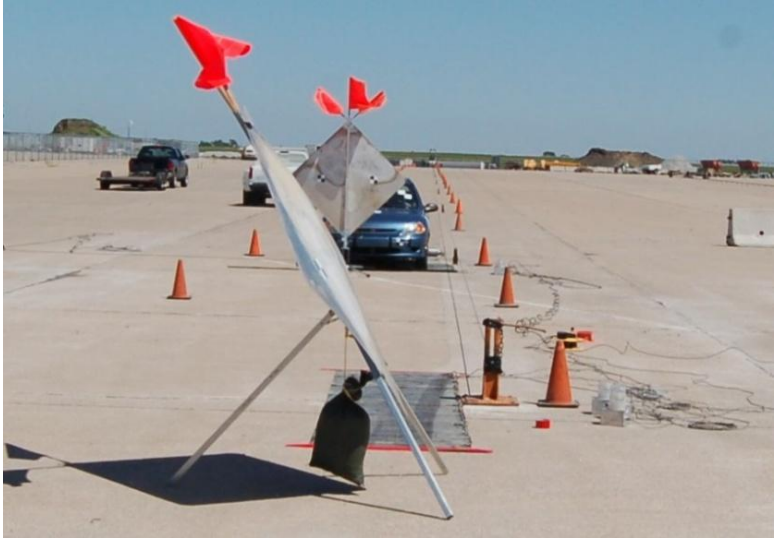
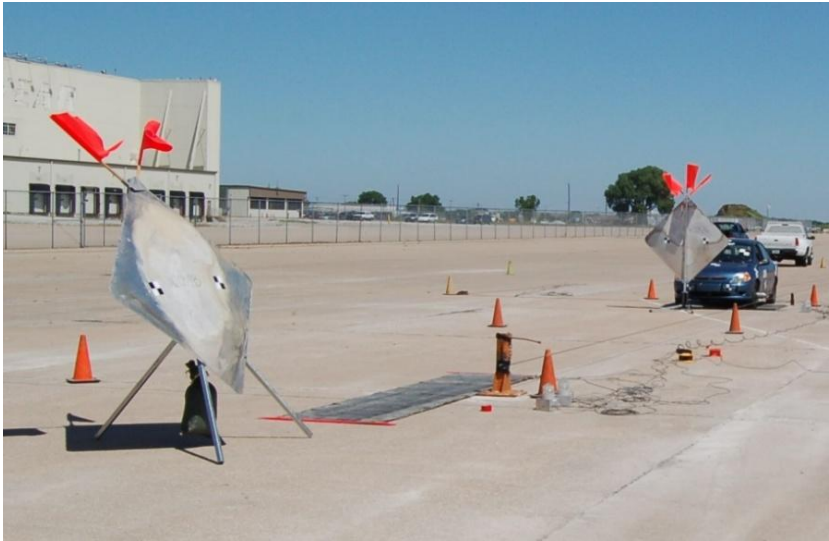
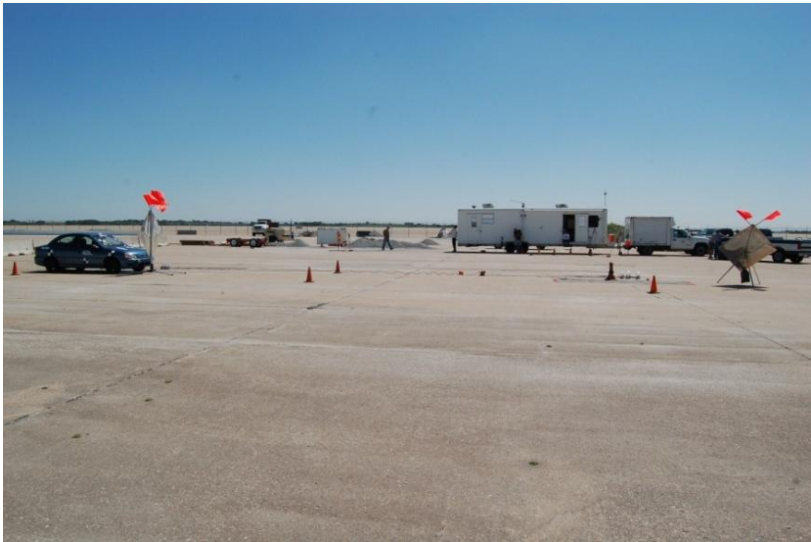
Figure 65. Impact Location, Test No. WZ09-2B

vehicle impact was to occur with the center of the sign panel at the left-side quarter point on the car's bumper, as shown in Figure 65. The actual point of impact was at the left-side quarter point. A sequential description of the impact events for test no. WZ09-2A is shown in Table 17. Approximately 0.678 seconds after the first impact, the second impact occurred. A sequential description of the impact events for test no. WZ09-2B is shown in Table 18. The vehicle came to rest 285 ft – 8 in. (87.1 m) downstream from the first impact and 16 ft – 4 in. (5.0 m) laterally towards the left of the first impact. The vehicle trajectory and final position are shown in Figures 59, 60, and 66.

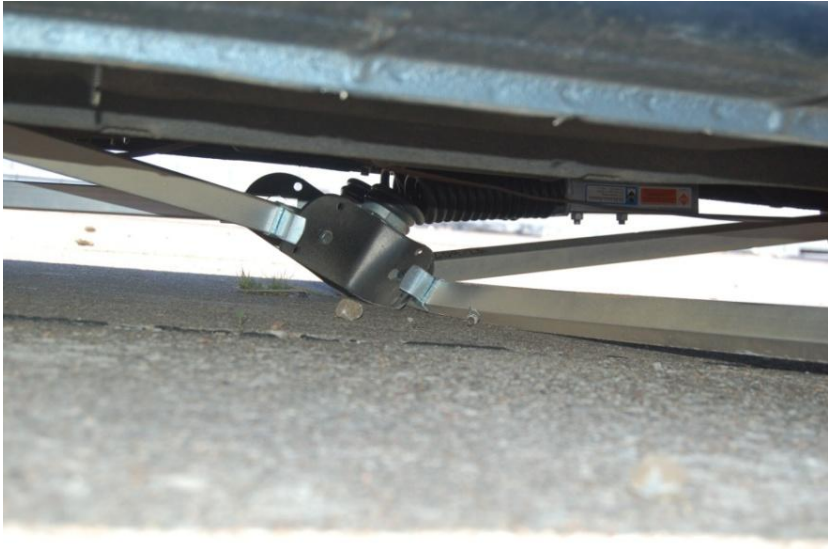
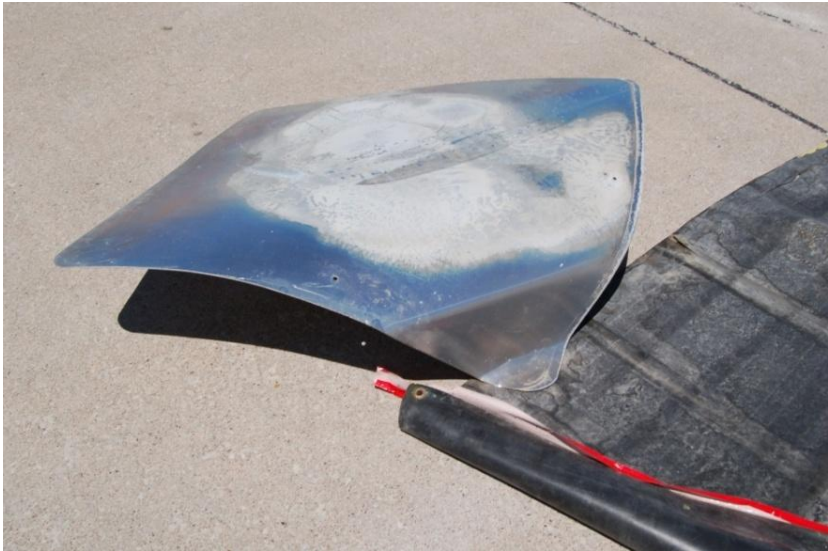
Figure 67. System Damage, Test No. WZ09-2A

Damage to System Nos. 2A and 2B is shown in Figures 67 through 70. System No. 2A encountered severe damage to the sign support stand. The lower mast fractured at the breakaway holes and landed upstream of the impact. The base, with all four legs attached, remained intact under the car. The angled plate attaching two of the legs was bent and torn at one of the bolt holes. The other angled plate's corner was deformed and crushed from dragging. Both coil springs were significantly deformed and bent over. The upper rigid bracket deformed out. The flag holders were slightly bent, and the bottoms of two flag staffs were fractured. The upper mast was bent slightly. The lower rigid bracket was slightly deformed out. The sign panel was deformed out with a crease at the top corner from the rigid panel bracket.

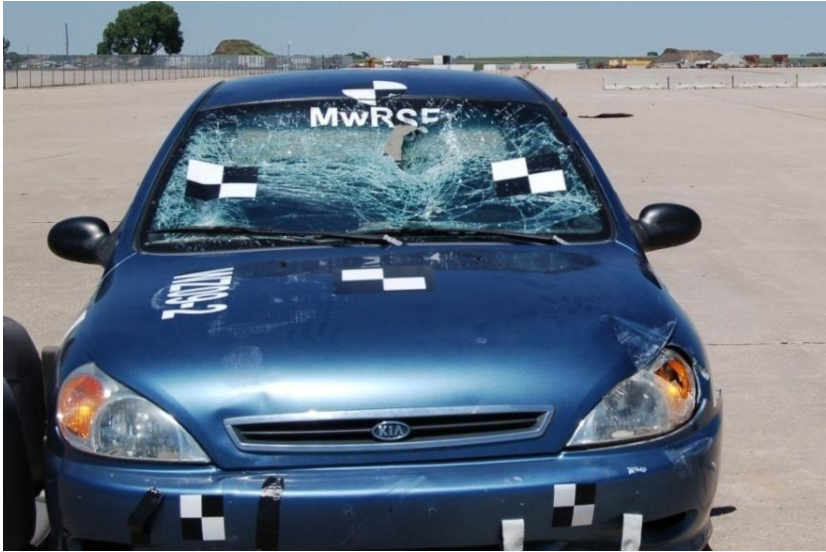
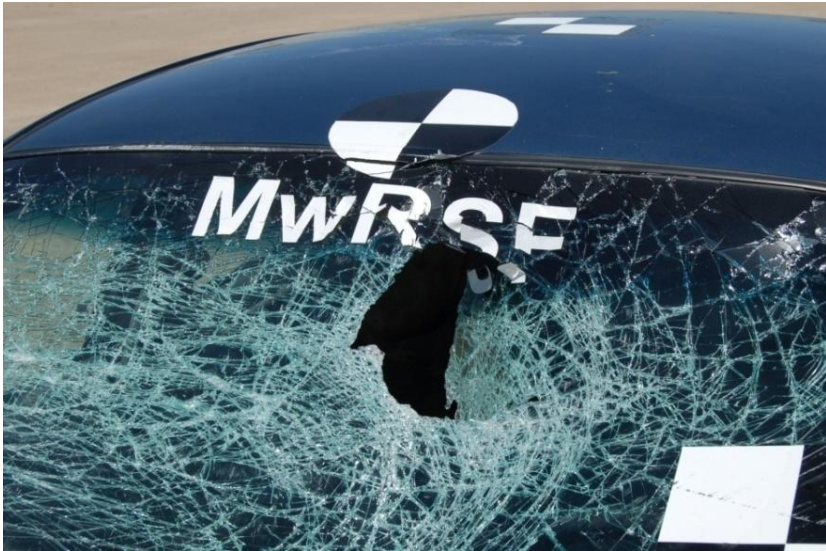
Figure 71. Vehicle Damage, Test No. WZ09-2

Vehicle damage is shown in Figures 71 and 72. The left side of the front plastic bumper was scuffed and cut where it contacted System No. 2B, and it was deformed outward from the left-front quarter panel. The lower-left side of the plastic bumper was deformed backward and torn. The left headlight was fractured. The left-front quarter panel was dented at the front. The left-front corner of the hood was deformed down. The right side of the engine hood and roof were scuffed from the sign panel of System No. 2A. A concentrated point of impact was found at the bottom-right corner of the windshield from the flash bulb deforming into the windshield. A large hole was found at the top of the windshield slightly to the left of center where the upper rigid bracket and mast of System No. 2B impacted. The entire windshield encountered cracking with severe cracking at the upper half of the windshield. The rearview mirror disengaged from the windshield, and glass was found on both the front and back seats.

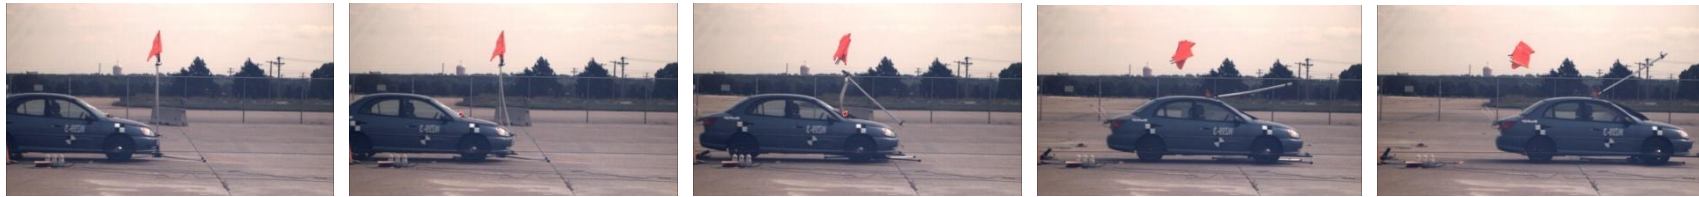
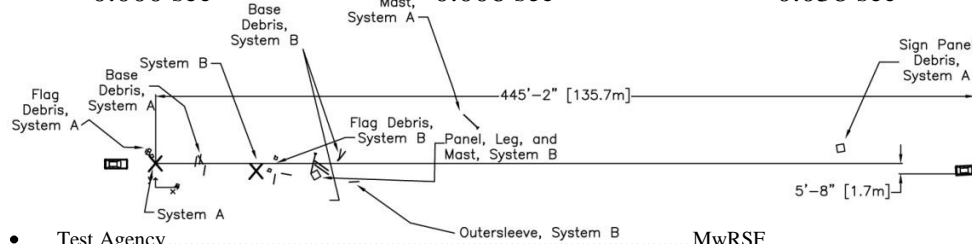
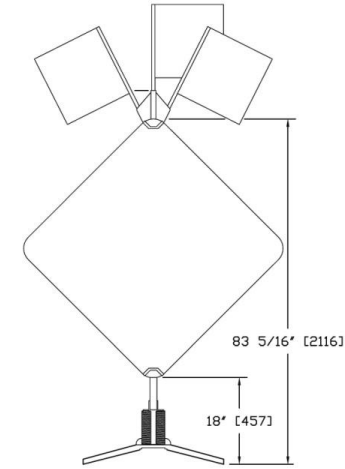
Figure 73. Summary of Test Results and Sequential Photographs, Test No. WZ09-3A

indentation greater than 3 in. (76 mm). Deformations of the occupant compartment did occur as the sign panel from System No. 3A contacted and indented the windshield a maximum of 4 in. (102 mm). The top of the mast contacted the back of the sign panel that was intact with the windshield and roof and left a small hole in the panel. In the event that the sign panel releases from the windshield, there is a potential for the mast to contact and penetrate the roof.

- Test Agency MwRSF
- Test Number WZ09-3A
- Date 9/14/09
- MASH Test Designation Number 3-71
- Test Article Portable Sign Support
 - Height to Bottom of Sign 18 in. (457 mm)
 - Mast Material Aluminum Tubing
- Key Component – X-Footprint Base
 - Length 81 3/4 in. (2,076 mm)
 - Width 40 7/16 in. (1,027 mm)
- Key Component – Aluminum Sign Panel
 - Dimension 48 in. x 48 in. (1,219 mm x 1,219 mm)
 - Thickness 0.093 in. (2.4 mm)
- Vehicle Make and Model 2002 Kia Rio Sedan
 - Curb 2,309 lb (1,047 kg)
 - Test Inertial 2,404 lb (1,090 kg)
 - Gross Static 2,573 lb (1,167 kg)
- Impact Conditions
 - Speed 66.0 mph (106.1 km/h)
 - Angle 0 deg
 - Impact Location centerline of mast
- Exit Conditions
 - Angle 0 deg
- Vehicle Stability Satisfactory
- Vehicle Stopping Distance (longitudinal) 445 ft - 2 in. (135.7 m) from Impact A
- Vehicle Stopping Distance (lateral) 5 ft - 8 in. (1.7 m) right of Impact A

- Occupant Ridedown Acceleration (DTS)
 - Longitudinal 0.77 g's < 20.49 g's
 - Lateral 0.79 g's < 20.49 g's
- Occupant Impact Velocity (DTS)
 - Longitudinal -9.15 ft/s (-2.79 m/s) < 16.4 ft/s (5.0 m/s)
 - Lateral 0.14 ft/s (0.04 m/s) < 16.4 ft/s (5.0 m/s)
- THIV (DTS – not required) 9.28 ft/s (2.83 m/s)
- PHD (DTS – not required) 0.95 g's
- Maximum Angular Displacements (DTS)
 - Yaw 4.59 deg
 - Pitch -3.84 deg
 - Roll 1.23 deg
- Vehicle Damage Severe Windshield Deformation
 - VDS^[33] 12-FR-1
 - CDC^[34] 12FZAW1
 - Maximum Interior Deformation NA

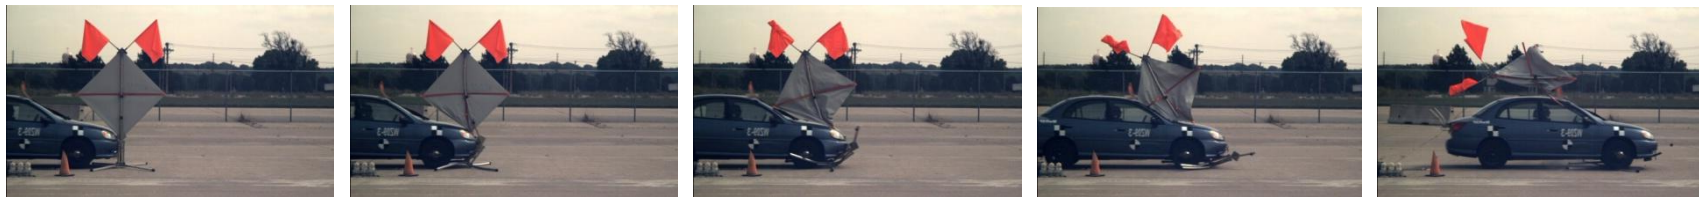
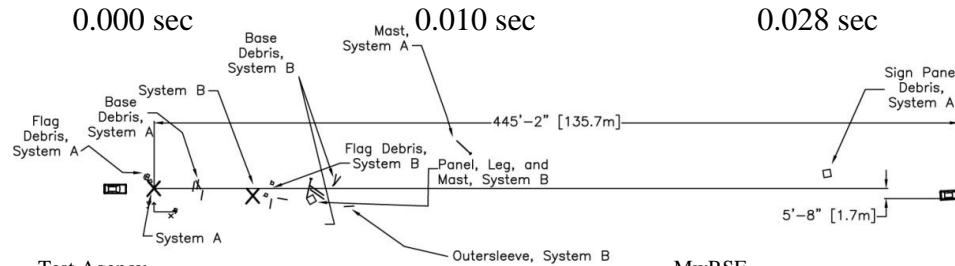
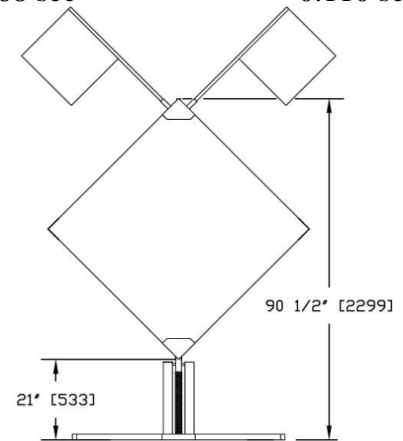
Figure 74. Summary of Test Results and Sequential Photographs, Test No. WZ09-3B

System No. 3B was determined to be acceptable according to the MASH criteria since the maximum deformation on the left side of the windshield was only 2¼ in. (57 mm). Windshield cracking was insufficient to cause obstruction of visibility, and the horizontal fiberglass crossbrace did not appear to have the potential for windshield penetration. The vehicle's trajectory did not intrude into adjacent traffic lanes.

- Occupant Ridedown Acceleration (DTS)
 - Longitudinal 0.79 g's < 20.49 g's
 - Lateral 0.43 g's < 20.49 g's
- Occupant Impact Velocity (DTS)
 - Longitudinal -3.88 ft/s (-1.18 m/s) < 16.4 ft/s (5.0 m/s)
 - Lateral -0.39 ft/s (-0.12 m/s) < 16.4 ft/s (5.0 m/s)
- THIV (DTS – not required) 3.94 ft/s (1.20 m/s)
- PHD (DTS – not required) 0.84 g's
- Maximum Angular Displacements (DTS)
 - Yaw 3.22 deg
 - Pitch 1.47 deg
 - Roll -2.64 deg
- Vehicle Damage Moderate Windshield Deformation
 - VDS^[33] 12-FL-1
 - CDC^[34] 12FLAN1
 - Maximum Interior Deformation NA
- Test Article Damage Moderate

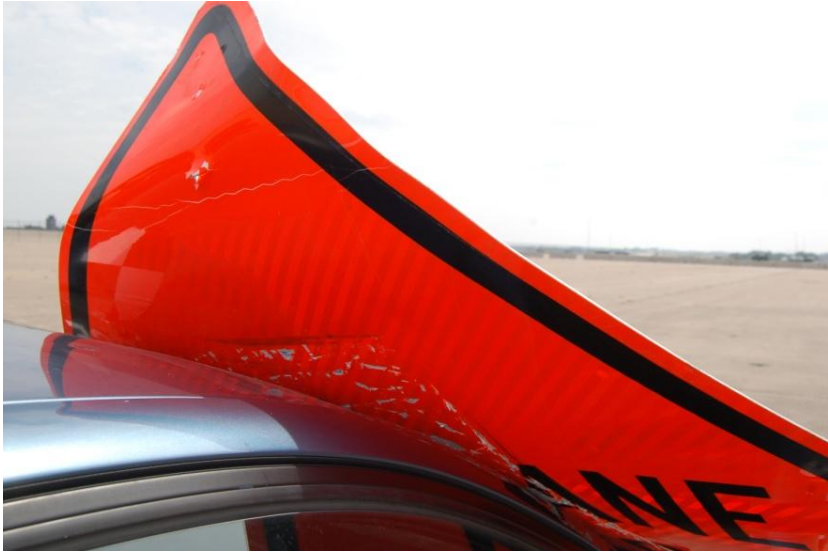
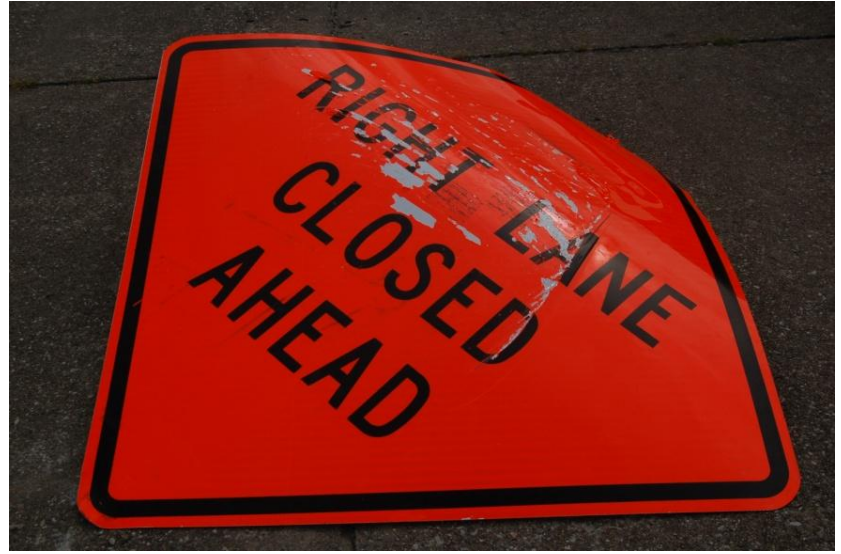
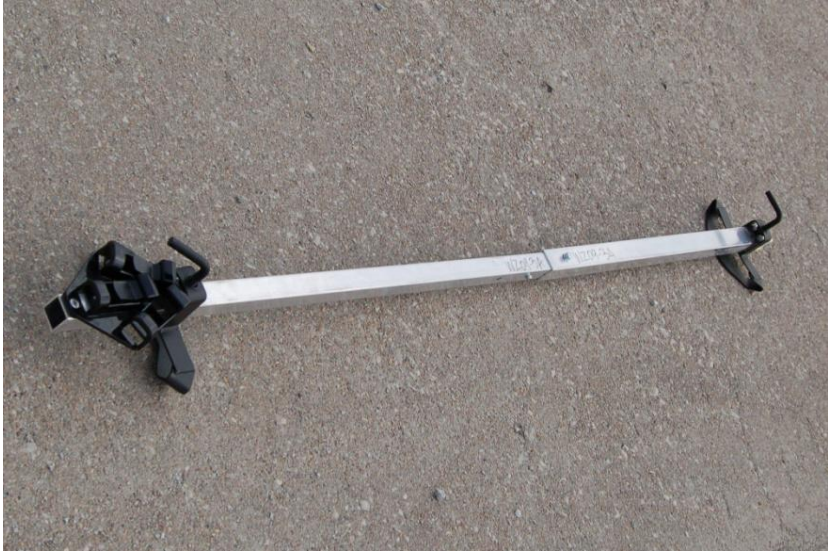
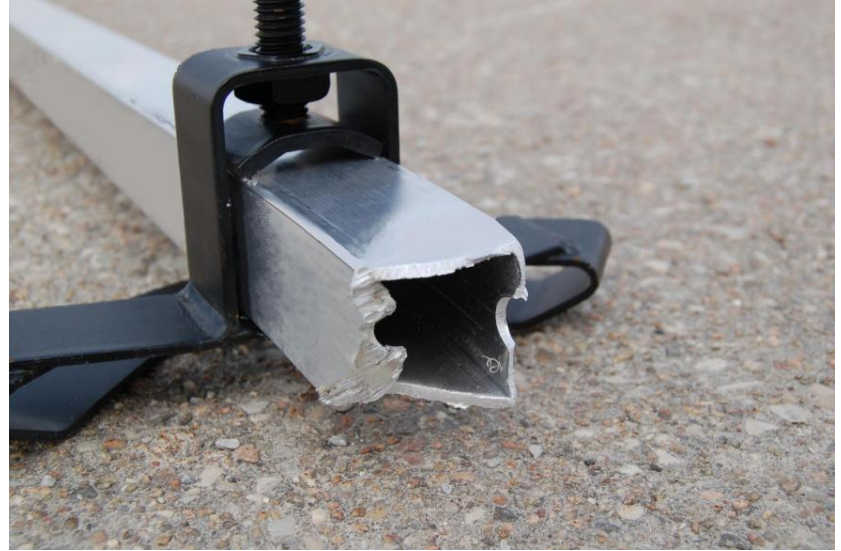
Figure 82. System Damage, Test No. WZ09-3A

Damage to System Nos. 3A and 3B is shown in Figures 82 through 85. System No. 3A encountered moderate damage. The three flags released from the flag holder. Both springs were deformed to a horizontal position. The front of base plate deformed inward, and the front legs were pushed closer together. The lower mast completely fractured at the top of bolt side plates and was crushed at the fracture point. The lower mast aluminum was torn below the fracture point at one corner. The sign panel remained intact with the car, and reflective material was scraped on the front face. The sign panel was also deformed outward with a small hole near the top. Damage to the concrete surface around the original location of System No. 3A included gouges 2½ ft (0.8 m) downstream of the impact, where the bottom part of the lower mast contacted the concrete.
