MID-AMERICA TRANSPORTATION CENTER

Report # MATC-UNL: 100

Safety Investigation and Guidance for Work-Zone Devices in Freight Transportation Systems Subjected to Passenger Car and Truck Impacts with New Crash Standards

2010

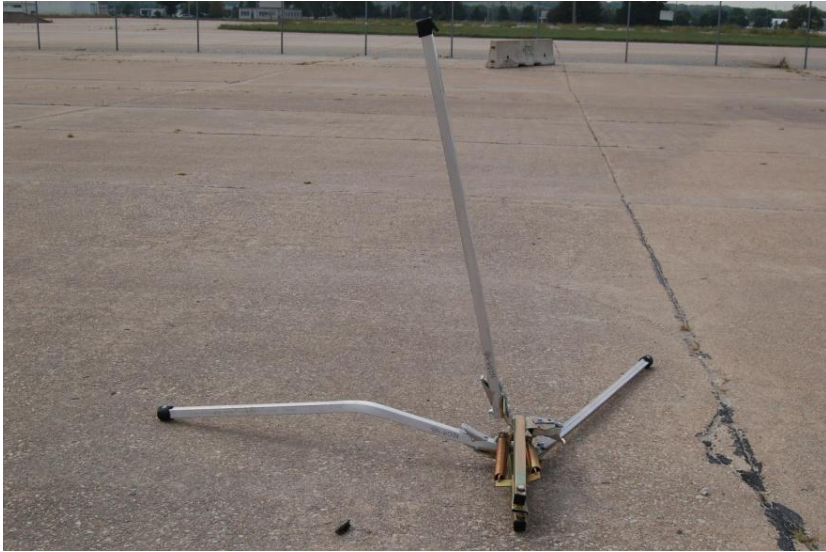
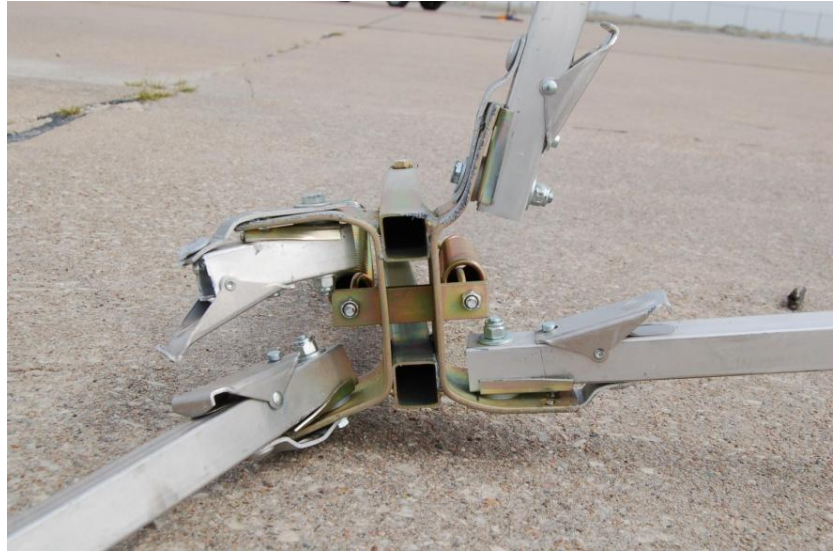
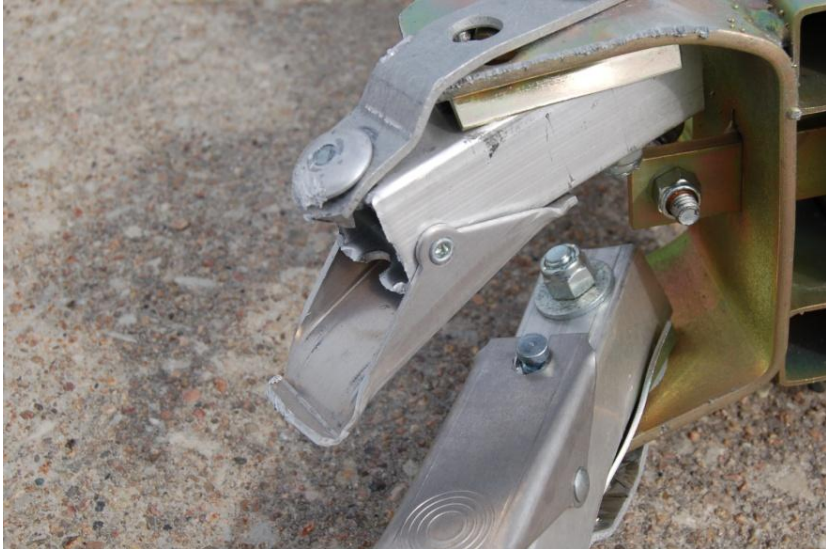
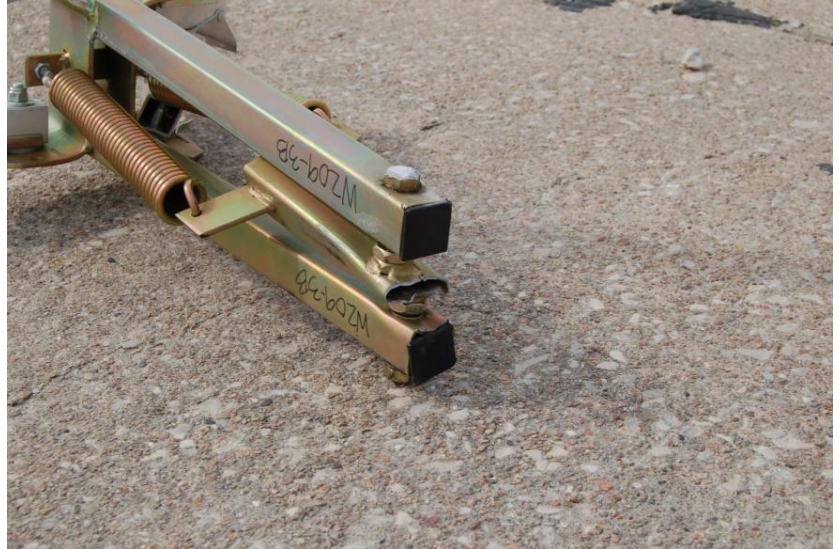
Figure 83. System Damage, Test No. WZ09-3A

Damage to System Nos. 3A and 3B is shown in Figures 82 through 85. System No. 3A encountered moderate damage. The three flags released from the flag holder. Both springs were deformed to a horizontal position. The front of base plate deformed inward, and the front legs were pushed closer together. The lower mast completely fractured at the top of bolt side plates and was crushed at the fracture point. The lower mast aluminum was torn below the fracture point at one corner. The sign panel remained intact with the car, and reflective material was scraped on the front face. The sign panel was also deformed outward with a small hole near the top. Damage to the concrete surface around the original location of System No. 3A included gouges 2½ ft (0.8 m) downstream of the impact, where the bottom part of the lower mast contacted the concrete.

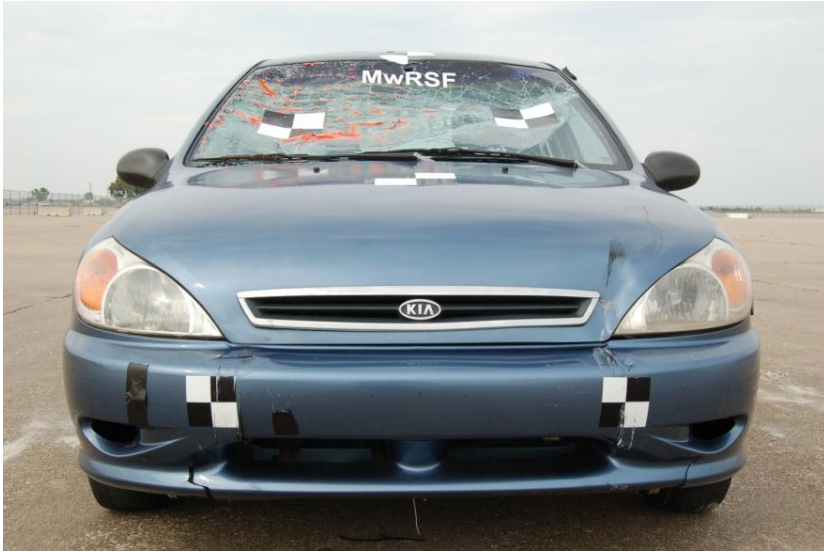
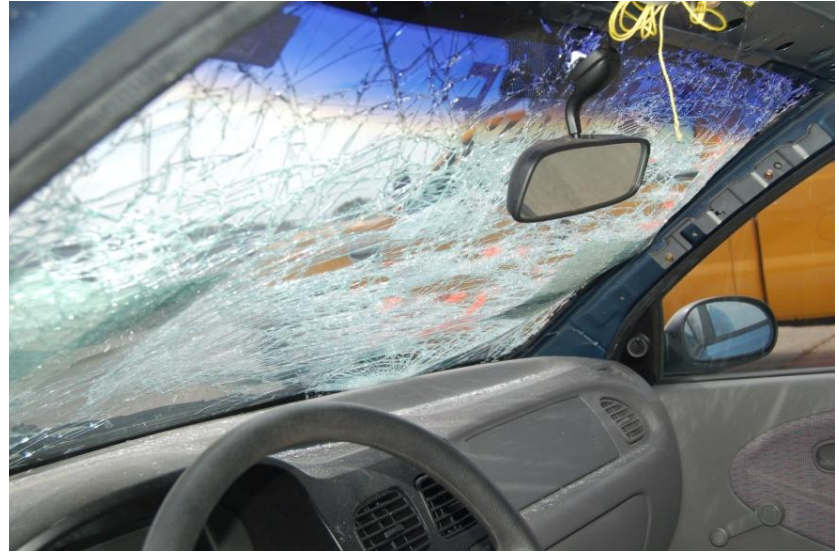
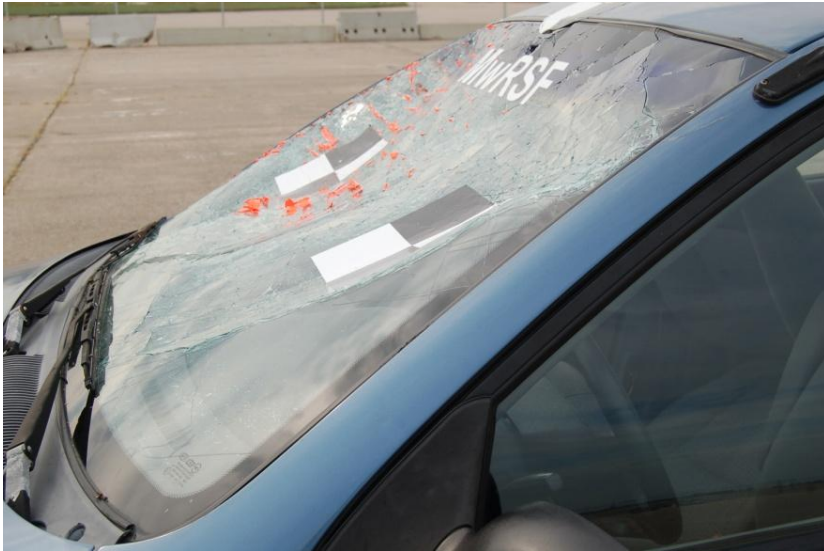
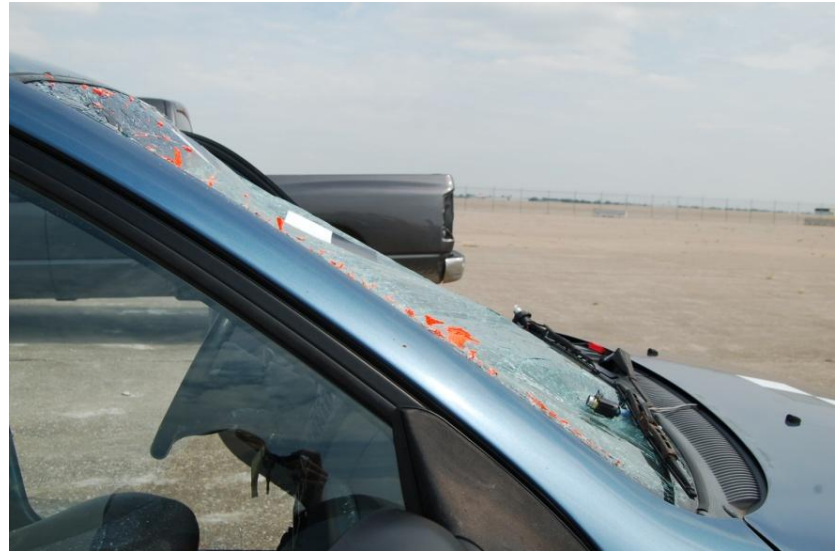
Figure 86. Vehicle Damage, Test No. WZ09-3

Vehicle damage is shown in Figures 86 and 87. The lower and upper plastic front bumpers were fractured at both the left- and right-side impact locations. The bolts underneath the car were scuffed on the left and right sides. The left front of the engine hood was dented and scraped, and black scuff marks were found on the left side of the hood. Minor scraping occurred along the right side of the hood. Significant windshield cracking occurred with a concentrated point of impact from the right-side flash bulb deforming into the windshield. Orange reflective material was embedded in the windshield cracks on the right side. A hole was found in the upper-middle region of the windshield where the rearview mirror was attached. A small scrape was found on the right-front roof, and minor scuffing occurred along the right side of the roof.

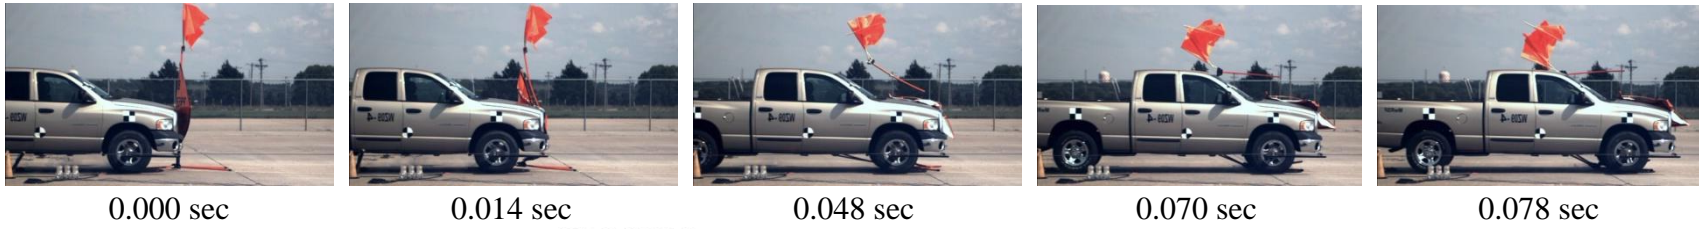
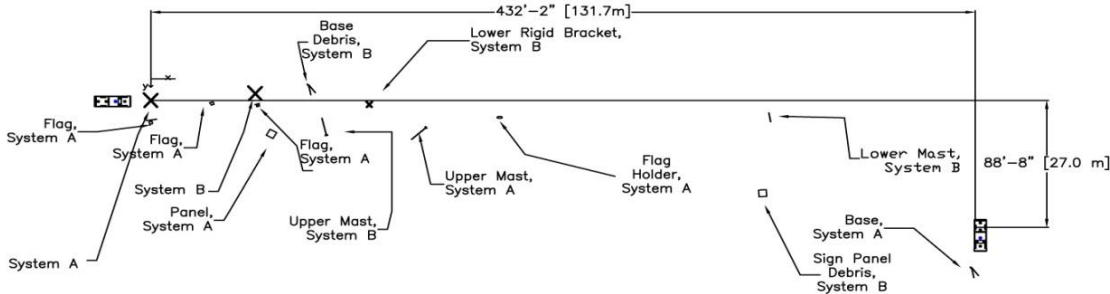
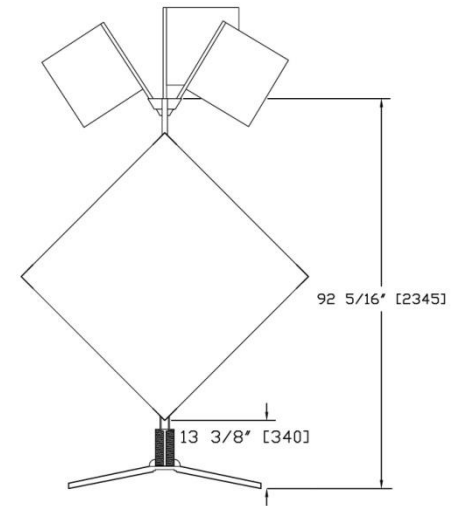
Figure 88. Summary of Test Results and Sequential Photographs, Test No. WZ09-4A

Following test no. WZ09-4, a safety performance evaluation was conducted, and the performance of System No. 4A was determined to be unacceptable according to the MASH criteria. It was deemed unacceptable due to the mast penetrating the windshield and a leg penetrating into the occupant compartment. Deformations of, and intrusion into, the occupant compartment did occur as System No. 4A penetrated into the upper-right corner of the windshield and the occupant compartment on the floorboard behind the left-front seat. Also, one of the legs on System No. 4A was wedged behind the right-front tire which inhibited the braking system on the pickup truck. This caused the pickup truck to veer to the right and impact a concrete barrier prior to stopping. This result could be considered a danger to workers in the work-zone area as well as to the occupants of vehicle depending on what objects would have been located to the right side of the roadway.

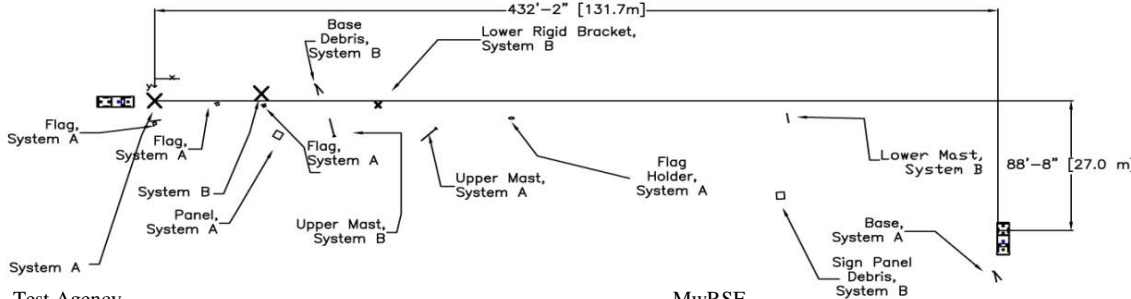
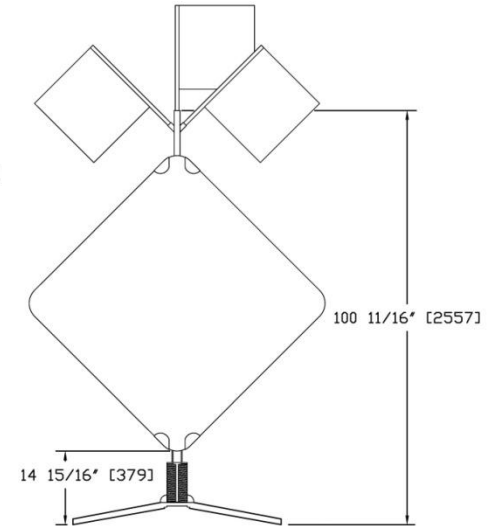
Figure 89. Summary of Test Results and Sequential Photographs, Test No. WZ09-4B

System No. 4B was determined to be acceptable according to the MASH criteria since the components of System No. 4B did not contact the pickup truck's windshield or roof. Deformations of, and intrusion into, the occupant compartment did not occur, and System No. 4B did not show any potential for occupant compartment penetration. The impact with System No. 4B did not affect the vehicle's trajectory.

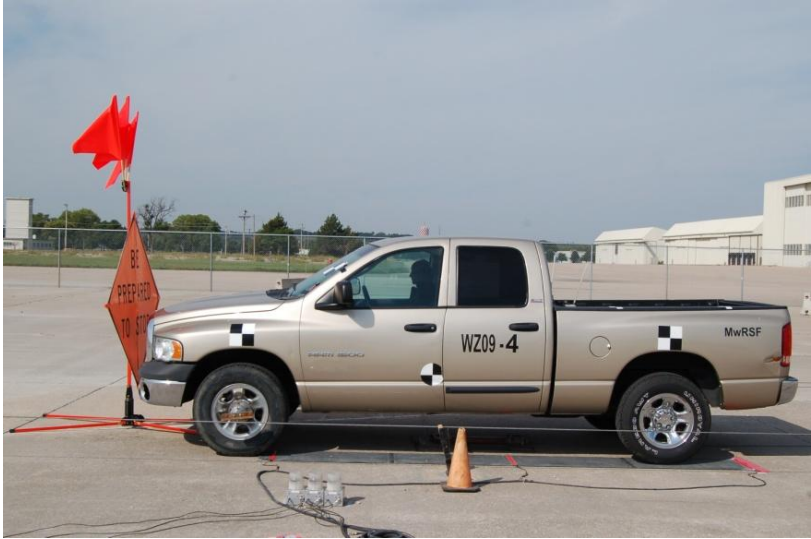
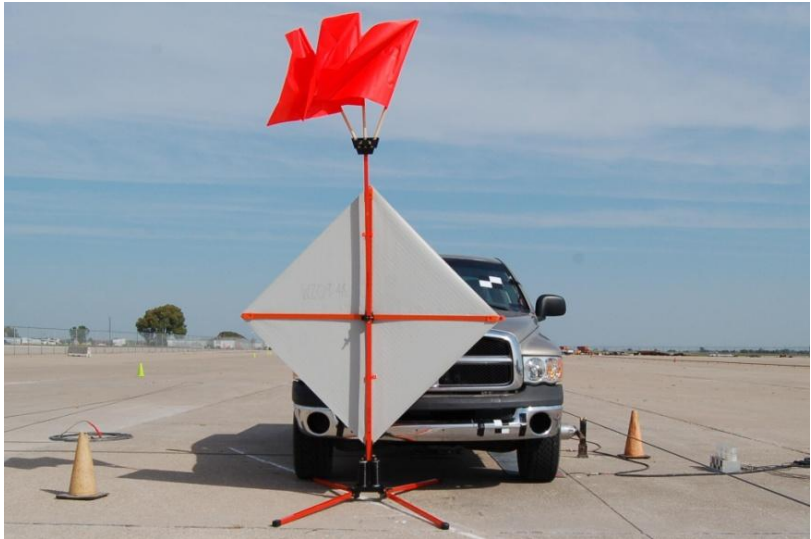
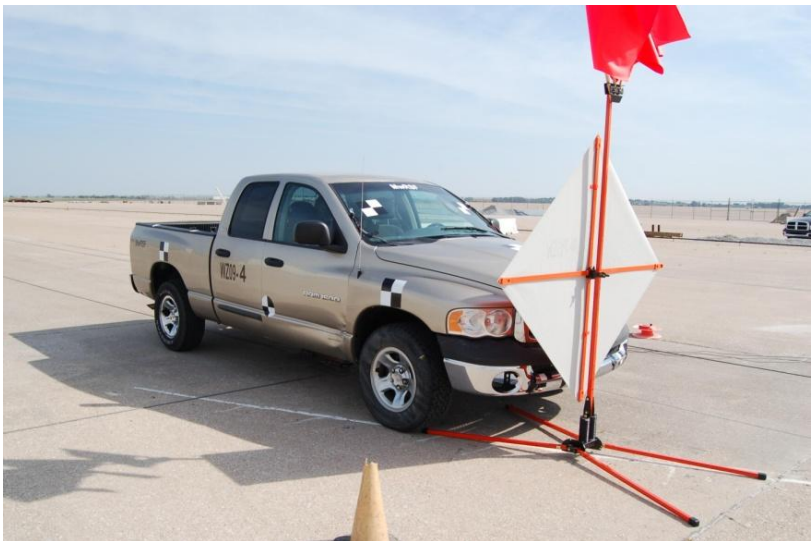
Figure 93. Impact Location, Test No. WZ09-4A

For System No. 4A, initial vehicle impact was to occur with the centerline of the mast at the right-side quarter point on the pickup truck's bumper, as shown in Figure 93. The actual point of impact was 1½ in. (38 mm) to the left of the right-side quarter point. For System No. 4B,

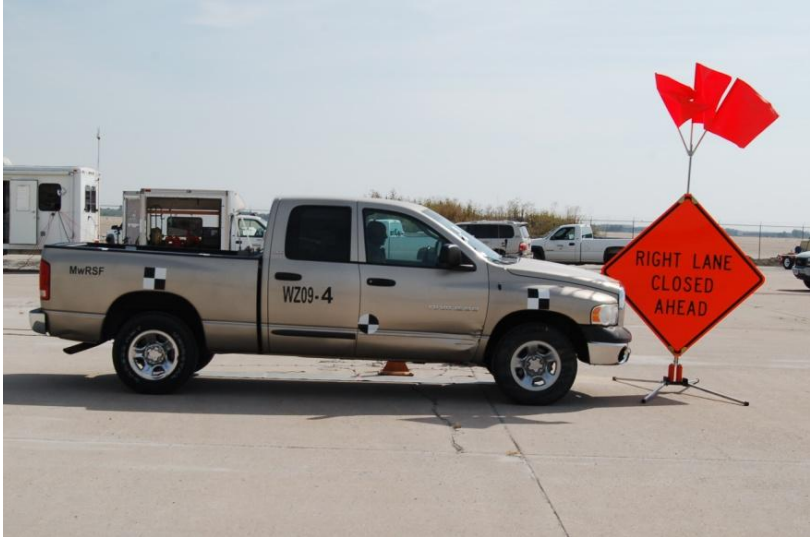
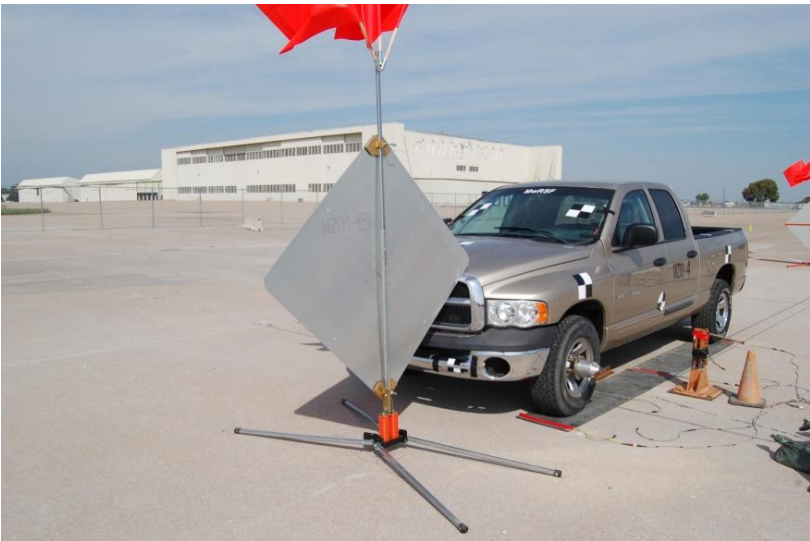
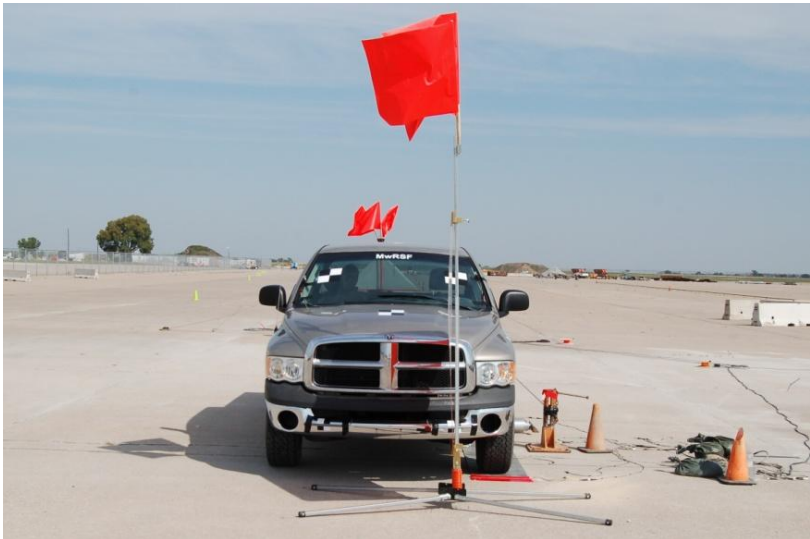
Figure 94. Impact Location, Test No. WZ09-4B

initial vehicle impact was to occur with the centerline of the mast to the right of the left-side quarter point on the pickup truck’s bumper, as shown in Figure 94. The actual point of impact was 2 in. (51 mm) to the right of the left-side quarter point.

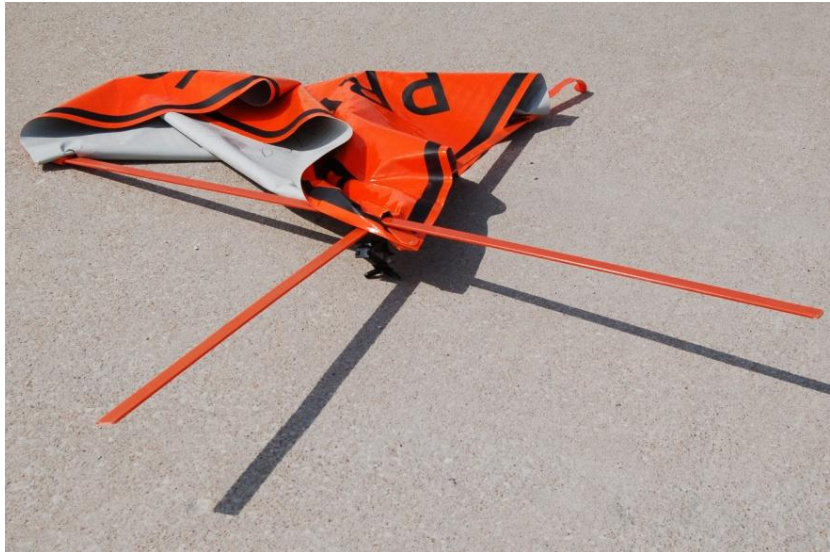
Figure 96. System Damage, Test No. WZ09-4A

Damage to System Nos. 4A and 4B is shown in Figures 96 through 99. System No. 4A encountered severe damage. All three flag staffs fractured at the top of the flag holder, and the ends remained intact with the flag holder. The vertical crossbracing tore through the top of sign panel. The upper mast was bent slightly and separated from the lower mast. The flag holder separated from the upper mast and had scratches and denting on one corner. The base was carried underneath the truck the entire time. One leg penetrated the floorboard and was bent significantly. One leg was wedged behind the right-front wheel and was bent slightly. The lower mast almost completely fractured 1½ in. (38 mm) above the top bent plates. The springs deformed to a horizontal position and were scraped on their sides. All legs released from their original lock positions.

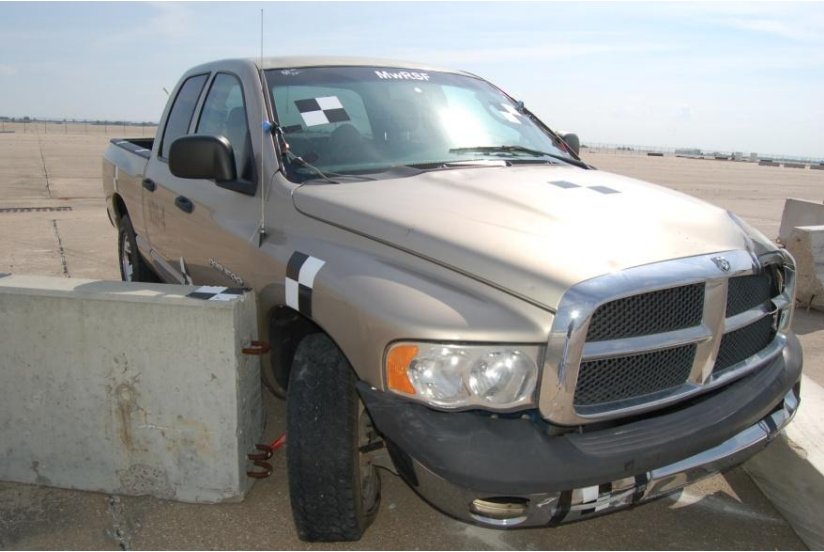
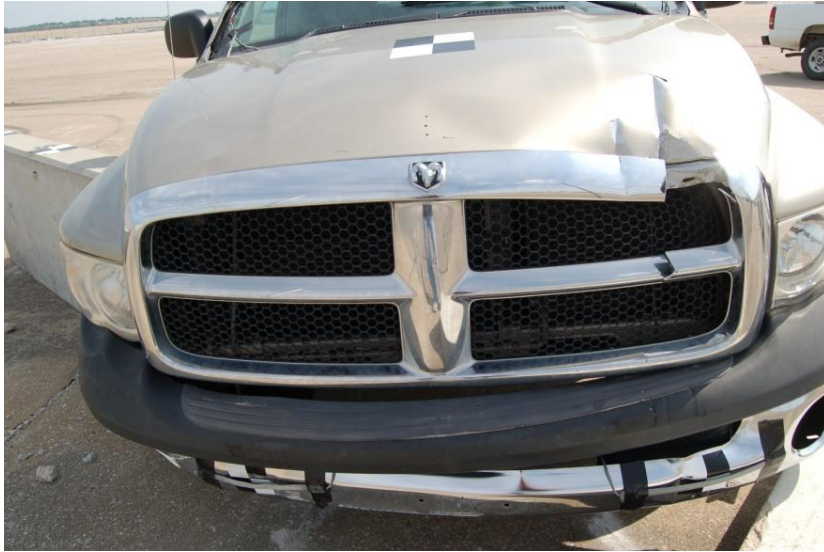
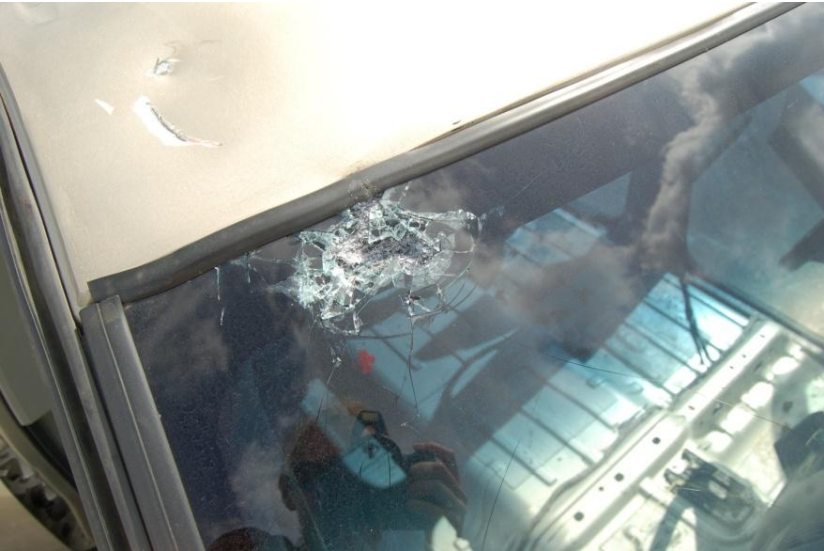
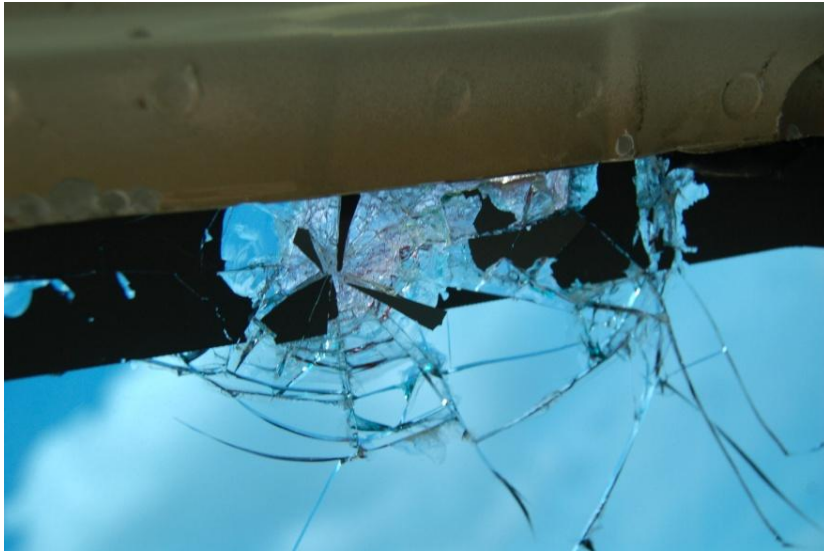
Figure 100. Vehicle Damage, Test No. WZ09-4

Vehicle damage is shown in Figures 100 and 101. The bumper was dented inward where it contacted System No. 4A and where it contacted System No. 4B. The grill was sliced at the upper-left region. The left front of the engine hood was dented inward and sliced. Scraping occurred on the right-front corner of the hood. A small dent was found in the right-front corner of the hood, and a scratch was found down the right side of the hood. A concentrated tear occurred in the upper-right corner of the windshield where it was contacted by the flag holder from System No. 4A. Two hairline cracks were found beginning at the lower-left corner of the windshield and spanning to the upper-right corner of the windshield. A dent and a scratch were found at the right-front region of the roof. A small hole was found in the floorboard on the left side with one of the legs of System No. 4A protruding through it. The right-front tire was deflated, and one leg of System No. 4A was wedged behind the right-front tire. The front bumper was pushed down and scuffed from a secondary impact with a concrete barrier prior to stopping.

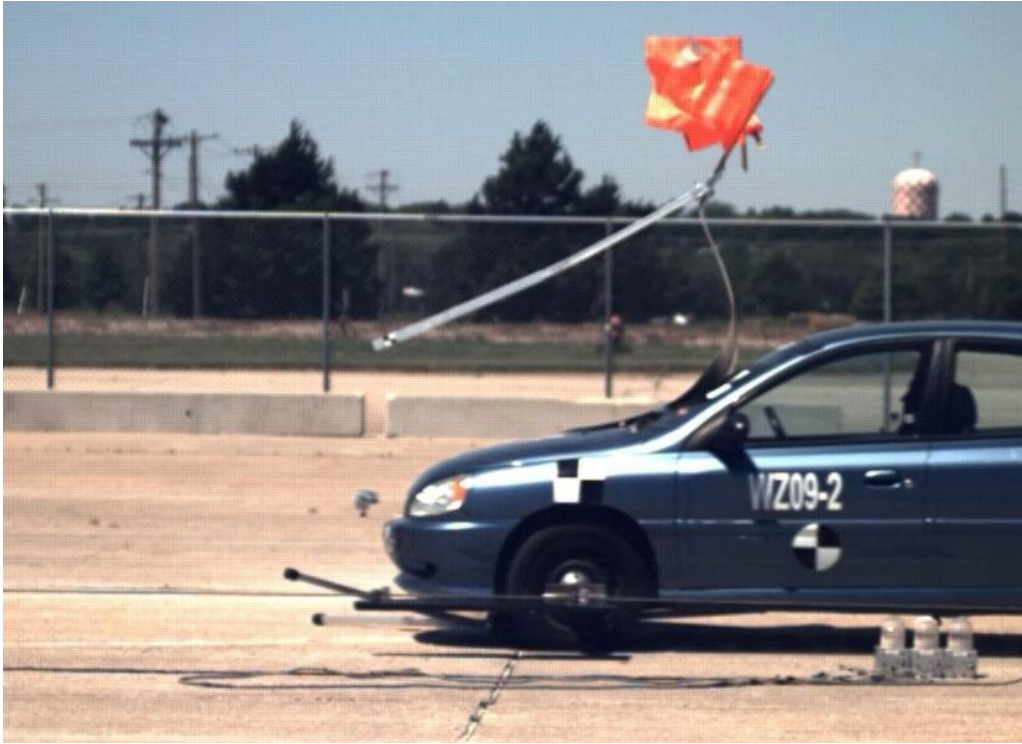
Figure 103. System No. 3A, Frangible Mast

A mast with a frangible base reduces the amount of flex that develops in the sign panel and mast (System Nos. 1A, 2A, 3A, and 4A). This relatively quick release of the mast from the stand allows the sign panel and mast to fall upon the vehicle with little additional force than what normally occurs through the impact event, as shown in Figure 103. However, this force can still be sufficient to cause indentation or penetration of the windshield. On the other hand, when base bending occurs, as shown in Figure 104, the sign panel and the top of mast are accelerated downward into the windshield (System No. 1B). When the mast was unloaded, the sign panel and mast have the tendency to "whip" downward onto the vehicle. In addition, a base-bending

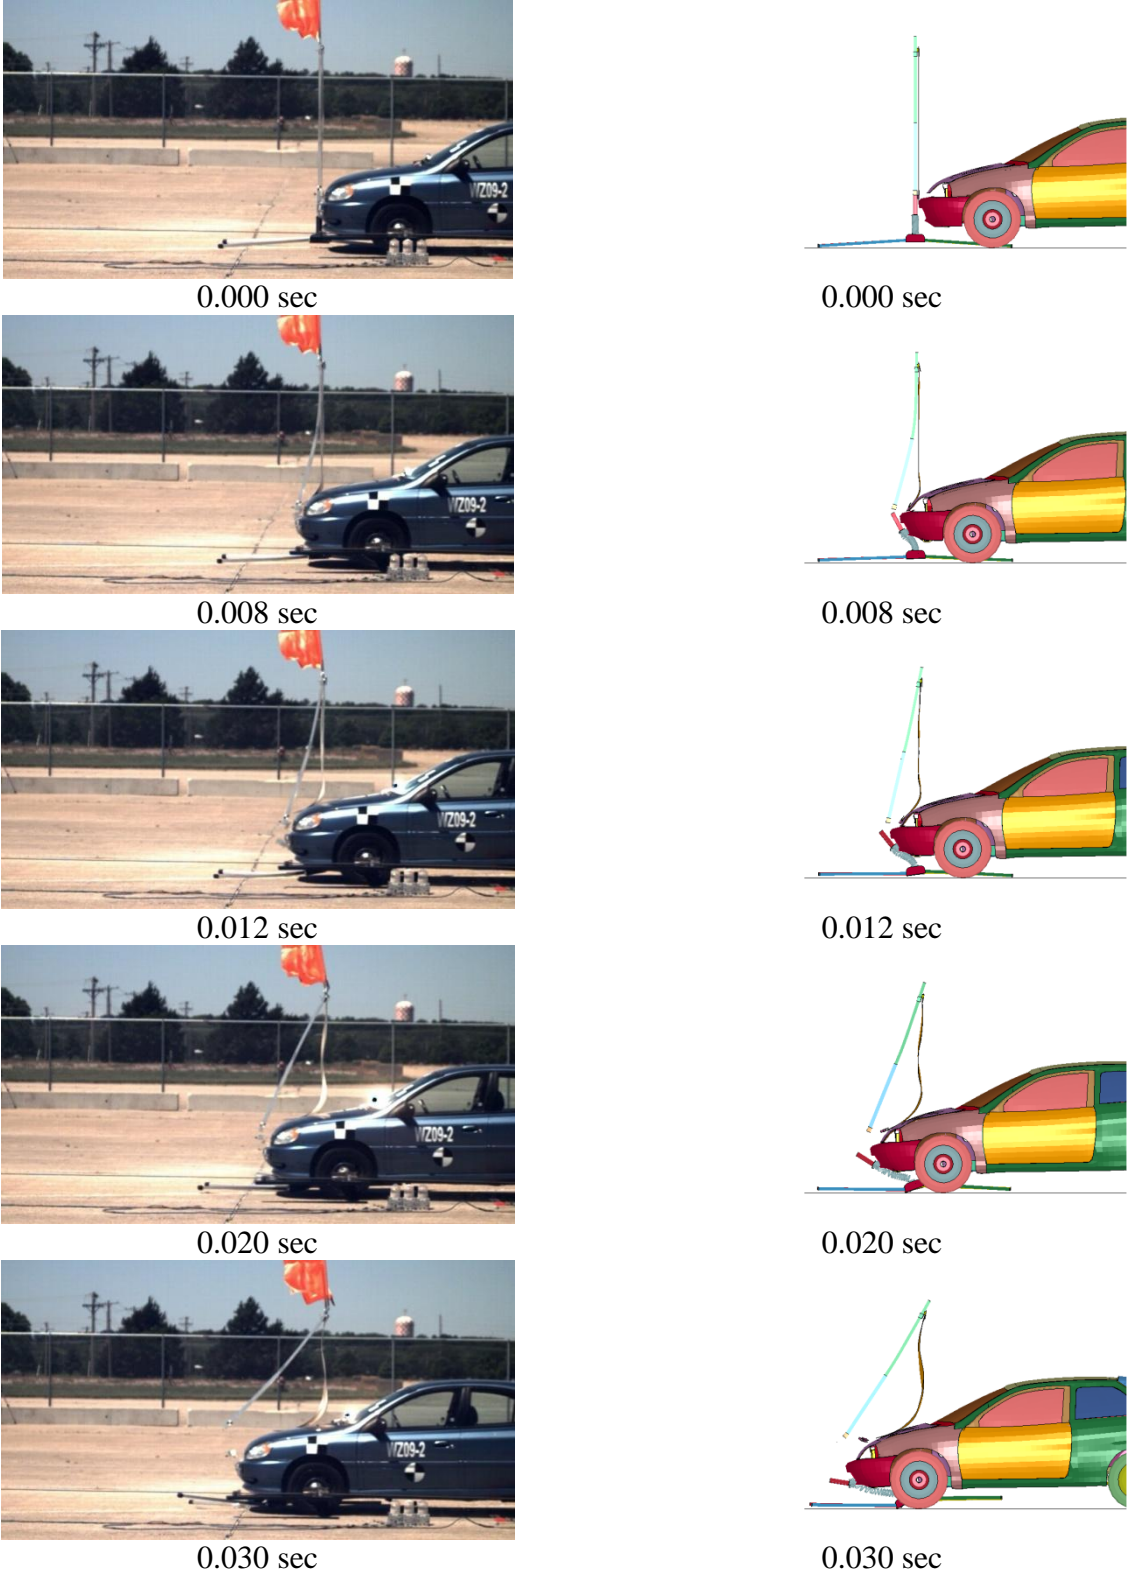
Figure 110. Comparison of Full-Scale Crash Test and Simulation Results

A comparison between the simulation and the full-scale test video is shown in Figures 110 and 111. The lower mast fractured at the breakaway holes, which was critical for the trajectory of the sign system to be accurate. The fracture appears accurate when compared to the full-scale crash test, except the lower mast in the full-scale crash test lags the simulation by 3 ms. The trajectories of all parts appear similar for the first 40 ms. Around 50 ms, the sign panel in the simulation began to slip out of the upper rigid bracket therefore the sign panel does not bend as much as was observed in the full-scale crash test. At this same time, the bottom of the mast began to rotate slower than observed in test no. WZ09-2A.

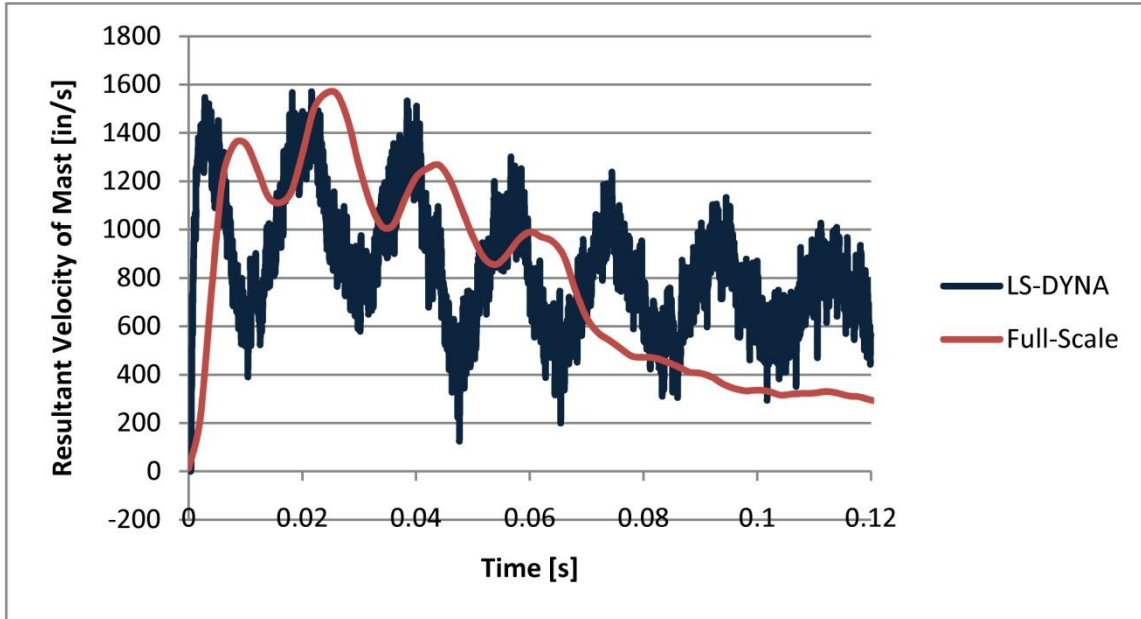
Figure 112. Velocity of Mast vs. Time

A target was placed above the fracture point on the lower mast in test no. WZ09-2A. The velocity of the target was compared to the velocity at an equivalent point on the mast in the simulation and is shown in Figure 112. The full-scale crash test and the simulation achieved the same peak values, and the curves were nearly identical except for a phase shift. The curves oscillate because the mast vibrates through the air after the impact event.

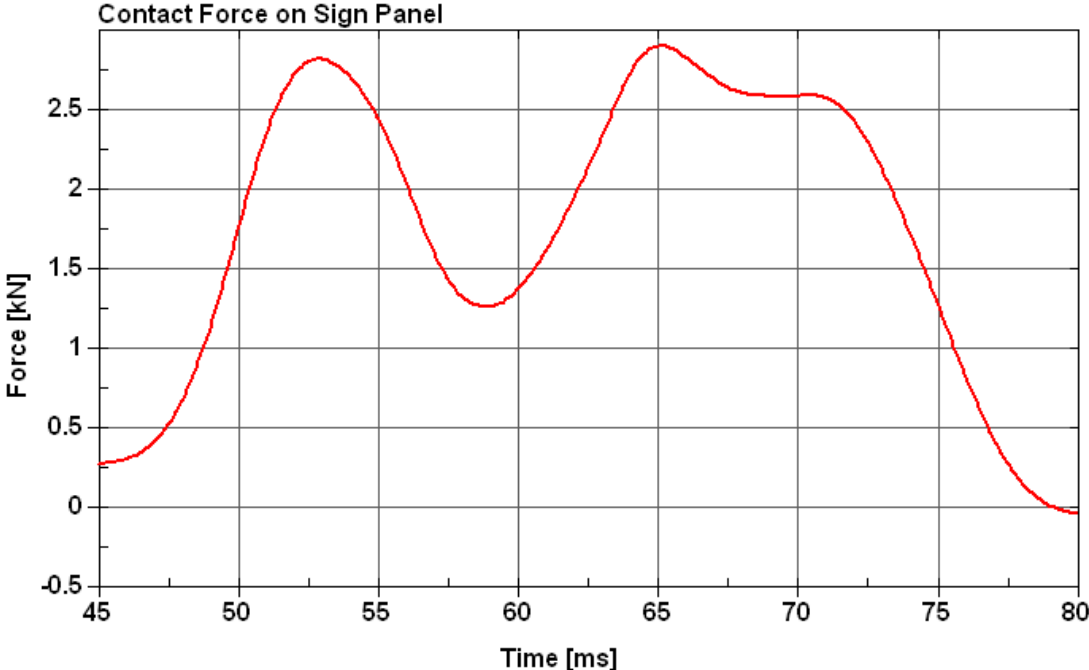
Figure 113. Contact Force between Sign Panel and Windshield

Since the mass of the sign stand is small and the actual accelerations are low, the force exerted on the sign stand should also be low. The contact force was filtered with Butterworth (BW) at 100 Hz. The contact force between the sign panel and windshield is shown in Figure 113. A maximum force of 654 lb (2.91 kN) occurred at the initial impact. There is no validation data to compare if this force is accurate, but it seems slightly high to cause 2¼ in. (57 mm) of windshield deformation.

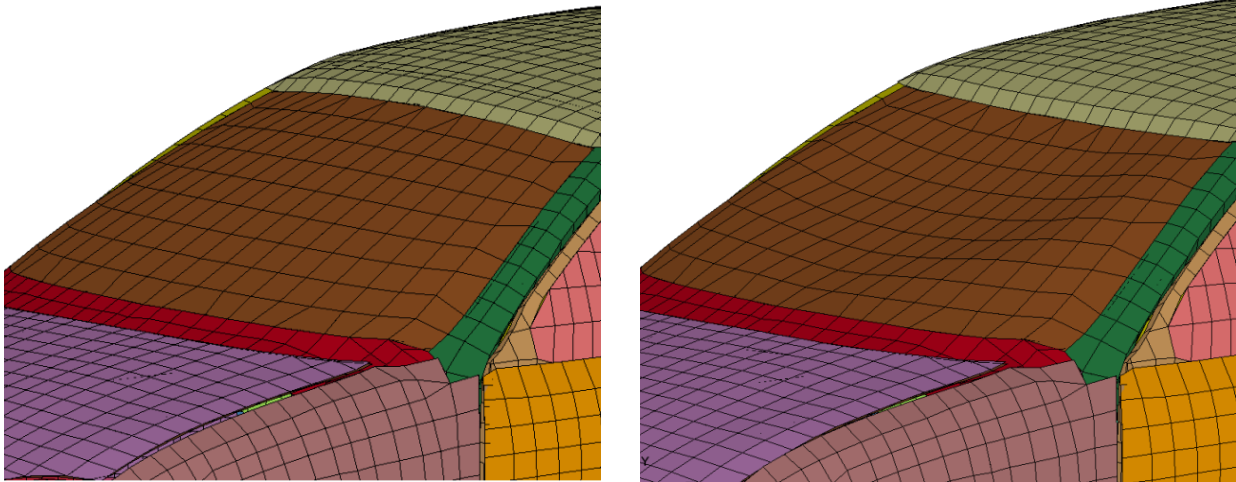
Figure 117. Windshield Deformation

Although the windshield material model was believed to be inaccurate in predicting deformations, the windshield deformed similar to what was found in test no. WZ09-2A. A comparison of the deformation in the simulation is shown in Figure 117. The vertical displacement of the windshield was compared over time, as shown in Figure 118. The maximum vertical deformation in the simulation was 2.24 in. (56.8 mm). The maximum windshield deformation in the full scale crash test was 2¼ in. (57 mm).

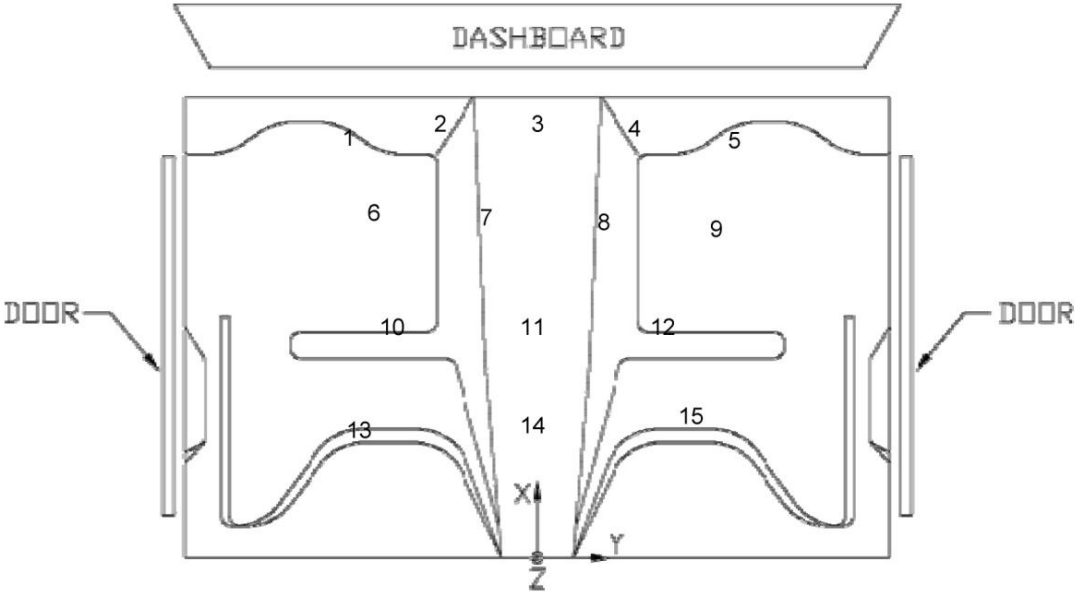
Figure E-1. Roof Deformation Data, Test No. WZ09-1

Max is at roof edge of glass, passenger side, 1.5inches in from roof seam.

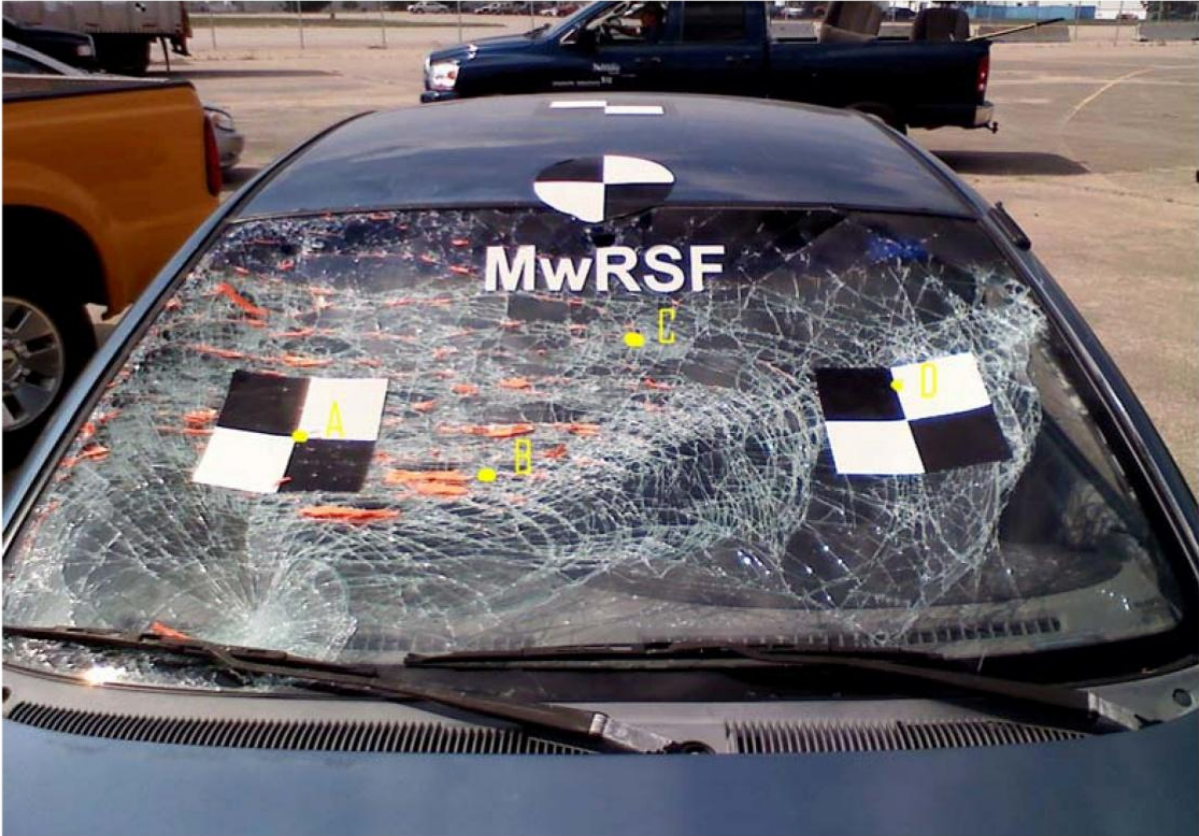
Figure E-7. Windshield Deformation Data, Test No. WZ09-3

Lateral (X)	Longitudinal (Y)	Pre test	Post test	Crush
Point A	6.5	14.5	5.25	9.25	4
Point B	15.5	17.75	4.5	8.25	3.75
Point C	23.75	10.5	5	7.75	2.75
Point D	34.75	12.25	5.5	7.75	2.25
Max Crush	6.5	14.75	5.25	9.25	4
