# Testing and Evaluation of a Portable Workzone Sign Support: FOIL Test Numbers 98F008 and 98F009

PUBLICATION NO. FHWA-RD-98-183

DECEMBER 1998

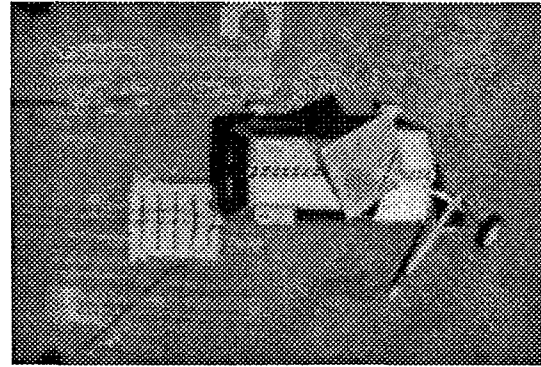
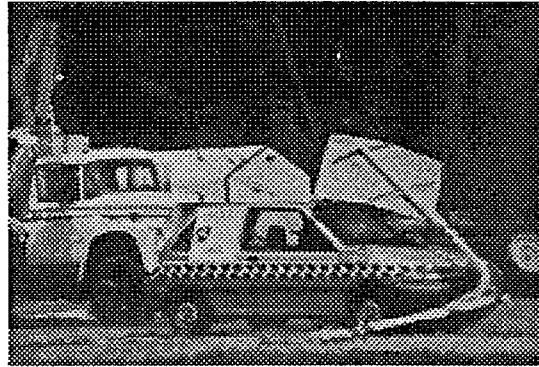
Figure 5. Test photographs during impact, test 98F008.

**Test 98F008.** The Ford Festiva was accelerated to 100.4 km/h prior to striking the portable sign trailer. The Ford Festiva centerline struck the sign trailer at one wheel as intended. The wheel of the sign trailer began to tuck under the vehicle and the axle began to buckle directly behind the wheel at 0.006 s. Movement of the sign trailer frame was observed at 0.010 s. The sign trailer pivoted about the end of the trailer tongue at the hitch. The struck wheel had folded over flat but remained attached to the axle by 0.054 s. The folded wheel assembly and buckled axle initiated the sign panel motion toward the windshield. The sign panel made contact with the windshield at 0.100 s. No contact between the sign post or panel and the hood was observed. As the vehicle continued to push on the end of the axle and sign panel, the sign trailer continued to rotate clockwise. The sign trailer was also being lifted by the vehicle's front end. The vehicle remained in contact with the sign trailer until approximately 0.250 s. The vehicle continued

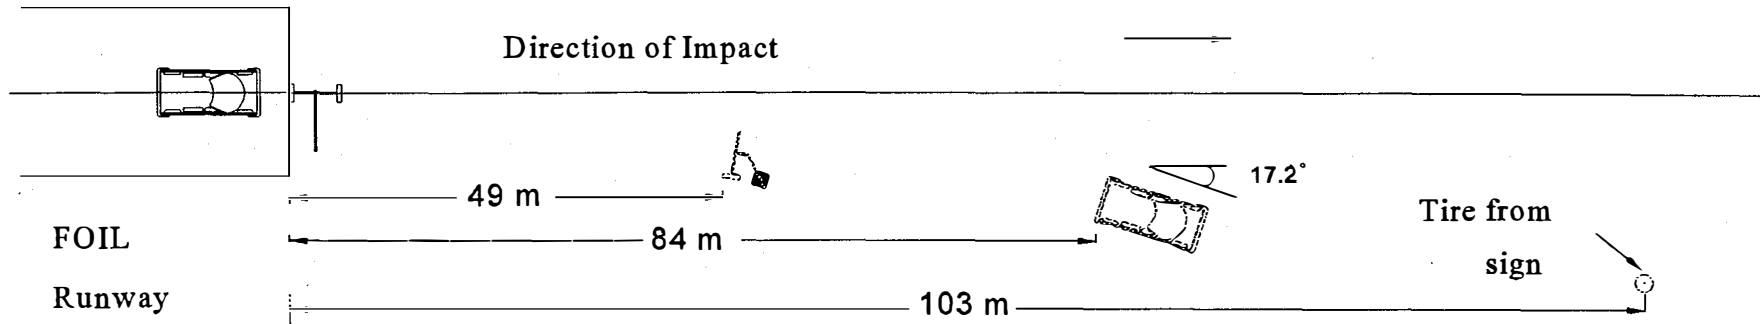
Figure 6. Summary of test 98F008.

Test number.....98F008	Vehicle analysis:	<u>Observed</u>	<u>Design/Limit</u>
Date.....May 28, 1998	Longitudinal:		
Test article....work-zone portable sign trailer	Vehicle Delta V.....	3.6 m/s	3/5 m/s
Support.....50 mm box tube post set	Occupant Delta V at 0.6 m.....	3.3 m/s	9/12 m/s
inside a steel sleeve	Ridedown acceleration.....	0.9 g's	15/20 g's
Tires.....P205/75 R14	Lateral:		
Tire pressure.....220 kPa	Occupant Delta V at 0.3 m.....	N/A	9/12 m/s
Sign panel.....aluminum 1.7 m by 1.7 m	Ridedown acceleration.....	N/A	15/20 g's
Foundation.....placed at end of FOIL runway	Peak 50 ms acceleration:		
Vehicle.....1990 Ford Festiva	Longitudinal.....	5.3 g's	
Weight: Inertial.....819 kg	Lateral.....	N/A	
Gross.....888 kg	Vehicle Damage:		
Dummy.....68 kg	Traffic Accident Data (TAD).....	12-FC-2	
Impact speed.....100.4 km/h	Vehicle Damage Index (VDI).....	12TDCN1	
Impact location.....at one tire, center	Vehicle crush.....	159 mm

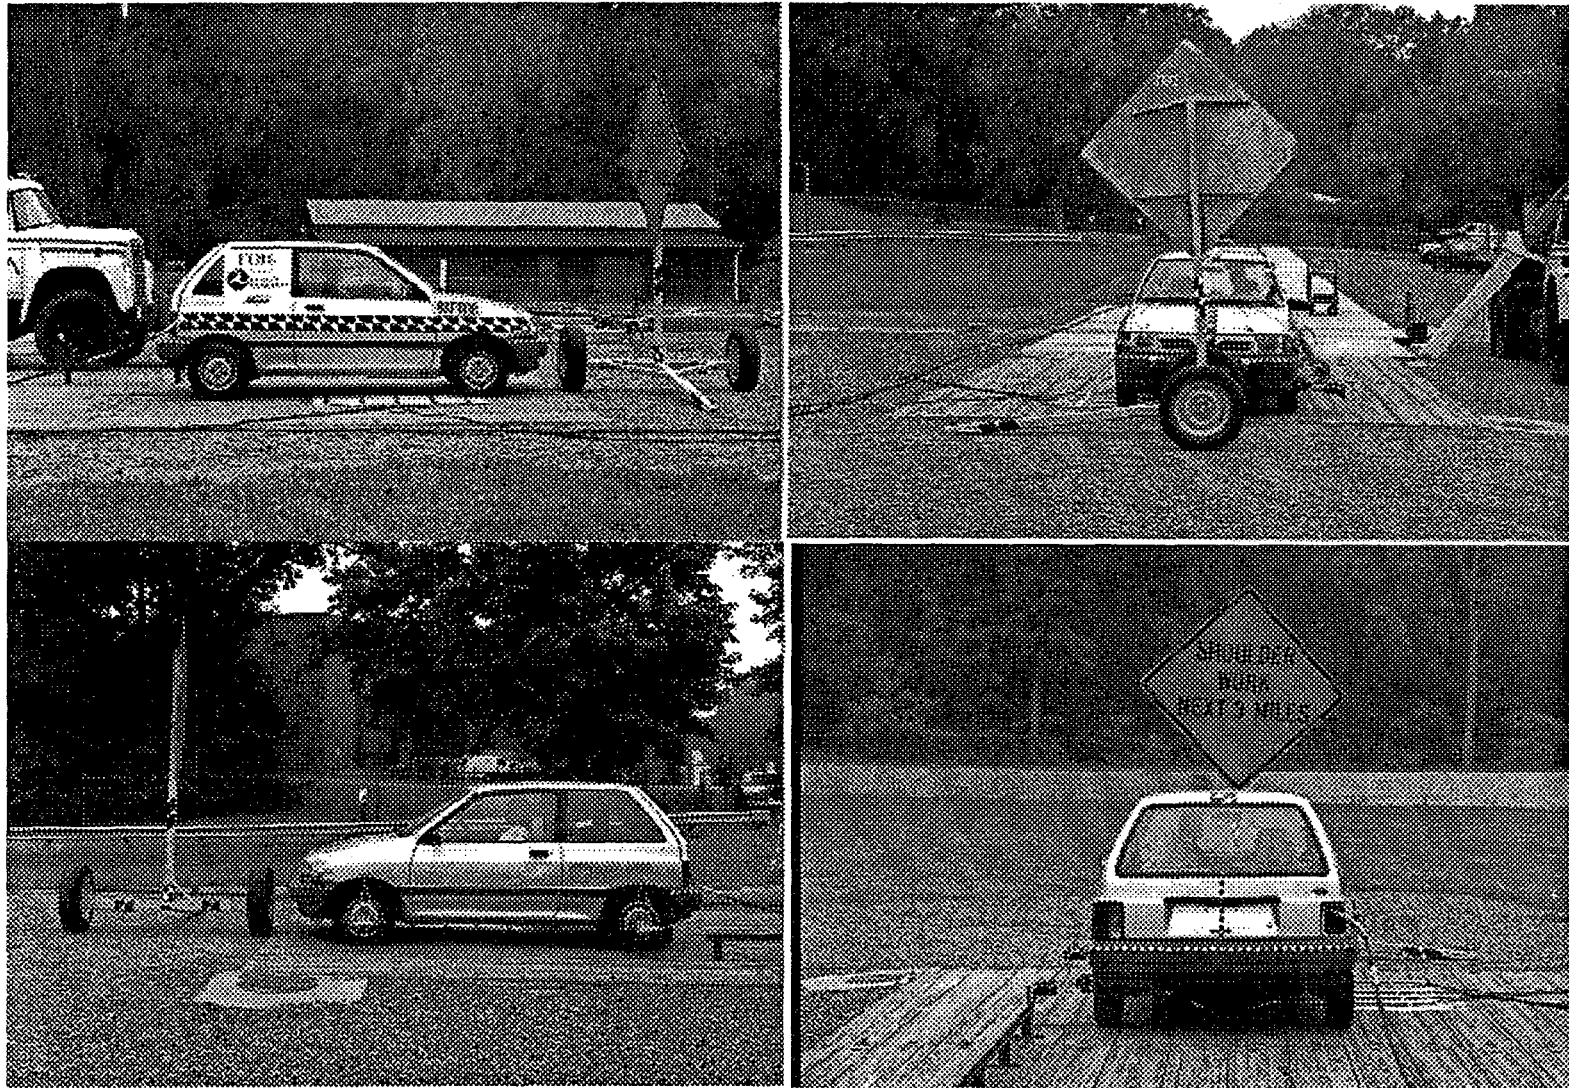
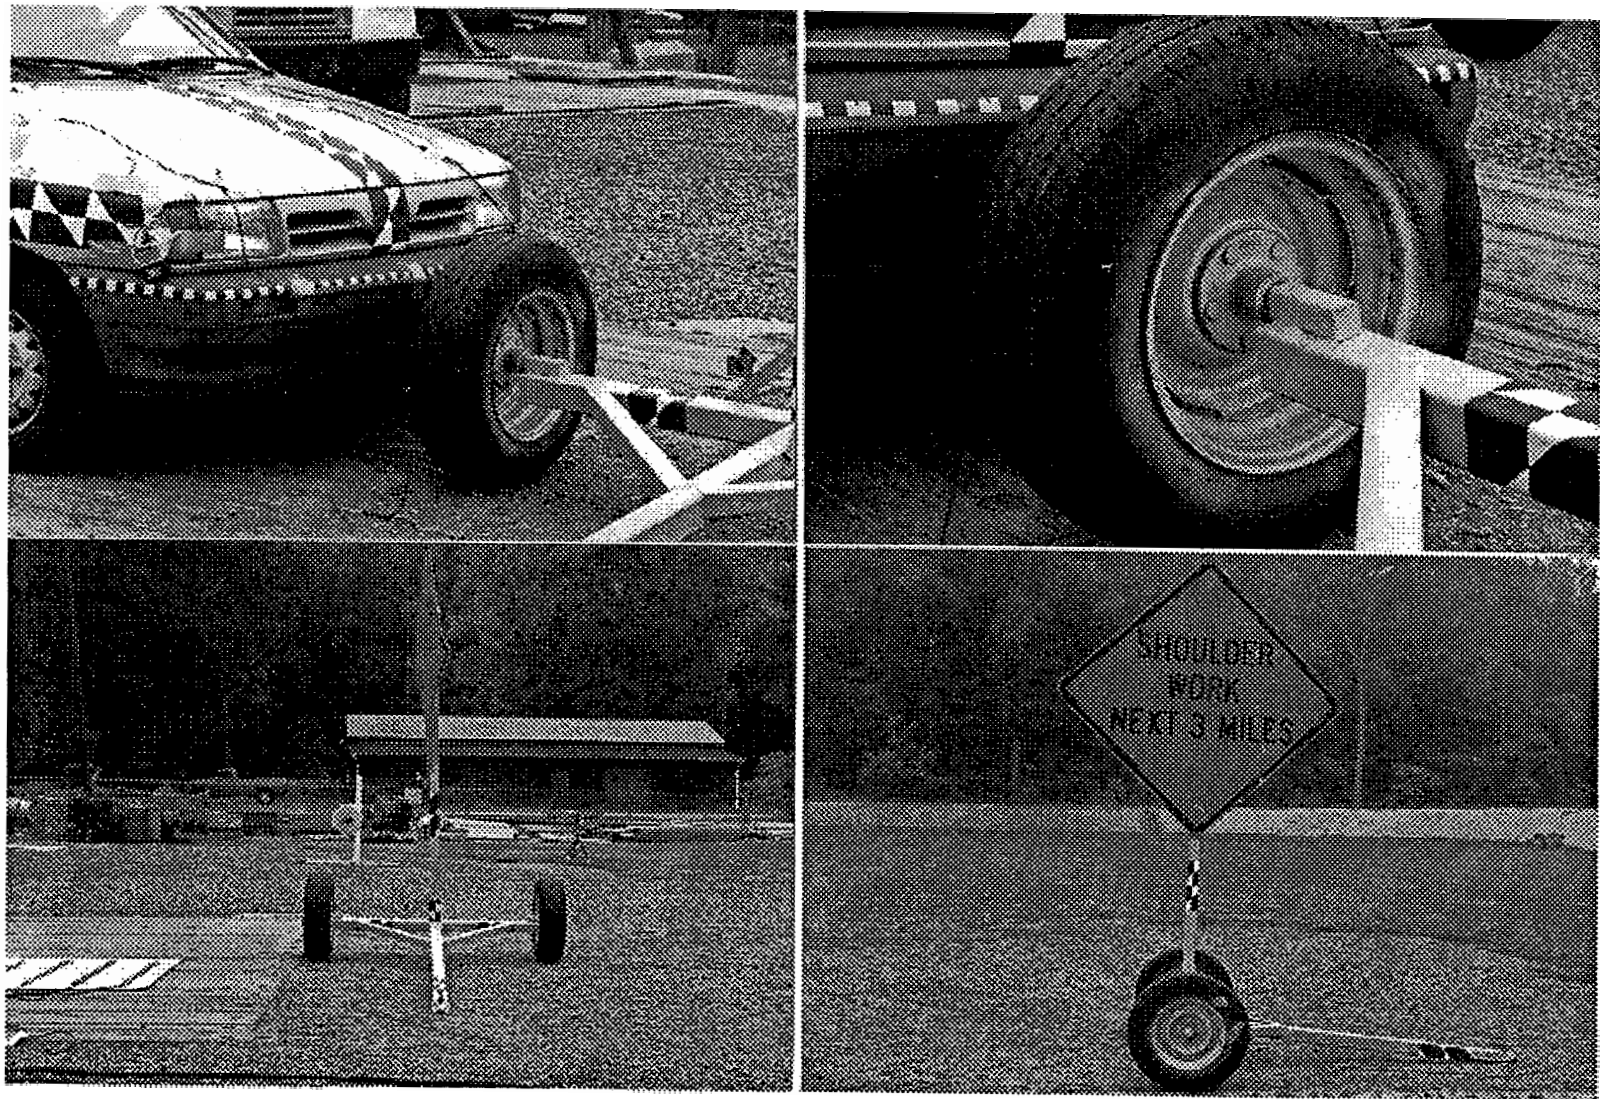
Figure 7. Pretest photographs, test 98F008.

b. Vehicle damage. Damage to the Ford Festiva consisted of minor to significant cosmetic dents to the bumper and roof. The maximum crush of the bumper was 159 mm and the roof was dented approximately 20 mm. The windshield was cracked but there was no intrusion and no loss of visibility. No debris from the test vehicle was observed in the runout path of the vehicle. The vehicle trajectory did not change after contact with the sign. No yaw was observed in the test vehicle's path. The vehicle remained stable throughout the test.

c. Test device damage. Damage to the portable sign trailer was substantial. The axle and sign post buckled severely. The sign panel remained fastened to the sign post, and the post remained inside the trailer sleeve. The sign trailer landed 49 m downrange and to the right of the test vehicle's trajectory. The struck wheel hub broke at the spindle and the tire rolled 103 m downrange. The sign trailer could not be repaired and reused without significant structural repair.

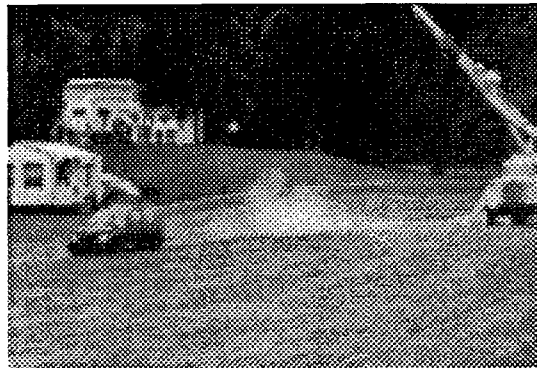
Figure 23. Test photographs during impact, test 98F009.

**Test 98F009.** The Ford Festiva was accelerated to 99.1 km/h prior to striking the portable sign trailer. The Ford Festiva centerline struck the sign trailer on the sign post between the trailer's two tires. The sign trailer began to move on contact and the bumper, grill, and hood had crushed significantly by 0.026 s. The vehicle bumper contacted the sign trailer 230 mm above the trailer's axle, but on the sign post sleeve (not directly on the sign post). The contact and the inertia of the tall sign post caused the sign panel and post to rotate down on top of the vehicle, striking the windshield at 0.110 s. The sign trailer's tongue and hitch pushed through the soil slightly before being rotated upward as the sign tipped toward the vehicle. The entire trailer was lifted up and rode on the hood of the vehicle before being launched upward and away from the vehicle. The maximum height of the sign trailer was approximately 2.3 m. The vehicle continued along its original line of trajectory. The sign trailer landed 75 m downrange from its original position and to the left of the vehicle's trajectory. The sign trailer remained intact, although with significant structural damage.

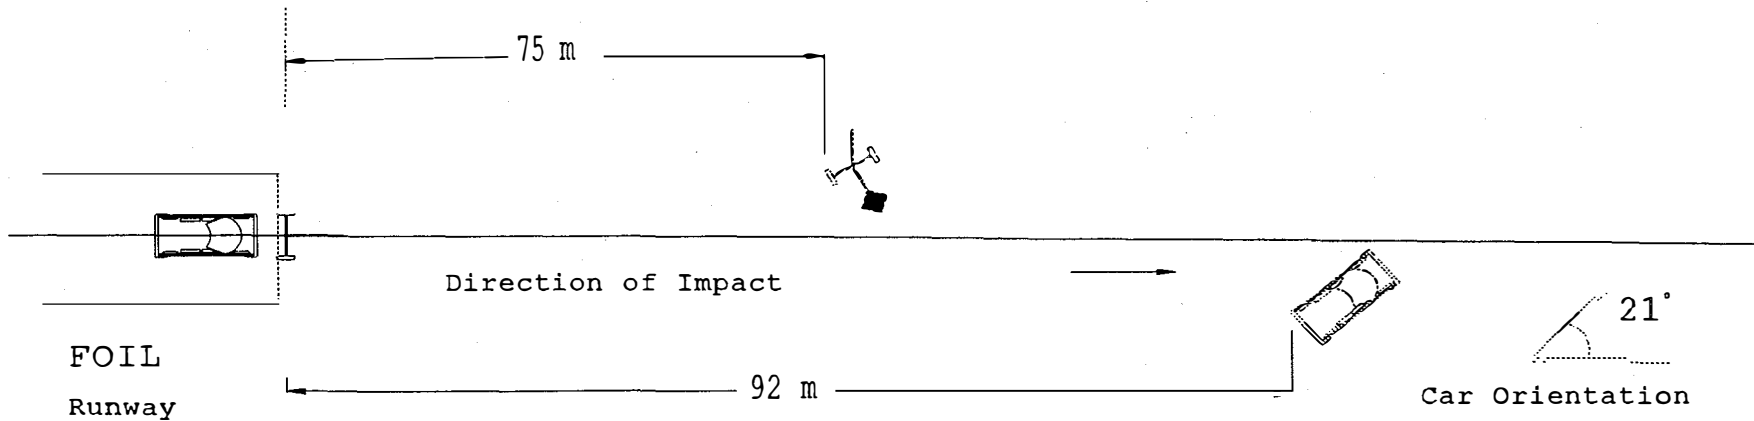
Figure 24. Summary of test 98F009.

Vehicle analysis:	<u>Observed</u>	<u>Design/Limit</u>
Longitudinal:		
Vehicle Delta V.....	3.6 m/s	3/5 m/s
Occupant Delta V at 0.6 m.....	3.3 m/s	9/12 m/s
Ridedown acceleration.....	0.9 g's	15/20 g's
Lateral:		
Occupant Delta V at 0.3 m.....	N/A	9/12 m/s
Ridedown acceleration.....	N/A	15/20 g's
Peak 50 ms acceleration:		
Longitudinal.....	6.9 g's	
Lateral.....	N/A	
Vehicle Damage:		
Traffic Accident Data (TAD).....	12-FC-2	
Vehicle Damage Index (VDI).....	12TDCN1	
Vehicle crush.....	159 mm

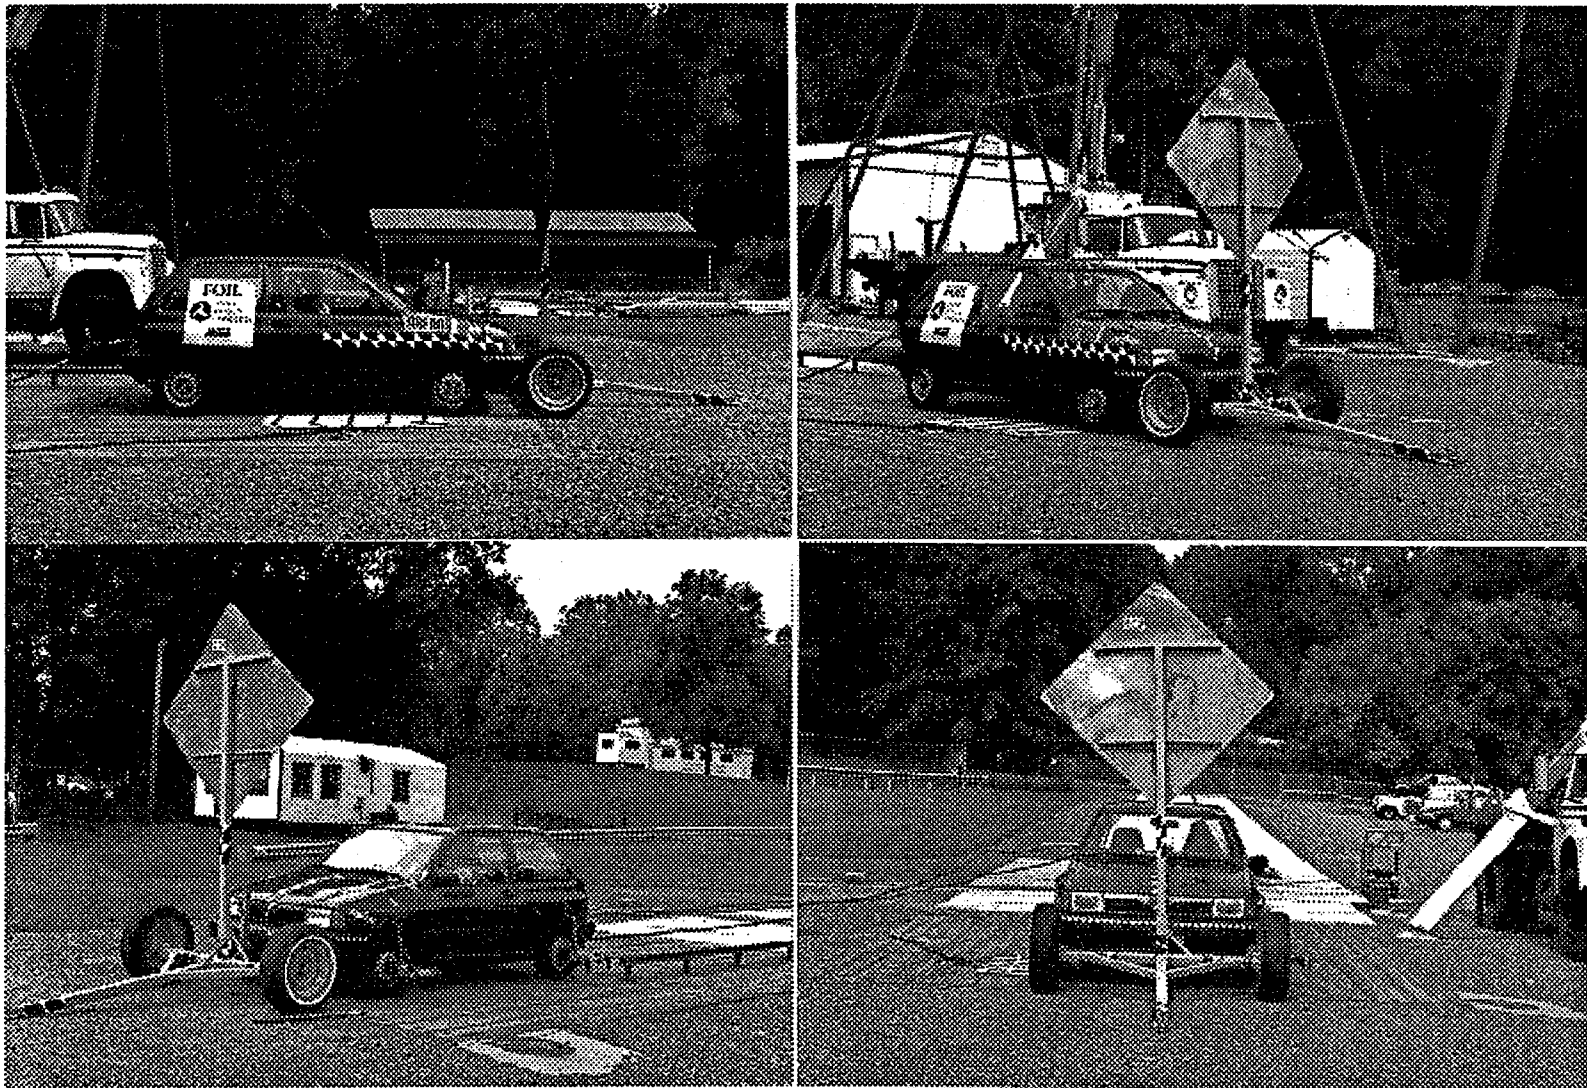
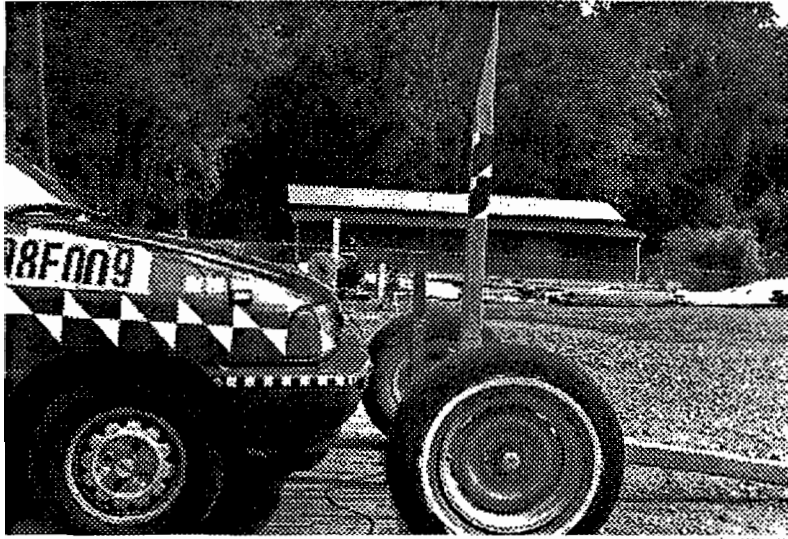
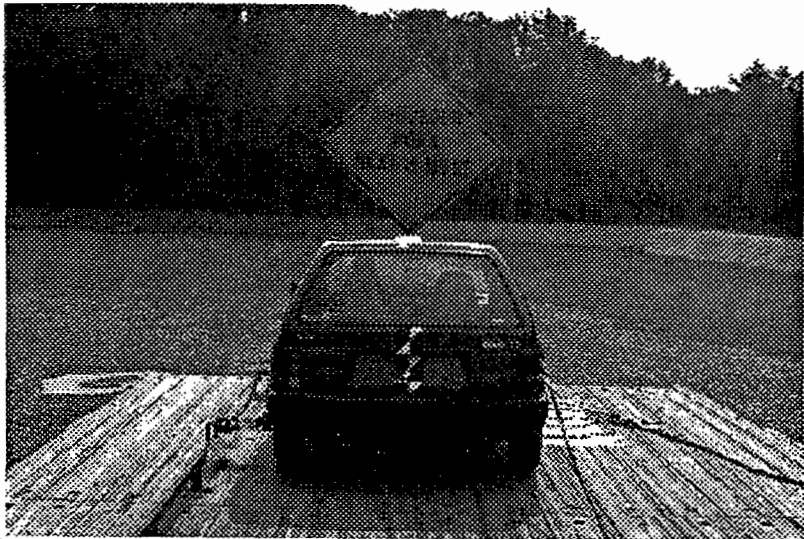
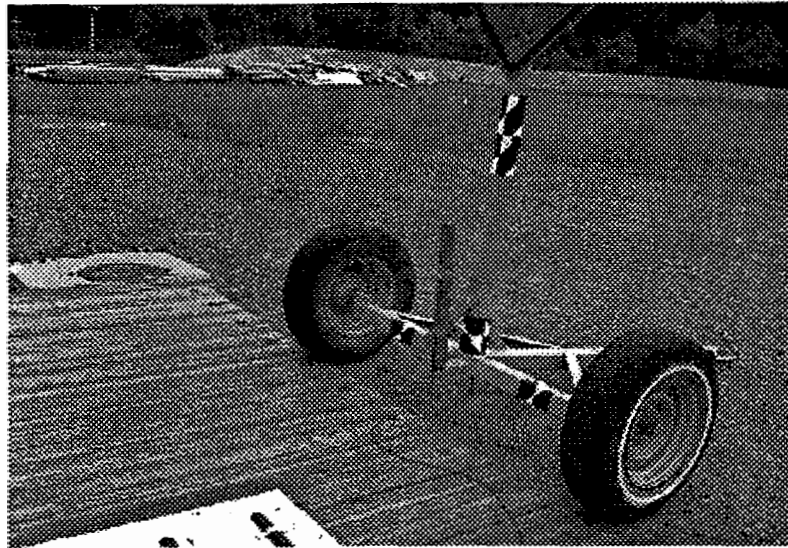
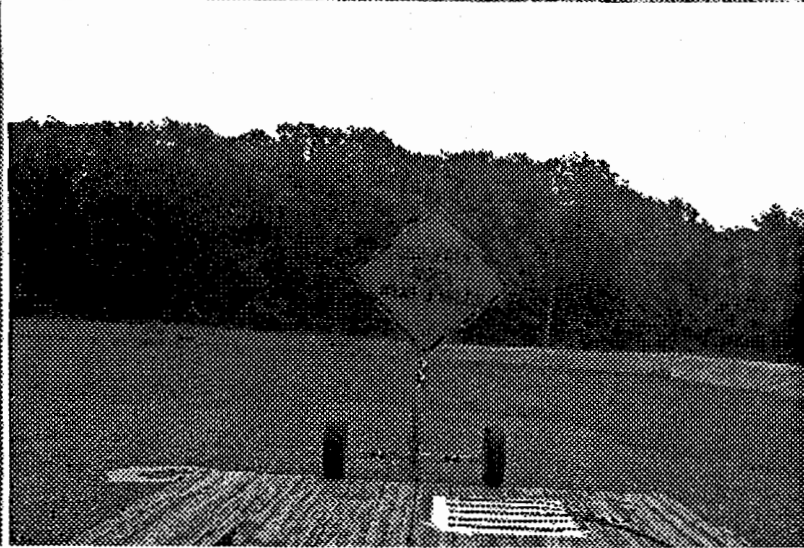
Figure 25. Pretest photographs, test 98F009.

b. Vehicle damage. Damage to the Ford Festiva consisted of minor to significant cosmetic dents and crush of the bumper, hood, and roof. The maximum crush of the bumper was 249 mm and the roof was dented approximately 50 mm. The windshield was cracked but there was no intrusion and no loss of visibility. No debris from the test vehicle was observed in the runout path of the vehicle. The vehicle trajectory did not change after contact with the sign. No yaw was observed in test vehicle's path. The vehicle remained stable throughout the test.

c. Test device damage. Damage to the portable sign trailer was substantial. The axle and sign post did not buckle, however, the base of the sign sleeve tore from the axle. Both axle/spindle connections were bent inward, causing both wheels to have severe "toe-in." The sign panel remained fastened to the sign post and the post remained inside the trailer sleeve. The sign trailer landed 75 m downrange and to the left of the test vehicle's trajectory. The sign trailer could not be repaired and reused without significant structural repair.
