Technical Assistance Report 17-01TA-C

Cracked Pavement Investigation

Re: H.003496
I-49 North: Segment J
Caddo Parish
DRAFT Cracked Pavement Investigation

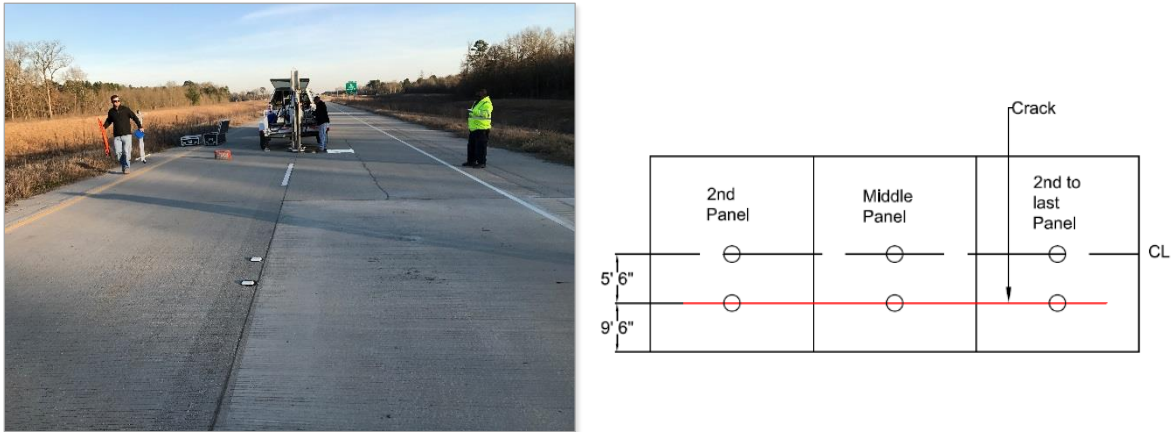
Figure 5: Core Locations

LTRC Concrete Research Laboratory personnel obtained a total of seven cores in the presence of District 04 personnel in February 2017. The location of the coring relative to the panels is shown in Figure 5. The cores were visually examined for the depth of saw cut and evidence of aggregate segregation, excessive air entrapment, and vibrator trails. The cores were also photographed and the visual observations are documented in the results section.

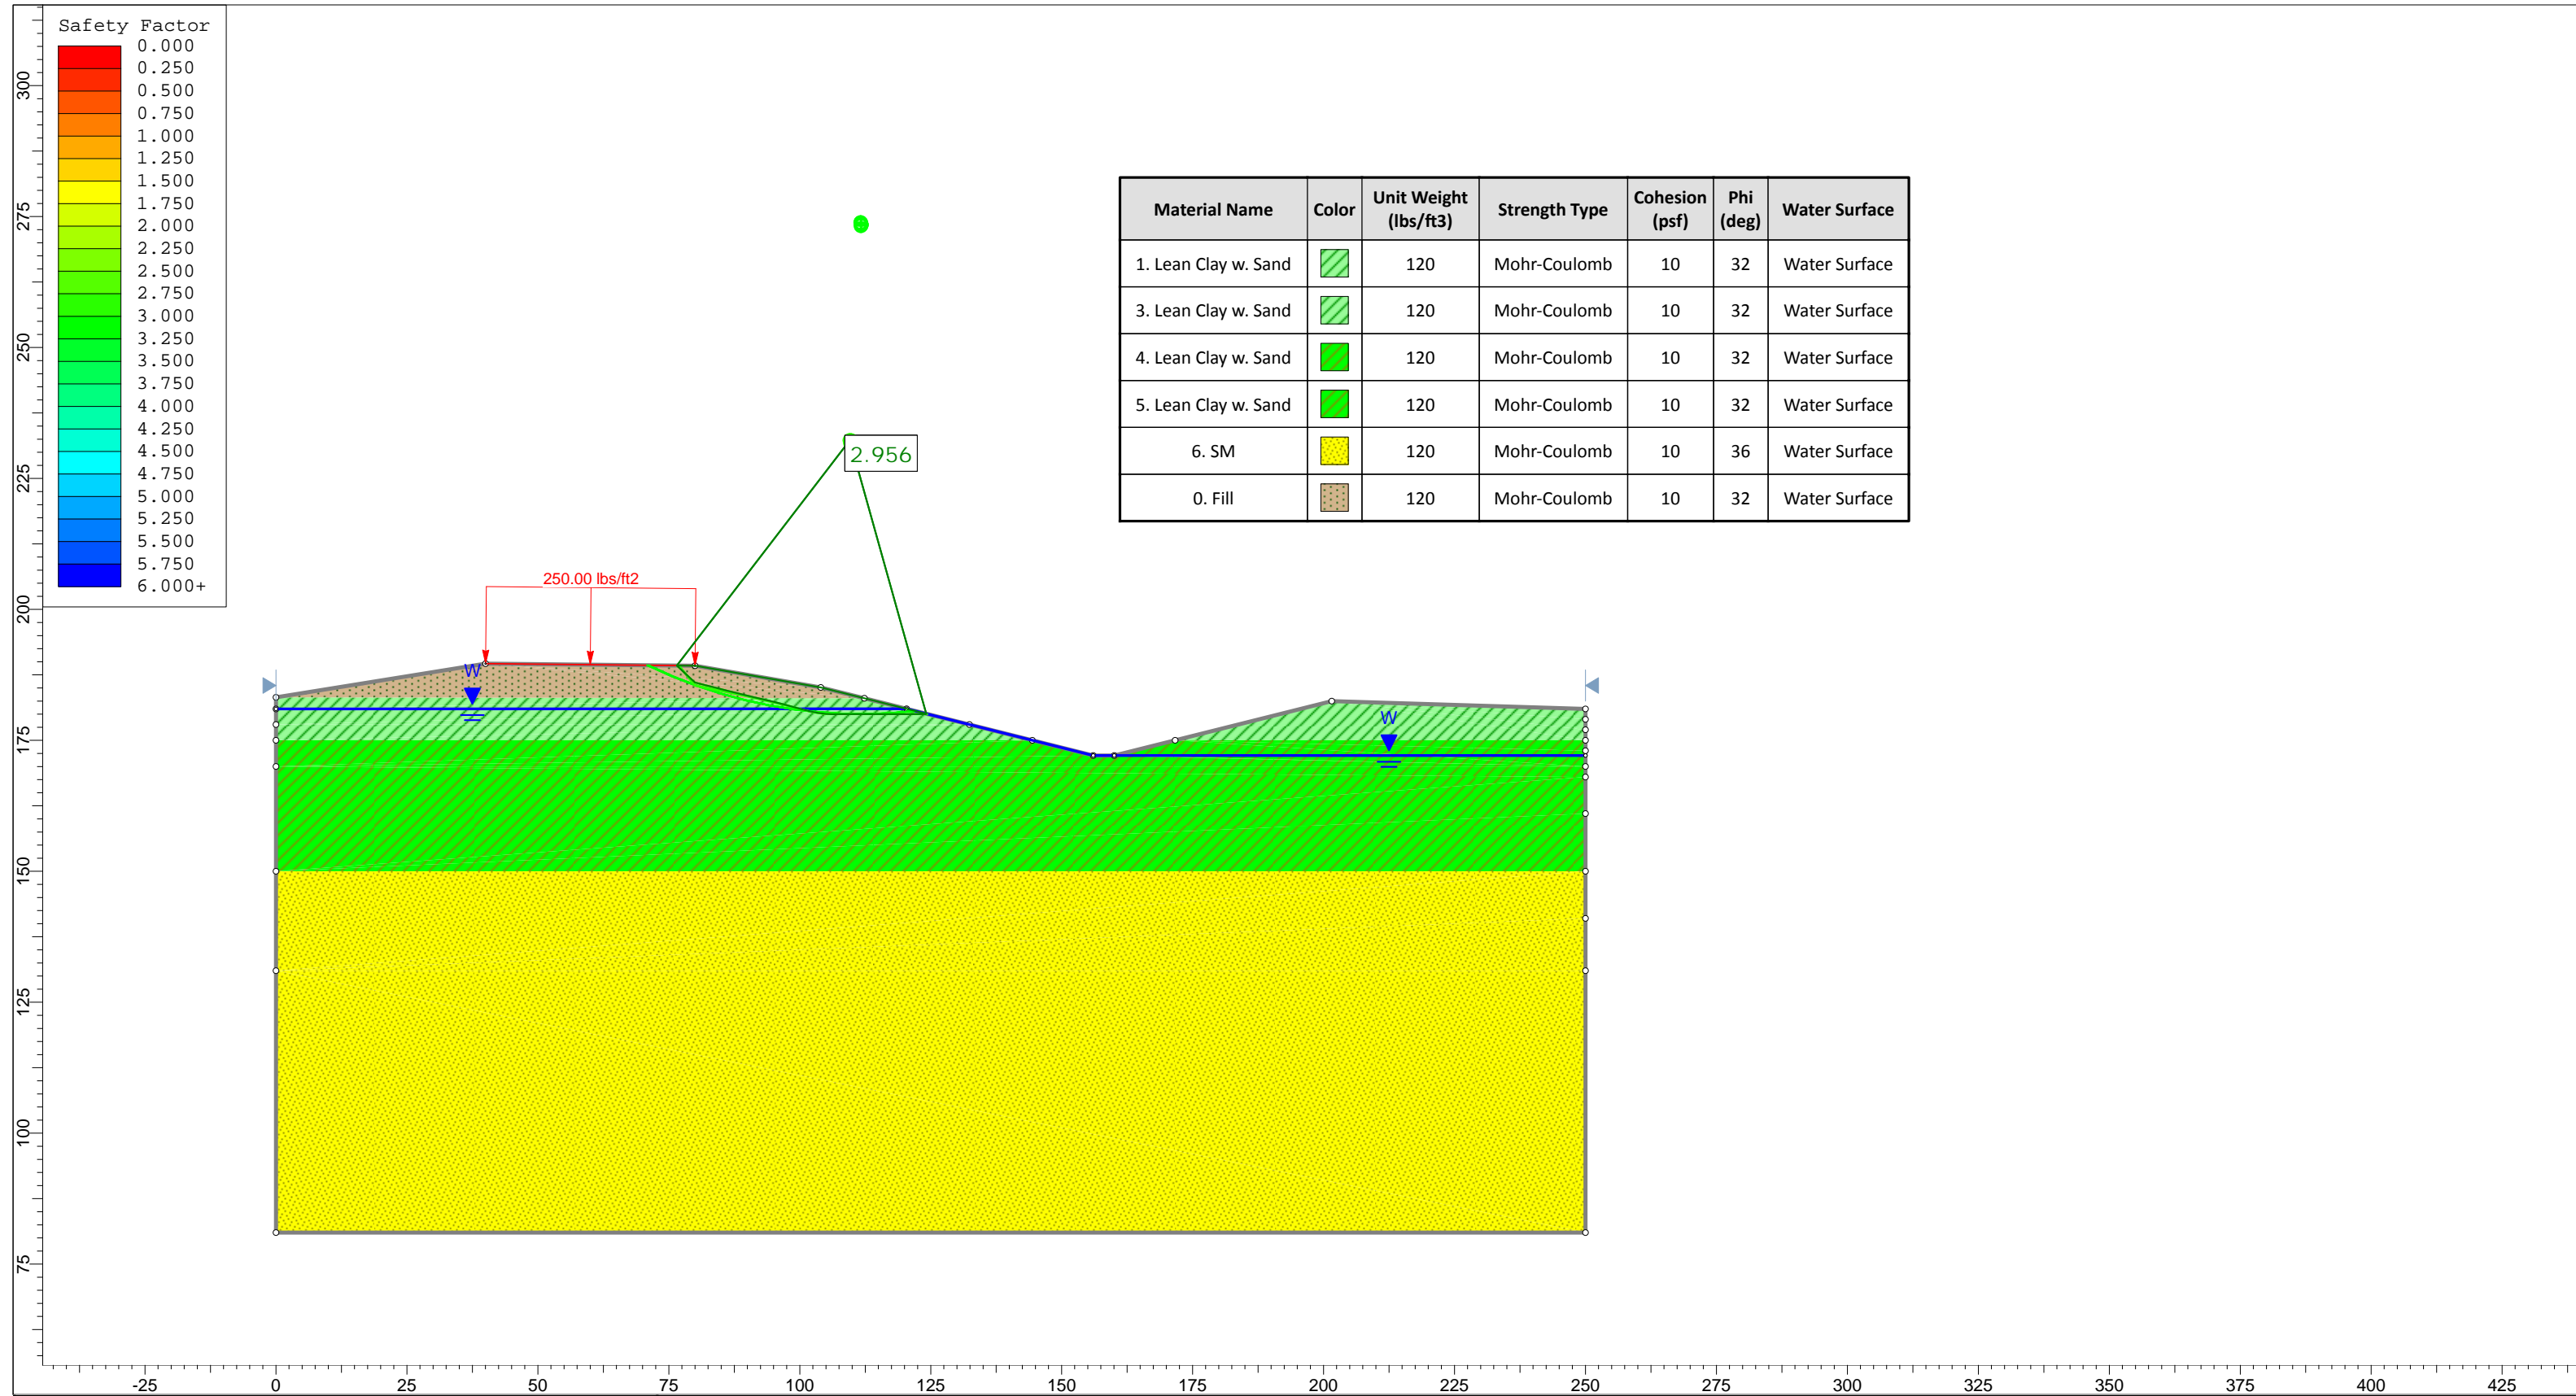
Project		H.003496 - I-49 North, Seg J	
Analysis Description		Sta 342+78, Long Term Baseline	
Drawn By	JGR	Scale	1:358
Date	4/6/2017, 1:52:15 PM	Company	LADOTD
		File Name	343+00 LT - Baseline.slim

The minimum factors of safety from the analyses are shown in Table 2 and in Appendix 6. Note that the drained analysis was constrained to fail through the embankment; otherwise, the critical failure surface (still having a FoS greater than 1.0) did not pass through the embankment or pavement.

Case	FoS
Undrained, baseline conditions	2.68
Undrained, saturated embankment	2.67
Undrained, saturated embankment with $S_u = 400$ psf zone beneath the fill	2.62
Drained, baseline conditions	2.96

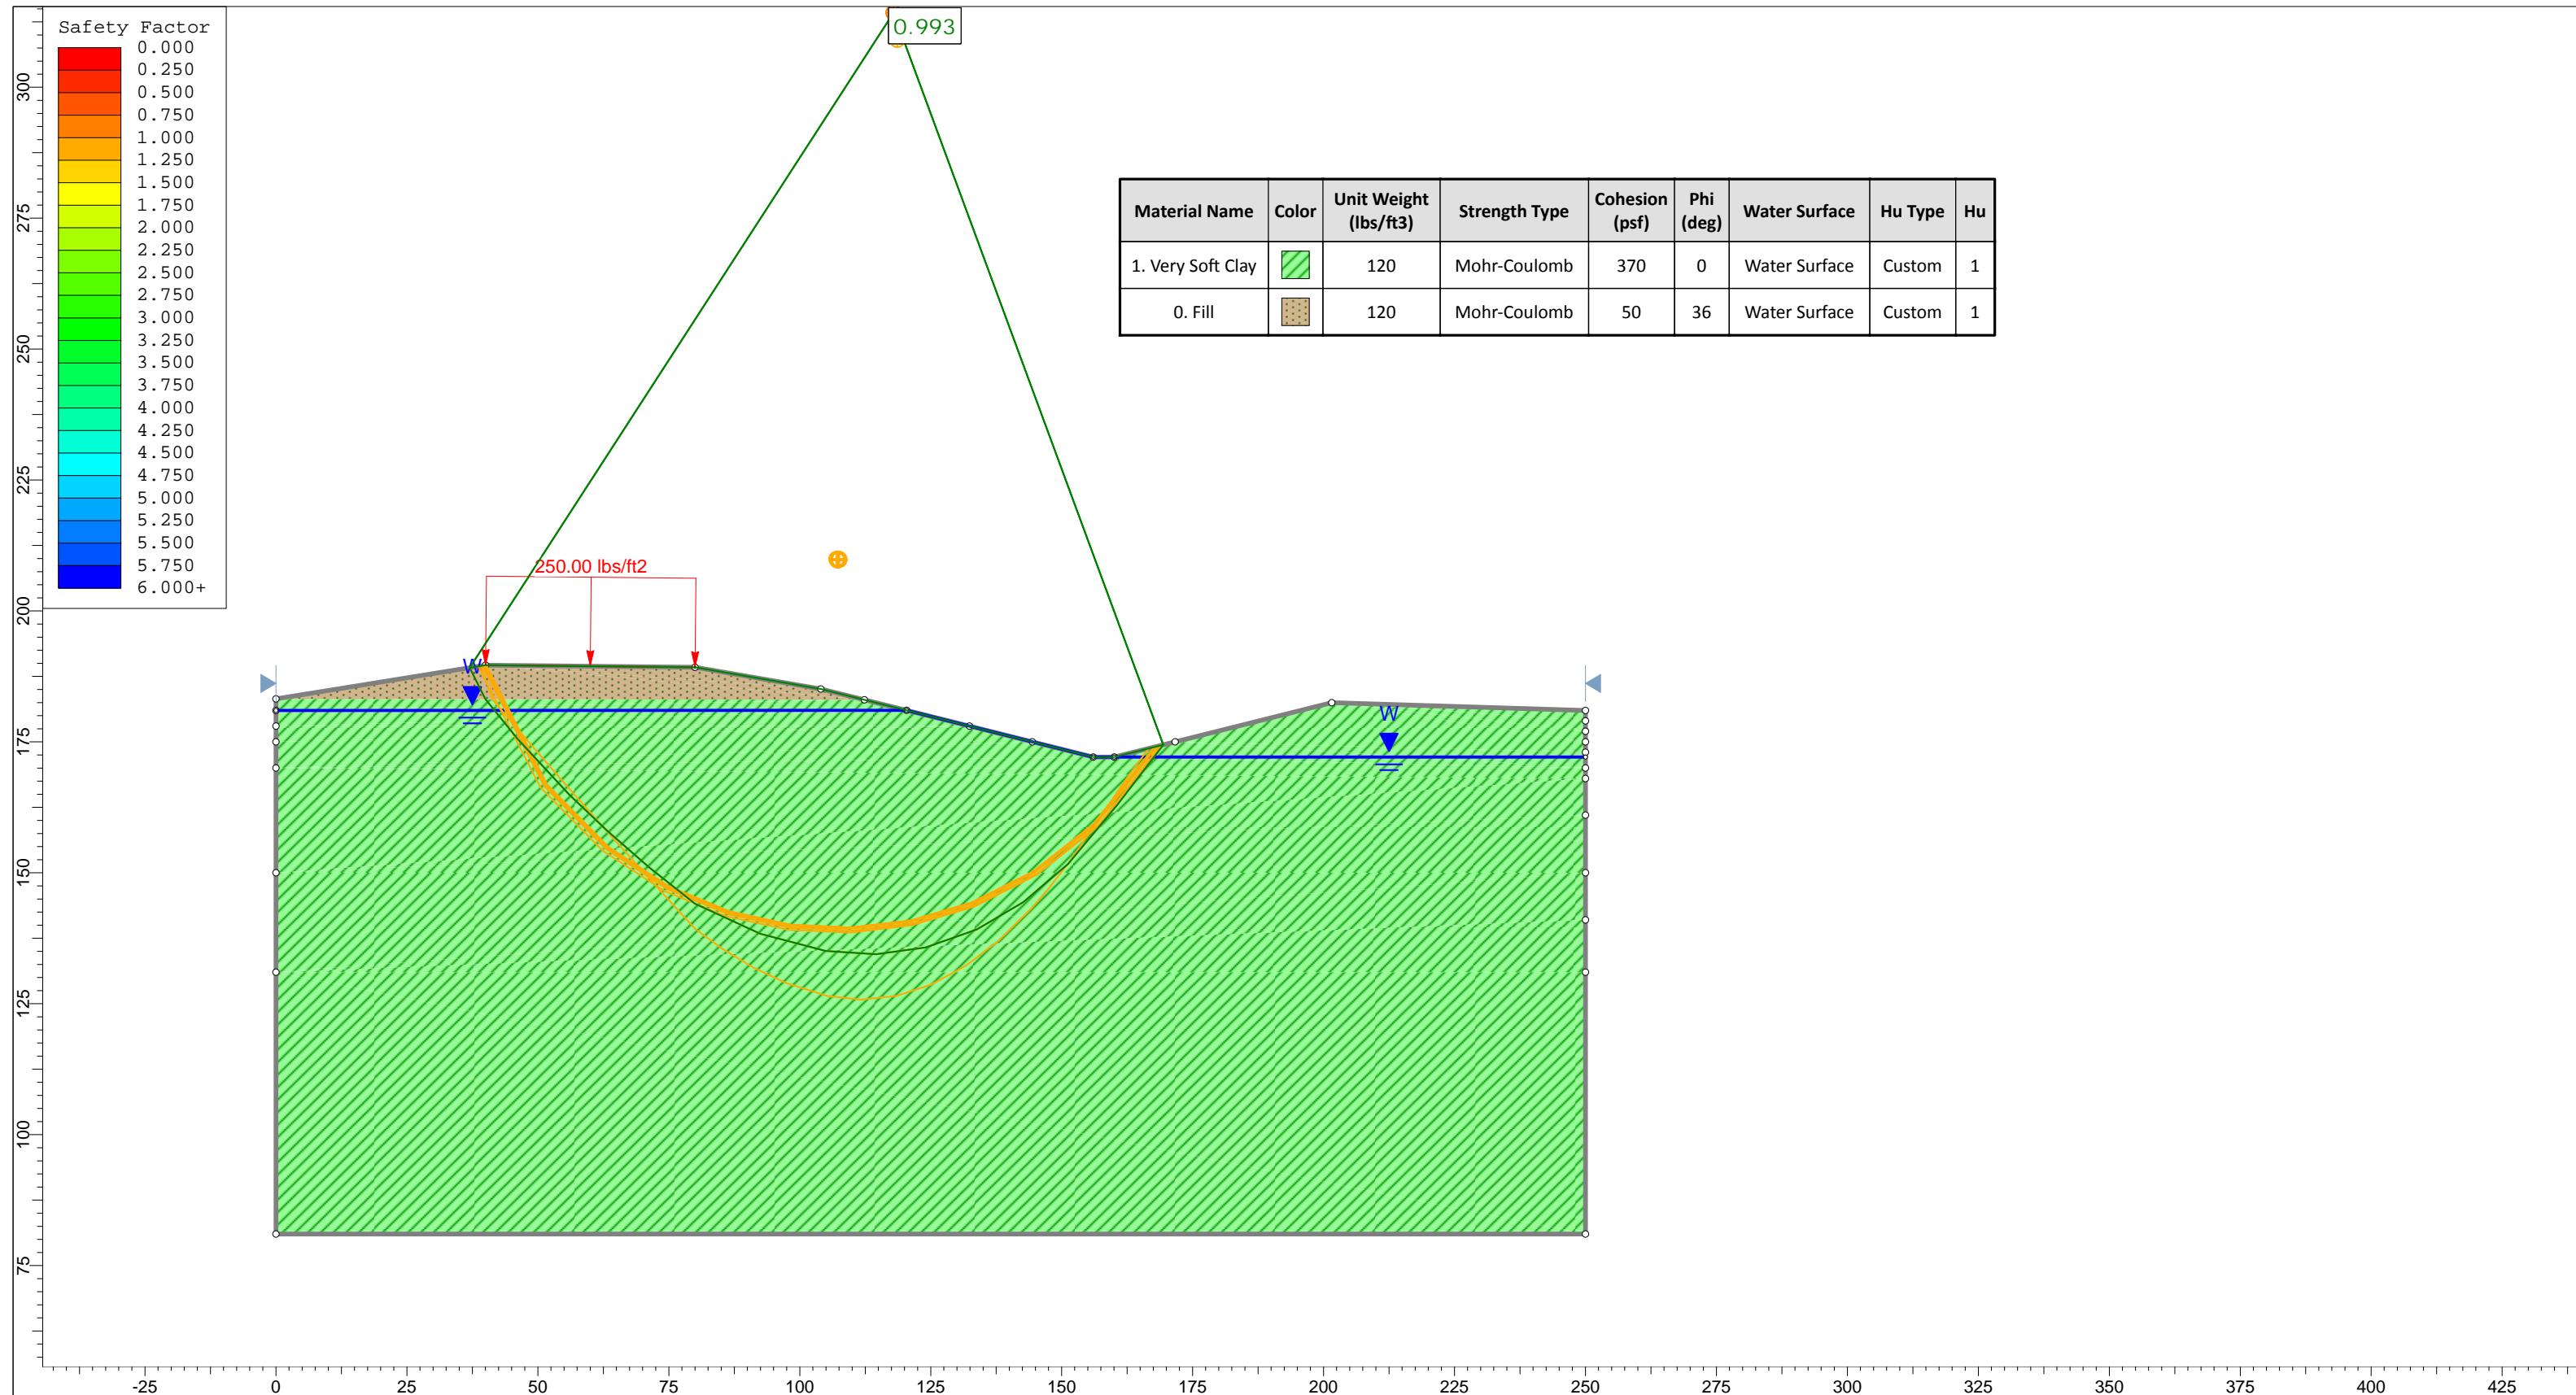
Project		H.003496 - I-49 North, Seg J	
Analysis Description		Sta 342+78, Short Term Forced Failure	
Drawn By	JGR	Scale	1:358
Date	4/6/2017, 1:52:15 PM	Company	LADOTD
		File Name	343+00 ST - Failure Case.slim

In light of these observations, it is unlikely that a slope stability failure is the cause of the cracking.
