Report No.  
SSRP-16/12

**Evaluation of Durability and Wear Characteristics of  
Viscous Fluid Dampers for Seismic Bridge Retrofits  
with Significant & Sustained Traffic Loadings**

**Santiago Creek Damper Tests**

Final Report.

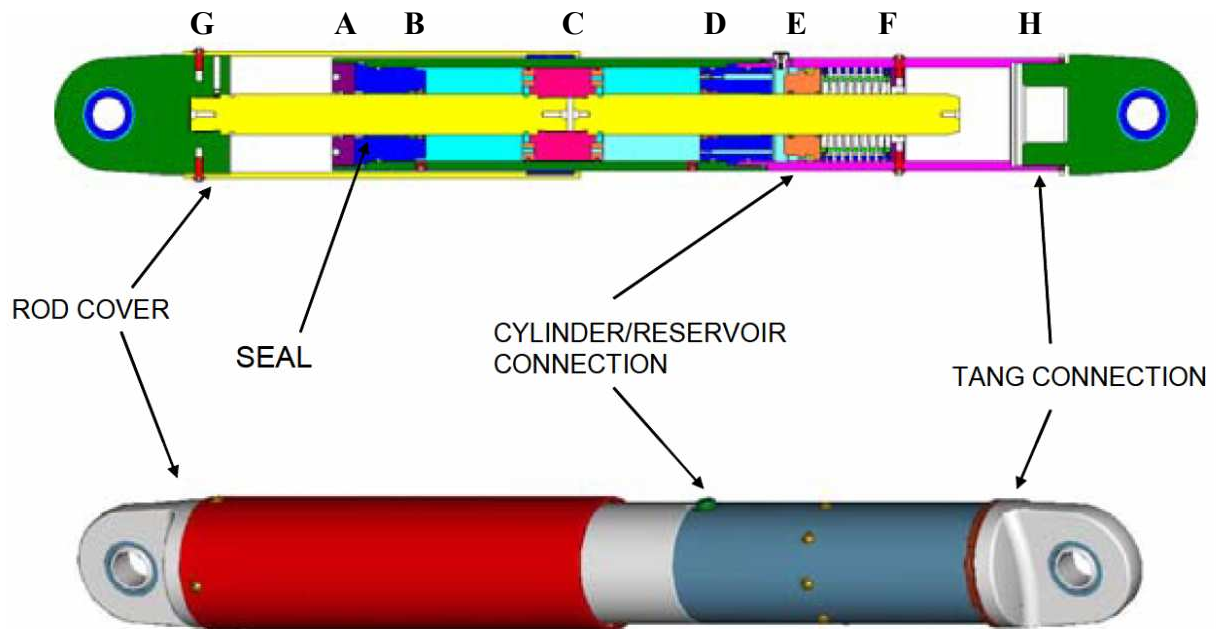
**Figure 3.** Schematic of a telescoping damper with the operating silicon fluid.

Figure 3 outlines the basic construction of the dampers installed on the Santiago Creek Bridge. It is a telescoping piston type device which incorporates flow of an appropriate high viscosity silicon fluid through orifices in the piston head to absorb energy. A fluid reservoir extension, attached via a threaded connection, providing additional fluid if needed. Since the device is only designed to dissipate energy, it is not intended to carry compressive or other loads. The operating high viscosity silicon fluid is located in the primary chamber, partitioned into two cavities by the piston head. The orifices in the piston head allow constrained fluid flow back and forth during piston movements under live-load conditions or seismic events – thereby providing the resistive force to external events. The energy dissipation is intrinsically linked to the filled fluid chamber and any loss creates operational dead zones where the force versus displacement hysteresis loop indicates negligible resistance and/or energy dissipation.

The damper includes a total of five seals identified in Figure 3 as – labeled **A**, **B** housed in the front bearing, labeled **D** housed in the rear bearing, and labeled **E**, **F** in the spring retainer. It is worth noting that the combination of rear bearing and the spring retainer with the three seals **D**, **E**, **F** provide a greater bearing support length for the piston rod. Looking ahead to the next

A noteworthy observation is the shear failure and stripping of the damper sleeve screws, occurring just prior to the onset of the 5<sup>th</sup> cycle, in SN#003, #004 and #006 dampers. Looking back, Figure 3 shows that the damper sleeve is affixed to the clevis via 4 screws (also labeled as location G). Similar stripping events are observed on VTB, Figure 1©, and in VTB recovered dampers, Figure 2. This shear failure is observed at the end of the compression cycle, during load reversal into the tension cycle, and just prior to the onset of the 5<sup>th</sup> cycle. This is evident from the near vertical force curve, at the end of the 4<sup>th</sup> cycle, at -11 in. displacement in Figure 9 for the SN#003, #004 and #006 dampers. Once the sleeve is stripped, no further displacement can be recorded from the sleeve mounted displacement sensor resulting in the vertical force curve.

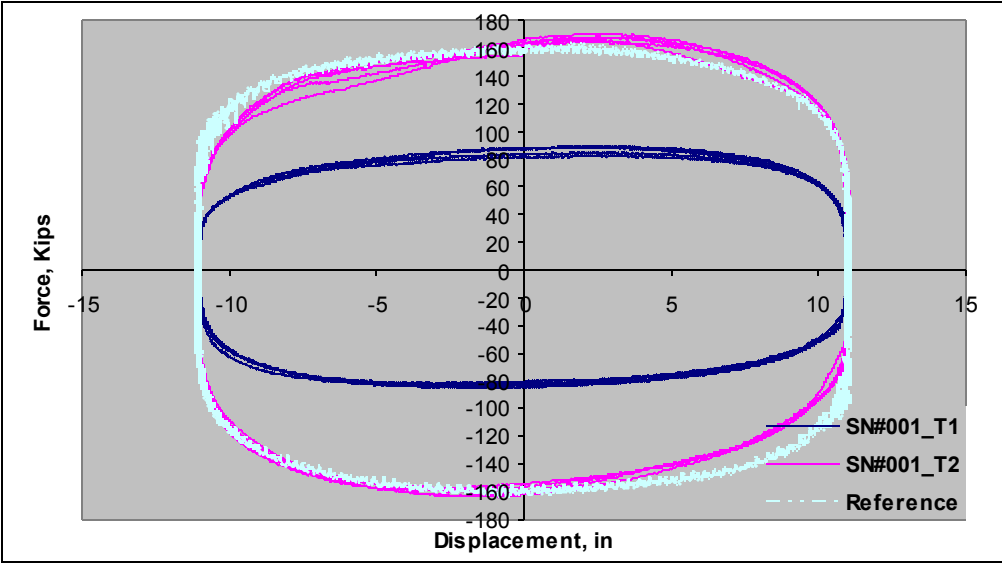
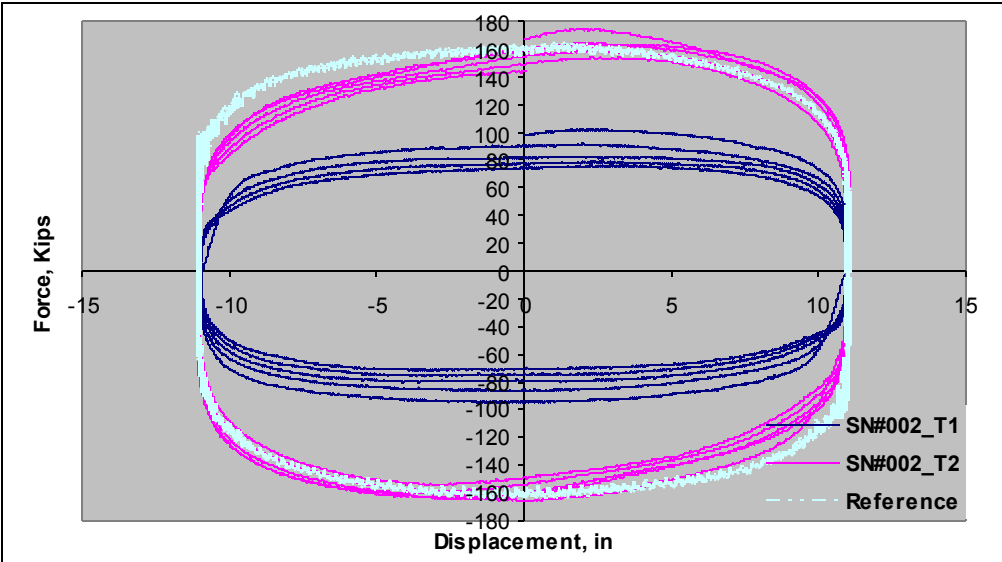
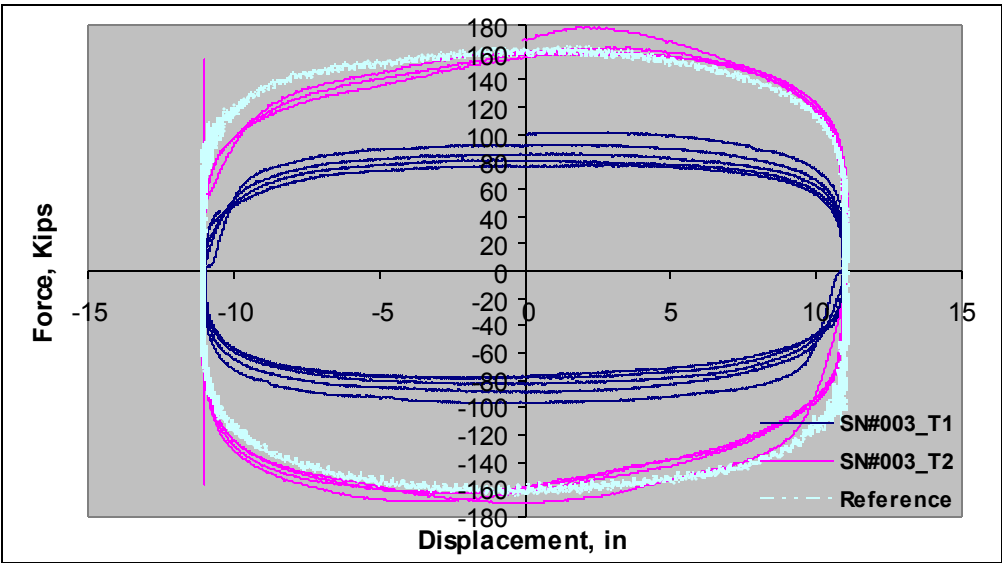
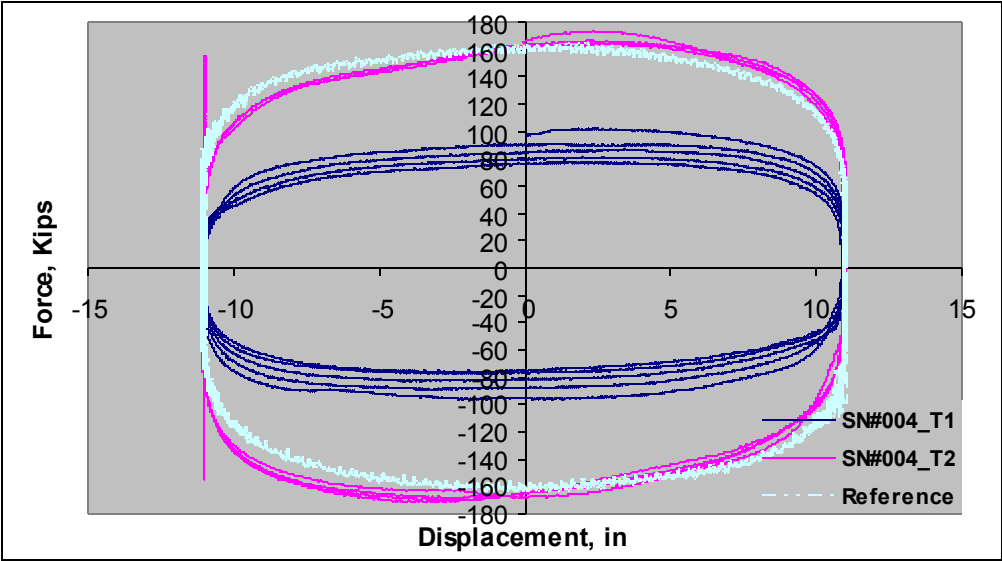
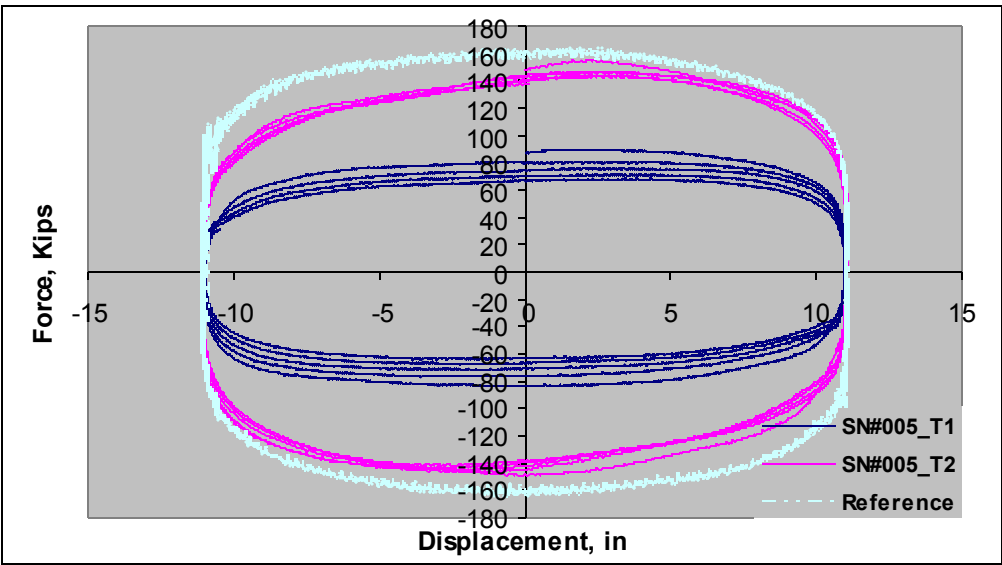
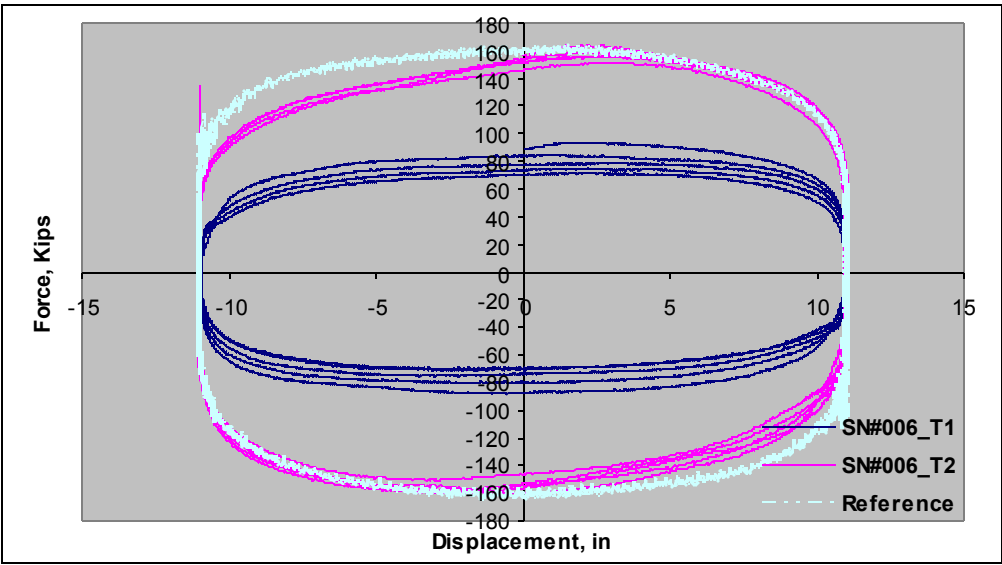
Figure 9. Load displacement plots for the 5 cycle proof testing for SN#001 – #006 dampers.

The principal results of Stage I (test velocity 10.5 in/sec) and Stage II (test velocity 42 in/sec) testing are presented in Figure 9. A brief overview of Stage I (blue curves) and Stage II (pink curves) test results indicate that dampers exhibit satisfactory Force-Displacement characteristics at the requisite test velocity. To illustrate this graphically, a reference Force-Displacement curve (Light Blue) for the stage II testing is superimposed on Figure 9. A quick visual examination shows fairly consistent overlap of the reference curve over the Stage II test data for SN#001, 002, 003, 004, 006. A quick examination also reveals that the Stage II test curve for SN#005 consistently underperforms the reference curve. As shown later, damper SN#005 indeed failed the current acceptance criterion outlined by Caltrans.

A comparison between the experimental test loops at  $V=42$  in/sec (pink curves) and the ideal reference force curve (light blue) is illustrated graphically in Figure 9. A visual examination shows fairly consistent overlap of the reference curve over the Stage II test data for SN#001, 002, 003, 004, 006. The experimental force curves underperform slightly at force reversals (i.e., corresponding to stroke reversals at the +/- 11in displacement) for SN#001, #002, #003, #004, #006 and approach or exceed ideal performance at peak velocity at mean displacement=0. Similarly, a quick examination also reveals that the Stage II test curve for SN#005 consistently underperforms the reference curve, never approaching the ideal curve during any stage of the +/-

11 in. travel. As shown later in summary discussion, Section 6, damper SN#005 indeed passes the current acceptance criterion outlined by Caltrans.

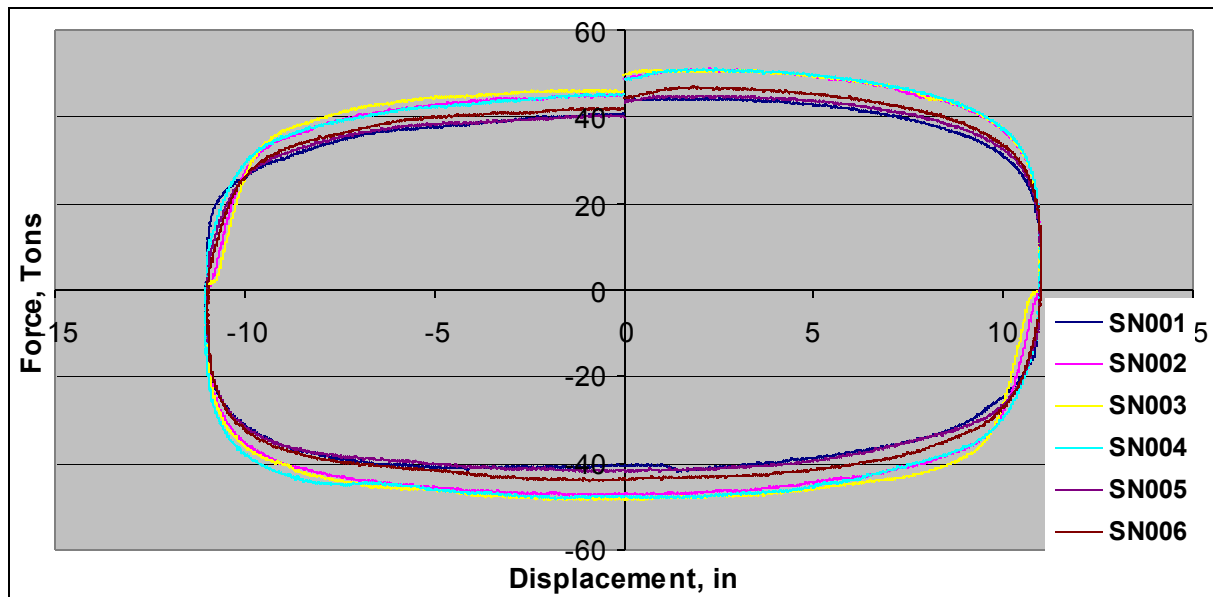
**Figure 10.** Stage I test performance of the 1<sup>st</sup> cycle behavior of SN#001 – #006 dampers.

A brief description of the test loops follows: SN#001 exhibits an extremely tight loop with force vs. displacement performance fairly consistent over the 1<sup>st</sup> -5<sup>th</sup> cycles. SN#002 – SN#006 all show similar performance with 1<sup>st</sup> cycle exhibiting high peak force and decaying over the 2<sup>nd</sup> – 5<sup>th</sup> cycle. A rather negligible dead zone is observed for SN#002 and SN#003 in the first cycle which disappears in the subsequent cycles. Nonetheless, both SN#002 and SN#003 exhibit performance similar to the rest of the dampers. Figure 10 shows a comparative look of the 1<sup>st</sup> complete cycle response of all the dampers. We note that SN#003 and SN#004 exhibited marginally higher peak force; the rest have a slightly lower, and similar, peak force. The dead zone is clearly visible for SN#002 (small) and SN#003 (larger).

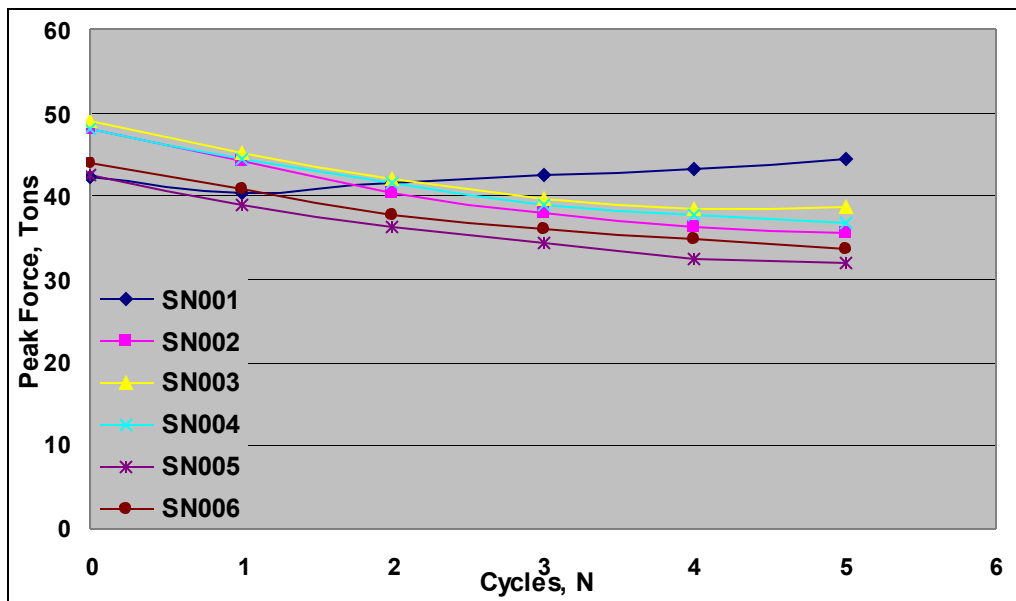
**Figure 11.** Stage I Peak force decay in 1<sup>st</sup> – 5<sup>th</sup> extension cycle for SN#001–SN#006 dampers.

The peak force data, as recorded at displacement = 0 is further recorded in Table 2, with +value denoting the pull cycle (i.e. damper extension) and -value denoting the push cycle (damper compression). The tabulated peak forces of Table 2 are further illustrated graphically in Figure 11. SN#001 indicates stable to mildly increasing peak force in what is clearly noted as anomalous behavior at variance with the remaining dampers. SN#002 – SN#005 indicate nearly similar response of gradually decaying peak force. The range of force drop is 10.6-13.21 short tons (21.2 – 26.42 kips), with the largest drop exhibited by SN#002 and the smallest drop exhibited by SN#006.

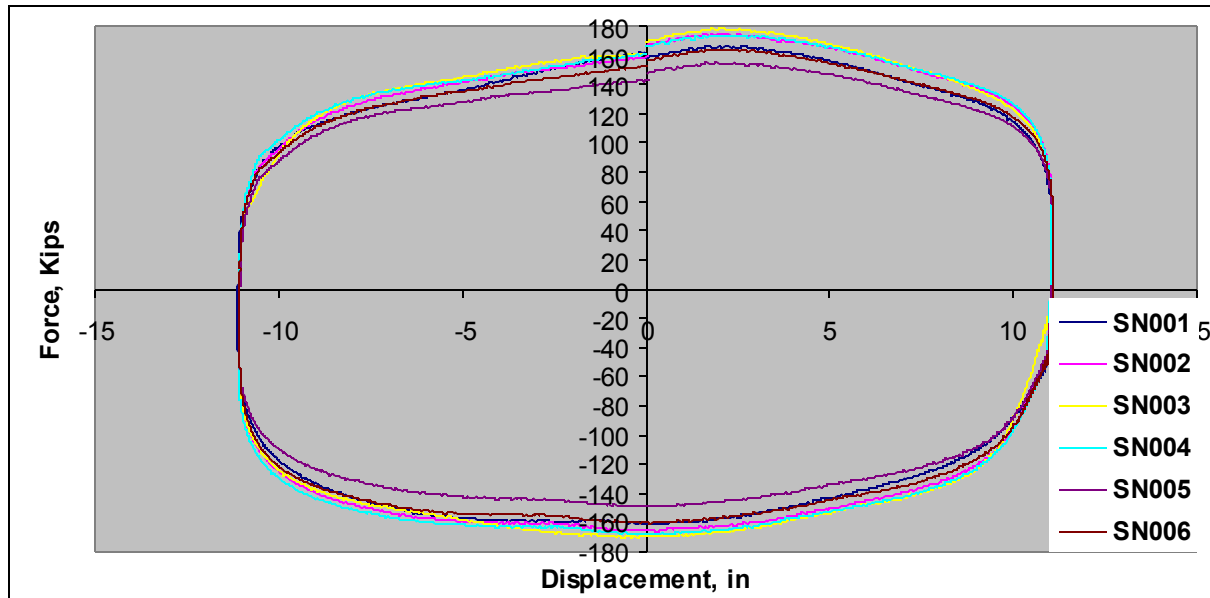
**Figure 12.** Stage II test performance of 1<sup>st</sup> Cycle behavior for SN#001 - #006 Dampers

Figure 12 shows a comparative look of the 1<sup>st</sup> complete cycle response of all the dampers. We note that contrary to stage I testing, no dead zone is observed for SN#002, SN#003 during the first cycle. We also note, as before, that SN#003 (yellow) and SN#004 (light blue) exhibit marginally higher peak force; the rest have a slightly lower, and similar, peak force. Once again SN#005 has the lowest peak force.

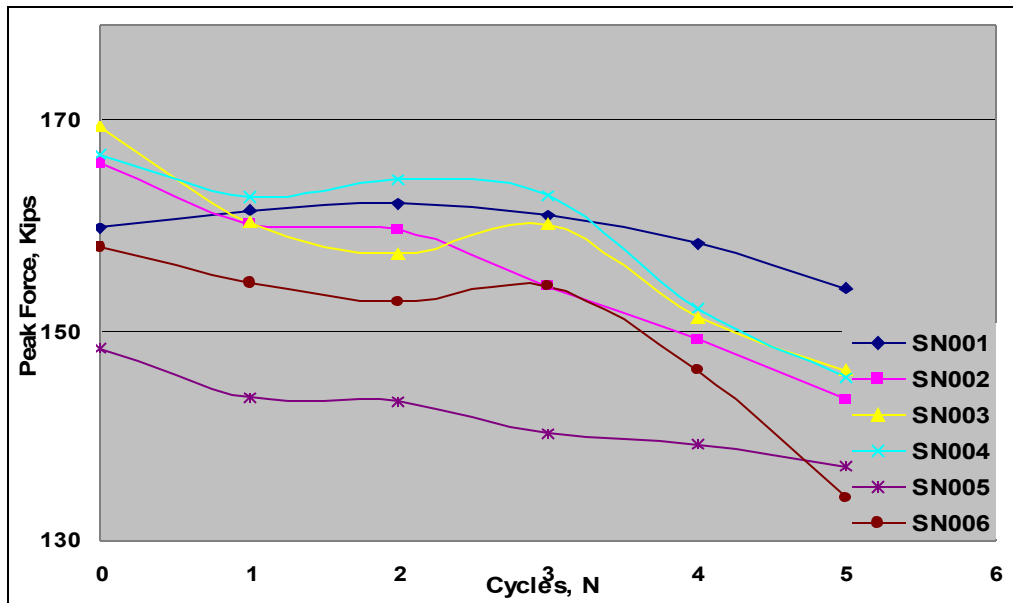
**Figure 15.** Stage II Peak force decay observed for cycles 1-5 for SN#001–SN#006 dampers.

The peak force data, as recorded at displacement = 0 is recorded in Table 3, with +value denoting the pull cycle (i.e. damper extension) and –value denoting the push cycle (damper compression). The tabulated peak forces of Table 3 are further illustrated graphically in Figure 15. SN#001 indicates very consistent peak force over 5 cycles of testing with minimal variation of about 10kips. We note that dampers with stripped sleeves (i.e., SN#003, SN#004, SN#006) show larger peak force drops in the later 4<sup>th</sup> and 5<sup>th</sup> cycles.
