# Evaluation of Dowel Bar Retrofit for Long-Term Pavement Life in Washington State

WA-RD 727.1

May 2009

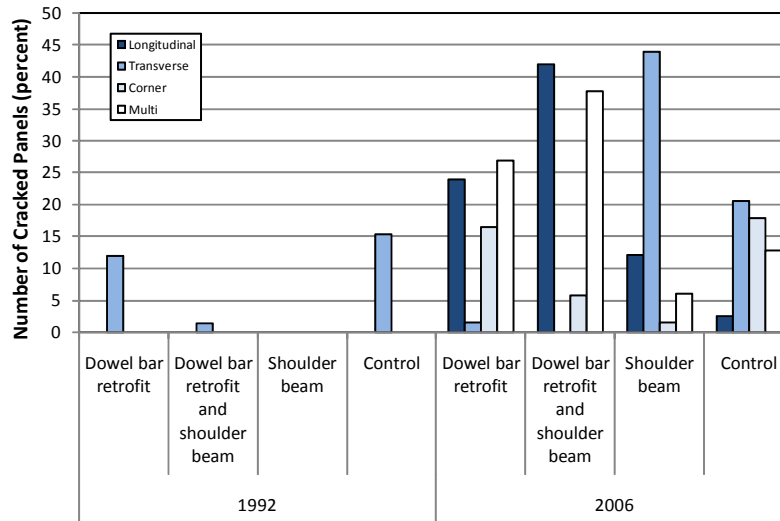
sections have seen an increase in faulting and poor load transfer efficiencies. However, a high number of cracked panels have occurred, especially transverse cracking in the concrete shoulder beam section and longitudinal cracking in the dowel bar retrofit sections (Figure E-1).

**Figure E-1. WSDOT dowel bar retrofit test section cracking.**

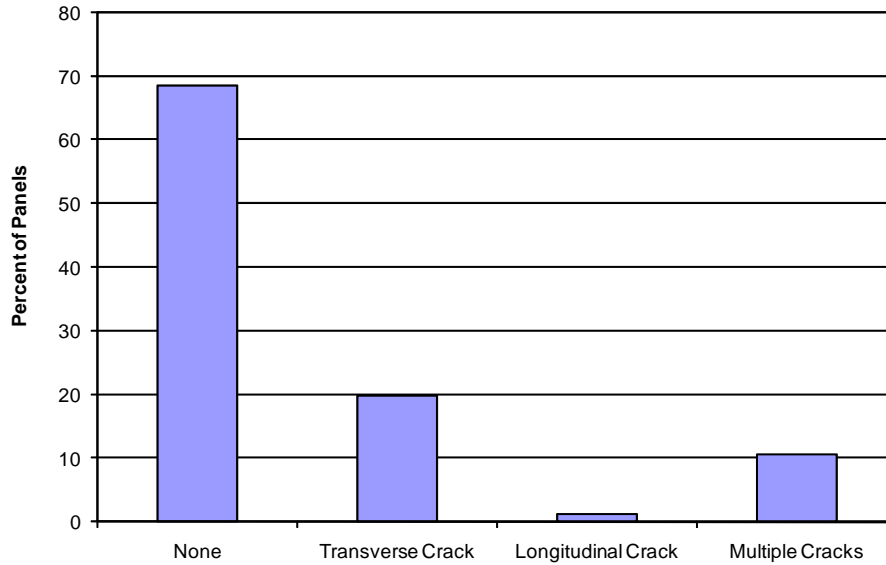
To further investigate the cracking noted in the panel replacements, an analysis was conducted to determine the extent of the panel cracking. All panel replacements that occurred within the surveyed lane (typically the rightmost lane) were reviewed and summarized based on no cracking, a single transverse crack, a single longitudinal crack, or multiple cracks. From this it was determined that approximately 30 percent of all panel replacements contained some type of crack (Figure E-2), with transverse cracking being the most predominant.

**Figure E-2. WSDOT dowel bar retrofit test section cracking.**

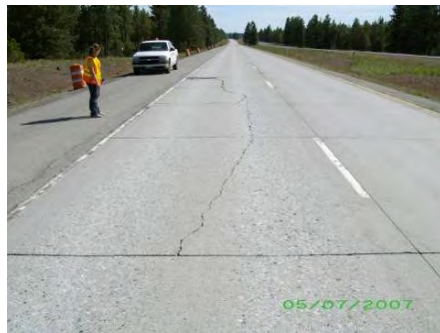
In the detailed review of the Washington State dowel bar retrofit projects, an assessment was made to determine the presence of transverse, longitudinal, corner cracking, and 45-degree cracking (Figure E-3) that developed after dowel bar retrofit construction. Of the 23 roadway sections reviewed, the occurrence of new cracking is relatively low, below 10 percent (Figure E-4), for all but Contracts 4235, 4340 and 4902. These three projects are all located on I-90 in the vicinity of Snoqualmie Pass and are subjected to other pavement performance issues (freeze-thaw and/or cracking due to failure of the longitudinal tape joint from initial construction). As can be seen in Figure E-4, longitudinal cracking is the prevalent distress on the majority of projects and is considered to be the primary mode of distress for dowel bar retrofitted pavements.

a. Longitudinal cracking

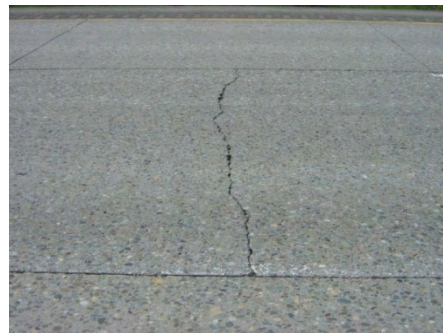
b. Transverse cracking

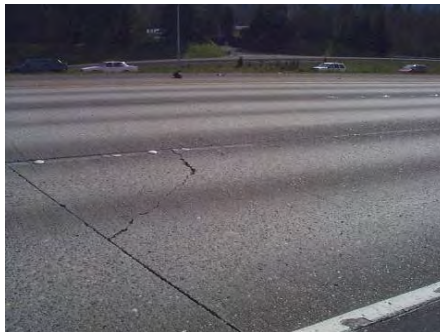
c. Corner cracking

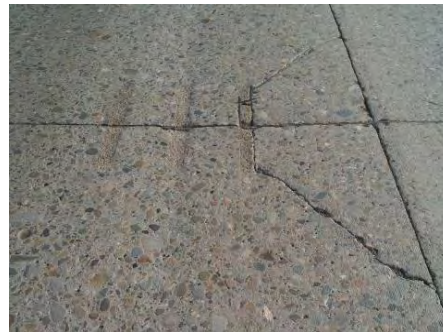
d. 45-degree cracking

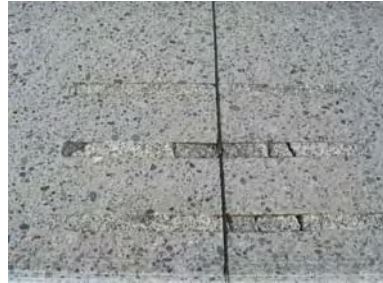
As part of the detailed project review, over 380,000 dowel bar slots were evaluated for the presence of spalling, cracking, and debonding (Figure E-5).

**a. Cracking**

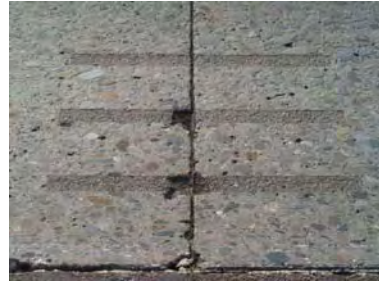
**b. Spalling**

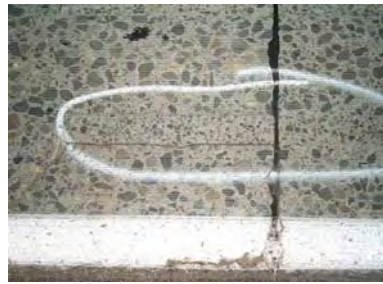
**c. Debonding**

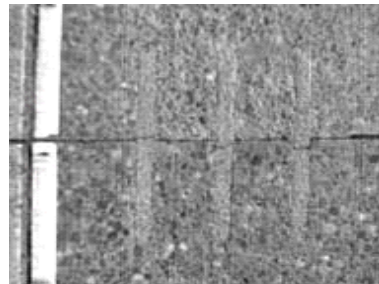
**d. Misaligned foam core board**

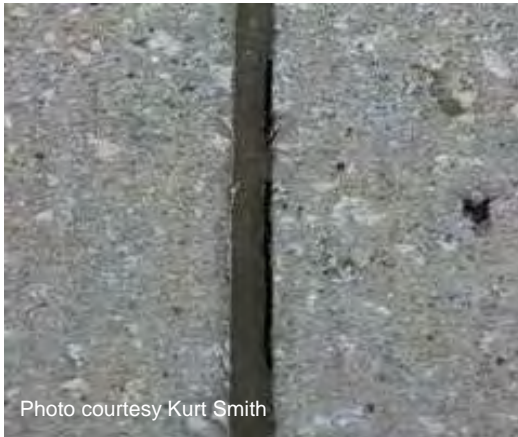
There are five primary forms of joint seal damage: (1) adhesive failure occurs when the joint seal material debonds from the concrete surface (Figure 13a); (2) cohesive failure occurs when the joint seal material splits within the sealant (Figure 13b); (3) extrusion occurs when the joint sealant is pushed or pulled out of the joint due to slab movement and/or traffic; (4) oxidation occurs due to exposure to the elements; and (5) infiltration occurs when incompressibles and/or vegetation is present in the joint (Hall et al., 2001). Regardless of the type of joint seal damage, the end result is a joint that no longer functions as intended, which is to keep moisture and incompressibles out of the joints. Moisture entering the joint can lead to

(a) Adhesive failure.

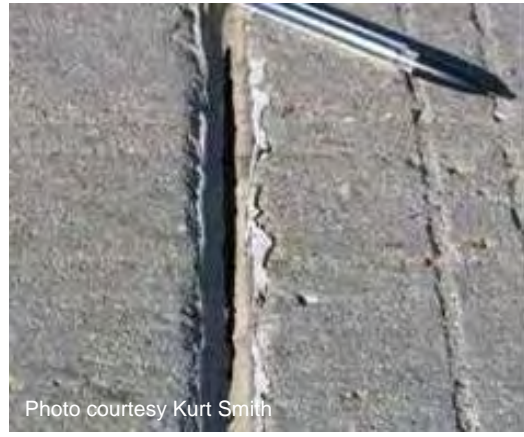
(b) Cohesive failure.

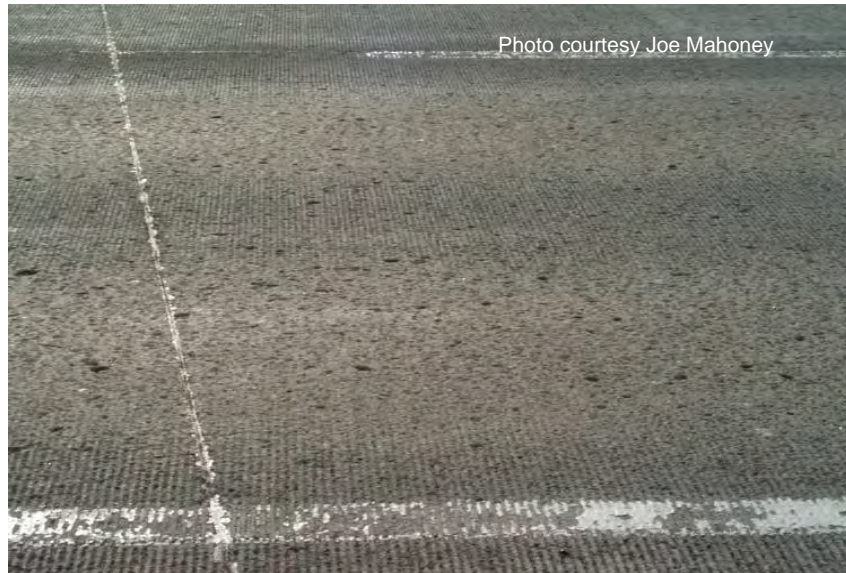
Damage caused by studded tires (Figure 14 and Figure 15) is a predominant distress of concrete pavements in Washington State. Studded tires remove the fine aggregate/cement from the concrete surface leaving an uneven roadway surface similar to rutting in HMA.

**Figure 14 Moderate studded tire wear (SR 395 - no tining in wheelpaths).**

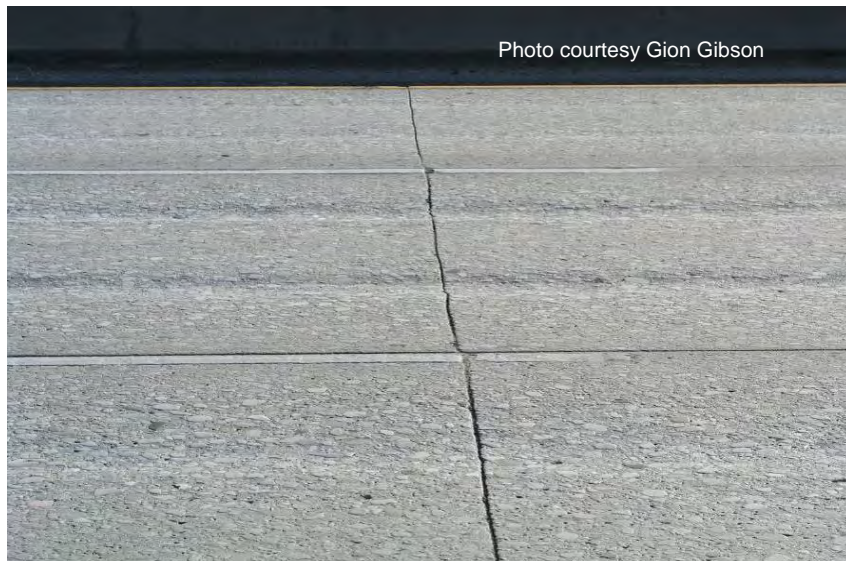
**Figure 15 Severe studded tire wear (I-90 Spokane).**

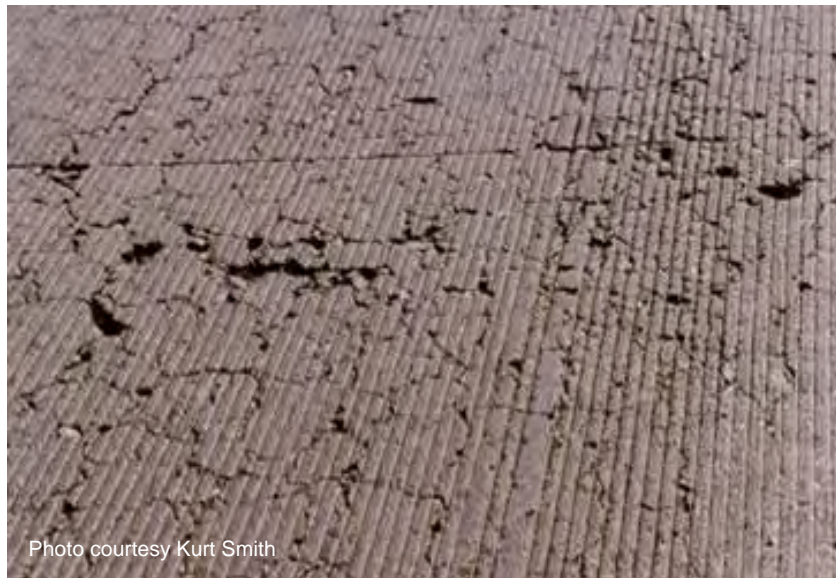
Alkali-silica reaction (ASR) is the more common type of alkali-aggregate reaction (Figure 16). Aggregates containing certain forms of silica react with the alkali hydroxide in concrete. This reaction forms a gel which can swell as it adsorbs water from the surrounding cement paste and/or the environment (PCA, 2007). The swelling of the gel can induce enough expansive pressure to cause cracking in the concrete.

**Figure 16 Alkali-Silica Reactivity.**

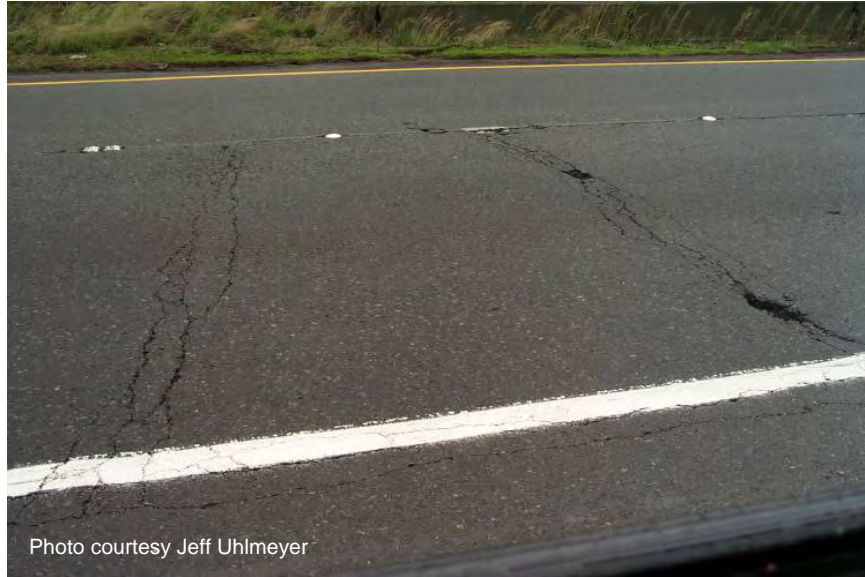
WSDOT successfully overlaid a number of non-interstate concrete pavements by placing two to four inches of HMA directly over the concrete pavement. Since the major concrete pavement distress in Washington State is joint faulting, reflective cracking (the underlying concrete continues to move horizontally and vertically due to temperature, moisture and traffic

loadings, resulting in excessive tensile stress in the HMA overlay cracking at the approximate joint location) was always a concern and the main factor which drove future rehabilitation (Pierce, 1997) of the HMA overlay (Figure 106).

**Figure 106 Reflection cracking (I-5 Centralia vicinity).**

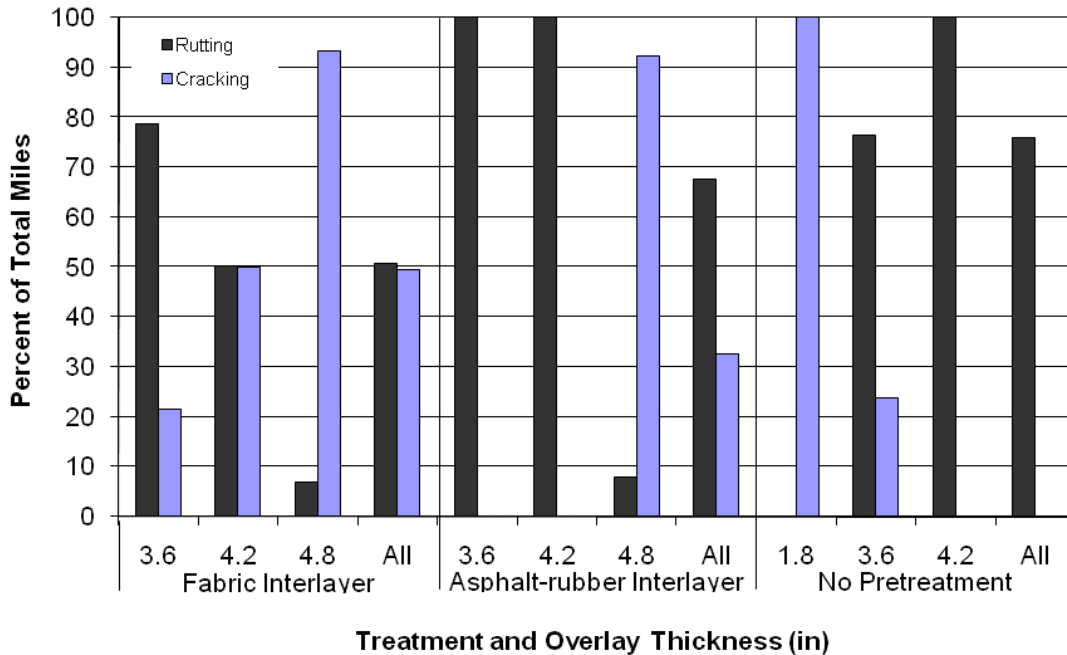
The percent of pavement sections by treatment and overlay thickness rehabilitated due to rutting and cracking is shown in Figure 108.

There does not appear to be any consistent trend in either the potential for rutting or cracking failure based on either treatment type or overlay thickness. For all three treatment types, rutting was the primary cause for rehabilitation on all 3.6 inch overlays, and cracking was the cause for rehabilitation on all 4.8 inch overlays.

The reason for the increased rutting rate on these sections of I-5 is unclear and deserves more investigation. Since the projects were not all constructed under the same contract, it is difficult to say whether this was caused by a project specific issue, aggregate source or HMA mix design. Unfortunately the cause of the HMA rutting is beyond the scope of this study.

**Figure 108 Rutting and cracking performance of HMA overlays.**

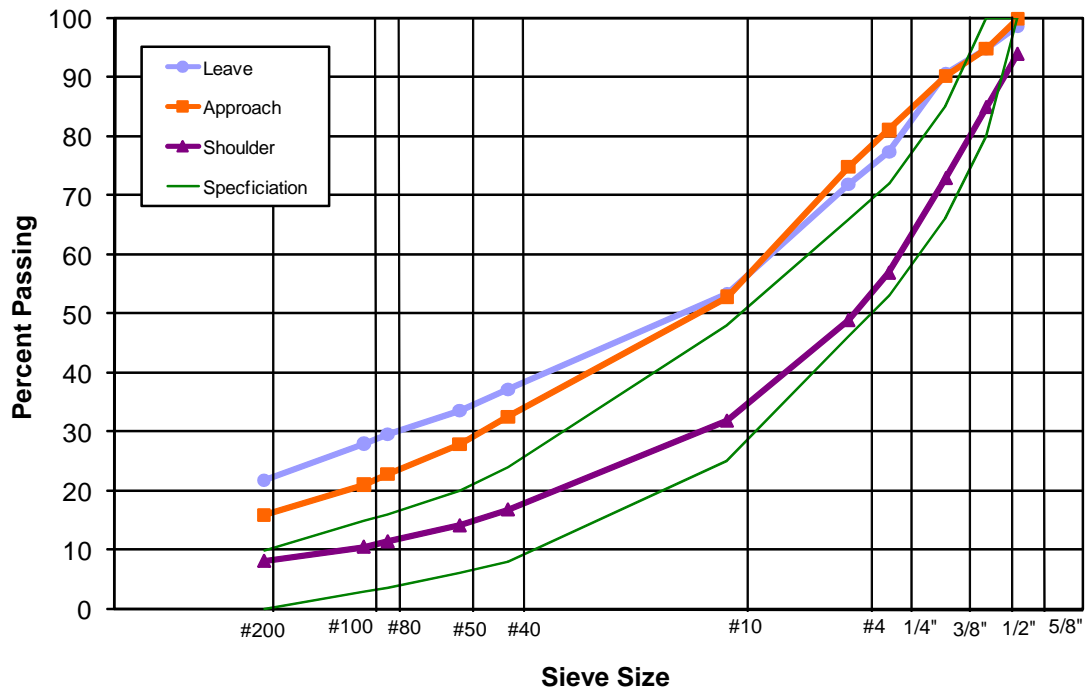
Figure 110 illustrates the base course material gradation beneath the right wheelpath of the approach slab, the leave slab, and the shoulder. The gradation of the shoulder base course material is within WSDOT gradation specification requirements, while the material at the approach and leave sides of the joint have a considerably finer gradation, and the gradation of the leave slab is finer than the approach slab. In all cases, tests showed that the base material beneath the leave slab was finer than the base material beneath the approach slab, validating the upward movement of the fine material and the development of a wedge of fine material and not a void.

When the concrete pavement was constructed over a cement treated base, the presence of a void was confirmed. Cement treated bases in Washington State were constructed with relatively high cement contents (more than five percent). When subjected to loading, and in the presence water, these cement treated bases became highly erodible due to the high pressure water action at the transverse joints. In these instances, subsealing successfully filled the voids and provided some level of support.

**Figure 110 Typical base course gradation.**

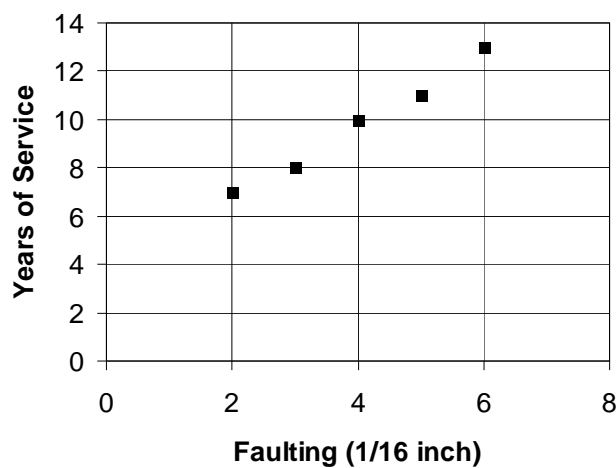
If the concrete pavement has lost its structural integrity (i.e. cracking), load transfer restoration is not an appropriate rehabilitation treatment. Load transfer restoration results for the New York study are illustrated in Figure 118. Bendana et al. indicated that joint faulting became noticeable to the traveling public when it averaged  $\frac{1}{8}$  inch and objectionable at  $\frac{3}{16}$  to  $\frac{1}{4}$  inch. Long-term performance is dependent on quality control during the construction process, the use of quality patching material, load transfer restoration being performed on sound concrete slabs, and ensuring that adequate load transfer devices are used. In addition, this study indicated that using fewer than four dowels per wheelpath may be satisfactory.

**Figure 118 Faulting of dowel bar retrofit (redrawn, Bendana et al., 1992).**

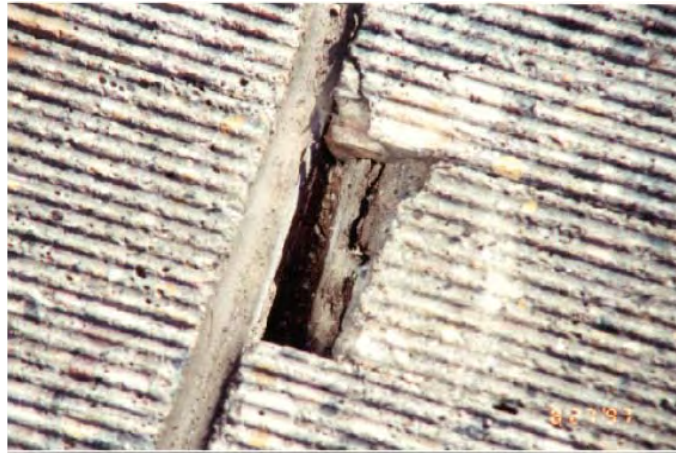
- In general, load transfer prior to dowel bar retrofit on the first project ranged from 20 to 30 percent, and after dowel bar retrofit the average load transfer was approximately 76 percent. On the second project, load transfer prior to installation ranged from 20 to 30 percent, and after dowel bar retrofit the load transfer averaged approximately 85 percent;
- On one project the contractor had challenges with the foam core board (width of  $\frac{1}{4}$  inch) remaining vertical in the dowel bar slot during placement of the patching material. Typical distress associated with foam core board movement is shown in Figure 119;

**Figure 119 Typical distress caused at core board failure (Dunn et al., 1998).**

- Due to this distress a revision to the foam core board was proposed (Figure 120). The redesign includes a “T” section (which is inserted into the existing transverse joint) and increasing the board thickness to  $\frac{3}{8}$  inch;

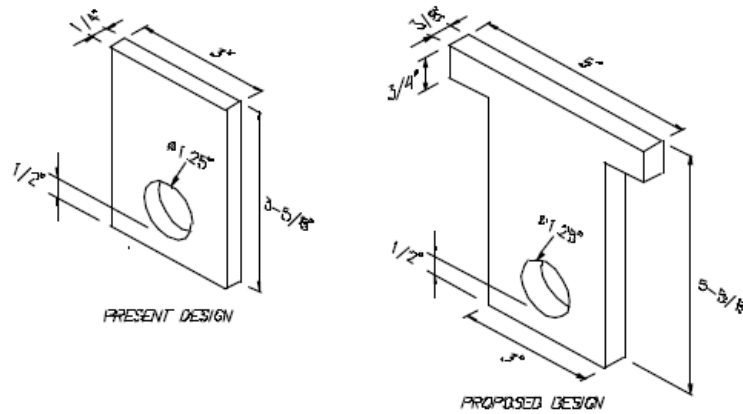
**Figure 120 Proposed change in foam core board design (Dunn et al., 1998).**

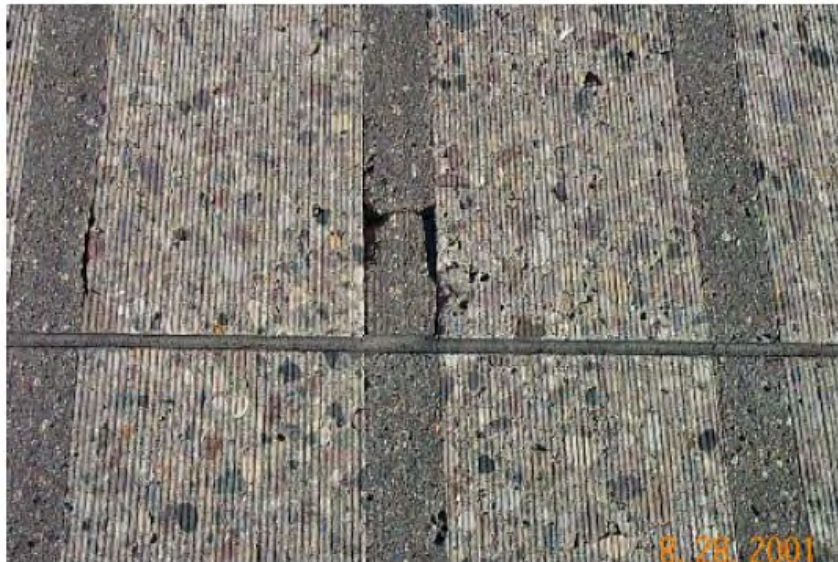
- Shrinkage cracking occurred within the MNDOT mixture;
- A prevalent distress in the Patchroc 10-60 material is shown in Figure 121 and is believed to be due to lack of consolidation around the dowel bar;
- In general, nearly all of the distresses (in both the Patchroc 10-60 and the MNDOT 3U18) in the dowel bar slots appear to be either related to the mix, bonding, core board failures, or improper vibration of the mix. The majority of distresses could be avoided with proper control of construction practices.

**Figure 121 Typical distress in Patchroc 10-60 (Dunn et al., 1998).**

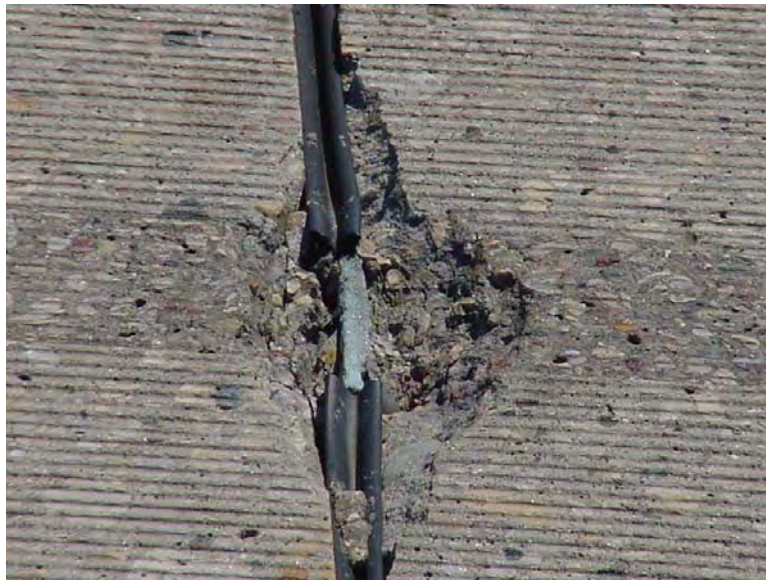
In 1999, Wisconsin DOT constructed its first dowel bar retrofit test section (several more followed in different areas of the state). Two years after construction, Wisconsin noted good load transfer efficiency (Bischoff et al., 2002), but frequent locations where the patching material failed (Figure 122) around the dowel bars.

**Figure 122 Mortar deterioration and spalling (Wilson et al., 2002).**

In 2001, the Wisconsin DOT placed a moratorium on the continued use of dowel bar retrofit until resolution of the patching material failure could be determined. A 2002 study

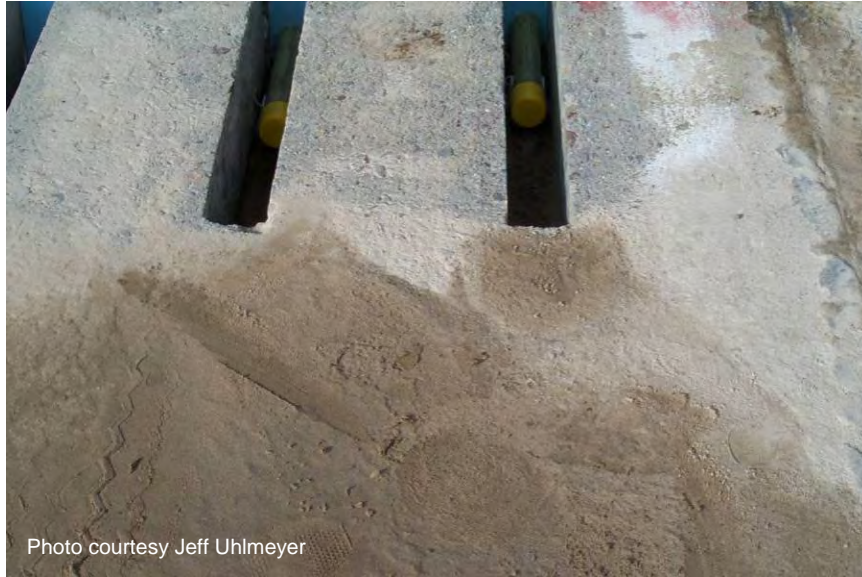
that the Contractor did not remove the debris very far from the dowel bar slots (Figure 124). The debris was continually kicked into the dowel bar slots by both observers and workers;

**Figure 124 Debris left adjacent to dowel bar slots.**

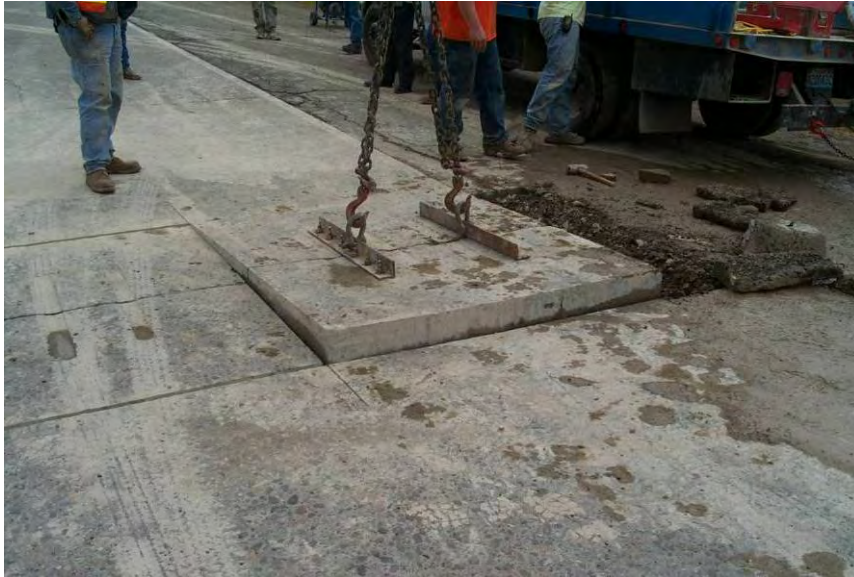
Results from the I-90 joint evaluation showed that a considerable amount of corrosion had formed beneath the epoxy coating at the center of the dowel (i.e. at the joint). The corrosion of the bar was shown to be a likely contributor to the reduction in load transfer efficiency (Harvey et al., 2005). In general, the corrosion study concluded that corrosion is a problem for bare steel dowels and a potential problem for epoxy coated steel dowels. Corrosion may be a contributor to a loss of load transfer efficiency with dowel bars retrofitted in concrete pavements. Prior to use, a quality control check should be conducted on dowel bars to ensure that the epoxy coating completely covers the bar and is free of holidays.

**Figure 125 Removal of dowel bar retrofitted joint on I-90 test section.**

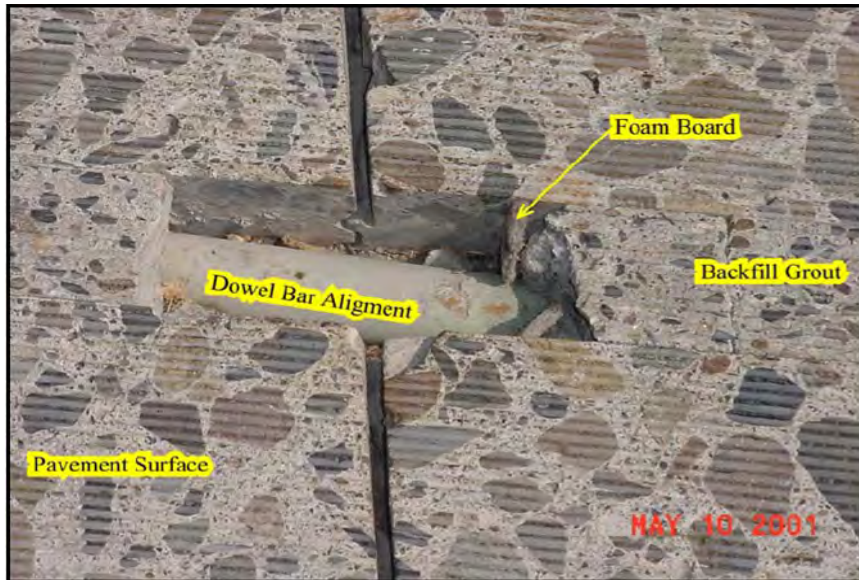
Figure 126 Misaligned foam core board I-405 (Glauz et al., 2002a).

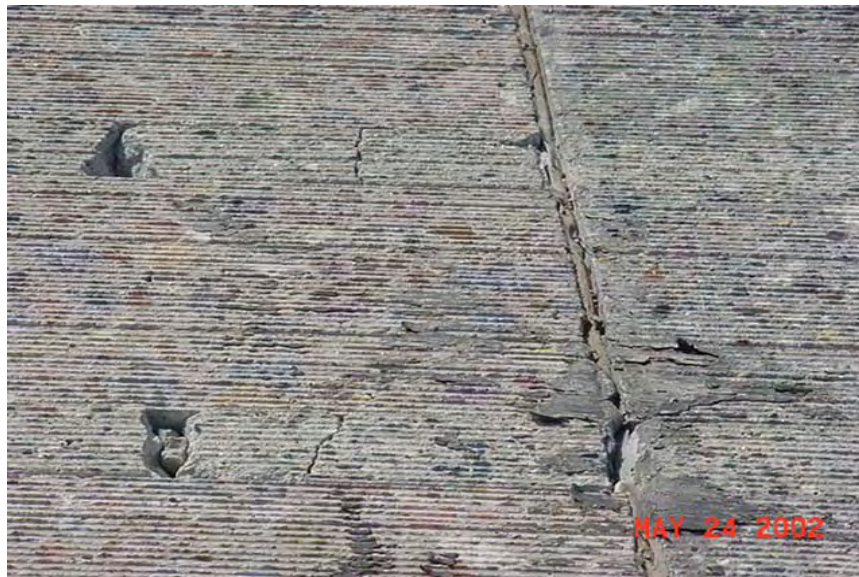
Figure 127 Shrinkage cracking and spalling State Route 8 (Glauz et al., 2002b).

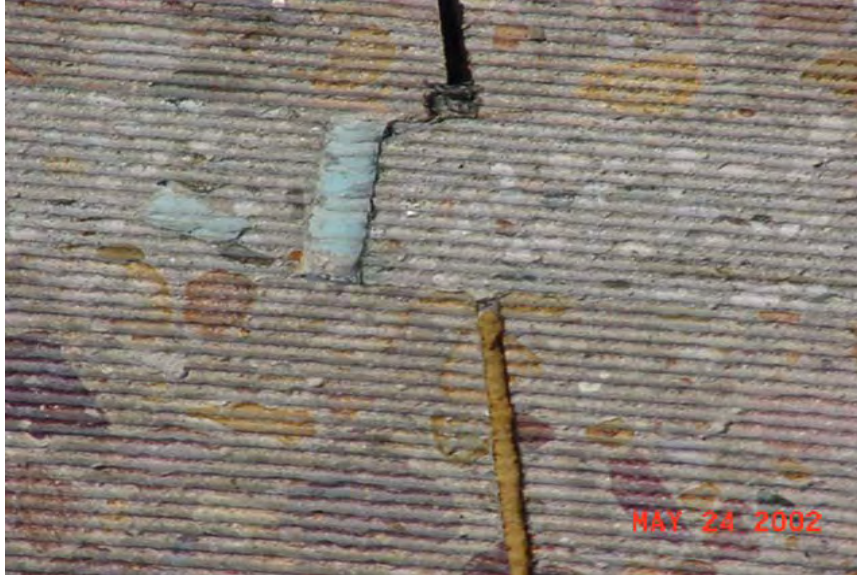
**Figure 128 Misaligned foam core board State Route 8 (Glauz et al., 2002b).**

material was not properly consolidated, and deleterious material was found between the patching material and the existing concrete. Specific findings for the State Route 8 project indicated that the dowel bar slots were constructed incorrectly (construction crew used 60 pound jackhammers when 30 pounds was specified, and dowel bar slots were cut too short to allow proper placement of the dowel bar retrofit assembly), foam core boards were not properly aligned with the existing transverse joint, and joint sealant was not applied.

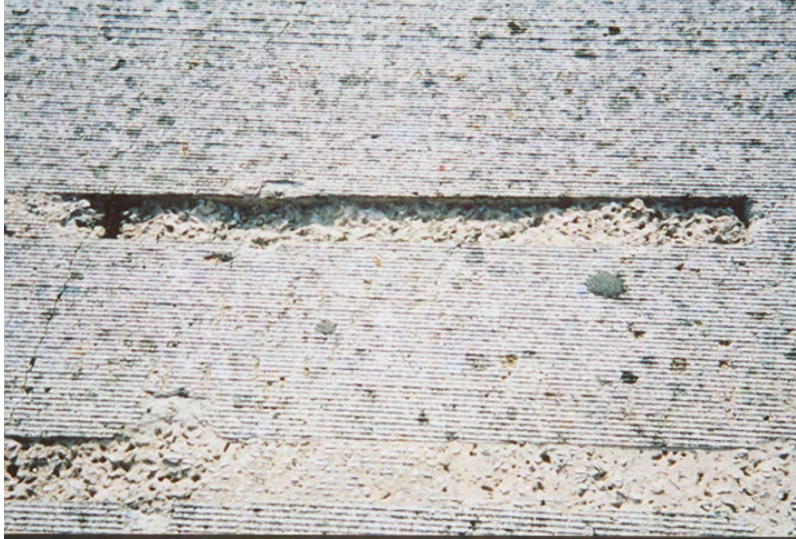
Michigan (Eacker, 2008) – It has been reported that a couple of dowel bar retrofit projects had major failures (spalling of patching material due to over consolidation [Figure 133] and cracking around slots [Figure 134] due to use of larger than specified jackhammers). Currently, there is very little interest in using dowel bar retrofit due to previous failures. One dowel bar retrofit project is scheduled to be let in 2008 (4,500 slots). Michigan DOT requires a two year materials and workmanship warranty (Appendix B);

**Figure 133 Spalling of patching material.**

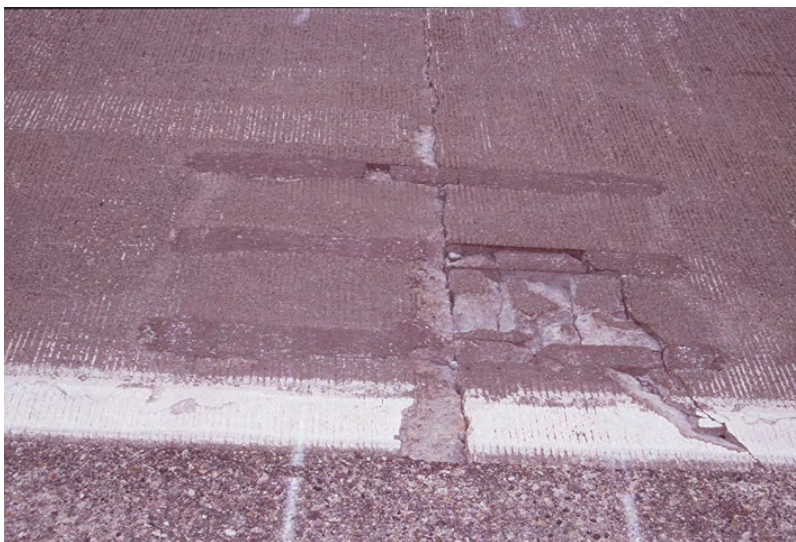
**Figure 134 Cracking between dowel bar slots.**

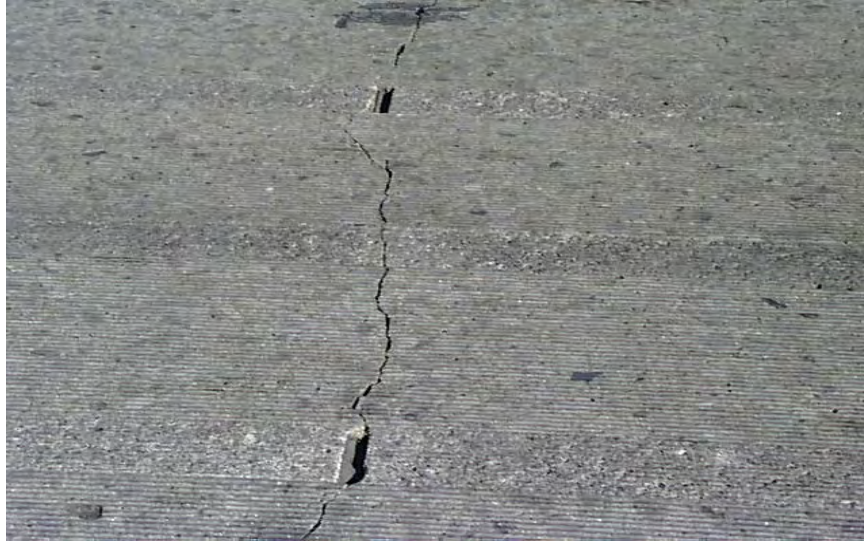
**Figure 135 Minor spalling between foam core board and transverse crack.**

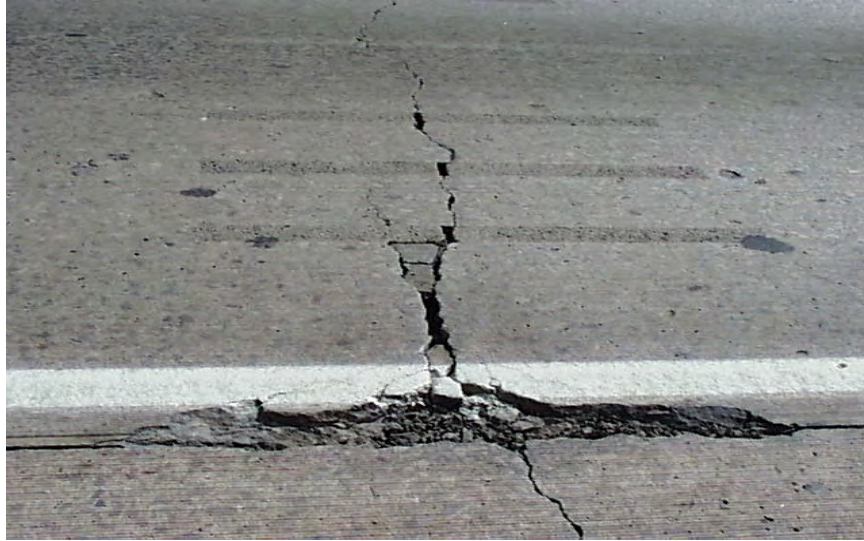
mixed, with failures primarily due to improper installation or use on badly deteriorated cracks (Figure 136). It is currently recommend that dowel bar retrofit only be applied to hairline or narrow cracks and that full depth repairs be conducted on working and/or faulted cracks. Future dowel bar retrofit is anticipated to be less than 70 lane miles;

**Figure 136 Spalling of dowel bar retrofitted transverse crack.**

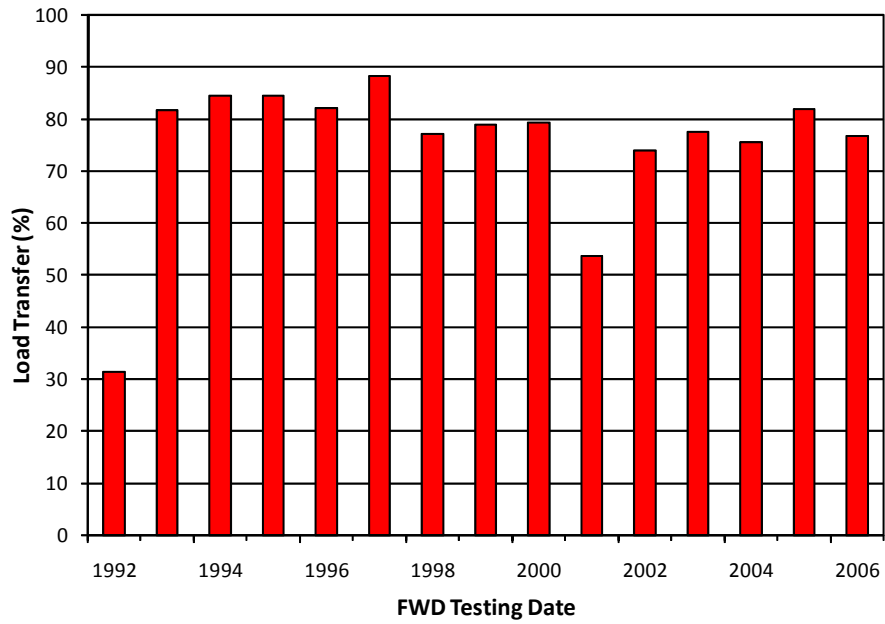
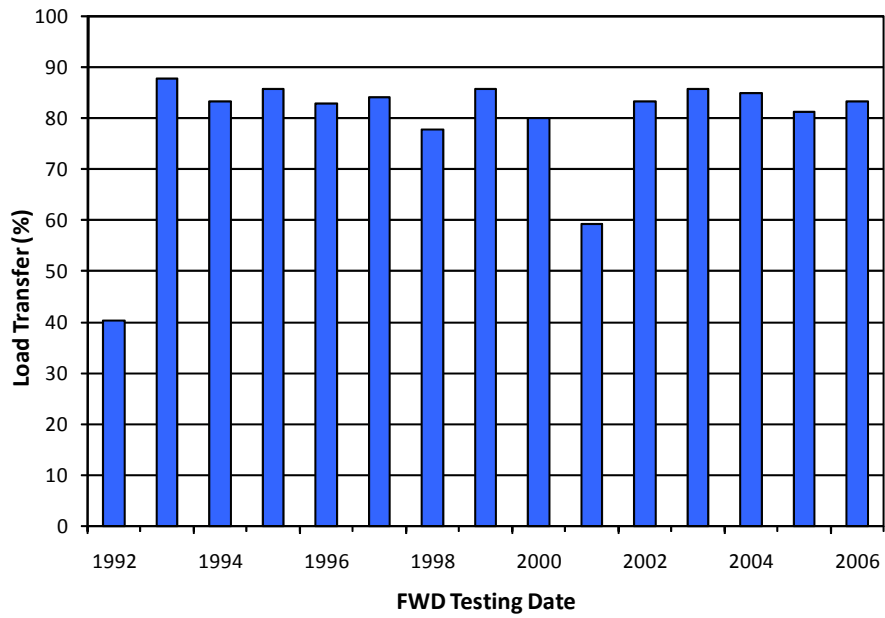
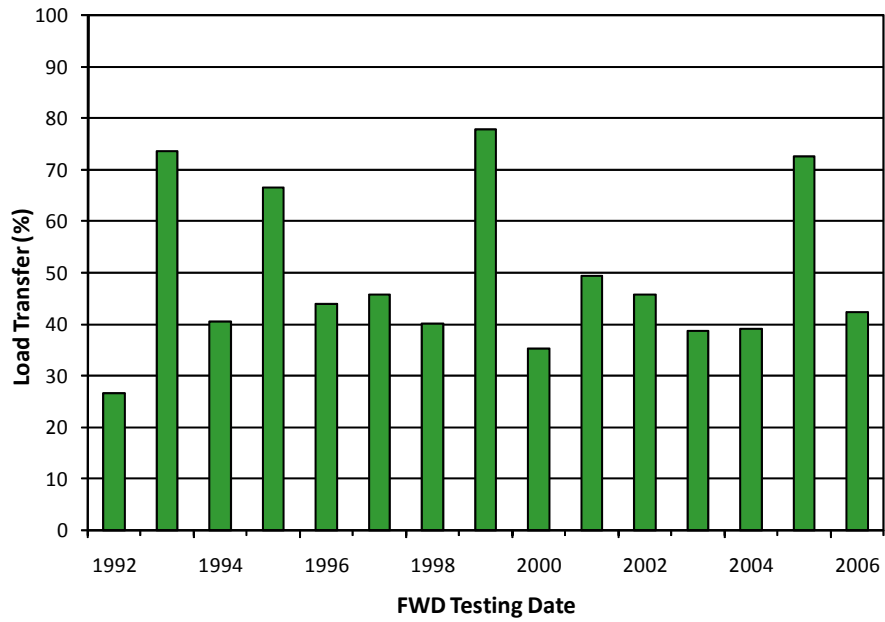
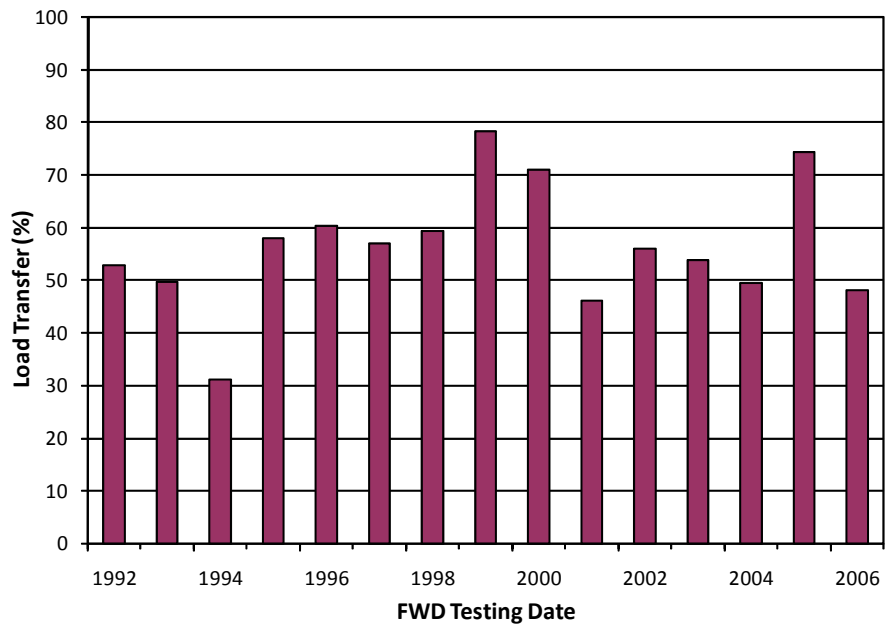
Prior to construction of the dowel bar retrofit test section in 1992, the concrete pavement on this section of Interstate 90 had average load transfer efficiencies ranging from a low of 27 percent to a high of 53 percent, indicating poor performance. Immediately following construction, all sections increased in load transfer efficiency (Figure 141 through Figure 144) except the control section. This result was expected since this section had received no treatment for restoring load transfer. Immediately after construction the average load transfer efficiencies on the dowel bar retrofit sections increased to over 80 percent.

As can be seen in the above figures, the average load transfer can vary from one year to the next (specifically for the control and concrete shoulder beam sections and in 2001 for the dowel bar retrofit sections). This variation can either be a function of the FWD testing

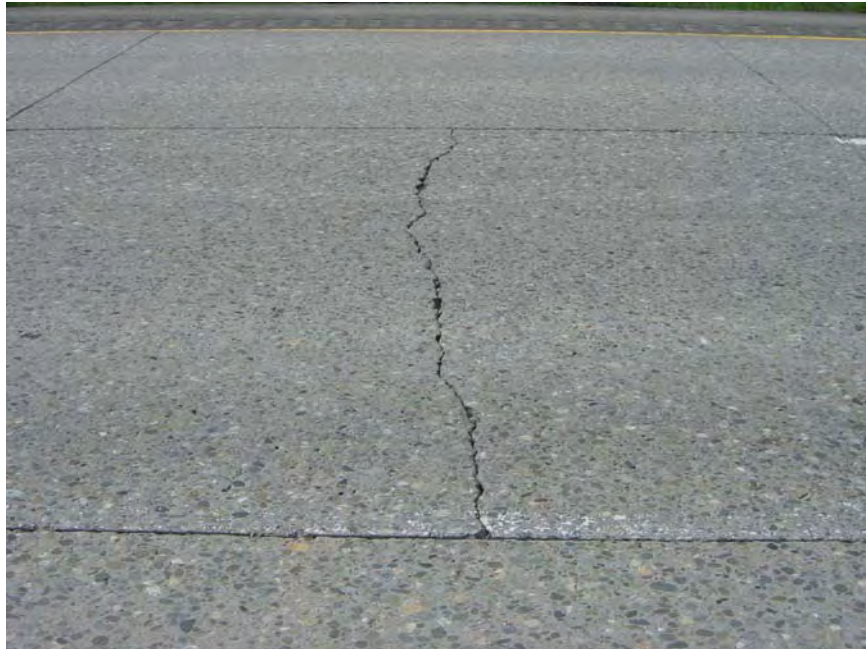
**Figure 152 Test section – transverse cracking.**

Due to the lack of load transfer restoration, it is expected that the control section should show an increase in the number of cracked panels (from 15 percent in 1992 to 54 percent in 2006). Notable is the increase in both the number of longitudinally cracked panels and the number of multiple cracked panels. This may in part be attributed to a dowel bar retrofit project (Contract 4902) in 1996 that encompassed the dowel bar retrofit test section. On Contract 4902 the Contractor sawcut the dowel bar retrofit slots within the control section but did not remove the concrete from between the parallel sawcuts (Figure 156). In consultation with the Pavements Office, the Project Office was requested to not remove the concrete from between the sawcuts (Figure 157) but to instead seal the sawcuts with an epoxy material. This action had no effect on the load transfer characteristics of the control section. However, several panels within the control section have since cracked longitudinally (Figure 157), initiating at the sawcut for the dowel bar retrofit slot. It is probable that this cracking is a function of the creation of an inconsistency (by sawcutting the dowel bar retrofit slot) within the concrete panel which created a point of high stress which may have led to crack initiation.

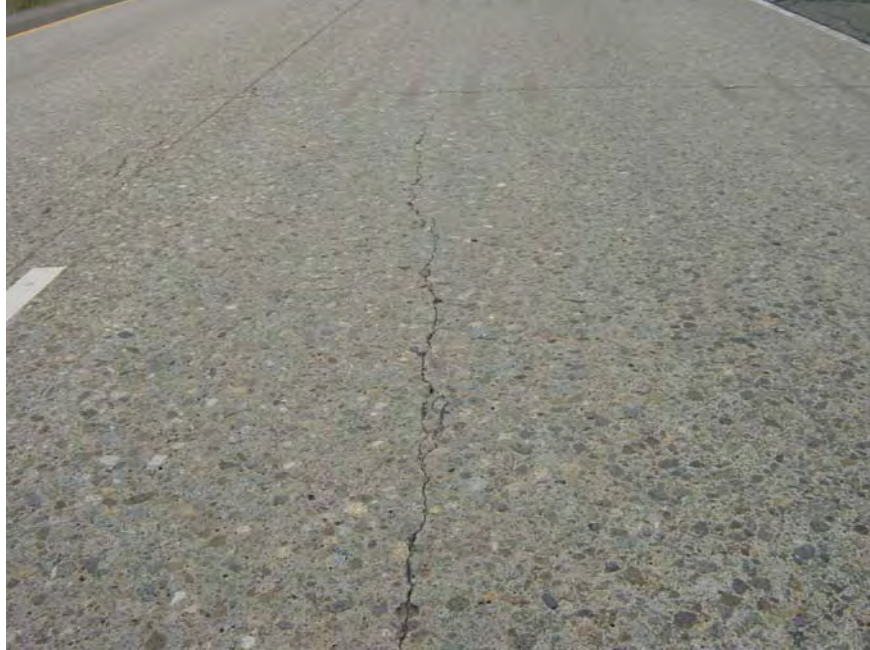
**Figure 153 Test section – longitudinal cracking.**

What is intriguing about the test section cracking is the significant amount of longitudinal cracking, specifically in the dowel bar retrofit test sections. As may be recalled from the WSDOT Jointed Plain Concrete Pavement Design and Performance section, in general a significant amount of cracking is not present on any of the concrete pavements in Washington State. Reviewing the amount of cracking in eastern and western Washington (Figure 158), longitudinal cracking occurs almost twice as frequently in western Washington than it does in eastern Washington. Figure 158 is based on the WSDOT annual survey for 2004, which included all lanes of concrete pavement and is based on the number of panels that contain a single longitudinal crack, a single transverse crack, or a panel with multiple cracks. In eastern Washington the number of longitudinal cracks on I-90 heavily influences the results; many of these cracks are due to the failure of the longitudinal tape joint. If I-90 is removed from the analysis, then the amount of cracking in eastern Washington decreases for all cracking types.

As stated previously, it is believed that the longitudinal cracking is fatigue related, not construction related. One hypothesis (Mahoney et al., 1991) is the potential existence of in-plane compressive stress parallel to the pavement centerline. The basis for this hypothesis was a typical concrete pavement section located on I-5 north of Seattle, which demonstrated high transverse joint load transfer results, low average faulting, and longitudinal cracking. It is believed that this also explains what is occurring on the dowel bar retrofit projects, especially since longitudinal cracking is not a common occurrence on eastern Washington concrete pavements. The test section load transfer was very low prior to dowel bar retrofit. Dowel bar retrofit has restored the joint load transfer to the high 80s, resulting in the potential build-up of

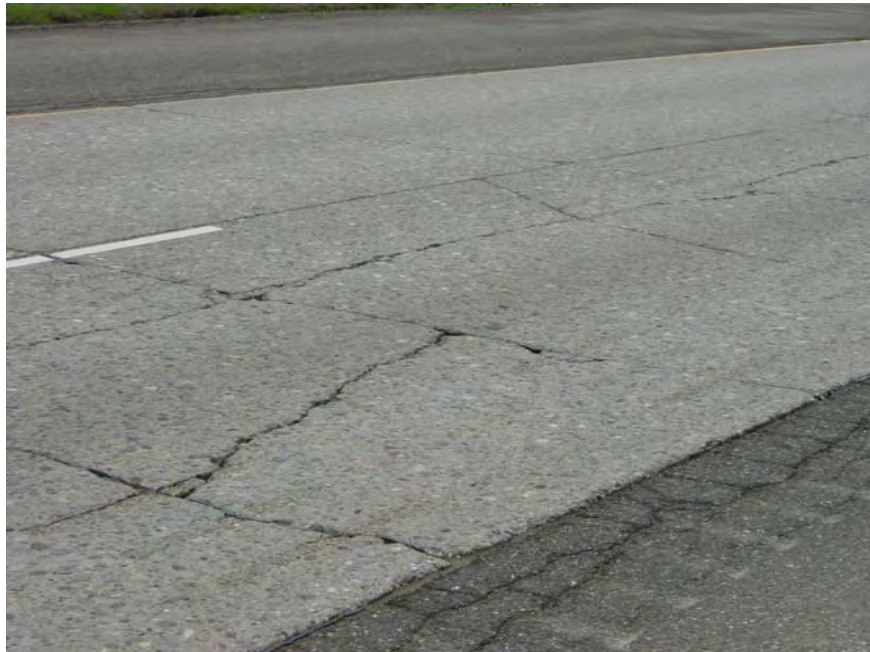
**Figure 154 Test section – multi-cracked slab.**

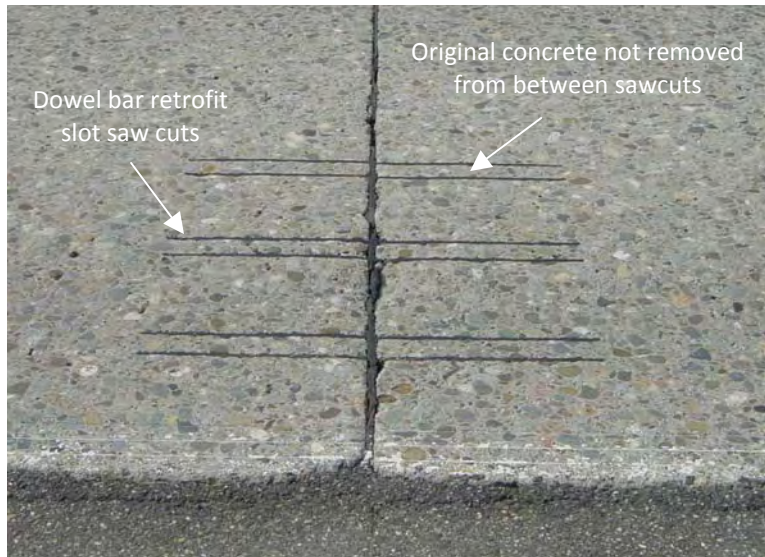
**Figure 156 Test section – dowel bar slots sawed and material not removed.**

tensile stress and potentially causing the longitudinal crack. Another explanation may be the construction of a discontinuity in the concrete panel with the dowel bar retrofit slot. This would explain why the control section cracked longitudinally when the slots were sawcut but the concrete was not removed. The presence of the longitudinal cracking will be discussed below in the Distress, Cause and Evaluation section.

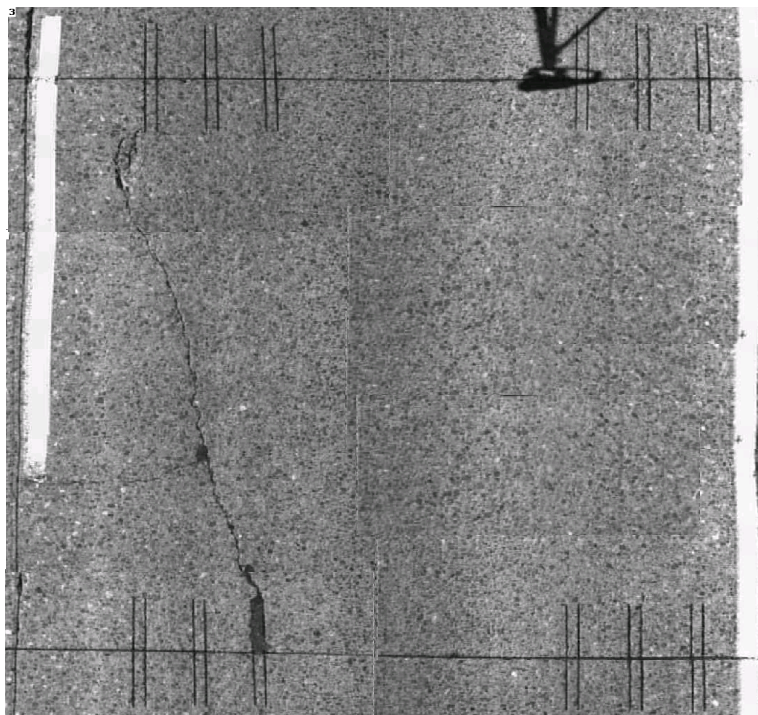
**Figure 157 Longitudinal cracking in control section.**

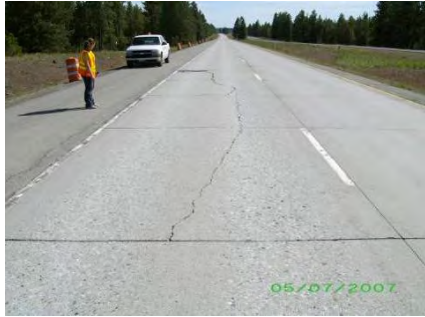
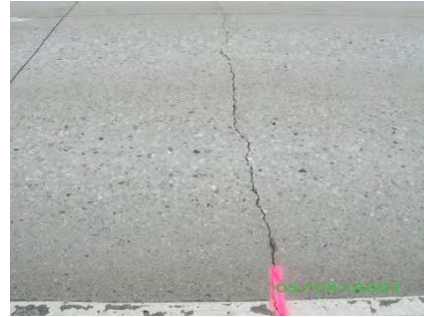
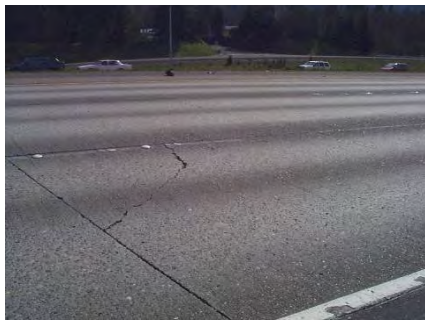
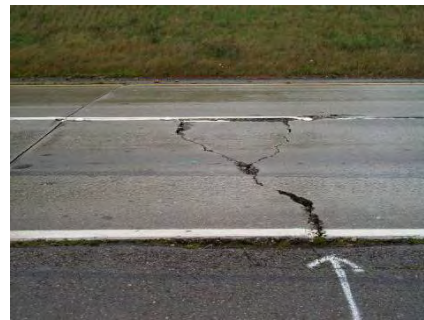
(a) Longitudinal cracking.

**Figure 162 Concrete pavement distress.**
