# Evaluation of Dowel Bar Retrofit for Long-Term Pavement Life in Washington State

WA-RD 727.1

May 2009

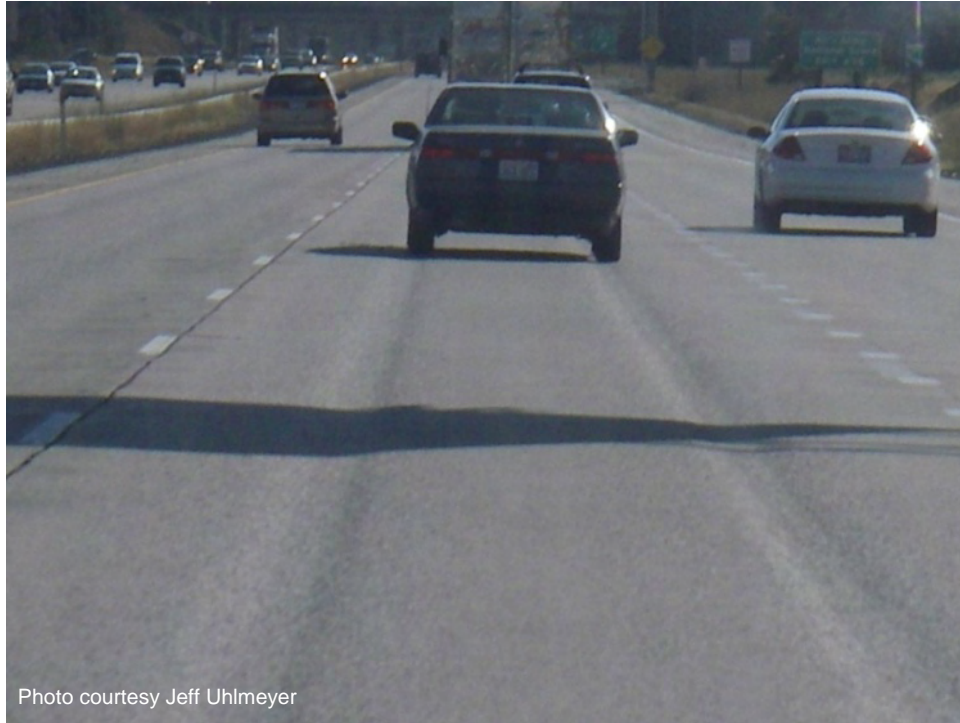
Photo courtesy Jeff Uhlmeier

**Figure 164 Studded tire wear on I-90, Spokane, Washington (2008).**

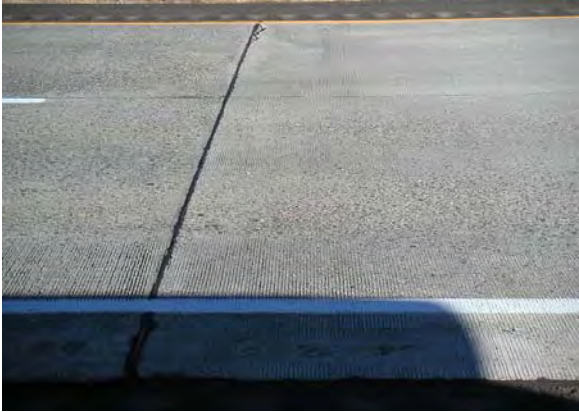
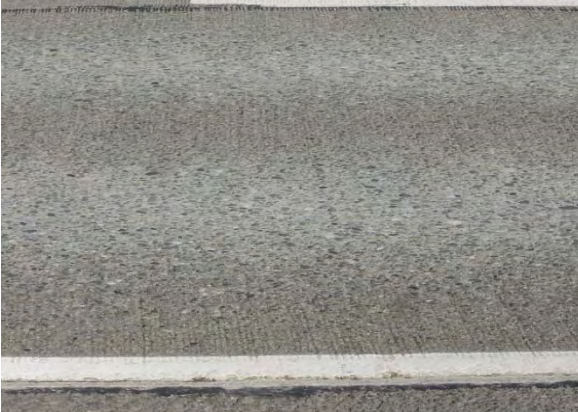
(a) SR-395 – south of Spokane, WA.

What is interesting to note from this analysis is that the pavements in California, Minnesota, and Texas are subjected to similar traffic loadings as those in Washington State. However, wear of the concrete pavement surfaces in these three states is nonexistent. Specifically, in Figure 167, images (a) and (b) illustrate concrete pavement surfaces in Washington State and demonstrate the lack of tining within the wheelpaths due to studded tire wear, while images (c) through (e) show concrete pavement surfaces from the other three states where tining within the wheelpath is still visible.

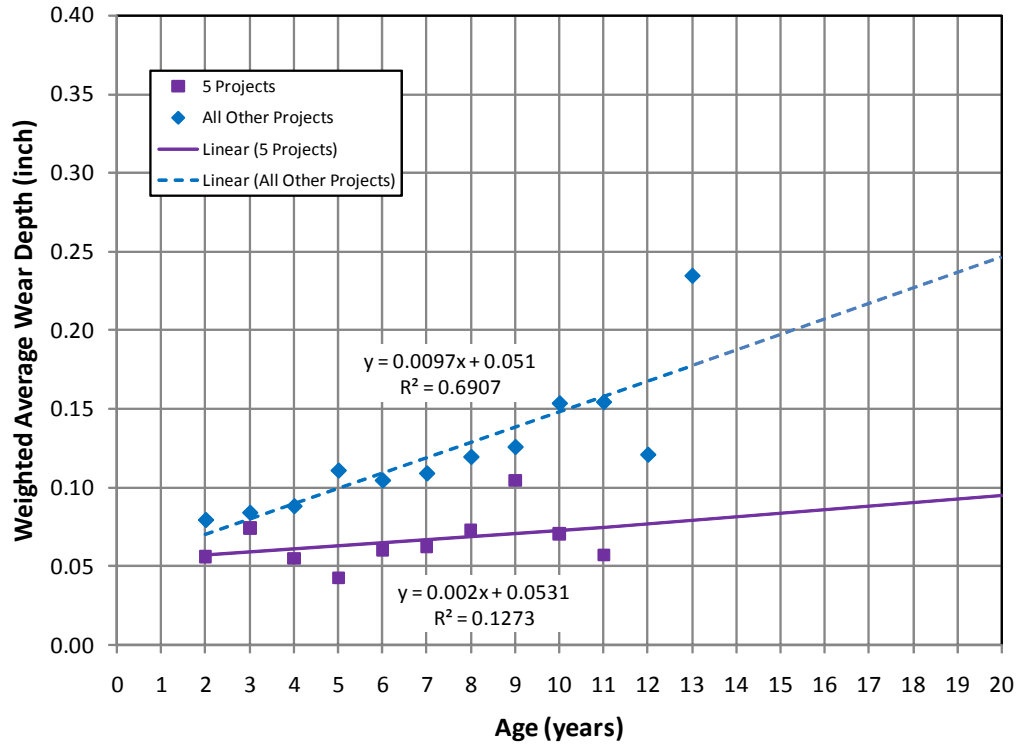
**Figure 171 Wear performance trends.**

Figure 171 illustrates the wear depth for the five projects as compared to all other projects. The trend in wear on the five projects indicates approximately half the wear rate as compared to all other dowel bar retrofit projects. For wear the WSDOT criteria is 0.40 inches, neither the five projects nor other dowel bar retrofit projects reached this level over the 20 year evaluation period. As discussed earlier, wear is a function of studded tire wear, and the difference between the two data sets is more than likely related to the predominant number of dowel bar retrofit projects on I-90 (which are included in the all other projects data set), which is subjected to higher frequencies of studded tire and chain use.

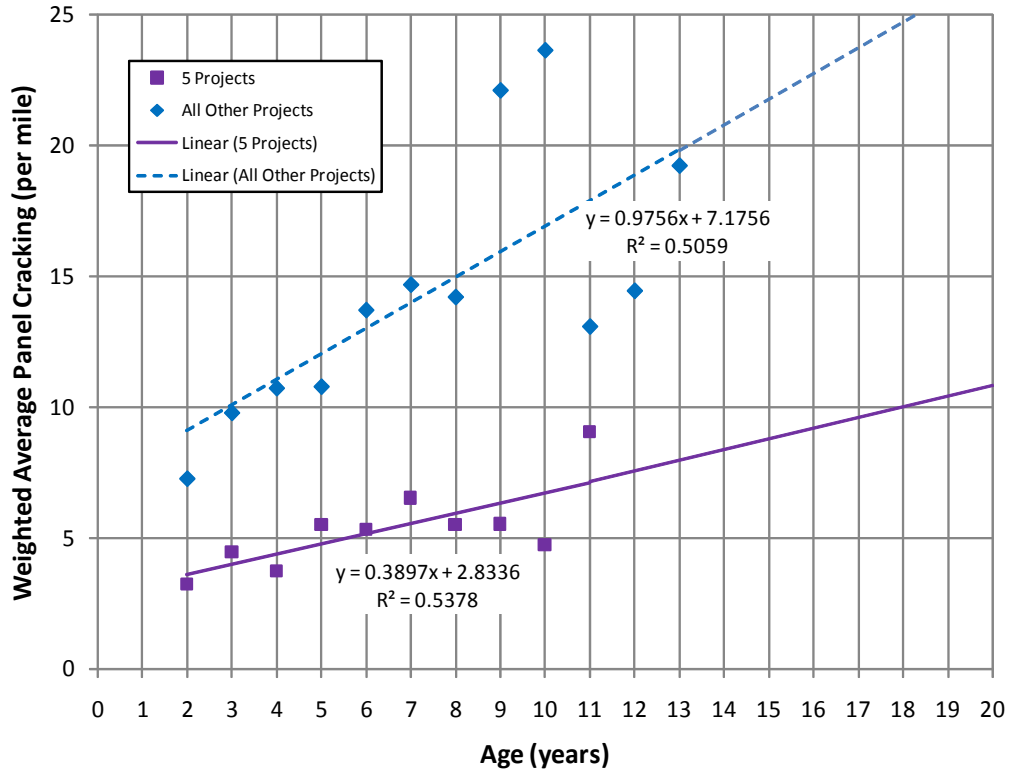
**Figure 172 Panel cracking performance trends.**

Figure 172 illustrates the percent of cracked panels that have occurred after dowel bar retrofit. As with the previous two figures, the five project data set shows better performance (fewer percent of cracked slabs) than all the other projects. Though it is unclear if an increase in panel cracking is a function of dowel bar retrofit, those projects that are dowel bar retrofitted early in the deterioration cycle appear to have a fewer future cracked panels.

As will be discussed later in this chapter, a large increase in panel cracking is not expected. It is suggested that WSDOT investigate the cause of the increased panel replacement cracking (e.g. Contracts 4235, 4340, 4902, 5686, 5968) on the dowel bar retrofit projects, which is believed to be due in part to construction practices.

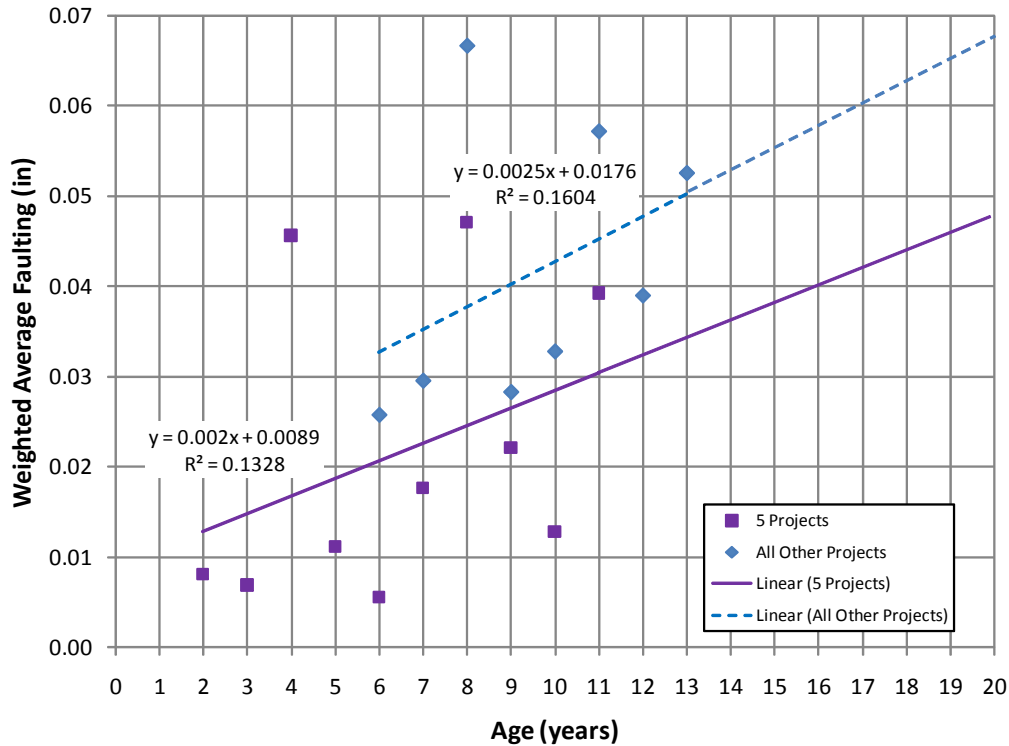
**Figure 173 Faulting performance trends.**

Finally, Figure 173 illustrates the amount of faulting that has occurred on the five projects compared to all other projects. One noted difference in the faulting performance trends from the previous three figures is that the slope of the trends between the two data sets is approximately the same (trend lines are roughly parallel). This implies that the five projects have lower levels of faulting, but the rate of fault return is similar as compared to all other dowel bar retrofit projects. Due to potential issues with faulting data collection and/or analysis, any conclusions from this analysis should be made cautiously.

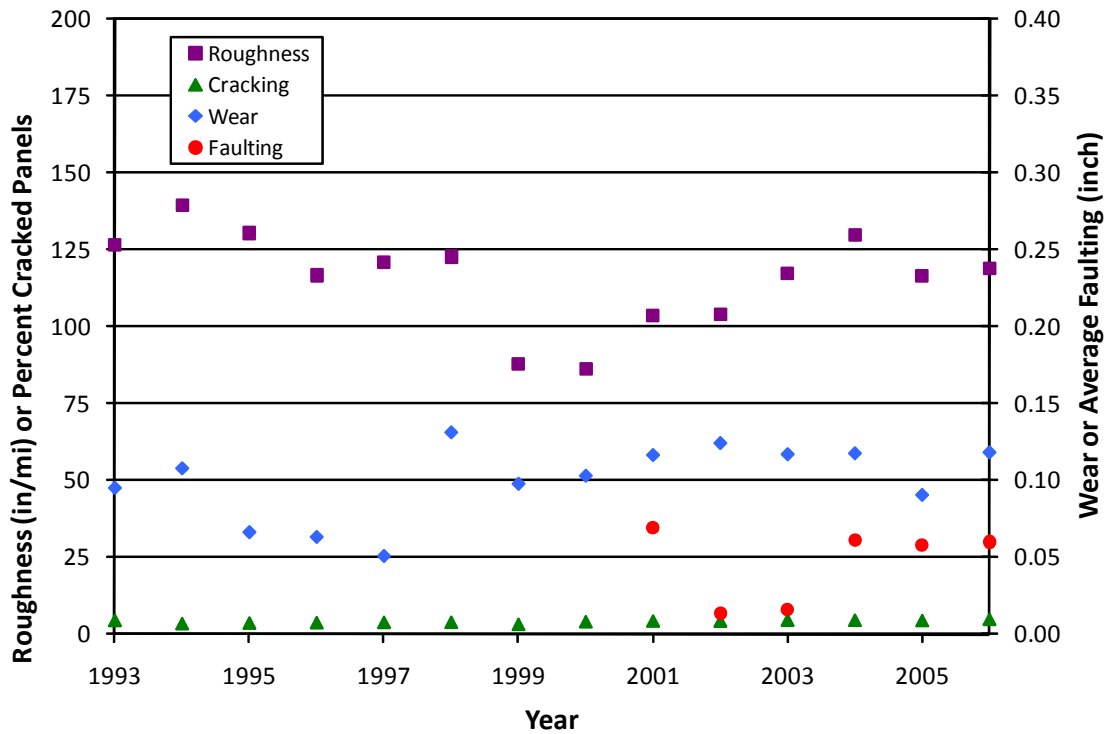
**Figure 174 Non-dowel bar retrofit pavement performance.**

- On average, roughness on the non-dowel bar retrofitted sections averaged from a low of 86 inches per mile in 1999, to a high of 136 inches per mile in 1994 (a roughness increase of approximately 3.8 inches per year). The dowel bar retrofit sections

averaged 162 inches per mile prior to construction and dropped to a low of 89 inches per mile in year 2 and after 13 years have increased to 150 inches per mile (a roughness increase of approximately 4.7 inches per year). The combination of dowel bar retrofit and diamond grinding can significantly improve pavement roughness (showing, on average, a 70 inch per mile decrease); however the return of roughness due to studded tire usage greatly reduces this benefit in a relatively short period of time. In Figure 174, the decrease in roughness from 1998 to 1999 is due to the change from ultrasonic to laser sensors for measuring pavement roughness. This change is not noticed in Figure 163, since data is plotted according to dowel bar retrofit age and not according to condition year;

- Initially, the percent of cracked slabs on the non-dowel bar retrofitted sections was slightly higher than the dowel bar retrofitted sections (six versus five percent, respectively). Over the 13 year period, the percent of cracked slabs remained relatively unchanged for the non-dowel bar retrofitted sections, but has increased to 19 percent in the dowel bar retrofitted sections;

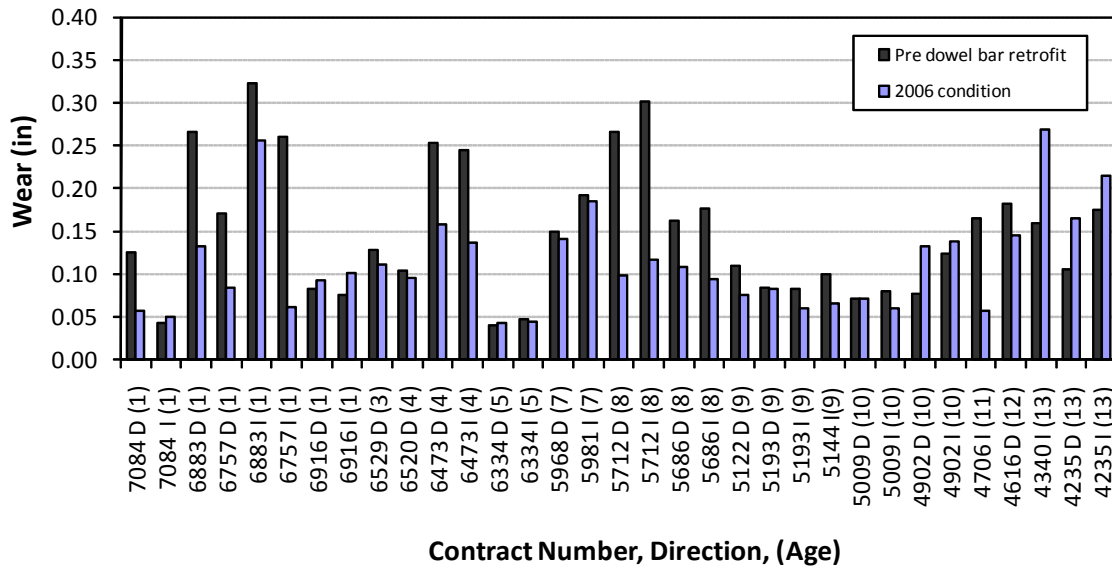
**Figure 175 Wear by contract number.**

Figure 175 illustrates the amount of pavement wear for each project. As may be seen, neither the pavement wear prior to construction nor the pavement wear as of 2006 exceeds WSDOT criteria (0.40 inch or more) for triggering pavement rehabilitation, although 16 projects (almost half of all projects) are nearing or have exceeded the pre dowel bar retrofit wear depth. Wear on the two oldest projects, Contracts 4235 and 4340, have both exceeded the pre dowel bar retrofit wear condition. Both of these projects are on I-90 (vicinity Snoqualmie Pass) and are subjected to heavy use of studded tires and snow chains. In addition, during the construction of these two projects (which were the first two large scale dowel bar retrofit projects conducted in the state) over finishing of the dowel bar retrofit slot occurred, resulting in a higher potential for wear due to bleed water and fines being brought to the dowel bar retrofit slot surface.

Contract 6916 (both directions) is located on I-205 between Portland, Oregon and Vancouver, Washington. This project had challenges associated with the diamond grinding contractor which may have resulted in the full depth of wear not being completely removed. The wear rate on this project increased slightly (0.01 inch in the decreasing direction and 0.02 inches in the increasing direction) within a one year period. When diamond grinding is conducted properly, a reduction in the wear depth is expected. Contract 6883 (I-5, north of Tacoma) in the increasing direction experienced several challenges, again due to the presence of studded tire wear. This project included many more features than just concrete pavement

However, coupled with the fact that the deepest wear was located in the passing lanes, the depth of diamond grinding in the truck lane needed to be minimized to maintain structural integrity, and the desire to not diamond grind the newly placed high occupancy vehicle lane resulted in not all of the pavement wear being removed during the diamond grinding operation. Though it performed slightly better than Contract 6883, Contract 5981 has been in-service for seven years and is in the opposite direction of travel from Contract 6883. Therefore a similar instance occurred; the passing lanes contained more pavement wear than could be removed while still maintaining the structural integrity of the concrete pavement.

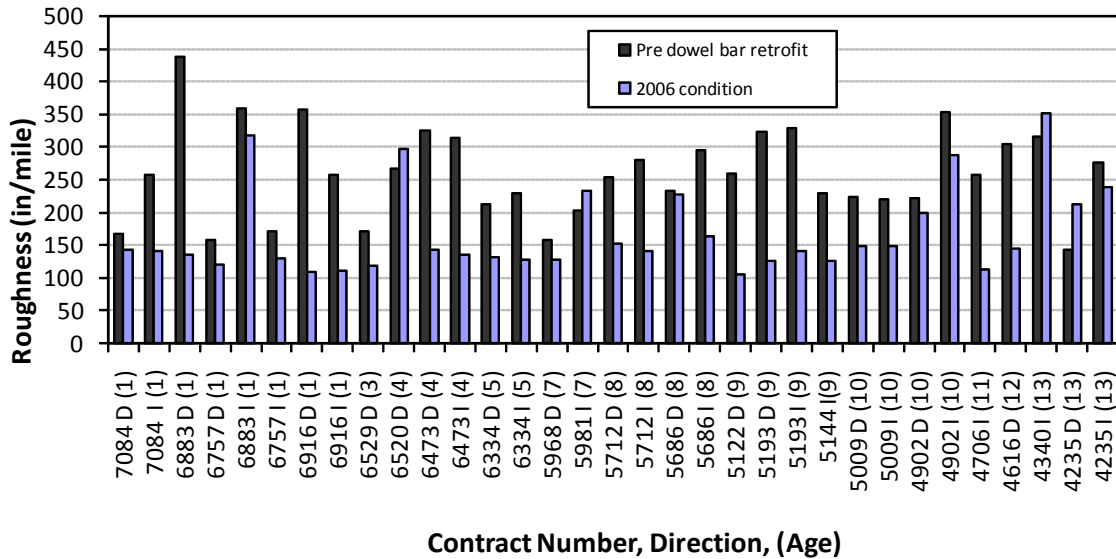
**Figure 176 Roughness by contract number.**

Figure 176 provides pavement roughness results. As noted previously, the majority of the dowels bar retrofit projects exceeded the WSDOT roughness criteria prior to dowel bar retrofit construction. In 2006, nine dowel bar retrofit projects exceeded the 170 inches per mile criteria, and one-third of the projects were nearing or had exceeded the pre dowel bar retrofit roughness condition. For the same reason as above, Contracts 4235, 4340, 5981, and 6883 are some of the rougher projects. Two other projects showed a relatively rapid increase in roughness values: Contract 5686 (I-5, southbound, Ferndale vicinity) and Contract 6520, (I-5,

southbound, Stanwood vicinity). It is uncertain why Contract 5686 showed a rapid increase in roughness. On Contract 6520 dowel bar retrofit and diamond grinding was not conducted on the entire project length (applied only in the worst sections), therefore, a significant reduction in roughness after construction would not be expected.

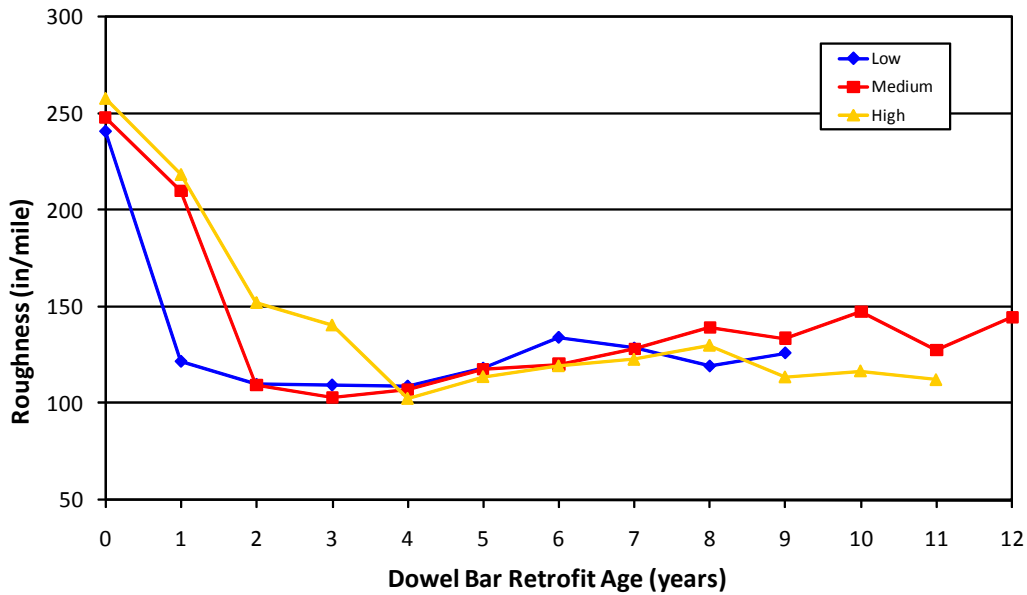
**Figure 177 Roughness by truck volume.**

The following discusses the initial improvement and longer-term effects of pavement roughness as a result of diamond grinding and dowel bar retrofit. In this analysis, projects with diamond grinding issues (Contracts 4235, 4340, 5686, 5981, 6520, and 6883) were removed. The remaining projects were arranged according to the total number of trucks that traversed the pavement sections from the year of dowel bar retrofit construction through 2006. Three ranges of truck volumes were identified: (1) Low – less than or equal to 10,000,000 (total of 30 lane miles); (2) Medium – greater than 10,000,000 and less than or equal to 30,000,000 (total of 83 lane miles); and (3) High – greater than 30,000,000 total volume of trucks (total of 20 lane miles). Very little difference is noted in pavement roughness prior to dowel bar retrofit (year 0) between the three truck volume ranges (Figure 177). This relationship is not unexpected, since, for the most part, WSDOT dowel bar retrofitted projects had relatively high levels of joint faulting and/or roughness regardless of the amount of truck traffic. A significant reduction in pavement roughness was noted for all truck volume ranges (44 percent for low, 49 percent for medium and 30 percent for high traffic volumes) after diamond grinding. Finally, over the 12 year period there is a slight increase in pavement roughness for all three truck traffic volume

ranges, with a slightly higher increase in the medium truck traffic volume range (approximately 4.2 inches per year).

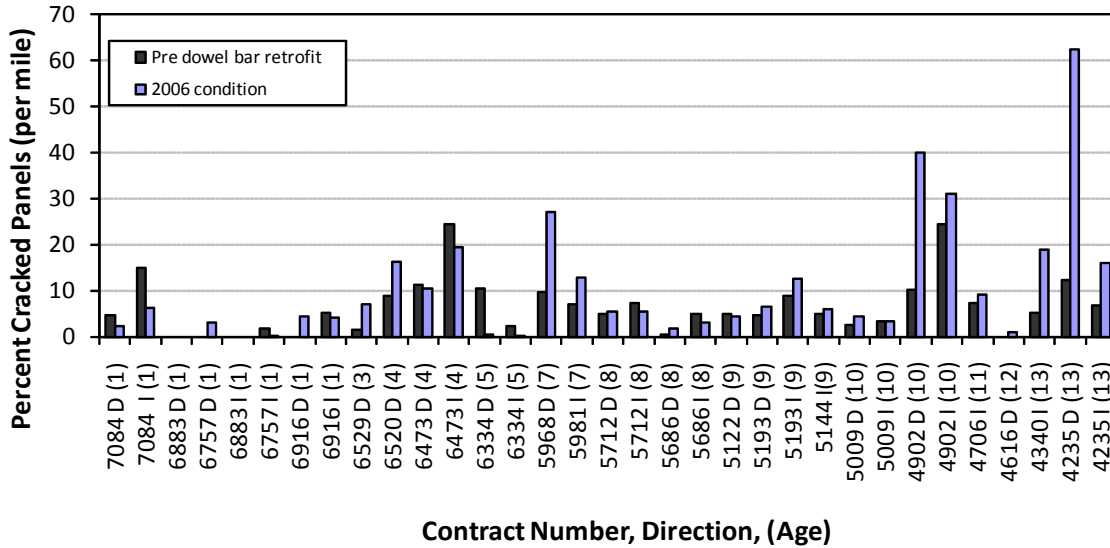
Figure 178 Cracked panels by contract number.

The next WSPMS summary includes the percent of cracked panels (Figure 178). In this analysis, the pre dowel bar condition includes all cracked panels, while the post condition excludes any cracked panels that were replaced during dowel bar retrofit construction. For dowel bar retrofit projects, it is standard WSDOT practice to replace all panels with two or more cracks and those that have settled more than ½ inch. This alone is not an issue, but the difference in measurement from pre to post dowel bar retrofit needs to be clarified, since the improvement in panel cracking condition is a function of the number of panel replacements. In the WSPMS, details on panel replacement locations are not identified (and do not all occur within the surveyed lane) nor are they counted uniquely if distressed. Therefore, it is difficult to remove the number of panel replacements from either the pre dowel bar retrofit or the 2006

From Figure 178 one may see that there are several projects with a greater percent of panel cracking in 2006 than existed prior to dowel bar retrofit. Approximately 25 (75 percent) of all projects are either nearing or have exceeded the pre dowel bar retrofit percent of cracked panels. What is more of a concern are those projects that have significantly increased in the percent of cracked panels. In order to determine this impact, the percent of cracked panels (pre construction and as of 2006) were arranged into three categories: less than 10 percent; 10 to 15 percent; and more than 15 percent. Table 21 provides the results of this analysis and indicates the following:

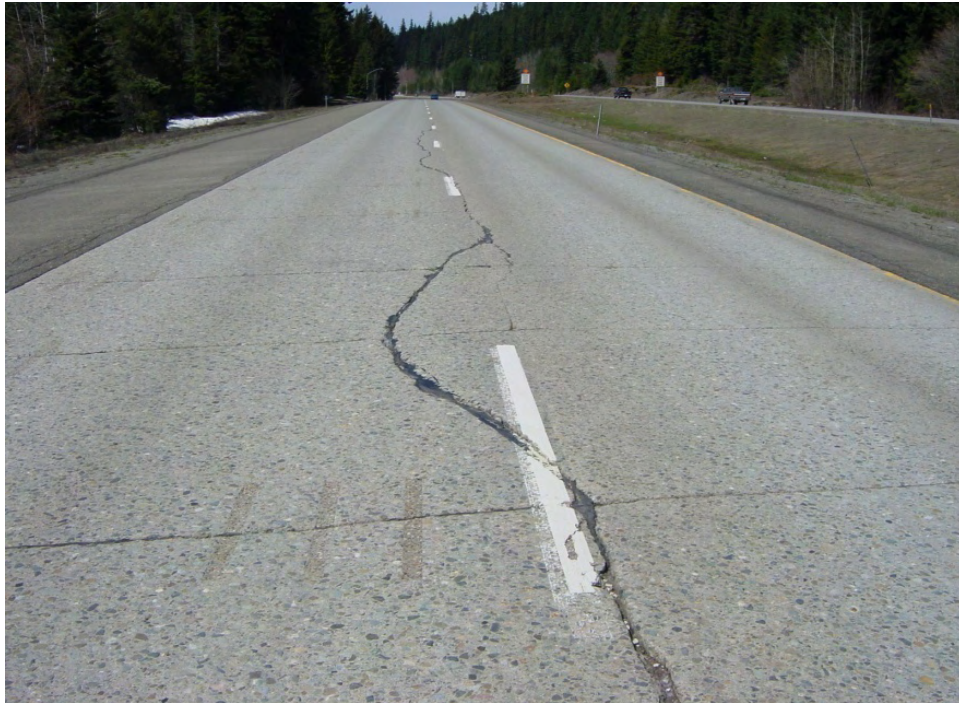
On Contract 6520 D, panel replacement construction included over-excavation of the underlying material which was then replaced with shoulder ballast or quarry spalls. In isolated areas it is difficult to obtain adequate compaction of the shoulder ballast material (Uhlmeier, 2008). If settlement of the shoulder ballast material continues to occur due to vehicle traffic, there is an increased potential for uneven support beneath the concrete panel. The lack of underlying support can lead to increased panel cracking.

**Figure 179 Failed longitudinal tape resulting in longitudinal cracking.**

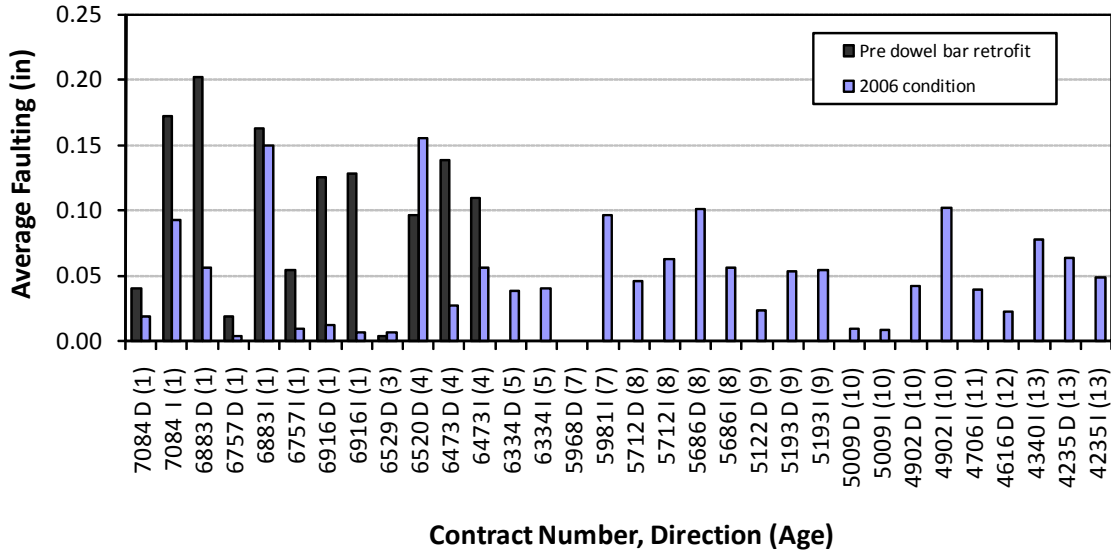
Figure 180 Faulting by contract number.

The final WSPMS pavement distress evaluation is faulting (Figure 180). Prior to 2001, WSDOT did not have the capability to capture accurate faulting measurements (assessment was based on visual judgment and not an actual measurement). Therefore, projects constructed prior to 2001 will not have pre dowel bar retrofit faulting test results. Of the 12 projects that have pre dowel bar retrofit faulting test results, only two projects, Contracts 6520 D and 6883 I have either exceeded or are close to exceeding the pre dowel bar retrofit condition. These two projects have only been in service for less than four years (four and one, respectively). As discussed previously, Contract 6520 only conducted dowel bar retrofit in the higher faulted areas, leaving the potential for increased faulting in non-dowel bar retrofitted areas. Contract

6883 had challenges associated with diamond grinding and more than likely did not completely remove the faulting depth. This explains why, after one year of performance, the faulting level is not significantly different from the pre dowel bar retrofit condition.

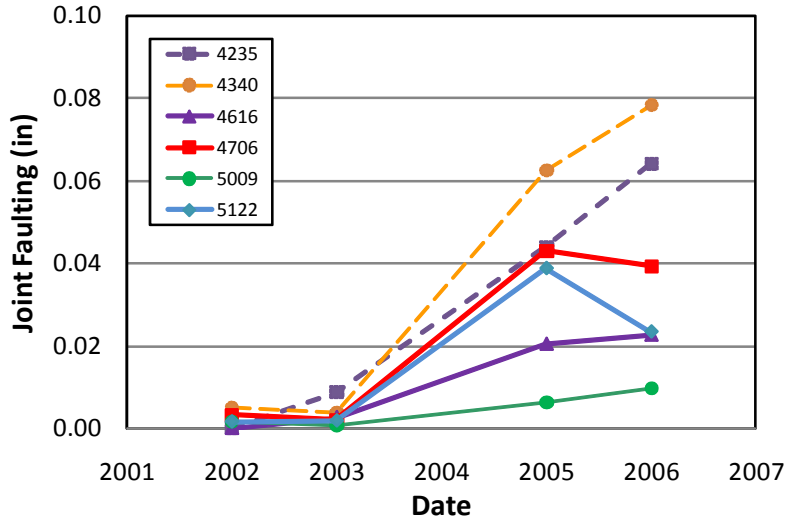
**Figure 181 Average faulting on contracts with low faulting prior to dowel bar retrofit.**

In comparison, Contracts 4706, 5009 and 5122 have been in service from between nine to 11 years. As of 2006 all have less than 0.05 inches of average faulting. These three contracts illustrate improved performance in minimizing faulting when dowel bar retrofit is applied prior to significant fault development. Though accurate faulting measurements of the level of faulting prior to dowel bar retrofit for Contracts 4706, 5009 and 5122 is not available (all projects were constructed between 1994 and 1997), based on personal knowledge, all of these projects had average joint faulting below  $\frac{1}{8}$  inch prior to dowel bar retrofit. Contracts 4235 and 4340 are examples of concrete projects that were dowel bar retrofitted after significant faulting had occurred ( $> \frac{1}{2}$  inch) and have not performed as well (Figure 181) as other projects. From this review it appears that increases in pavement wear and roughness are a function of studded tire and winter snow chain usage and may not be the best indicators of dowel bar retrofit performance. Additional analysis will therefore only include investigations related to panel cracking and joint faulting.

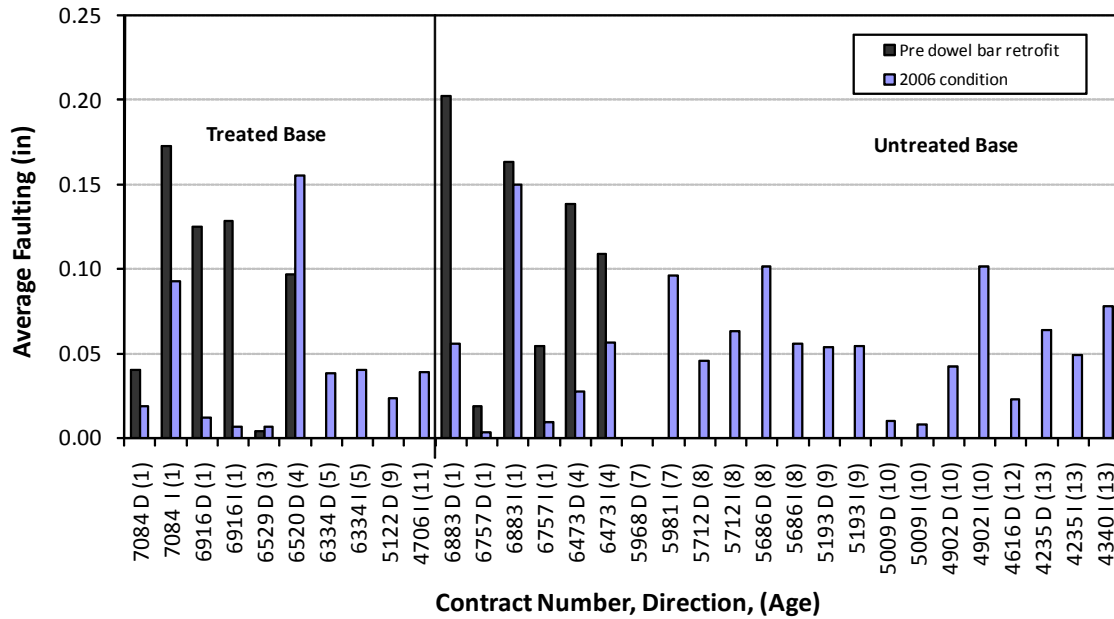
**Figure 182 Faulting by base type.**

Of the 33 projects evaluated, nine were originally constructed with treated base (Contract 6334 utilized a cement treated base and Contracts 4706, 5122, 6520, 6529, 6916, and 7084 were constructed with an asphalt treated base), and the remaining projects were originally constructed with an untreated base (crushed stone). Figure 182 arranges the dowel bar retrofit projects according to average faulting and base type. All but two of the treated base projects (Contracts 6520 and 7084) have 2006 average faulting values below 0.05 inches, where more than half of the untreated base projects have average faulting values greater than 0.05 inches. All but two projects (Contract 6520 with an asphalt treated base and Contract 6883 I with an untreated base) remain below the 0.15 inch value, which is considered to be poor performance with regard to load transfer. This graph suggests that the presence of a treated base provides some benefit in reducing and maintaining low faulting levels.

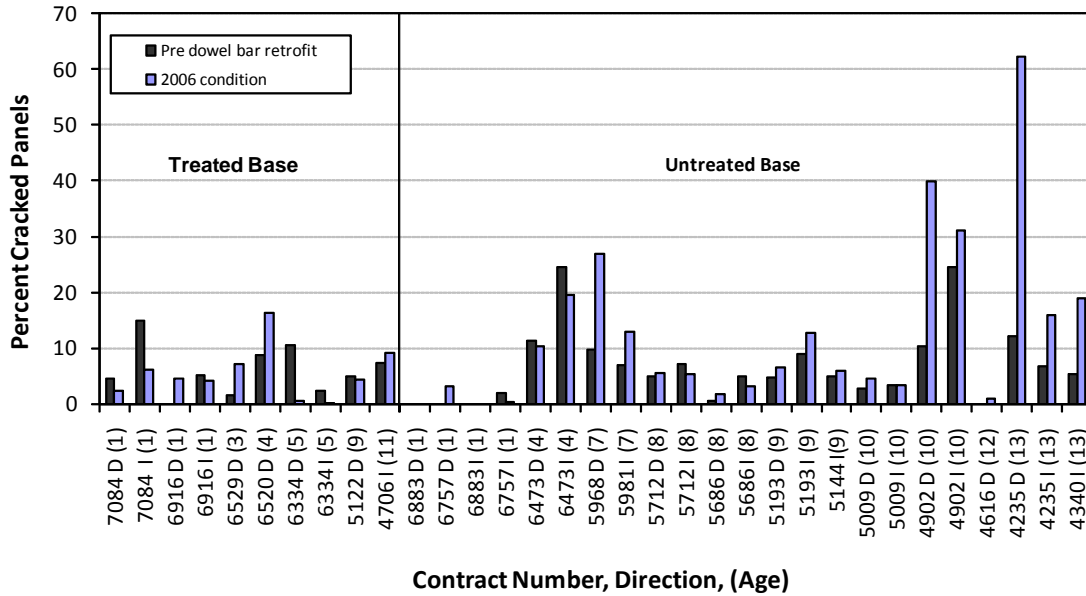
**Figure 183 Cracked panels by base type.**

Similarly, Figure 183 shows the variation of base type on the percent of cracked panels. The percent of cracked panels does not exclude panels repaired during construction, nor does it exclude any panel replacements that have cracked since construction. Therefore, as is the case on several projects, there may be more panels cracked in the pre dowel bar retrofit than there are in the 2006 condition (e.g. Contract 6334, 7084). As with faulting, there are fewer cracked panels when a treated base is used than there are when an untreated base is used. All but one of the treated base projects (Contract 6520) has less than 10 percent panel cracking as per the 2006 pavement condition, while slightly more than half (13 of 23) of the untreated base projects have panel cracking less than 10 percent. For the untreated base, 10 projects have panel cracking greater than 10 percent, three projects (Contracts 6473 I, 5968 D and 4235 D) have cracking greater than 20 percent, and one project (Contract 4235 D) has more than 60 percent cracked panels. From the cracking analysis, a pavement performance trend is not obvious, since there are several untreated base projects that have a very low occurrence of panel cracking (with up to 12 years of performance life). In this case, base type alone does not appear to have a significant impact on panel cracking.

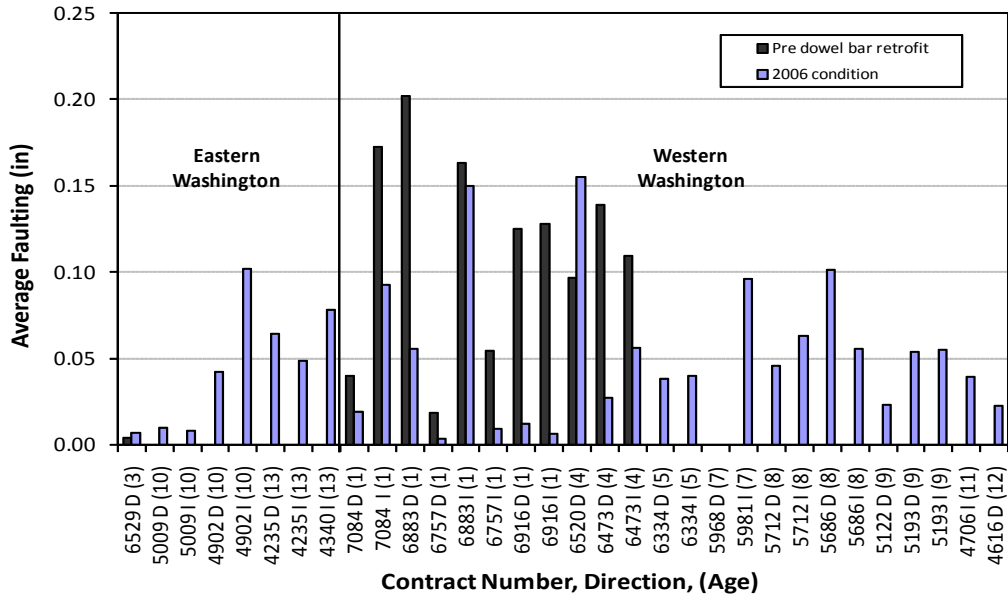
**Figure 184 Faulting – Eastern versus Western Washington.**

Evaluating the dowel bar retrofit projects according to western (wet no-freeze) and eastern (dry freeze) Washington is intended to determine impacts, if any, due to curling, warping and freezing effects. In this analysis, a total of nine projects were constructed in eastern Washington (two on I-82 between Yakima and Ellensburg, two on SR-195 between Spokane and Colfax, and five on I-90 between Snoqualmie Pass and Ellensburg). The remaining 25 projects were constructed in western Washington (two on I-205 in Vancouver and 23 on I-5 between Vancouver, Washington and Vancouver, British Columbia). Figure 184 illustrates the average faulting for eastern and western Washington. For the eastern Washington projects, Contract 5009 (I-82), is still performing well after 10 years of service. What is interesting about the I-82 projects is the pre-faulting condition. Though faulting was not physically measured until 2001, the I-82 projects were spot measured and indicated a faulting level of less than 1/8 inch. Contract 6529 (SR-195), is also performing well in faulting, albeit it has only in service for three years. However this project is subjected to very low truck traffic volumes (less than 900 trucks per day). In western Washington there are several projects with low levels of faulting after seven years or more (Contracts 5968 D, 4616 D, 5122 D, 4706 I). Several projects of similar ages are not doing as well in faulting. As far as faulting is concerned, there does not appear to be a distinct pattern between western and eastern Washington. One of the challenges is that the pre dowel bar retrofit faulting condition is unknown for the majority of the dowel bar retrofit sections.

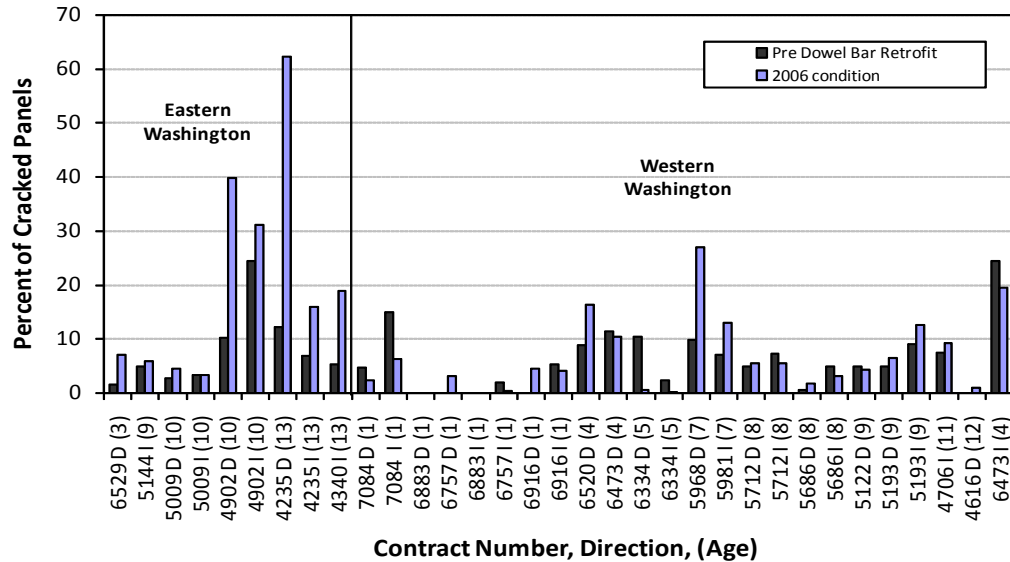
**Figure 185 Cracked panels – Eastern versus Western Washington.**

Figure 185 illustrates the percent of panel cracking in western and eastern Washington. Unlike base type, the difference between eastern and western Washington with respect to panel cracking is significant. In eastern Washington more than 50 percent (five of nine) of the projects have more than 10 percent panel cracking, while only 21 percent (five of 23) of the projects in western Washington have more than 10 percent panel cracking. The majority of the eastern Washington pavements that were dowel bar retrofitted are located on I-90 over Snoqualmie Pass which is subject to high levels of freezing and thawing cycles and therefore is susceptible to increased panel cracking over time.

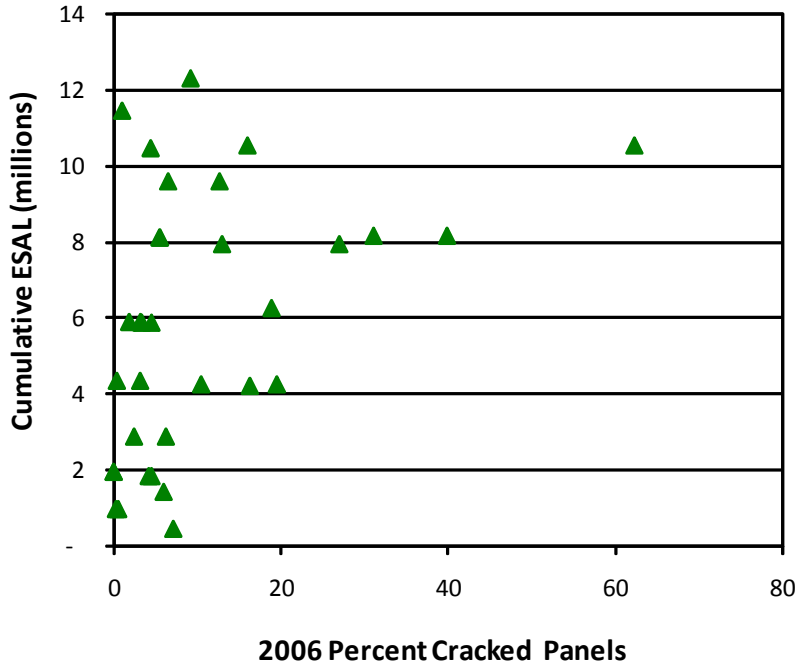
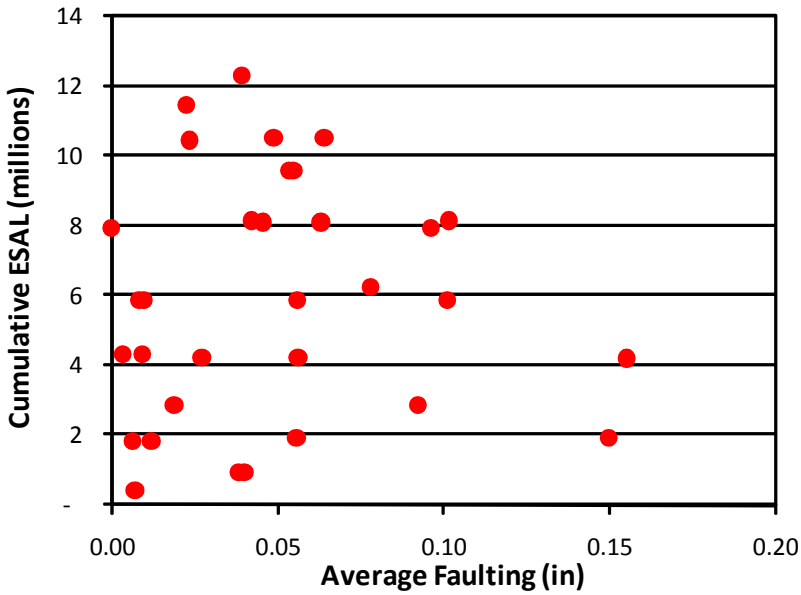
Truck volumes may also play a role in this analysis. The percent of cracked panels (Figure 186) and the average faulting (Figure 187) was plotted according to the number of cumulative ESAL's. Potentially, due to a limited number of projects and a low variation in the faulting level (measurements only range from 0 to 0.15 inch), there does not appear to be a correlation between truck traffic volumes and faulting levels. Keep in mind that the majority of dowel bar retrofit projects had already experienced higher levels of joint faulting regardless of truck volume. The same can also be said for the number of cracked panels.

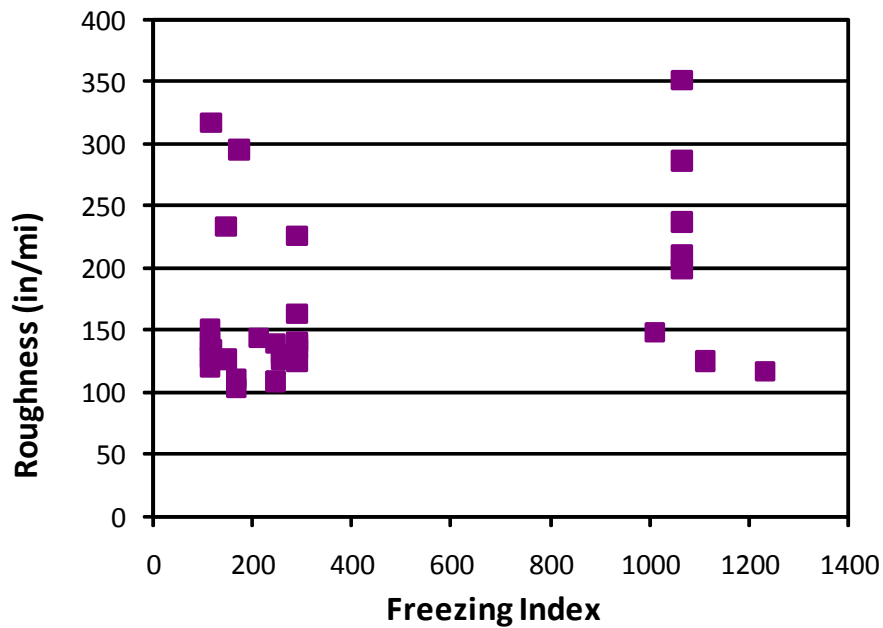
**Figure 188 Roughness versus freezing index.**

Figure 188 compares the freezing index and roughness of dowel bar retrofit projects. From this figure one may see that the range of roughness is approximately equal for both freezing index ranges. The higher freezing index range has three projects with lower roughness (< 150 inches per mile) values. One is on SR 195 (Contracts 5144 and 6529) with cumulative

truck volumes less than 10,000 vehicles and one on I-82 (Contract 5009) which was dowel bar retrofitted early in fault development. Each has cumulative truck volumes of 36,000 vehicles. The remaining projects are located on Snoqualmie Pass and are subjected to higher levels of studded tire and winter chain wear. A statistical analysis of the sample mean indicates that the null hypothesis ( $H_0$ : roughness west = roughness east) is not disproved (at  $\alpha= 0.05$ ). It cannot be stated that the means are different. Therefore, there does not appear to be a difference between dowel bar retrofit project roughness from eastern to western Washington.

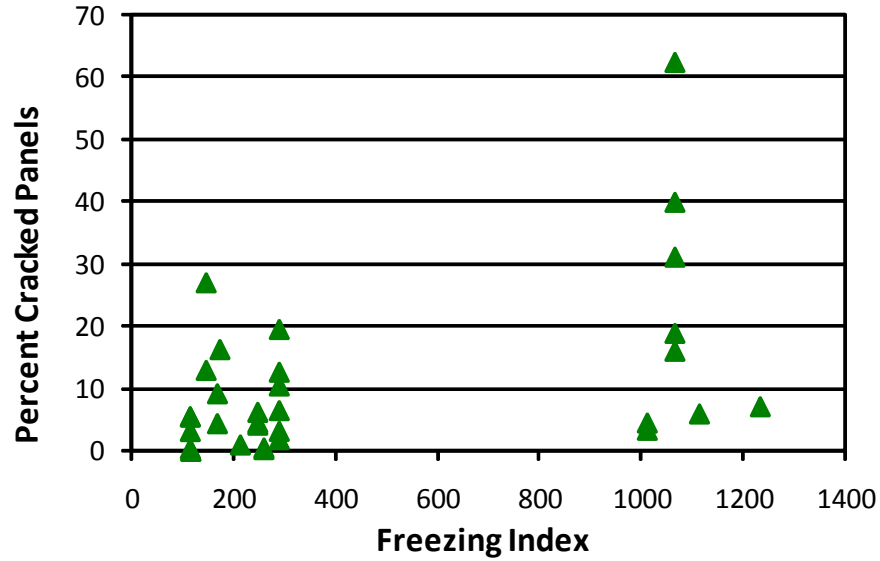
**Figure 189 Cracked panels versus freezing index.**

Figure 189 illustrates that projects located in areas with a higher freezing index show potential for an increased range of panel cracking. A statistical analysis of the sample mean indicates that the null hypothesis ( $H_0$ : cracking west = cracking east) is disproved (at  $\alpha= 0.05$ ) and the alternate hypothesis, that means are different, is accepted. Panel cracking on dowel bar retrofit projects is statistically higher in eastern than western Washington.

If the I-90 projects (Contract 4235 and 4902) are removed from the statistical analysis, than the null hypothesis is not disproved, and the percent of panel cracking is not statistically different from eastern to western Washington.

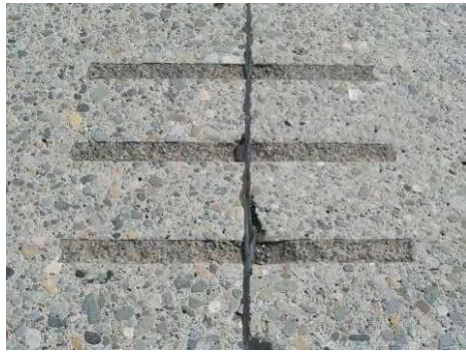
(a) Dowel bar slot spalling.

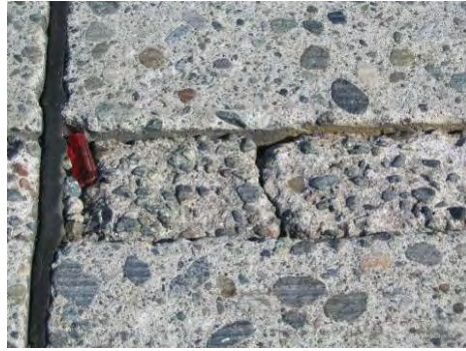
(b) Dowel bar slot cracking.

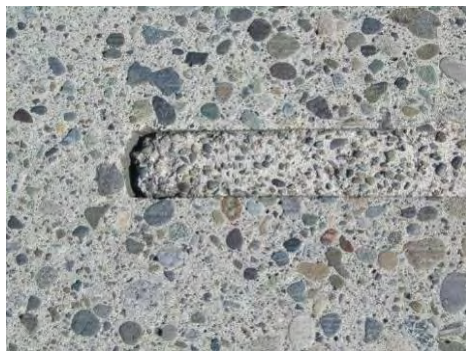
(c) Dowel bar slot debonding.

**Patching material debonding** – Debonding (Figure 207) is due to lack of adherence of the patching material to the sides of the dowel bar retrofit slot. There are three potential causes of this distress (1) inadequate bonding capability of the patching material; (2) inadequate texture on the dowel bar retrofit slot surface; and (3) inadequate cleaning of the dowel bar retrofit slot.

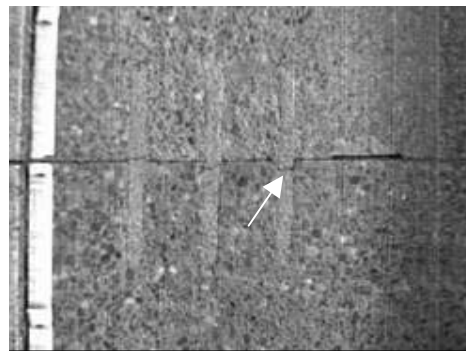
(d) Foam core board misalignment.

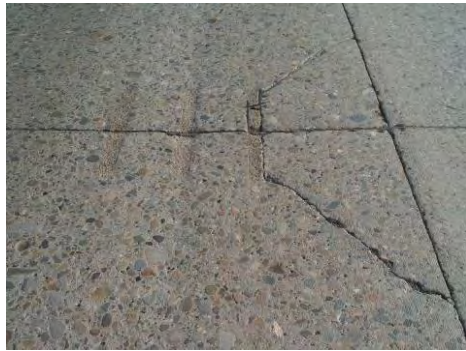
(e) 45-degree cracking.

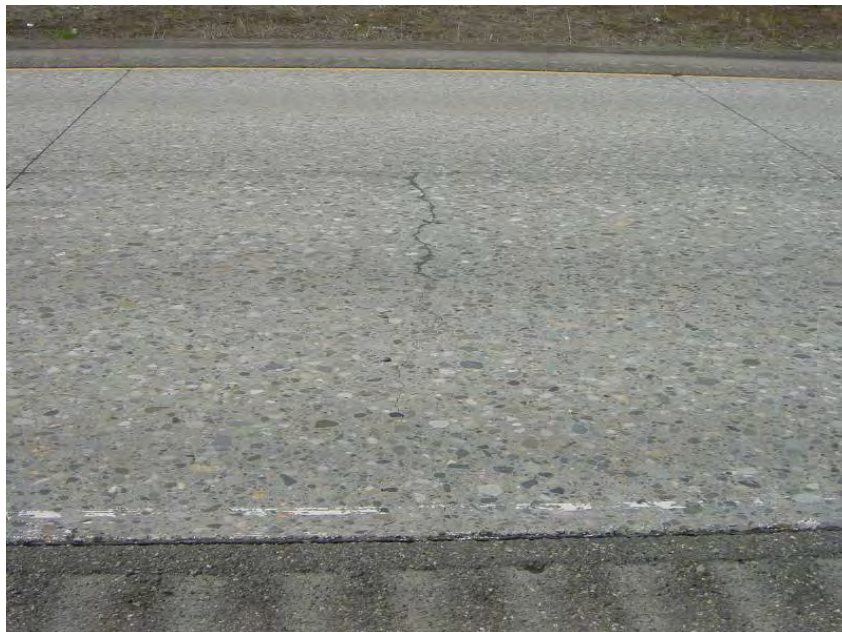
In addition to the review of each individual dowel bar retrofit slot, an assessment was made to determine the presence of new transverse, longitudinal, and corner cracking that developed after dowel bar retrofit construction. Standard WSDOT practice applies dowel bar retrofits to all existing transverse cracks; therefore, any transverse crack noted from the review of the 2006 annual survey that had not been dowel bar retrofitted is assumed to have developed after dowel bar retrofit construction. Newly formed cracks will also have a relatively narrow crack width and may or may not extend across the entire slab width (Figure 195).

**Figure 195 Transverse cracking after dowel bar retrofit.**

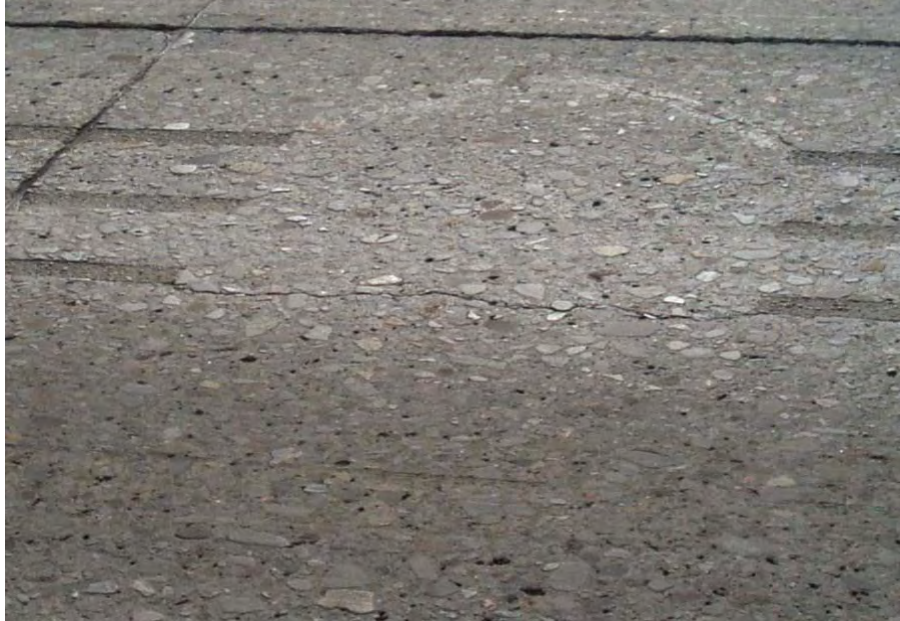
For longitudinal cracking, the determination of crack development before or after dowel bar retrofit was not as clear as it was with transverse cracking. WSDOT practice, at a minimum, may only seal the longitudinal crack. In many cases the longitudinal crack will receive no treatment. Therefore, if the longitudinal crack had not been sealed (Figure 196) and a narrow crack width (Figure 197) was noted it was assumed that the longitudinal crack occurred after dowel bar retrofit.

**Figure 197 Longitudinal cracking after dowel bar retrofit.**

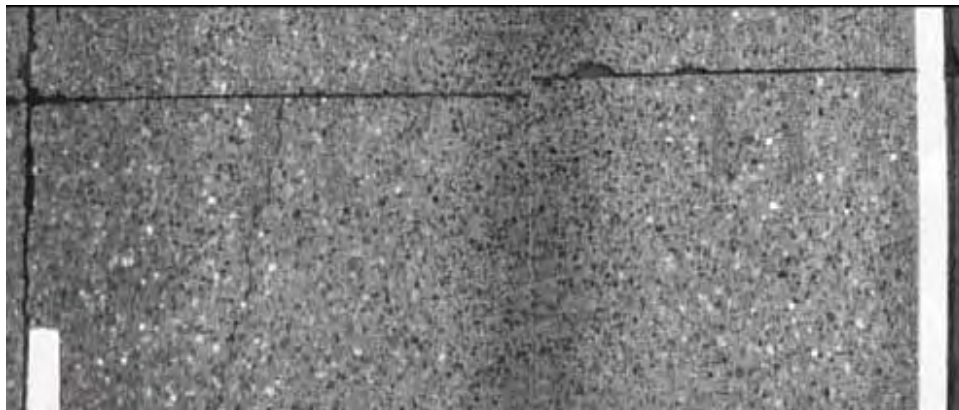
Similarly, any corner crack that was either not sealed or had a relatively narrow crack width (Figure 198) was estimated to have developed after dowel bar retrofit construction.

**Figure 198 Corner cracking after dowel bar retrofit.**
