# Evaluation of Dowel Bar Retrofit for Long-Term Pavement Life in Washington State

WA-RD 727.1

May 2009

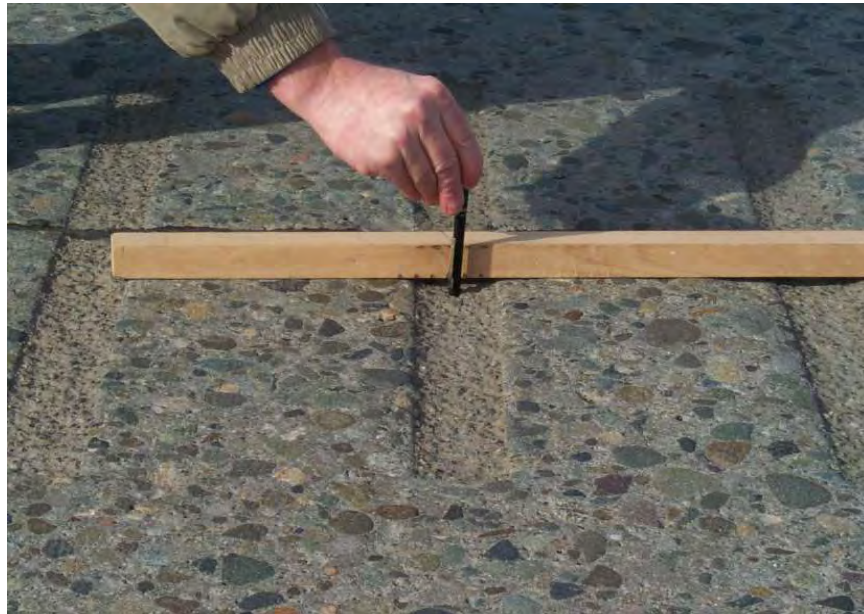
**Studded tire damage** – damage caused by studded tires is a prevalent form of distress on all concrete pavements in Washington State (WSDOT, 2006). Since the aggregate used in the

patching material for dowel bar retrofit consists of a smaller top size aggregate than the aggregate used in the original construction of the existing concrete pavement, the patching material may be more susceptible to studded tire wear. The dowel bar retrofit slot dimensions and the ability of the patching material to flow around the dowel bar limit the maximum aggregate size. Studded tire wear (Figure 199) within the dowel bar retrofit slot was noted on the first two dowel bar retrofit projects (Contracts 4235 and 4340) constructed on I-90 in the vicinity of Snoqualmie Pass. Wear within the dowel bar retrofit slot is the result of (1) high usage of studded tires and snow chains in this area, (2) the top size for the patching material aggregate was of insufficient size to minimize damage caused by studded tires, and (3) overworking of the patching material was noted during placement. Overworking of the patching material brings excessive bleed water and fines to the surface of the slot. This finer material is more susceptible to studded tire wear.

**Figure 199 Studded tire wear of grout in dowel bar retrofit slot.**

The first two dowel bar retrofit projects (Contracts 4235 and 4340) specified AASHTO Grading No. 57 for the extender aggregate. Due to the amount of noticeable wear after a short period of time, WSDOT realized that this aggregate gradation did not provide a sufficient uniform aggregate gradation (lack of intermediate size stone resulted in more area of paste between the larger stones, with the paste being more susceptible to studded tire wear) to minimize studded tire damage. In 1997 WSDOT modified the specification requiring the patching

material aggregate to meet either an AASHTO Grading No. 7 or No. 8 (Table 22). Since this specification modification studded tire wear within the dowel bar retrofit slots has not been noted on any other dowel bar retrofit project.

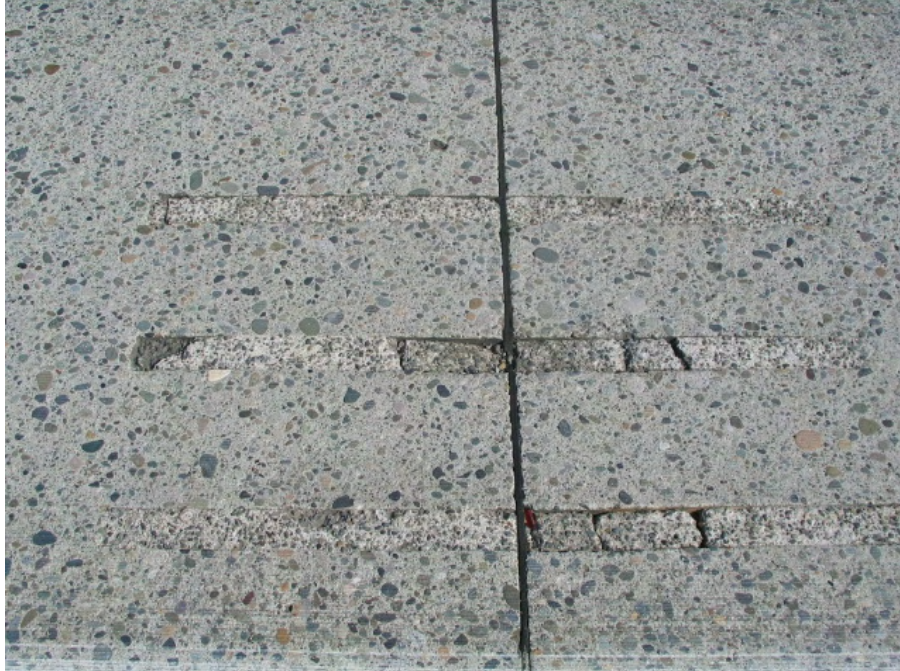
**Patching material cracking** – shrinkage of the patching material occurs during the concrete curing process. Concrete shrinkage is the result of moisture loss, and concrete volume reduction is due to cement hydration. The loss in moisture and the change in volume can result in sufficient stress to cause cracking (Figure 200). Over time and with traffic loading the cracks can increase in depth and width and lead to material loss (spalling) around the crack.

Figure 200 Patching material cracking.

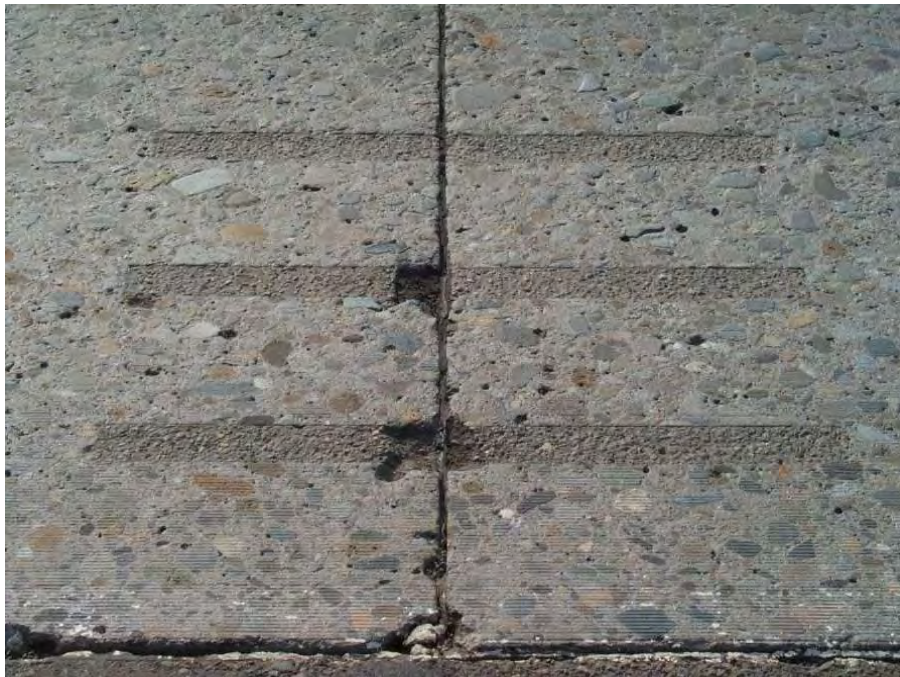
**Patching Material Spalling** – Spalling (Figure 204) is a loss of patching material within the dowel bar retrofit slot. Spalling may be caused by the misalignment of the foam core board, lack of consolidation, and/or adhesion failure of the patching material.

**Figure 204** Spalling of patching material.

Figure 206 illustrates the number of slots per mile that are spalled for each project reviewed. Slot spalling does not appear to be related to dowel bar age, though it is minimal in projects five years of age and less. Patching material spalling can be minimized via careful construction practices.

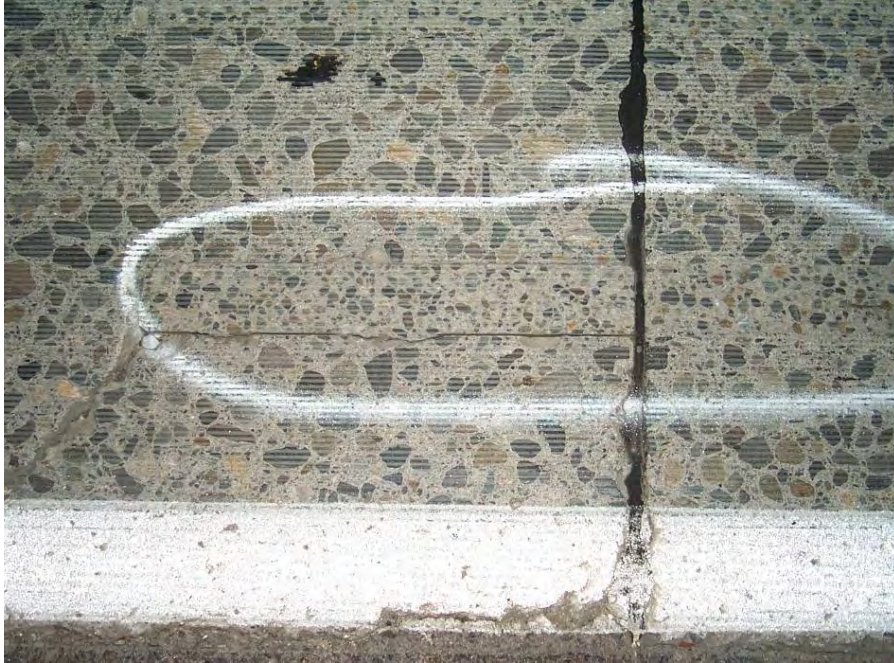
**Patching material debonding** – Debonding (Figure 207) is due to lack of adherence of the patching material to the sides of the dowel bar retrofit slot. There are three potential causes of this distress (1) inadequate bonding capability of the patching material; (2) inadequate texture on the dowel bar retrofit slot surface; and (3) inadequate cleaning of the dowel bar retrofit slot.

**Figure 207 Debonding of patching material.**

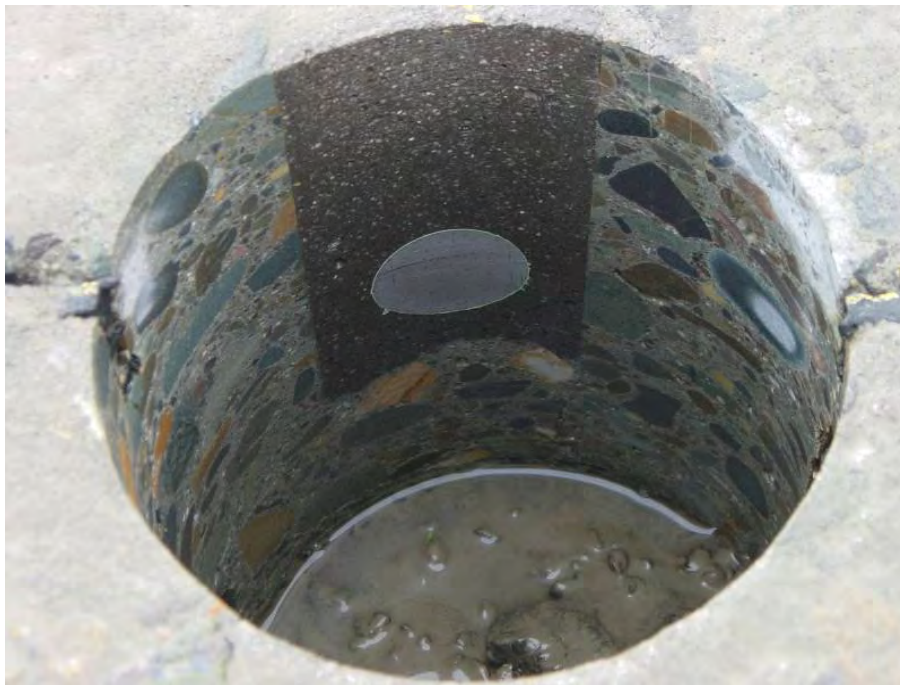
**Other patching material discussion** – In 2004, due to other construction related issues, core samples of the dowel bar retrofit slots were taken on the I-205 dowel bar retrofit project (Contract 6916). Core samples indicated that voids existed within the dowel bar retrofit slot. For this project the Contractor selected the AASHTO Grading No. 7 (WSDOT specification allowed for either an AASHTO Grading No. 7 or No. 8) and followed all required WSDOT specifications and construction procedures. Figure 212 is a photo of a core hole taken over a dowel bar retrofit slot where consolidation of the patching material was adequately obtained.

**Figure 212 Good consolidation of patching material in dowel bar retrofit slot.**

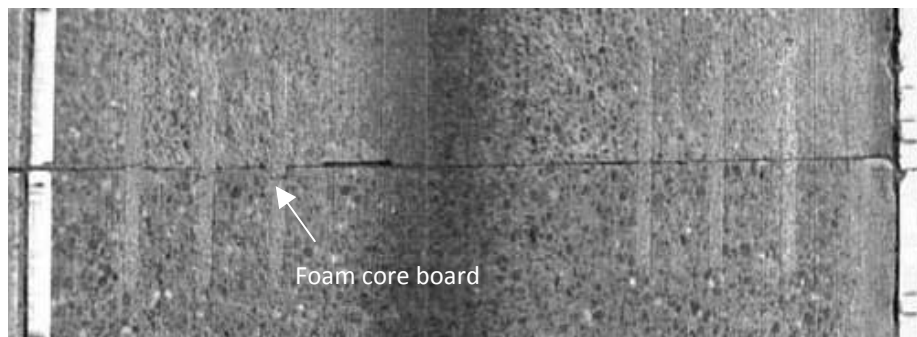
**Misaligned foam core board** – is defined as the movement of the foam core board away from the transverse joint (Figure 214). Misalignment of the foam core board can occur due to (1) incorrect foam core board dimensions, which allows the foam core board to move during patching material placement; (2) improper placement of the foam core board on the dowel bar in relation to the transverse joint; (3) movement of either the entire dowel bar retrofit assembly or the foam core board during placement or consolidation of the patching material.

The primary concern with misaligned foam core boards is the occurrence of spalling between the foam core board and the transverse joint. Misalignment of the foam core board is an uncommon distress on Washington State dowel bar retrofit projects, occurring on only 0.06 percent (or fewer than two slots per mile) of dowel bar retrofit slots (Figure 215).

**Figure 214 Misaligned foam core board.**

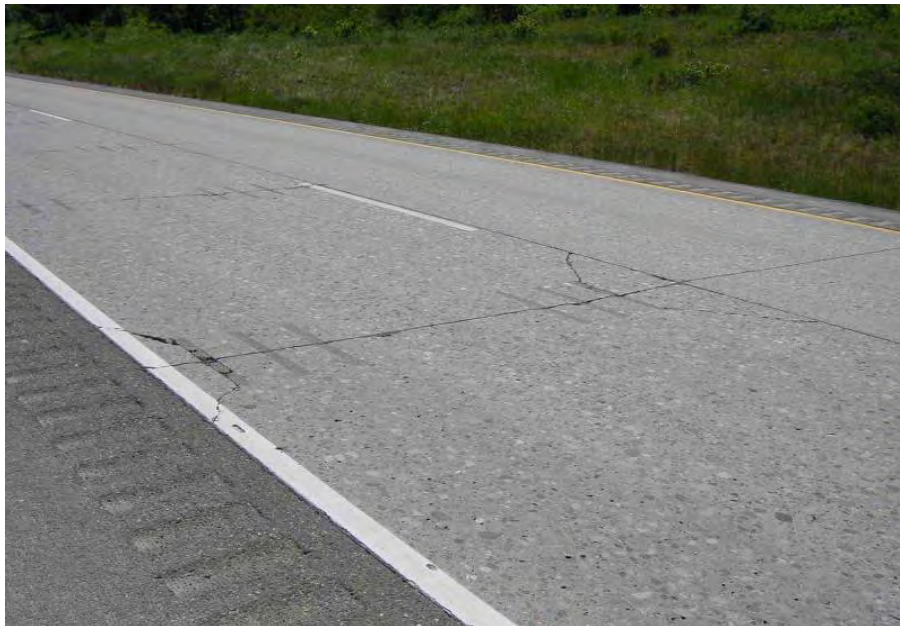
**45-degree cracking** – is defined as a crack that develops between the end of the dowel bar retrofit slot and the longitudinal joint or lane edge (Figure 216), occurring at a 45 degree angle. With continued traffic loading, cracking within the patching material as well as the potential of settlement of the concrete within the 45-degree crack area can occur.

One project on I-90 (Contract 4902) had several hundred consecutive joints which were distressed with 45-degree cracking. WSDOT conducted a forensic investigation on this project and concluded (Uhlmeier, 2001):

- Specifications required that dowel bar retrofit slots be cut to a depth of 5-¾ inches; however, cores showed that slots had been cut to a depth of seven inches;
- Heavy (60 pounds) jackhammers were used for concrete removal;

Cutting the dowel bar retrofit slot too deep, in combination with the use of heavy jackhammers, may have caused cracking in the bottom of the dowel bar slot, which in turn may have increased the potential for the jackhammer to punch through the bottom of the slot. In addition, if the slots were cut too deep, there is a potential that the dowel bars were not placed at the neutral axis. The result of both of these possibilities would result in higher stresses around the dowel bar that could lead to the development of a 45-degree crack. In 1997, WSDOT revised the special provisions to limit the jackhammer size to less than 30 pounds. In addition, inspectors are now asked to confirm that slots have been properly constructed.

**Figure 216 45-degree cracking.**

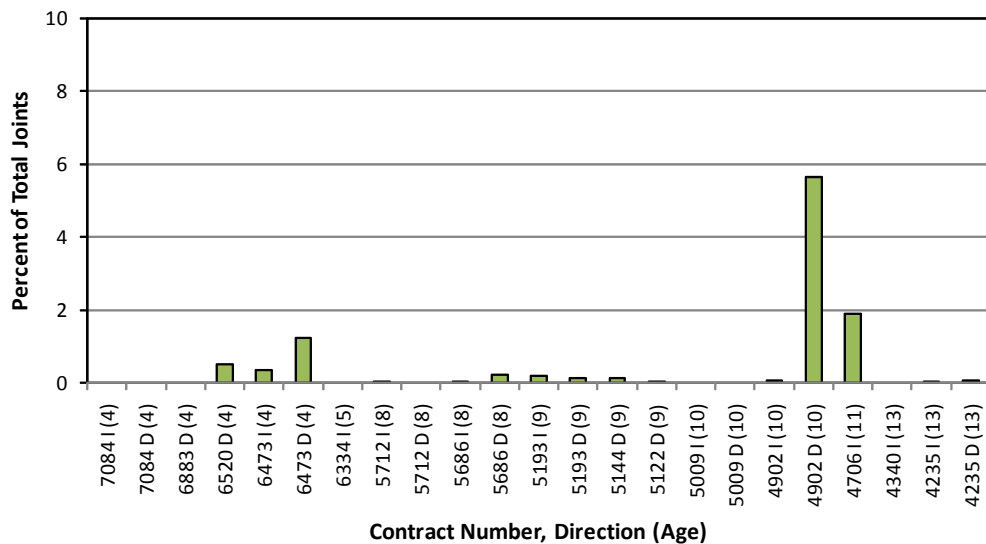
**Figure 217 45-degree cracking by contract number.**

Excluding Contract 4902, 45-degree cracking is not a typical form of distress found on the majority of dowel bar retrofit projects in Washington State, occurring on less than 0.14 percent (less than one joint per mile) of dowel bar retrofitted transverse joints. Figure 217 shows the percentage of transverse joints that are distressed with 45-degree cracking. As with patching material spalling, this distress is believed to be construction related and could be resolved by following appropriate construction practices (Appendix A).

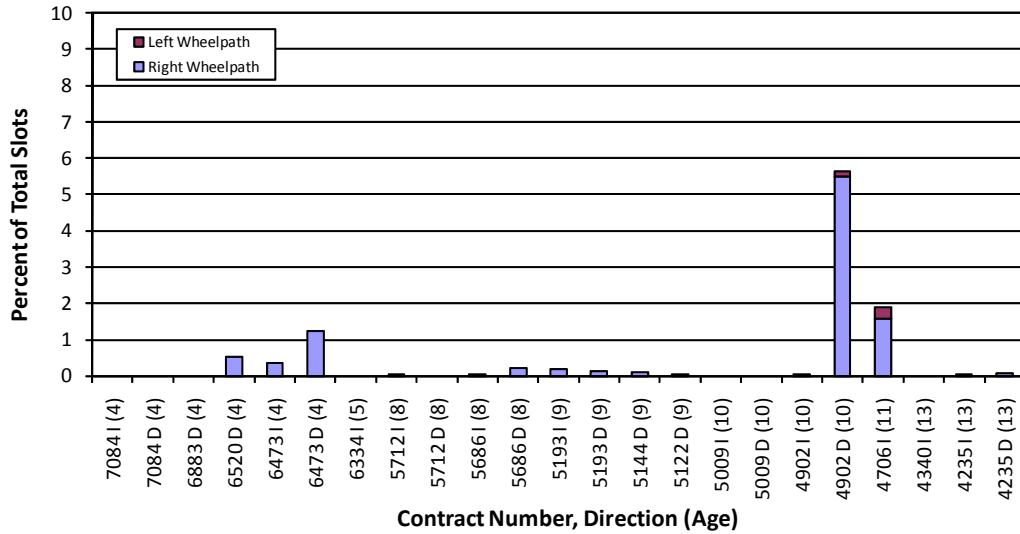
**Figure 218 45-degree cracking by wheelpath location.**

The location of the 45-degree crack was plotted to show that the majority of this type of cracking occurs on the right most dowel bar retrofit slots (Figure 218). With the understanding that this type of distress occurs primarily due to either sawcutting the dowel bar retrofit slot too deep or jackhammering through the bottom of the slot, it makes sense that this damage occurs predominately in the right wheelpath. The shoulder type on all dowel bar retrofit projects in Washington State consists of HMA pavement. HMA provides no support to the adjacent concrete lane. Knowing that over cutting the dowel bar retrofit slots or jackhammering through the bottom of the dowel bar retrofit slot could compromise the structural section of the concrete; the HMA shoulder provides no support, and the pavement is allowed to crack freely. Where sawcutting or jackhammering is too deep in the left most slots, the adjacent concrete lane provides support (adjacent lanes are tied with No. 5 deformed bars) and minimizes the potential for cracking.

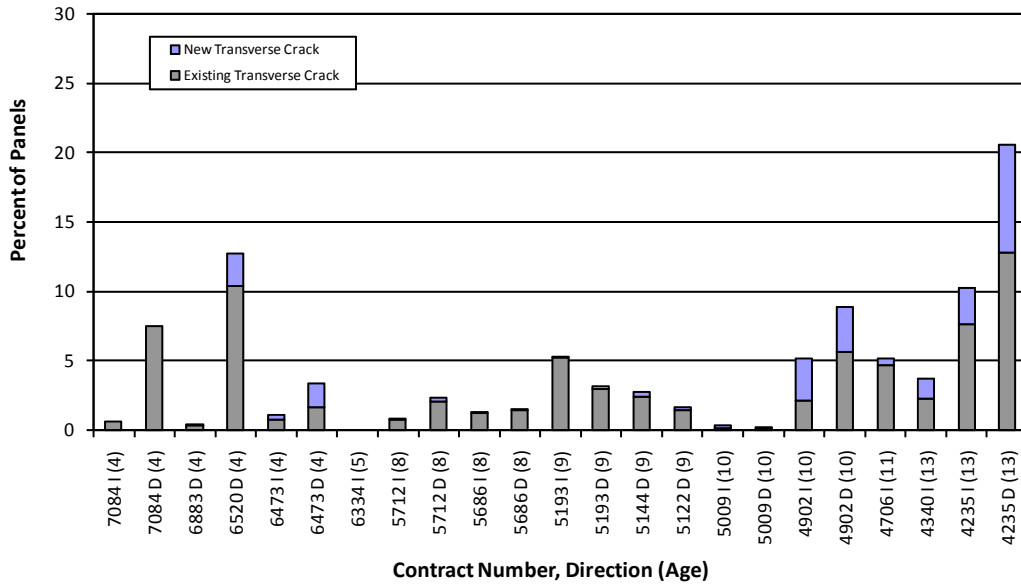
**Figure 219 Transverse cracking by contract number.**

**Transverse cracking** – Figure 219 illustrates the number of transverse cracks that existed prior to and following (as of 2006) dowel bar retrofit. Very few pavement sections are distressed with transverse cracking after dowel bar retrofit. Of the 23 pavement sections: 16 pavement sections have fewer than five new transverse cracks per mile, four pavement sections have five to 10 new transverse cracks per mile, and three pavement sections have more than 10 new transverse cracks per mile. Of the seven pavement sections with more than five or more new transverse cracks per mile (Contracts 4235, 4340, 4902, 6473 and 6520), five of the pavement sections are located on I-90 over Snoqualmie Pass, and the other two (Contracts 6473 and 6520) had construction related issues that may have caused an increase in panel cracking. Construction related issues on Contract 6520 were previously discussed, and Contract 6473 had increased panel cracking potentially due to the method used for removing panels to be replaced. This will be discussed in the Panel Replacement section below.

As of 2006, approximately 1.1 percent of all panels (or approximately four panels per mile) have developed a new transverse crack after dowel bar retrofit construction. It is unclear if the increase in transverse cracking is related to dowel bar retrofit or just the natural progression of distress in the aging concrete pavements. Approximately half of the projects with more than 10 existing transverse cracked panels per mile, had more than 10 new transverse cracked panels per mile after dowel bar retrofit. In the Finite Element Analysis chapter investigation of the development of new transverse (and longitudinal) cracking after dowel bar retrofit is evaluated.

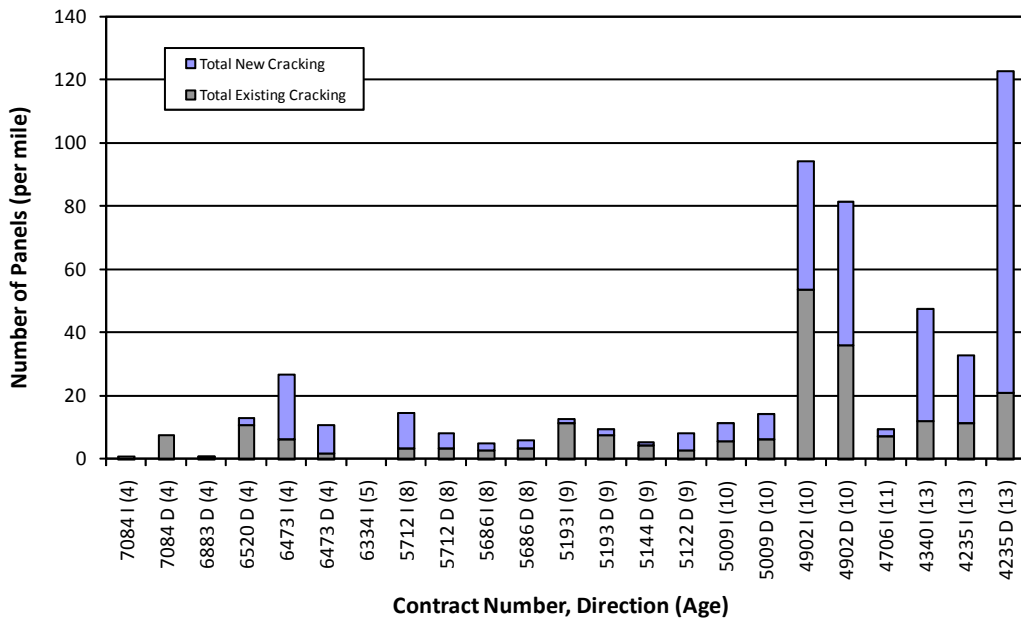
**Figure 220 Longitudinal cracking by project.**

**Longitudinal cracking** – Of the 23 dowel bar retrofit projects evaluated, 18 projects developed new longitudinal cracks, with the three contracts on I-90 over Snoqualmie Pass (Contracts 4235, 4340 and 4902) having the highest occurrence of new longitudinal cracks (Figure 220). As previously described, the dowel bar retrofit contracts located on I-90 over Snoqualmie Pass are showing extreme signs of fatigue (due to the failed longitudinal joint and freeze-thaw effects) and an increase in new longitudinal cracks is to be expected. The development of new longitudinal cracks appears to be significant, since it is occurring on the majority of projects. On average, approximately four percent (or 13 panels per mile) of the concrete panels have new longitudinal cracks, slightly more than twice the pre-existing longitudinal cracks. Longitudinal cracking appears to be one of the primary distresses of dowel bar retrofit since it is seen on about 80 percent of dowel bar retrofit projects in Washington State. Approximately 11 projects have fewer than five new longitudinally cracked panels per

mile, five projects have five to 10 new longitudinally cracked panels per mile, and seven projects have more than 10 new longitudinally cracked panels per mile.

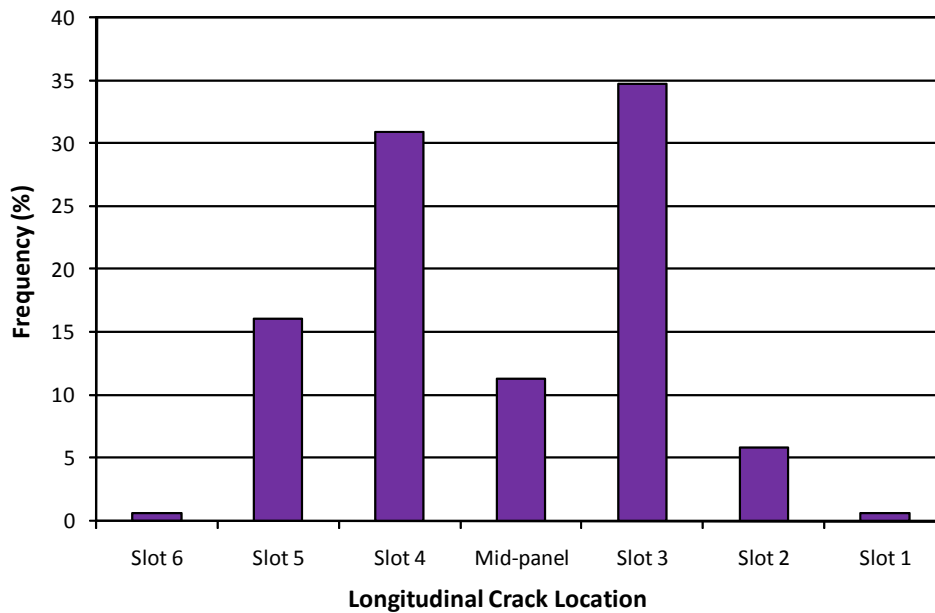
**Figure 223 Longitudinal cracking after dowel bar retrofit by slot location.**

A 10 percent sample length (first mile of each 10 mile segment) of the dowel bar retrofit projects was conducted. From this analysis it was determined that 35 percent of the new longitudinal cracks originated in the vicinity of slot 3, and 31 percent of the new longitudinal cracking originates in the vicinity of slot 4 (Figure 223), with over 75 percent of all longitudinal

cracks originating between slots 3 and 4. From this it appears that the development of new longitudinal cracking is not a function of slot proximity to the lane edge. However, it is interesting that the propensity of longitudinal cracking originates in slots 3 and 4, both of which are at the inner most locations of each wheelpath. It is unclear if this is a function of dowel bar retrofit. This will be investigated as part of the finite element analysis.

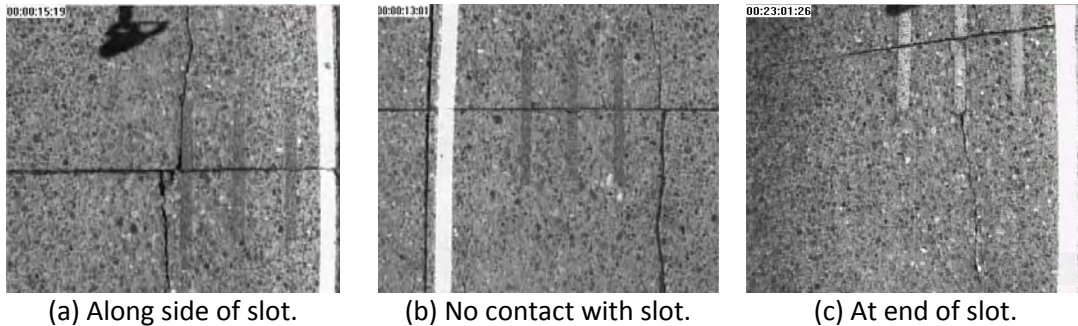
**Figure 224 Longitudinal crack location with respect to dowel bar retrofit slot.**

Three crack locations were identified: (1) along the dowel bar retrofit slot; (2) no contact with a dowel bar retrofit slot; and (3) at the dowel bar retrofit slot (Figure 224). The results of this analysis shows that approximately 63 percent of the cracks initiate along the slot edge, 35 percent of the cracks have no contact with the dowel bar retrofit slot, and two percent of the cracks initiate at the end of the dowel bar retrofit slot. Though a high percentage of longitudinal cracks originate at the dowel bar retrofit slot, the development of the longitudinal crack cannot be totally explained by the discontinuity caused by placement of the dowel bar retrofit slot. In

concrete pavements typically, discontinuities result in the potential for a high stress location which can lead to the development of a crack. At this time longitudinal cracking is not believed to cause a significant reduction in performance (as related to faulting or pavement roughness). The Finite Element Analysis chapter evaluates several different dowel bar retrofit scenarios and determines if a high stress location occurs that could potentially assist in explaining the development of the longitudinal cracking.

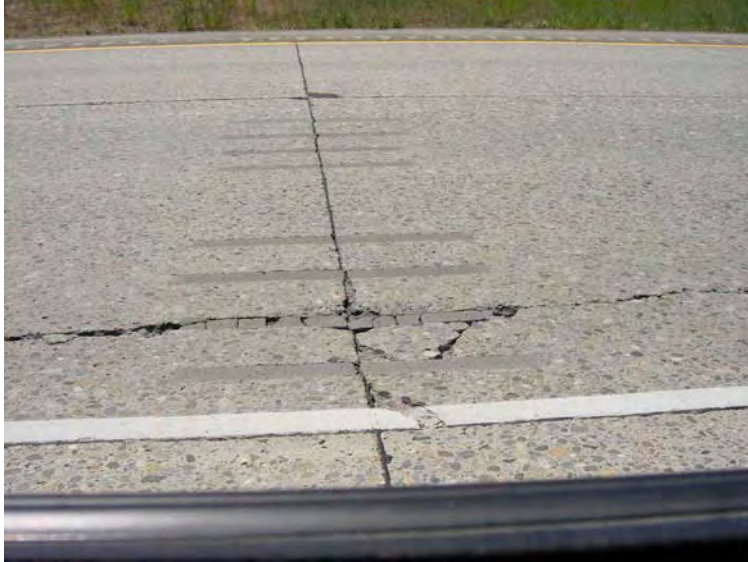
**Figure 225 Existing longitudinal crack at dowel bar retrofit slot.**

Based on the performance of the first several dowel bar retrofit projects, WSDOT determined that if an existing longitudinal crack intersects a dowel bar retrofit slot failure of the dowel bar retrofit slot will occur (Figure 225). Typically, the failure mechanisms are cracking, debonding, and eventual loss of material within the dowel bar retrofit slot. To minimize this distress, the dowel bar retrofit slots should be realigned to avoid the existing longitudinal crack, sawcut but not retrofitted (Figure 226), or completely eliminated (Figure 227). This modification has been included in the WSDOT Standard Specification, Section 5-01.3(6).

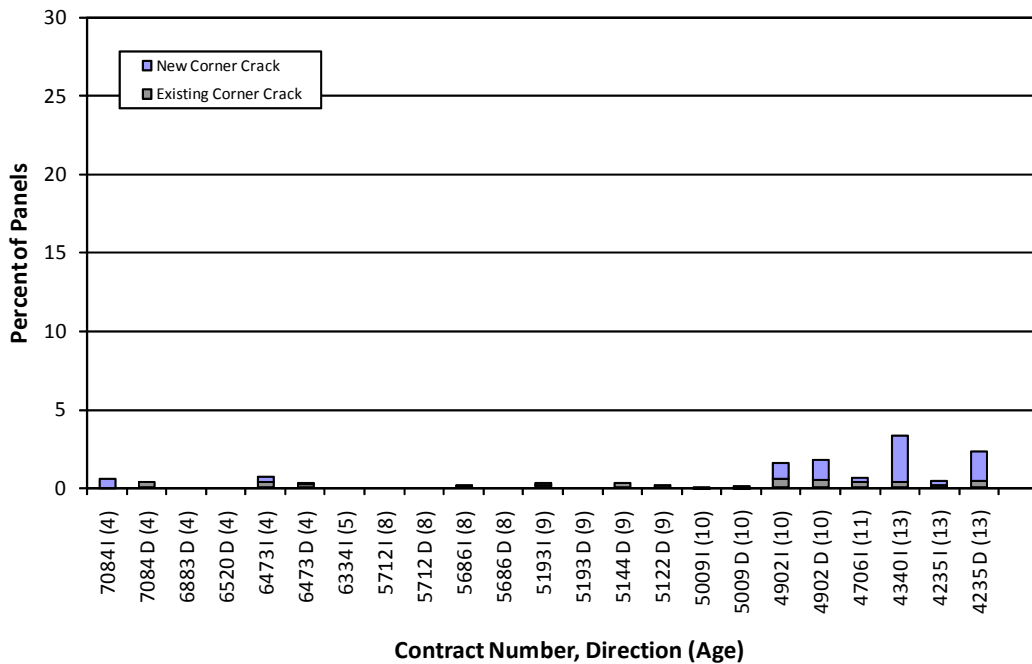
**Figure 228 Corner cracking by project.**

**Corner cracking** – Corner cracking is a function of fatigue and continues to progress with continued wheel and climate loadings. However, the inclusion of dowel bar retrofit improves the joint load transfer, thereby supporting the rightmost concrete edge and implying a potential reduction in corner cracking. From Figure 228, all projects on I-90 (excluding Contract 4235 I) over Snoqualmie Pass have experienced a significant increase in the number of corner cracks after dowel bar retrofit. The increase in corner cracking is not significant for all other projects, therefore the increase in corner cracking on I-90 is more than likely due to freeze-thaw and higher occurrence of fatigue on this section of the interstate. Newly formed corner cracks occur on approximately 0.4 percent of all panels (or one per mile).

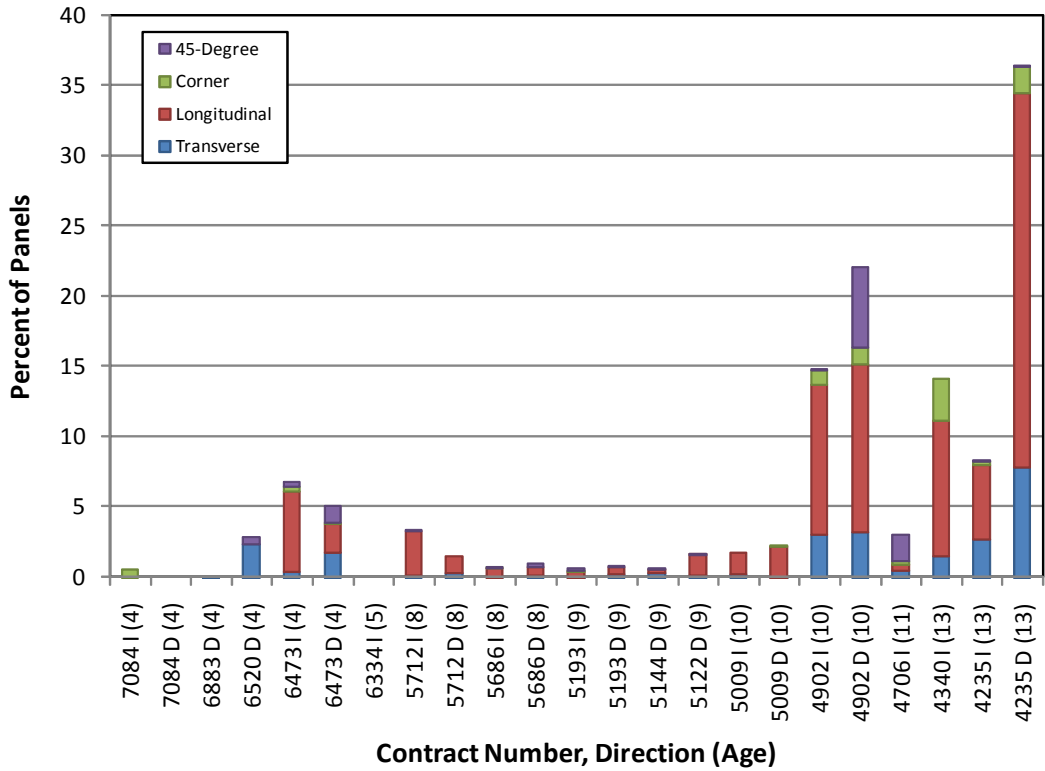
**Figure 229 All new panel cracking by contract number.**

All of the distresses (dowel bar retrofit slot and concrete panel) described in this section are present on many of the dowel bar retrofit projects; however the occurrence of these distresses over a given project length is relatively low. Figure 229 illustrates all forms of cracking (transverse, longitudinal, corner and 45-degree) following dowel bar retrofit on each project reviewed.

In each instance cracking is defined as cracking that occurred after dowel bar retrofit. As was described previously, some of the cracking was subjectively evaluated for whether or not it occurred prior to or following the dowel bar retrofit process. For example, WSDOT standard practice included dowel bar retrofitting all transverse cracks. Therefore, during the video review of the completed projects any transverse crack that was not dowel bar retrofitted was considered to have occurred after the dowel bar retrofit process. In addition, crack width and the presence of crack sealing was used to determine the timing of the crack with respect to the dowel bar retrofit process. Narrow cracks were identified to have occurred after the dowel bar retrofit process (pre-existing cracks were wider due to spalling and widening of the crack due to loading and climate effects). Sealed cracks were assumed to have been sealed during the dowel bar retrofit process (which is a safe assumption since many of the maintenance areas do not routinely reseal concrete joints or cracks) and therefore occurred (or were present) before the dowel bar retrofit process. Of the 23 roadway sections reviewed, the occurrence of new cracking is relatively low, below 10 percent (for all but three projects). As described previously, Contracts 4235, 4340 and 4902 are all located on I-90 in the vicinity of Snoqualmie Pass and are

subjected to other pavement performance issues (freeze-thaw damage and/or cracking due to failure of the longitudinal tape joint during initial construction). Longitudinal cracking is the most prevalent form of distress on the majority of projects.

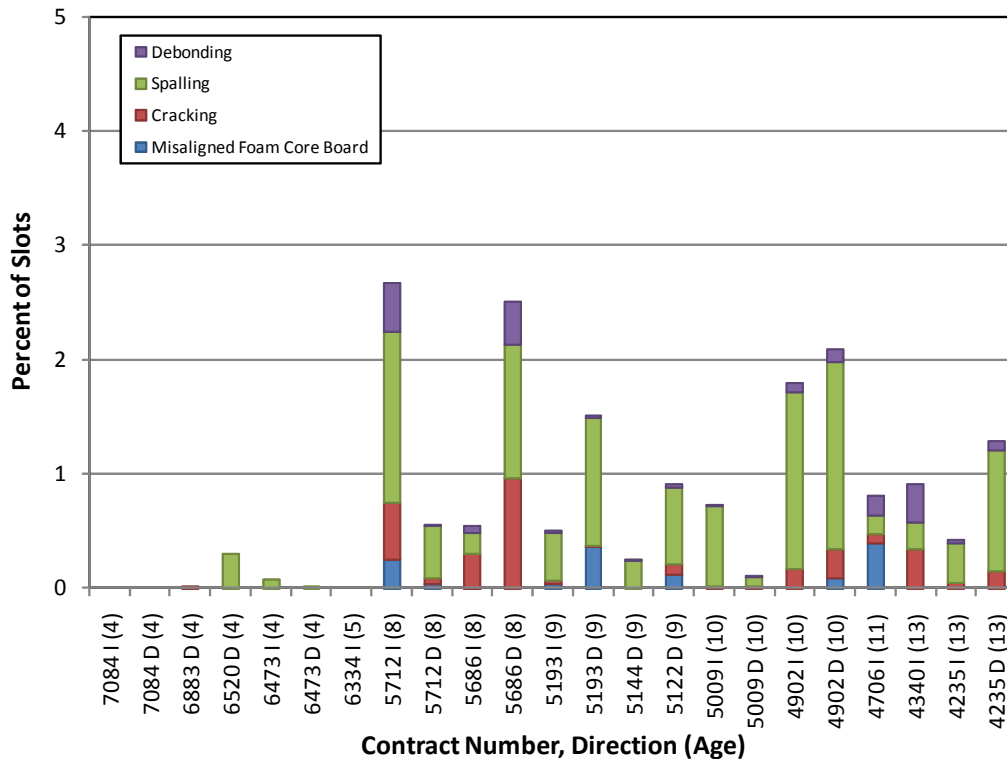
**Figure 230 All dowel bar retrofit slot distress by project number.**

Figure 230 illustrates the primary distresses found within the dowel bar retrofit slot (misaligned foam core board, cracking, spalling and debonding of the patching material). As with new panel cracking, the presence of dowel bar retrofit slot distress is very low in all projects below three percent total distress.

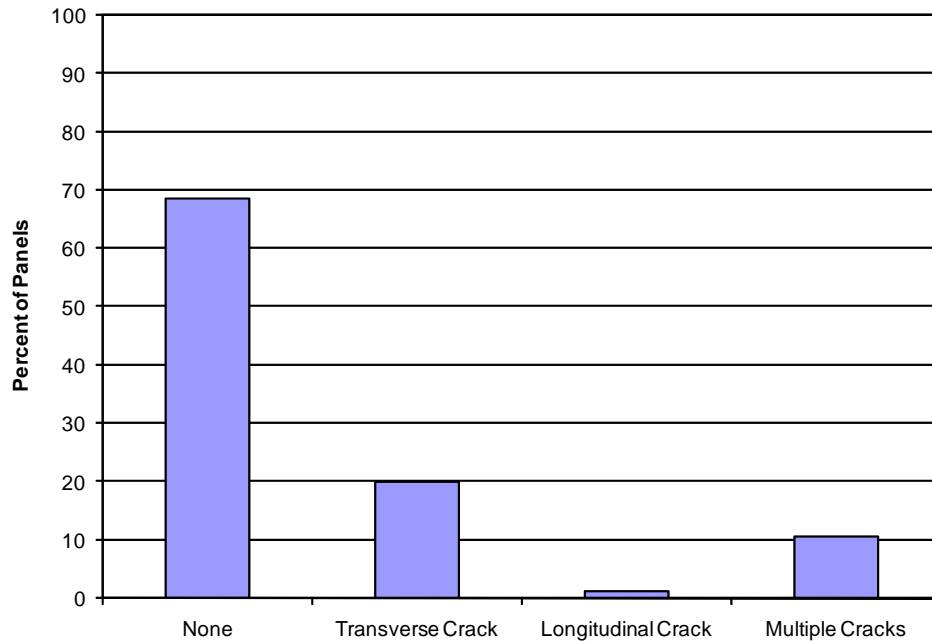
**Figure 231 Cracking in panel replacements.**

During the review of the 2006 pavement condition survey it was noted that a number of panel replacements, placed as part of the dowel bar retrofit project, contained some type of crack (transverse, longitudinal, or multiple). Considering that very few of the existing concrete pavements in service for more than 25 years contain any type of crack, it was assumed that the same would hold for panel replacements. When it became apparent that numerous panel replacements were cracked, an analysis was conducted to determine the extent of the cracking. All panel replacements that occurred within the surveyed lane (typically the rightmost lane) were reviewed and summarized based on no cracking, a single transverse crack, a single longitudinal crack, or multiple cracks. From this it was determined that approximately 30 percent of all panel replacements contained some type of crack (Figure 231), with the predominate type being a transverse crack.

Based on the high occurrence of panel replacement cracking, it is recommended that WSDOT investigate its panel replacement construction practices. As a result of experience obtained on various concrete rehabilitation projects, causes of distress in the panel replacements include: (1) subgrade condition; (2) process used to remove the existing concrete;

(3) adequate consolidation and/or selection of base material; (4) concrete placement; and (5) the presence of adjacent distress. Each of these causes will be described below.

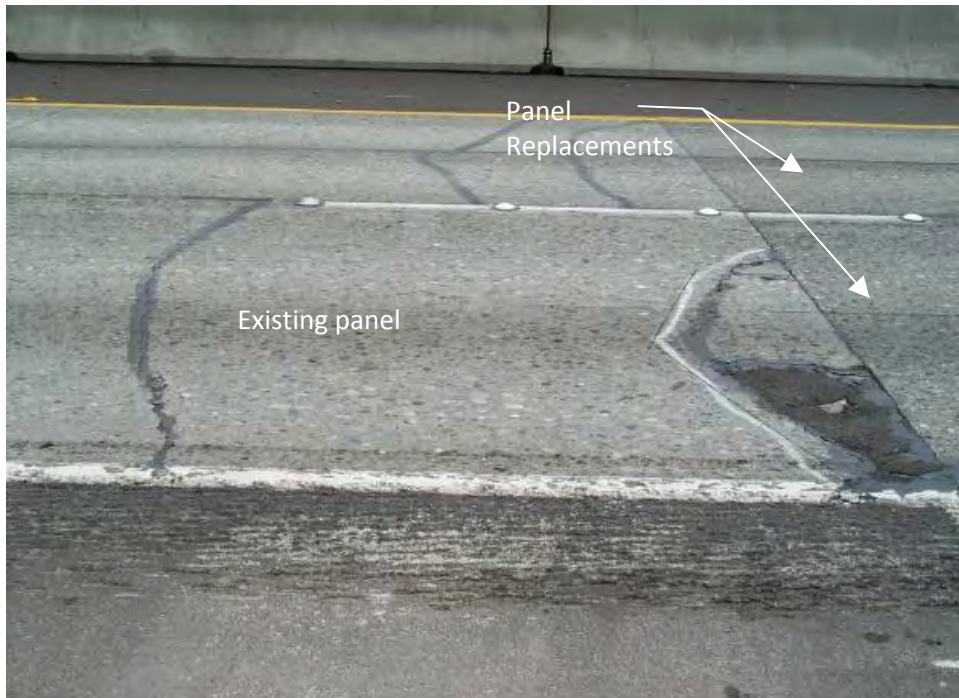
**Figure 235 Typical failure of existing panels adjacent to panel replacements.**

WSDOT reported significant cracking (Figure 235) on a dowel bar retrofit project (Contract 6473) on I-5 in the vicinity of Bellingham, Washington (Uhlmeyer et al., 2006). Contract 6473 included dowel bar retrofit, diamond grinding and extensive panel replacements (approximately 270 panels). Within three months of project completion, WSDOT Maintenance forces had to conduct temporary repairs at six locations, and within two years of construction a total of 35 locations had been identified as needing partial or full panel replacement. Maintenance noted that the typical distress was a transverse crack on the adjacent existing panel within two to four feet of the transverse joint with the panel replacement. WSDOT initiated a forensic investigation to determine the cause of the increased panel cracking, since this type of distress was not characteristic of previous concrete rehabilitation projects.

As part of this investigation, WSDOT reviewed contract specifications and construction records, conducted interviews with construction personnel, and conducted Magnetic Imaging Tomography (MIT) Scan (FHWA, 2005) testing to confirm dowel bar placement and alignment. The findings of this investigation are summarized below:

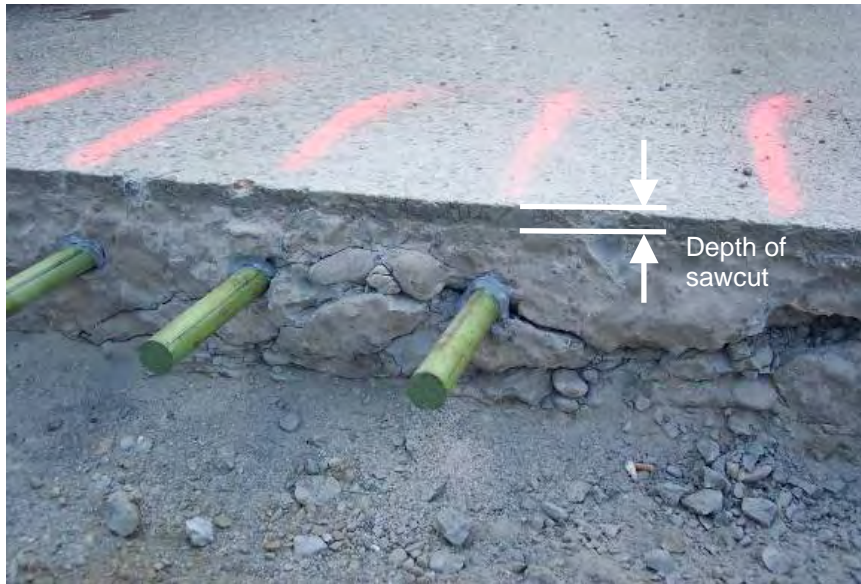
**Figure 236 Panel not sawcut full-depth.**

- Project records showed the existence of poor soil conditions in numerous locations, yet contract plans did not clearly identify areas for excavation, many of which were not addressed during panel replacement. However, not all areas that had been identified with weak soils resulted in panel cracking;
- Construction details included sawcutting the perimeter of the panels to be removed, breaking of panels with a guillotine style hammer, removing concrete with a backhoe equipped with a hoe point, and loading into end dumps with a backhoe. Dowel and tie bar holes were drilled into the existing adjacent panels using a pneumatic driven impact hammer (typical on WSDOT projects);
- In several instances full depth sawcutting did not occur (Figure 236);

**Removal of existing concrete** – full depth saw cuts are required on the perimeter of the concrete panels to be removed. If the saw cut is of inadequate depth, adjacent panels may remain jointed, and the removal process may cause damage in the new panel replacement, as well as adjacent panels that remain in place. It is recommended that WSDOT (during the inspection phase) ensure that an adequate saw depth has occurred.

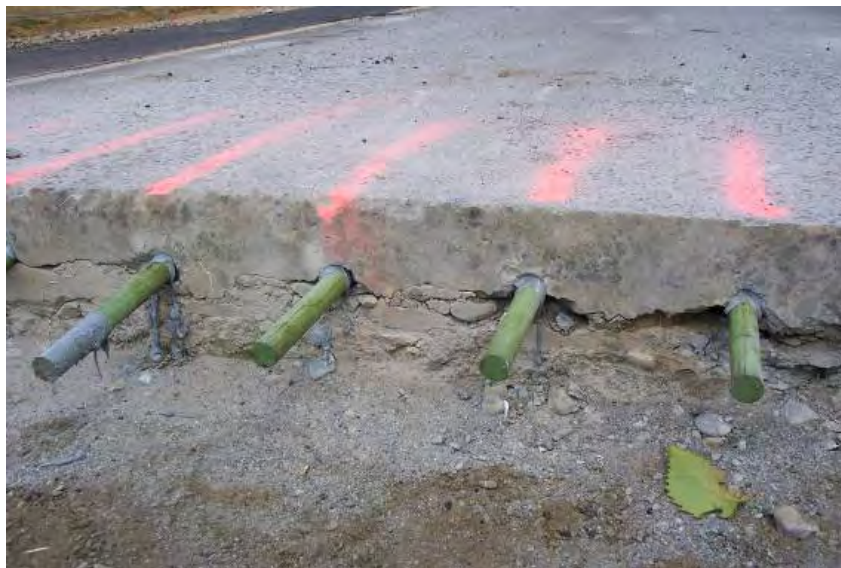
**Figure 237 Spalling of concrete slab during drilling for dowel bars.**

- During dowel bar installation spalling (Figure 237) beneath the dowel bars occurred and, at many locations, dowel bars were eliminated due to excessive spalling;

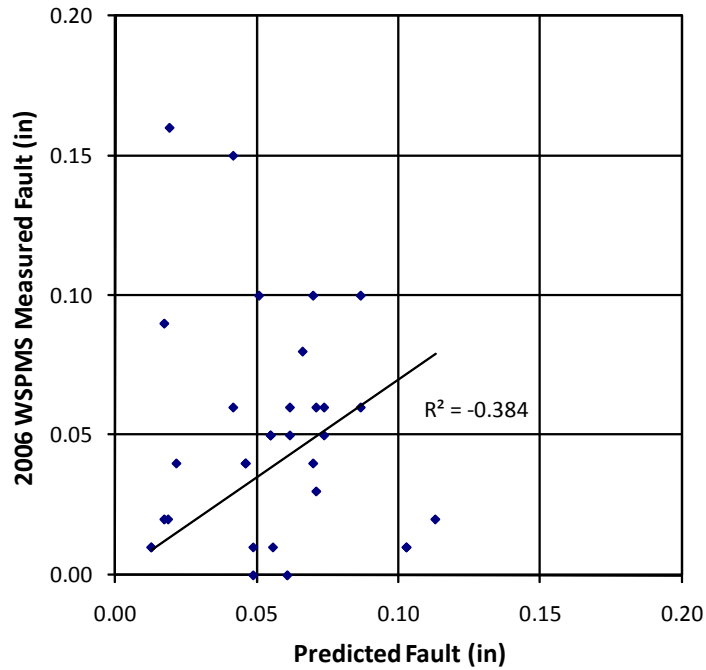
Figure 239 Measured versus predicted faulting.

Data from 32 of the dowel bar retrofit sections were input into the model for the determination of the predicted faulting level (Table 25). The resulting analysis shows a poor correlation between the measured and predicted faulting levels (Figure 239). In a study conducted by Li et al. (2006) challenges in modeling WSDOT concrete pavement conditions to nationally developed models contained within the NCHRP 1-37A project were also realized. The noted poor correlation could be a function of materials (high quality aggregates found in Washington State), climate, and traffic conditions of WSDOT pavements as compared to the

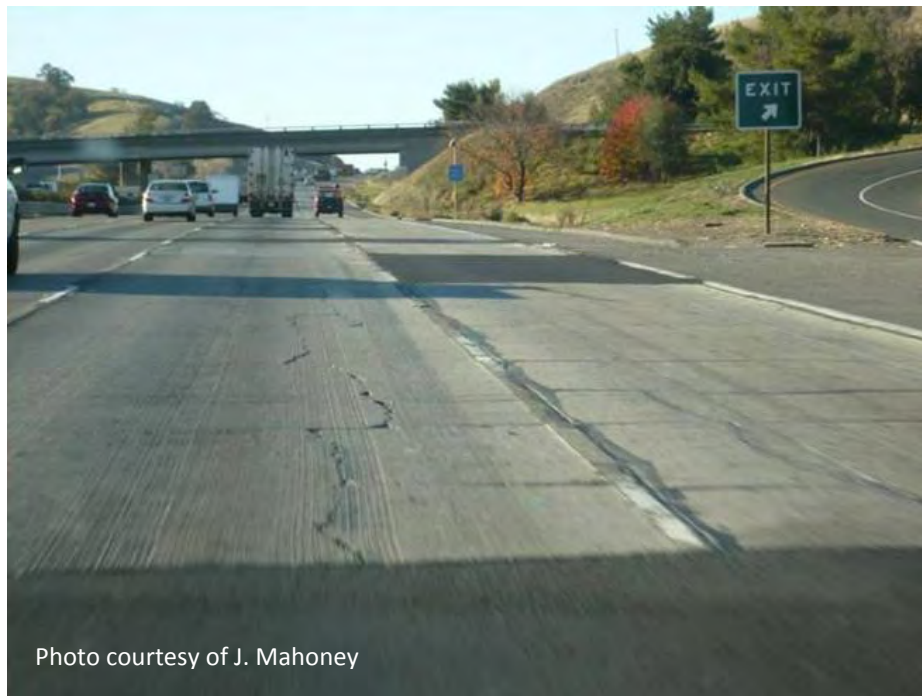
**Figure 240 Severely deteriorated concrete pavement (I-80, California).**

Work conducted by the California Department of Transportation (Caltrans) has shown that a relatively thick (4.2 inch) HMA overlay has performed well on severely faulted and cracked concrete pavements (Figure 240). The typical concrete pavement section in California consists of eight to 10 inches of undoweled concrete over a cement treated base. The Caltrans HMA overlay design practice includes placement of 1.2 inches of a HMA leveling course, an asphalt impregnated pavement reinforcement fabric, and a three inch HMA wearing surface (Lea et al., 2002). Performance life for this overlay design prior to needed rehabilitation ranges from 10 to 15 years, this includes either a mill and fill<sup>7</sup> or a traditional HMA overlay (Harvey et al., 2007).

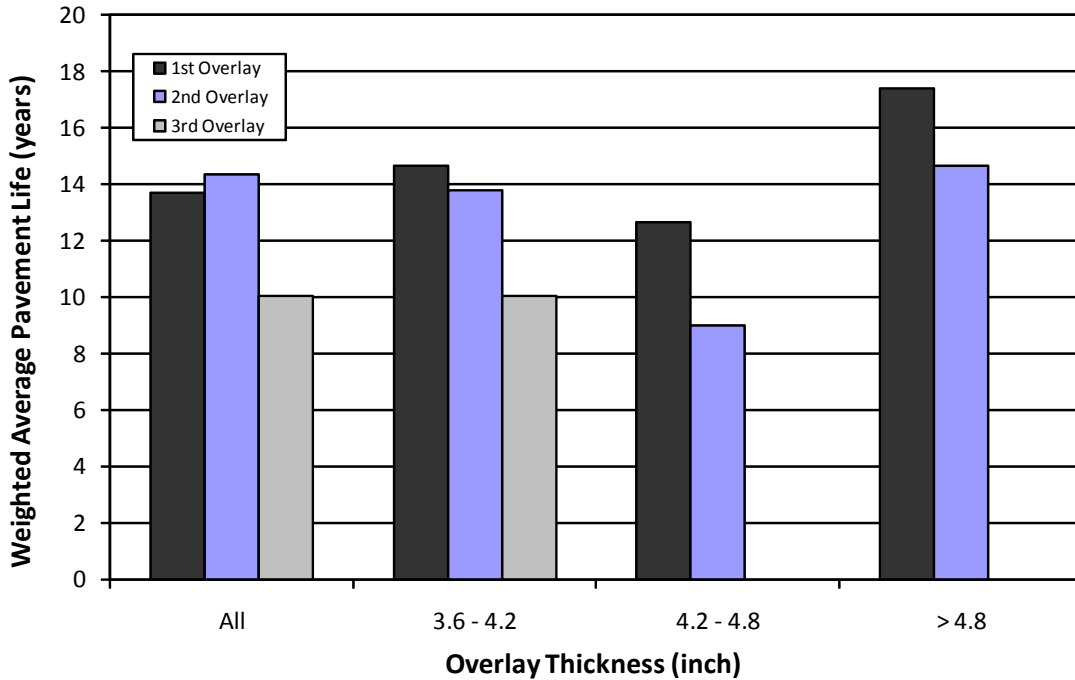
**Figure 241 Performance life of interstate HMA overlays of concrete pavements.**

Further review of the WSDOT pavement management system was conducted on the 4.2 to 4.8 inch overlay sections to determine if there were any obvious reasons why the pavement life for the second overlay showed a reduced pavement life. From this investigation, the 29 percent reduction in performance life for the second overlay is influenced by approximately 38 lane miles of Interstate 5 through Olympia, WA. On this section of interstate, WSDOT placed a ¾ inch thick open-graded friction course in conjunction with the second HMA overlay. The

premature raveling of the open-graded friction course, due to studded tires, caused this pavement section to be prematurely overlaid. The weighted average performance life of the second HMA overlay increases to 14 years when the Interstate 5 Olympia project is removed from the analysis. The nine year life of the second overlay is due to widening of I-5 in the Vancouver area and not due to premature failure of the thick overlay sections.

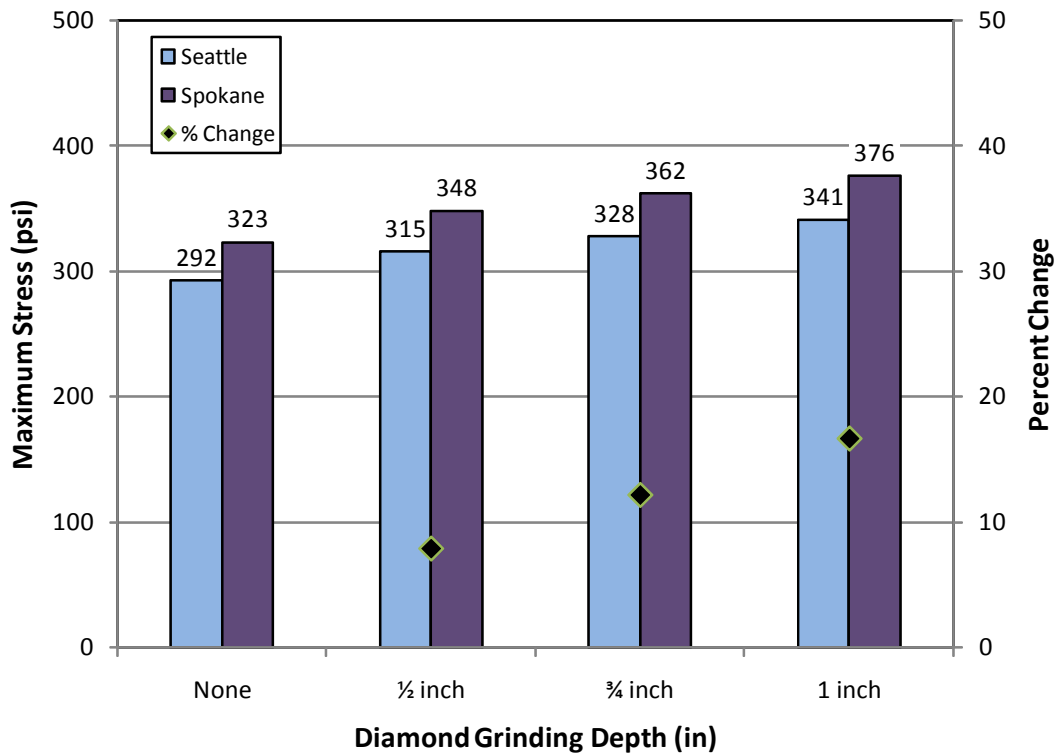
maximum stress results in Figure 273 have been normalized to the no diamond grinding condition (shown as percent change). Based on the thickness evaluated, there is a noted difference in the maximum stress between the various diamond grinding depths. A reduction in thickness of up to one inch can result in an increase in the maximum stress by approximately 17 percent (for either the Seattle or Spokane temperature gradient conditions). To determine if the increase in maximum stress results in the potential increase in the amount of panel cracking the WSPMS condition data was reviewed. For this analysis, the amount of panel cracking in 2006, and the wear depth results, just prior to and immediately following construction (typically one to two years), were evaluated, and the difference in wear depth was calculated. Ideally, the depth of fault removal would be the preferred value, but, again inconsistencies noted in the faulting data measurements made the depth of wear removal a more consistent<sup>13</sup> measurement.
