# Evaluation of Dowel Bar Retrofit for Long-Term Pavement Life in Washington State

WA-RD 727.1

May 2009

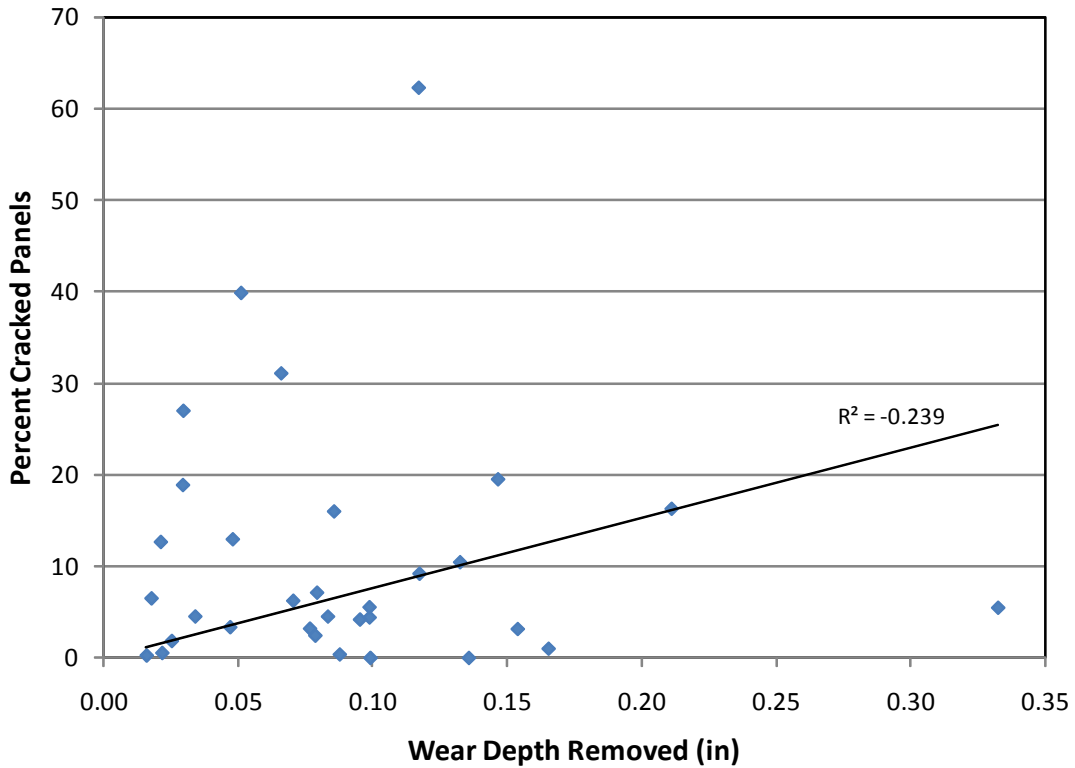
Figure 274 shows a comparison of the difference in pavement wear both prior to and immediately following dowel bar retrofit versus the amount of panel cracking. With a very low  $R^2$ , there appears to be very little correlation between wear depth removal and the rate of panel cracking. This conclusion is also supported by the diamond grinding only project that was

conducted in Spokane, Washington on I-90. This project removed up to 1½ inches of the concrete surface. After 13 years of service no appreciable increase in panel cracking has occurred.

**Figure 274 Wear depth removed versus percent panel cracking.**

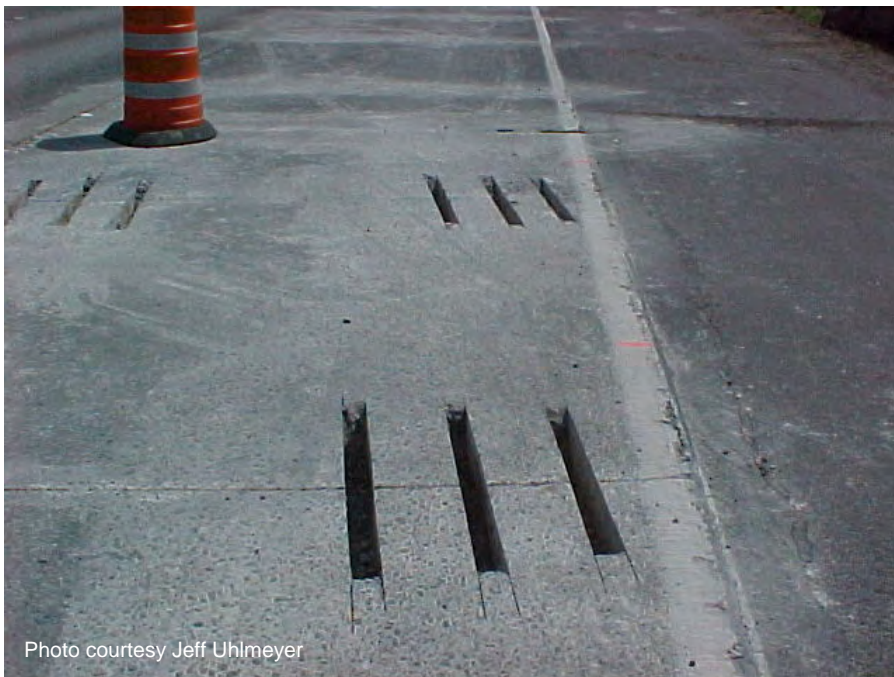
Proper alignment of the dowel bar slot is essential for minimizing the potential for dowel bar lockup. Lockup is the inability of the dowel bar to move freely as the slab expands and contracts due to curling and warping. If the dowel bar movement is restricted, stresses can be induced within the dowel bar slot and eventual cracking and spalling of patching material may occur. Stresses may also be significant to cause cracking within the concrete panel.

Figure A-15 illustrates dowel bar slots that have not been correctly sawcut on a skewed joint. In this case, the dowel bar slots were cut perpendicular to the skewed joint (as is necessary for non-skewed joints) rather than parallel to centerline.

**Figure A-15. Dowel bar slots incorrectly cut on skewed joints.**

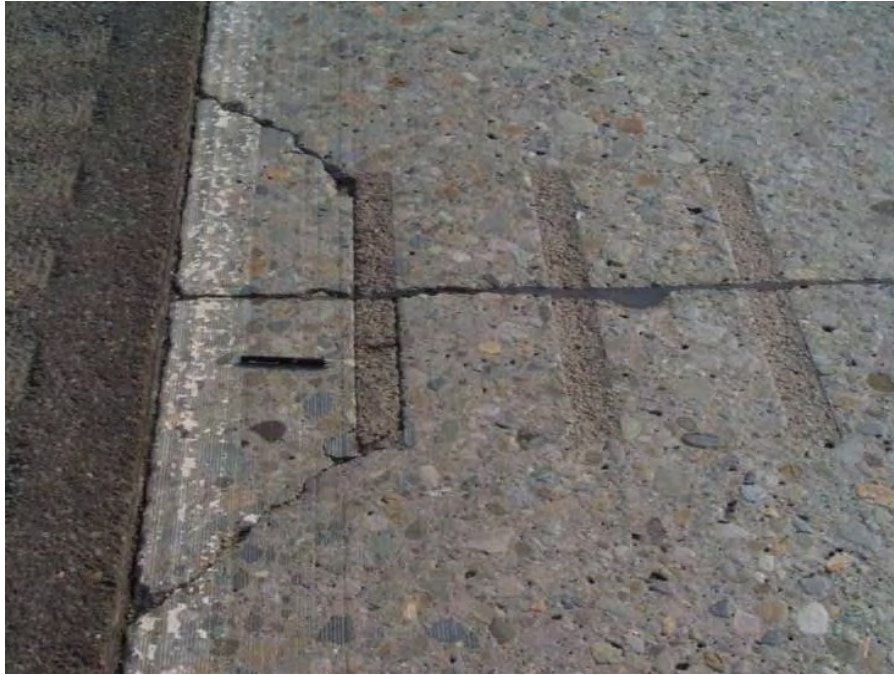
Slots cut deeper than necessary can contribute to corner cracking (Figure A-16) and patching material failure and the potential of the jackhammer punching through the bottom of

**Figure A-16. Dowel bar slot cut and/or chipped to deep.**

the dowel bar slot. The Contractor/Inspector should physically measure (Figure A-17) the dowel bar retrofit assembly height (including chairs) to ensure proper sawcut depth.

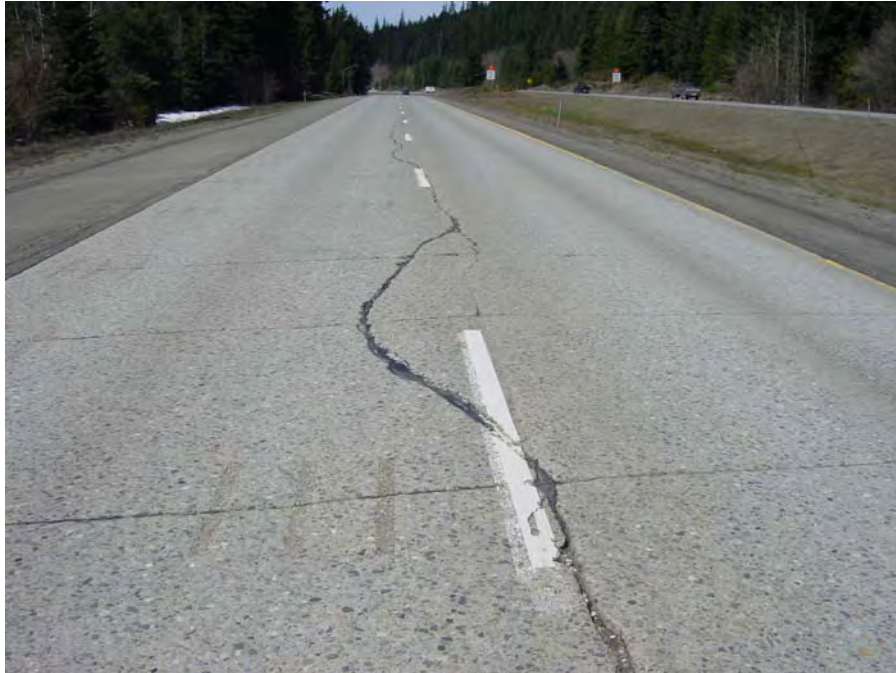
Dowel bar slots should be aligned to miss (Figure A-18) any existing longitudinal crack. Depending on the wander of the longitudinal crack, dowel bar slots could also be eliminated (Figure A-19). If the longitudinal crack was located in the right wheelpath, completely eliminating all dowel bar slots would not be recommended. In this instance, it may be best to place as many dowel bar slots as possible without intersecting the longitudinal crack.

**Figure A-19. Left wheelpath dowel bar slots not installed to avoid existing longitudinal crack.**

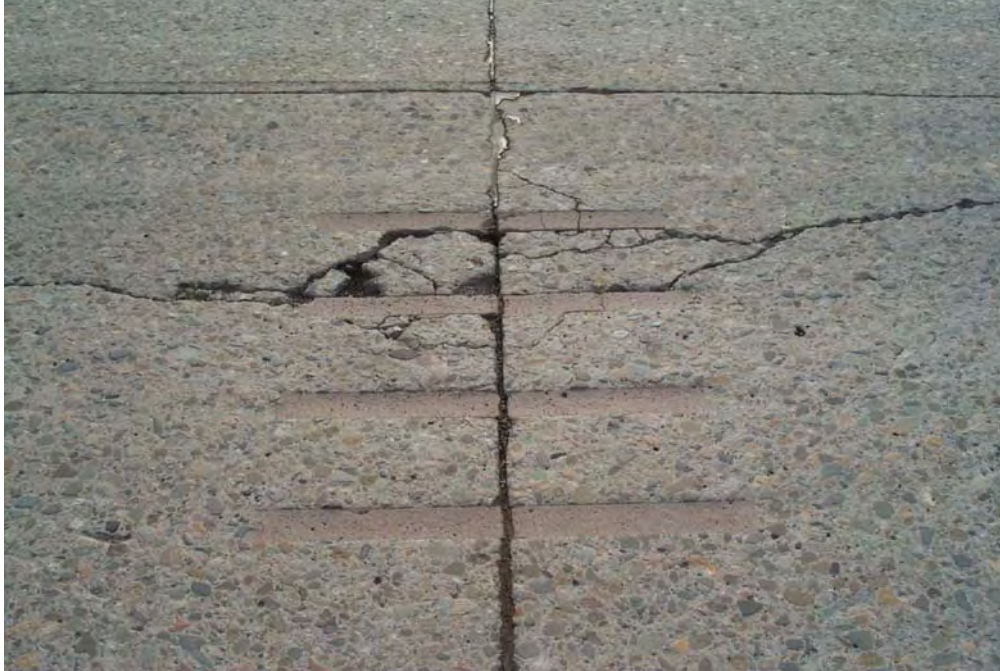
Figure A-20 through Figure A-21 illustrates instances where the dowel bar slot was not placed to miss the existing longitudinal crack resulting in failure of the patching material. Dowel bar slots placed over a longitudinal crack will fail (Figure A-20) within a very short period of time (< 12 months). The failure mechanism is typically debonding, cracking and spalling of the concrete patching material. Shifting dowel bar slots, three to four inches, will prevent this distress while still providing the required load transfer. If a gang saw is used, dowel bar slots may be sawed but not retrofitted, any non-retrofitted sawcuts should be cleaned and sealed with an epoxy resin.

**Figure A-21. Failure of dowel bar slot placed over existing longitudinal crack.**

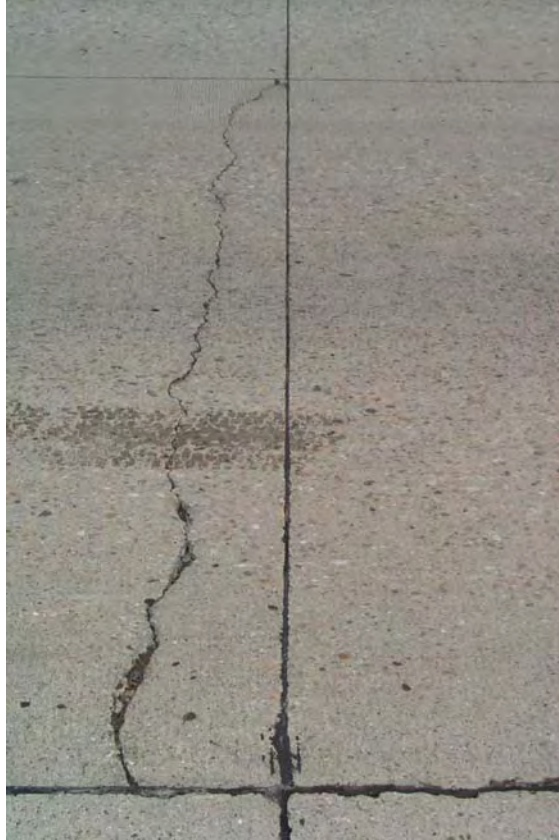
All existing transverse joints and cracks should be dowel bar retrofitted. Figure A-22 shows a non-working joint (narrow joint opening and excellent joint sealant condition after being in-service for more than 20 years with no maintenance) and a transverse crack that is functioning as the working joint. In this case, the crack should be dowel bar retrofitted and not the joint.

**Figure A-22. Transverse crack is functioning as the working joint.**

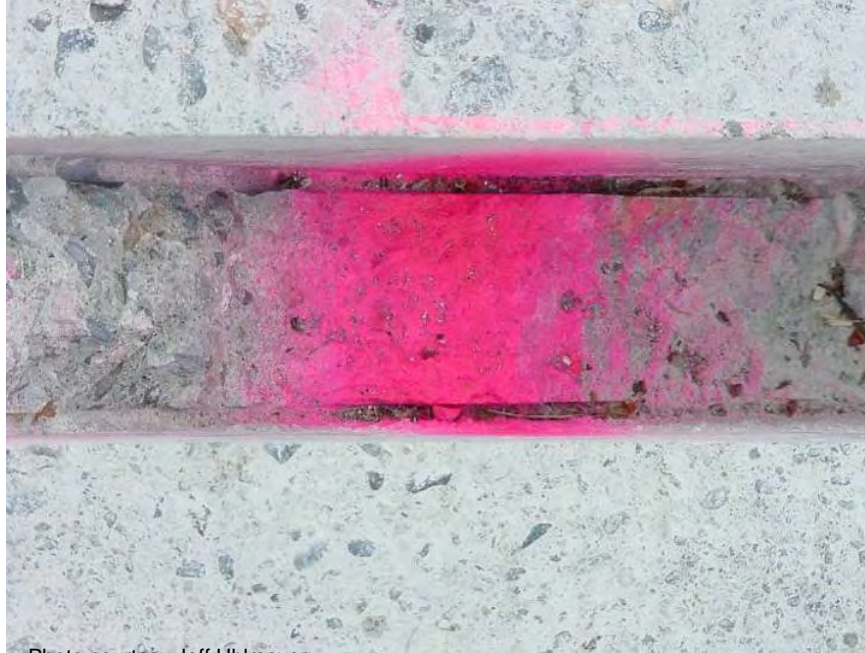
Figure A-29 illustrates insufficient removal of the existing concrete from the bottom of the dowel bar slot. This high point may result in a skew in the horizontal position of the dowel bar beyond that which is allowed by specification tolerances. If this skew is severe, dowel bar lockup and eventual failure of the patching material may occur. Slot bottom should be leveled using a lightweight (< 15 pound) jackhammer.

**Figure A-29. Concrete not fully removed from the bottom of the dowel bar slot.**

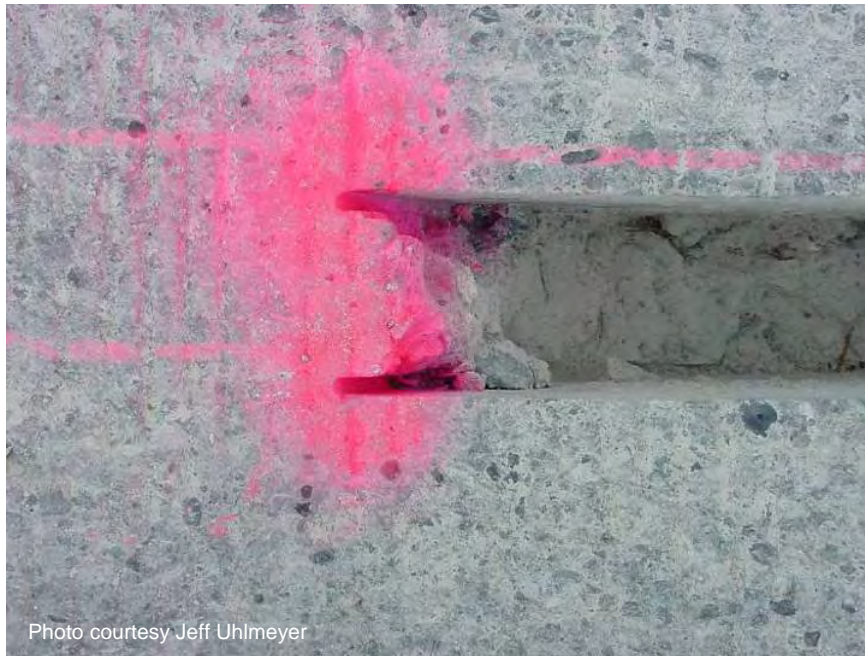
Figure A-30 illustrates insufficient removal of the existing concrete at the end of the dowel bar slot. Improper concrete removal could result in insufficient length for the dowel bar to sit level in the dowel bar slot and may not allow for sufficient patching material around the dowel bar. Though this may not be extreme in this case, spalling at the end of the dowel bar slot may occur due to difficulty in obtaining patching material consolidation.

**Figure A-30. Concrete not sufficiently removed from the end of the dowel bar slot.**

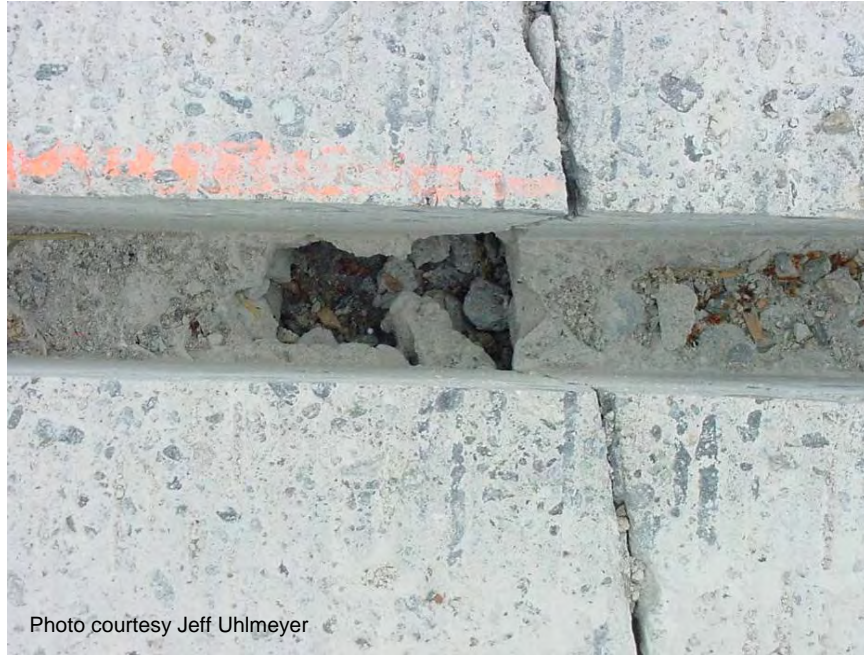
Figure A-31 illustrates a situation where the jackhammer operation caused failure of the bottom of the dowel bar slot. This may have occurred due to operating the jackhammer at an angle greater than 45 degrees, the dowel bar slot was sawcut to deep leaving an insufficient depth of concrete between the dowel bar slot bottom and the bottom of the concrete slab, which was easily broken during the jackhammering process or the use of jackhammers weighing more than 30 pounds.

**Figure A-31. Jackhammer punching through the bottom of the dowel bar slot.**

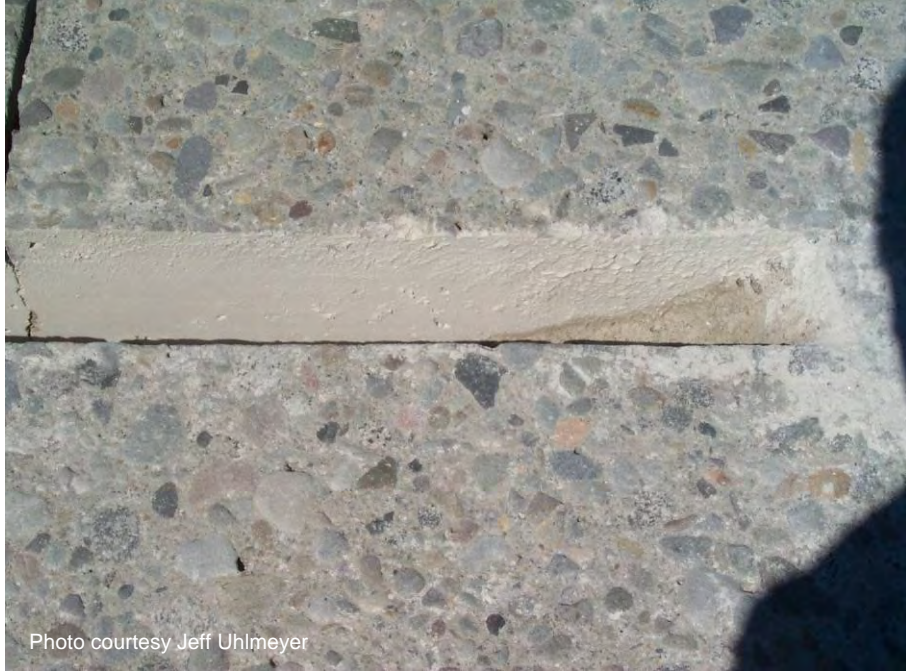
After completion of the sawcutting and concrete removal process, debris and saw blade slurry exists in the dowel bar slot (Figure A-36). This material must be removed prior to installation of the dowel bar retrofit assembly. Insufficient cleaning of the dowel bar slot will prohibit adherence of the patching material to the existing concrete, which will result in a bonding failure between the patching material and the existing concrete.

**Figure A-36. Sawcut blade residue on slot walls.**

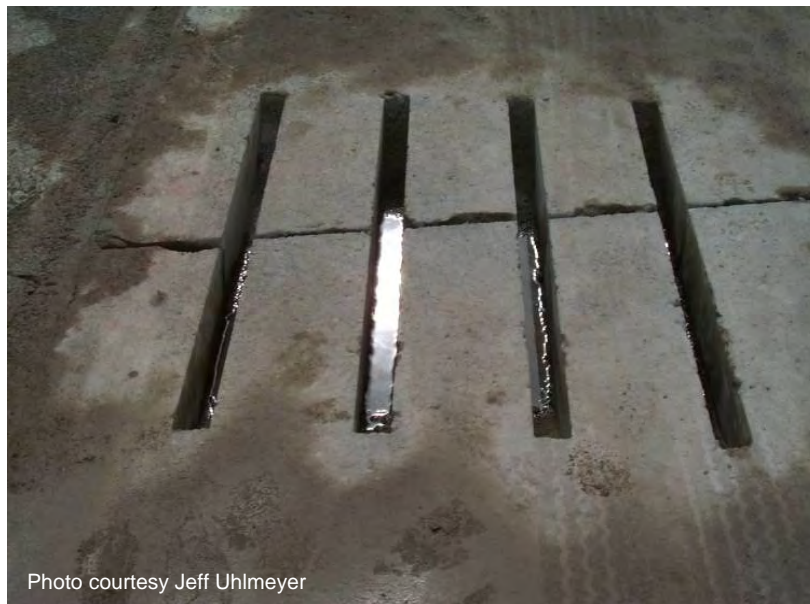
Removal of debris and slurry residue can be challenging if water is present in the dowel bar slot. If water is present (Figure A-43), slurry residue is redistributed to the bottom or sides of the dowel bar slots by sandblasting or compressed air. More than one attempt at cleaning the dowel bar slot may be required to obtain the desired cleanliness.

**Figure A-43. Water must be removed prior to placement of patching material.**

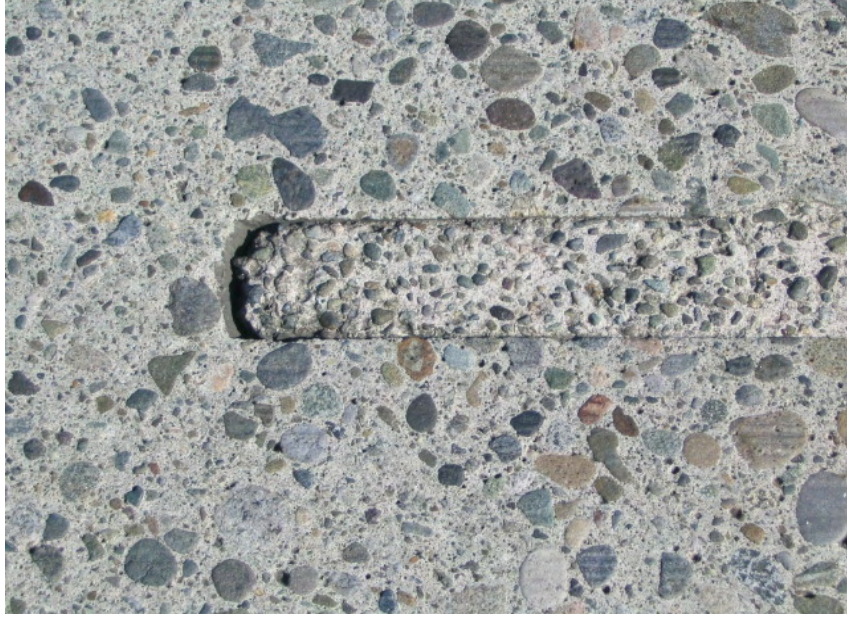
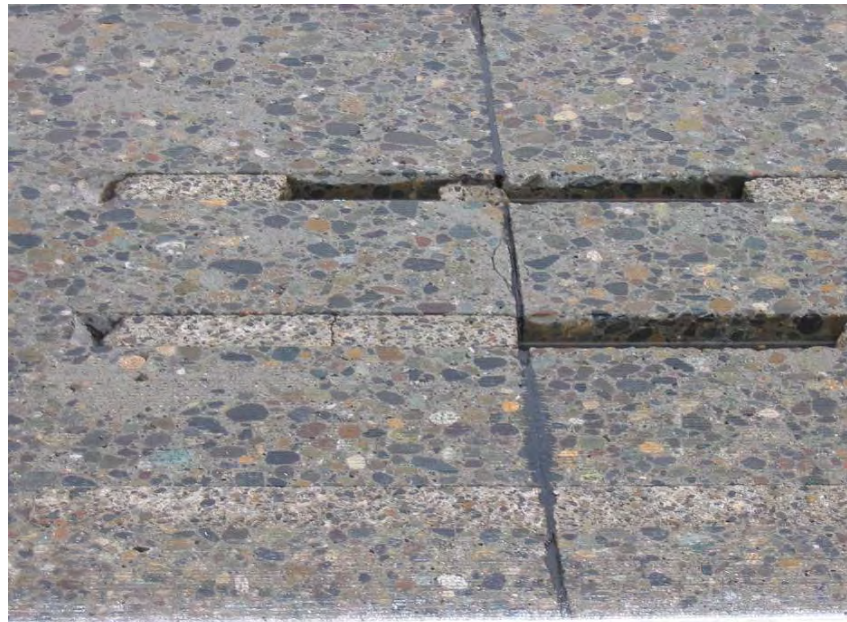
Figure A-44 and Figure A-45 shows debonding of the patching material from the dowel bar slot. This distress is typically related to inadequate cleaning of the dowel bar slot. Repair of this distress requires removal and replacement of the patching material.

**Figure A-44. Patching material bond failure.**

**Figure A-45. Patching material bond failure.**

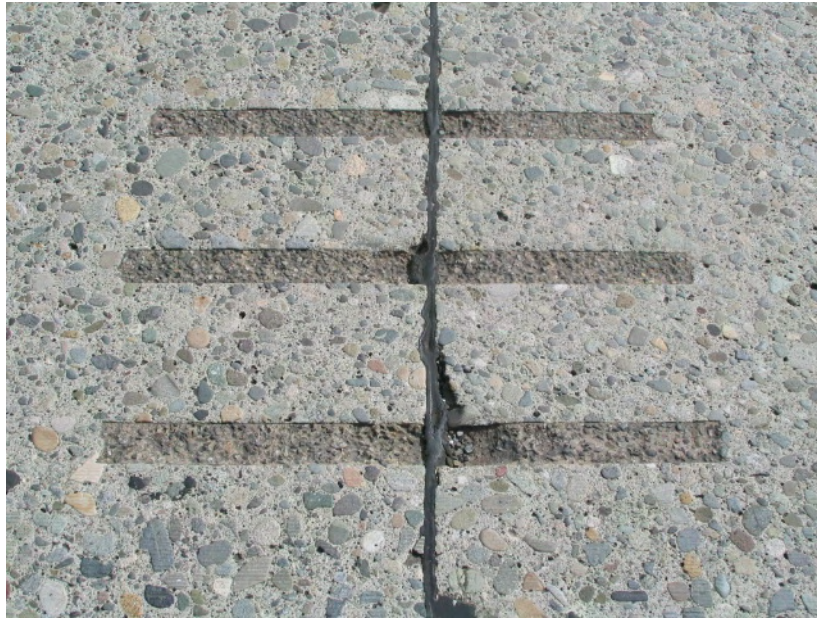
Figure A-46 illustrates spalling of the patching material. Potential causes of this distress can be related to consolidation, lack of sufficient aggregate or opening too early to traffic. Figure A-47 illustrates insufficient consolidation in the patching material. Repair, for both instances would include removal and replacement of two to three inches of the patching material.

**Figure A-46. Spalling of patching material.**

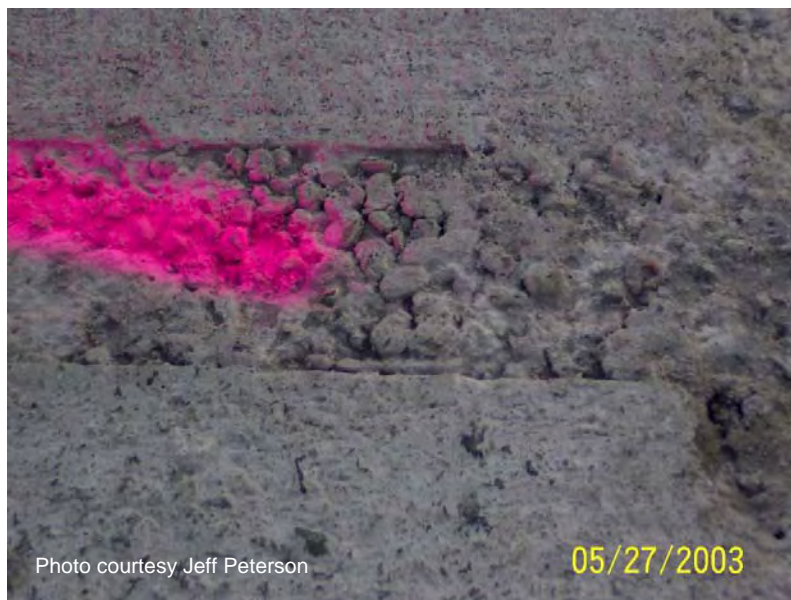
**Figure A-47. Insufficient consolidation of patching material.**

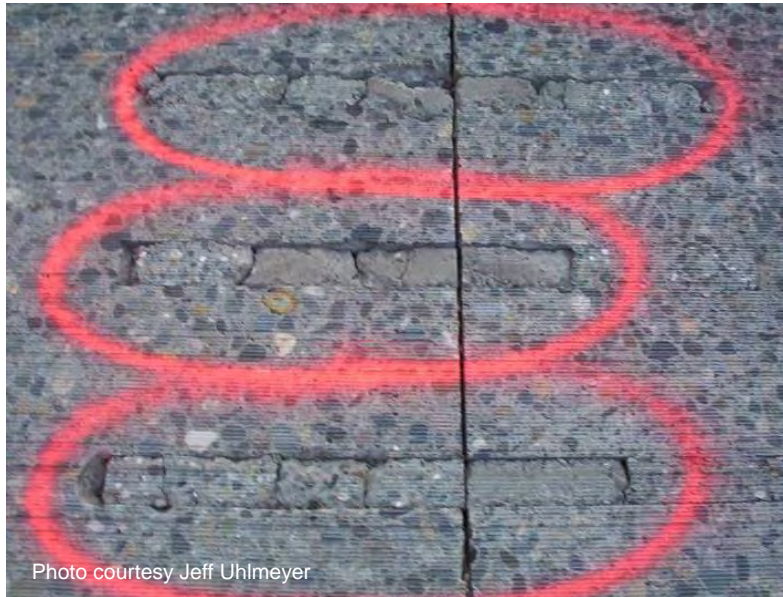
Figure A-48 illustrates shrinkage cracking of the patching material. This type of cracking is repaired by removal and replacement of distressed patching material.

**Figure A-48. Shrinkage cracks of pour back material.**

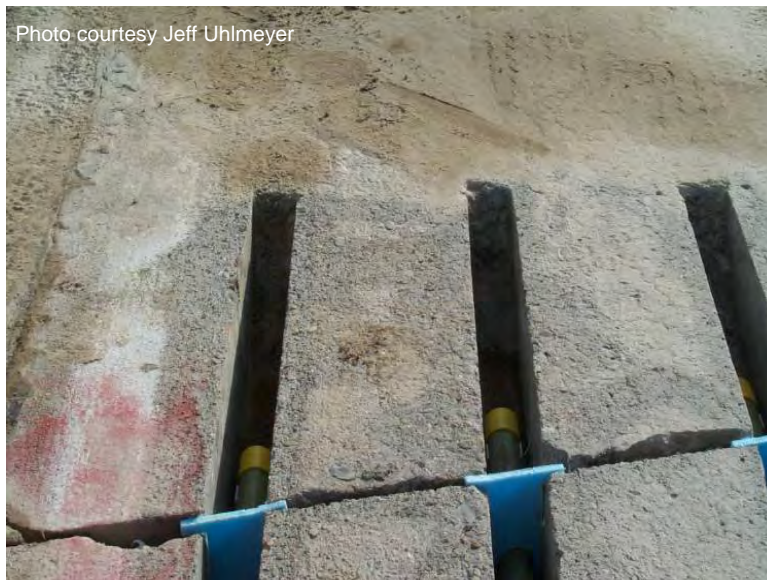
Debris should be removed a minimum of four feet from the dowel bar slots. This material can be reintroduced (Figure A-49) into the dowel bar slot and may result in bonding issues.

**Figure A-49. Debris should be cleared to a sufficient distance to prevent intrusion.**

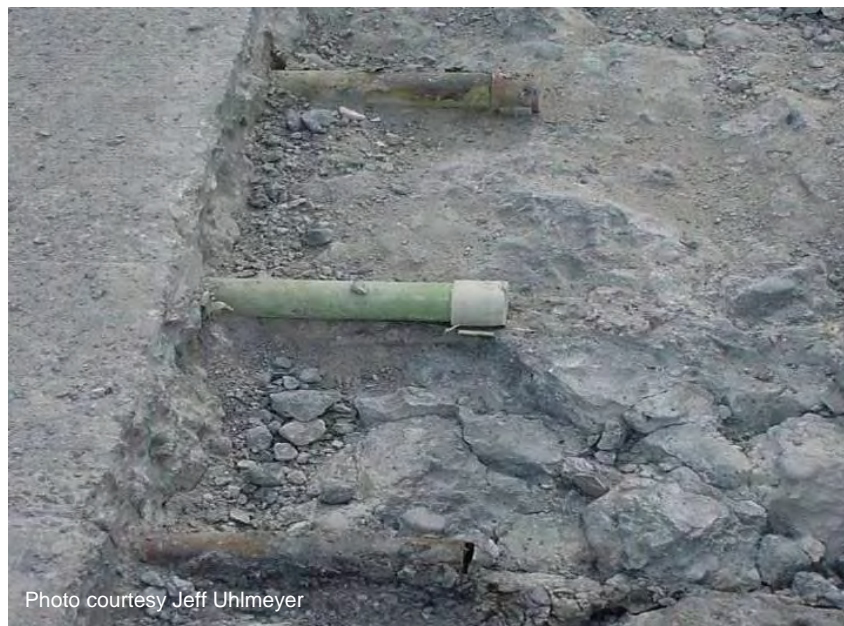
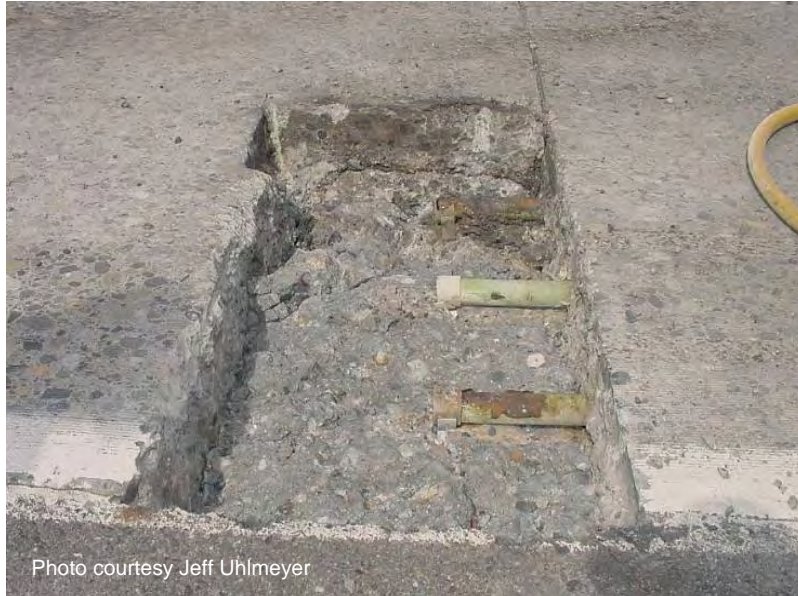
The dowel bar epoxy coating should be inspected and if any discrepancies are present the dowel bar should be rejected. On one particular project, dowel bar corrosion (Figure A-59 and Figure A-60) was determined to be the cause of the dowel bar slot failure.

**Figure A-59. Corroded epoxy coated dowel bars.**

**Figure A-60. Corroded epoxy coated dowel bars.**

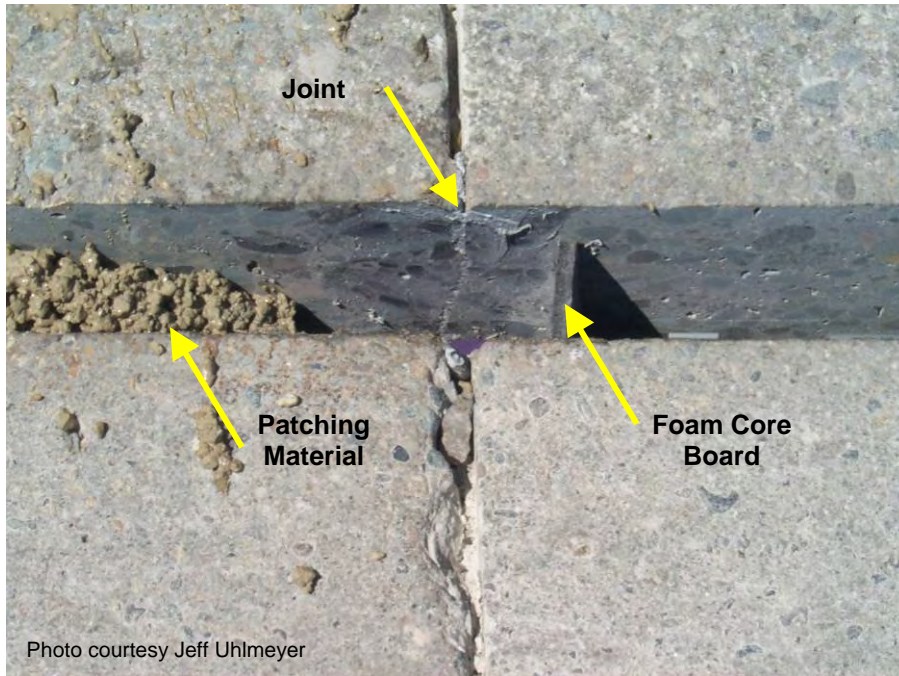
Placement of patching material that causes movement (Figure A-66 and Figure A-67) of the dowel bar retrofit assembly should be rejected and replaced.

**Figure A-66. Movement of bar during placement of patching material.**

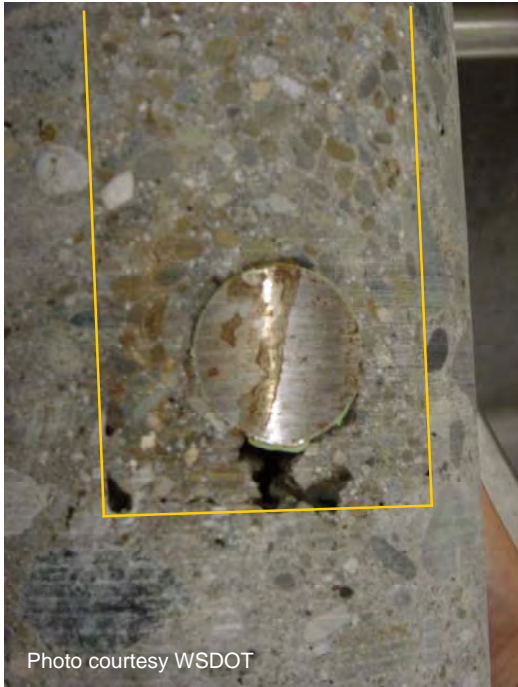
Figure A-69 and Figure A-70 illustrate patching material voids in the vicinity of the dowel bar. The core shown in Figure A-69 was taken from the first dowel bar retrofit project and illustrates lack of consolidation beneath the dowel bar, which could be due to aggregate size

and the inability to move the aggregate around the dowel bar or lack of consolidation. Figure A-70, on the other hand, was taken from a more recent project (2006) and shows lack of consolidation around and above the bar. In this case, it was determined that the aggregate gradation was too large to adequately fit around the bar and WSDOT modified specifications to allow only AASHTO Grading No. 8 (prior to this project, either AASHTO Grading No. 7 or 8 was allowed).

**Figure A-69. Poor consolidation.**

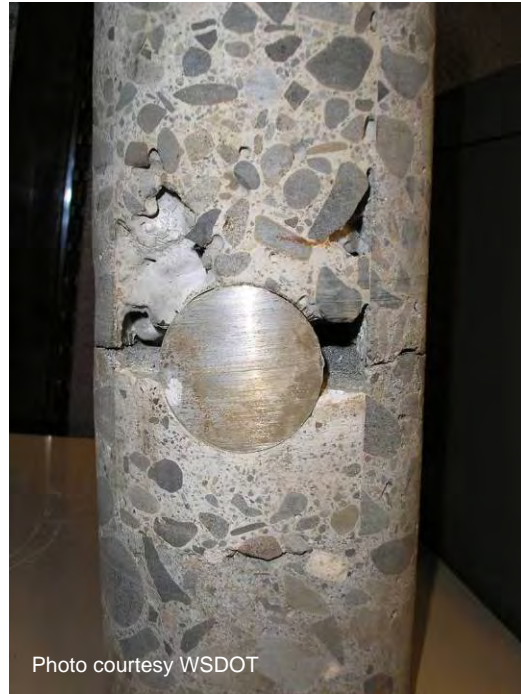
**Figure A-70. Poor consolidation.**

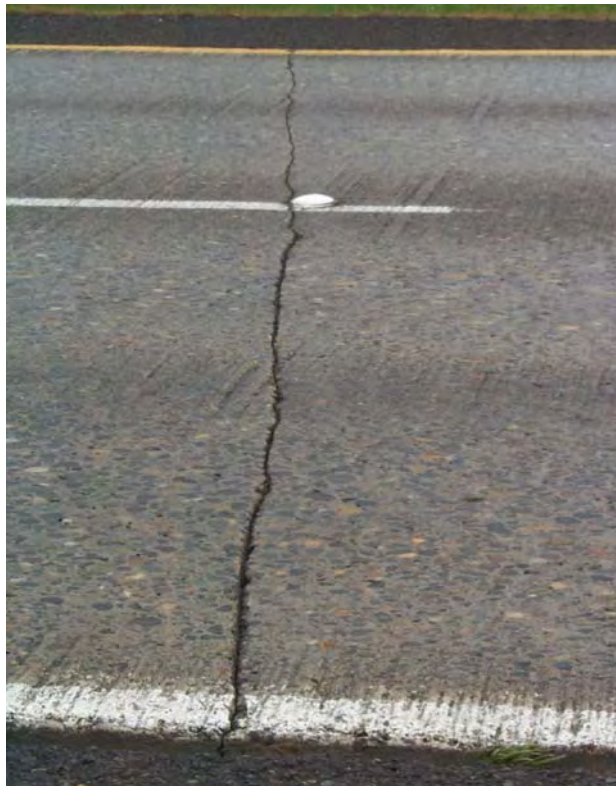
Establishing the transverse joint within the dowel bar slots (Figure A-76) should be conducted within 24 hours after placement. If the transverse joints were originally constructed with a tape joint and the joint is uneven (Figure A-77), the transverse joint should not be sawcut. In this situation, sawcutting a straight line would be challenging without creating slivers that would eventually spall.

**Figure A-77. Transverse tape joint (original construction).**

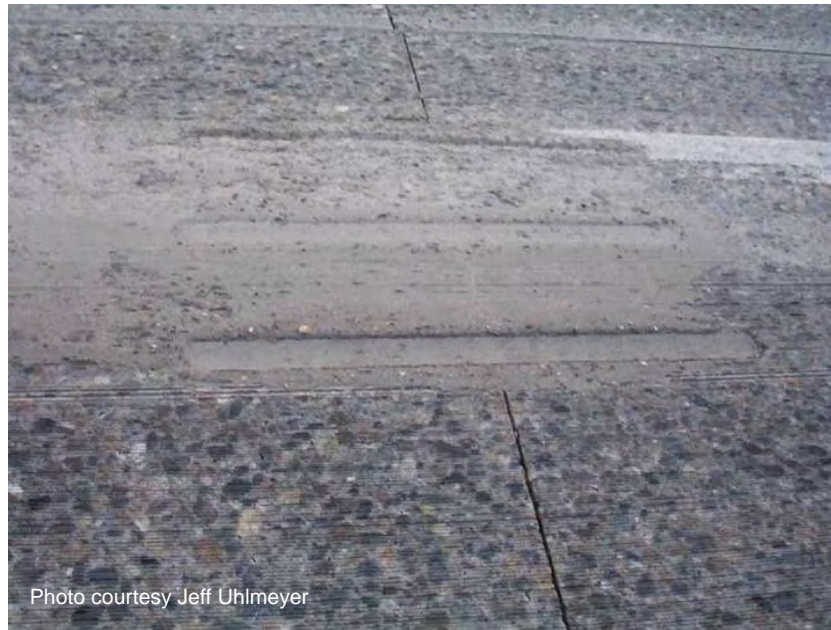
Figure A-78 illustrates damage caused by mechanically sweeping the roadway prior to the patching material reaching the required strength. As before, the methodology for repairing this distress is to saw cut, remove and replace two to three inches of the distressed material.

**Figure A-78. Mechanical sweeping prior to patching material reaching strength.**

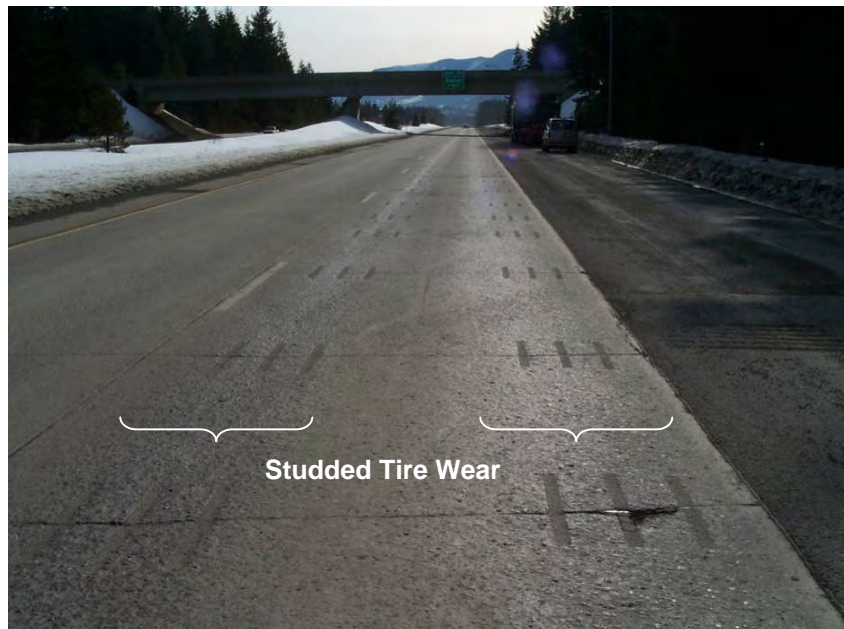
Studded tire wear is one of the more predominant distresses affecting pavement (both HMA and concrete) performance in Washington State. For dowel bar retrofit, the largest impact of studded tires is wear in the dowel bar slot (Figure A-79 and Figure A-80).

**Figure A-79. Wear due to studded tires.**

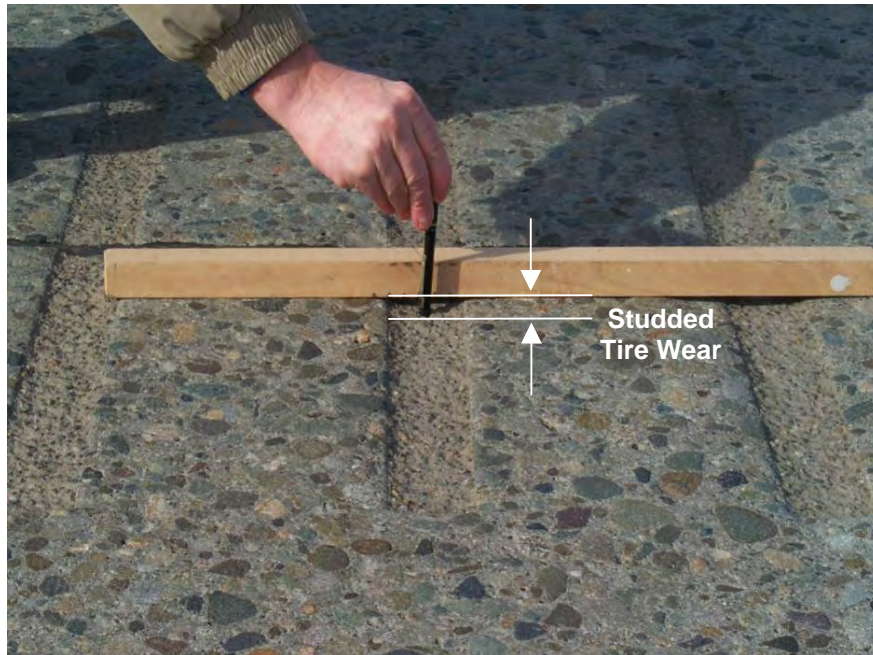
**Figure A-80. Wear due to studded tires.**

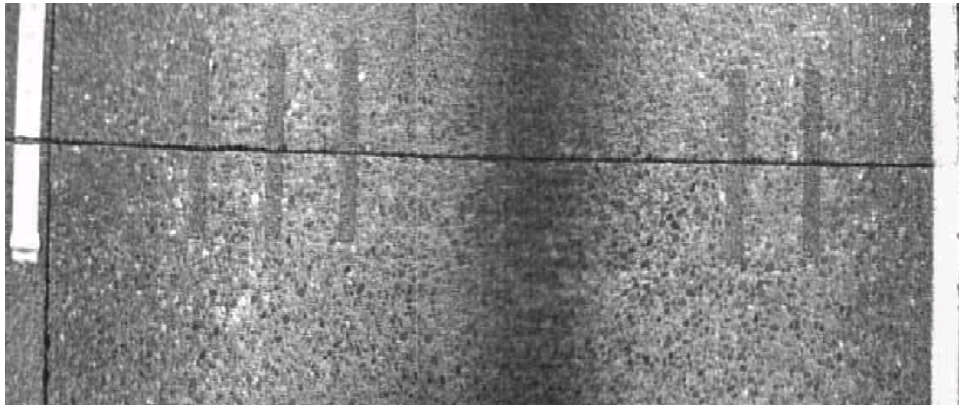
Figures E-1 and E-2 depict the typical performance of perpendicular and skewed, respectively, transverse joints that have been dowel bar retrofitted. The majority of dowel bar retrofitted transverse joints in Washington State have no noticeable distress.

**Figure E-1 No distress – perpendicular joint**

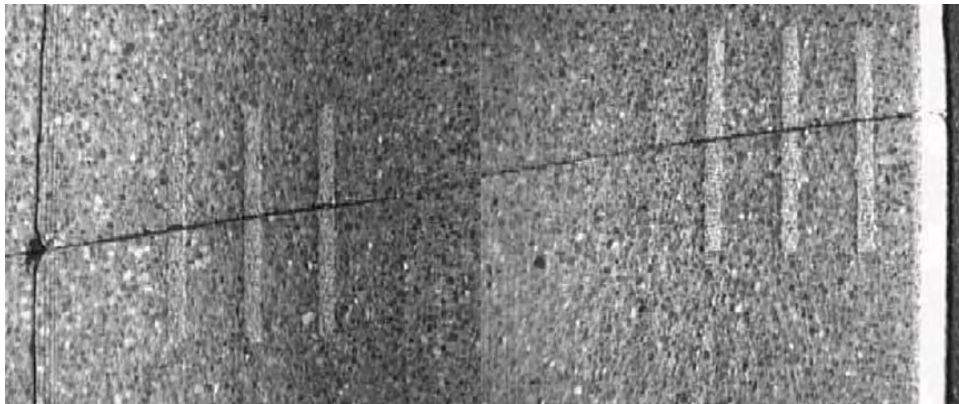
**Figure E-2 No distress – skewed joint**

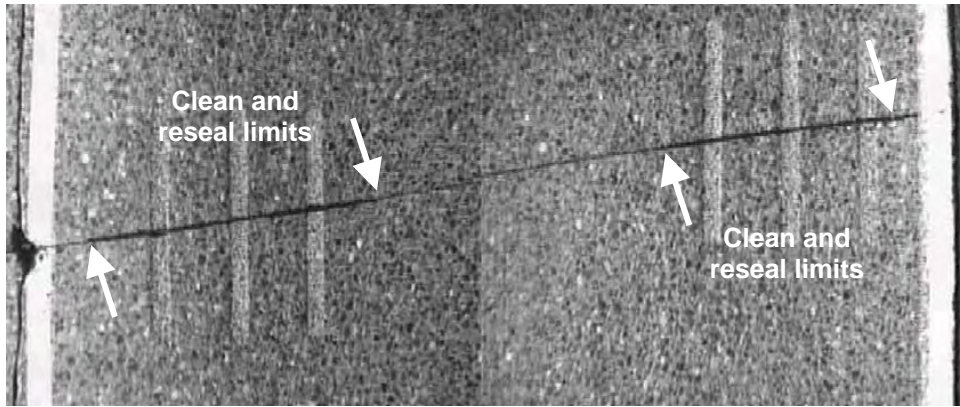
Figure E-3 was captured on the I-82 project, where the contract allowed for sawing and resealing of the transverse joint only over the width of the dowel bar retrofitted slots. Based on the observations of this one project, this practice appears to be performing well.

**Figure E-3 Clean and reseal joint only over dowel bar slots.**

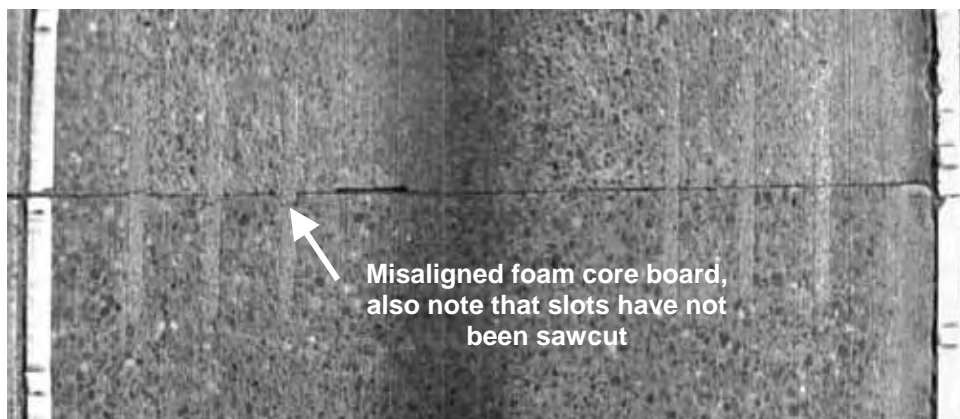
Figure E-4 illustrates where the foam core board was either not properly centered over the transverse joint or more likely, the foam core board was displaced during placement of the patching material. In addition, on this project (I-5, Contract 5712, Gravelly Lake Interchange Vicinity to Puyallup River Bridge), the requirement to saw and seal the transverse joint after dowel bar retrofit was removed due to budgetary constraints. Based on a visual survey of dowel bar slot condition, this project had a high percentage of slots that were cracked and/or spalled, as compared to other projects with similar traffic volumes and dowel bar retrofit age. The presence of slot distress can not be completely explained by the lack of sawcutting and sealing the transverse joint after dowel bar retrofit, however, sawcutting and sealing is considered to be a low cost item that does provide some benefit and it is recommended that this item not be deleted from the construction requirements.

**Figure E-4 Misaligned foam core board.**

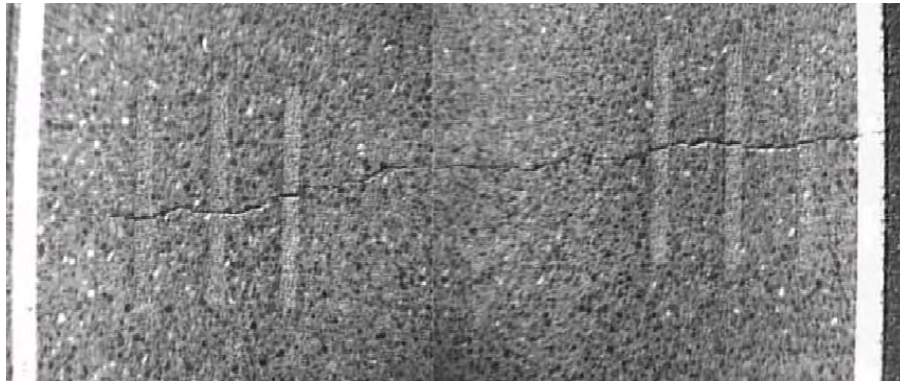
Figure E-5 illustrates the typical performance of an existing transverse crack that has been dowel bar retrofitted.

**Figure E-5 Dowel bar retrofit of existing transverse crack.**

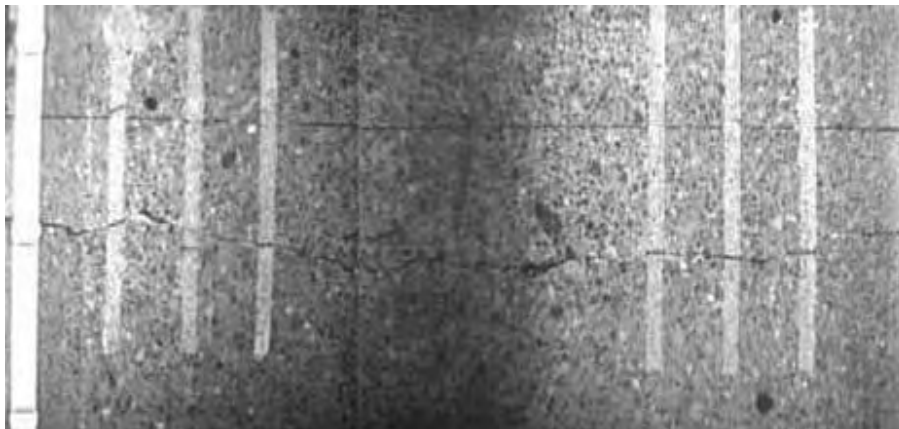
Figure E-6 shows a transverse crack (note the narrow width of sawed joint) that is functioning as the working joint (joint more than likely sawed to late during original construction) that has been dowel bar retrofitted. The transverse crack is located within approximately one to two feet of the transverse joint. The Contractor sawcut the dowel bar slot over both the joint and the working crack, however, it is not clear if the dowel bar assembly was centered over the transverse crack, over the transverse joint or over both the joint and crack. In this case, it would be best to center the dowel bar assembly over the transverse crack (Figure E-7). In general, dowel bar retrofit of working cracks has performed well in Washington State.

**Figure E-6 Dowel bar retrofitted transverse crack and joint.**

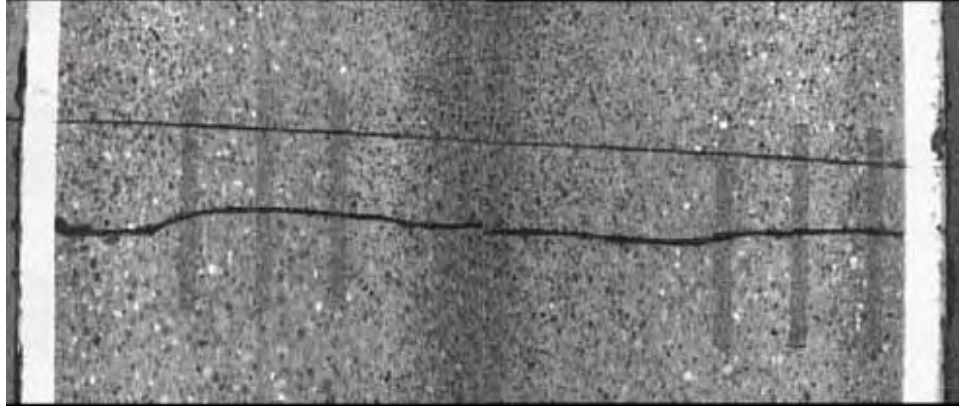
**Figure E-7 Dowel bar retrofit of working crack.**

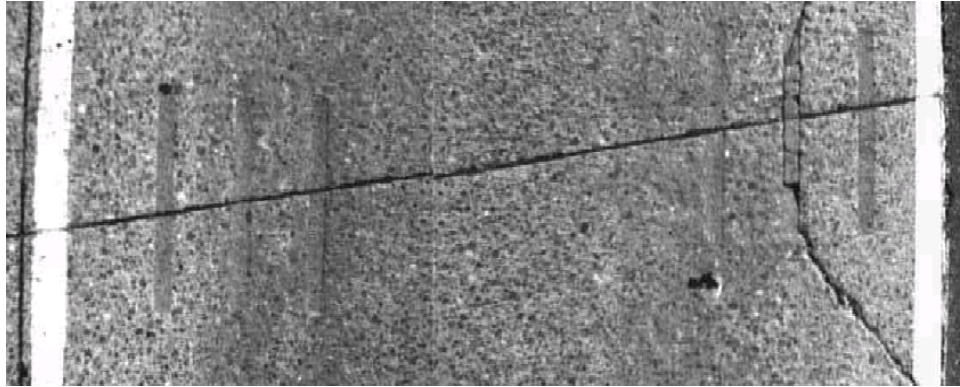
Figure E-10 shows an existing corner crack (note width of crack) that was dowel bar retrofitted. Slot failure, both cracking within the slot and slot debonding has occurred. It has been noted that many existing corner cracks only occur on one panel, following dowel bar retrofit; the adjacent panel develops a corner crack. In this case, it may have been better to either not retrofit the slot that intersects the crack or conduct a panel replacement to repair the corner crack. The latter becomes a very expensive option and it should be evaluated by each agency to determine the consequences of dowel bar retrofitting at a lower cost, but higher potential of noted distress versus the cost of a panel replacement.

**Figure E-10 Pre existing corner crack.**

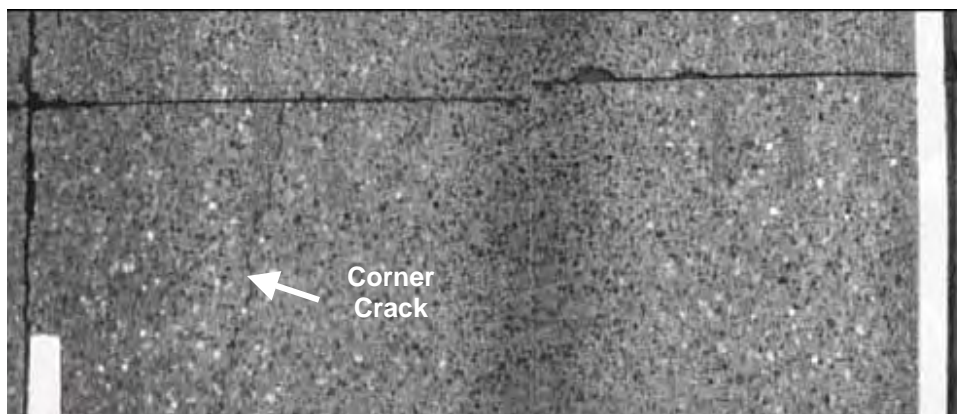
Figure E-11 shows a corner crack that developed after dowel bar retrofit (note tightness of the crack). This distress more commonly occurs in the right wheel path, but has been known to occur in the left wheel path as shown in Figure E-11.

**Figure E-11 Corner crack after dowel bar retrofit.**

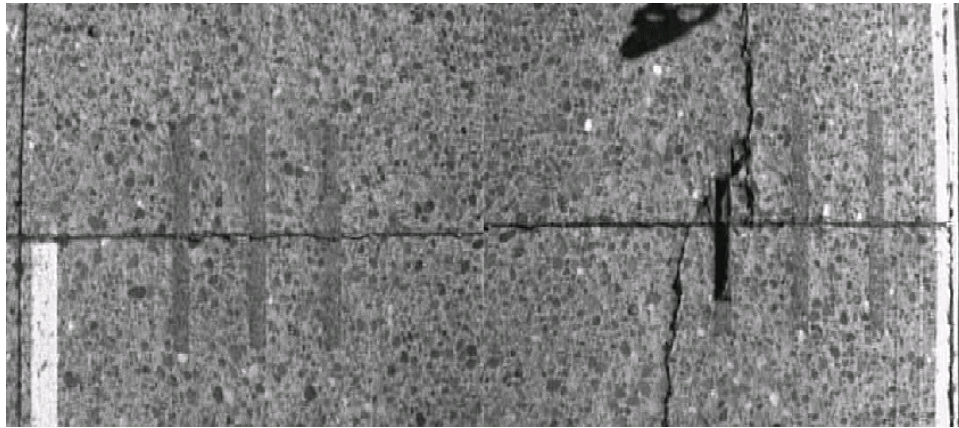
Figure E-14 illustrates a typical distress when the longitudinal crack intersects the dowel bar retrofit slot. This image shows late stage distress development where the loss of patching material has occurred. Typically distress progresses via debonding of patching material from the sides of the slot (longitudinal crack propagates through patching material) or cracking within the patching material or both. Over time and traffic, the material spalls or breaks loose from the dowel bar slot. Total loss of the patching material has been noted in several instances in

**Figure E-14 Failure of dowel bar slot over existing longitudinal crack.**

Washington State. Therefore, it is recommended that longitudinal cracks be avoided when dowel bar retrofitting transverse joints and cracks.

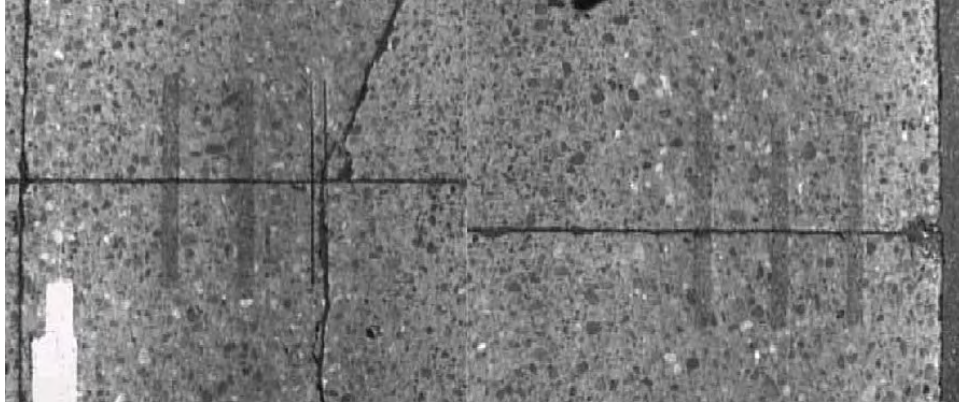
Figure E-16 illustrates a situation where the longitudinal crack would intersect a dowel bar retrofit slot. In this instance, the slot was cut but the existing concrete between the saw cuts was not removed. The saw cuts should be sealed with epoxy. The other option would be to shift

**Figure E-16 Slots sawed by not removed to avoid longitudinal crack.**

the dowel bar slots to the left or right to avoid the longitudinal crack. The latter may be more difficult to accomplish, especially when a full-width gang saw is used for cutting the dowel bar retrofit slots. The practice of sawcutting but not removing the existing concrete within the dowel bar slot has provided good performance in Washington State.
