# Evaluation of Dowel Bar Retrofit for Long-Term Pavement Life in Washington State

WA-RD 727.1

May 2009

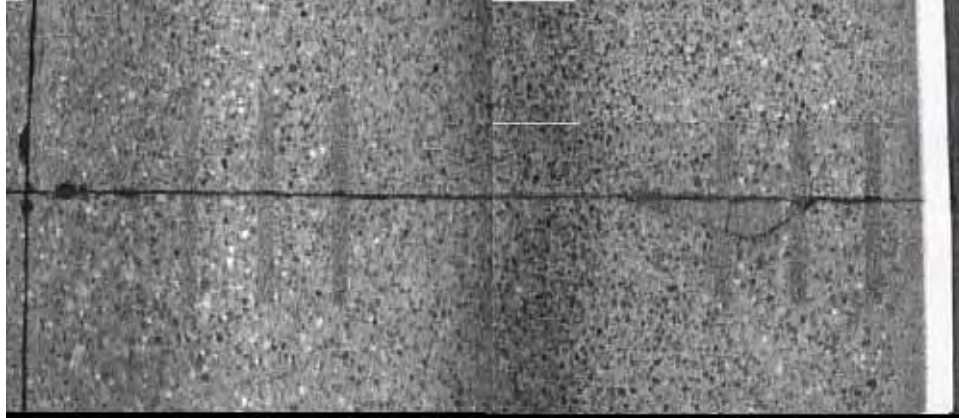
Figures E-18 through E-20 illustrates locations where a spall repair was conducted in conjunction with dowel bar retrofit. In Figures E-18 and E-19, the spall appears to have been simply filled while placing the patching material in the dowel bar retrofit slot. It can be noted that the shape of the spall repair is irregular indicating that a saw cut was not conducted to define the extent of the spalled area. Ideally, spalled areas should be saw cut, as shown in Figure E-20, prior to placement of patching material. It is interesting to note, that in all three instances, the spall repair is not performing poorly, cracking is present regardless of the spall repair technique.

**Figure E-18 Distressed spall repair with dowel bar retrofit.**

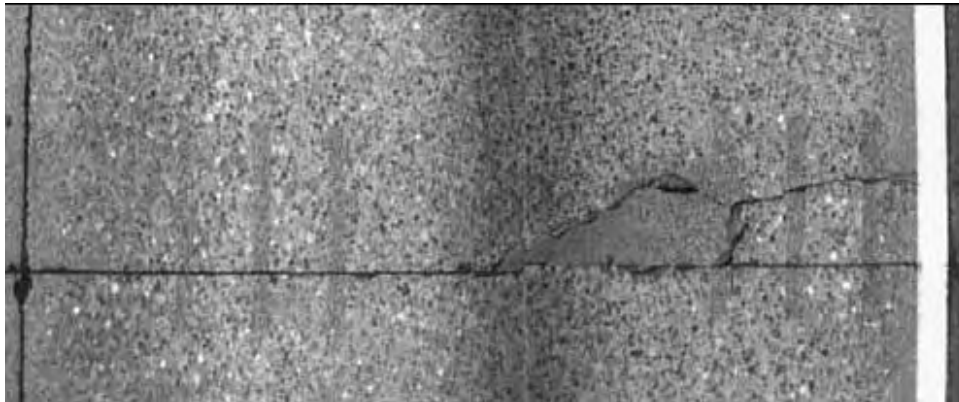
**Figure E-19 Spall repair with dowel bar retrofit.**

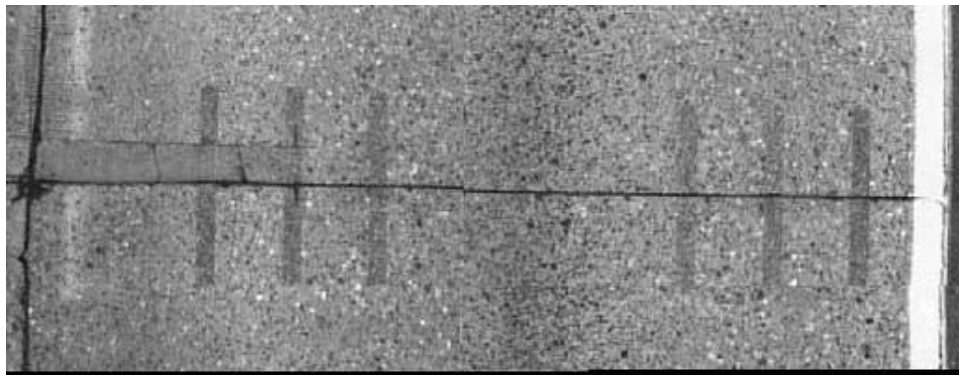
**Figure E-20 Distressed spall repair with dowel bar retrofit.**

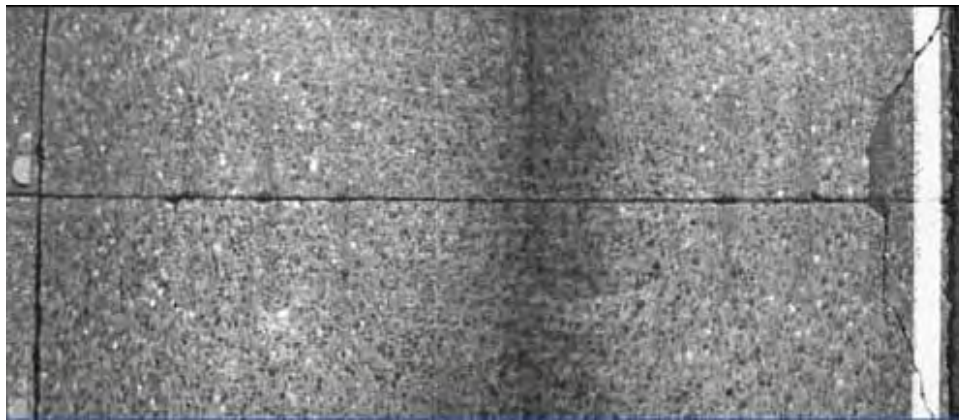
Figure E-21 illustrates cracking that has occurred, more than likely, due to saw cutting the dowel bar slot to deep or by using heavy jackhammers. When the concrete is removed in a slot that has been saw cut to deep, the dowel bar will not be placed at the neutral axis, which can

lead to high stresses and lead to slot or panel cracking. In addition, a deeper saw cut can result in the jackhammer causing cracking in the bottom of the dowel bar slot, due to insufficient thickness between the bottom of the slot and the bottom of the concrete panel. Cracking in the bottom of the slot becomes an issue since the patching material can enter into the crack and lead to joint lockup and cracking. In Washington State, this type of cracking is a very rare occurrence; however, on one project on I-90, the Contractor requested and was allowed to use a 60 pound jackhammer for dowel bar slot removal. This resulted in the jackhammer punching through the bottom of the slot, once realized the Contractor was directed to use 30 pound jackhammers.

**Figure E- 21 Joint lockup due to sawing and/or jackhammering to deep.**

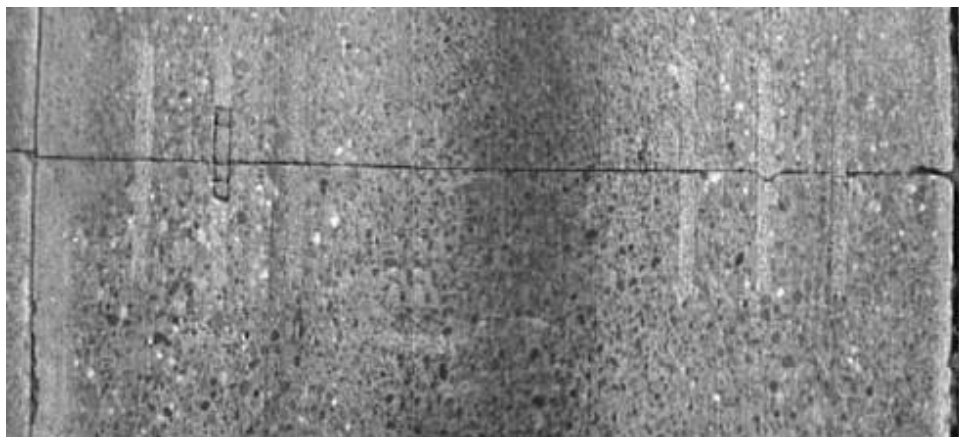
Figures E-22 and E-23 shows cracking within the dowel bar slot, which is more than likely caused by shrinkage. This distress occurs infrequently in Washington State.

**Figure E-22 Low severity cracking within dowel bar slot.**

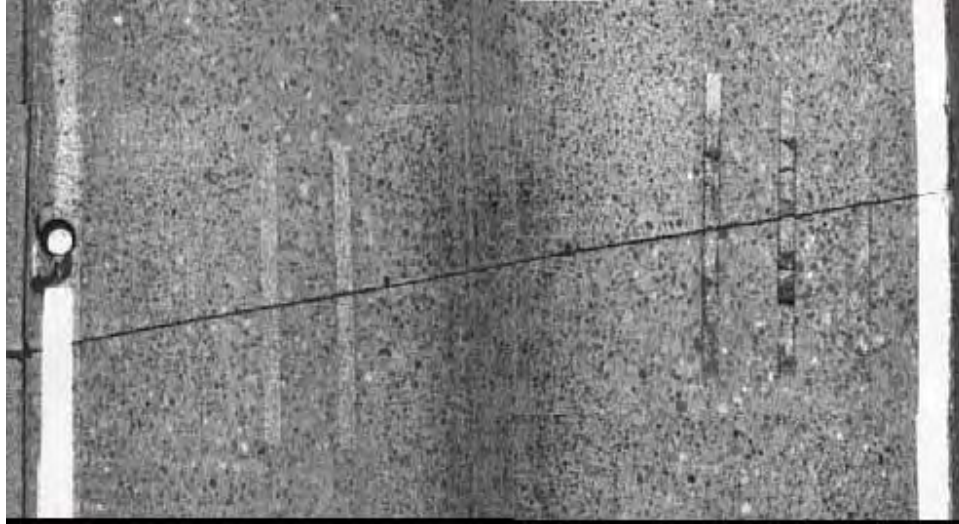
**Figure E-23 High severity cracking within dowel bar slot.**

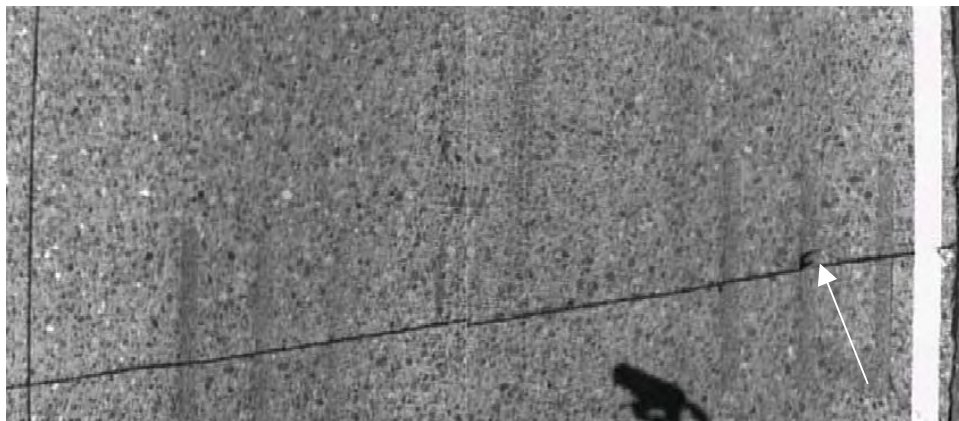
Figures E-24 and E-25 illustrate dowel bar retrofit slot spalling. Spalling has been noted on very few dowel bar retrofit slots in Washington State. Spalling can occur due to poor consolidation, misaligned foam core board and advanced stages of cracking which causes a portion of the patching material to become dislodged from the dowel bar retrofit slot. Spalling can be minimized by following approved construction practices.

**Figure E-24 Low severity spalling within dowel bar slot.**

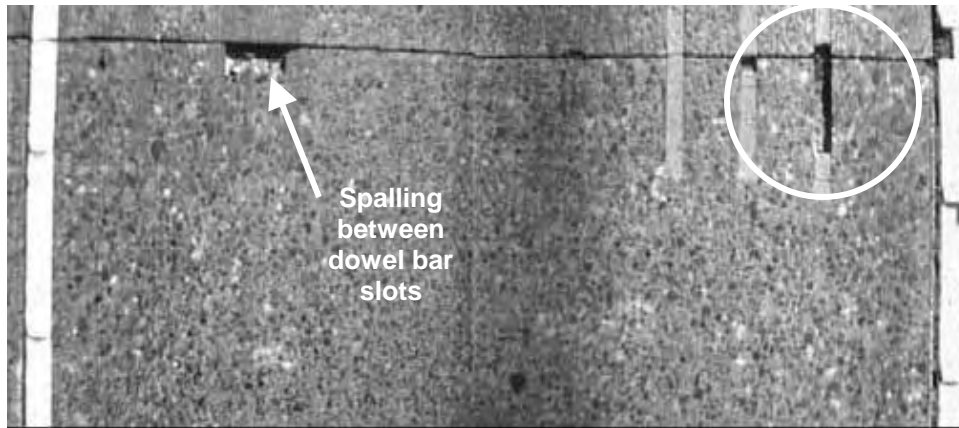
**Figure E-25 High severity spalling within dowel bar slot.**

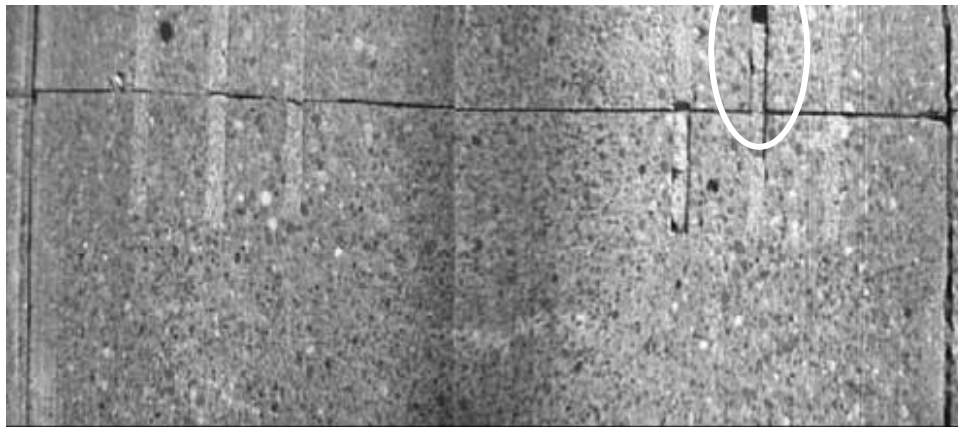
Figure E-26 Illustrates debonding of the patching material from the sides of the dowel bar retrofit slot. Debonding is typically due to poor adhesion of the patching material to the sides of the dowel bar retrofit slots. This is typically due to the presence of fine material (saw residue and debris) on the sides of the dowel bar retrofit slot that were not adequately removed during the cleaning process. The dowel bar retrofit slot is considered to be clean when no residue exists on the sides of the dowel bar retrofit slot.

**Figure E-26 Debonding of dowel bar slot.**
