1. Report No. FHWA/TX-11/0-4562-4		2. Government Accession No.		3. Recipient's Catalog No.	
4. Title and Subtitle Evaluation of Corrosion Resistance of Improved Post-tensioning Materials after Long-term Exposure Testing			5. Report Date October 2011

CTR Technical Report:	0-4562-4
Report Date:	October 2011
Project:	0-4562
Project Title:	Corrosion Resistance of Grouted Post-Tensioning Systems
Sponsoring Agency:	Texas Department of Transportation
Performing Agency:	Center for Transportation Research at The University of Texas at Austin

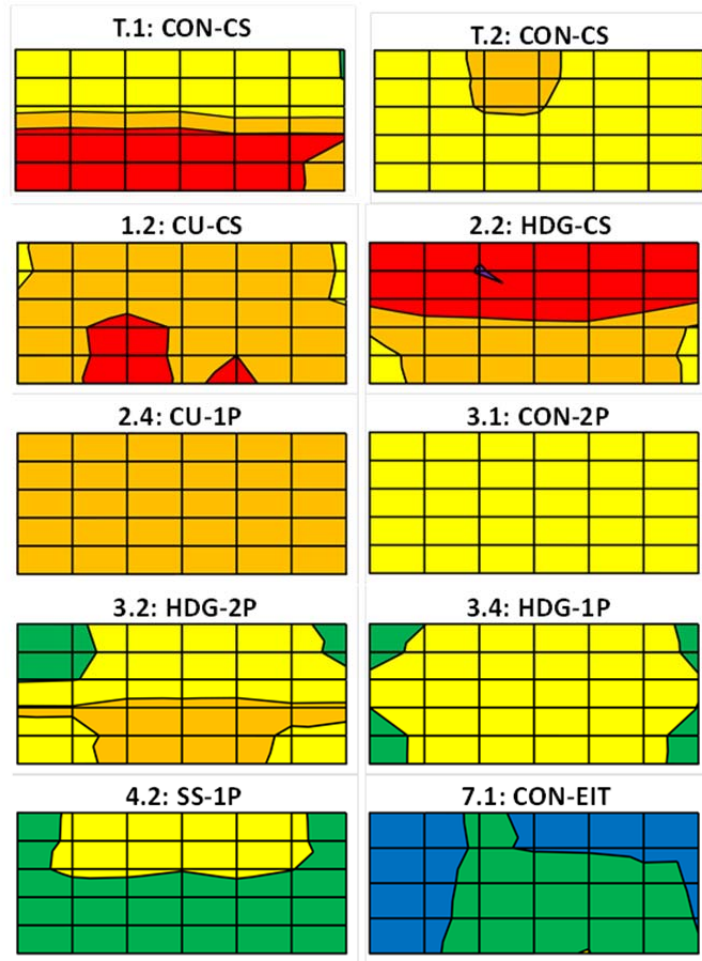
*Figure 4.1: Final Half-Cell Reading Contour Maps*

Spatially, there are some discernible patterns visible in the contour maps. For specimens T.1, 2.2, 3.2, and 4.2, the potentials were noticeably different between the north and south tendon regions, implying that damage may have been more severe in one tendon. For other specimens, the difference was not as clear. Specimens 4.2 and 7.1 had the least negative readings overall, indicating that they had experienced less corrosion than the other specimens. In addition, it appears from nearly all the contour maps that potentials were least negative at the live and dead ends of the monitoring region. This may have occurred because the tendons are draped, making

Specimen 2.2 had the most negative final average potential, while specimen 7.1 had the least negative potential. This probably indicates the effectiveness of the electrically isolated system used in specimen 7.1. Specimens with galvanized steel ducts had an average final half-cell potential of  $-509 \text{ mV}_{\text{SCE}}$ , while those with plastic ducts had an average final potential of  $-329 \text{ mV}_{\text{SCE}}$ . This suggests that specimens with plastic ducts had less corrosion at the time of autopsy. Average final potential for specimens with conventional strand was  $-346 \text{ mV}_{\text{SCE}}$ , while the average for specimens with any other type of strand was  $-437 \text{ mV}_{\text{SCE}}$ , indicating that the specimens with conventional strand were actually less corroded than the specimens with novel strand types at autopsy. This seems highly counterintuitive but can be explained. Averaging the final readings in this manner ignores the individual contributions of each element to corrosion. The higher potentials of the specimens with novel strand types may have occurred due to a higher degree of corrosion in the specimens' reinforcing steel or ducts. Also, different types of strand are likely to corrode in ways that produce different potentials. Analysis of the final half-cell potentials alongside the results of the forensic analysis will shed more light on the corrosion within each specimen.

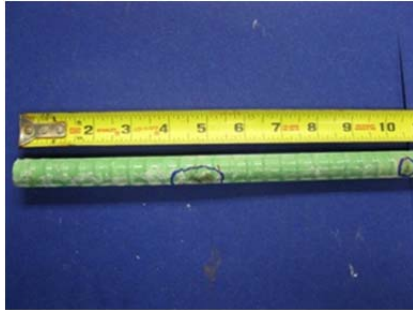
**Longitudinal Bar**

Both longitudinal bars were only lightly damaged, as shown in Figure 5.10. Discoloration was present at several spots along the top side of both bars, mostly coinciding with the locations where the stirrups were tied. The stirrups showed more damage than the longitudinal bars. Six stirrups had corrosion that could not be completely scoured away along at least one interval, as pictured in Figure 5.10. Corrosion ratings were highest for stirrups #2 and #4, which were located underneath the two large transverse cracks. Stirrup #4 showed the worst damage with approximately 5% area loss at the location where the north duct was tied to it.

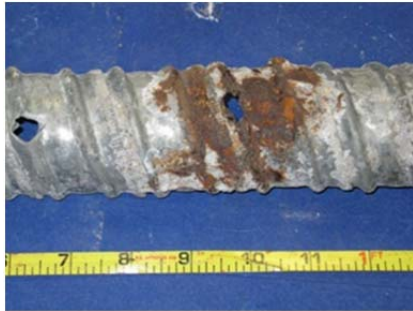
**Top of North Duct**

The north and south ducts both had localized severe corrosion damage as shown in Figure 5.10. Most damage on the north duct occurred at midspan and at the live end quarter point. Pitting and corrosion were more extensive on the inside of the duct. The shape and extent of the damage indicate the presence of small grout voids along the top of the entire duct. Significant corrosion and pitting also extended along the bottom inside surface. Here, the location of damage suggests that voids may have formed under the strands during grouting (see Figure 5.9).

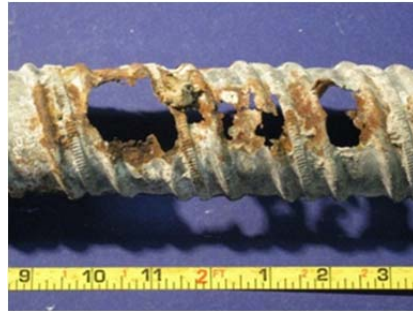
**Top of South Duct**

Damage was somewhat more extensive in the south duct. Moderate to severe area loss occurred on the top of the duct at midspan, and much smaller holes were found on top of the duct near the dead end quarter point. These holes tended to form inside the helical flutes of the duct, as seen in Figure 5.10. Duct corrosion ratings are shown in Figure 5.11 and summarized in Table 5.5.

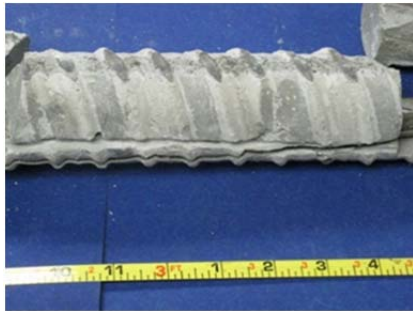
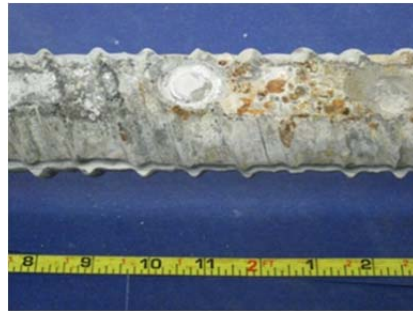
The tendon grout had very few discernible transverse cracks and no longitudinal cracks. Corrosion staining could be seen near midspan and the live end quarter point, coinciding with the corrosion observed in the duct at those locations. Orange-yellow staining was also visible at seemingly random points along the grout. Maximum chloride content was 0.085% at midspan, well above the corrosion threshold. Chloride content distributions are shown in Figure 5.11.

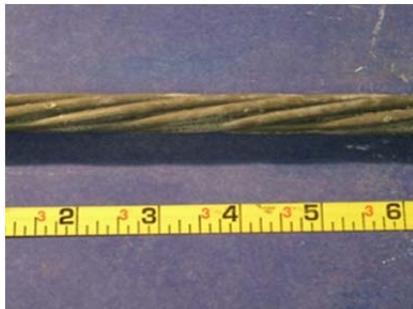
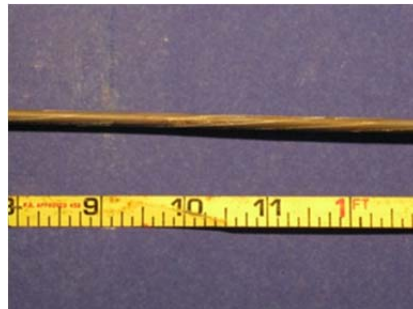
The three strands in the north tendon suffered only minor damage. The inner wires were more damaged, with light corrosion present on nearly all intervals. Corrosion ratings were uniform over the entire tendon, and all corrosion could be removed with a scouring pad.

The strands in the south tendon were somewhat more severely affected. On the outer wires, discoloration and light corrosion were present on many intervals. Corrosion that could not be scoured off occurred at a few points along each strand. The inner wires had light corrosion spots on almost all intervals. Corrosion ratings were mostly uniform over the entire tendon, although strand corrosion ratings were higher for the south tendon than for the north. A typical strand and inner wire are shown in Figure 5.10. Strand corrosion ratings are shown in Figure 5.11 and are summarized in Table 5.5.

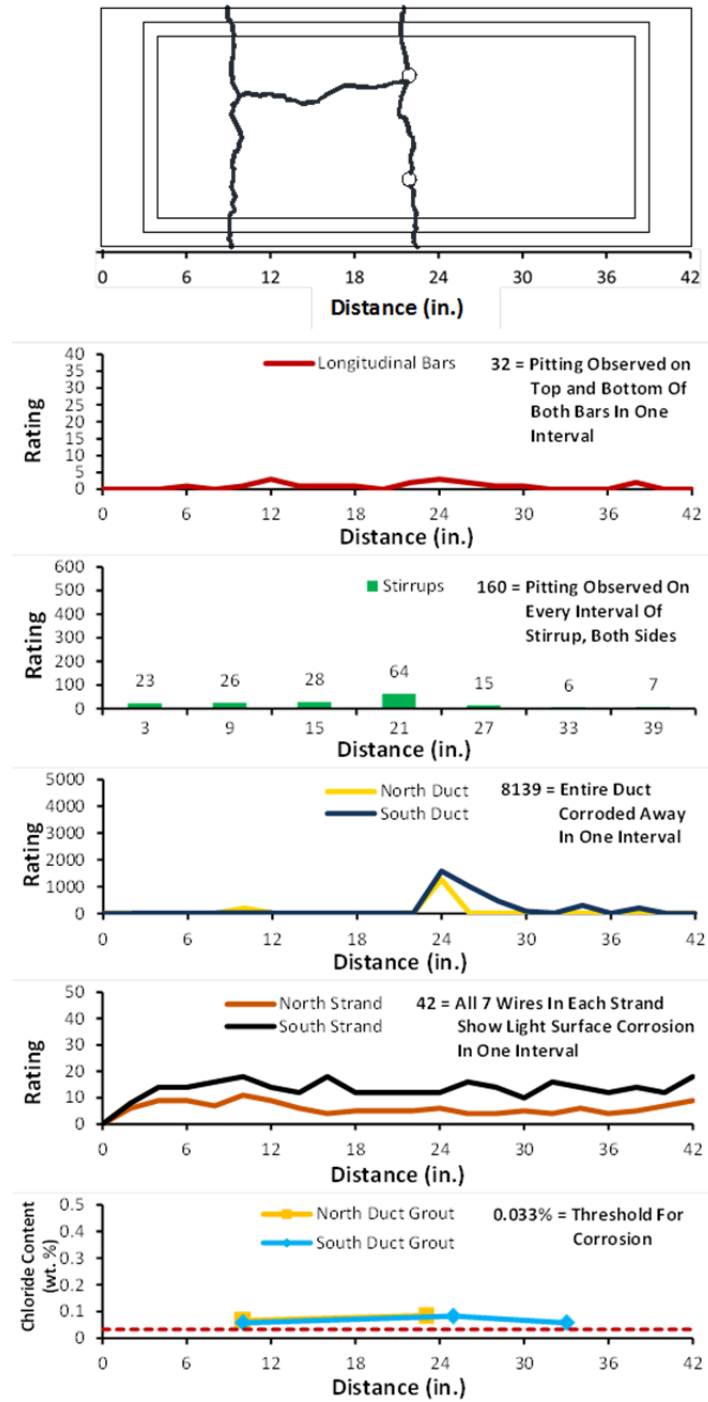
Figure 5.11: Specimen T.1 Crack Map and Corrosion Rating Plots

The specimen had two large transverse cracks running across its top face, each with an average width of 0.03 inches. These cracks extended down the north and south faces of the specimen. There was one longitudinal crack with an average width of 0.004 inches running perpendicular from the north grout vent to the transverse crack near the live end of the specimen. The crack diagram is shown in Figure 5.11.

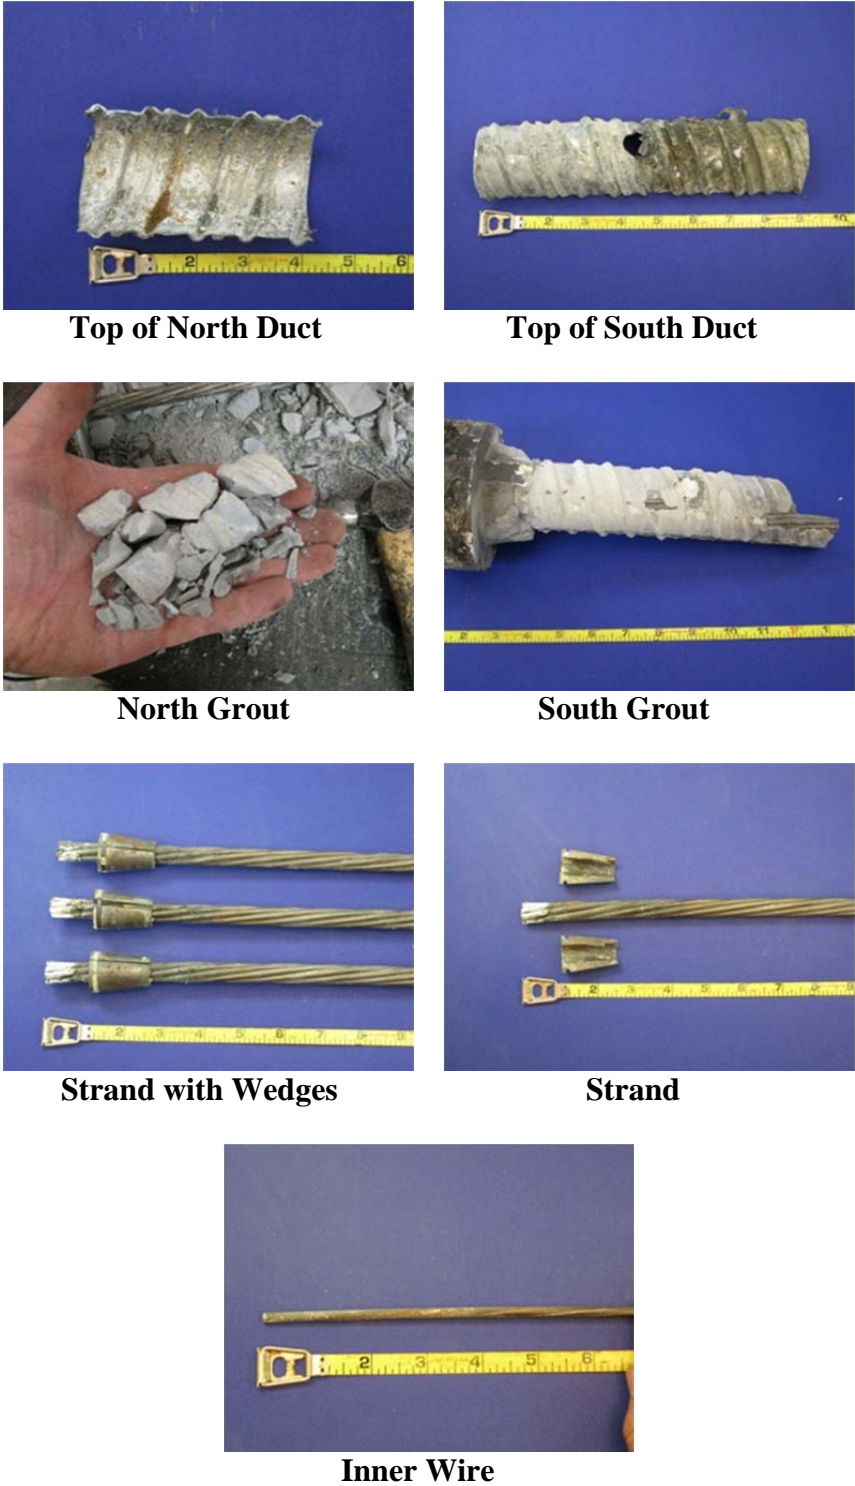
Figure 5.13: Specimen T.1 Anchorage Region Elements

The strands in the anchorage zones of both the north and south tendons experienced light localized corrosion and discoloration scattered across their lengths. As with the main specimen tendons, the center wire of all strands was slightly more damaged than the outer wires. Damage to both sets of strands was most severe at the ends that were outside the anchor head. One strand in each duct experienced moderate corrosion on several wires in its outermost interval. All wedges were substantially intact with only light localized corrosion. The appearance of a typical

strand, with and without wedges, is shown in Figure 5.13. Corrosion ratings for the anchorage zone strands are summarized in Table 5.6.

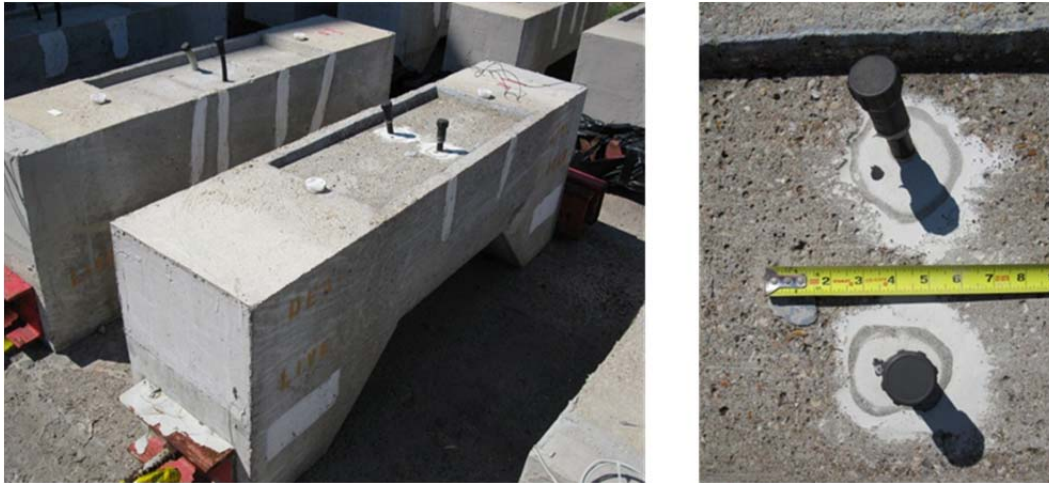
Figure 5.14: Specimen T.2 Overall (Left) and Grout Vents (Right)

This specimen showed light to moderate scaling on many of its exposed surfaces, mostly on the top face and the upper north and south faces. Extremely faint discoloration was found at the base of the north grout vent, suggesting the presence of corrosion inside the specimen there. The exterior of the specimen is shown in Figure 5.14.

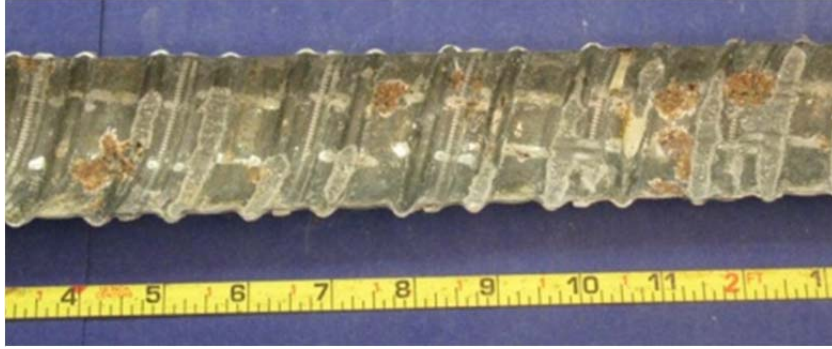
Both ducts were severely damaged. The north duct had substantial area loss on its top portion amounting to over half of the total cross-sectional area in several intervals. This damage occurred mostly in the intervals between transverse cracks on the beam's surface (see Figure 5.18). The overall shape of the area loss and pitting inside the duct indicates the presence of a very large void extending over most of the duct's length. The bottom portion of the north duct was less damaged. Inside, there was widespread discoloration and light localized corrosion, mostly occurring on the same intervals as the area loss on the top half. Most of the corrosion inside the duct occurred where the strands had rubbed against it. This is shown in Figure 5.16.

*Figure 5.16: Specimen T.2, Corrosion Along Gouges on Bottom Half of North Duct*

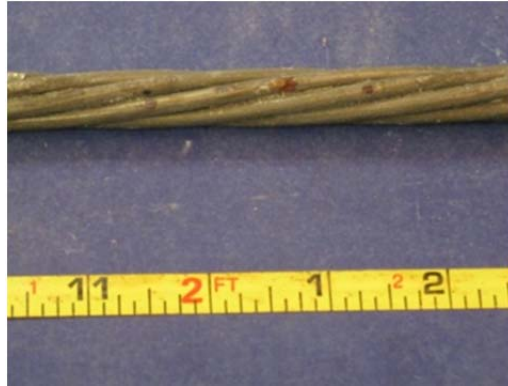
midspan, with discoloration or light corrosion over the remaining intervals (see Figure 5.17). The inner wires of these strands were also more damaged, with flecks of light to moderate corrosion over most of their length. Overall, the corrosion ratings were highest at the location of transverse surface cracks and consistent over the rest of the tendon.

*Figure 5.17: Specimen T.2, North Duct Strand Showing Pitting Near Midspan*

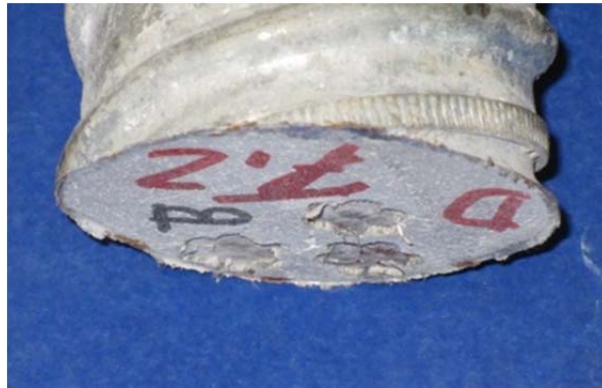
The south tendon strands shortened by approximately 0.1 inches after the anchorage had been removed from the specimen, as shown in Figure 5.20. Strands in both tendons experienced light to moderate corrosion at their exposed ends and more localized light corrosion or discoloration elsewhere. The wedges showed some surface corrosion but were substantially intact. The appearance of a typical strand, with and without wedges, is shown in Figure 5.21. Corrosion ratings for the anchorage zone strands are and summarized in Table 5.8.

*Figure 5.20: Specimen T.2, Debonded Strands in South Anchorage*

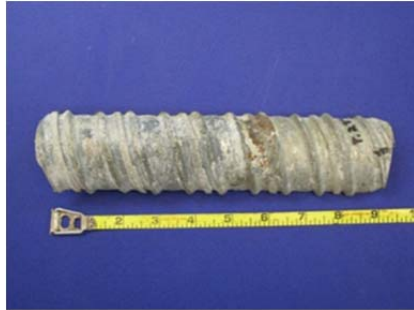
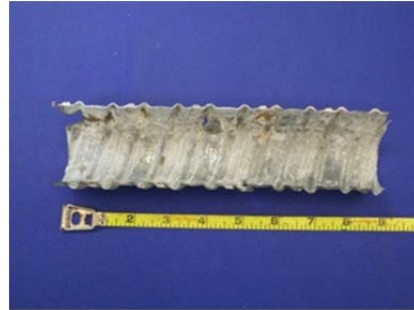
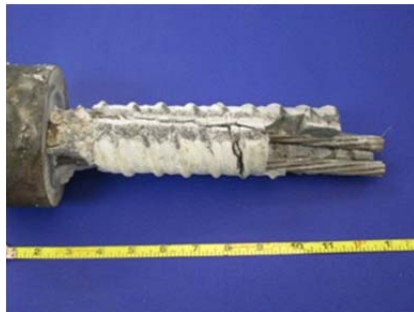
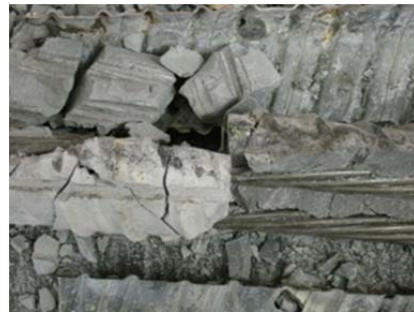
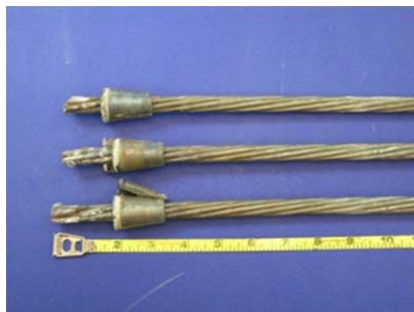
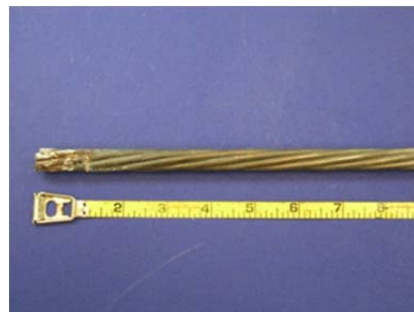
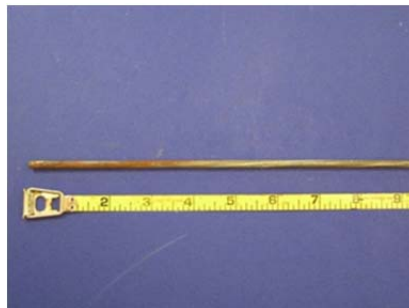
*Figure 5.21: Specimen T.2 Anchorage Region Elements*

The epoxy applied to the anchorages before casting the pourback was largely intact. The epoxied surfaces were mostly either undamaged or lightly discolored. The bottom surfaces and outside edges of both bearing plates experienced some localized moderate corrosion. The duct

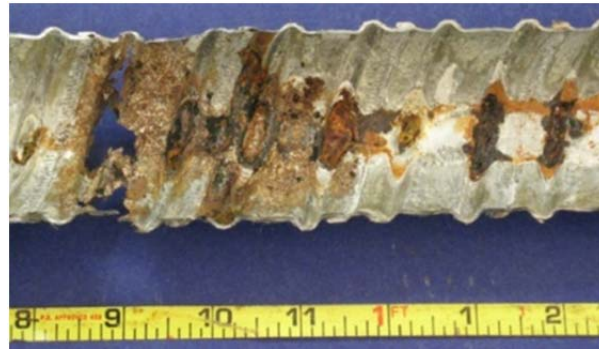
Both galvanized steel ducts showed severe localized corrosion damage. The outside top half of the north duct experienced area loss and extensive pitting over several intervals near midspan and its quarter points, as shown in Figure 5.26. Inside the top half, pitting and area loss were just as severe. The void appeared to be continuous between 8 inches and 22 inches from the live end of the autopsy region. Corrosion may have initiated at midspan and traveled outward over this void (see Figure 5.23). The pattern of the discoloration on the bottom of the duct suggests that the grout was cracked over much of its length and that at least two of the strands had rubbed against it during its life. Among large areas of discoloration, some regions of the inside even showed the characteristic sheen of new metal.

Figure 5.23: Specimen 1.2, Area Loss and Large Void on Top Inner Surface of North Duct

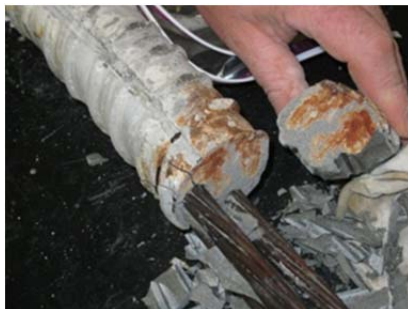
*Figure 5.24: Corrosion Staining Within South Grout*

The south tendon grout was also cracked transversely every few inches along its length. Staining occurred at the locations corresponding to area loss and pitting of the surrounding duct. This staining permeated from the top of the grout down to the level of the strands (see Figure 5.24). Localized yellow-orange discoloration spots were also observed on all sides of the grout. Some portions of strand were exposed on the bottom of the grout, but not nearly to the extent of the north grout. The south grout was extremely well-consolidated compared to the north grout. Maximum chloride concentration in the grout was 0.112% at midspan. Measurements taken at 8 and 32 inches from the live end were approximately at the threshold for corrosion. Chloride content for grout in both tendons is given in Figure 5.27.

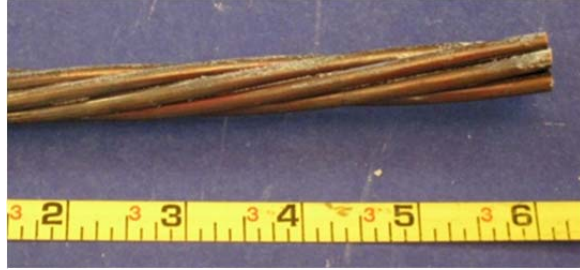
Strand damage was minor and extremely uniform in both tendons. The copper-clad strands did not show any corrosion on any wire within any interval. Instead, the strands assumed a dark black patina over their entire length. The patina was darkest and glossiest on the inner wire of each strand, but could be scoured off of the outer wires more easily than the inner wires. The patina as seen on the inner and outer wires of the strands is shown in Figure 5.26. The ends of each strand took on a slightly lighter patina than the areas within the autopsy region. The distinctive orange color of copper was even visible in spots at the ends of some strands. At the ends of several strands, a bright red color was observed, as shown in Figure 5.25. This may have been a phenomenon known as dezincification. This is a type of selective corrosion in which zinc leaches out from copper alloys and oxidizes, forming a characteristic red color<sup>22</sup>. The zinc content of the copper-clad strand is unknown. Transverse lines were visible on many outside wires of the strands in both ducts. These lines coincide with the locations of cracks in the north duct grout. Strand corrosion ratings are shown in Figure 5.27 and summarized in Table 5.9.

*Figure 5.25: Specimen 1.2, Possible Dezincification*

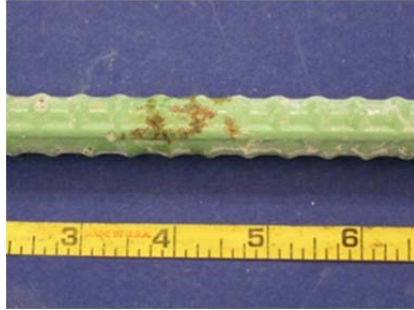
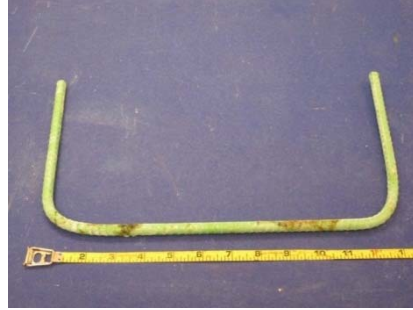
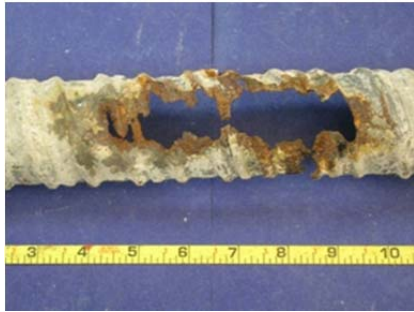
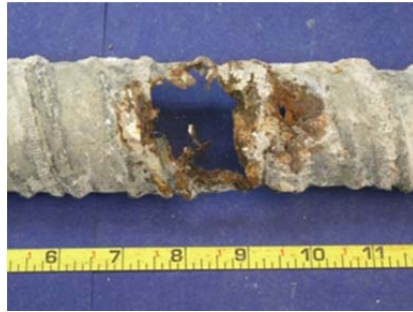
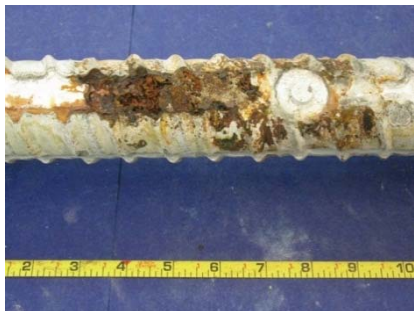
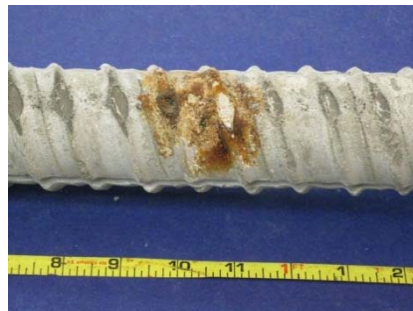
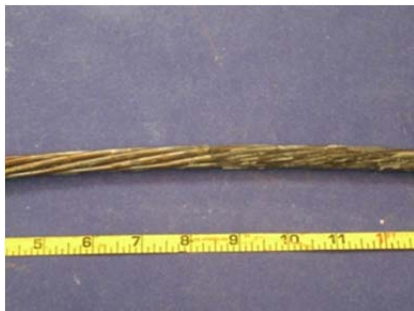
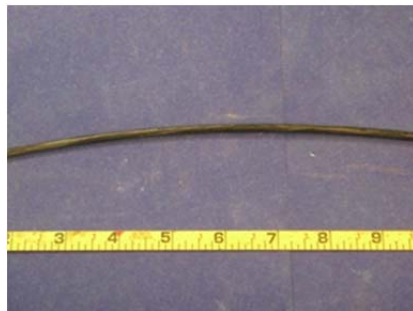
*Figure 5.26: Specimen 1.2, Main Autopsy Region Elements*

Damage to both longitudinal bars was minor. Spots of discoloration and light surface corrosion occurred on the top and bottom of both bars at the locations where stirrups were tied. Typical longitudinal bar corrosion for this specimen is shown in Figure 5.26. Longitudinal bar corrosion ratings are shown in Figure 5.27 and summarized in Table 5.9.

The south duct was similarly damaged. Its area loss was more extreme than the north duct at the live end quarter point. Pitting and area loss occurred over only a few intervals near each quarter point and midspan. The remainder of the duct was only slightly discolored or lightly corroded, as shown in Figure 5.26. Overall, the discoloration within both ducts was much darker than expected. This may be due to the dark patina of the copper-clad strand in this specimen. Duct corrosion ratings are shown in Figure 5.27 and summarized in Table 5.9.

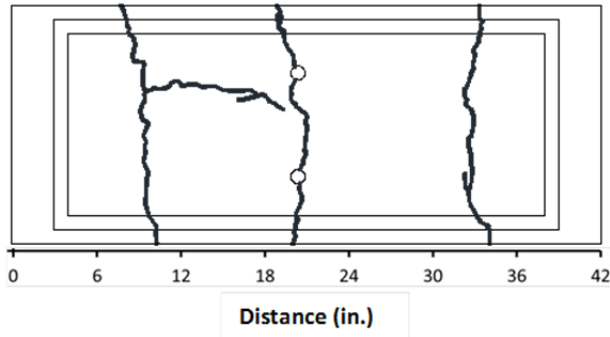
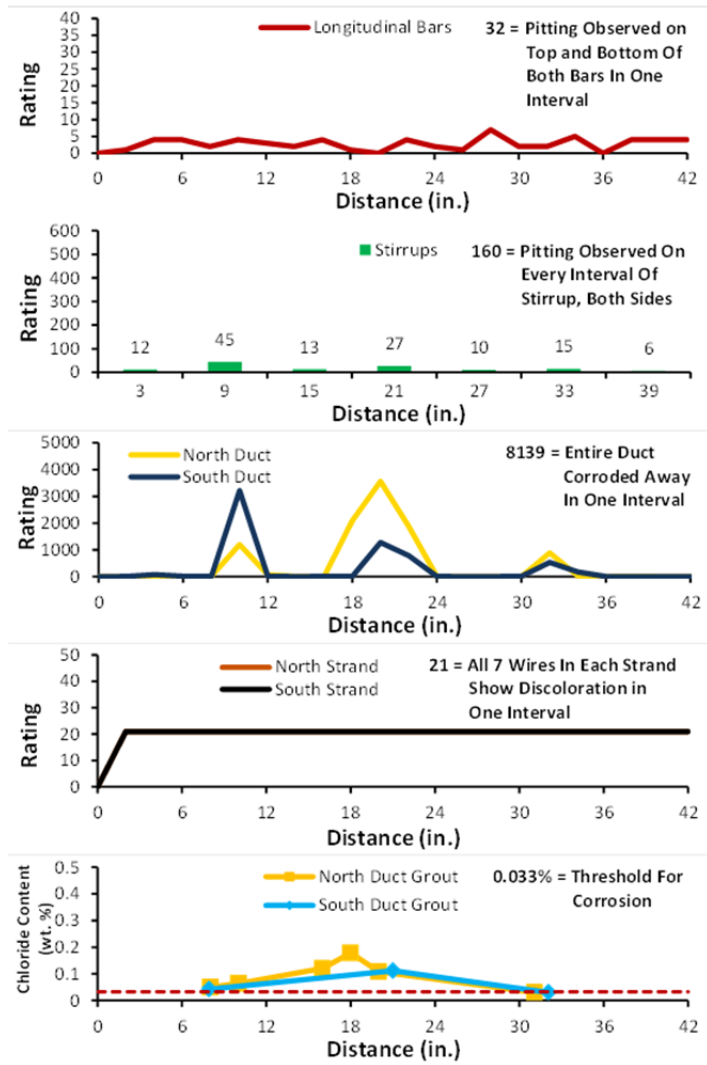
Figure 5.27: Specimen 1.2 Crack Map and Corrosion Rating Plots

There were three large transverse cracks that crossed the top of the specimen and extended down its north and south faces. These cracks were located roughly at the quarter points of the specimen. Their average width was 0.02 inches. One longitudinal crack extended from near the middle transverse crack to the live end transverse crack approximately six inches from the north edge of the specimen, and its width was 0.004 inches. The crack diagram is shown in Figure 5.27.

Both tendon grouts had similar chloride distributions. However, the north tendon grout had a long continuous void on its top surface, while the south did not. This means that chlorides are transported through strand interstices and grout voids at approximately the same rate, achieving the uniform distributions shown in Figure 5.27.

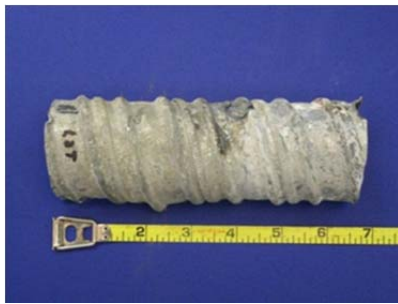
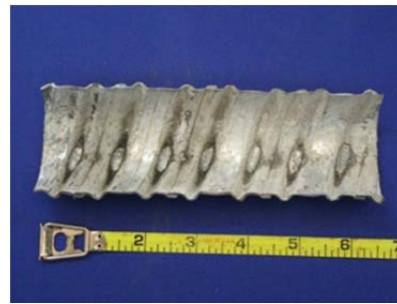
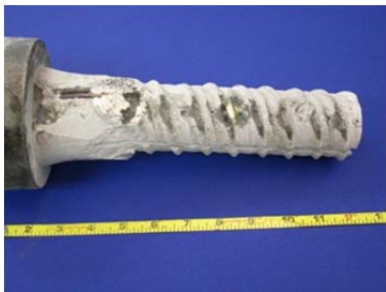
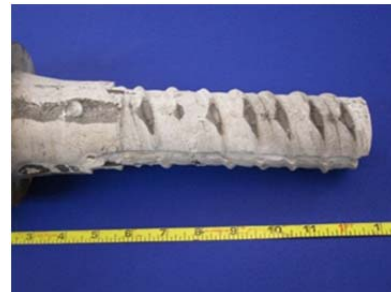
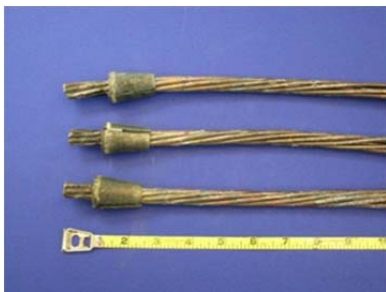
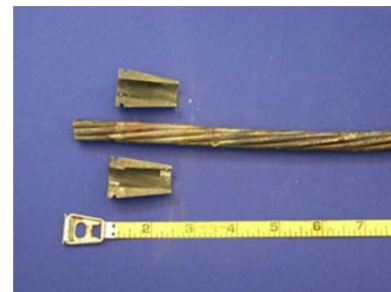
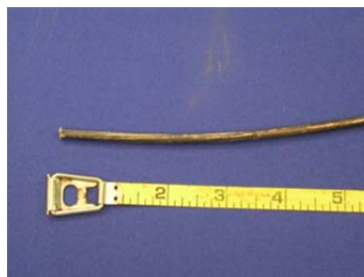
*Figure 5.28: Specimen 1.2 Anchorage Region Elements*

Discoloration on the anchorage zone strands was not as uniform as in the main autopsy region. The black patina was intermittent over most of each anchorage zone strand. Multi-colored staining and some extremely localized corrosion were found in the wedge region. This suggests that the wedges may have damaged the copper coating and exposed the regular steel below. Damage to the inner wires was comparable to that of the outer wires for all strands. All wedges were found to be intact. The appearance of a typical strand, with and without wedges, is shown in Figure 5.28. Corrosion ratings for the anchorage zone strands are in Table 5.10.

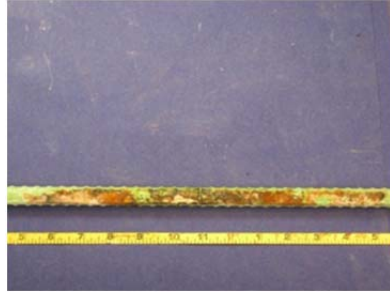
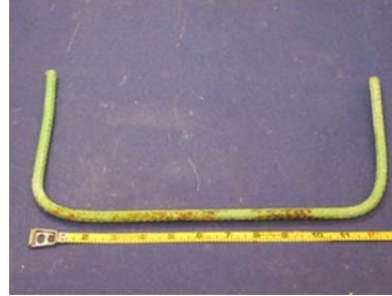
*Figure 5.31: Specimen 2.2 Main Autopsy Region Elements*

The stirrups also experienced moderate but consistent damage (see Figure 5.31). Only two stirrups experienced pitting on any interval. The three most severely damaged stirrups were the ones located beneath each of the specimen's transverse surface cracks. Stirrup corrosion ratings are shown in Figure 5.32 and summarized in Table 5.11.

The north and south ducts showed severe localized corrosion damage. The north duct had significant area loss over the intervals corresponding to the locations of the specimen's transverse surface cracks (see Figure 5.31). Damage to the south duct was comparable to that of the north duct. Duct corrosion ratings are shown in Figure 5.32 and summarized in Table 5.11.

The north tendon grout was cracked transversely every few inches along its entire length. Significant staining was present in the areas corresponding to duct corrosion and area loss. This staining seeped down the grout through its transverse cracks, though not to the level of the strands (see Figure 5.31). The grout appeared not to have consolidated well around the lowest strands in the tendon. At least one strand was partially exposed over much of the duct's length. Maximum chloride concentration in the grout was 0.084%, occurring 20 inches from the live end. Elsewhere in the north grout, the chloride levels were at or just above the corrosion threshold.

The south tendon grout was similar in appearance to the north tendon grout. A large, continuous void was present from about 8 inches to about 20 inches from the live end. This void was approximately 1 inch wide (see Figure 5.31). Extensive corrosion staining was found corresponding to the regions of the duct that experienced the most severe corrosion and area loss. Like the north duct, this staining seeped downward through the grout's transverse cracks. The maximum chloride content of 0.43% occurred 18 inches from the live end of the grout. Beneath the live end transverse surface crack, the chloride concentration was 0.14%. Beneath the dead end crack, chloride levels were just above the corrosion threshold. Chloride content for grout in both ducts is given in Figure 5.32.

discoloration at worst. Damage to the south tendon strands was comparable to the north duct strands. A typical strand and inner wire are shown in Figure 5.31. Strand corrosion ratings are shown in Figure 5.32 and summarized in Table 5.11.

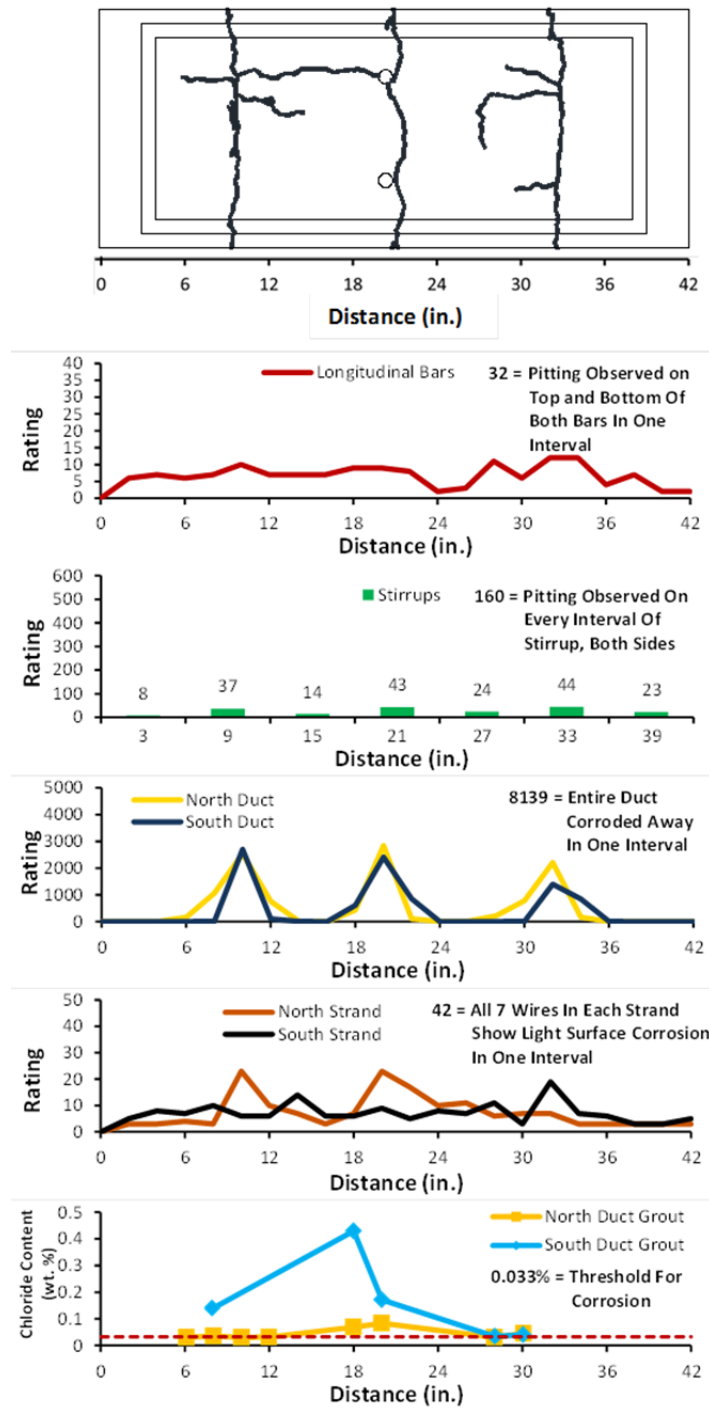
Figure 5.32: Specimen 2.2 Crack Map and Corrosion Rating

Both the north and south anchorage zone ducts experienced very mild corrosion damage. Lines visible in the duct surface discoloration suggest that the grout was cracked transversely. North and south ducts are shown in Figure 5.33. Anchorage zone duct corrosion ratings are shown in Figure 5.32 and summarized in Table 5.12.

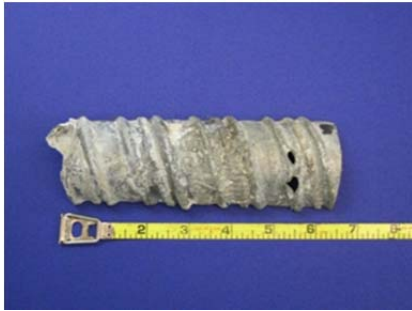
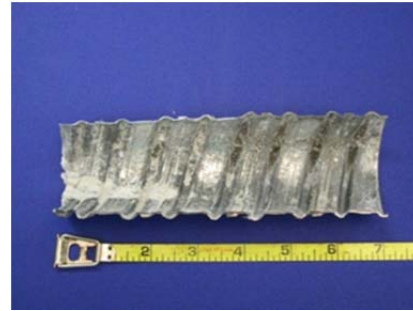
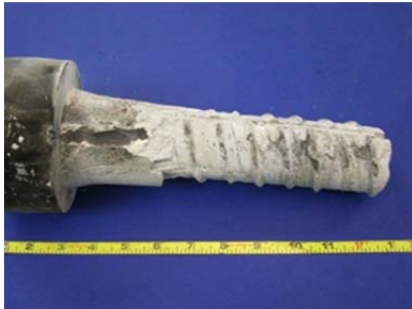
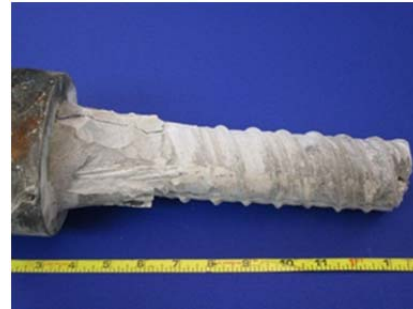
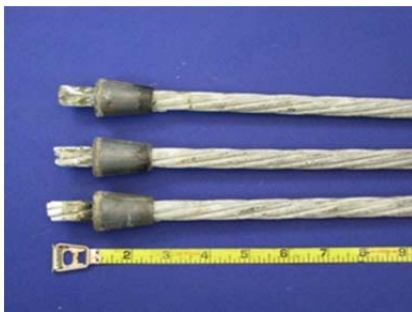
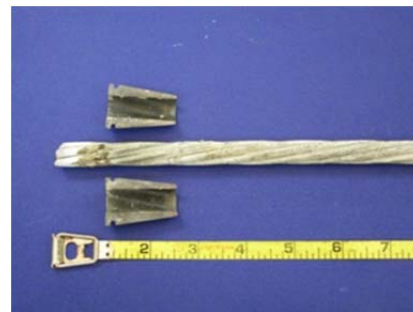
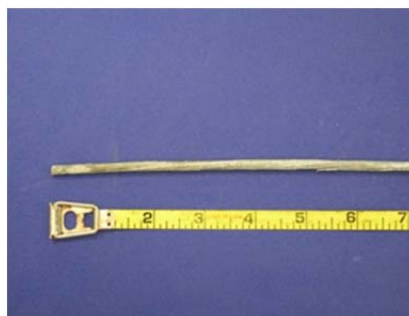
*Figure 5.33: Specimen 2.2 Anchorage Region Elements*

In the anchorage zone, all strands were found to have an extremely strong bond with the surrounding grout, just as was observed in the main autopsy region. Damage to all anchorage zone strands was limited to discoloration or light surface corrosion for all wires in all intervals. All wedges were found to be intact. Some localized light corrosion was found on their exteriors as well as slight discoloration in their inner regions. Typical strands, with and without wedges, are shown in Figure 5.33. Anchorage zone strand corrosion ratings are summarized in Table 5.11.

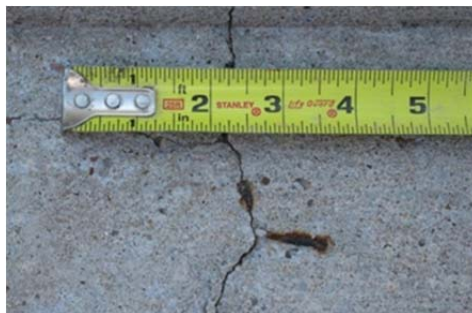
Figure 5.35: Specimen 2.4, Corroded Wire Tie at Top Surface

Light to moderate spalling was visible around the specimen's transverse cracks, especially toward the middle of the specimen. The top of a corroded wire tie was visible through the surface of the concrete just toward the live end from the north grout vent. This is shown in Figure 5.35.

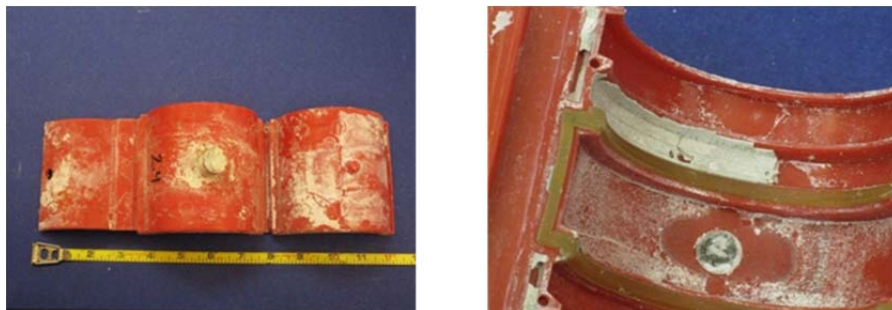
*Figure 5.36: Specimen 2.4 North Duct Coupler Exterior (Left) and Gasket (Right)*

The north duct coupler appeared undamaged. There were some small orange-brown flecks present on and around the coupler's grout vent outlet, and the same chalky white residue

that was observed on the ducts was also present on the exterior of the coupler. The coupler's mechanical connections and gaskets were intact. The latter did not appear to be affected by the widespread scratching that occurred in the duct itself (see Figure 5.36). Cement paste was present inside the coupler but outside the gasket. Inside the gasket were grout residue and the white crystals that were present inside both ducts. There was also evidence of a small void in the vicinity of the coupler's grout vent. The south duct was continuous and did not have a coupler. The epoxy used to seal the south duct grout vent was slightly detached from the duct at midspan.

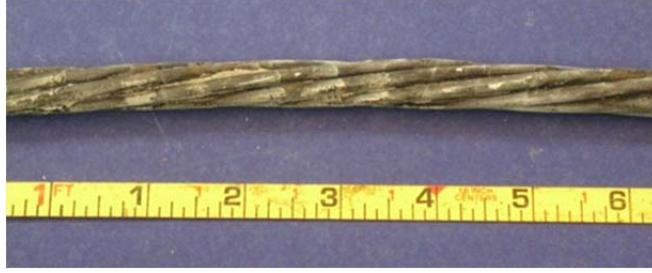
*Figure 5.37: Specimen 2.4, Lines in Strand Discoloration*

A uniform, glossy black patina was observed over every interval of every wire in every strand of the specimen. The patina was much glossier and somewhat darker on the inner wires than the outer wires. At the ends of each strand, the patina was less prevalent, and traces of the original copper color were visible in many spots. This can be seen in Figure 5.38. On the outer wires, the patina could generally be removed with a scouring pad. This was not the case for the inner wires. Transverse lines were visible in the traces of grout near midspan of all strands. These lines indicated the locations of cracks in the surrounding grout (see Figure 5.37). Unlike specimen 1.2, no signs of dezincification were found. Strand corrosion ratings are shown in Figure 5.39 and summarized in Table 5.13.

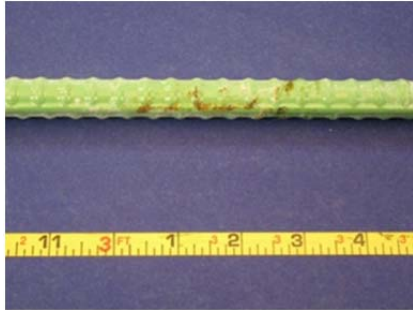
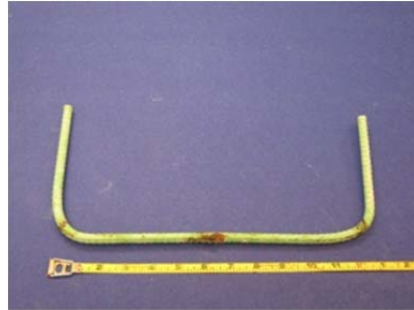
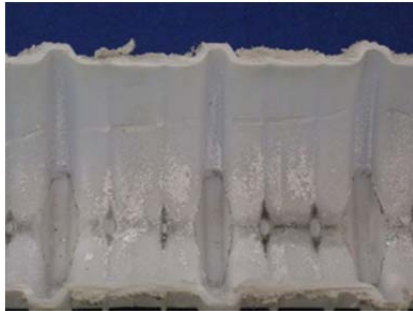
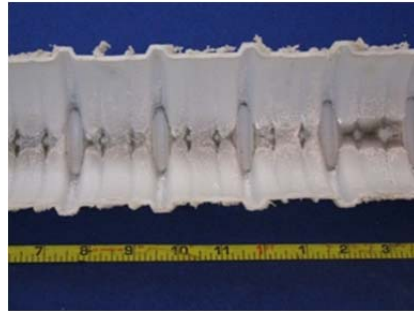
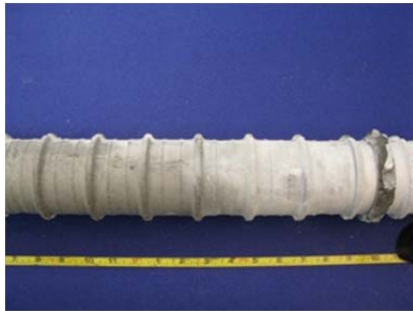
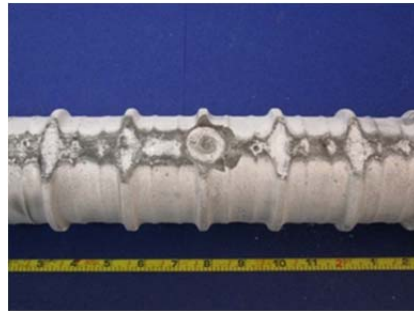
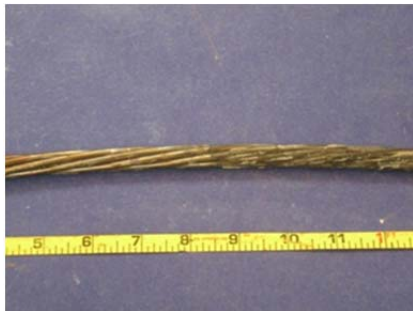
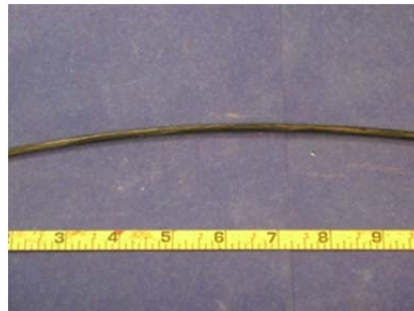
*Figure 5.38: Specimen 2.4 Main Autopsy Region Elements*

Damage to the north and south longitudinal bars was moderate and localized, mostly where stirrups were tied (see Figure 5.38). Damage was more severe to the underside of the bar than to the top. The extent of corrosion was similar in the south bar, although somewhat more severe. Localized pitting was observed over one interval near the live end of the bar. Longitudinal bar corrosion ratings are shown in Figure 5.39 and summarized in Table 5.13.

The north and south plastic ducts were in near-perfect shape upon autopsy. The top of the inside of the north duct had scratches along approximately 36 inches of its length. These scratches had a depth of between 5 and 10 percent of the duct's wall thickness (see Figure 5.38). The top of the inside of the south duct was similarly damaged, although the scratches were shallower and shorter in length. Duct damage ratings are shown in Figure 5.39 and summarized in Table 5.13.

The north tendon grout was cracked transversely every few inches along its entire length. One longitudinal crack was visible on the underside of the grout. This crack appeared to terminate within approximately 6 inches of each end of the grout (see Figure 5.38). Chloride concentration at midspan was 0.2% in the north tendon.

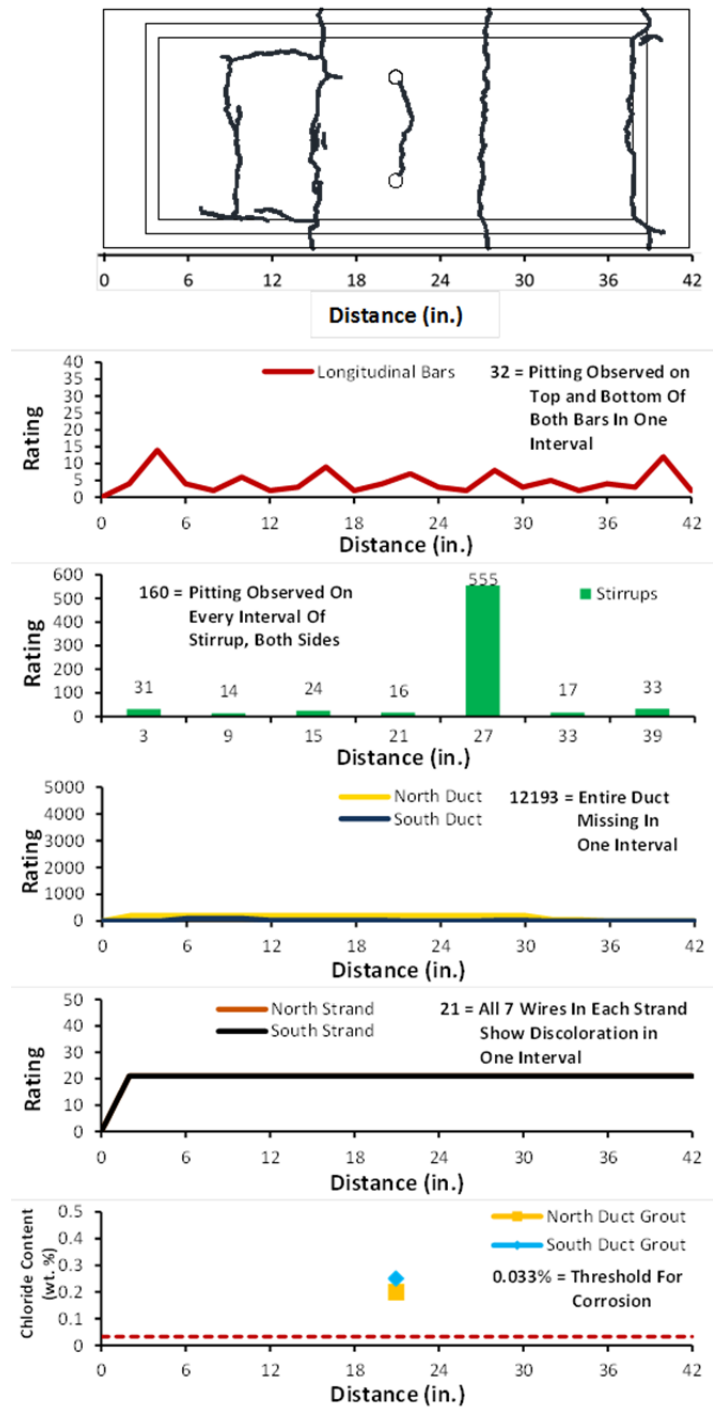
Figure 5.39: Specimen 2.4 Crack Map and Corrosion/Damage Rating Plots

leakage was still intact. These transverse cracks had an average width of 0.04 inches. Two secondary transverse cracks were also visible. These did not cross the entire specimen and had an average width of 0.035 inches. Two longitudinal cracks were found that connected the two transverse cracks nearest to the specimen's live end. The average width of these cracks was 0.015 inches. Most of the cracks on the specimen had more than one branch. Overall, the top of this specimen was the most cracked of any seen up to this point. The crack diagram is shown in Figure 5.39.

Stirrups in this specimen were moderately damaged. Six of the seven stirrups had moderate corrosion or pitting over at least one interval. The worst damage tended to occur at the bend points of the stirrups and at locations where ducts were tied. Stirrup #5 suffered the heaviest damage. This stirrup lost over 20% of its cross sectional area over a small length at midspan of its horizontal portion (see Figure 5.38). Damage did not correspond clearly to surface crack location. Although stirrup #5 was located beneath a transverse surface crack, corrosion ratings for the other six stirrups were relatively independent of location. Stirrup corrosion ratings are shown in Figure 5.39 and summarized in Table 5.13.

The south tendon grout was also cracked every few inches along its length. One longitudinal crack was observed at roughly midheight of the grout. This crack extended along the grout's entire length. While intact, this grout was much smoother to the touch over its entire exposed surface than any grout encountered thus far. This may indicate that pressure was high and uniform during the grouting process. One strand was exposed on the underside of the grout from approximately 16 inches to 24 inches from the live end. Chloride concentration at midspan was 0.25% in the south duct. Chloride content for grout in both ducts is shown in Figure 5.39.

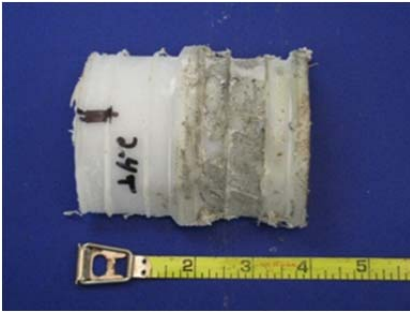
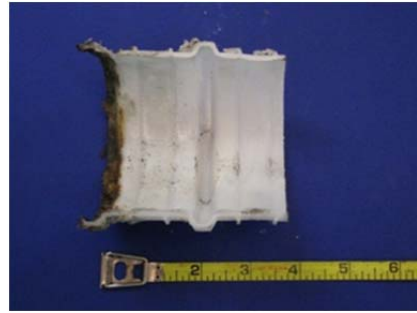
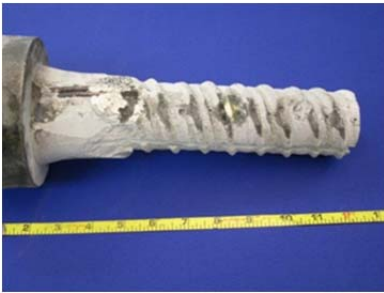
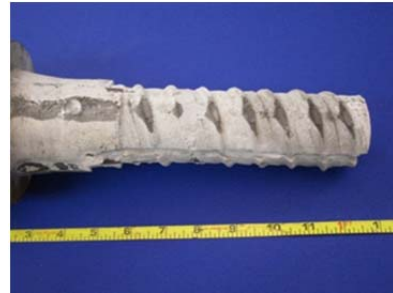
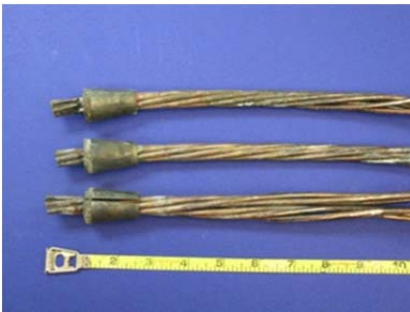
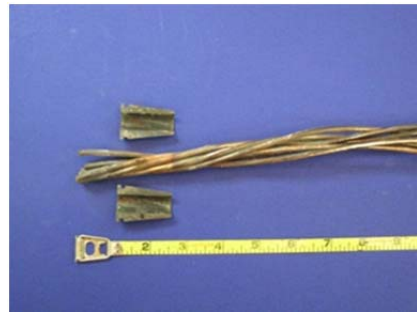
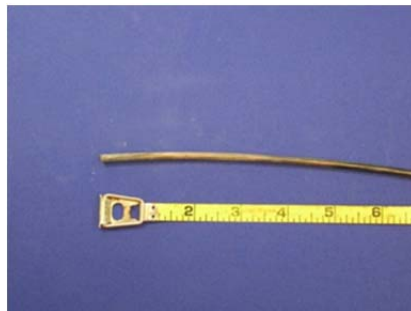
*Figure 5.40: Specimen 2.4 Anchorage Region Elements.*

Both anchorage zone ducts showed evidence of voids in their upper flutes, as well as traces of the same white crystals found in the ducts of the main autopsy region. In addition, the outside of the ducts were covered with traces of the same chalky white residue that had been found on the outside of the ducts in the main autopsy region. North and south anchorage zone ducts are shown in Figure 5.40. No scratches or gouges were found inside the ducts. Anchorage zone duct corrosion ratings summarized in Table 5.14.

Within the first four inches from the end of the specimen of all six strands, the distinctive green color of corroding copper was visible in very localized spots. No sign of steel corrosion was found in this region on any strand. Moving in toward the specimen interior, the same patina that covered the strands in the main autopsy region was found, although the patina covered much less of the strands' overall area. Two of the specimen's dead end wedges were cracked, and some spots of moderate corrosion were found on both the inside and outside surfaces of all six wedges. Typical strands, with and without wedges, are shown in Figure 5.40. Anchorage zone strand corrosion ratings are summarized in Table 5.14.

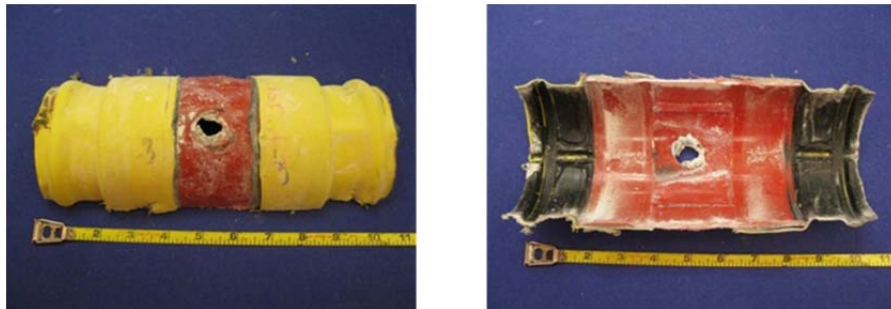
Figure 5.42: Specimen 3.1 North Duct Coupler Outer Surface (Left) and Inner Surface (Right)

The heat shrink coupler applied to the north duct was mostly intact at the time of autopsy. Both the inside and outside surfaces of the coupler showed similar discoloration and evidence of more voids than what was observed on the north duct itself. The seam between the dead end heat shrink and the coupler appeared somewhat detached around its entire circumference. This may have occurred during the autopsy process. The heat shrink tubing was somewhat brittle and easy to peel back from the duct surface. There may not have been a perfect heat shrink seal around both ducts. The coupler is pictured in Figure 5.42.
