1. Report No. FHWA/TX-11/0-4562-4		2. Government Accession No.		3. Recipient's Catalog No.	
4. Title and Subtitle Evaluation of Corrosion Resistance of Improved Post-tensioning Materials after Long-term Exposure Testing			5. Report Date October 2011

CTR Technical Report:	0-4562-4
Report Date:	October 2011
Project:	0-4562
Project Title:	Corrosion Resistance of Grouted Post-Tensioning Systems
Sponsoring Agency:	Texas Department of Transportation
Performing Agency:	Center for Transportation Research at The University of Texas at Austin

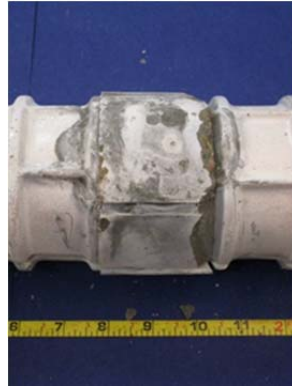
*Figure 5.43: Specimen 3.1 Cement Paste and Large Aggregate Embedded in North Grout*

The north tendon grout had transverse cracks every few inches along its entire length. This is not surprising because the grout is placed after the tendon has been post-tensioned so that the grout is not prestressed itself. No longitudinal cracks were observed. The outside wires of one strand were visible on the grout's bottom surface approximately 28 inches from the live end. There did not appear to be any problems with consolidation in this region. Large aggregate and

evidence of concrete paste intrusion were found on the underside of the splice region. This indicates that the heat shrink seal had been breached during the construction process (see Figure 5.43). The grout exterior was very smooth over its entire length, indicating high, uniform pressure during grouting. Chloride content at midspan was 0.067%.

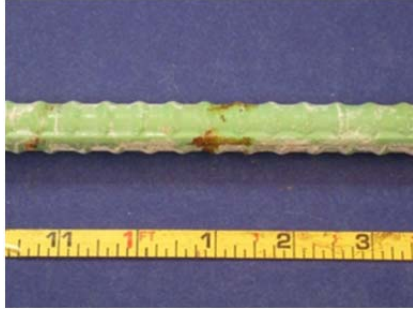
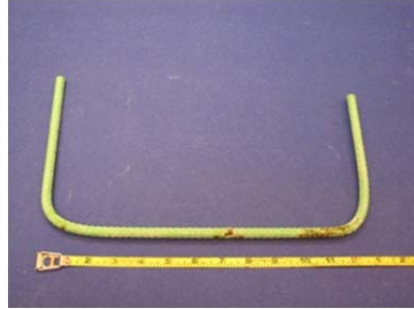
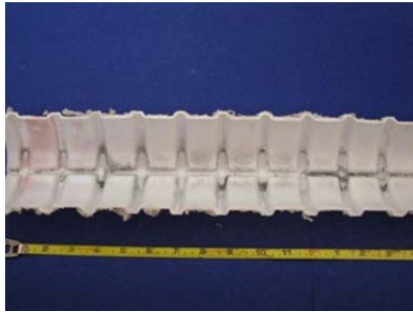
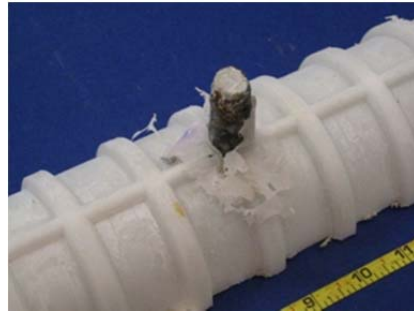
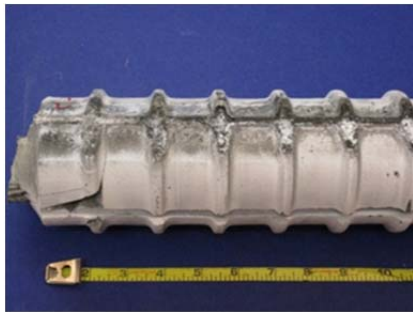
Both the north and south longitudinal bars showed only minor corrosion damage, mostly at the locations where stirrups had been tied, as shown in Figure 5.44. Corrosion ratings for both bars were highest underneath the location of the specimen's transverse surface cracks. Longitudinal bar corrosion ratings are shown in Figure 5.45 and summarized in Table 5.15.

The stirrups showed relatively minor damage. Only two stirrups showed pitting in any interval. Most corrosion and discoloration were observed at the inner and outer surfaces of the stirrups' bend radii, as well as at midspan of their horizontal regions (see Figure 5.44). The stirrups with the highest corrosion ratings were those found directly beneath the specimen's three transverse surface cracks. Stirrup corrosion ratings are shown in Figure 5.45 and summarized in Table 5.15.

The south tendon grout was cracked transversely every few inches along its length. No longitudinal cracks were found. One continuous void, approximately 1.25 inches wide, was found on the top of the grout extending from the live end to near midspan. The remainder of the grout showed smaller voids, about 0.5 inches across, on its top surface, connected by the top longitudinal rib of the duct. The surface of the large void was white in color with a gray perimeter and many small gray craze cracks. The smaller voids were uniformly gray in color, as shown in Figure 5.44. Chloride content for north and south grouts is shown in Figure 5.45.

Corrosion ratings were nearly uniform along the strands' length. No clear correlation with crack location was observed. A typical strand and inner wire are shown in Figure 5.44. Strand corrosion ratings are summarized in Table 5.15.

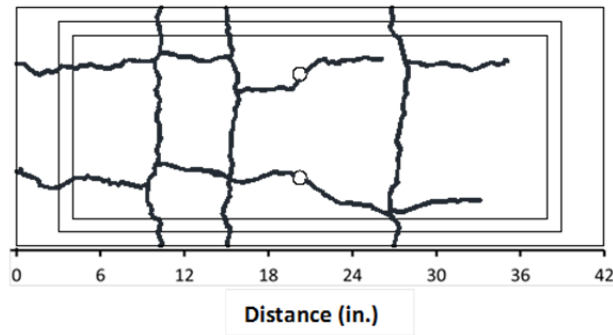
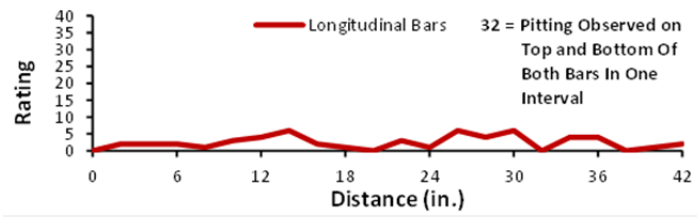
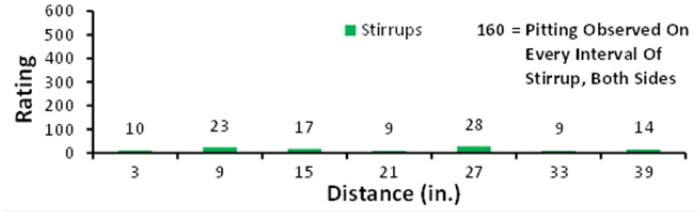
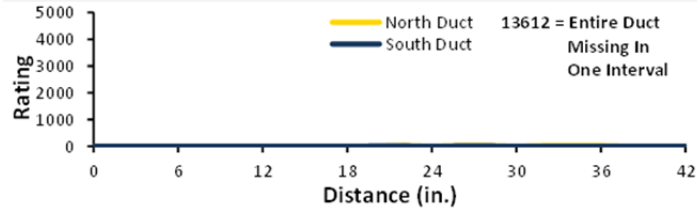
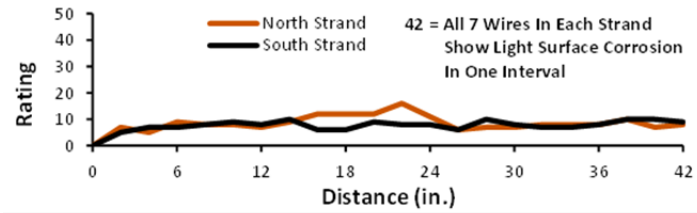
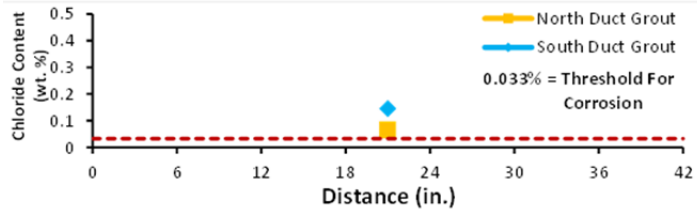
Figure 5.45: Specimen 3.1 Crack Map and Corrosion/Damage Rating Plots

The entire north plastic duct had a chalky white residue over its entire exterior, along with several localized corrosion stains. Many of these spots were located near the heat shrink splice at midspan. The top interior portion of the north duct showed evidence of small voids that had formed in the duct's top flutes over its entire length. These voids were somewhat larger near the live end of the duct than the dead end, and all of the voids were made continuous by the duct's top longitudinal rib (see Figure 5.44). Damage to the south duct was similar to that of the north duct. The epoxy that sealed the grout vent at midspan appeared to have detached from the duct somewhat. It is unknown whether this occurred during autopsy or some time before (see Figure 5.44). The bottom interior portion of the duct had some light gouges between midspan and the dead end. It appeared that one strand had been bearing directly on the duct there. Duct damage ratings are shown in Figure 5.45 and summarized in Table 5.15.

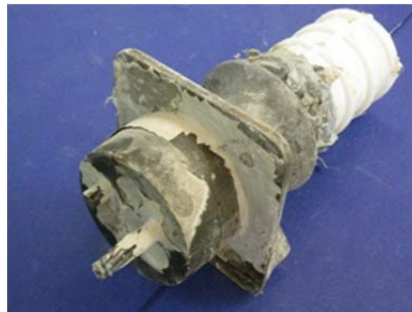
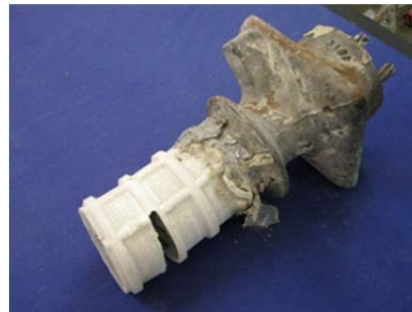
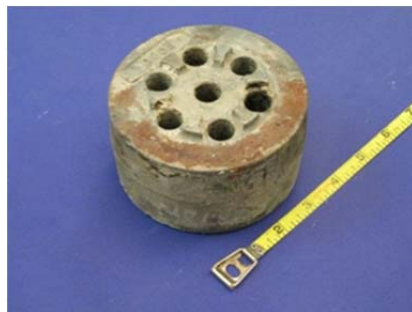
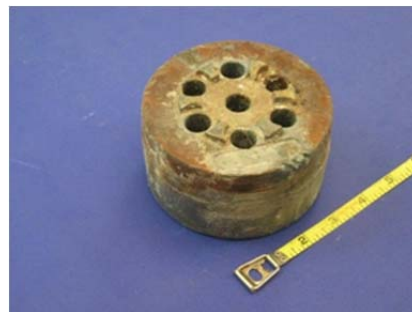
*Figure 5.46: Specimen 3.1 Dead End Anchorages and Anchor Heads*

Since the specimen had dead end anchorages exposure (drippers) photos are shown of both dead end (Figure 5.46) and live end anchorages for comparison (Figure 5.48). The epoxy used to seal the exposed areas of the anchorages was mostly intact on the bearing plates, but largely missing on the anchor heads. The exposed surface of the north bearing plate showed widespread moderate surface corrosion, mostly concentrated on the bottom half of the plate. The south bearing plate was much more affected, with moderate corrosion covering most of its outer surface. Extensive surface corrosion was found on the bottom surface of both bearing plates. Although the duct tape used to connect both ducts to the bearing plates was mostly intact, widespread corrosion and pitting were found underneath. This damage was more severe to the south bearing plate than to the north. The outer surfaces of both anchor heads had localized spots of light to moderate surface corrosion. The surfaces that had been bearing on the anchorages showed much more widespread moderate corrosion, corresponding to the respective level of corrosion in both bearing plates. The north and south anchorages and anchor heads are shown in Figure 5.46.

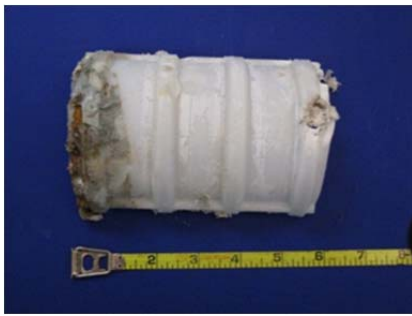
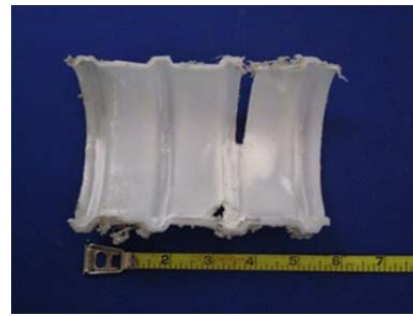
*Figure 5.47: Specimen 3.1 Dead End Anchorage Region Elements*

The outside of both the north and south ducts showed the same chalky white residue that was found on the ducts in the main autopsy region. In addition, prominent corrosion stains were found on the outer surface of the ducts where they had been spliced with the anchorages. Some very light gouges were observed in the interior of the south duct. However, the ducts were moderately damaged during the autopsy process, so the damage may have occurred at that time. The bottom interior surfaces of both ducts showed traces of the white crystals that were found in

the main autopsy regions, but to a much lesser extent. North and south ducts are shown in Figure 5.47. Dead end anchorage zone duct corrosion ratings are summarized in Table 5.16.

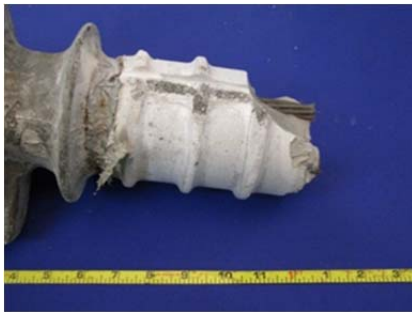
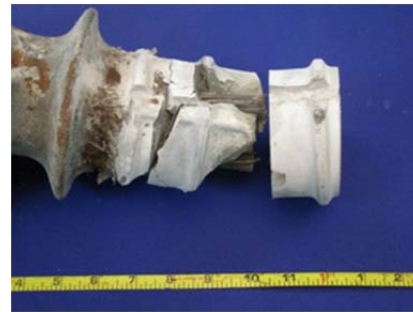
Both the north and south tendon grout had small voids corresponding to the top of the transverse duct flutes. Heavy corrosion staining was visible on the edge of the grout nearest to the corroded anchorage-duct splices. Both grouts were damaged during the duct removal process, so the extent of cracking could not be determined. North and south grouts are shown in Figure 5.47.

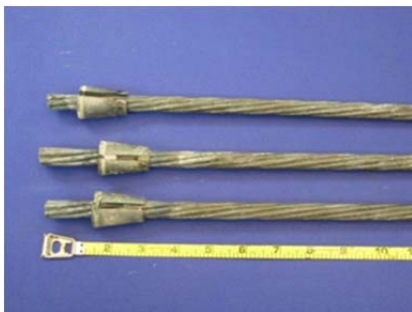
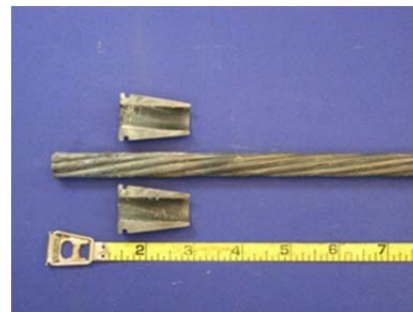
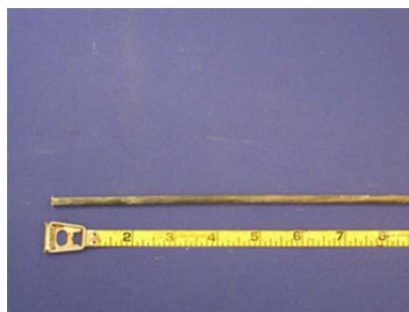
Damage to the strands in both ducts was most severe in the regions outside the anchor head and inside the wedges. Light to moderate surface corrosion spots were found on several outer wires per strand in these regions. Further into the specimen, the outer wires were far less damaged, showing light discoloration and the occasional light corrosion spot. The inner wires of all strands were much more uniformly damaged, with light surface corrosion spots on most intervals. All 6 sets of wedges showed light to moderate corrosion on their outer surfaces and some discoloration spots inside. Damage to the wedges tended to be more extreme near their narrow end. Typical strands, with and without wedges, are shown in Figure 5.47. Dead end anchorage zone strand corrosion ratings are summarized in Table 5.16.

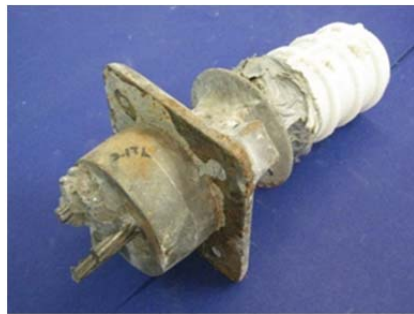
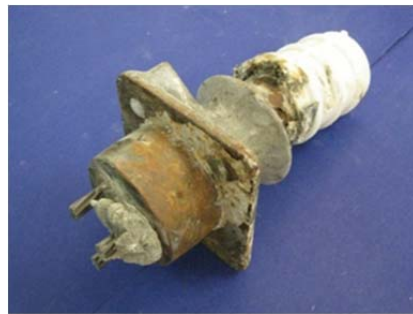
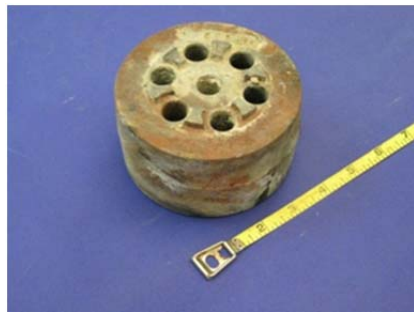
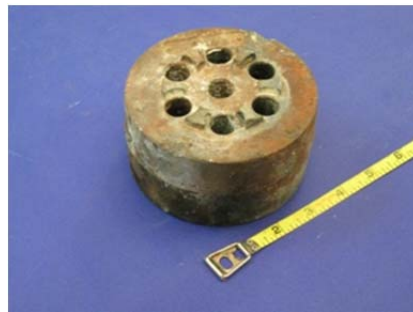
*Figure 5.48: Specimen 3.1 Live End Anchorages and Anchor Heads*

North and south anchorages and anchor heads are shown in Figure 5.48. The epoxy used to seal the exposed surfaces of both live end anchorages was almost entirely missing. The exposed front of the bearing plates were mostly covered with widespread moderate surface corrosion and some localized pitting. This damage tended to be more severe toward the bottom of the bearing plates. All outer surfaces showed some isolated surface corrosion, but widespread surface corrosion was found on the bottom surfaces of both bearing plates. This was most pronounced on the north bearing plate, whose bottom surface was nearly covered with corrosion. Some isolated damage occurred on the interior edges of both bearing plates, as well. The duct tape used to seal the bearing plate-duct connections was mostly intact on the north anchorage but mostly missing on the south anchorage. Heavy corrosion and some pitting were found underneath the duct tape. The inside surfaces of both anchor heads showed widespread moderate to heavy corrosion, while the outside surfaces were only slightly discolored. Corrosion on the sides of the anchor heads was more severe in the vicinity of the bearing plates.

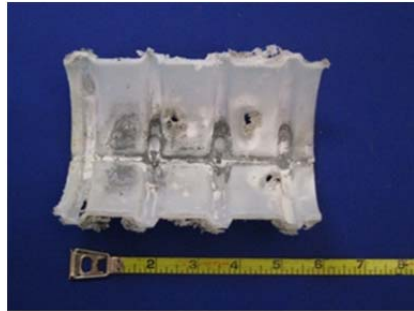
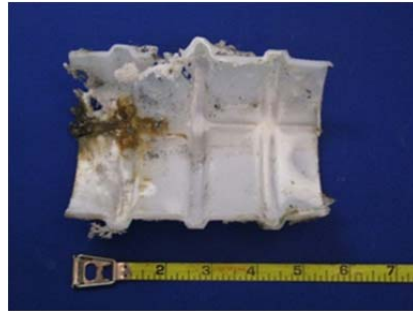
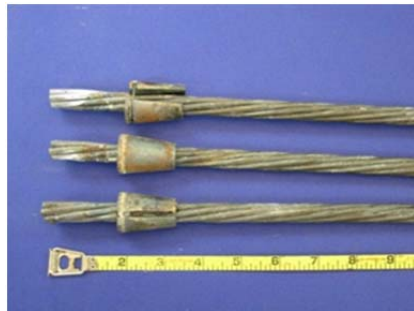
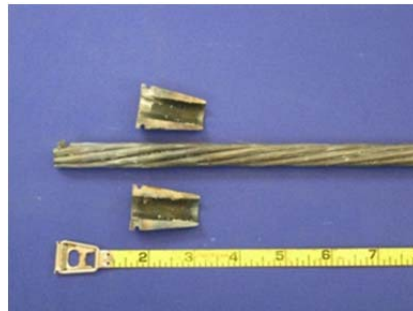
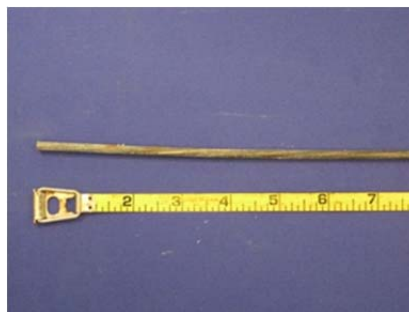
*Figure 5.49: Specimen 3.1 Live End Anchorage Region Elements*

North and south ducts are shown in Figure 5.49. Anchorage zone duct corrosion ratings are summarized in Table 5.16.

Both north and south tendon grouts were heavily damaged during the autopsy process. As a result, the extent of cracking and voids could not be ascertained. The grout appeared well-consolidated and uniform in color. Significant staining was present at the grout-anchorage interface for both the north and south duct grouts.

Damage to the anchorage zone strands was minor. Only two strands showed any corrosion spots that could not be scrubbed away. In general, the most severe corrosion occurred underneath the wedges and outside the anchor head. Corrosion spots were found on several wires per strand in these intervals. The outer wires on the remainder of the strands showed only minor surface corrosion spots or discoloration. The damage was only slightly more severe on the inner wires away from the anchor head region. All 6 wedges showed light to moderate surface corrosion on their outer surfaces and spots of discoloration on their inner surfaces. Typical strands, both with and without wedges, are shown in Figure 5.49. Anchorage zone strand corrosion ratings are summarized in Table 5.16.

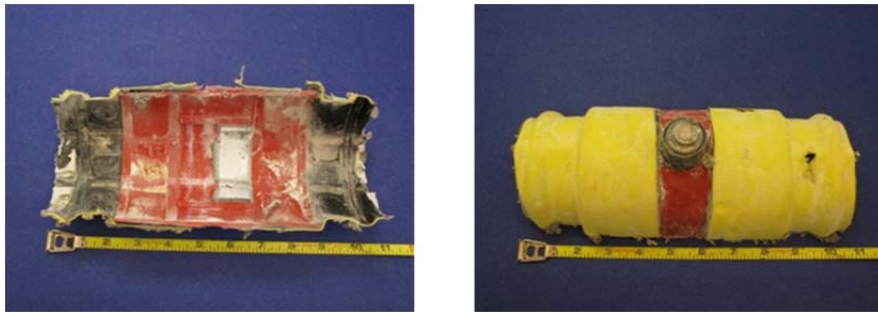
*Figure 5.51: Specimen 3.2 North Duct Coupler Inner Surface (Left) and Outer Surface (Right)*

The outer surfaces of the heat shrink splice showed the same chalky white residue as the rest of the north duct. The interfaces between the heat shrinks and the plastic coupler were somewhat detached (see Figure 5.51). This damage may have occurred during the autopsy process. The heat shrink tubing seemed somewhat brittle and was easy to peel back from the plastic coupler. The splice's seals may not have remained intact during the specimen's exposure.

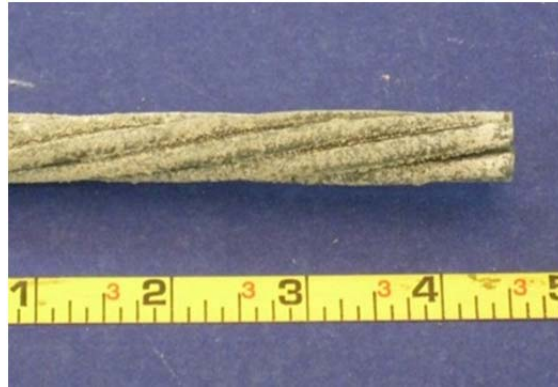
*Figure 5.52: Specimen 3.2, Bubbles in Interstices of Galvanized Strand*

Similar to Specimen 2.2, the galvanized strand in this specimen was observed to have a much stronger bond with the surrounding grout than other types of strand. In addition, small bubbles were observed in the interstices of several strands, most prominently within a few inches of the end of the strands, as shown in Figure 5.52. This may be a sign that a chemical reaction occurred between the strands' zinc coating and the surrounding grout.

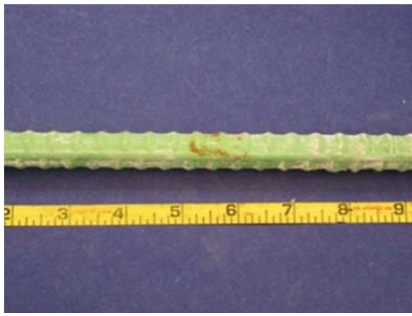
**Longitudinal Bar**

Both longitudinal bars experienced very minor corrosion damage (see Figure 5.53). The highest corrosion ratings occurred beneath the transverse surface crack nearest the live end of the autopsy region. Longitudinal bar corrosion ratings are shown in Figure 5.54 and summarized in Table 5.17.

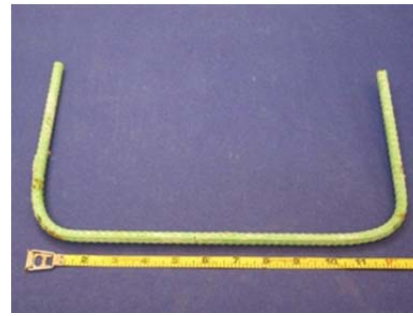
**Stirrup**

All stirrups showed localized corrosion damage as shown in Figure 5.53. Stirrup #1 showed the worst corrosion damage with localized pitting at the midpoint of its horizontal span. In general, corrosion ratings decreased across the autopsy region from live end to dead end. Stirrup corrosion ratings are shown in Figure 5.54 and summarized in Table 5.17.

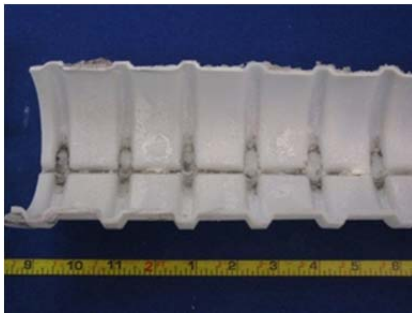
**Top of North Duct**

The exterior of the north duct was covered in chalky white residue. Some localized, dull corrosion staining was visible, as well. The top interior portion of the duct showed evidence of small voids that had formed within the top ribs of the duct. These voids appeared slightly larger on the live end half of the duct than on the dead end half. Traces of shiny white crystals were found around the upper ribs in the duct's interior, as well as intermittently on the lower region (see Figure 5.53). Light scratches were observed near midspan and near both ends of the duct on its bottom portion. This indicates that the duct was slightly damaged by the strand as it was passed through prior to stressing.

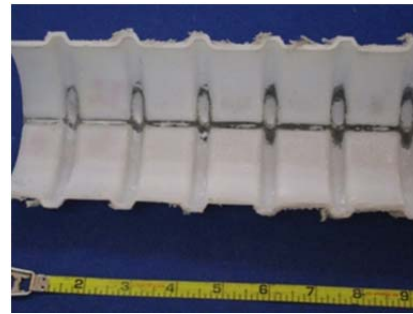
**Top of South Duct**

Chalky white residue and dull corrosion staining was observed on the outside of the south duct. The epoxy used to seal the joint between the duct and grout vent had separated somewhat from the duct surface. It is uncertain whether this occurred during autopsy or during construction. The inner top portion of the duct showed signs of voids within its upper transverse ribs. These voids were uniform in size along the duct's length and were made continuous by the duct's longitudinal rib, as shown in Figure 5.53. White crystals were observed near the upper ribs and on the bottom of the duct's interior. The bottom half of the duct had widespread light gouging over more than a foot of its length, centered at midspan. It appeared that one strand had

been bearing directly on the duct in that region. Duct damage ratings are shown in Figure 5.54 and summarized in Table 5.17.

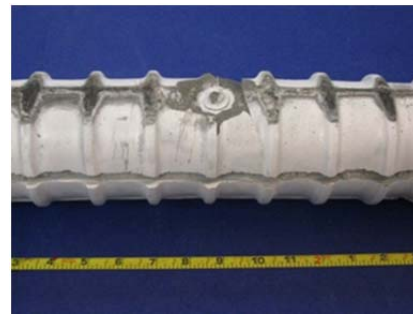
**South Grout**

The south tendon grout showed transverse cracks, but these cracks were only visible every few inches near midspan of the grout. Voids were observed in the top portion of the grout. These voids were approximately 1 inch in width along the entire length of grout and were connected by the duct's top longitudinal rib (see Figure 5.53). Like the north duct grout, this grout was difficult to break in order to extract the strands within. In addition, the grout was very smooth to the touch and shiny in appearance, especially on its bottom surface. These observations suggest that the south duct grout was extremely well consolidated. Chloride content at midspan was 0.188%. Chloride content for grout in both ducts is shown in Figure 5.54.

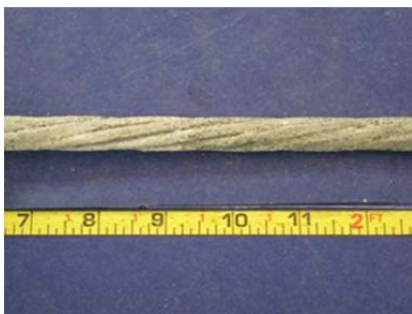
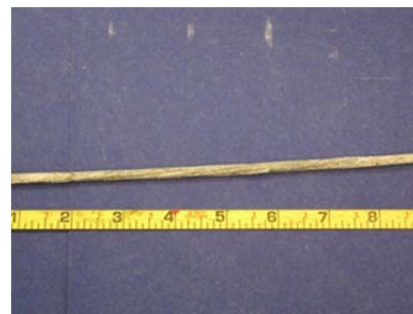
*Figure 5.53: Specimen 3.2 Main Autopsy Region Elements*

A typical strand and inner wire are shown in Figure 5.53. Strand corrosion ratings are shown in Figure 5.54 and summarized in Table 5.17.

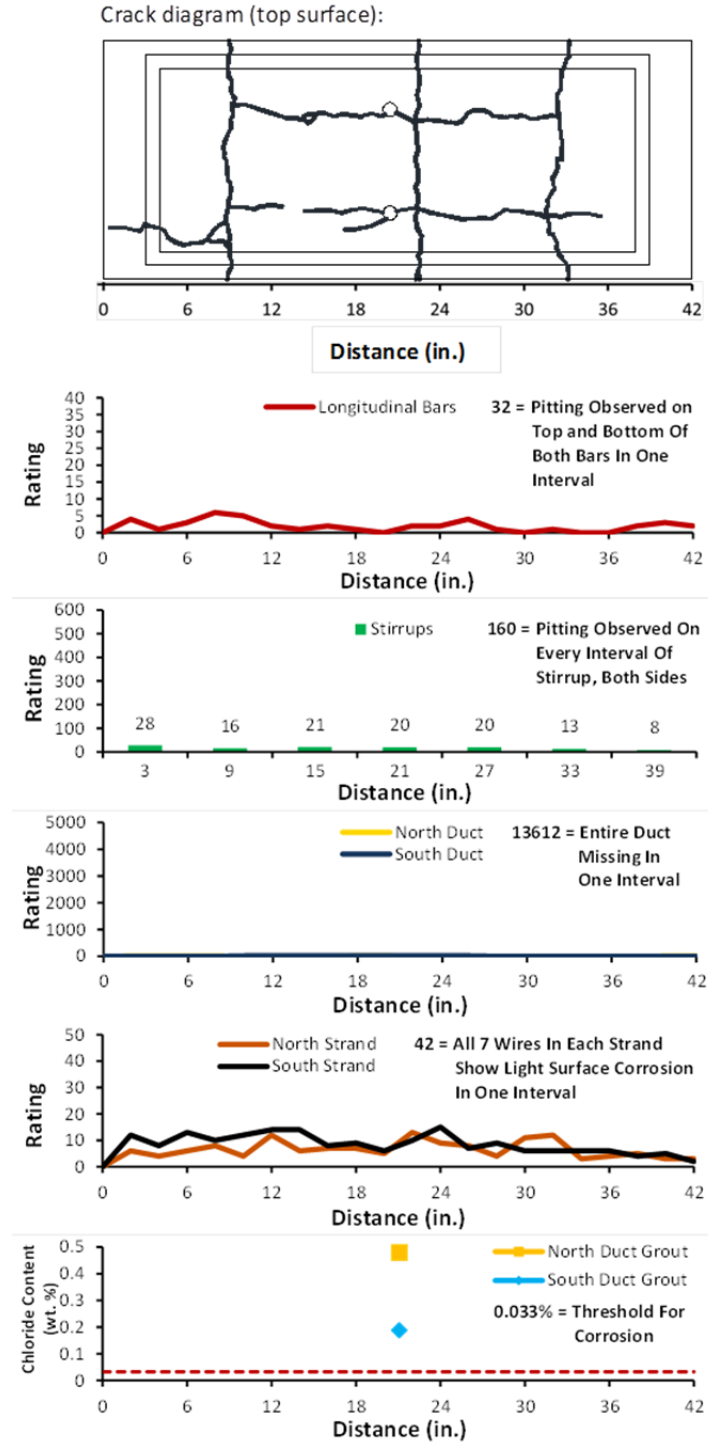
Figure 5.54: Specimen 3.2 Crack Map and Corrosion/Damage Rating Plots

Three primary transverse cracks crossed the top face of the specimen and extended down its sides. The average width of these cracks was 0.015 inches. Several longitudinal cracks extended along various portions of the top surface. These were mostly located above the specimen's ducts. Average width of the longitudinal cracks was 0.004 inches. The crack diagram is shown in Figure 5.54.

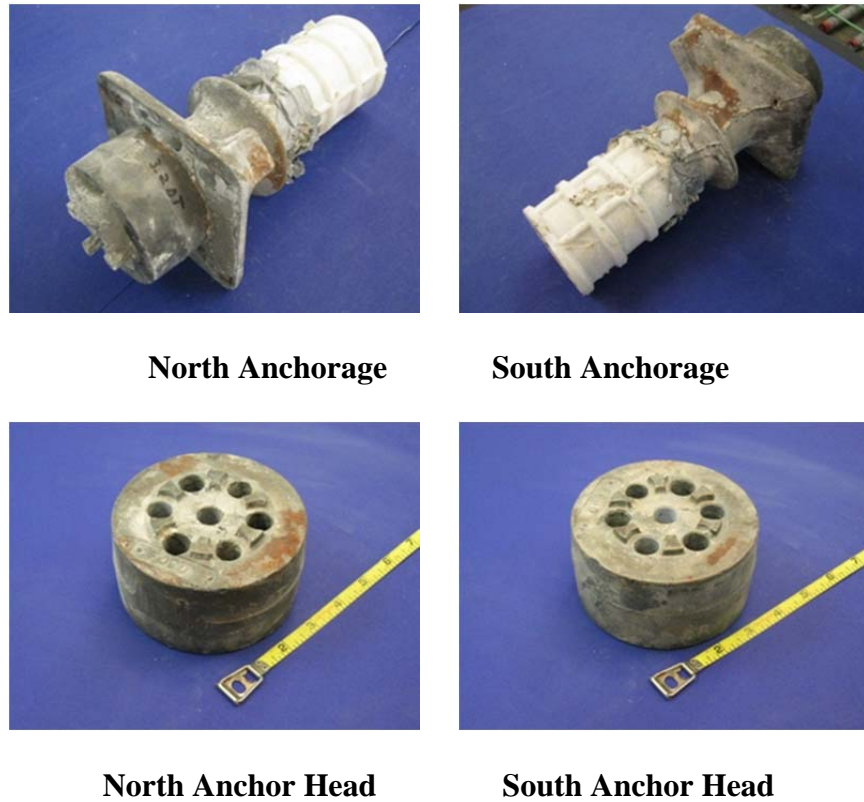
The epoxy used to seal the exposed surfaces of both dead end anchorages was mostly intact on the bearing plates and mostly missing on the anchor heads. Both bearing plates showed

only localized light to moderate corrosion over a small portion of their exposed area. Corrosion was much more widespread on the underside and along the lower interior edges of the bearing plates. The duct tape used to splice the ducts to the anchorages was mostly intact at the time of autopsy. Only one small spot of corrosion was observed on the interior side of the south anchor head. The level of discoloration on the other surfaces was comparable to the north anchor head. The north and south anchorages and anchor heads are shown in Figure 5.55.

*Figure 5.55: Specimen 3.2 Dead End Anchorages and Anchor Heads*

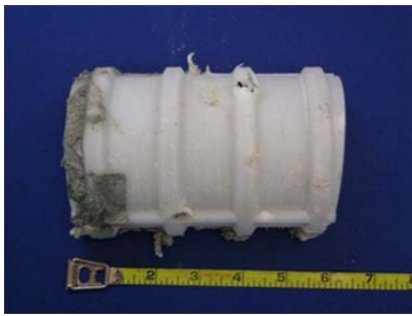
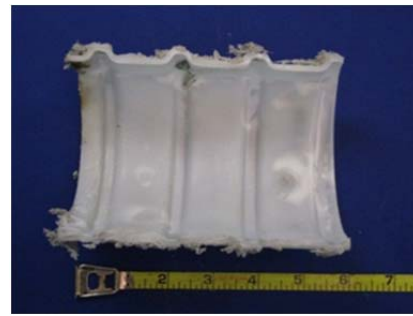
The exterior of both anchorage zone ducts showed traces of chalky white residue. Isolated corrosion staining was also observed on both ducts where they were spliced to the anchorages. Scattered patches of shiny white crystals were found on the interior portions of both ducts. Evidence of small voids was also seen on the top interior portion of both ducts. The north duct had some light gouging due to strands rubbing near the anchorage splice. There was no such damage observed in the south duct. North and south ducts are shown in Figure 5.56. Anchorage zone duct corrosion ratings are summarized in Table 5.18.

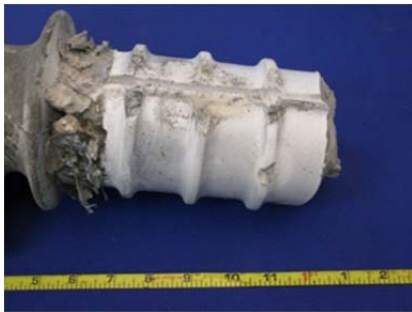
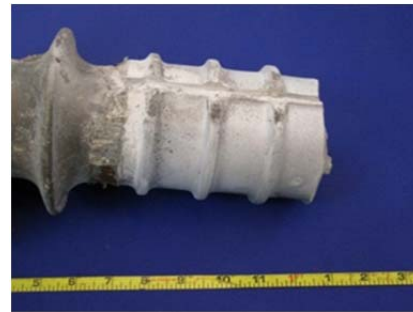
Both north and south tendon anchorage zone grouts showed evidence of voids on their top surfaces. These voids did not appear to be connected by the top longitudinal rib of the duct. The bottom surfaces of both grouts were smooth and appeared extremely well consolidated. Like the main autopsy region grouts, the dead end anchorage grouts were very difficult to chip away. North and south tendon grouts are shown in Figure 5.56.

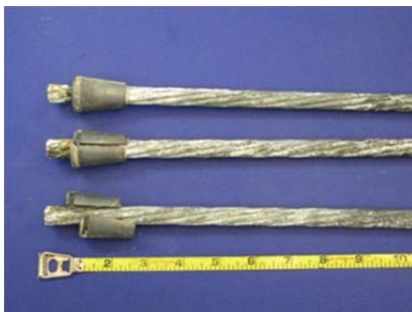
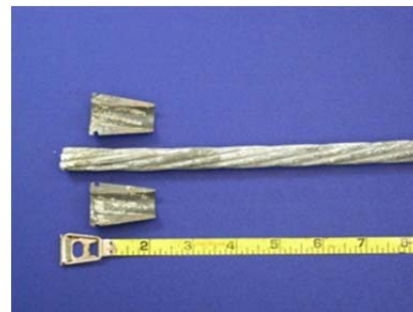
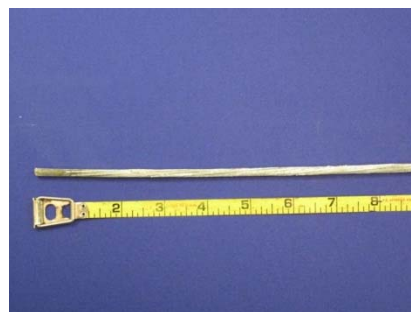
The dead end anchorage zone strands experienced localized discoloration and light surface corrosion along their entire lengths. The outer wires in all strands showed discoloration and flecks of corrosion that could be removed with a scouring pad over many intervals. Damage

was the worst at the exposed strand ends and in the region where the wedges were located. The inner wire on each strand was typically more extensively corroded or discolored near the wedge region than the outer wires. Inner wire damage further into the specimen was comparable to that of the outer wires. All wedges were found to be intact with only light localized corrosion or discoloration on their outer surfaces. Typical strands, with and without wedges, are shown in Figure 5.56. Dead end anchorage zone strand corrosion ratings are summarized in Table 5.18.

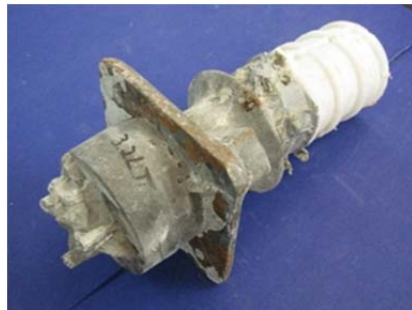
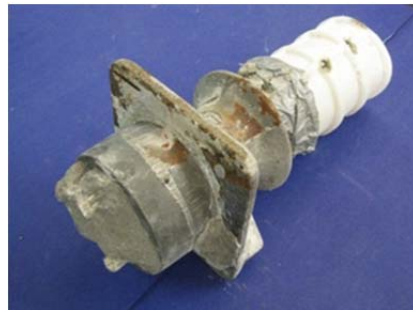
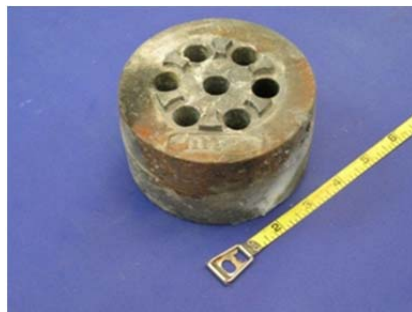
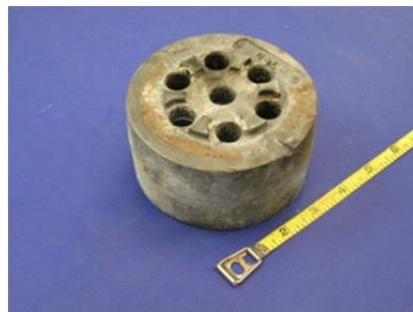
*Figure 5.57: Specimen 3.2 Live End Anchorages and Anchor Heads*

Most of the epoxy on the exposed surfaces of the live end anchorages was gone. The south bearing plate experienced light corrosion on some of its exposed surface, while the north bearing plate had moderate corrosion over the majority of its exposed area. The north and south bearing plates were moderately corroded on their bottom surfaces and on all inside edges of the bearing plates. This damage was more severe on the north anchorage than the south anchorage. Although the duct tape splices were mostly intact on both anchorages, there was extensive moderate corrosion and some pitting found underneath the duct tape. The north anchor head experienced widespread moderate corrosion on its inner surface and lighter localized corrosion on much of its other surfaces. The south anchor head was much less damaged, with light to moderate localized corrosion on its inside surface and extremely localized light corrosion or discoloration elsewhere. The north and south anchorages and anchor heads are shown in Figure 5.57.

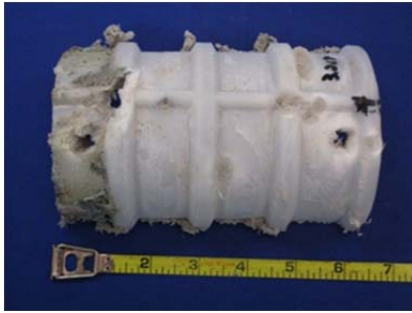
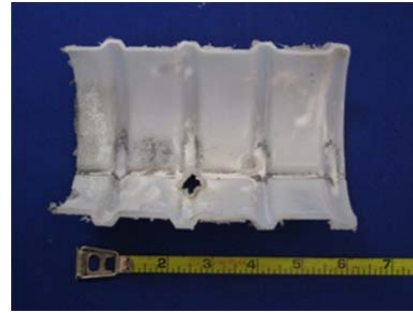
The outer surfaces of both ducts showed a chalky white residue. Additionally, the outer surface of the north duct was significantly stained at the duct's interface with the bearing plate due to the corrosion that had occurred there. Inside the duct, evidence of small voids was found in the duct's upper ribs. The voids appeared to be connected by the duct's narrow longitudinal rib. Patches of shiny white crystals were found on the inside surfaces of the duct. In addition, several light scratches were found on the inside of the south duct. These most likely occurred while the strands were being threaded through the duct. Light scratches were seen in the north duct, but these were not nearly as extensive and occurred over only one interval. North and south

ducts are shown in Figure 5.58. Live end anchorage zone corrosion ratings are summarized in Table 5.18.

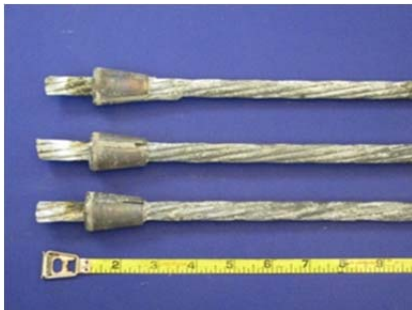
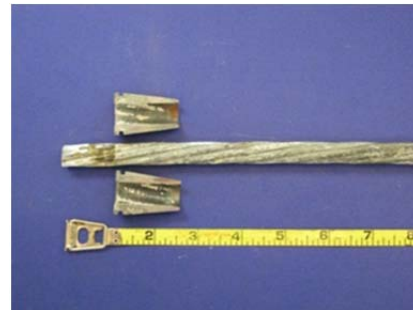
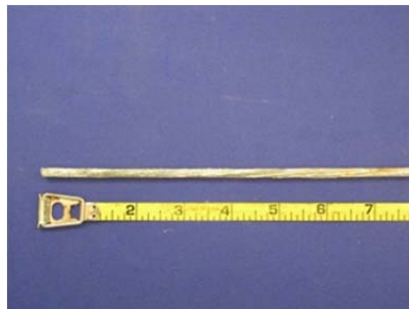
Damage to the live end anchorage zone strands was light to moderate. The outer wires of all strands showed some discoloration and localized light corrosion in most intervals. The inner wires showed similar damage, although corrosion was somewhat more widespread in the inner wires. Spots of corrosion that could not be scrubbed away were found on the inner wires of two of the north duct strands. Overall, corrosion ratings were highest where the strands had been exposed and where they had been inside the anchor heads. All wedges were intact, showing only localized light corrosion and discoloration. Most of this damage was observed on the outer surfaces of the wedges. Typical strands, with and without wedges, are shown in Figure 5.58. Live end anchorage zone strand corrosion ratings are summarized in Table 5.18.

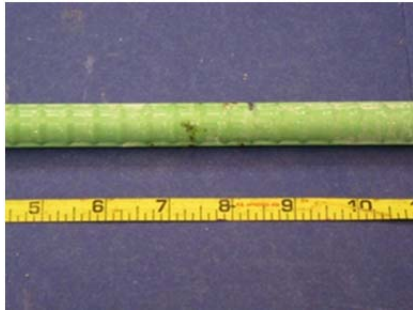
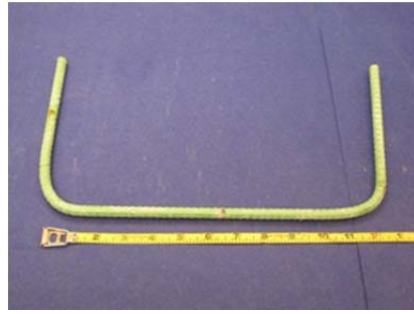
Damage to both the north and south longitudinal bars was light, with most of the bars' surface area showing no signs of corrosion whatsoever (see Figure 5.62). Longitudinal bar corrosion ratings are shown in Figure 5.63 and summarized in Table 5.19.

Corrosion observed in the stirrups was similarly mild. Stirrup corrosion ratings are shown in Figure 5.63 and summarized in Table 5.19.

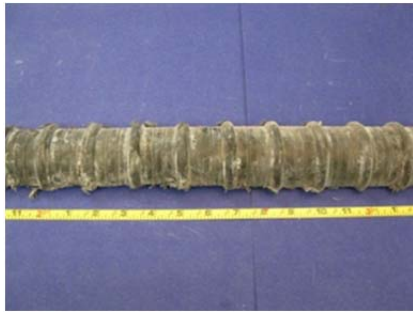
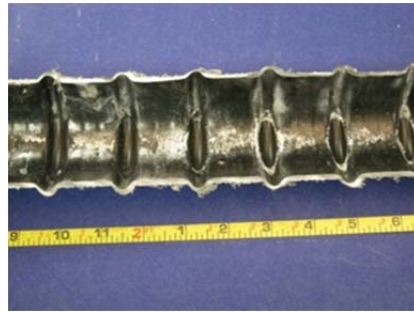
The exterior of the north duct was covered with a chalky white residue. No corrosion staining was observed. The pattern of the residue on the top of the duct in particular suggests that water was present there, as shown in Figure 5.62. Inside, the duct showed a shinier white residue along most of its length. Evidence of voids was found in the top inner portion of the duct. Most of these voids appeared to be confined in the top transverse ribs of the duct. However, evidence of one continuous void was visible within approximately 6 inches of the live end of the autopsy region. This void was visible from the cut live end of the duct before the grout was extracted. The bottom interior portion of the duct was marked with intermittent light gouges that were found along nearly its entire length. The pattern of the gouges suggests that two or more strands were bearing directly on the duct before grouting occurred (see Figure 5.60).

Damage to the south duct was similar to that of the north duct. Chalky white residue with apparent water marks was observed on the outside of the duct, and shiny white residue was found on the inside, as shown in Figure 5.62. Some extremely isolated corrosion staining was observed at a few points along the duct's length. The duct's midspan grout vent had been sealed with a zip tie, which was intact at the time of autopsy. No epoxy was found at the grout vent-duct interface. Inside the duct, evidence of voids was observed. The voids were isolated to the transverse ribs of the duct on the dead end half, while one continuous void was found on the live end half of the duct. This suggests that the grout vent at midspan may have slipped and blocked the flow of grout to the live end of the duct. Light gouges were seen along most of the duct's length on its bottom interior portion. It appeared that all three strands were bearing on the duct during the life of the specimen. Duct corrosion ratings are shown in Figure 5.63 and summarized in Table 5.19.

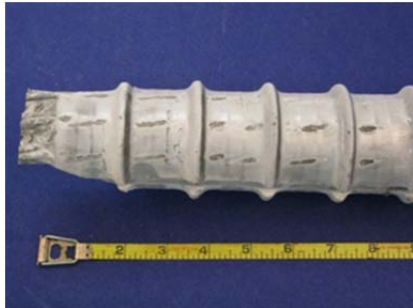
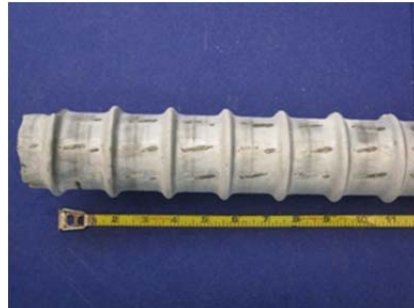
The north tendon grout was cracked transversely every few inches along its length. One large void, approximately 2 inches across, was found on nearly the entire live end half of the duct. Smaller voids, ranging in size from 1 to 1.5 inches, were found confined to the areas where the duct's ribs had been on the dead end half of the grout. Strands were visible on the surface of the grout over most of its length. All three strands were visible near the live end of the autopsy

region (see Figure 5.62). Chloride content was 0.45% at midspan and 0.039% 6 inches from the live end of the grout.

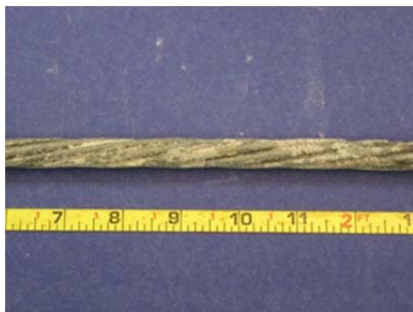
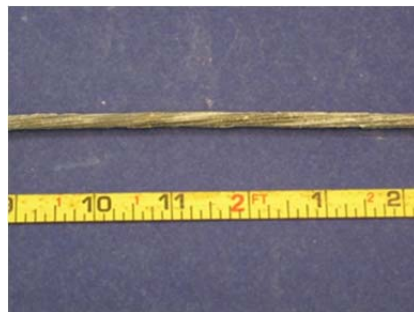
Damage to the north tendon strands was minor and relatively uniform along the length of the tendon. The south tendon strands were slightly more damaged than the north duct strands. On the outer wires, discoloration and spots of corrosion were found on almost every interval of every strand. On one interval of one strand, this corrosion could not be removed with a scouring pad. The inner wires were uniformly discolored, and light corrosion spots were found along much of their length. Corrosion ratings were higher in the south strands than the north. Ratings reached their peak roughly 15 inches from the dead end of the autopsy region. A typical strand and inner wire are shown in Figure 5.62. Strand corrosion ratings are shown in Figure 5.63 and summarized in Table 5.19.

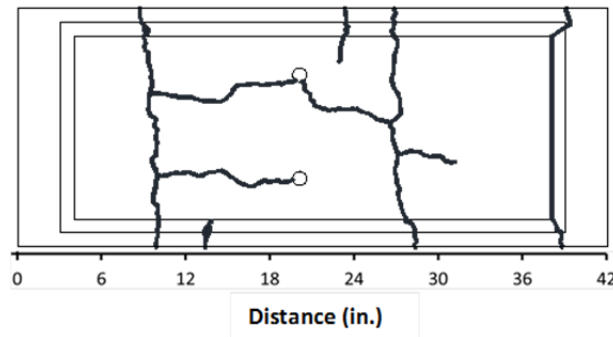
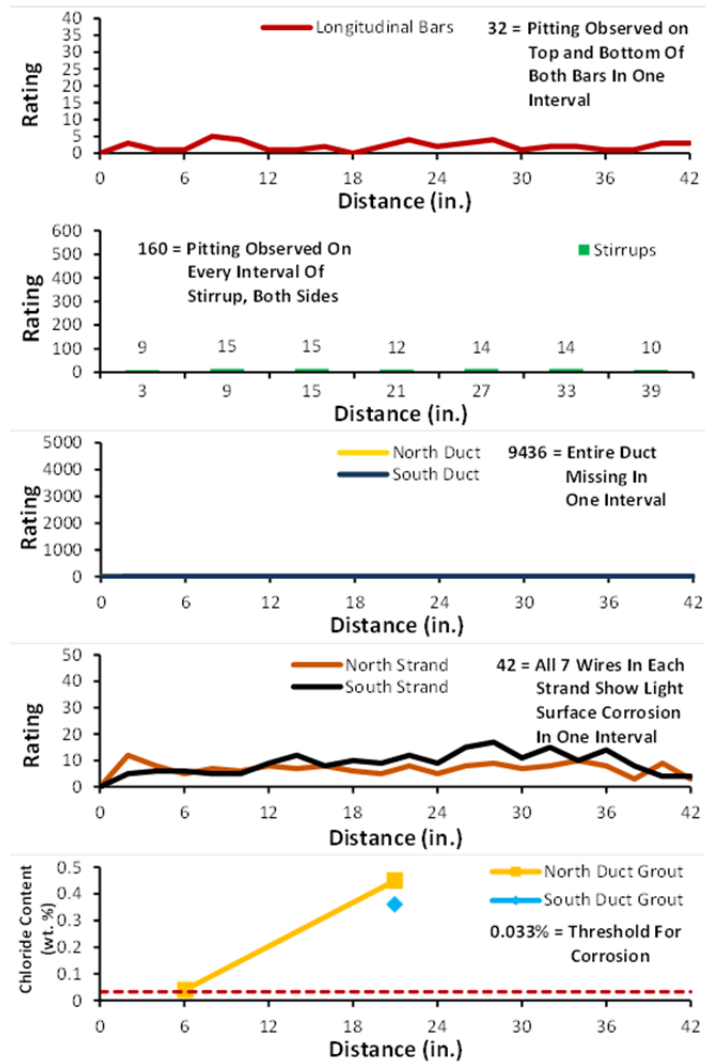
Figure 5.63: Specimen 3.4 Crack Map and Corrosion/Damage Rating Plots

The specimen had 5 transverse cracks. Three of these were continuous across the top surface, while the other 2 only extended a few inches into the saltwater tray. Average width of the transverse cracks was 0.02 inches. Two longitudinal cracks were observed on the specimen's top face. Both passed through one grout vent, and the crack closer to the north face of the specimen was the longer of the two. Average width of the longitudinal cracks was 0.008 inches. The crack diagram is shown in Figure 5.63.

The south tendon grout was similar in appearance to the north tendon grout. The south tendon grout was cracked every few inches along its length. No longitudinal cracks were found. One continuous void, about 1.5 inches wide, was observed along most of the live end half of the grout. On the dead end half of the grout, all voids were approximately 1 inch wide and isolated to the ribs of the duct. All voids were somewhat smaller than in the north grout, although their color was comparable. All three strands were visible on the underside of the grout along most of its length, and at least one strand was visible along the entire length of the grout. Chloride content was 0.36% at midspan. Chloride content for both ducts is shown in Figure 5.63.

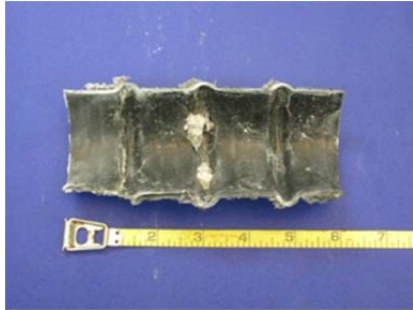
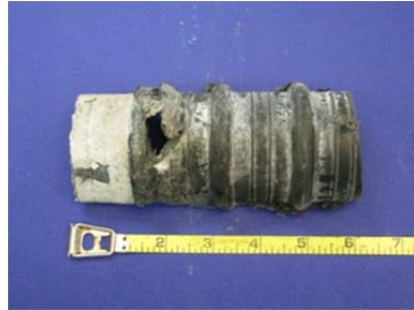
The outside surface of both ducts showed the same chalky white residue that was found on the ducts in the main autopsy region. Large deposits of cement paste were found in the splice region of both ducts. This occurred because the ducts are slightly smaller than the anchorage opening, which allowed paste to enter and adhere to the ducts. North and south ducts are shown in Figure 5.64. Anchorage zone corrosion ratings are summarized in Table 5.20.

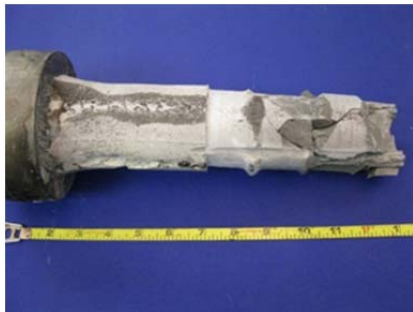
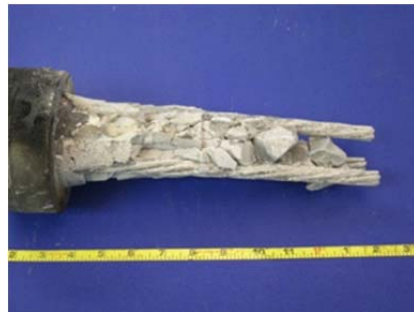
The south tendon grout was severely damaged during extraction, so no meaningful observations could be made. The north tendon grout showed signs of small voids on its top surface and a long void within the anchorage itself. Over the region that had been covered by the north duct, the grout appeared to be well consolidated. The grout in this region was very dark and very hard to break. Two strands were visible on the grout's bottom surface over the entire duct region. The grout was not observed to be cracked. North and south tendon grouts are shown in Figure 5.64.

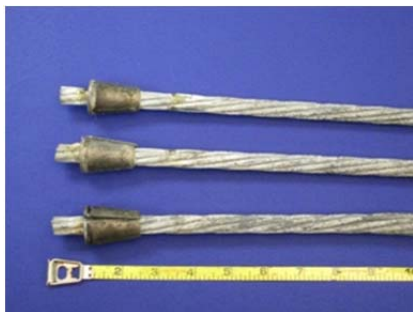
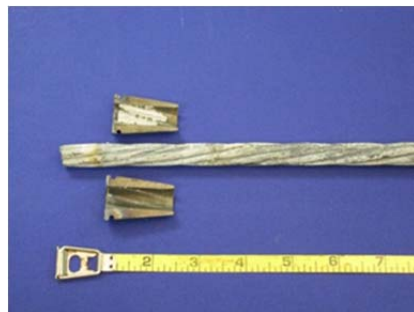
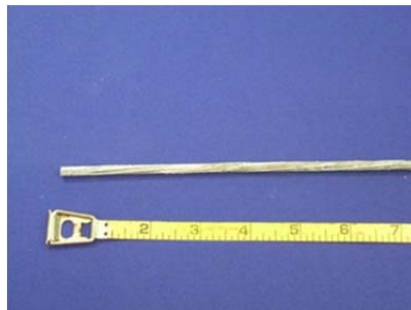
The anchorage zone strands in both tendons showed similar levels of corrosion. Small flecks of light surface corrosion and discoloration were observed over the entire length of strand, generally on more than one wire per interval. Outer wire damage was greatest in the region that had been inside the wedges. Inner wire damage was uniform, with discoloration and light surface corrosion spots found along the entire length of wire on every strand. All wedges were physically intact, showing only mild surface corrosion on their outer surfaces and isolated spots of discoloration inside. Typical strands, with and without wedges, are shown in Figure 5.64. Anchorage zone strand corrosion ratings are summarized in Table 5.20.

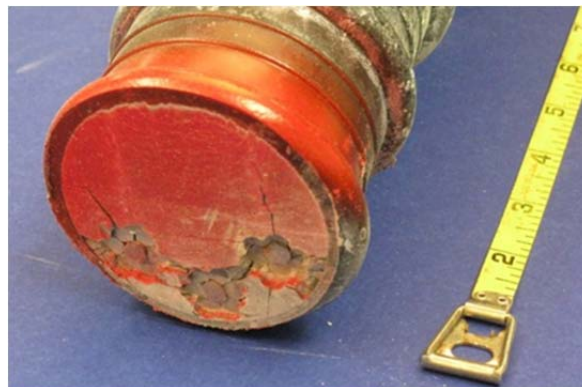
The stainless steel strands were observed to have a much weaker bond with the surrounding grout than other strand types. Grout easily fell away from the strands after the ducts were removed due to the weak bond and the strands' large curvature. Additionally, the strands in both ducts showed evidence of debonding after the concrete had been chipped away from the autopsy region, as shown in Figure 5.67.

Figure 5.67: Specimen 4.2, Debonded Strands at Live End of South Duct

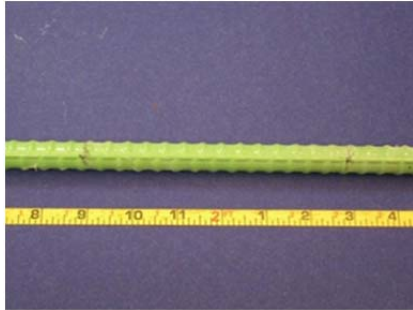
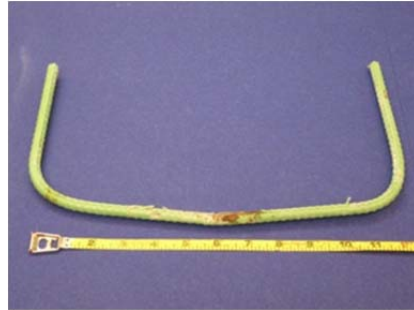
Both the north and south longitudinal bars experienced no corrosion and very little discoloration, as shown in Figure 5.68. Longitudinal bar corrosion ratings are shown in Figure 5.68 and summarized in Table 5.21. Corrosion damage to the stirrups was mild. However, stirrup #5, shown in Figure 5.68, showed pitting over one interval at its center. The highest corrosion ratings were observed in the stirrups underneath the specimen's transverse surface cracks. Stirrup corrosion ratings are shown in Figure 5.69 and summarized in Table 5.21.

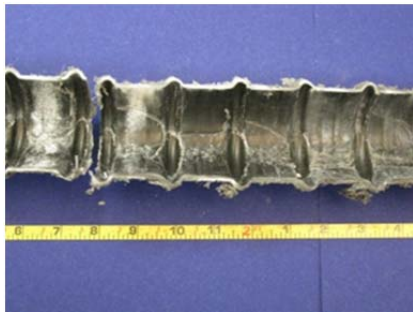
The north plastic duct showed a large amount of chalky white residue on its outer surface. This residue formed small swirls near the live end of the duct, suggesting that small pockets of moisture may have been present there. Patches of shiny white crystals were found inside the duct. Evidence of a large, continuous void was found on the inner top portion of the duct, extending from the live end of the duct to the splice at midspan. Smaller voids were observed on the dead end half of the duct. These appeared to be confined to the top ribs of the duct. Gouges were observed on the duct's bottom interior surface, suggesting that at least one strand had been bearing on the duct over its entire length. Deep scratches, amounting to approximately 10% of the duct's thickness, were seen on the top interior surface of the duct along almost its entire length. This damage was likely caused by the highly curved strands as they were threaded through the duct prior to stressing (see Figure 5.68).

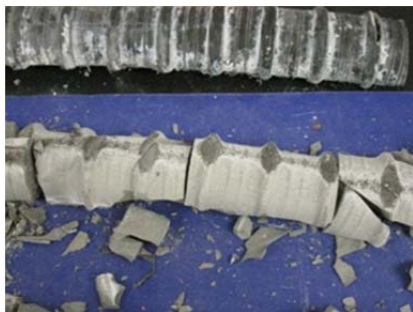
**Top of South Duct**

Damage to the south duct was comparable to that of the north duct. Chalky white residue was found on the outside of the duct, and isolated spots of shiny white crystals were found inside. Evidence of a large void was observed on the live end half of the duct's top interior surface. This void extended from 2 inches from the live end of the duct to just past midspan (see Figure 5.68). Smaller voids were found on the dead end half of the duct. These voids appeared to be completely contained within the top ribs of the duct. Extensive scratching was present on the entire interior of the duct, amounting to about 10% of the duct's thickness in places. No gouges were observed. The epoxy used to seal the grout vent at its intersection with the duct was somewhat separated from the duct surface. It is unknown whether this occurred during autopsy or during exposure. Duct corrosion ratings are shown in Figure 5.69 and summarized in Table 5.21.

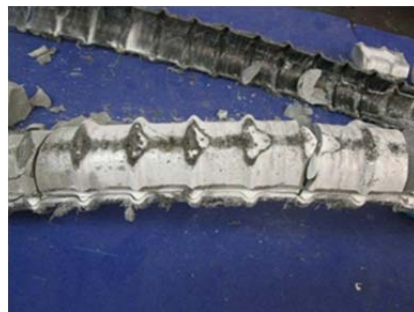
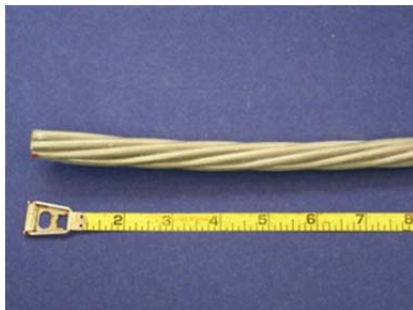
The large curvature of the strands caused both the north and south grout to fracture along their lengths as the ducts were removed. Large, continuous voids, approximately 2 inches across, were present on the live end half of each grout, and smaller voids were seen on the dead end half (see Figure 5.68). These voids were approximately 0.75 inches in width. Chloride content was 0.39% at midspan of the north grout and 0.32% at midspan of the south grout. Chloride content for north and south grouts is shown in Figure 5.69.

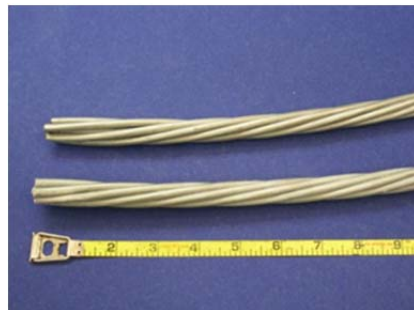
**Strand**

All stainless steel strands in both the north and south tendons were nearly immaculate upon inspection. No corrosion or corrosion staining was found on the outer wires of any strand. The only discoloration observed was a light coating of white-gray grout residue (see Figure 5.68). This could easily be rubbed off over all intervals. When compared to a length of stainless steel strand that had been stored indoors for the duration of the exposure period, the strands extracted from the specimen showed no discernible difference in appearance, as shown in Figure 5.68. Small flecks of light surface corrosion were found at the dead end of every strand's inner wire, but this may have been due to water intrusion during the autopsy process. Strand corrosion ratings are summarized in Table 5.21.
