1. Report No. FHWA/TX-11/0-4562-4		2. Government Accession No.		3. Recipient's Catalog No.	
4. Title and Subtitle Evaluation of Corrosion Resistance of Improved Post-tensioning Materials after Long-term Exposure Testing			5. Report Date October 2011

CTR Technical Report:	0-4562-4
Report Date:	October 2011
Project:	0-4562
Project Title:	Corrosion Resistance of Grouted Post-Tensioning Systems
Sponsoring Agency:	Texas Department of Transportation
Performing Agency:	Center for Transportation Research at The University of Texas at Austin

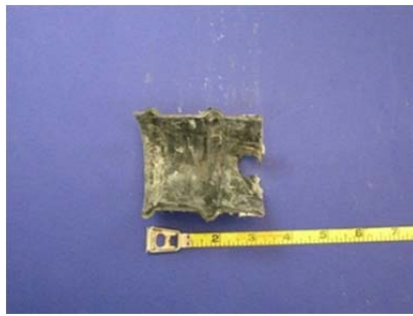
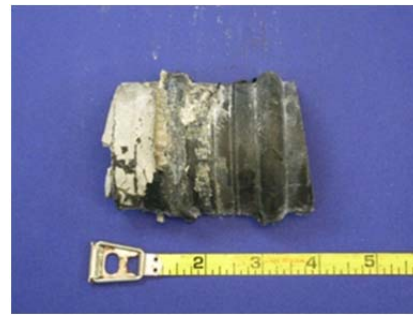
Only a short length of anchorage zone duct was recovered for both the north and south anchorages. These duct segments were also heavily damaged, limiting the conclusions that could be drawn. The north duct showed substantial scratches on its bottom interior surface and some faint scratches on its top interior surface. The strands appeared to have damaged the duct as they were being threaded through prior to stressing. No scratches or gouges were observed within the south duct. North and south tendon ducts are shown in Figure 5.70. Anchorage zone duct corrosion ratings are summarized in Table 5.22.

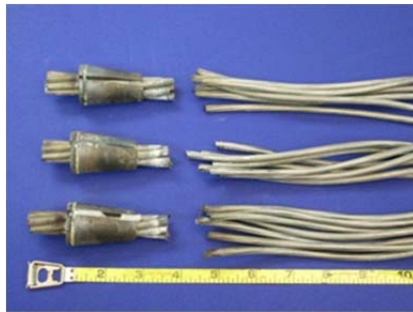
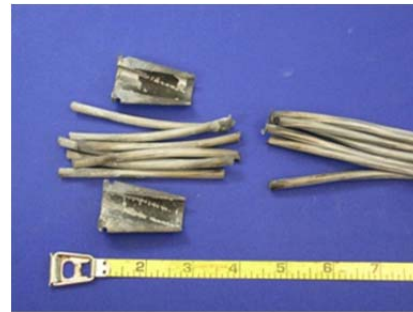
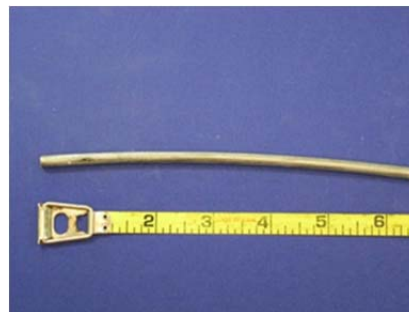
The north and south anchorage zone grouts shattered as the ducts were being removed, so observations were limited. The north and south anchorage zone strands were not in the same condition as those in the main autopsy region of the specimen. Discoloration was found on all strands in the region where wedges had been applied, both on the inner and outer wires of every strand. The only corrosion present on the anchorage zone strands was one small spot found on the end away from the anchor head on the inner wire of one south duct strand. All discoloration could be wiped away to reveal clean strand underneath. Typical strands, with and without wedges, are shown in Figure 5.70. Anchorage zone strand corrosion ratings are summarized in Table 5.22.

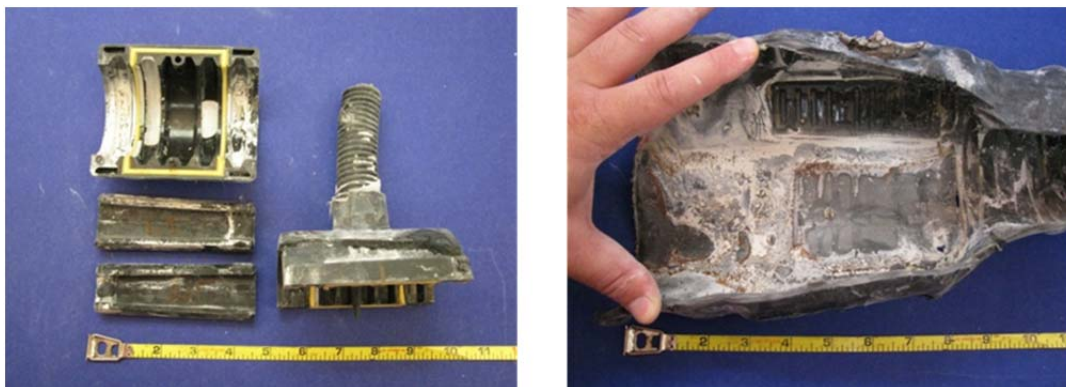
Figure 5.72: Specimen 7.1 Live End Coupler (Left) and Live End Sheath (Right)

The outside of the duct was extensively coated with chalky white residue. Some traces of corrosion products were found near the live end of the duct underneath the heat shrink sleeve. Inside, a shinier white residue was found, along with evidence of voids in the top inner ribs of the duct. These voids were uniform in size and did not appear to be continuous along the length of the duct (see Figure 5.73). Isolated light gouges were found on the duct's inner surface at various points along its length. It appeared that at least one strand had been bearing on the duct at those locations. Duct corrosion ratings are shown in Figure 5.74 and summarized in Table 5.23. The dead end and live end couplers were completely intact. Both sets of fasteners were fully functional at the time of autopsy, and no cement paste appeared to have breached the gaskets at any point of either coupler (see Figure 5.72). The outer and inner surfaces of both couplers showed similar discoloration to that which was seen on the duct. Both primary heat shrink sleeves were also intact. Extensive paste intrusion was observed near the outer end of each sleeve, along with some corrosion staining, as shown in Figure 5.72. The sleeves had a somewhat loose fit on the ducts. It is unknown how much of the cement paste was introduced during construction and how much was a byproduct of the autopsy process. At the dead end coupler, an additional heat shrink sleeve had been applied to the top of the duct because the primary sleeve had split during its application. This additional sleeve was observed to be loose at the time of autopsy, although it may have been jarred loose during the extraction process.

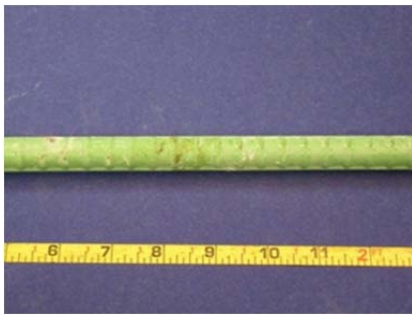
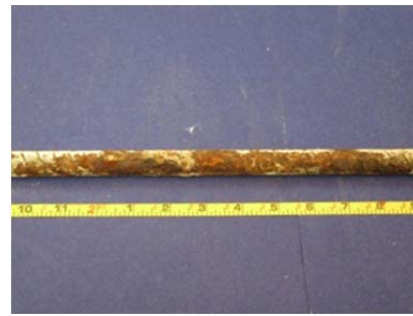
Damage to the epoxy-coated longitudinal bars was minor, as shown in Figure 5.73. The uncoated longitudinal bars provided for resistance monitoring showed moderate to severe corrosion damage. Spots of corrosion were observed along most of the bars' length. Near midspan, both bars were also pitted over several intervals (see Figure 5.73). The south uncoated bar was substantially more damaged than the north bar. It showed pitting on almost half of its total length. Longitudinal bar corrosion ratings are shown in Figure 5.74 and summarized in Table 5.23.

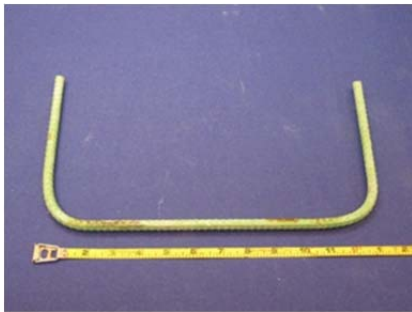
**Stirrup**

The stirrups were mildly damaged, as shown in Figure 5.73. It is possible that much of the discoloration at these locations was transported there from the uncoated bars. Stirrup #3 was

the most damaged, with nonremovable corrosion visible on top of its horizontal region over several intervals. This stirrup was located directly beneath the specimen's largest transverse surface crack. Stirrup corrosion ratings are shown in Figure 5.74 and summarized in Table 5.23.

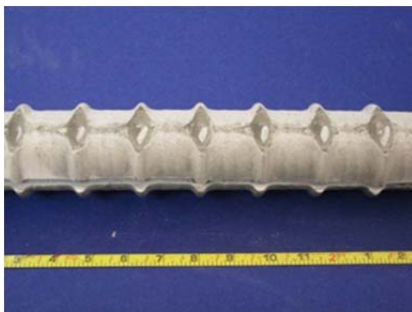
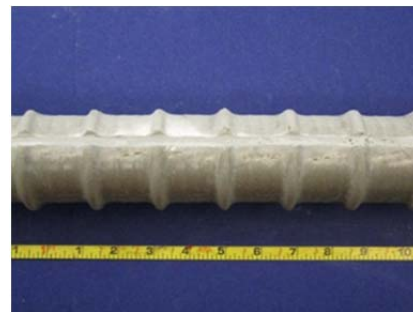
The specimen's grout was cracked every few inches along its length. These cracks were very faint, and no longitudinal cracks were observed. Voids that were approximately 1 inch wide were found along the top surface of the grout. These voids were confined by the upper ribs of the duct, but some small bubbles were also observed between ribs (see Figure 5.73). Chloride contents were below the corrosion threshold along the length of the grout: 0.029% at midspan, and 0.030% and 0.027% at the live end and dead end couplers, respectively. Grout chloride content is shown in Figure 5.74. Because no breaches were found in the duct couplers, chlorides

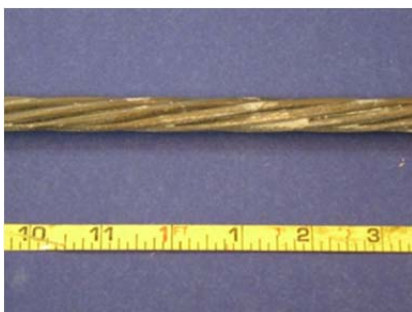
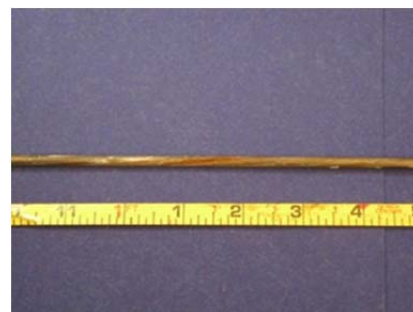
Corrosion damage to the strands was uniform and minor. The outer wires of each strand showed spots of discoloration and light surface corrosion over most intervals. All corrosion could be removed with a scouring pad (see Figure 5.73). The inner wire on each strand was somewhat more damaged. Corrosion that could not be removed was found in several intervals along each strand. Strand corrosion ratings are shown in Figure 5.74 and summarized in Table 5.23.

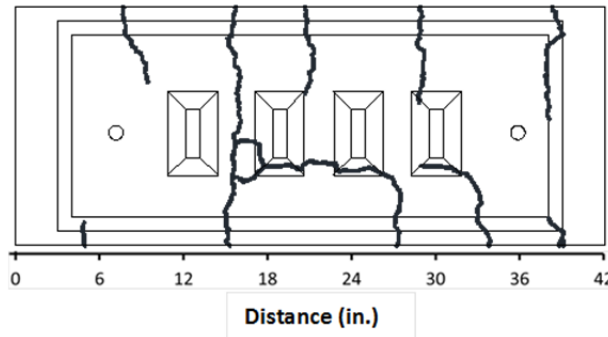
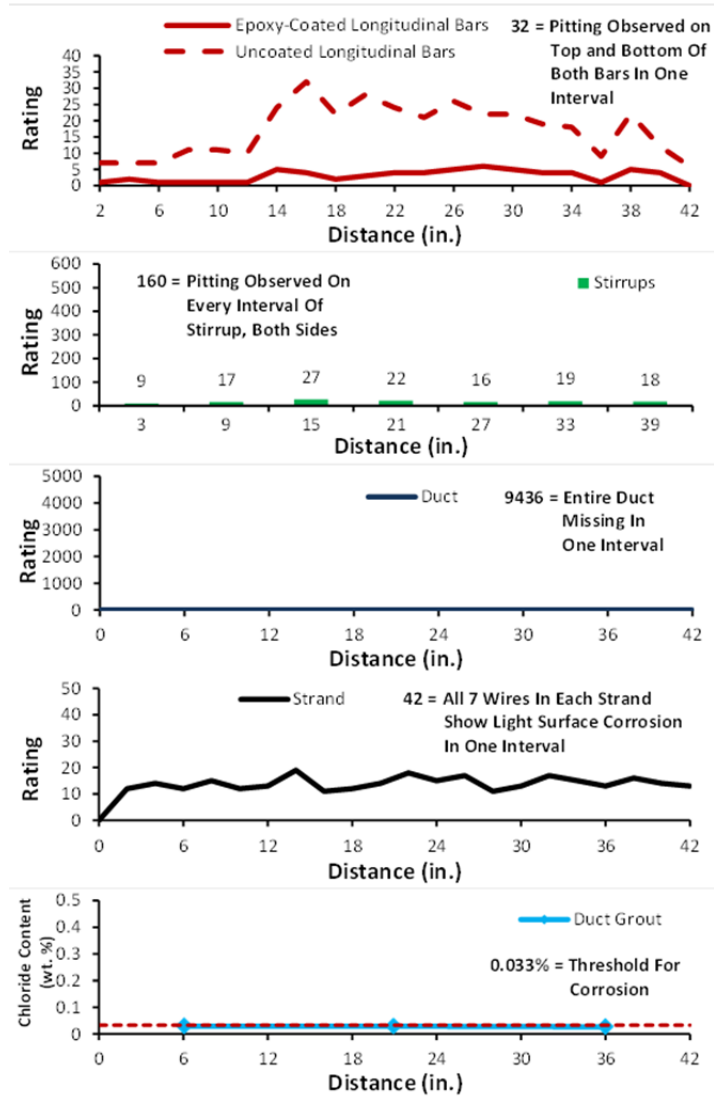
Figure 5.74: Specimen 7.1 Crack Map and Corrosion/Damage Rating Plots

Several transverse cracks were present on the top face of the specimen. Although only one crossed the full width of the specimen, five of the cracks extended down both the north and south faces. Two of the transverse cracks were connected to longitudinal cracks that ran approximately 6 inches from the south face of the specimen. Average crack width for all surface cracks was 0.015 inches. Some separation was found at the joint between the live and dead end pourbacks and the surrounding concrete. The crack diagram is shown in Figure 5.74.

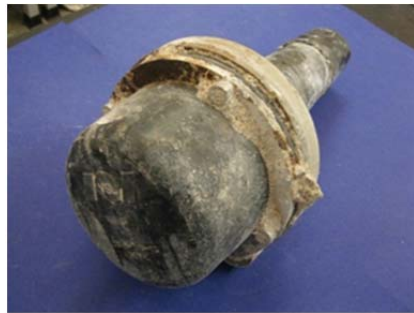
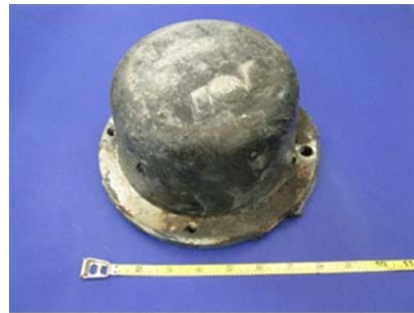
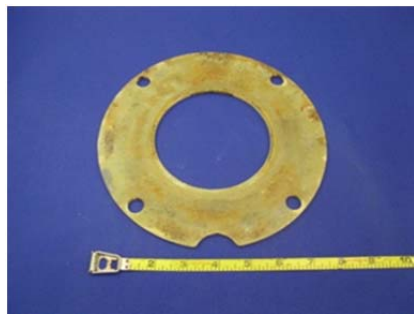
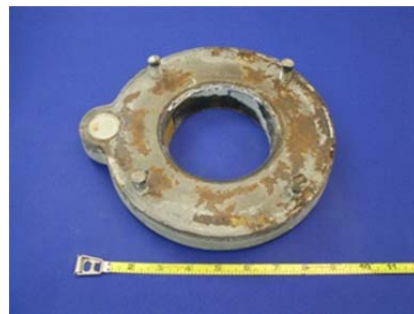
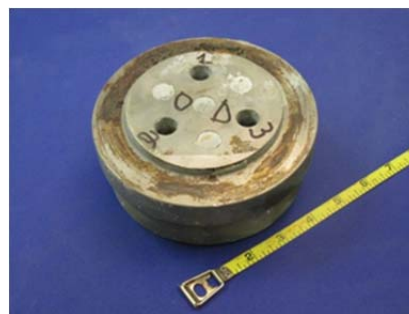
*Figure 5.76: Specimen 7.1 Dead End Anchorage Cap Components*

The VSL CS-2000 anchorage system contained several cap components that will be described here in order from the end of the specimen toward the inside. See Figure 5.75 for the layout and names of these components. The outside of the grout cap was covered in chalky white residue. Some light corrosion staining was also observed on the top of its outer surface and along its outer lip. The retaining ring was severely pitted around the top of its outer face. Localized pitting and corrosion was found elsewhere on the retaining ring, mostly on or near its outer edges. The insulation plate showed widespread corrosion staining on both of its faces. The discoloration was most severe near the top of the plate. The bearing plate showed widespread moderate surface corrosion on the surface in contact with the insulation plate. Lighter corrosion was also observed around the bearing plate's forward edge. Some light to moderate surface corrosion was observed on the rear of the bearing plate. The anchor head was lightly discolored over much of its exposed surfaces. The surface that had been bearing on the bearing plate showed widespread moderate corrosion and some pitting. Also, a small "window" of corrosion was observed on the top, outer surface of the anchor head. A grout void that was similar in shape to the "window" appeared to have been located there. This may have been a chloride ingress point. Anchorage components are shown in Figure 5.76.

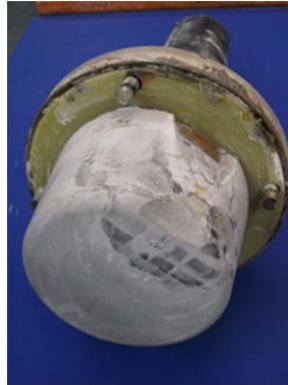
The grout inside the grout cap was not cracked. The top third of the grout cap was slightly darker than the rest, and a clear boundary was visible between these regions, as shown in Figure 5.77. This may have occurred because grouting was completed in stages. It is possible that the time between stages was too great. A void was observed on the top of the grout within the grout cap adjacent to the insulation plate. The corroded “window” of the anchor head was visible beneath the void. Some corrosion products were found around the perimeter of the void,

*Figure 5.77: Specimen 7.1 Dead End Grout Cap Showing Grout Discontinuity*

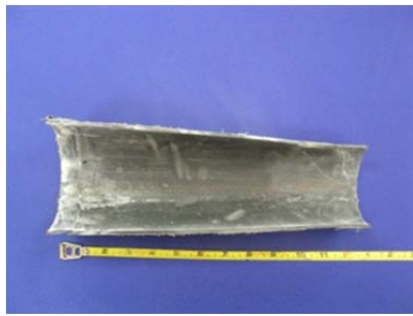
**Top of Trumpet**

The trumpet was completely intact at the time of autopsy. Chalky white residue was observed on the outer surface of the trumpet. Some localized corrosion staining was observed near the bearing plate. Inside the trumpet, lines were visible in the shiny grout residue that suggested that the grout was cracked longitudinally there. The trumpet is pictured in Figure 5.78. Trumpet damage ratings are summarized in Table 5.24.

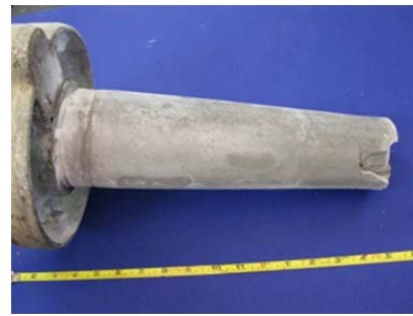
**Grout**

and the void appeared to terminate at the location of the grout cap vent. The grout within the trumpet was also uncracked, contradicting evidence found to the contrary inside the dead end trumpet. The grout was darker on its bottom surface along its whole length, as shown in Figure 5.78. This indicates that segregation may have occurred. A small void surrounded by dark bubbling was found on the top of the grout.

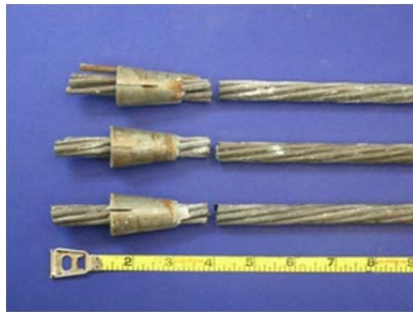
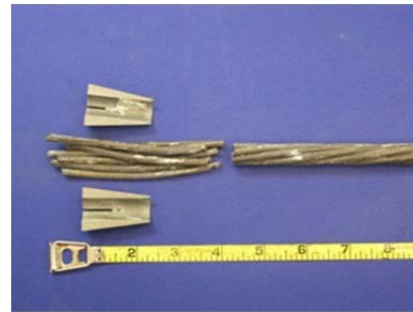
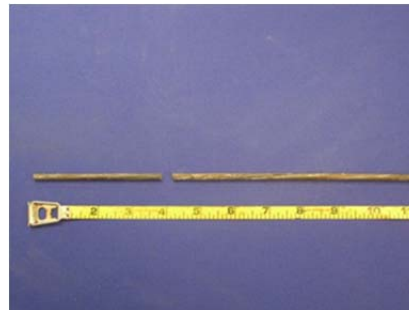
The dead end anchorage zone strands were somewhat damaged but overall in good condition. The outer wires of each strand showed spots of discoloration or light surface corrosion over most of their length. All corrosion could be scrubbed away with a scouring pad. The inner wires were more damaged, with light to moderate surface corrosion occurring over all intervals, as shown in Figure 5.78. On the inner wires of two strands, the heaviest corrosion occurred on the intervals that had been located inside the anchor head. Light to moderate surface corrosion was found on the exterior of all three wedges. The interior of each wedge was not damaged. A typical strand is shown with and without wedges in Figure 5.78. Dead end anchorage zone strand corrosion ratings are summarized in Table 5.24.

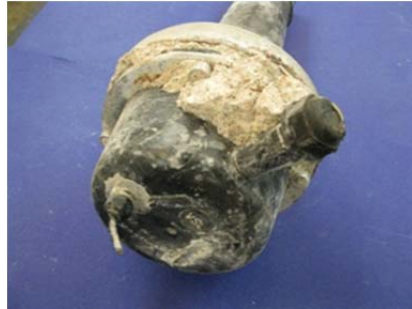
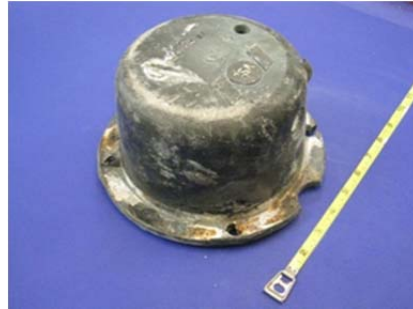
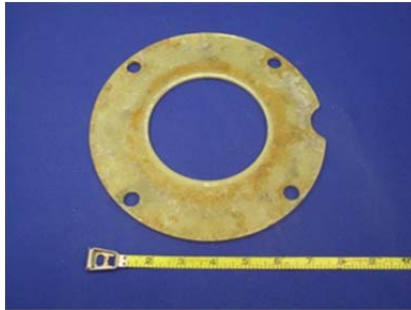
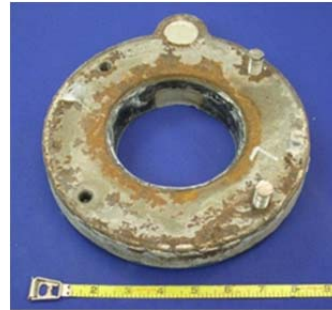
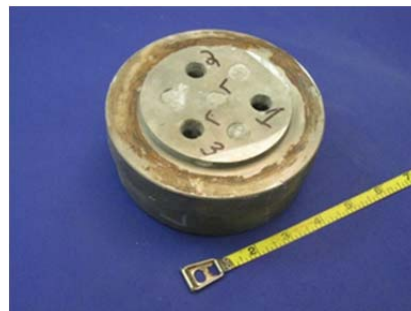
*Figure 5.79: Specimen 7.1 Live End Anchorage Cap Components*

The orientation of the components within the live end anchorage cap is shown in Figure 5.75. The grout cap was covered in white, chalky residue and showed moderate corrosion staining along its outer lip. Localized moderate corrosion and pitting were found on all surfaces of the retaining ring. The most severe damage occurred near the top of the ring. The insulation plate was lightly stained on both sides. Staining was most severe in the vicinity of its inner edge. The bearing plate showed widespread moderate corrosion and some localized pitting on the surface it shared with the insulation plate. The corrosion near the middle of this outer surface was burnt orange in color, while the corrosion around the bearing plate's outer edge was a much darker red. The inboard side of the bearing plate had localized light to moderate surface corrosion, mostly occurring on its upper portion. Many small spots of light surface corrosion were observed on the outer surfaces of the anchor head, while moderate surface corrosion

covered much of the surface that had rested on the bearing plate. A small “window” of moderate corrosion was found on the upper surface of the anchor head. This appeared to coincide with the location of small grout void there and may have been another chloride ingress point for the tendon. Anchorage cap components are shown in Figure 5.79.

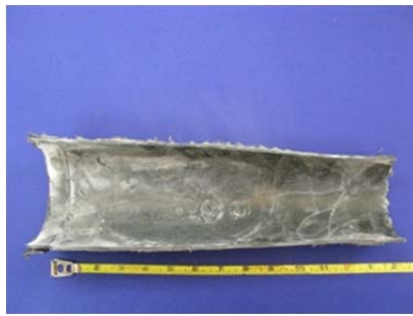
**Top of Trumpet**

The live end trumpet was similar in appearance to the dead end trumpet. Chalky white residue was found on its outer surface, along with small areas of corrosion staining on the portion of the trumpet that had been inside the bearing plate. Shiny white residue was present on the inner surfaces of the trumpet. Lines in this residue suggested that the grout may have been cracked there. The live end trumpet is pictured in Figure 5.80. Trumpet damage ratings are summarized in Table 5.24.

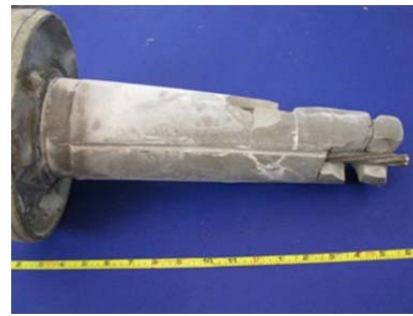
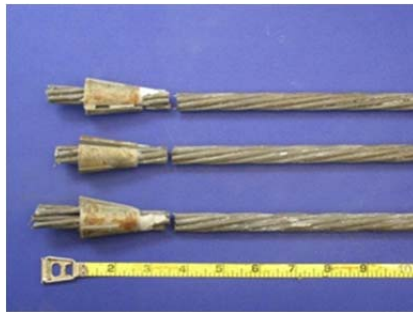
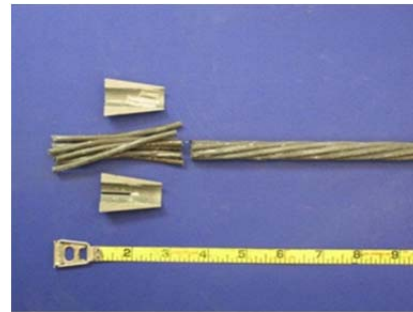
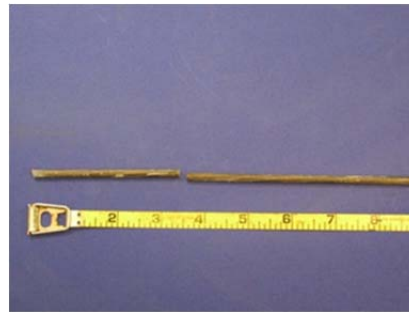
*Figure 5.80: Specimen 7.1 Live End Anchorage Region Elements*

The grout within the live end grout cap was uncracked and showed similar evidence of a cold joint near its top surface to that observed within the dead end anchorage. A large void was visible on the top surface of the grout, and some light corrosion staining was present around its edges all the way to the location of the grout vent. The “window” of corrosion on the top of the anchor head was visible within the void. The grout within the trumpet was cracked transversely on its end nearest to the inside of the specimen. These cracks appeared to correspond to the pattern observed on the inside of the trumpet. Some efflorescence was observed in the vicinity of these cracks, as shown in Figure 5.80. It is unknown whether this was due to chlorides or bleed water from the grout. One longitudinal crack was also observed extending along the middle of the grout from the inside end to the bearing plate. The bottom half of the grout appeared much darker in color than the top half, indicating that segregation may have occurred during grouting. A very small void was present on top of the grout near the bearing plate.

The live end anchorage strands were somewhat less damaged than the dead end strands. Discoloration spots were visible along many of the outer wires’ length in all three strands, as shown in Figure 5.80. Occasional spots of light surface corrosion were observed on the outer wires. These did not occur solely in the anchor head regions of each strand. The inner wires were more corroded. Localized light surface corrosion was present on all intervals (see Figure 5.80). With the exception of one interval on one of the outer wires, this corrosion could be removed with a scouring pad. All three wedges were substantially intact, although spots of moderate surface corrosion were found on their outer surfaces. Typical live end anchorage region strands, with and without wedges, are shown in Figure 5.80. Live end anchorage zone strand corrosion ratings are summarized in Table 5.24.

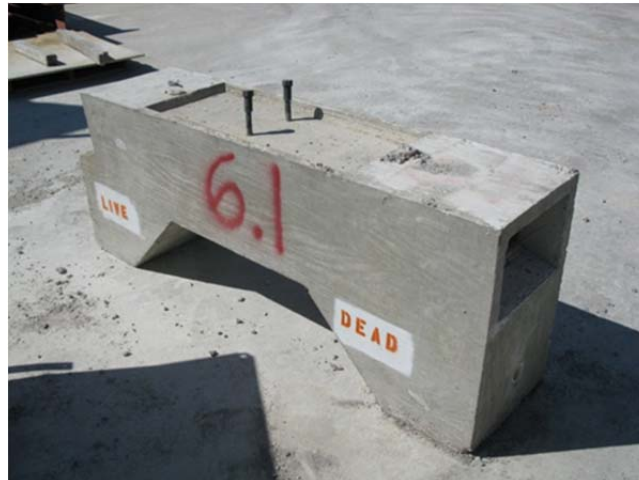
Figure 5.81: Control Specimen Overall Appearance

The beam was in near-immaculate condition at the time of autopsy, as shown in Figure 5.81. Some light scaling had taken place along the edges of the saltwater tray. Small surface air voids were visible on the north and south faces of the specimen, as well as within the saltwater tray. No cracks were observed at any location on the specimen, as it had never been stressed.

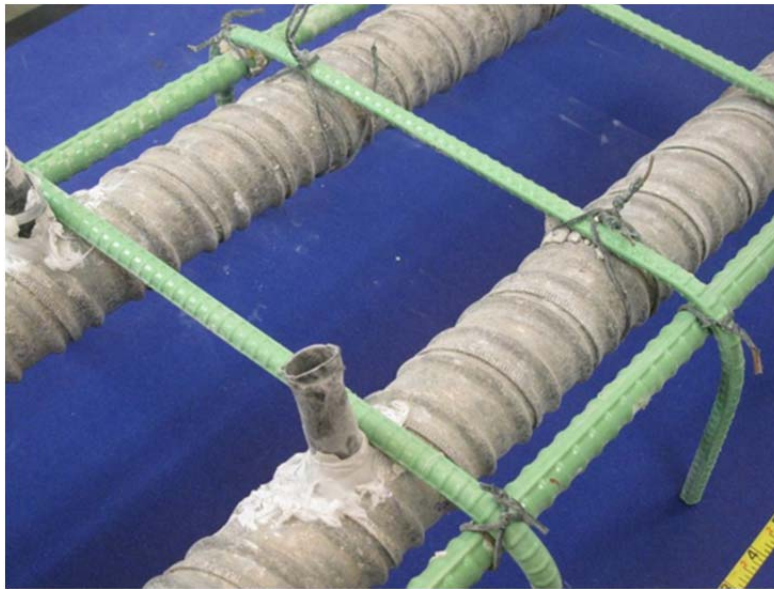
*Figure 5.82: Control Specimen Rebar Cage and Ducts*

None of the epoxy-coated bars or stirrups within the specimen showed any signs of corrosion whatsoever (see Figure 5.82). Longitudinal bar and stirrup corrosion ratings are shown in Figure 5.83 and summarized in Table 5.25.

The outside of both the north and south ducts was covered in a dull gray residue, as seen in Figure 5.82. No corrosion damage was found on the outer surfaces of either duct. Because the ducts had not been grouted, their inner surfaces were exposed to air for the entire exposure period. As this was not consistent with conditions inside the ducts of the exposure specimens, the inside surfaces of the control specimen were not evaluated for corrosion. Duct corrosion ratings are shown in Figure 5.83 and summarized in Table 5.25.

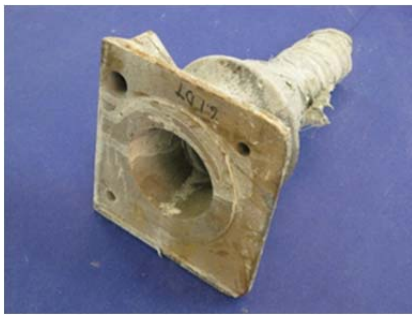
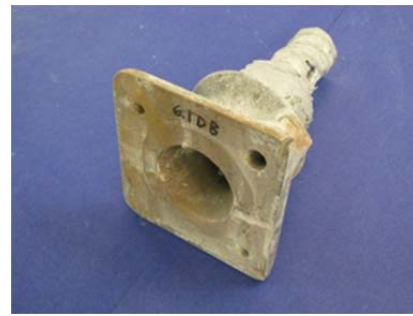
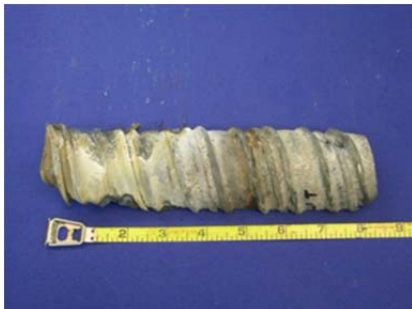
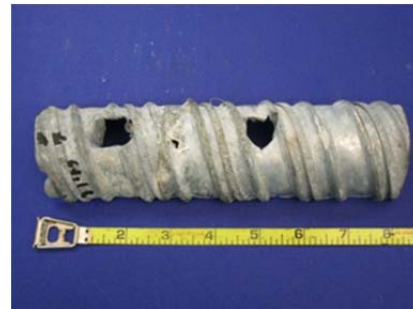
*Figure 5.84: Control Specimen Anchorages and Ducts*

A uniform layer of light surface corrosion was present on the exposed surface of the bearing plates. Localized light to moderate surface corrosion was found along the outside edges of the bearing plates, as well as on the portions of the anchorages around that concrete had been cast. The duct tape used to make the connection between the ducts and bearing plates was intact. A small amount of light surface corrosion was found beneath the duct tape on both bearing plates. North and south anchorages are shown in Figure 5.84.

Some spots of discoloration were present on the outside of the north and south ducts in the area where the duct tape had been applied. This is shown in Figure 5.84. The inner surfaces of the ducts were not evaluated because they had spent several years exposed to air. Anchorage zone duct corrosion ratings are summarized in Table 5.26.

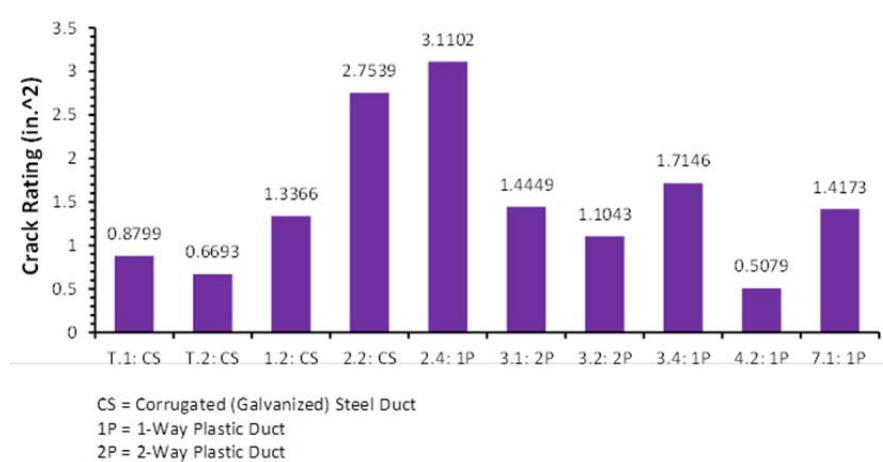
Figure 6.1: Crack Ratings

The surface concrete of all specimens developed scaling in and around the saltwater tray. Corrosion staining was visible on the top surface of several specimens, most often near the base of one or both grout vents. Most specimens displayed wider and more numerous top surface cracks than had been observed immediately after live load application. Crack ratings for all specimens are shown in Figure 6.1. The highest crack ratings occurred in Specimens 2.2 and 2.4, while the lowest crack ratings were computed for Specimens T.2 and 4.2. Crack ratings do not show a strong correlation with duct type. In fact, the two highest and two lowest crack ratings were found in one specimen with plastic ducts and one with galvanized steel, respectively. This suggests that galvanized duct corrosion, while quite extensive, was not extensive enough to cause surface cracking.

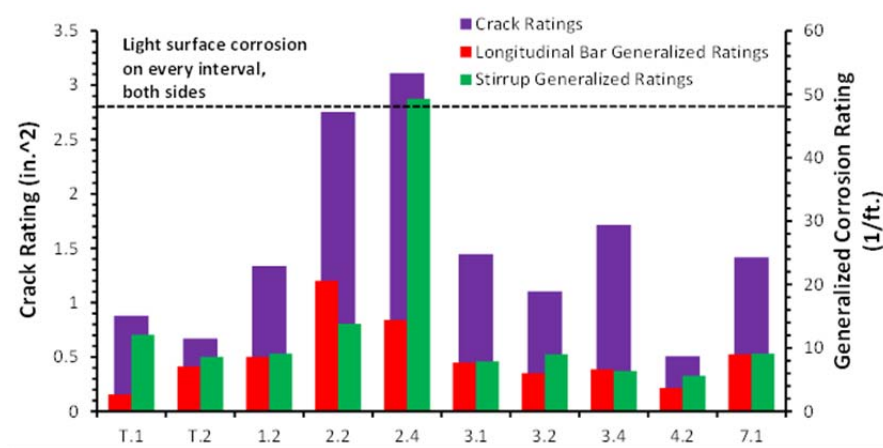
Figure 6.2: Generalized Longitudinal Bar and Stirrup Corrosion Ratings and Crack Ratings

Generalized longitudinal bar and stirrup corrosion ratings are shown in Figure 6.2 and plotted with crack ratings for each specimen. In general, it appears that specimens with higher crack ratings also tend to have higher longitudinal bar and stirrup corrosion ratings. For most specimens, it was observed during autopsy that corrosion ratings were highest for the regions of the bars and stirrups located directly underneath each specimen's surface cracks. Figure 6.2 supports this finding by linking the extent of epoxy-coated bar corrosion to crack rating.

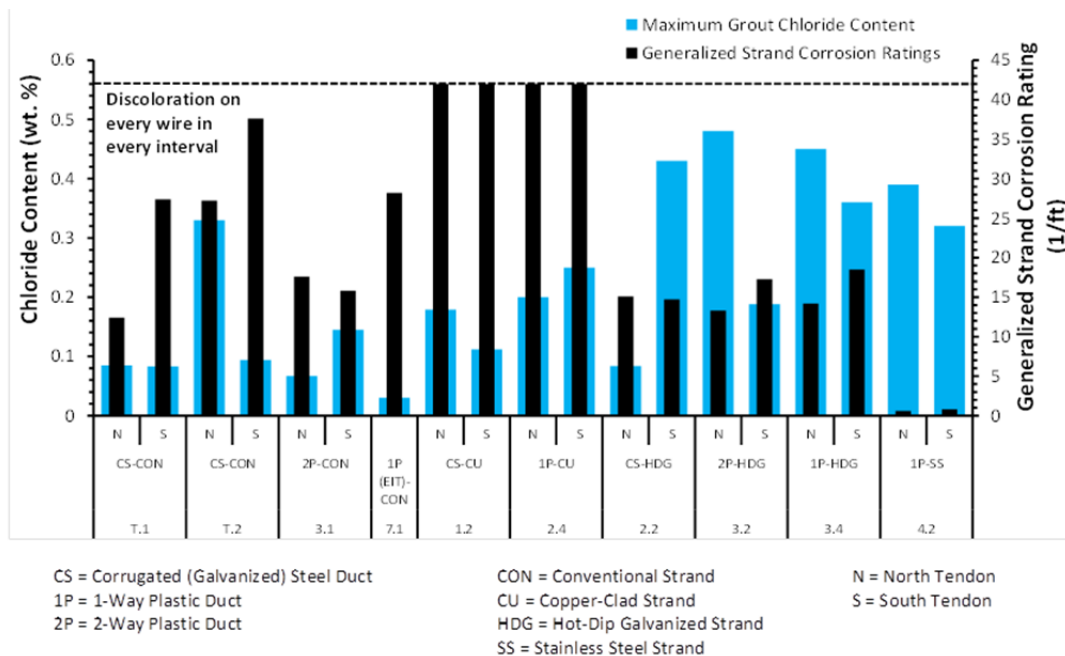
Figure 6.3: Generalized Strand Corrosion Ratings and Maximum Tendon Chloride Content, Organized by Strand Type

Because the different strand types corroded in different ways, direct comparison among them is difficult. Generalized strand corrosion ratings are plotted with maximum chloride content for both tendons in each autopsy specimen in Figure 6.3. Note that the plots are organized by strand type.

For tendons with conventional strand, only Specimen 7.1 (electrically isolated tendon) had a maximum chloride content below the corrosion threshold. The north duct of Specimen T.2 had the highest strand corrosion rating but one of the lowest grout chloride concentrations. The south tendon of Specimen T.1, the north tendon of T.2, and the tendon in Specimen 7.1 all had similar generalized strand corrosion ratings. However, the maximum chloride content of these tendons varied dramatically, showing that corrosion rating is not dependent on chloride concentrations once the corrosion threshold has been exceeded.

Only one specimen with stainless steel strands was autopsied. Generalized strand corrosion ratings were very low in both tendons of Specimen 4.2, while maximum chloride concentrations were about ten times higher than the corrosion threshold. This shows that the stainless steel strands were extremely corrosion resistant. None of the specimens autopsied had epoxy coated or stainless clad strands.

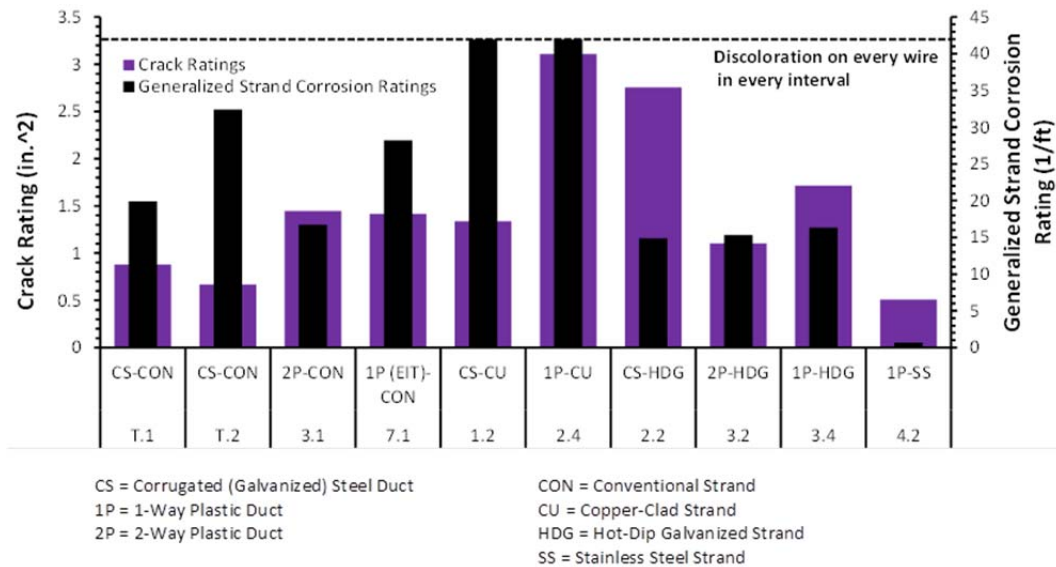
Figure 6.4: Average Generalized Strand Corrosion Ratings and Crack Ratings, Organized by Strand Type

Figure 6.4 shows generalized strand corrosion ratings plotted with crack ratings for each specimen. The corrosion ratings shown represent the average of the tendons in each specimen. For each individual strand type, there is no clear correlation between strand corrosion rating and crack rating. High crack ratings do not necessarily correspond to high corrosion ratings. If cracking is assumed to indicate the extent of chloride ingress, this data confirms that strand corrosion does not depend on chloride content above the corrosion threshold.

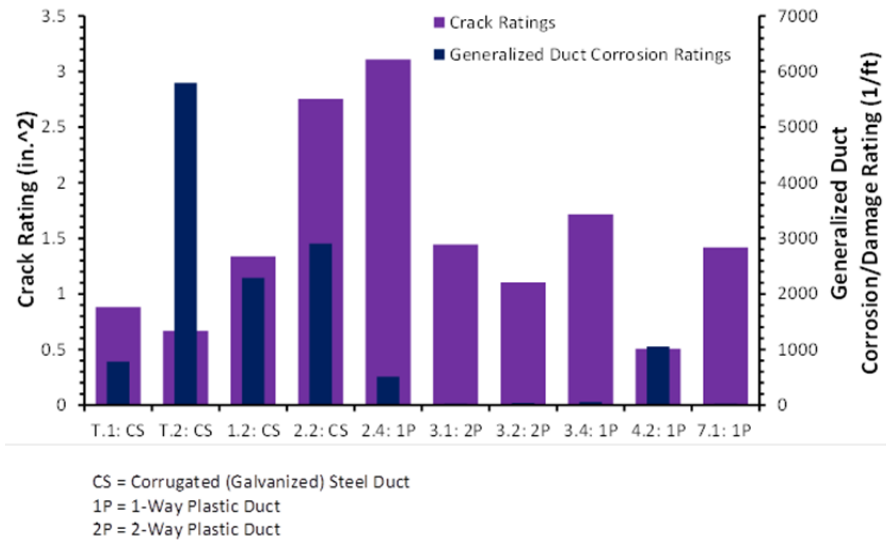
Figure 6.5: Average Generalized Duct Corrosion/Damage Ratings and Crack Ratings

The autopsy specimens contained galvanized steel duct or one of three types of plastic duct from two suppliers. Specimen 7.1, which was electrically isolated, contained the same type of one-way plastic duct as Specimens 3.4 and 4.2. In Figure 6.5, average generalized duct corrosion or damage ratings for each specimen are plotted with crack ratings.

Among the four specimens with galvanized steel ducts, corrosion ratings increased with crack ratings for Specimens T.1, 1.2, and 2.2. However, the highest duct corrosion ratings occurred for Specimen T.2, which had the lowest crack rating. This suggests a correlation between crack rating and duct corrosion rating, but other factors must also influence the extent of corrosion. From the forensic analysis, it was clear that corrosion initiated in the galvanized steel ducts at locations corresponding to each specimen’s transverse surface cracks. For Specimen T.2, cracking allowed duct corrosion to initiate at crack locations, then travel along the length of the large voids as chlorides continued to enter the tendons. Therefore, crack location and the presence of grout voids are just as important as crack rating in determining the extent of duct corrosion.

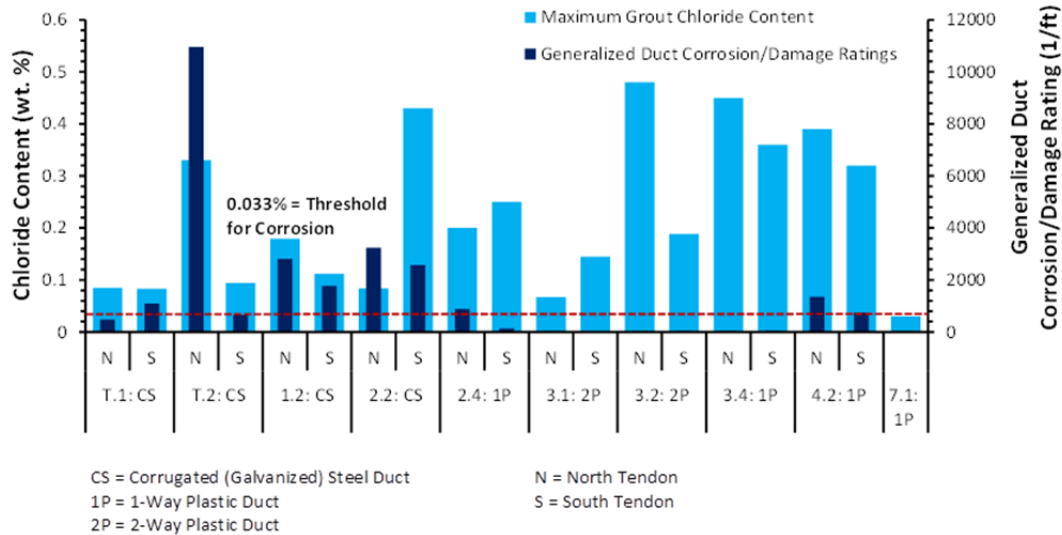
Figure 6.6: Generalized Duct Corrosion/Damage Ratings and Maximum Grout Chloride Content

Figure 5.66 shows generalized duct corrosion and damage ratings plotted with maximum chloride content in each tendon. For the steel ducts, chloride content seemed to increase in each tendon along with the generalized corrosion rating in the surrounding duct. However, the highest overall chloride contents occurred in tendons with plastic ducts. This is a puzzling result, given the extensive area loss in the steel ducts. However, it confirms the presence of leaks in the couplers of the north plastic ducts and the grout vents of the south plastic ducts, as observed during the autopsy process. Plastic duct damage ratings showed no correlation to the grout chloride content.

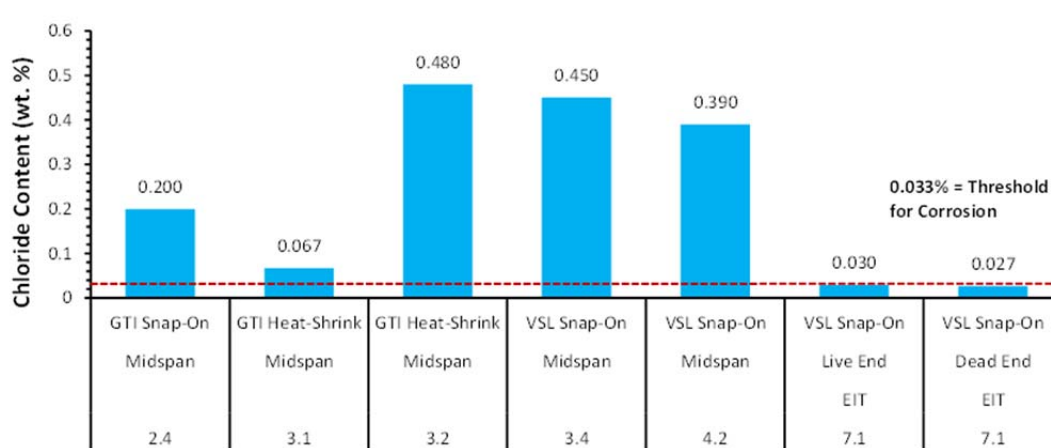
Figure 6.7: Grout-Chloride Contents at Coupler Locations

The specimens with galvanized steel ducts did not contain couplers. In each specimen with plastic ducts, the two halves of the north duct were connected with one of three couplers: GTI slip-on, GTI snap-on, or VSL snap-on. For each specimen, Figure 6.7 shows the chloride content within the tendon grout at the location of each coupler.

The highest grout chloride concentration was found inside the GTI heat shrink coupler within Specimen 3.2. The lowest concentrations were found in both VSL snap-on couplers inside Specimen 7.1, although these couplers had the benefit of being covered with an additional plastic sheath. Both chloride concentrations in Specimen 7.1 were below the corrosion threshold. The presence of chlorides within the couplers confirms that breaches had occurred, as observed during autopsies. For each coupler that was installed in more than one specimen, chloride concentrations vary significantly. This suggests that the integrity of the couplers depends more on workmanship during construction than on coupler type and manufacturer. The inexperience of the project team at construction time may have resulted in couplers that were not properly installed and that allowed chloride ingress during exposure.

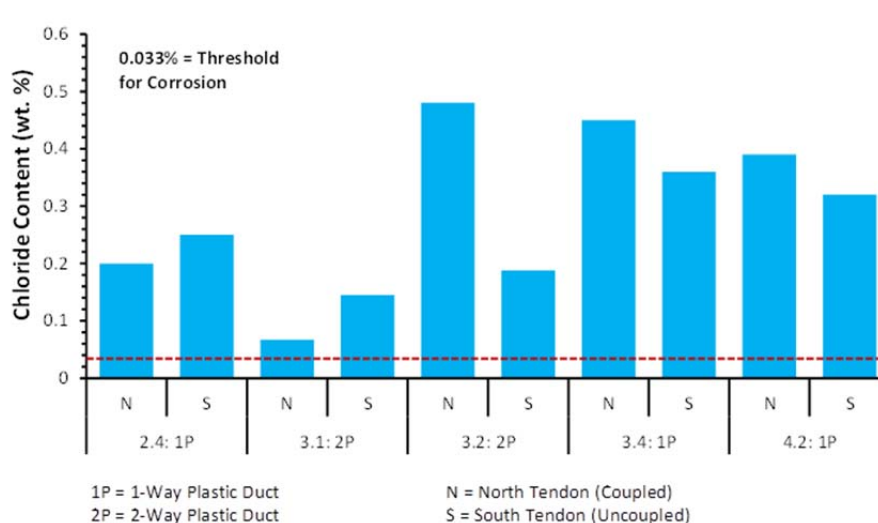
Figure 6.8: Midspan Grout Chloride Contents for Specimens with Two Plastic Ducts

For all specimens with one coupled and one uncoupled plastic duct, grout chloride concentrations at midspan are plotted in Figure 5.68. From this figure, it is clear that chloride levels at midspan were well above the corrosion threshold in both tendons of each specimen. While chloride levels were generally higher in the north tendons, concentrations were of similar magnitude in the corresponding south tendons. This is most clear for Specimens 2.4, 3.4, and 4.2, for which both chloride concentrations were nearly equal. This trend confirms that the grout vents at midspan of the south ducts were indeed breached by chlorides during the exposure period.

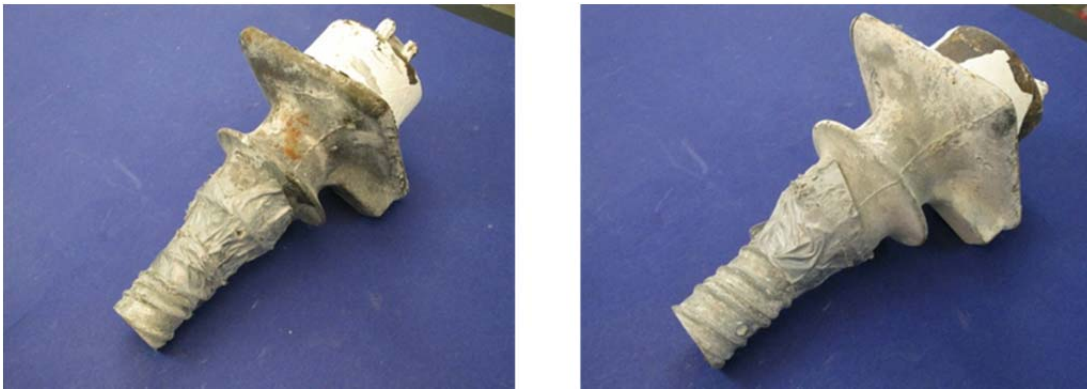
*Figure 6.9: Underside View of Anchorage with Non-Galvanized Bearing Plate (Left) and Galvanized Bearing Plate (Right)*

galvanized bearing plates were generally less corroded, and the corrosion found had occurred on the zinc, not on the steel beneath (see Figure 6.9).

Specimens T.1 and T.2 were both constructed with steel ducts and conventional steel strand, so these specimens can be used to compare the effects of bearing plate type on other elements within the specimens. Less corrosion was found on the bearing plate splice regions of the ducts in Specimen T.2 than Specimen T.1. This suggests that the galvanized bearing plates may have acted as a sacrificial anode and reduced corrosion in the galvanized ducts connected to them. Conversely, slightly more corrosion was found on the anchorage region strands in Specimen T.2 than in T.1. This may have been galvanic corrosion caused by the difference in potentials between the zinc bearing plates and the plain steel strands.

The galvanized bearing plates in Specimen T.2 performed better than the non-galvanized plates in Specimen T.1. However, the effect of the galvanizing zinc on the corrosion of other steel elements is not fully understood and should be carefully weighed before opting for galvanized bearing plates in a post-tensioned structure. In addition, the non-galvanized bearing plates on all other autopsy specimens showed corrosion but remained structurally intact after four years of exposure. This casts doubt on the need for galvanized components in the first place.

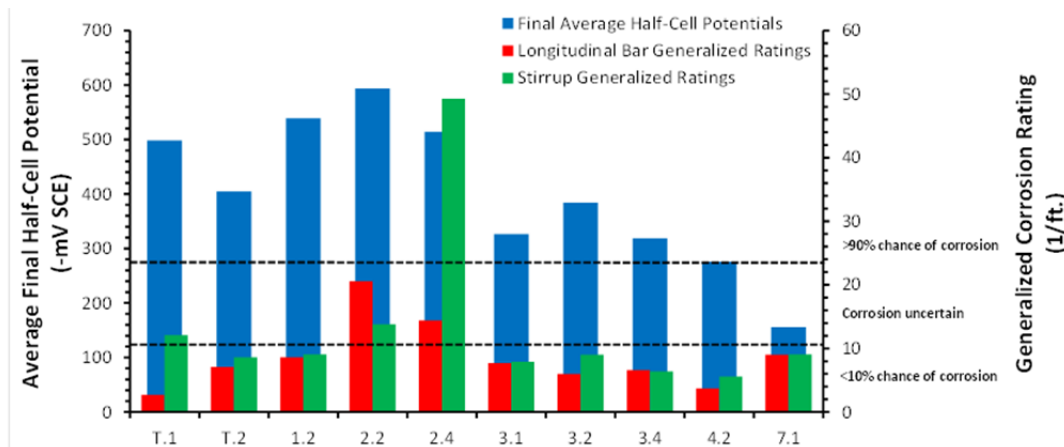
Figure 6.10: Average Final Half-Cell Potentials and Generalized Longitudinal Bar and Stirrup Corrosion

Average final half-cell potentials for each specimen are shown in Figure 6.10 with generalized longitudinal bar and stirrup corrosion ratings. All specimens except for 7.1 ended the test period with an average half-cell potential within the 90% chance of corrosion region, indicating that corrosion is very likely to be present<sup>14</sup>. Specimen 7.1 ended the test period in the uncertain corrosion category. Corrosion was present to some extent on the bars and stirrups in all specimens. In the sense of predicting the presence of corrosion, the final half-cell potential method was accurate. However, the half-cell potentials did not correlate well to the magnitude of the stirrup and longitudinal bar generalized corrosion ratings. Thus, the half-cell method did not accurately predict the relative severity of corrosion for the mild steel components in the autopsy specimens.

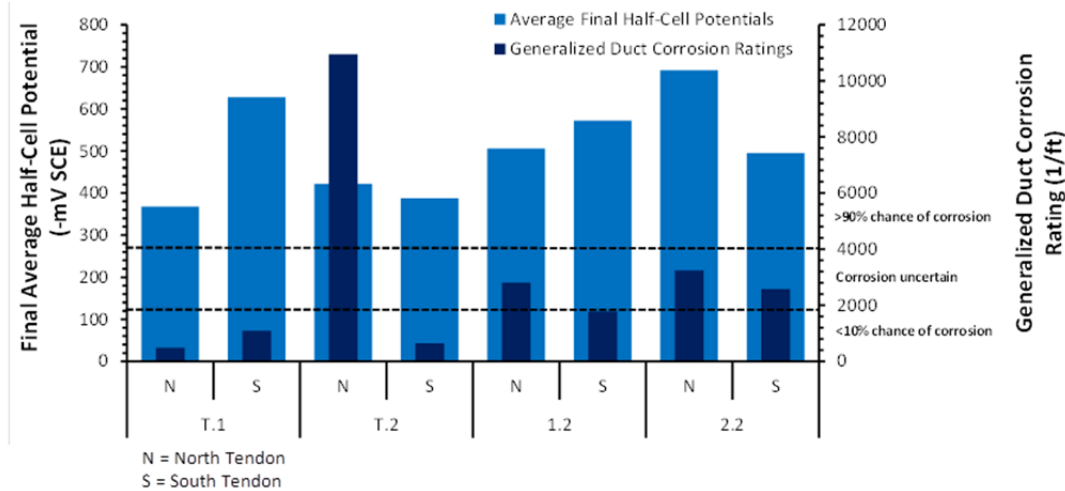
Figure 6.11: Average Final Half-Cell Potentials and Generalized Duct Corrosion Ratings for Specimens with Galvanized Steel Duct

Average final half-cell potentials for the north and south tendon in every specimen are shown in Figure 6.11 plotted with generalized duct corrosion ratings. Only the specimens with galvanized steel ducts were considered because the half-cell method would be unable to predict damage to the plastic ducts. For these four specimens, final average half-cell readings were all in the greater than 90% chance of corrosion range. This might indicate that half-cell readings predicted corrosion in those specimens. However, almost all of the specimens with plastic ducts also had readings within the 90% probability range, as shown in Figure 6.10. It is likely that the

presence of duct corrosion made the half-cell readings more negative, but they were already very negative due to rebar corrosion.

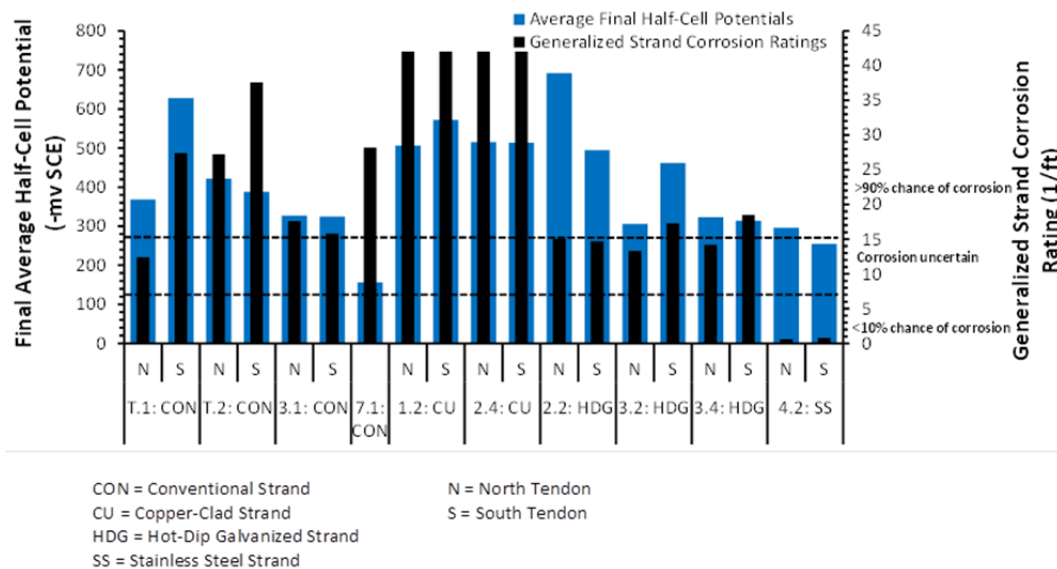
Figure 6.12: Average Final Half-Cell Potentials and Generalized Strand Corrosion Ratings

Figure 6.12 shows average final half-cell potentials plotted with generalized strand corrosion ratings for north and south tendons of each Specimen, grouped by strand type. Final half-cell potentials for all seven tendons with conventional strand indicated that corrosion was uncertain or more than 90% likely. Because all conventional strands had some corrosion, the half-cell method was accurate in this regard. However, no relationship can be seen between the final half-cell potential and generalized corrosion rating.

The three specimens with hot-dip galvanized strands all showed similar generalized corrosion ratings. Final average half-cell potentials were all above the 90% threshold and generally decreased from Specimen 2.2 to 3.2 to 3.4. In this case, a slight correlation can be seen between half-cell potential and strand corrosion rating.

Almost no corrosion was found on the stainless steel strands in Specimen 4.2. However, the final average half-cell potentials for the two tendons in that specimen indicated that corrosion was uncertain or more than 90% likely. The half-cell method was not accurate for stainless steel strands and probably was meaningless for detecting strand corrosion at all.

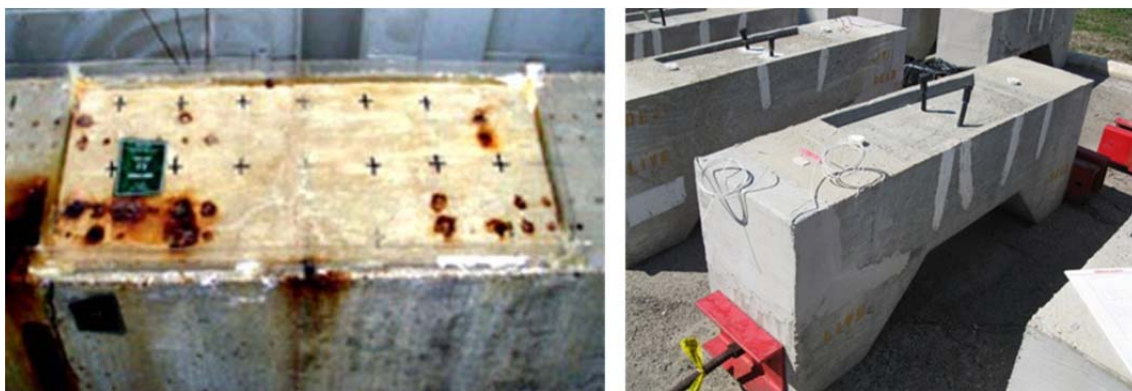
The external appearance of typical specimens from both projects is shown in Figure 6.18. The 0-1405 autopsy specimens were very poor in appearance after four years of aggressive exposure. Most specimens had moderate to severe staining on their top surface. Expansive stresses due to internal corrosion resulted in extensive surface cracking in addition to the pre-existing flexural cracks on some specimens. The large cracks provided easy ingress for chlorides from the top surface saltwater pond, and corrosion easily spread to regions of the specimens where no flexural cracks had been present.

The Project 0-4562 specimens were much better in appearance. Limited staining was observed on a few specimens, although some efflorescence was present on the top and end face surface cracks of several others. Additional cracks formed on some specimens after live load application, but there is no evidence to suggest that these cracks were the result of expansive stresses due to corrosion products within the specimens.

Figure 6.18: Typical Specimen from Project 0-14058 (Left) and Project 0-4562 (Right)
