1. Report No. FHWA/TX-11/0-4562-4		2. Government Accession No.		3. Recipient's Catalog No.	
4. Title and Subtitle Evaluation of Corrosion Resistance of Improved Post-tensioning Materials after Long-term Exposure Testing			5. Report Date October 2011

CTR Technical Report:	0-4562-4
Report Date:	October 2011
Project:	0-4562
Project Title:	Corrosion Resistance of Grouted Post-Tensioning Systems
Sponsoring Agency:	Texas Department of Transportation
Performing Agency:	Center for Transportation Research at The University of Texas at Austin

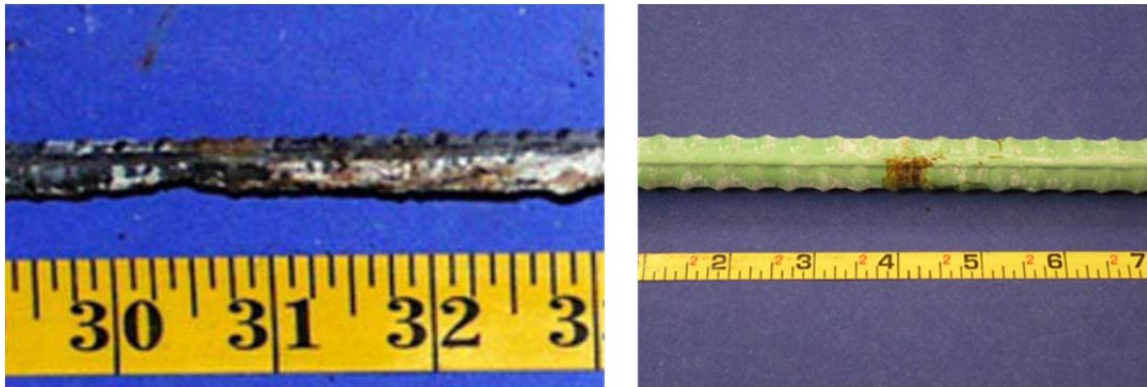
Uncoated rebar was used to form the longitudinal bars and stirrups of each 0-1405 specimen. These bars were found to have serious corrosion over most of the autopsy region. This corrosion resulted in substantial area loss, especially in the partially prestressed specimens. Crack width was observed to have a direct effect on the corrosion of reinforcement.

Project 0-4562 specimens made use of epoxy-coated rebar. Some discoloration and corrosion were present at locations where the coating was most likely to have been disturbed, such as bar curves and lifting points. Pitting was even found on occasion. However, most of the bars' and stirrups' epoxy coating remained intact, preventing widespread corrosion to those components. This indicates substantial value in the use of epoxy-coated reinforcement in aggressive exposures. A typical longitudinal bar from both projects is shown in Figure 6.19

Figure 6.19: Typical Longitudinal Bar from Project 0-14058 (Left) and Project 0-4562 (Right)

The epoxy-coated mild steel reinforcement showed minimal corrosion that mostly occurred at the points where it had been handled or disturbed in some way. It is recommended that epoxy-coated rebar fulfill the applicable ASTM standard. The rebar must also be handled with care to avoid damaging the coating. Any defects that arise during handling or construction should be patched with the appropriate repair compound prior to casting. In many instances, coating damage was caused by the coated rebar ties that were used to construct the reinforcement cages of the autopsy specimens. It is therefore recommended that epoxy-coated rebar be tied with non-metallic plastic ties to minimize coating damage.

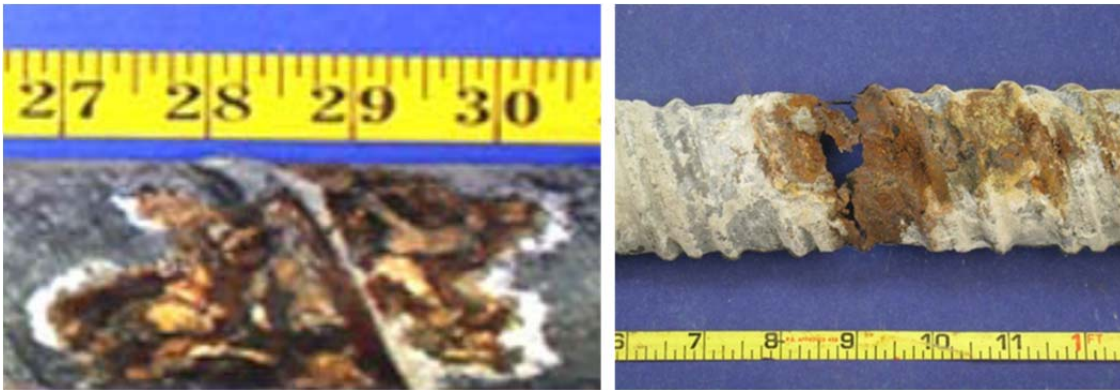
Typical steel ducts from both projects are shown in Figure 6.20. The comparable damage in the ducts indicates that the testing conditions were generally compatible in both projects. The galvanized steel ducts experienced pitting and area loss in several 0-1405 specimens, with the worst corrosion occurring at locations of grout voids. “Industry standard” (duct tape) and heat shrink splices performed very poorly, allowing chloride ingress at splice locations. Salas did not include any specimens with plastic ducts in his autopsies.

Galvanized duct corrosion was comparable in the 0-4562 specimens. Despite very little visible corrosion on the outer surface of the specimens, the galvanized duct within experienced substantial area loss and some pitting. This damage occurred mostly around transverse surface cracks and the locations of grout voids.

Figure 6.20: Typical Galvanized Steel Duct from Project 0-14058 (Left) and Project 0-4562 (Right)

Galvanized steel duct performed very poorly and should not be used in aggressive environments. The plastic ducts studied herein were robust enough to prevent significant damage during casting and post-tensioning. Their use is recommended in aggressive environments. However, chlorides were able to enter continuous plastic ducts through grout vent openings that had been drilled on-site and inadequately sealed. Therefore, it is recommended that all grout vents be installed at couplers equipped with integral grout vents and positively attached grout hoses for maximum watertightness.
