RDT 03-010

Signal Mast Arm Failure Investigation

RI 97-019

July, 2003

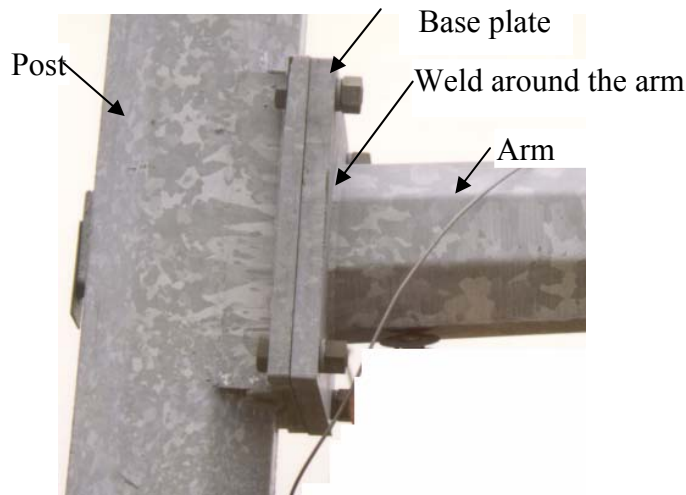
Figure 2.1 Arm-to-post connection

The cracks on all failed mast arms are located at the connection of arm to the base plate. They were observed to initiate on top of the arms and are primarily associated with the bending effect of the mast arms in the vertical plane.

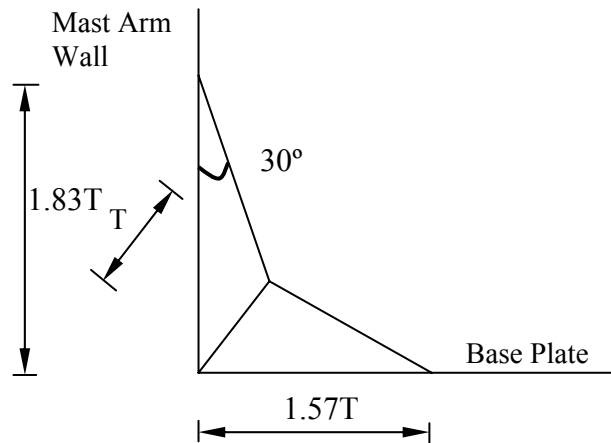
Figure 2.9 Fatigue-resistant weld

To determine the fatigue strength of a typical weld connection as shown in Figure 2.1, five full-scale arms were tested in the laboratory. They include products from three manufacturers and two with a new “fatigue-resistant” weld (Figure 2.9). The main objectives of these tests are two fold. One was to verify if the “fatigue-resistant” weld increases the fatigue strength and the other was to compare the performance of the mast arms from three vendors.

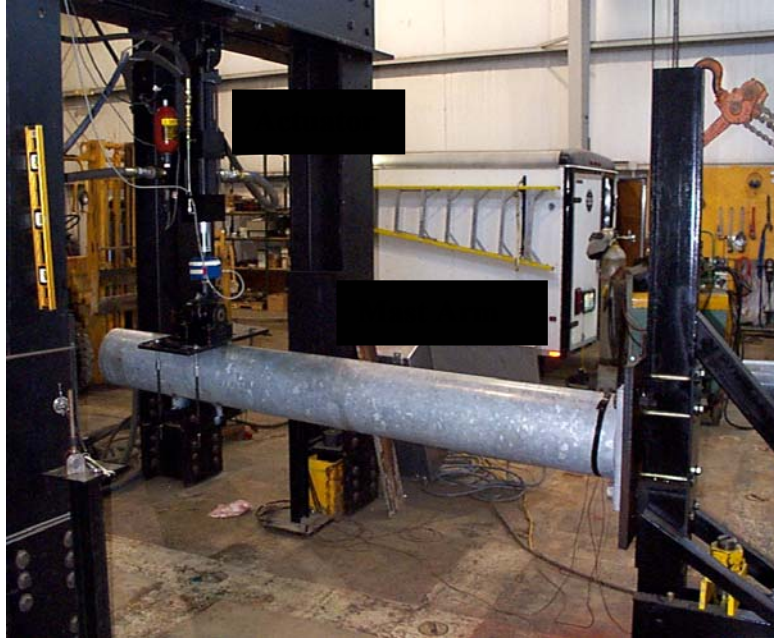
Figure 2.10 Test Set-Up for Fatigue Tests Valmont Mast Arm CB 12917

Mast Arm	Manufacturer	Weld Type	Failure Cycles	Comments
254682	Valmont	Old	1.8 million	None
BB 34970	Valmont	New	2.1 million	None
CB 12917	Valmont	New	0.4 million	Possible lack of fusion of weld
88791	Union Metals	Old	0.5 million	Flaw detected by Mag Particle prior to loading
9539 CL54	JEM	Old	0.0 million	Flaw detected by inspection prior to loading

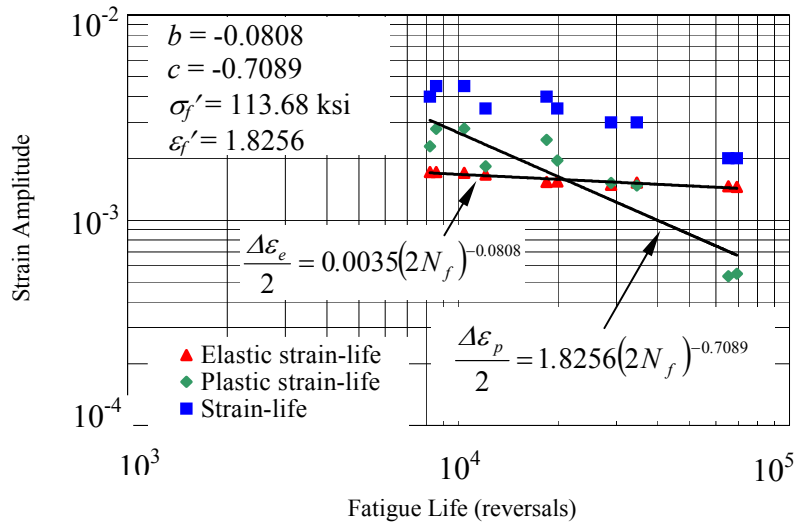
(b) Strain and fatigue life relation

To determine the parameters in the above equations, ten flat-sheet specimens were made from the failed mast arm and tested on MTS810 machine according to the ASTM standard E606-92. The test results are presented in Figure 5.5. The parameters in Equation 5.1 and 5.2 are identified by curve fitting the plastic strain-stress and the strain-life model with the experimental data and they are listed in Table 5.1. The corresponding parameters of A-595A steel determined

Figure 5.5 Parameters in the crack initiation prediction model

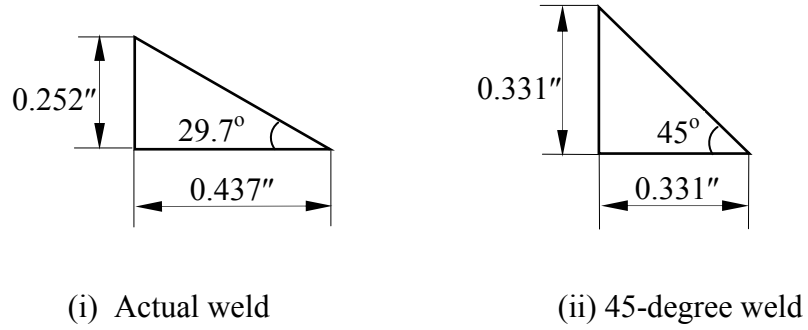
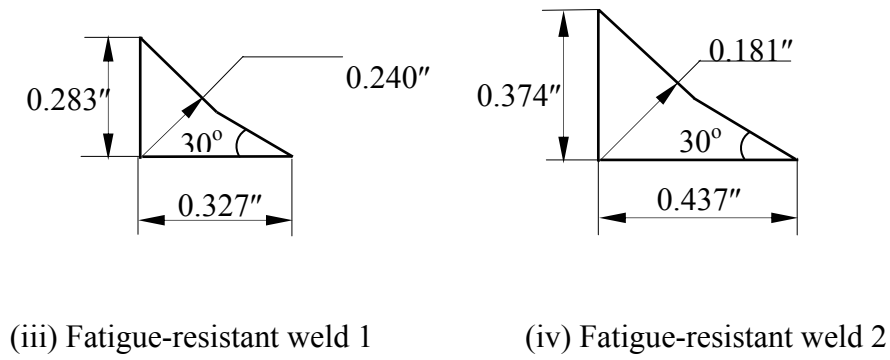
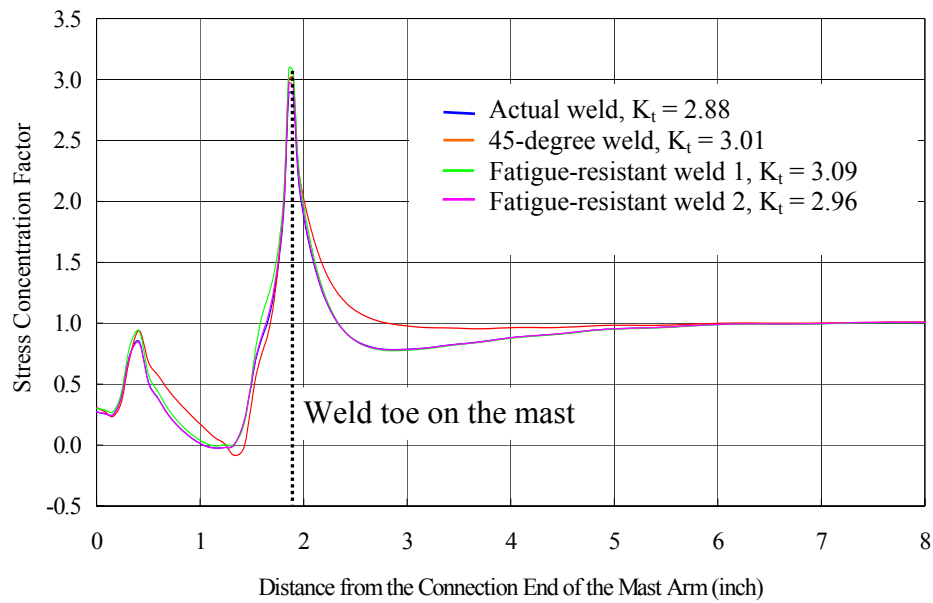
Figure 5.6 Stress concentration factors for various weld profiles

The Missouri Department of Transportation has recently introduced a so-called fatigue resistant weld profile with varying slopes. For this weld profile, the weld length on the mast arm is 1.83T, and that on the base plate is 1.57T, where T is the weld throat, i.e. the shortest distance between the root of the joint and the face of the weld. The maximum slope of the fatigue resistant weld is 30 degree. To understand the effects of weld profile on the stress concentration, four profiles for the octagonal mast arm are selected as shown in Figure 5.6(a). Profile (i) is the typical weld used in the current structure. Profile (ii) is a comparative weld, which possesses the same area as that of (i), but its slope on the mast arm is 45 degree. Profile (iii) is a fatigue-resistant weld with the weld throat equal to the thickness of the mast arm tube (0.1793 in). Profile (iv) is another fatigue-resistant weld. Its length on the mast arm is equal to that of Profile (i). Their effects on the stress concentration are presented in Figure 5.6(b). It can be observed that the actual weld yields the smallest concentration of stress with a factor of 2.88 at the weld toe even though its weld leg on the base plate is the shortest. This is mainly because the actual weld has the longest weld leg and the smallest slope on the mast arm wall. The stress concentration factor for the 45-degree weld is 3.01, although it has the same weld area as (i). The fatigue-resistant weld 1 has the largest stress concentration factor of 3.09, because its length on the mast arm is the shortest. Increasing the length of the fatigue-resistant weld to that of the actual weld, the stress concentration factor will be decreased to 2.96. Therefore, it is concluded that the stress concentration not only depends upon the slope of a weld profile but also depends on the weld length along the mast arm wall. The fatigue-resistant design could lessen the stress concentration if used to lengthen the weld leg on the arm wall.

(a) Weld profiles

(b) Stress concentration factors

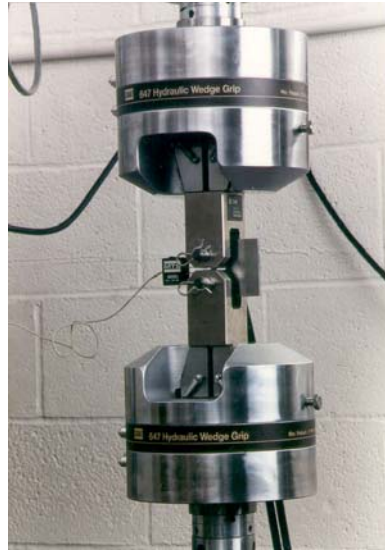
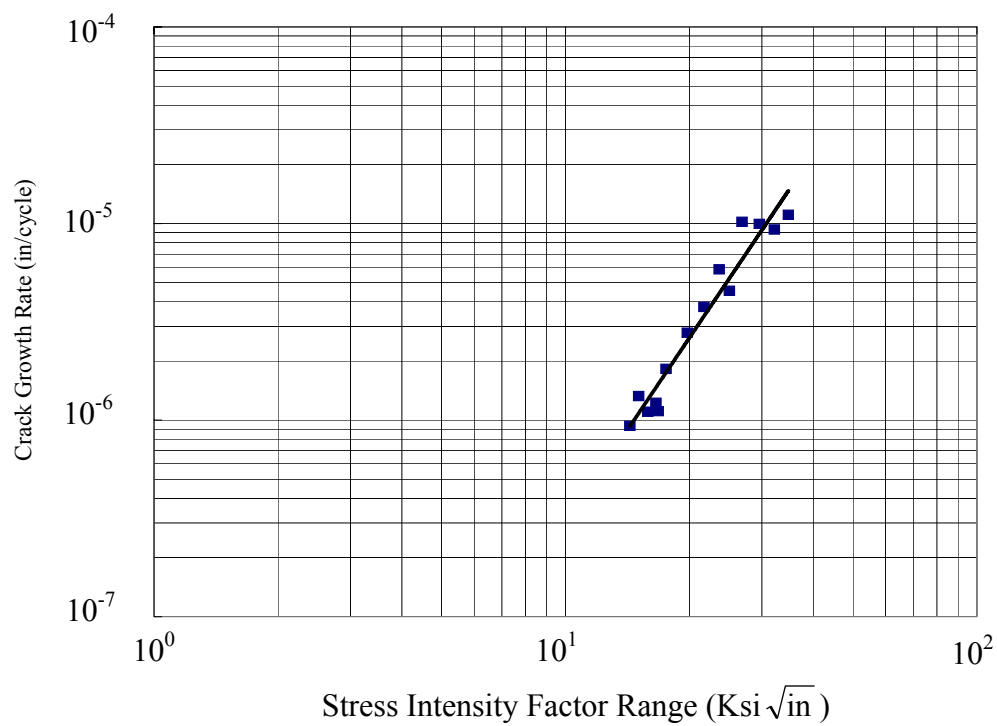
Figure 5.7 Determination of constants in the crack growth rate model

in which a is the crack length, N is the number of stress cycle applied to the structure, and C and m are two material constants. To determine these two constants, several compact tension specimens were made from the failed octagonal mast arm and tested in the MTS810 system according to ASTM standard E 647 - 95a. The test specimen and setup is shown in Figure 5.7(a). The material constants can be estimated as $C = 2.36 \times 10^{-10}$ in the units of a as inch and K as ksi $\sqrt{\text{in}}$ and $m=3.11$ from the test data shown in Figure 5.7(b).

(a) Test specimen and setup

(b) Crack growth rate vs. stress intensity factor range

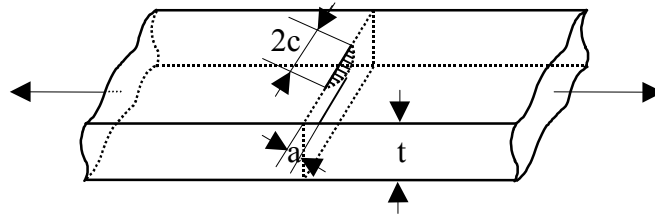
Figure 5.8 The part through thumbnail crack

Consider a thumbnail surface crack shown in Figure 5.8. The initial crack length is supposed as 0.05 inch, which is the maximum length of surface defects NDT can detect. For the surface crack, suppose $a/2c$ equal to 0.1. For the crack shown in Figure 5.8, the stress intensity factor K is a function of stress at the arm-post connection and the crack size, etc. The following equation can be used to calculate K (Bannantine *et al.*, 1990).

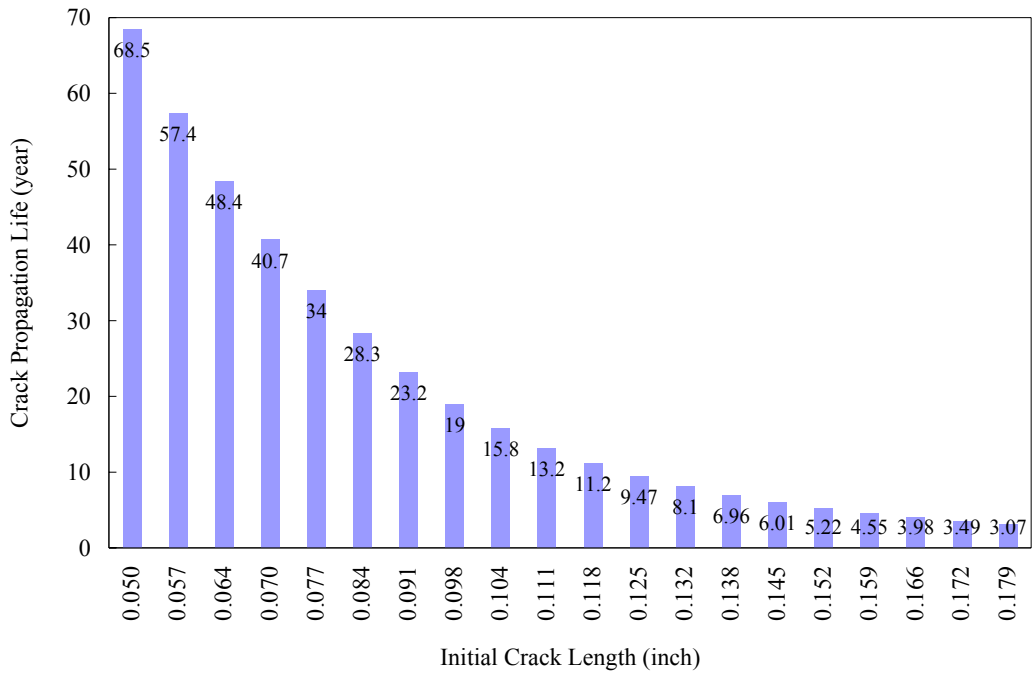
For each increment of crack length, compute ΔK_i for different stress level, and then use Equation 5.5 to get ΔK_{rms} . Use $\frac{\Delta a}{\Delta N} = C(\Delta K_{rms})^m$ to get ΔN_i . The total crack propagation life in cycles was obtained by summing ΔN_i . Figure 5.9 and 5.10 show the crack propagation life for different initial crack length.

Figure 5.9 Crack propagation life for the mast arm at Providence & Green Meadows

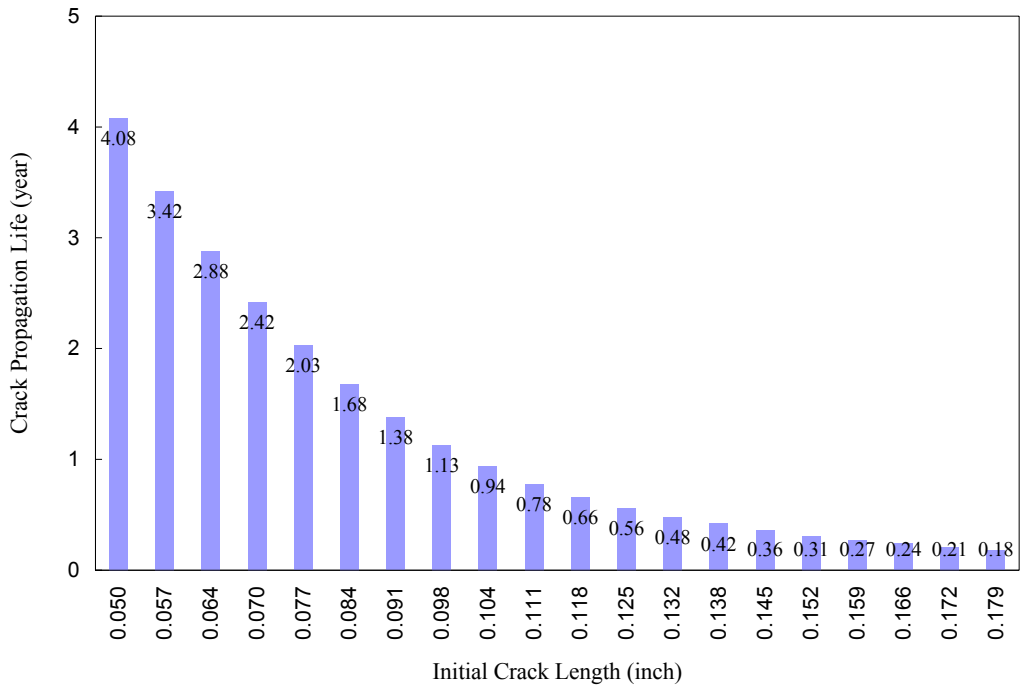
Figure 5.10 Crack propagation life for the mast arm at Stadium & Forum

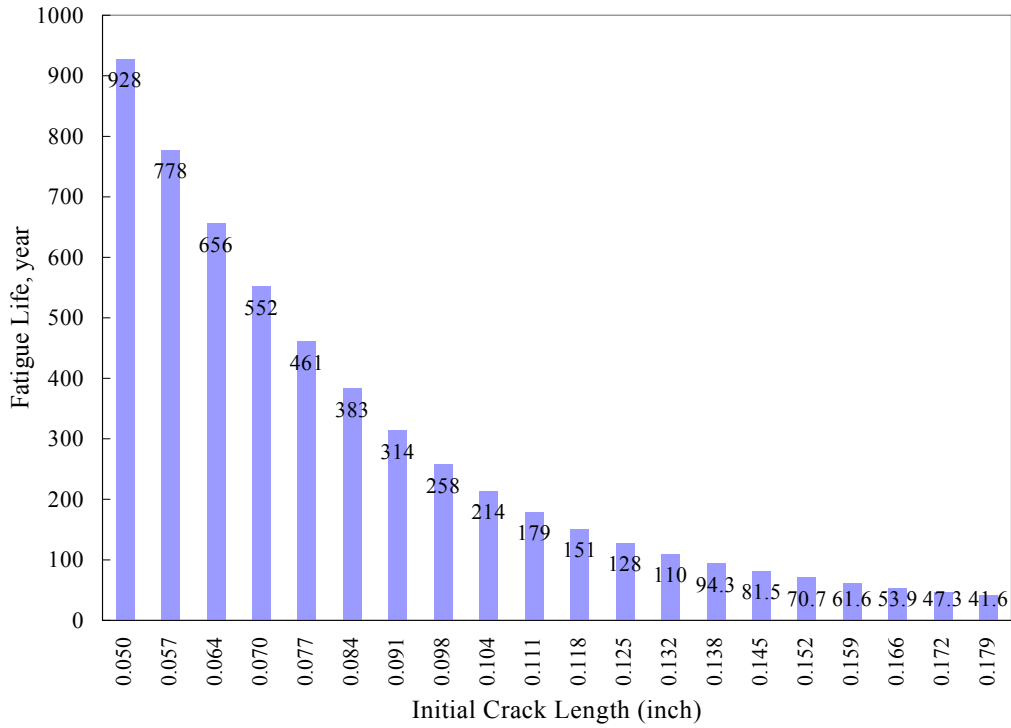
For welded structures, the above-mentioned flaws (such as inclusions, discontinuity, lack of penetration and undercut) are likely to be present; it is reasonable to assume that the entire fatigue life of the structure to consist of crack propagation phase. By comparing the predicted life with that determined experimentally in Section 2.3, a modified stress concentration factor is calculated for each cross section (octagonal and circular) of the mast arm. These modified stress concentration factors are 1.25 for octagonal section and 2.03 for circular section. Here, the analytical model predictions and the experimental test fatigue life data correspond to constant amplitude loading case. Using these stress concentration factors that are calibrated using constant amplitude fatigue data, the crack propagation life (remaining life) of the mast arm subjected to natural wind gusts (variable amplitude loading) is calculated. The remaining life predictions for the mast arm at Providence & Green Meadows and at Stadium & Forum are given in Figures 5.11-5.14.

Figure 5.11 Remaining fatigue life for the mast arm at Providence & Green Meadows (correlated with 1.8 million cycles fatigue life for the lab test)

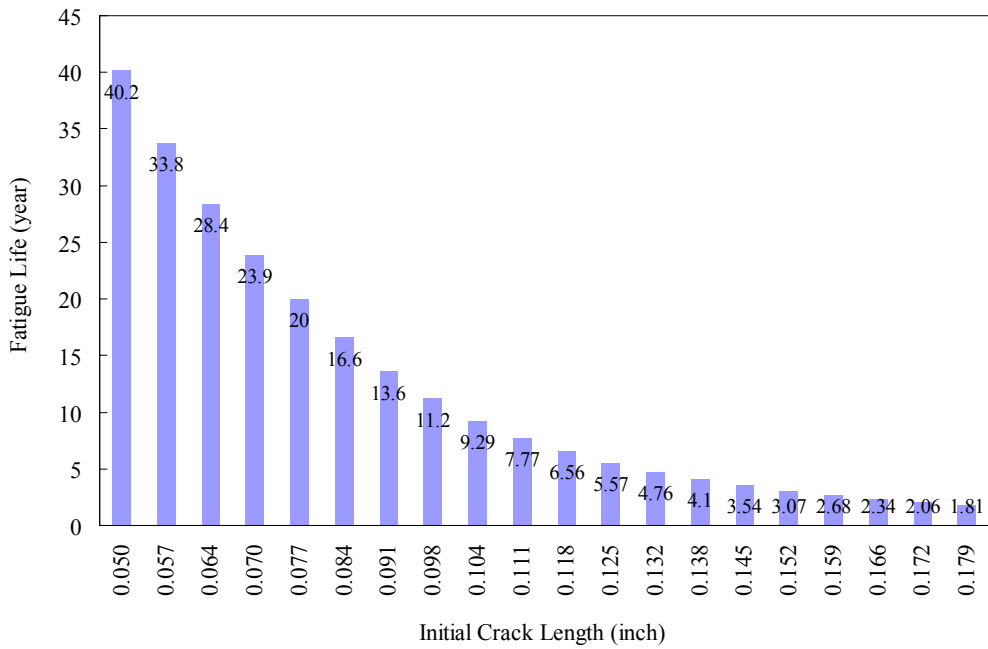
Figure 5.12 Remaining fatigue life for the mast arm at Stadium & Forum (correlated with 1.8 million cycles fatigue life for the lab test)

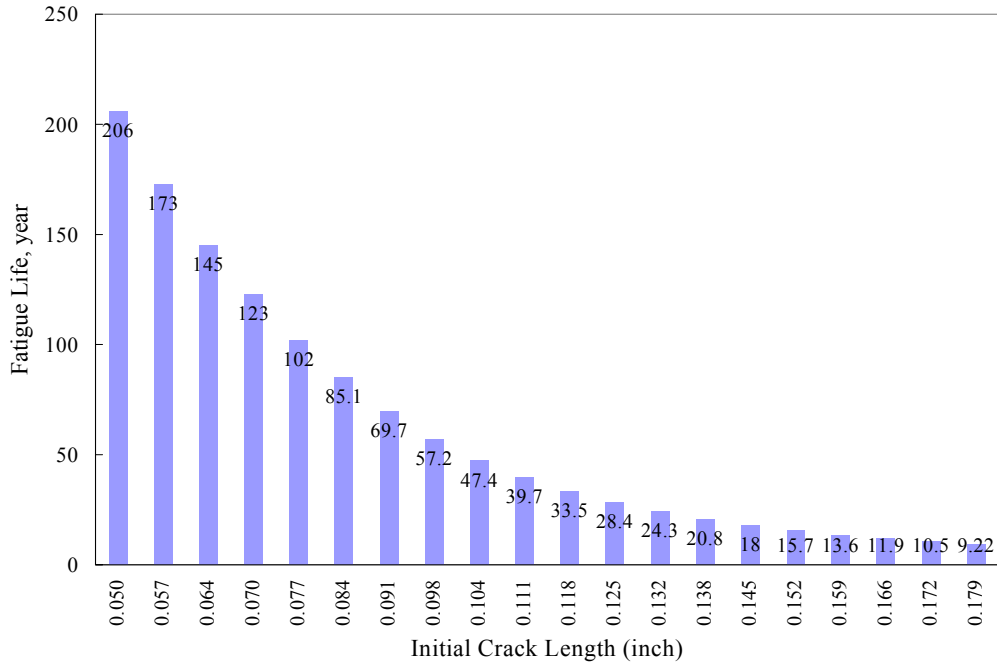
Figure 5.13 Remaining fatigue life for the mast arm at Providence & Green Meadows (correlated with 0.4 million cycles fatigue life for the lab test)

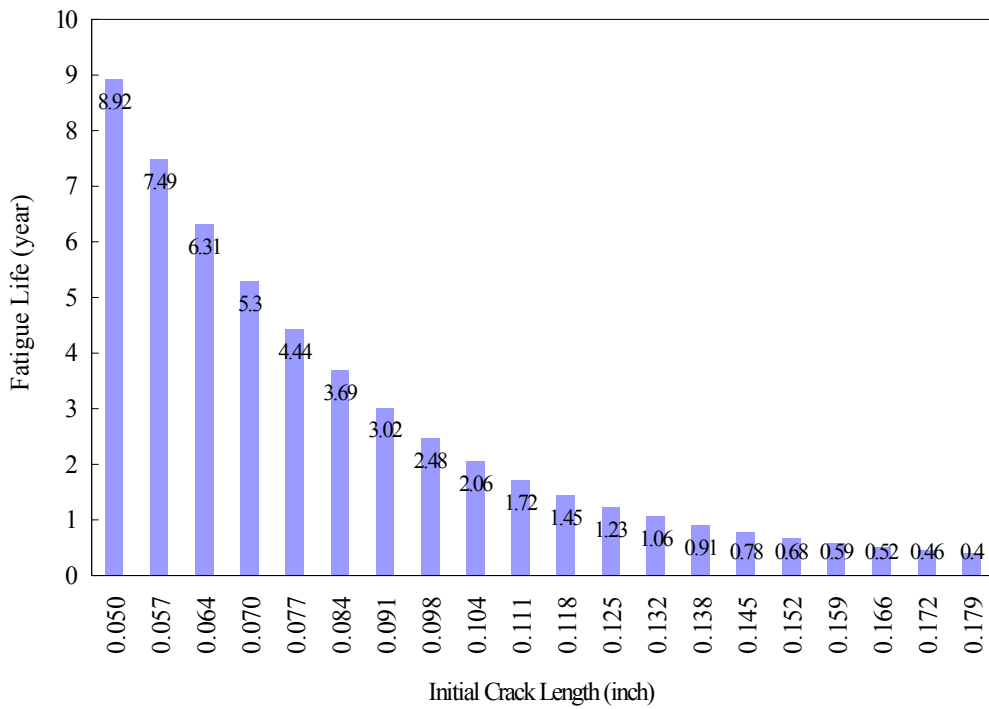
Figure 5.14 Remaining fatigue life for the mast arm at Stadium & Forum (correlated with 0.4 million cycles fatigue life for the lab test)
