Stabilization Procedures to Mitigate Edge Rutting for Granular Shoulders – Phase II

Final Report January 2011

Iowa Highway Research Board (IHRB Project TR-591) Iowa Department of Transportation (InTrans 08-319)

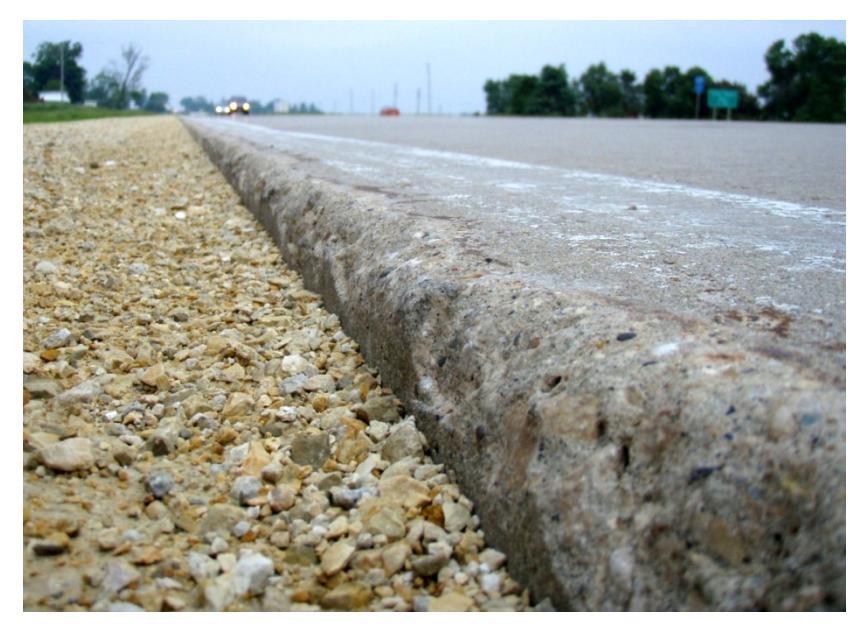
Figure 2. Shoulder drop-off Highway 63 milepost 172.5 northbound June 4, 2008

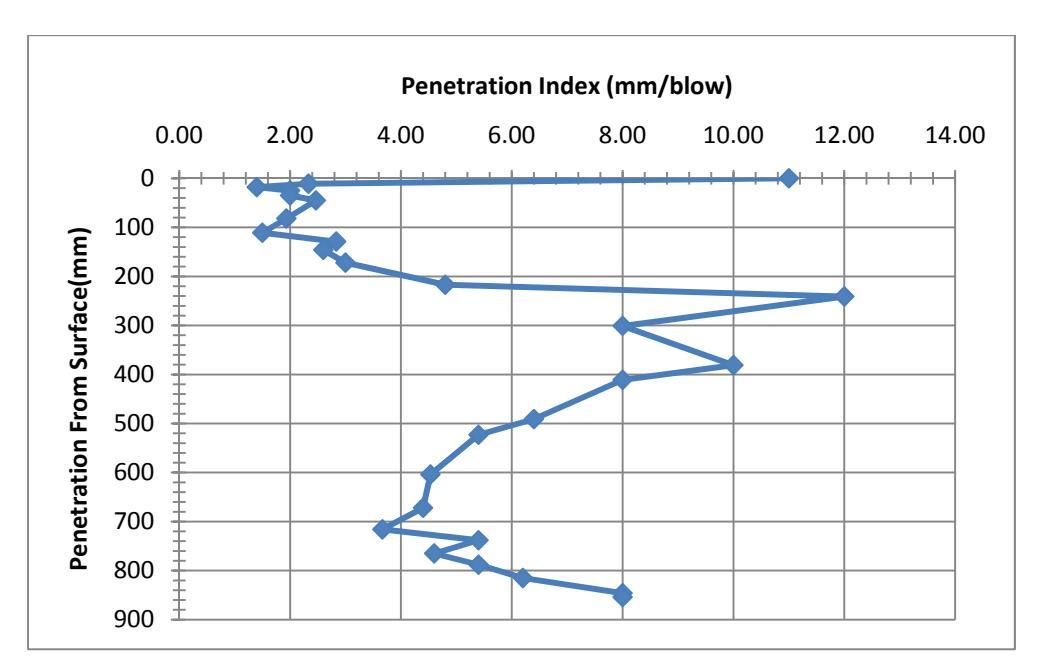
Figure 4. DCP test results Highway 3 milepost 215.16-215.63 June 4, 2008

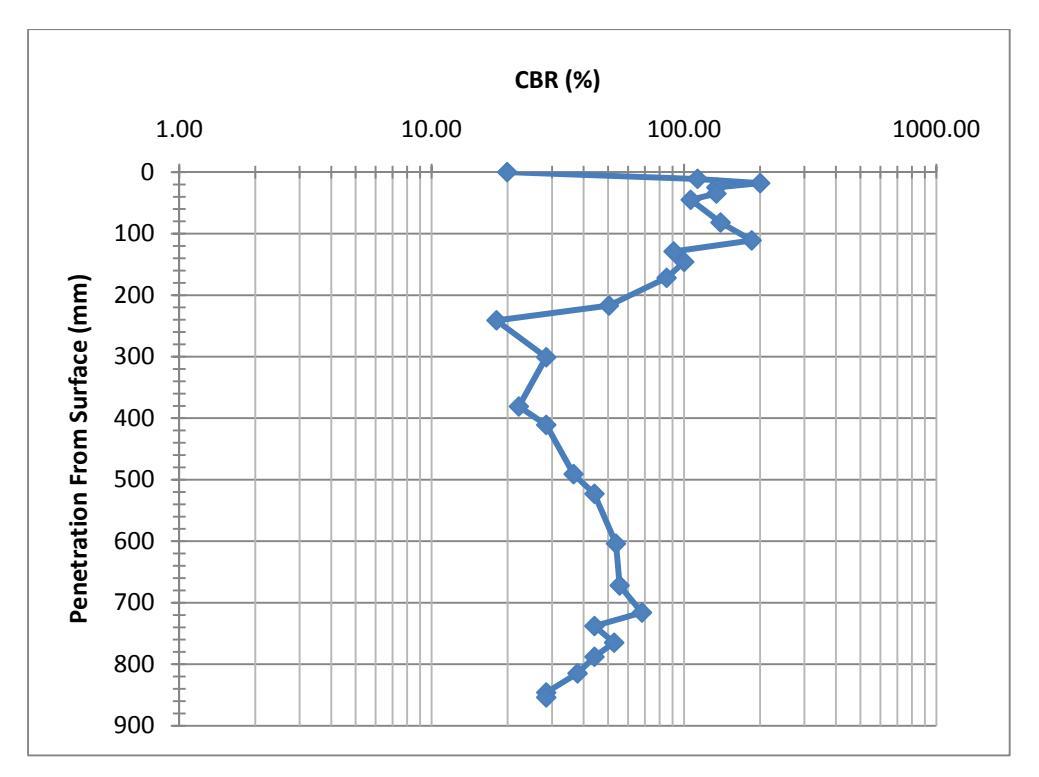
Figure 5. CBR measurements for Highway 3 milepost 215.16-215.63 June 4, 2008

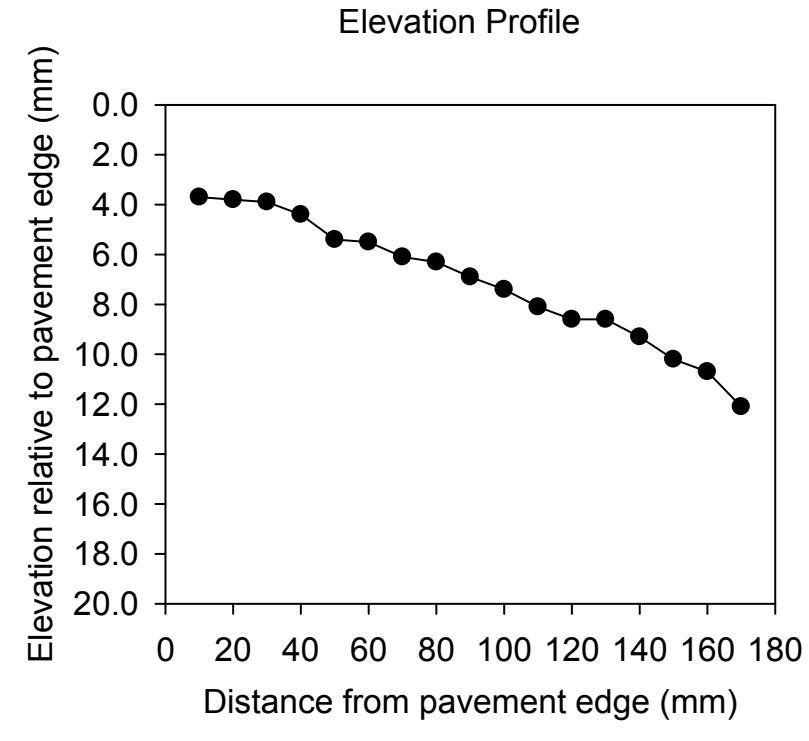
Figure 6. Elevation profile relative to the pavement edge for Highway 3 milepost 215.16-215.63

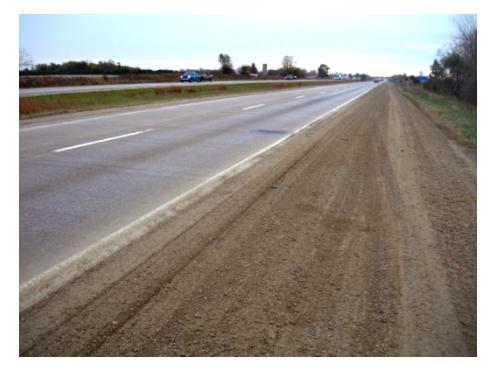
By the following week, much of the shoulder had stabilized, so it could support a 3/4 ton pickup truck (See Figure 17), but a few soft spots remained (See Figure 18).

Figure 17. Magnesium chloride full-depth after one week

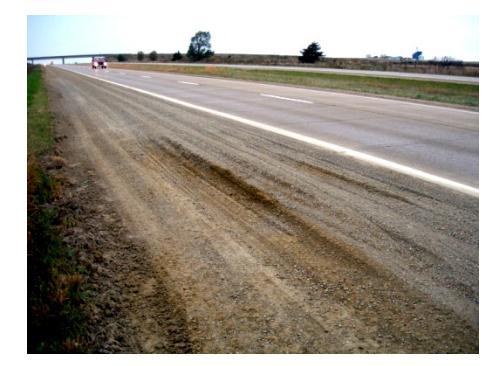
Figure 18. No stabilizer, full-depth, still soft one week later

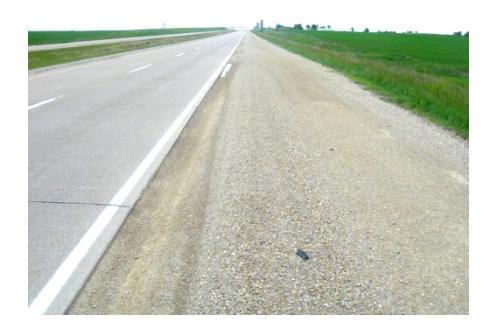
However, some research team members have performed some informal photo documentation after formal field reconiassance ended. Conditions appeared to be little changed from those that were present before test section construction took place (See Figure 21). And, difficulties maitaining the shoulder near the pavement edge prevailed (See Figure 22).

Figure 22. Calcium chloride scarify twice June 2009

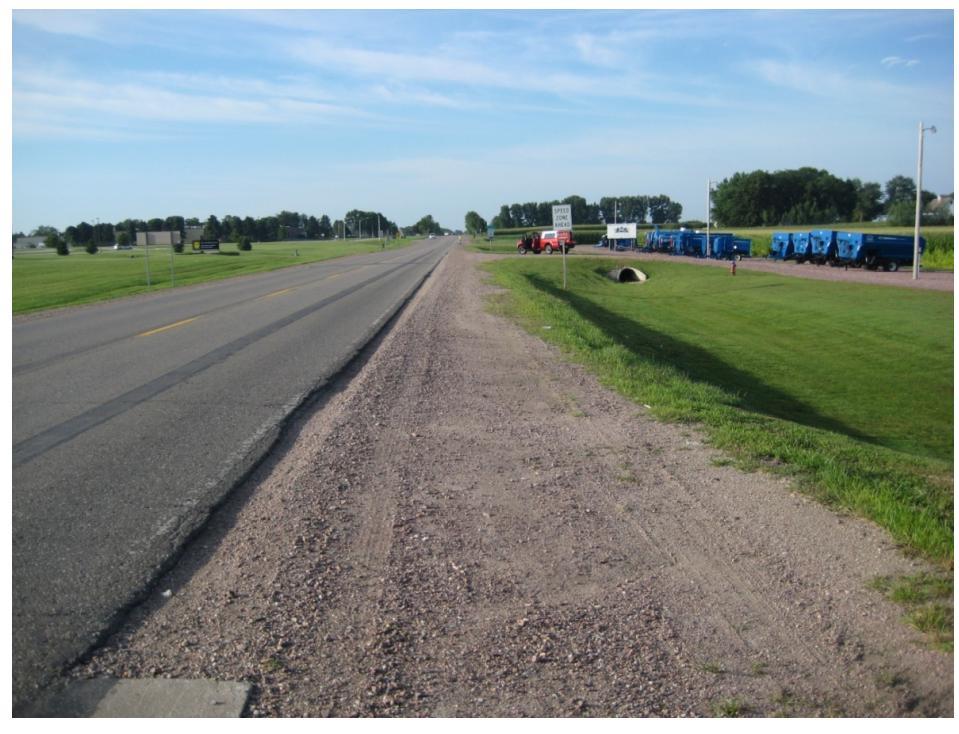
A preconstruction field investigation indicated that the granular shoulder along US 75 in the area was rutted due to heavy traffic. Rutting usually occurred on the shoulder surface within 12 in. (300 mm) from the pavement edge to a depth of 2.54 in. (50 mm) (See Figures 49 and 50).

Figure 49. Shoulder condition at Test Area I before stabilization

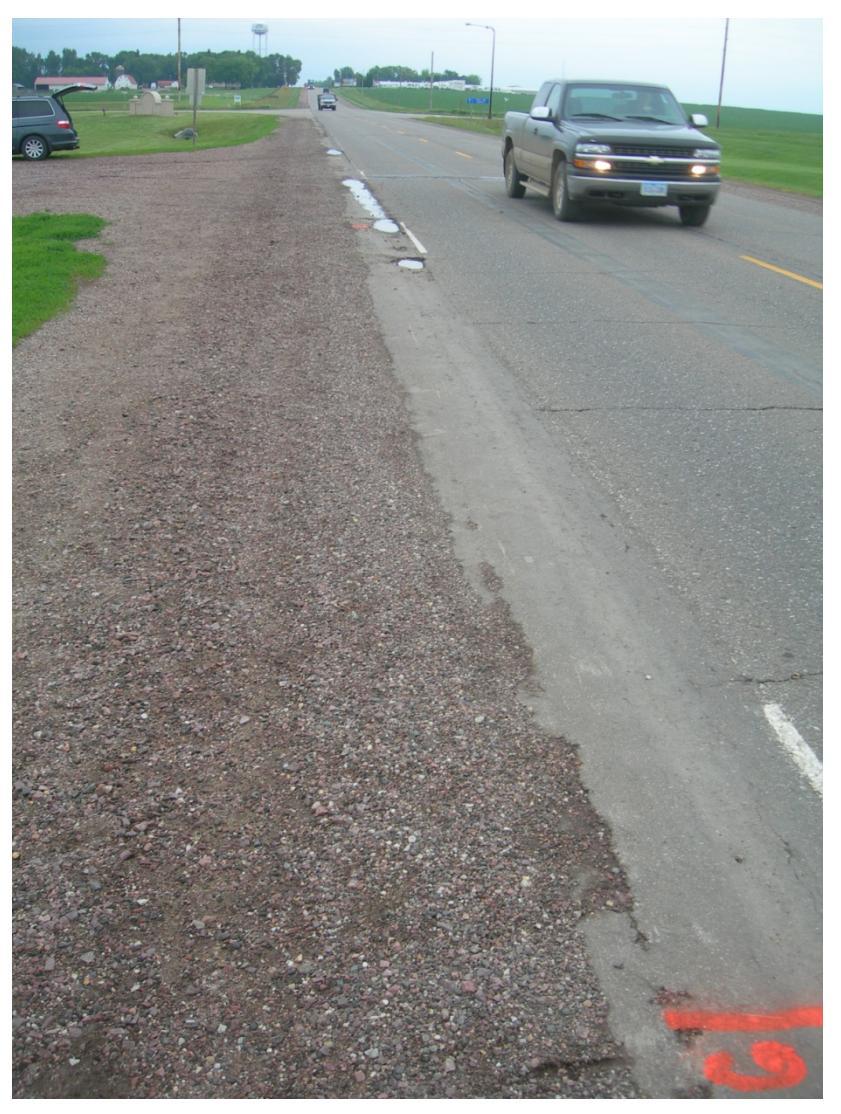
In the elevation profile, the solid line represents the elevation of the first measurement, the dashed red line with dots at the measurement points represents the second measurement , and the dashed blue line represents the third measurement. The profiles show that the shoulder generally lost elevation after two years in service and that the edge rut had returned in places after 10 months in service (See Figures 56 and 57). Repeated trafficking was considered as the likely cause. Despite the previously mentioned damage noted on many parts of the test section (especially away from the driveway area), the stabilized shoulder material remained completely intact.

Figure 56. Looking north from Point 9 at Test Area I on southbound shoulder of US 75 near Sioux Center, Iowa June 8, 2010.

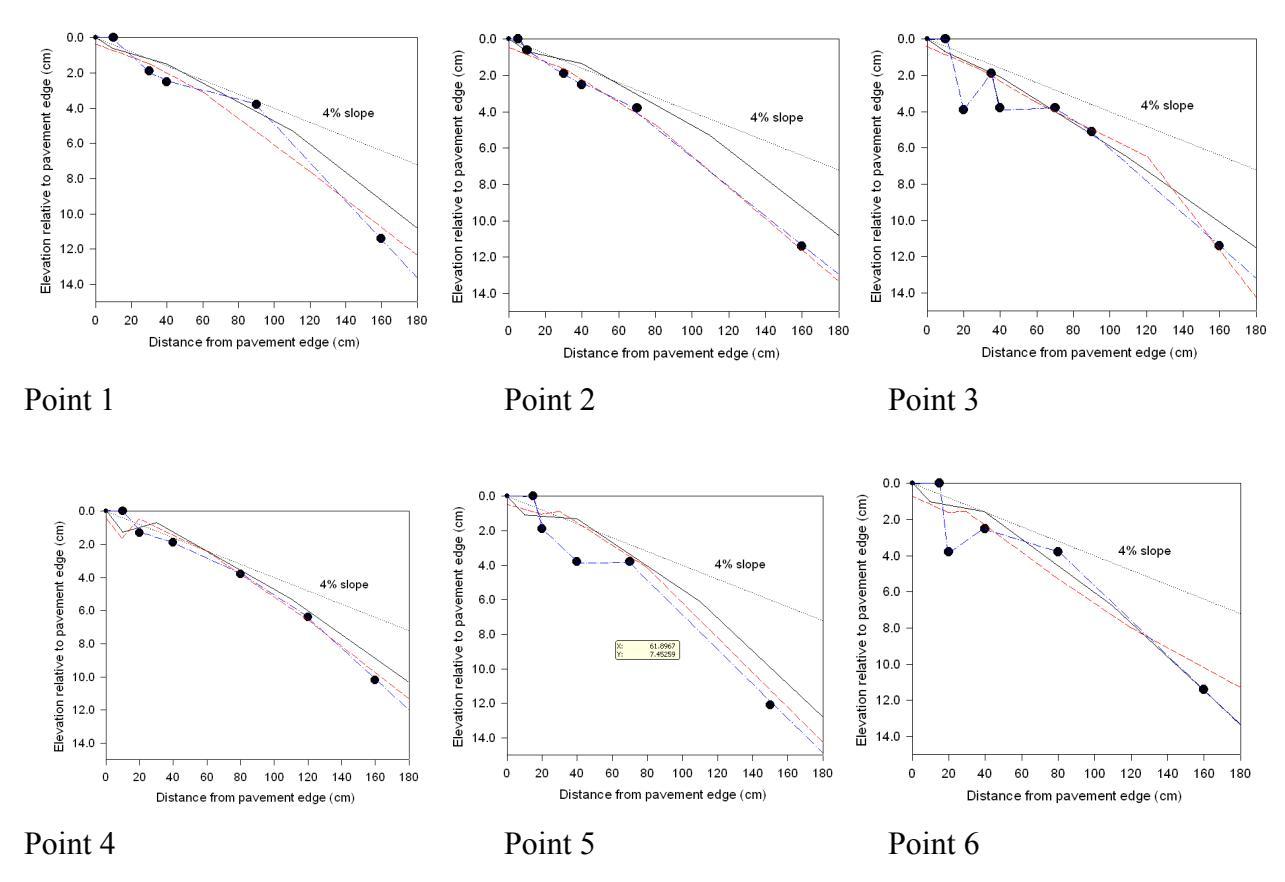
Figure 61. Elevation profiles of Test Area II on the southbound shoulder of US 75 near Sioux Center, Iowa

By October 27, 2009, some small areas of instability were evident (See Figure 62). The profiles show that shoulders generally lost elevation while in service and by June 2010 at some locations, the stabilized material had been removed from the edge of the road, resulting in small potholes (See Figure 63).

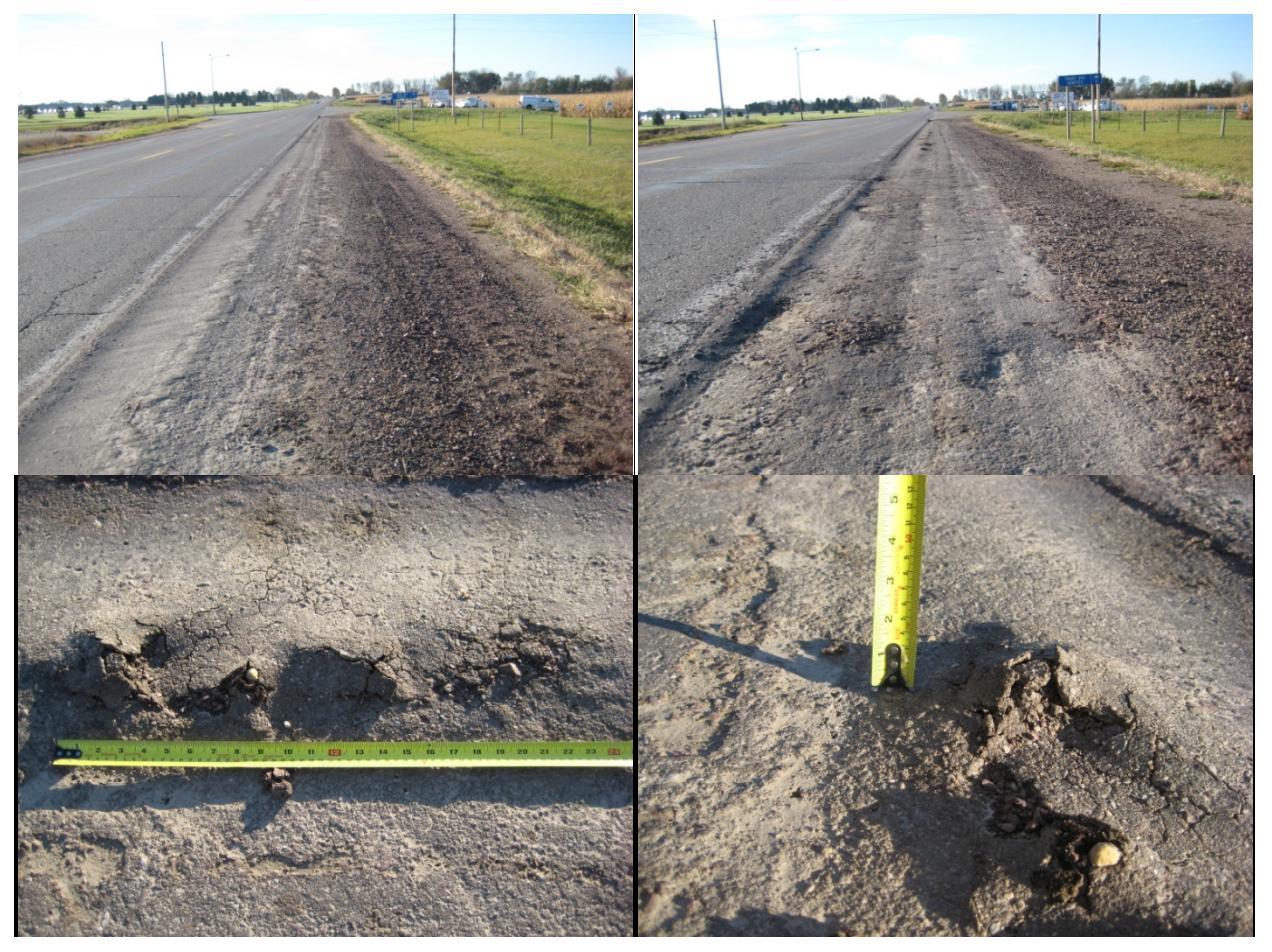
Figure 62. Stabilized shoulder surface October 27, 2009

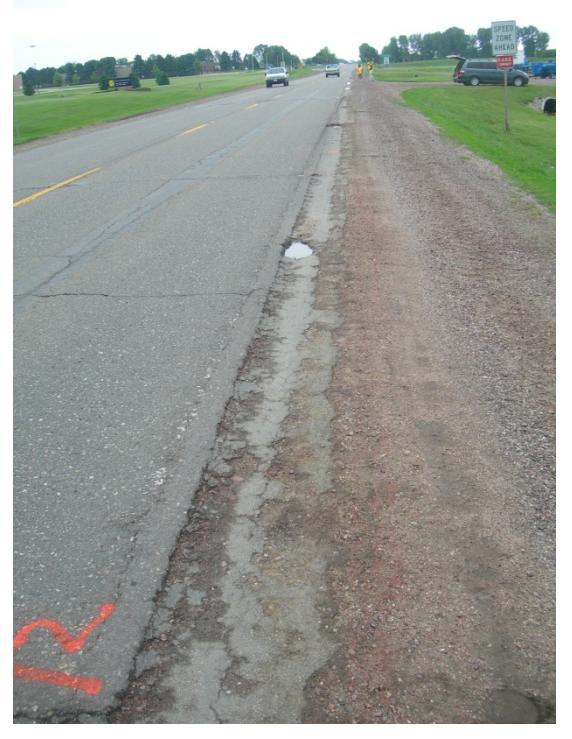
Figure 63. Looking south at Test Area II from Test Point 2 June 8, 2010

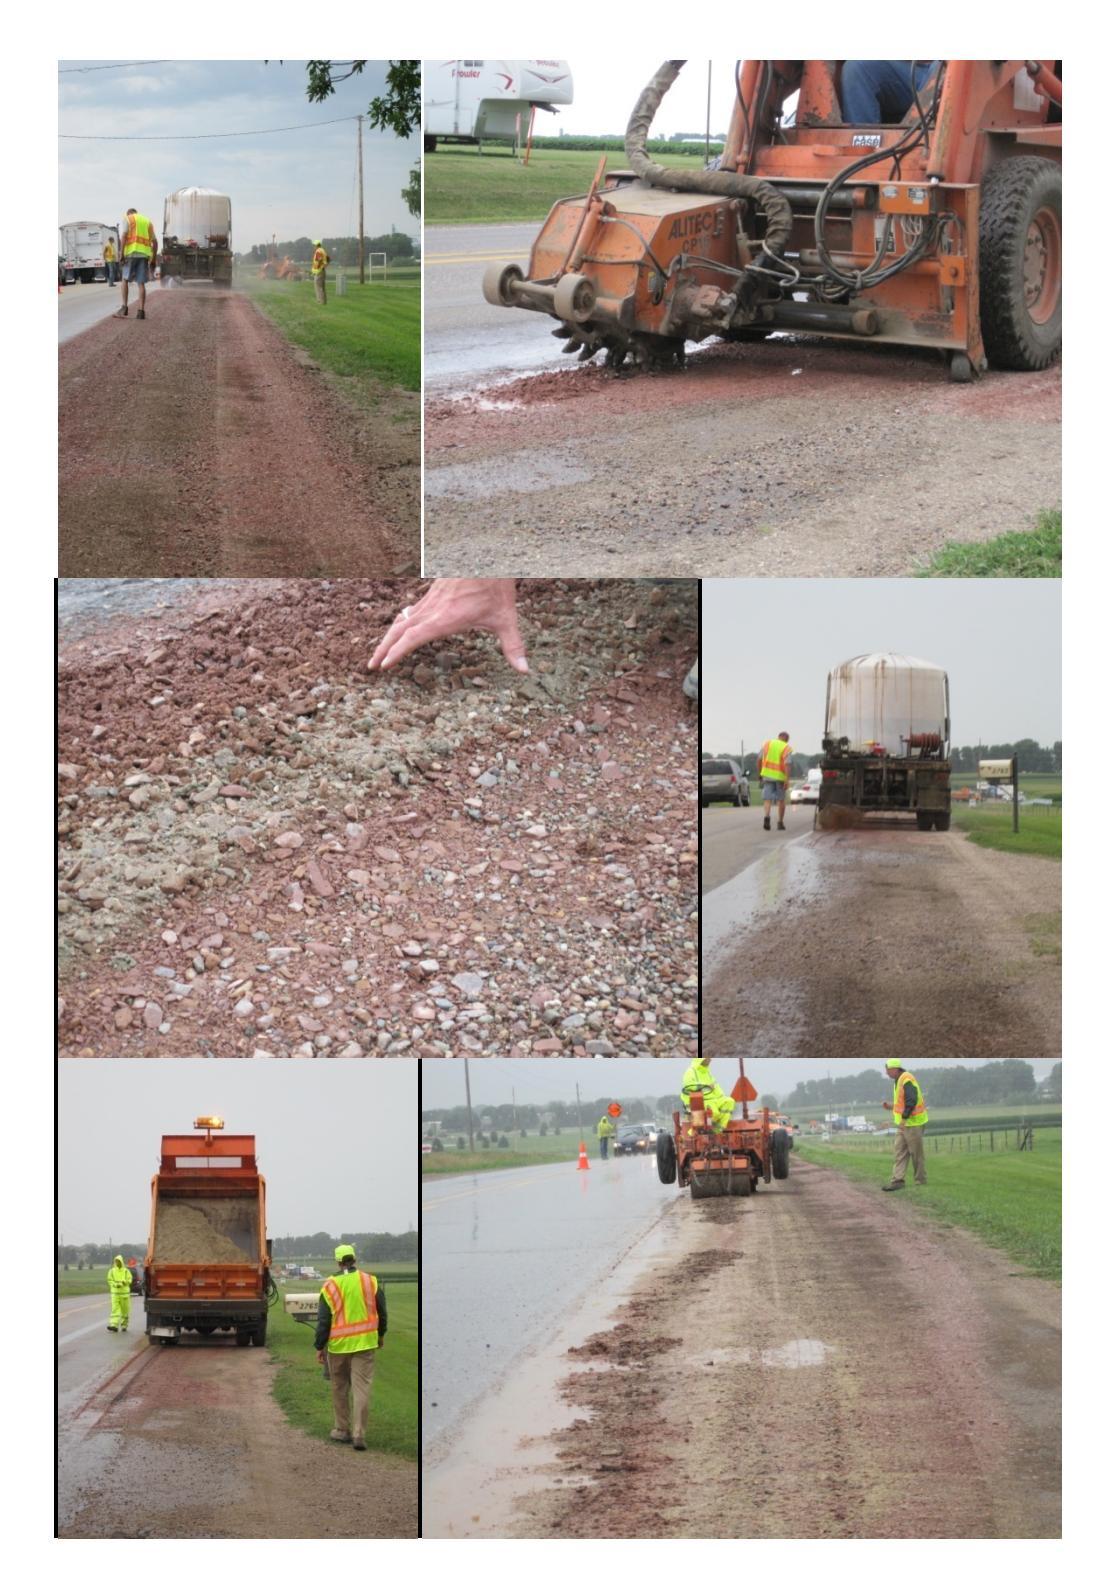
Test Area III was divided into two sections, in which Section I was topically stabilized and Section II was stabilized using stabilization Procedure 4 (See Figure 64). Moderate rain started to fall after water was sprayed over the area, resulting in the stabilizing agent being washed away along with the sand that was to cover the DUSTLOCK (See Figure 65).

Figure 65. Stabilization procedure of Test Area III on southbound shoulder of US 75 near Sioux Center, Iowa July 29, 2009

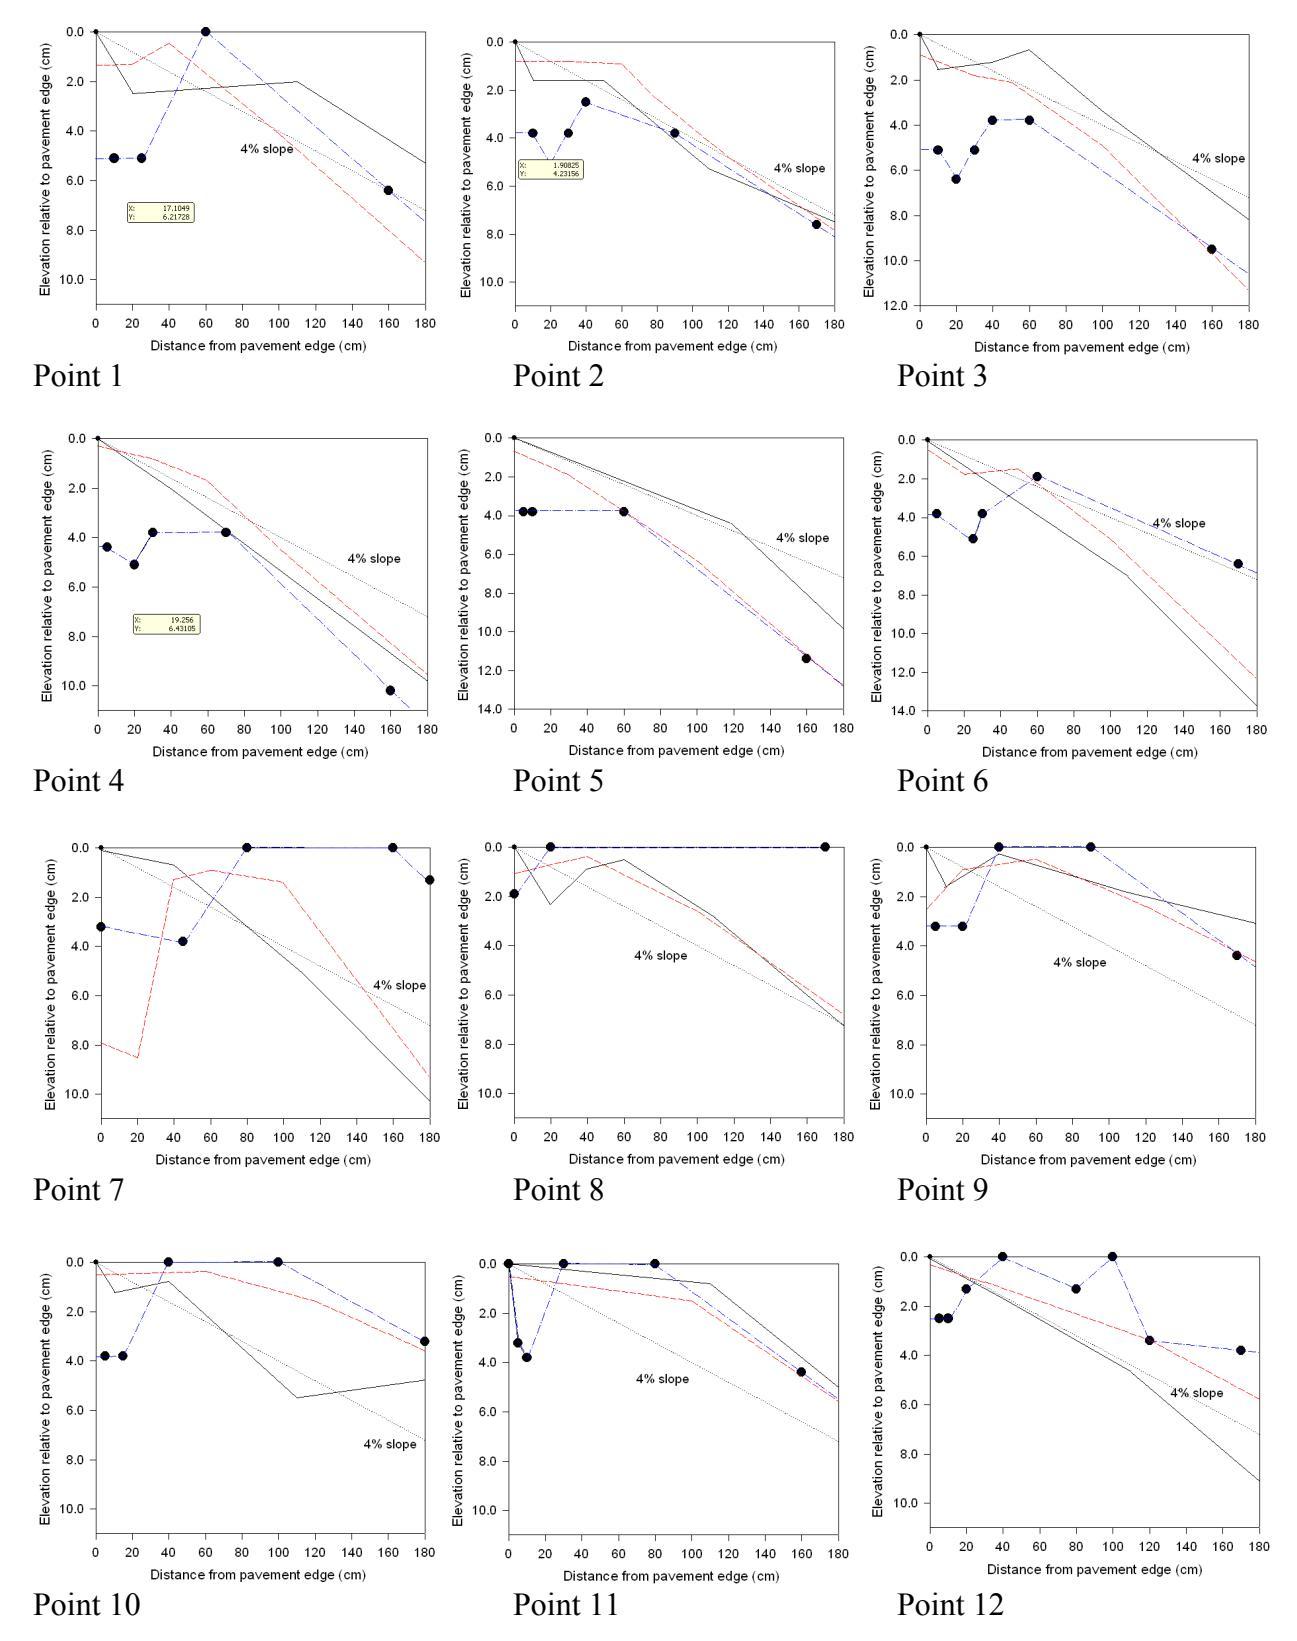
The elevation profiles showed that the elevation of the shoulder surface at the test points changed over several months. By October 2009, at some test points, the shoulder surface elevation had increased, while it decreased at the other points. The DUSTLOCK shoulder surface was observed to be damaged at several areas after about two months of construction.

Figure 67. Elevation profiles of Test Area III on the southbound shoulder of US 75 near Sioux Center, Iowa

The damage was observed in particular at Test Point 7 (See Figures 67 and 68). By June 2010, the stabilized material had mostly disappeared from the entire area (See Figure 69).

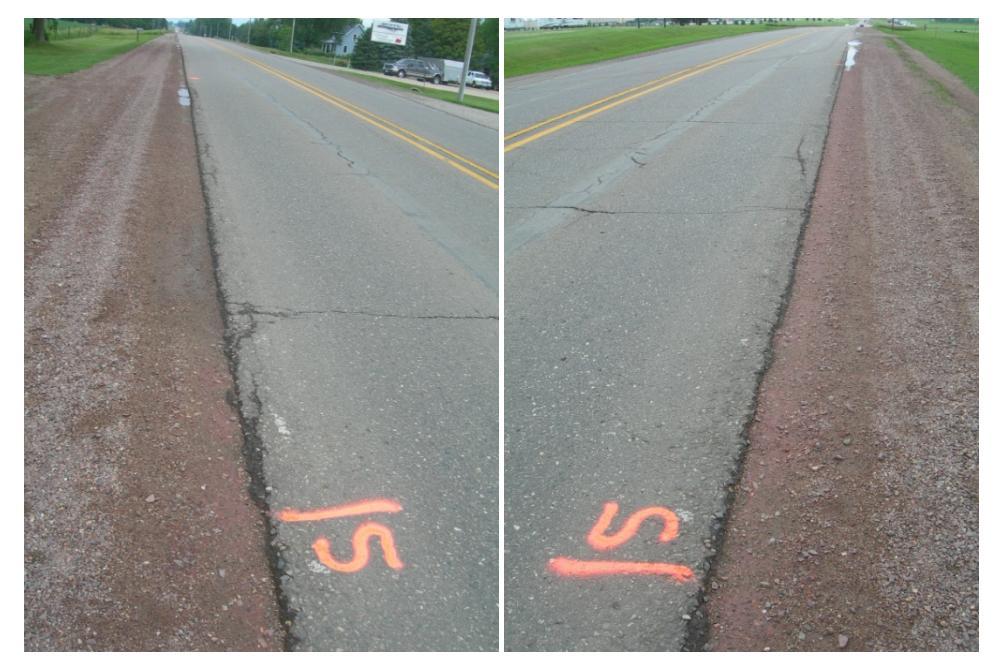
Figure 69. Looking north and south from Test Point 5 Area III on June 8, 2010 (approximately the same location as the photos in Figure 68)

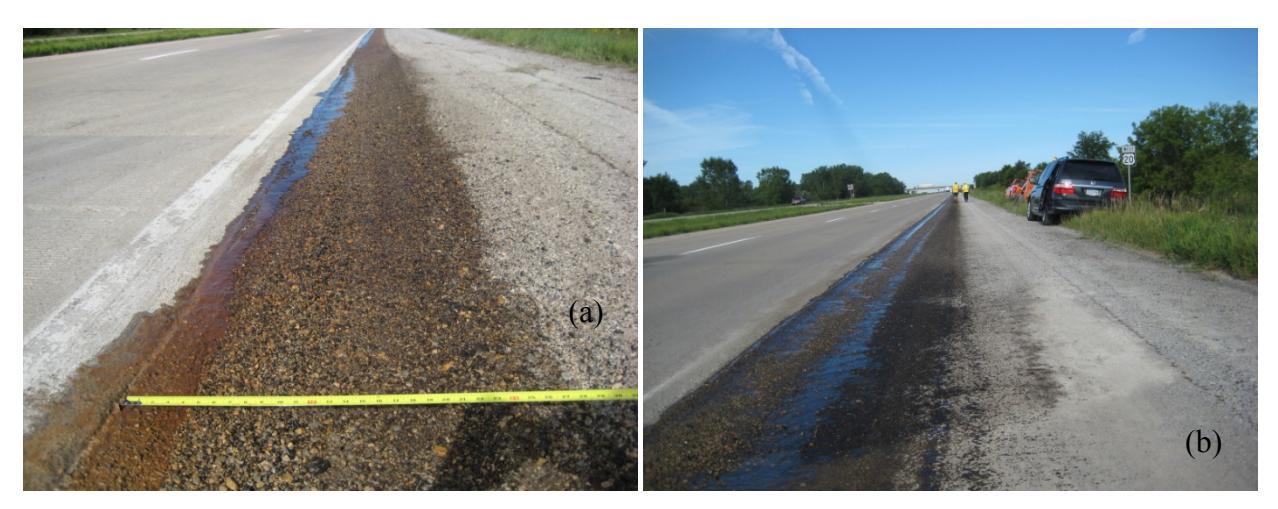
The grain size distribution for the granular shoulder material at Section I is shown in Figure 75. The stabilizing agent was topically applied to the section. DUSTLOCK was initially sprayed with one tip of the distributor, creating a strip that was 137 ft (41.8 m) long and 2 ft (0.6 m) wide. Two tips were used for the remainder of the test sections providing an average strip width of 4 ft (1.2 m) of DUSTLOCK (See Figure 76).

Figure 76. Topical application of DUSTLOCK: a) 2 ft (0.6 m) strip (sprayed with one tip) and b) 4 ft (1.2 m) strip (sprayed with two tips) August 18, 2009

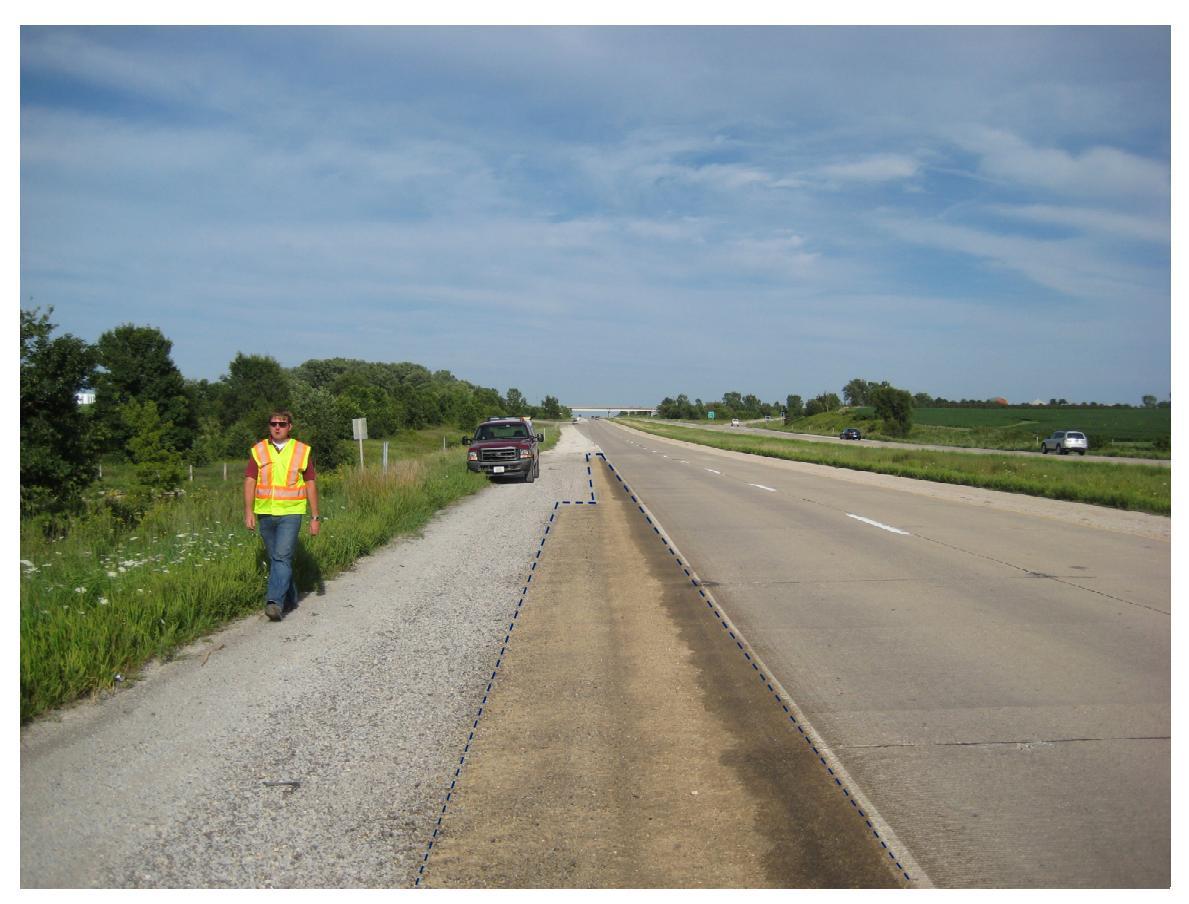
The shoulder surface was covered with sand provided by three passes of a dump truck with a sand spinner. The surface was then allowed to set for 15 minutes before being compacted by the roller. The construction period for this section, began at 9:34 a.m. and ended at 10:32 a.m., accounting for 58 minutes. The finished surface of the section is shown in Figure 77.

Figure 77. Section I after construction August 18, 2009

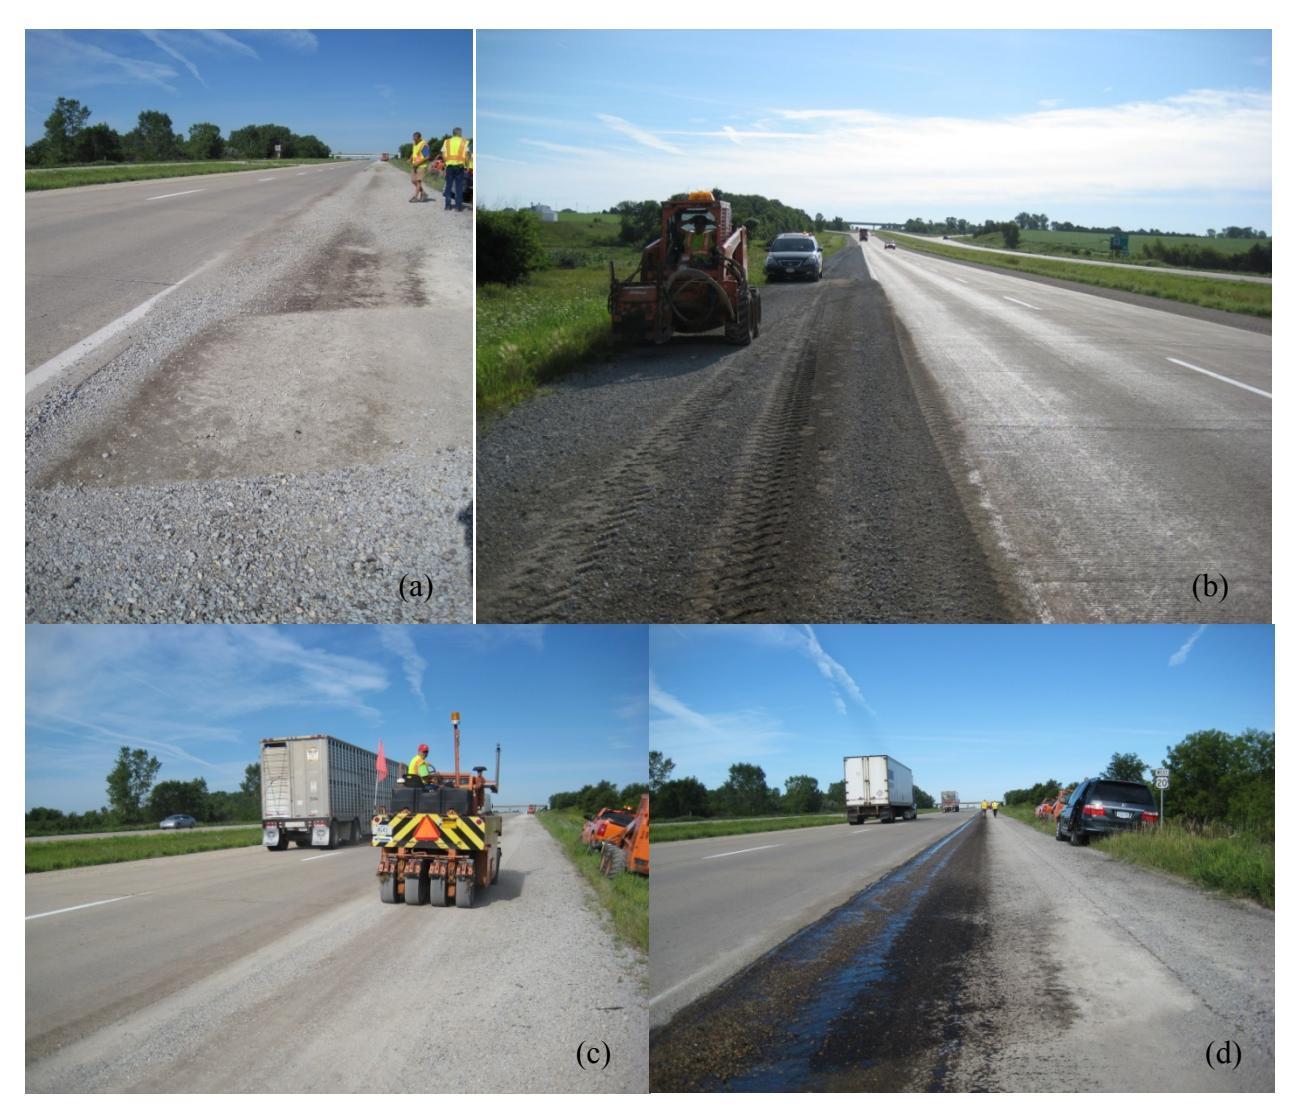
The grain size distribution for the granular shoulder materials at Test Section II is shown in Figure 78. The deepest edge rutting mostly occurred in this section. The shoulder surface was heavily graded by a motor grader on August 18, 2009. Loose aggregate was leveled to fill the edge rut along the pavement edge. This filled layer was from 1/2 to 1 in. (1.2 to 2.5 cm) thick, resulting in a surface that appeared to the researchers to be equivalent to a scarified surface. The loose surface was compacted with a pneumatic roller and then DUSTLOCK was topically applied (See Figure 79). Three passes of sand was broadcast on the surface. The roller was then used to compact the section.

Figure 79. Section II: a) grading, b) filling and leveling, c) compaction, and d) application of DUSTLOCK August 18, 2009

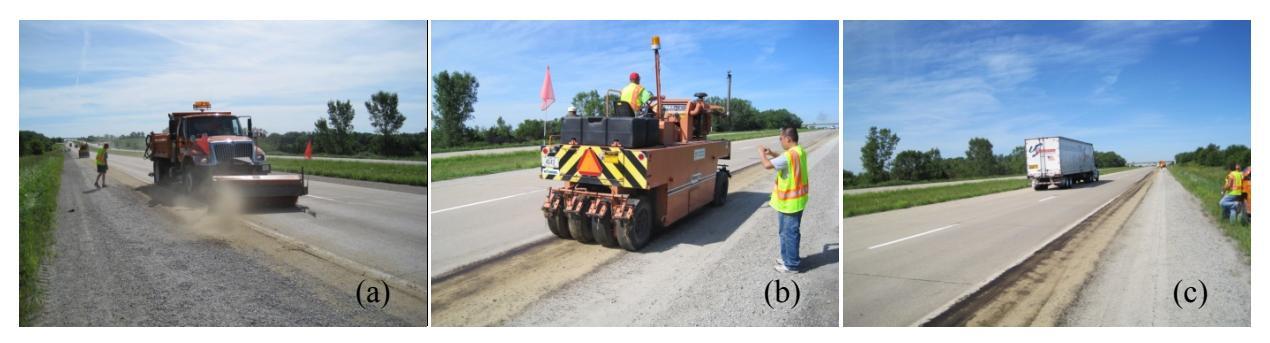
The construction duration of the section was 1 hour 20 minutes, from 9:18 a.m. to 10:38 a.m. The completed section is shown in Figure 80 (c).

Figure 80. Section II: a) pavement cleaning, b) compaction, and c) finished surface August 18, 2009

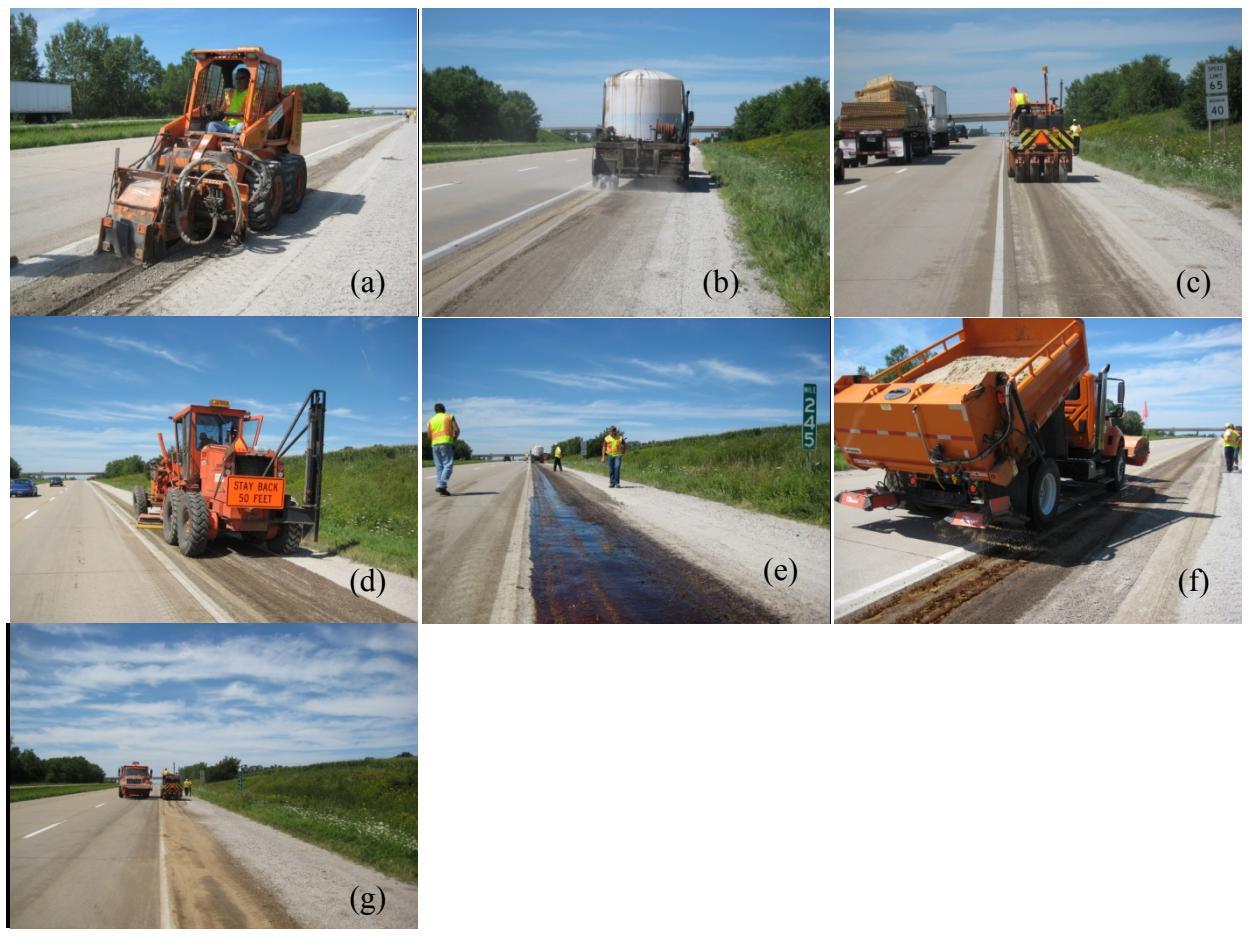
A skid steer mounted milling head was used to scarify the hardpan surface, creating a scarified strip of 4 ft (1.2 m) width and $\frac{1}{2}$ in. (1.2 cm) depth. Three passes of overlapping scarification were required to provide the 4 ft (1.2 m) test section width. The scarified layer was then sprayed with water and compacted with six passes of the pneumatic roller. The motor grader was then struck off the compacted shoulder surface, providing a surface with a constant cross slope. DUSTLOCK was then topically applied to the shoulder surface before the application of five passes of sand from the sand spinner of a dump truck. The DUSTLOCK and sand were allowed to set for 15 minutes before they were compacted by the pneumatic roller (See Figure 83). Section III was constructed from 10:44 a.m. to 1:04 p.m. for a duration of 2 hours 22 minutes.

Figure 83. Section III: a) shoulder scarification, b) moisturizing, c) roller compaction, d) surface grading, e) DUSTLOCK application, f) sand spraying, and g) roller compaction August 18, 2009

Although the construction process included surface grading after the initial compaction, the shoulder surface after construction did not have a cross slope that was as constant as desired. The moist aggregate materials that were bound with the high-viscosity binder (DUSTLOCK) and the rubber wheels of the roller might have interacted to create an uneven surface. The shoulder surface along the pavement edge was still slightly lower than the surrounding area.

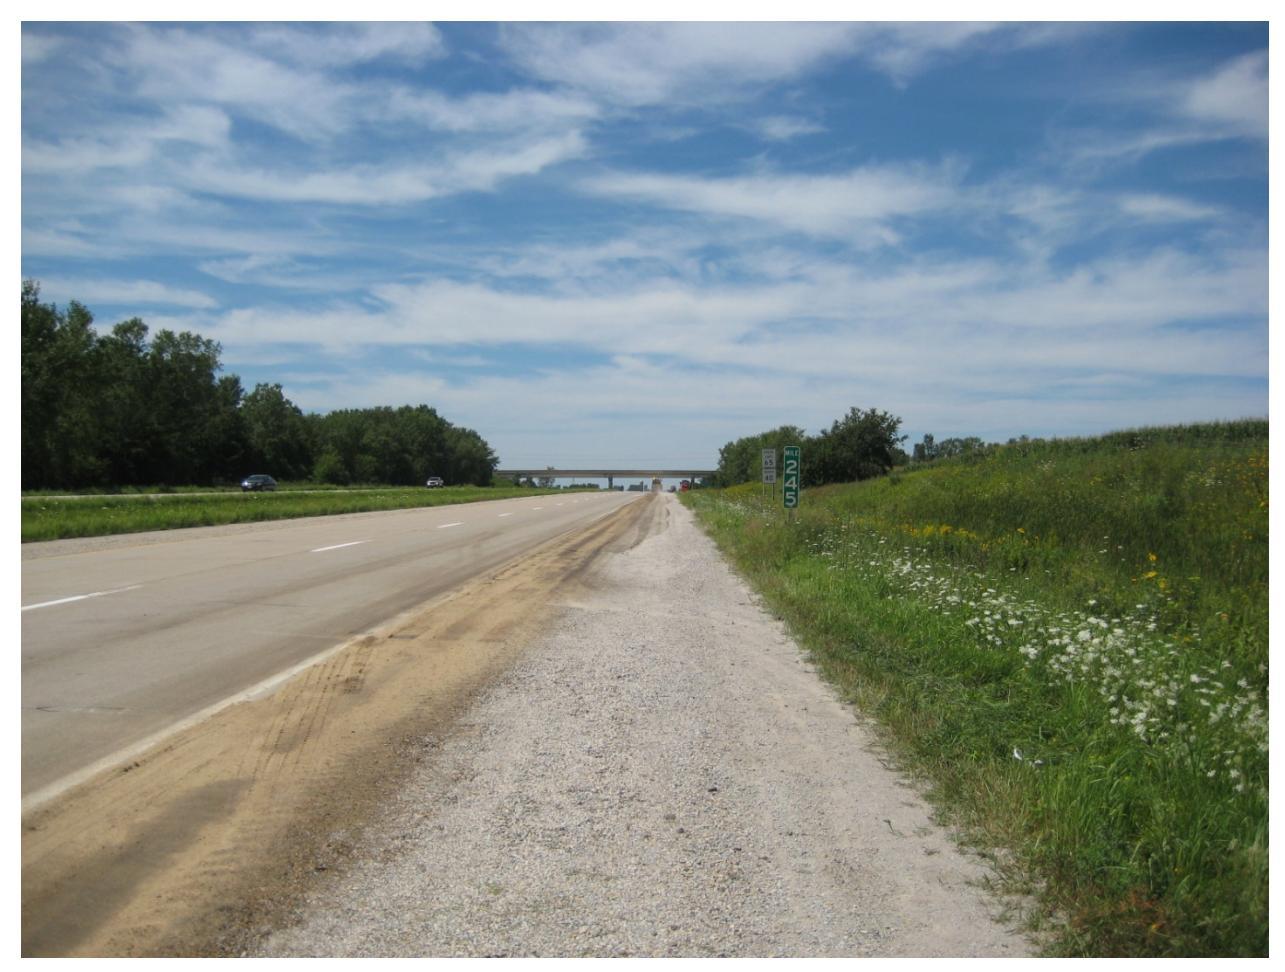
The original shoulder surface of Test Section IV was struck off to a constant cross slope with a motor grader, resulting in a pavement drop-off depth of 1.2 in. (3.0 cm) and a cross slope of 3% toward the ditch. Water and DUSTLOCK were then topically applied to the shoulder surface. Six passes of sand from the dump truck spinner were applied to the shoulder surface. The finished surface of the section is shown in Figure 84.

Figure 84. Stabilized shoulder surface of Sections II to IV (a) August 18, 2009

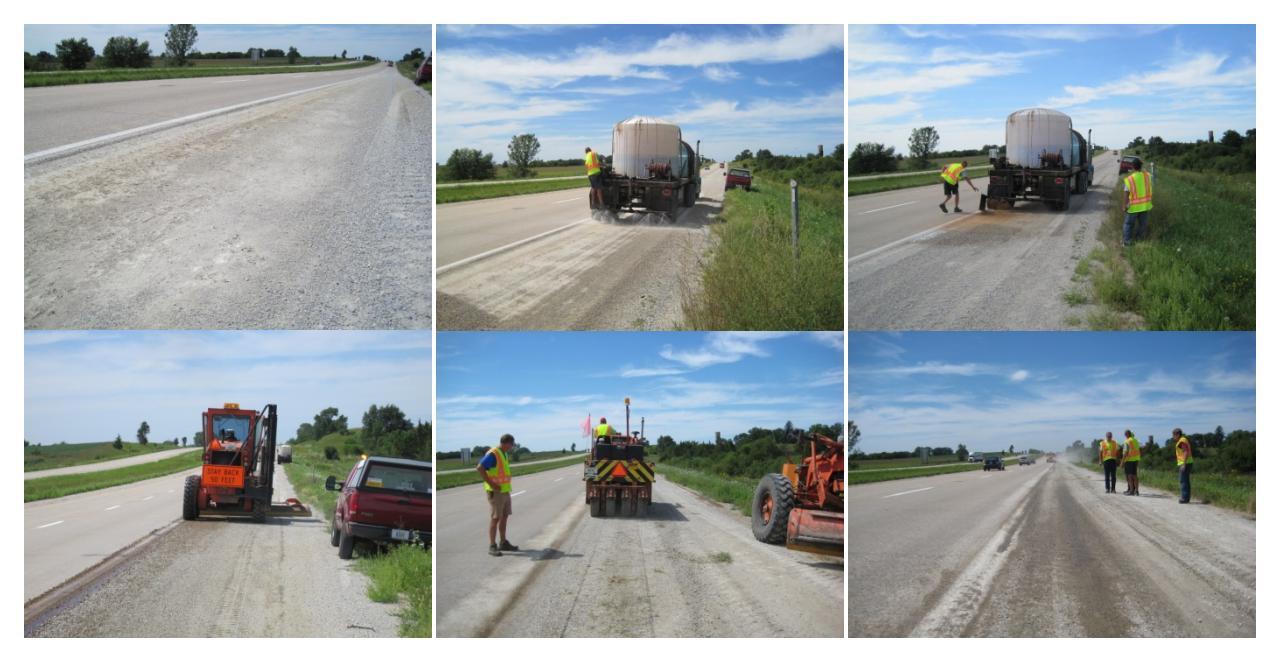
Test Section V was located at the bottom of a sag from milepost 244.45 to 244.35. This area was considered to be problematic to the maintenance crews. Aggregate shoulder for this section was struck off to a 3% cross slope by the motor grader. The struck surface was sprayed with water and then DUSTLOCK. To eliminate the use of sand, the struck-off aggregate materials were cast back by the motor grader to cover the DUSTLOCK. The test section was then compacted by six passes of the pneumatic roller (See Figure 60).

Figure 85. Construction process of Section V August 18, 2009

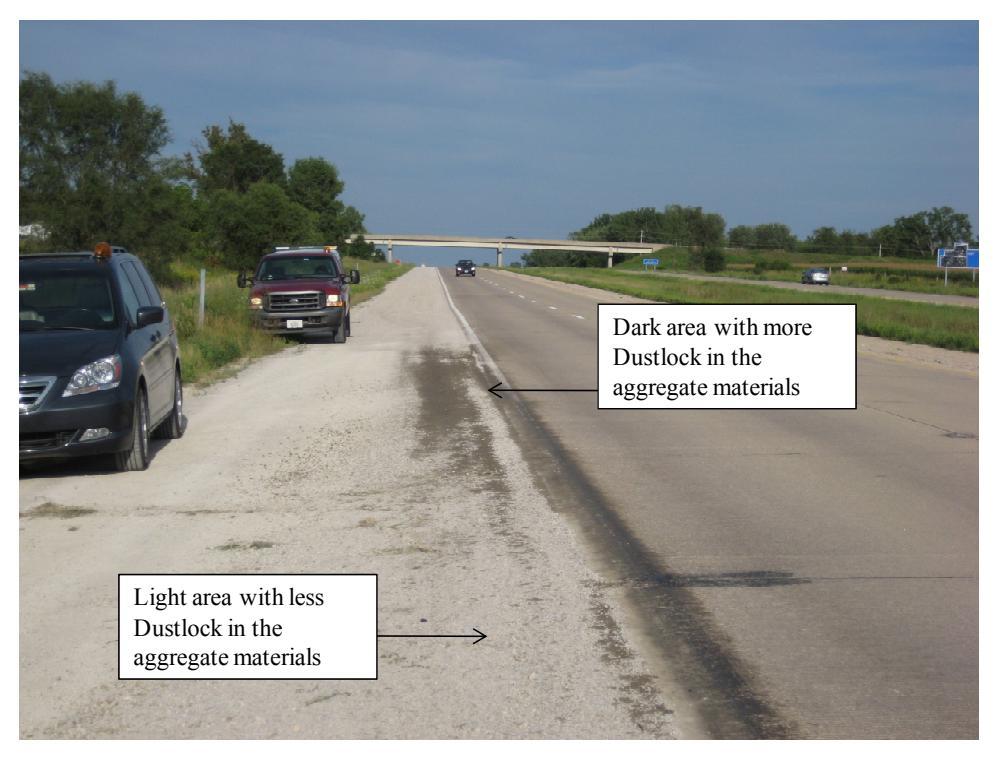
Redistribution of aggregate materials using the road grader reduced construction time and eliminated the use of sand. However, when the aggregate was cast back on top of the DUSTLOCK, the DUSTLOCK was rolled out of its original position. When the material was struck back away from the pavement, some of the mixture was unintentionally cast toward the ditch (See Figure 86). Nevertheless, this test section was constructed in a short period of time. The construction duration was only 34 minutes, starting at 1:15 p.m. and ending at 1:49 p.m..

Figure 86. Uneven mixed of DUSTLOCK due to grading process in Section V August 18, 2009

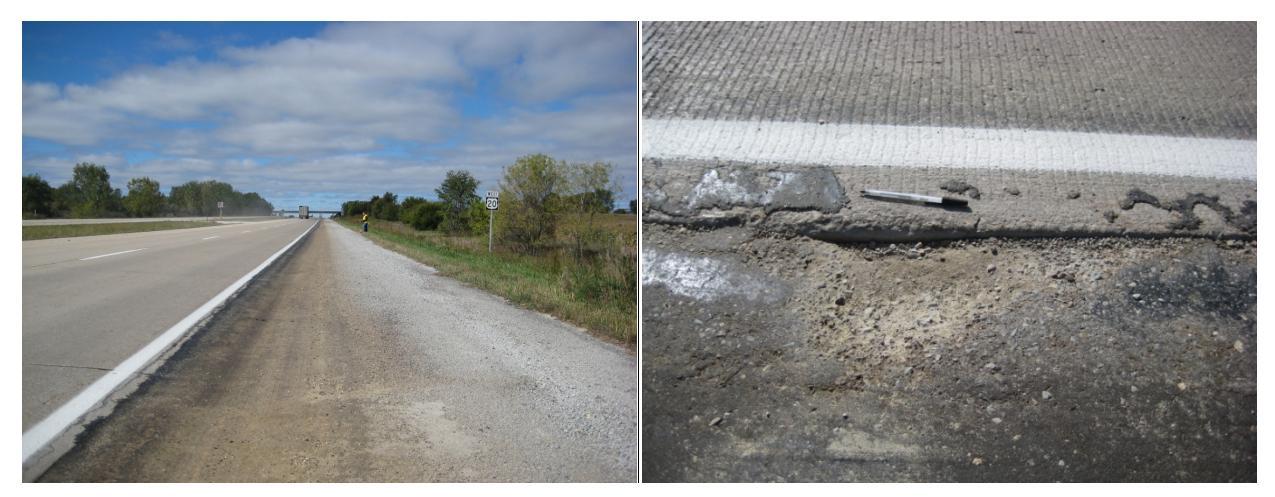
A field investigation was performed September 29, 2009 where elevation profiles were taken and Clegg impact hammer tests were conducted. The shoulder elevations were generally lower than those measured August 18, 2009. The surface of the stabilized shoulder was generally intact; however, it was damaged in places (See Figure 87).

Figure 87. Stabilized shoulder using DUSTLOCK on US 20 westbound September 29, 2009
